APPENDIX C

CCTV Reports

Project Name:		Town of Westwood MA WE 4-9-21						
US MH	DS MH	Pipe ID	Date	Street	Material	Size	Total	Insp
08-126	08-126A	08-126_08-126A	4/8/2021	Washington Street	Asbestos Cement	6	39	39
08-127	08-127A	08-127_08-127A	4/8/2021	Washington Street	Asbestos Cement	6	36	36
08-128	08-128A	08-128_08-128A	4/8/2021	Washington Street	Asbestos Cement	6	40	40
08-129	08-129A	08-129_08-129A	4/8/2021	Washington Street	Asbestos Cement	6	40	40

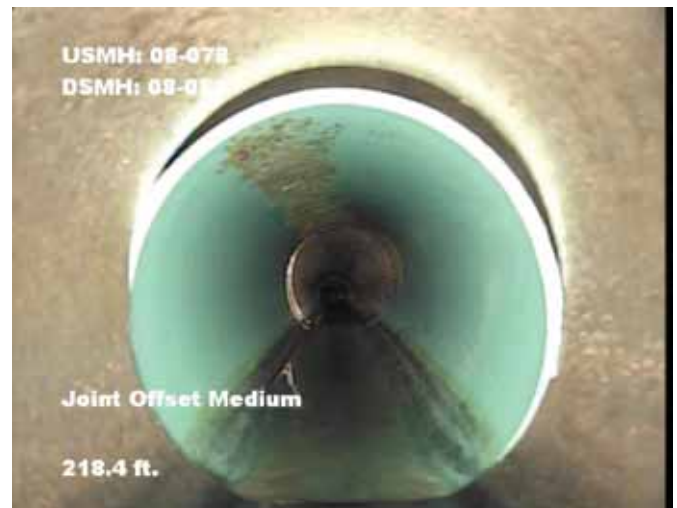
Distance: 218.4 ft. Grade: 3
Condition: Joint Offset Medium
Remarks: N/A

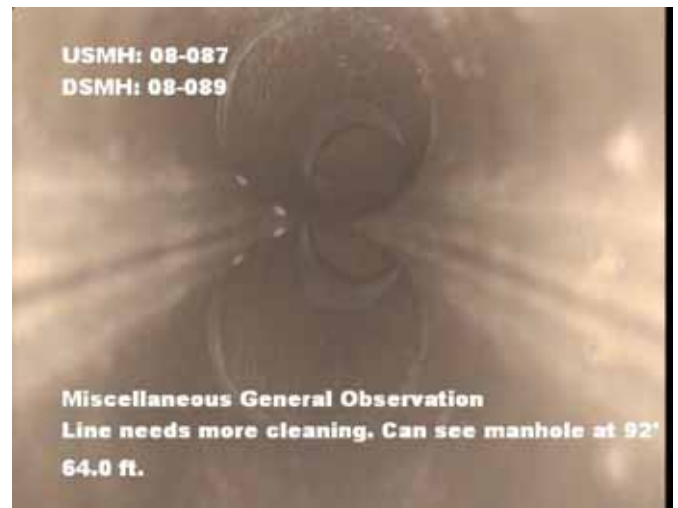
Distance: 64.0 ft. Grade: 0
Condition: Miscellaneous General Observation
Remarks: Line needs more cleaning. Can see manhole at 92'

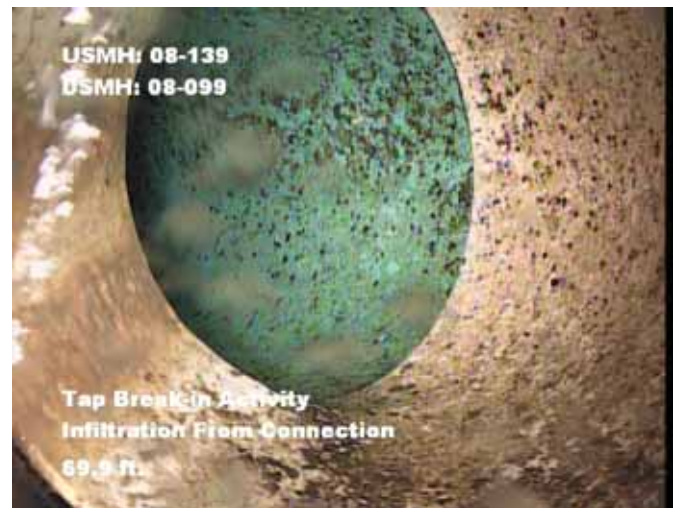
Distance: 68.3 ft. Grade: 4
Condition: Infiltration Runner Lateral
Remarks: N/A

Distance: 69.9 ft. Grade: 0
Condition: Tap Break-in Activity
Remarks: Infiltration From Connection

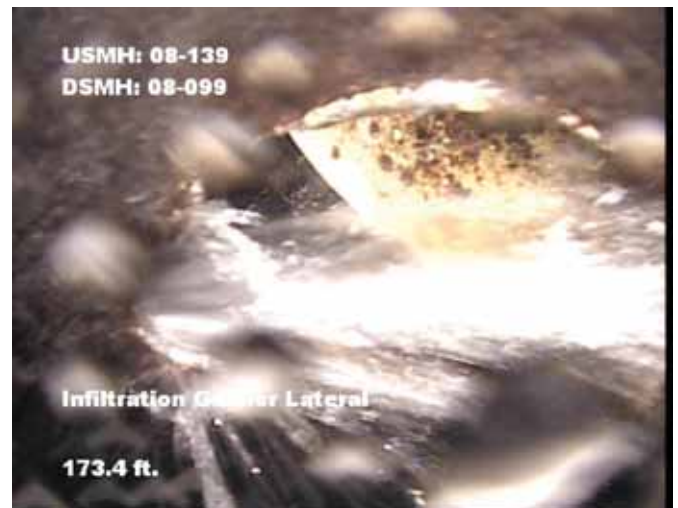
Distance: 173.4 ft. Grade: 5
Condition: Infiltration Gusher Lateral
Remarks: N/A

Distance: 173.9 ft. Grade: 0
Condition: Tap Break-in Activity
Remarks: Infiltratoin from service connection

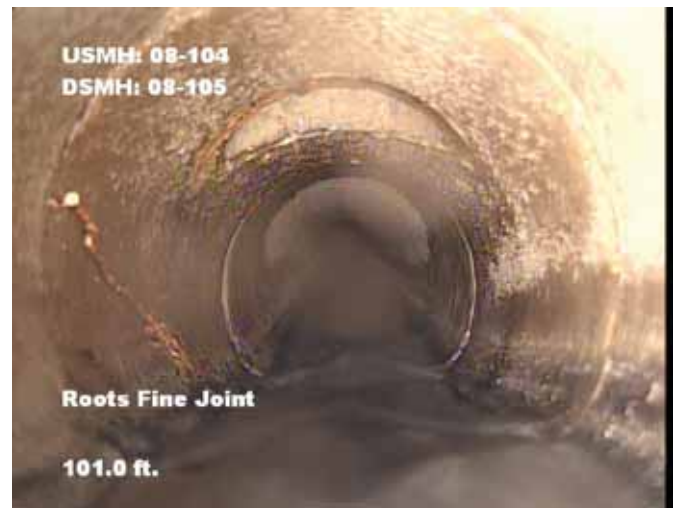
Distance: 101.0 ft. Grade: 1
Condition: Roots Fine Joint
Remarks: N/A
