APPENDIX D

Manhole Inspection Reports

Westwood Manhole Inspections

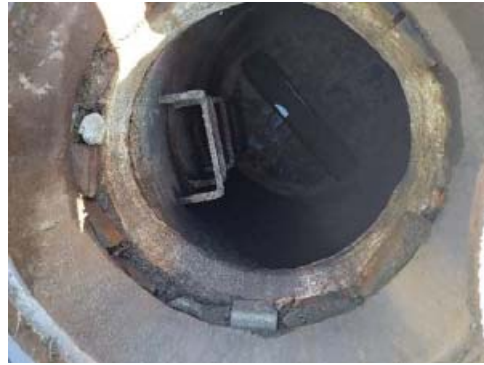
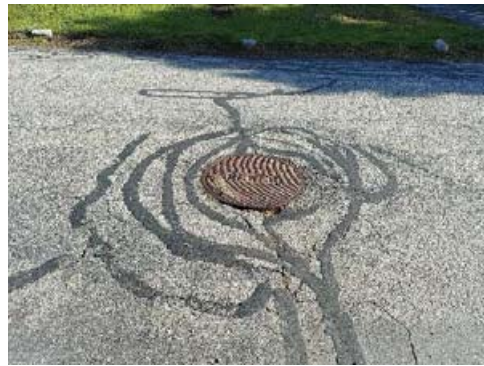
06-091 Photos

Defects	Depth	Clock Position	Comments
Missing Brick		12-12

Pavement cracking around cover

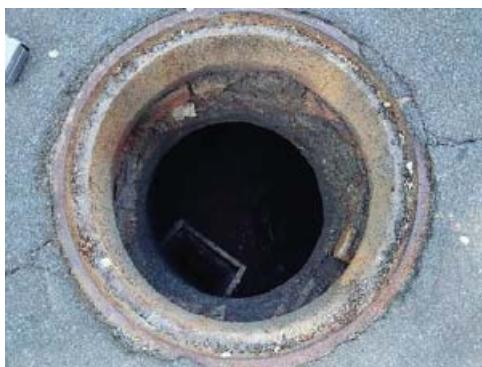
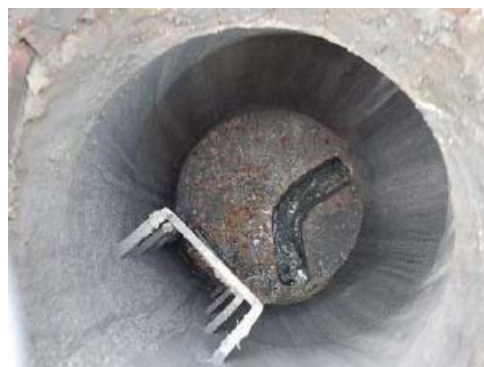
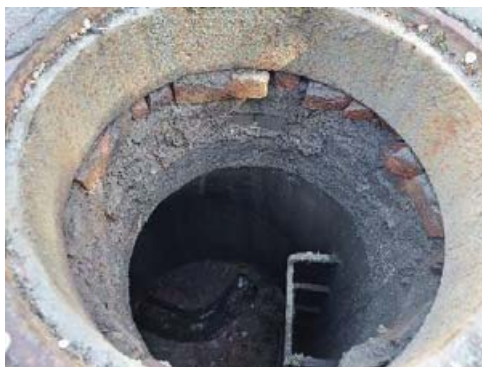
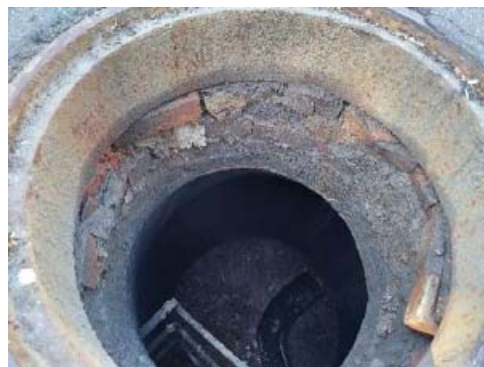
06-095 Photos

Defects	Depth	Clock Position	Comments
Missing Brick		12-12	Chimney
Construction Debris	90"	6-12	On bench
Solids in Channel	94.5"	5-7

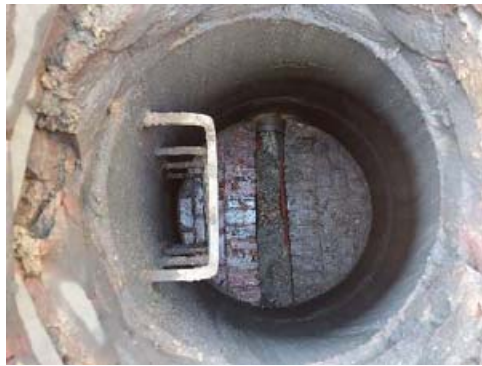
08-047 Photos

Defects	Depth	Clock Position	Comments
Missing Mortar	8"-26.5"	12-12	
Displaced Brick	8"-26.5"	12-12

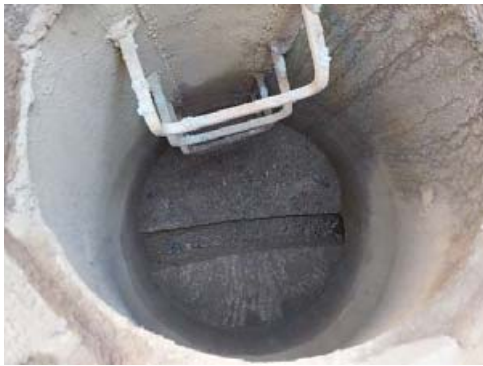
08-050 Photos

Defects	Depth	Clock Position	Comments
Missing Mortar	8.5"-12"	6-12	Small
Infiltration Stain	29"	5-7

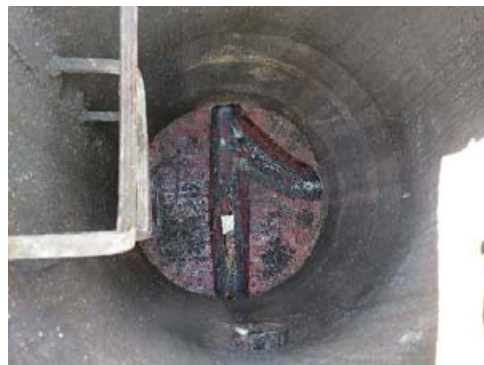
08-048 Photos

Defects	Depth	Clock Position	Comments
Missing Mortar	8"-16"	12-12	
Displaced Brick	8"-16"	12-12

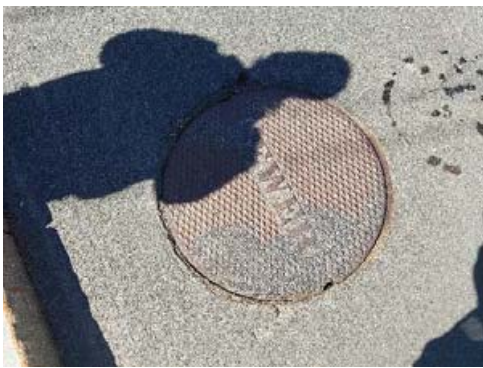
08-086 Photos

Defects	Depth	Clock Position	Comments
Concrete Debris	95"	2-5

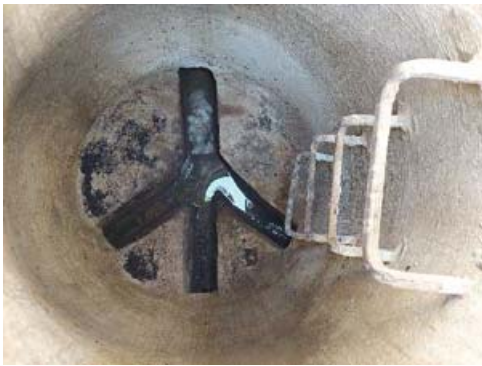
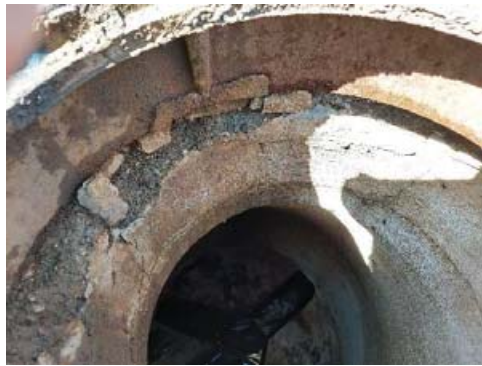
Defects	Depth	Clock Position	Comments
Minor Cracks	8"-20"	12-12	Circumferential
Infiltration Stain	8"-20"	12-12	
Missing Mortar	8"-20"

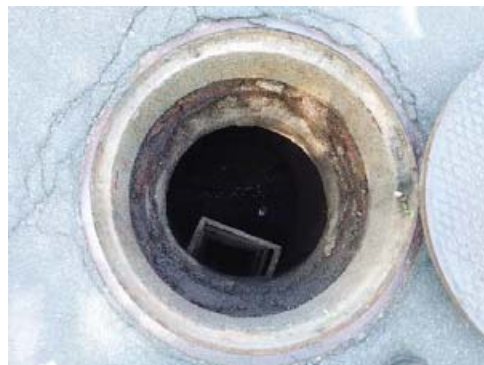
Defects	Depth	Clock Position	Comments
Infiltration Stain	73"	10, 11	
Missing Mortar		12-12

Brick in invert - removed by DPW

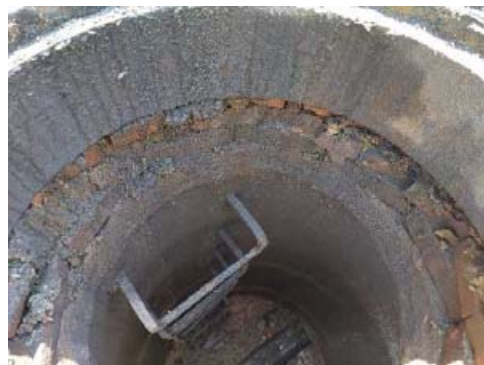
08-091 Photos

Defects	Depth	Clock Position	Comments
Missing Mortar	8.5"-15"	12-12	Chimney
Displaced Brick	8.5"-15"	12-12	Chimney
Infiltration Stain	15"	12-12	Chimney

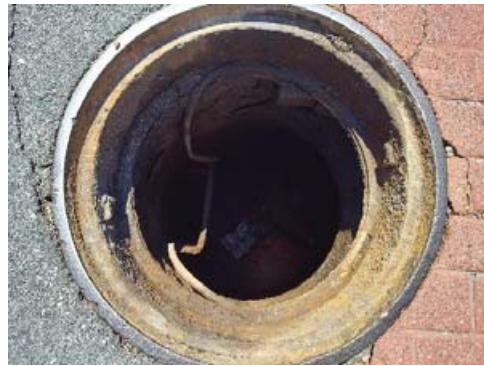
08-101 Photos

Defects	Depth	Clock Position	Comments
Infiltration Runner	109"	7-8	On bench
Cut Gasket

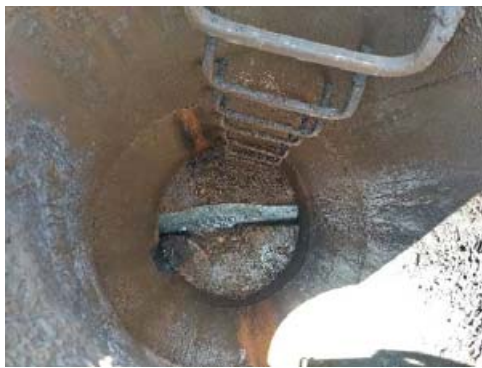
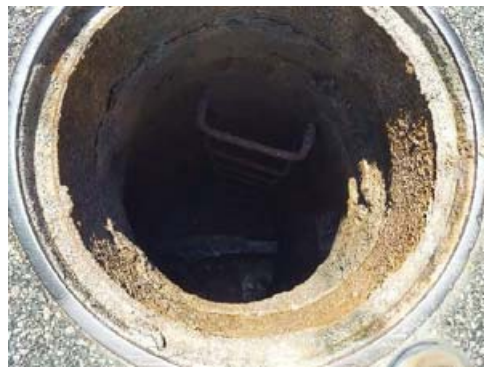
08-099 Photos

Defects	Depth	Clock Position	Comments
Missing Brick	119"	2-4	On bench
Infiltration Stain	64"	2, 8

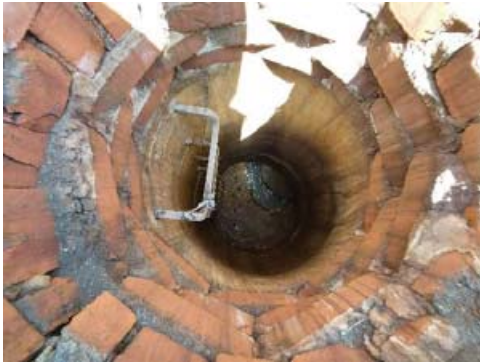
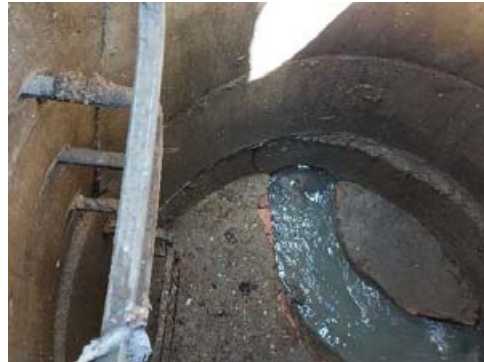
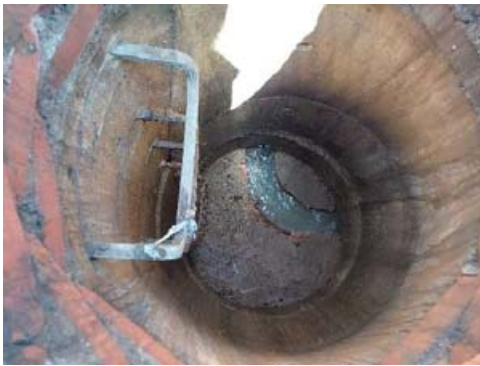
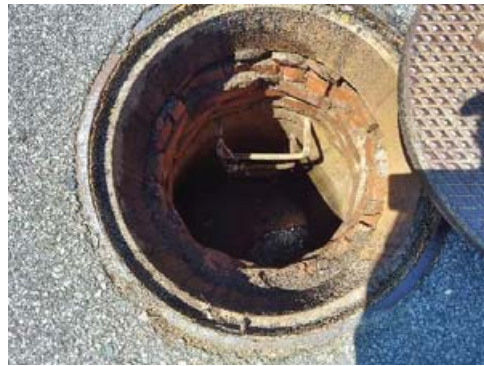
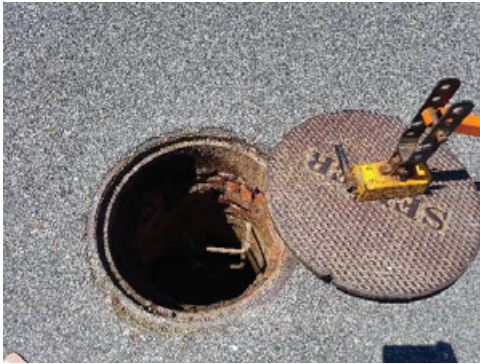
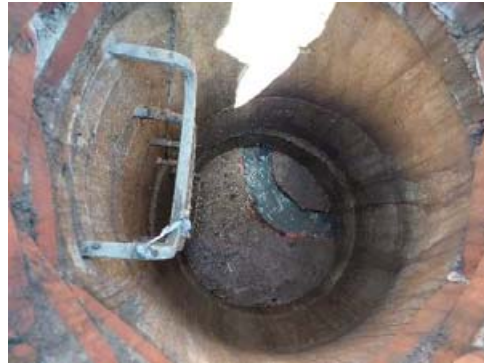
08-103 Photos

Defects	Depth	Clock Position	Comments
Infiltration Strain	27"	7-8	
Infiltration Dripper	95"	2:30

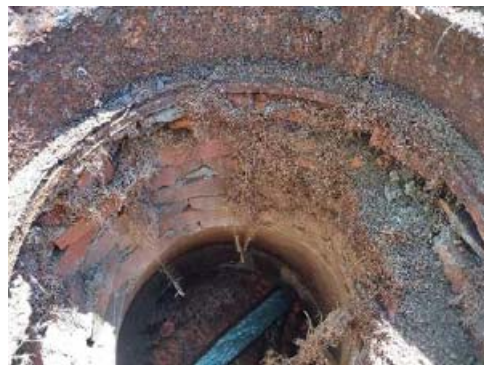
08-105 Photos

Defects	Depth	Clock Position	Comments
Missing Mortar	8"-12"	12-12	
Displaced Brick	8"-12"		
Medium Roots	12"	12-12

Buried 4" under soil near end of fence post

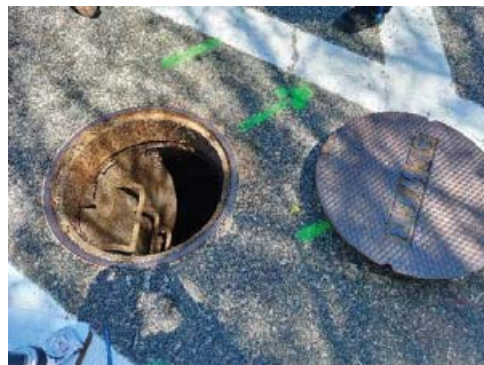
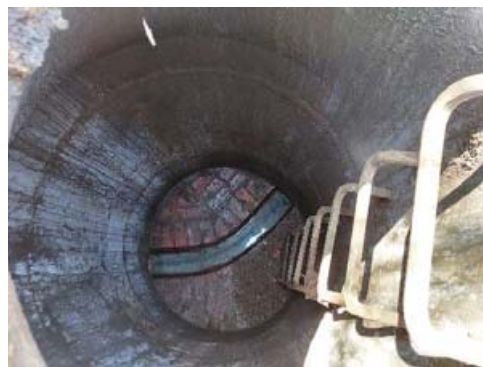
08-120 Photos

Defects	Depth	Clock Position	Comments
Displaced Brick	8"-10"	12-12	
Missing Mortar	8"-10"	12-12	
Infiltration Stain	10"	12-12

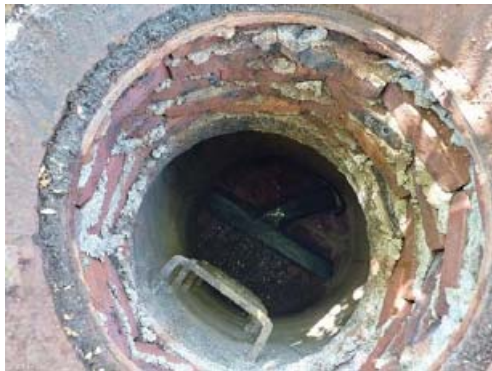
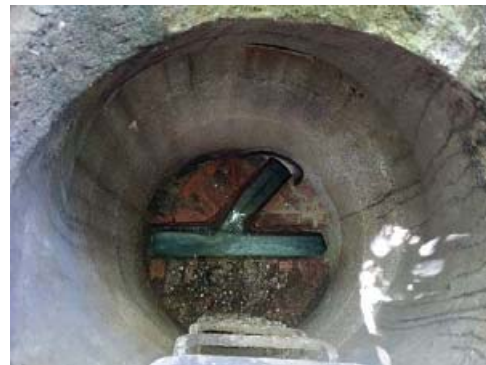
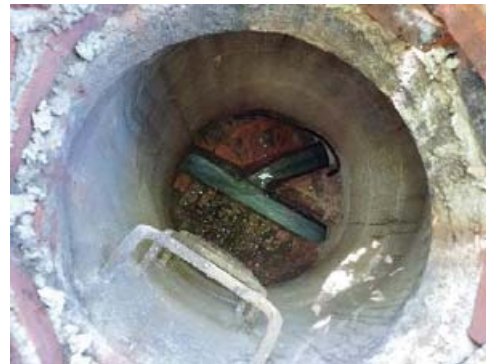
Defects	Depth	Clock Position	Comments
Infiltration Stain	28"	12-2, 6	
Infiltration Stain	~40"	10

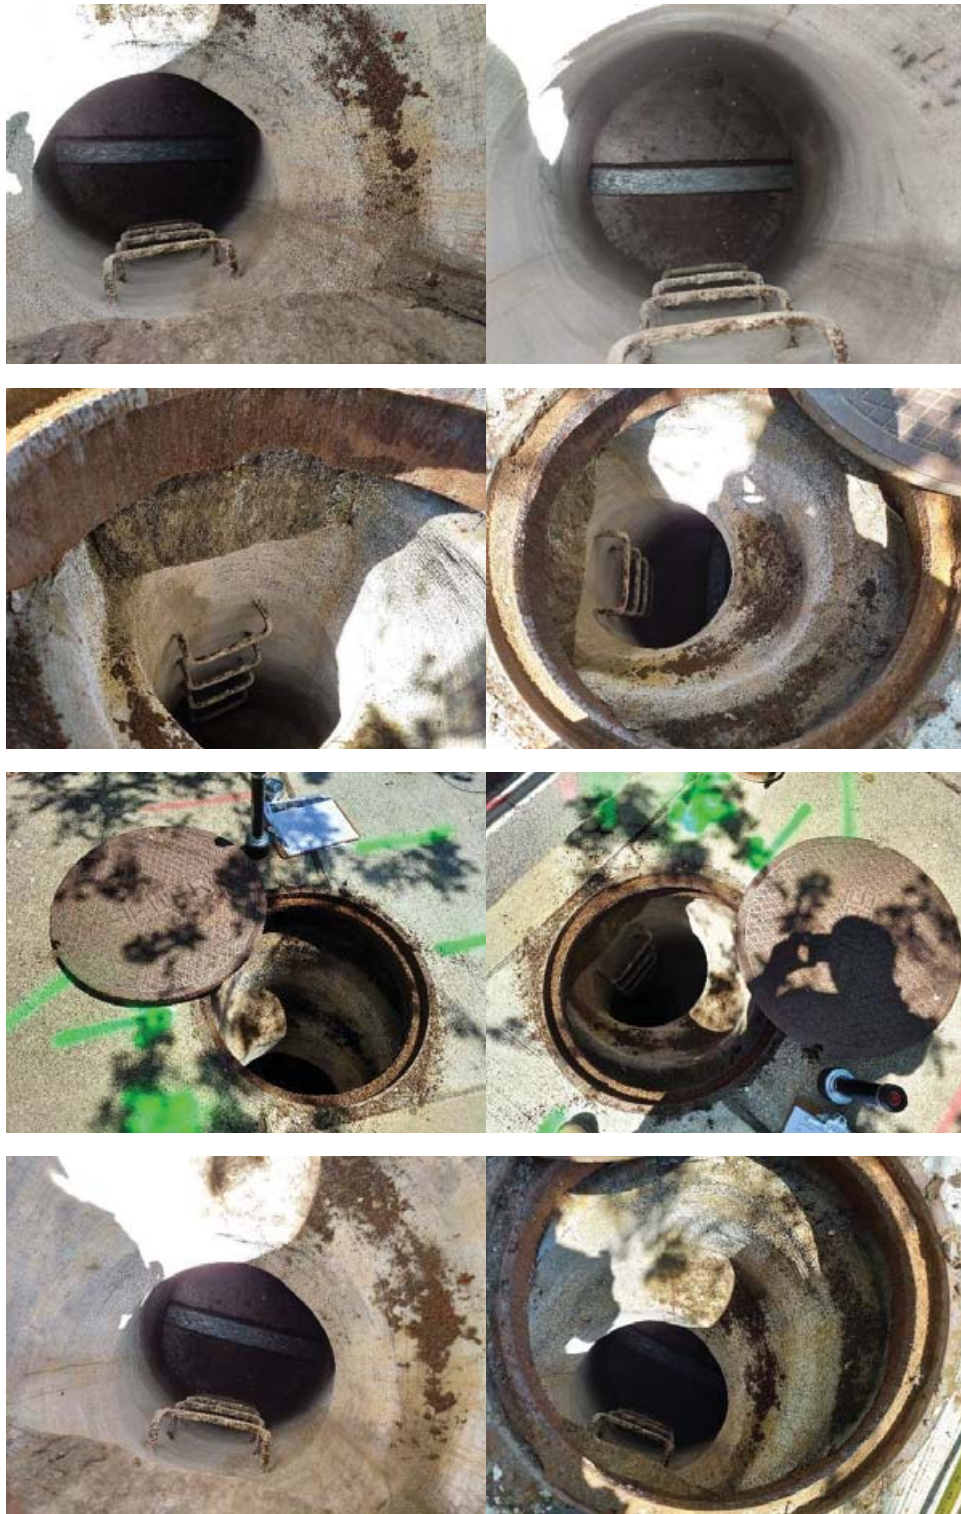
08-122 Photos

Defects	Depth	Clock Position	Comments
Offset Chimney	23"	12-6	7"
Granite in Riser

The granite in the riser is granite curbing that is built into the structure. The clearance access is approximately 24" wide, and is below the granite curb. DPW is concerned that personnel cannot fit through this constricted opening.

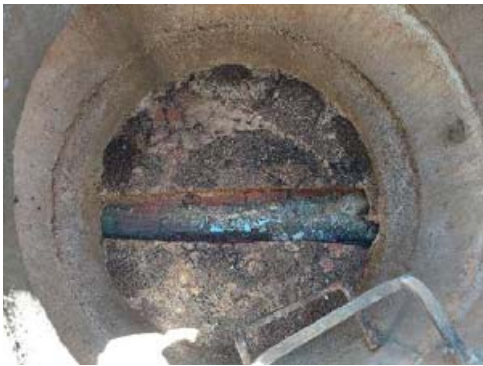
08-126 Photos

Defects	Depth	Clock Position	Comments
Cement/Debris	62"	12-12	On Bench

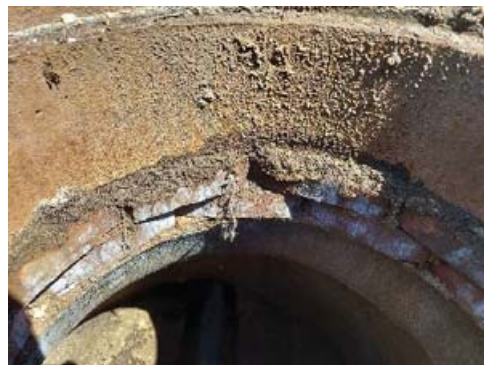
08-127 Photos

Defects	Depth	Clock Position	Comments
Roots Fine	15"	12-2	
Compacted Dirt	49"		On Bench
Roots Fine	34"	12	
Root Ball	49"	2

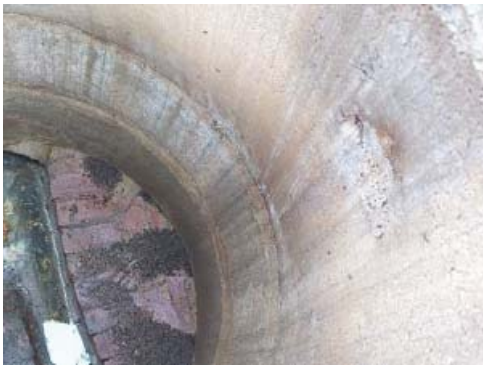
08-128 Photos

Defects	Depth	Clock Position	Comments
Missing Morrtar	8"-13"	12-12	
Displaced brick	8"-13"	12-12	
Infiltration Stain	13"	12-12	Minor
Minor Crack	56"		Joint

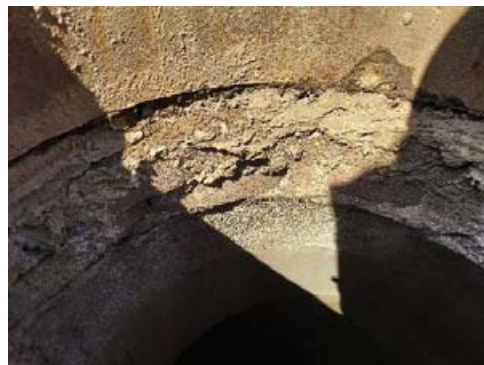
06-094 Photos

Defects	Depth	Clock Position	Comments
Missing Mortar	8"-16"	12-12	Chimney
Cracked	8"-16"	12-12	Chimney
Construction Debris	84"	12-12	Bench

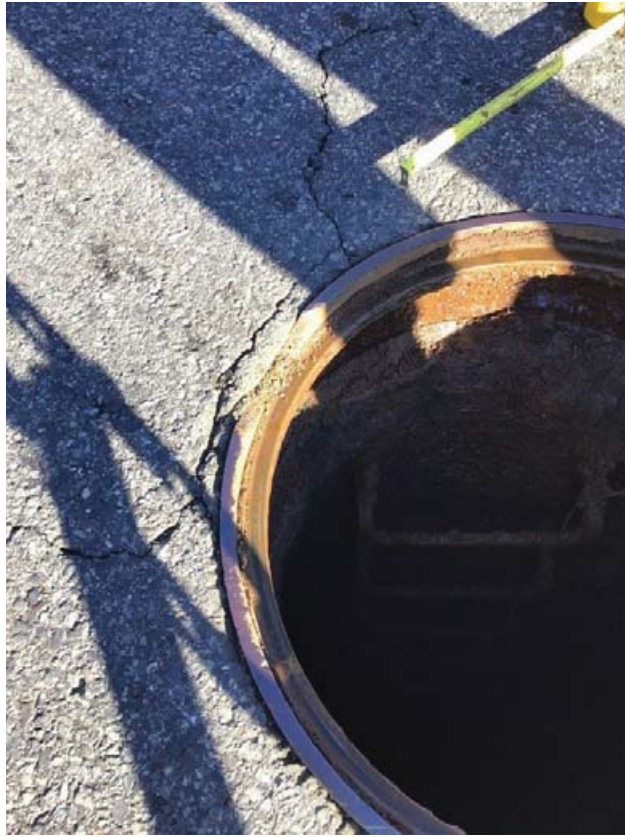
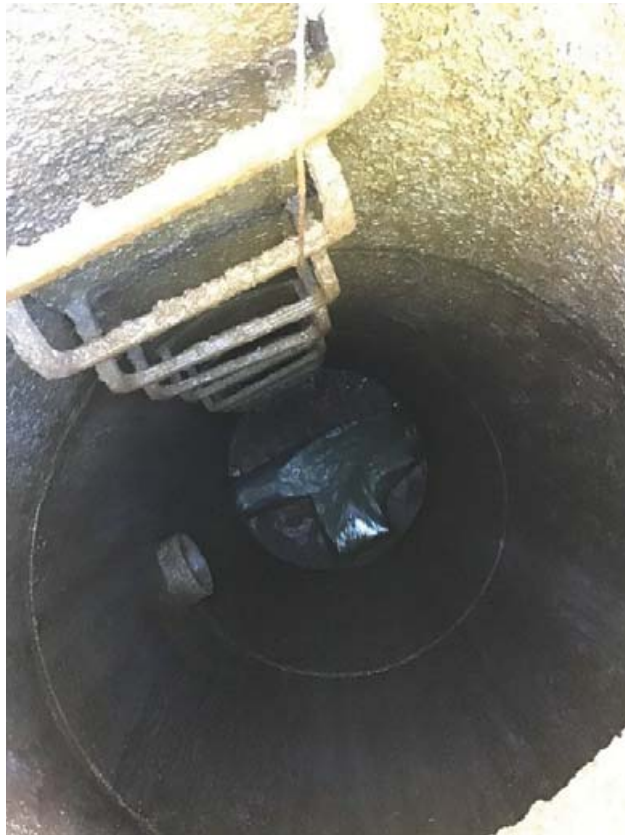
Overview Photos

Manhole ID Number	10/047
Street	GAY ST
Address	14 Thatcher St Westwood, MA 02090
Surveyor	Bill Watts
Date	2018-11-30
Time	09:15
Rim to Invert	16.5
Inner Diameter	4
Material	Concrete
Cover Condition	Sound
Frame Condition	Broken

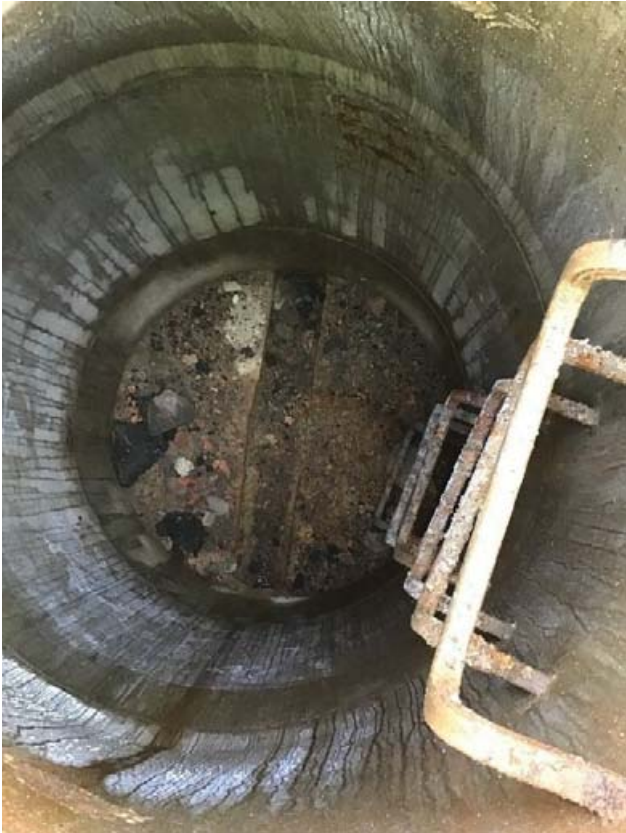
Overview Photos

Manhole ID Number	14/070
Street	FISHER ST
Address	2-22 Fisher St Westwood, MA 02090
Surveyor	Bill Watts
Date	2018-11-28
Time	09:50
Rim to Invert	9.83
Inner Diameter	4
Material	Concrete
Cover Condition	Sound
Frame Condition	Cracked
