# *Municipal* Capital Needs Assessment and Replacement Reserve Analysis

Prepared for:

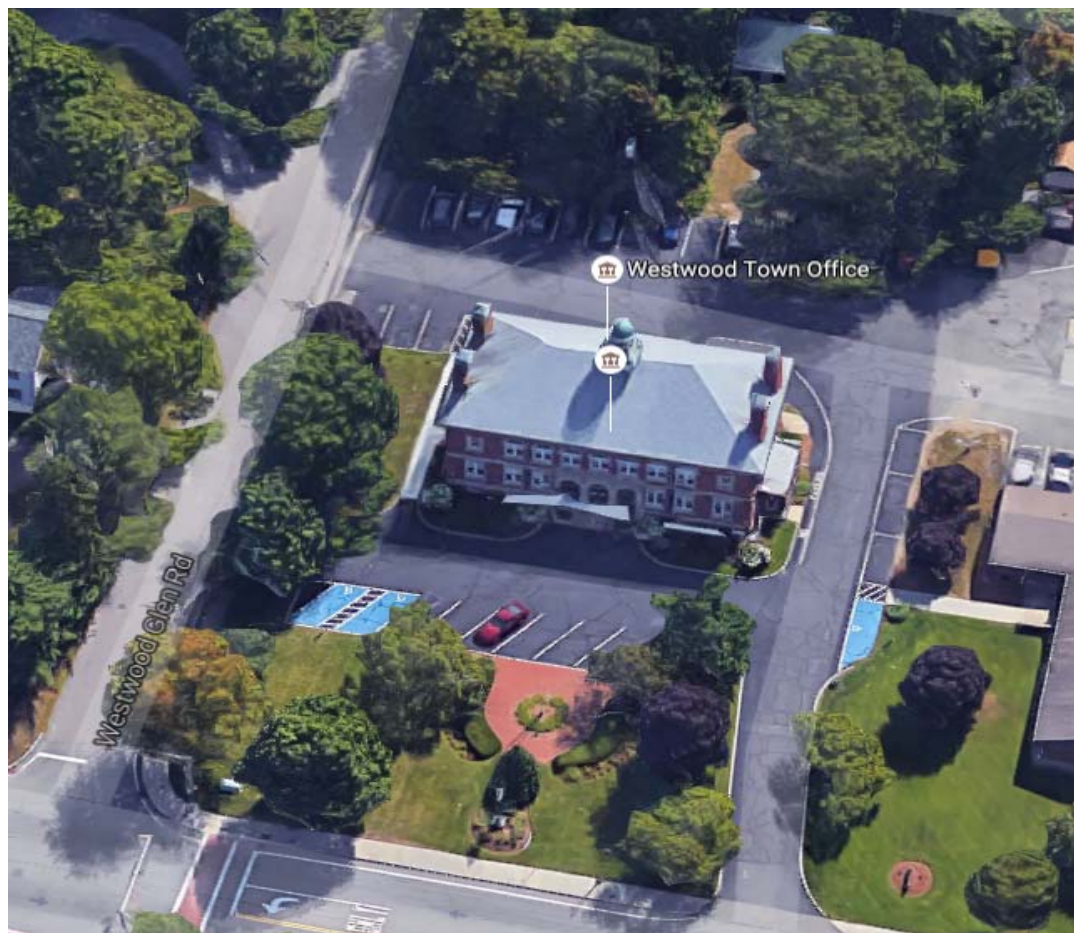
## **Property Description:**

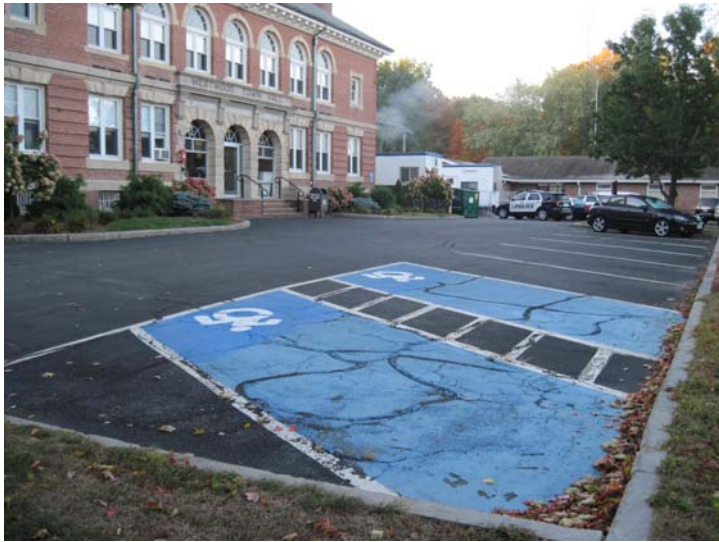
View of the aging front parking lot asphalt surface conditions. Complete resurfacing is planned for 2016.

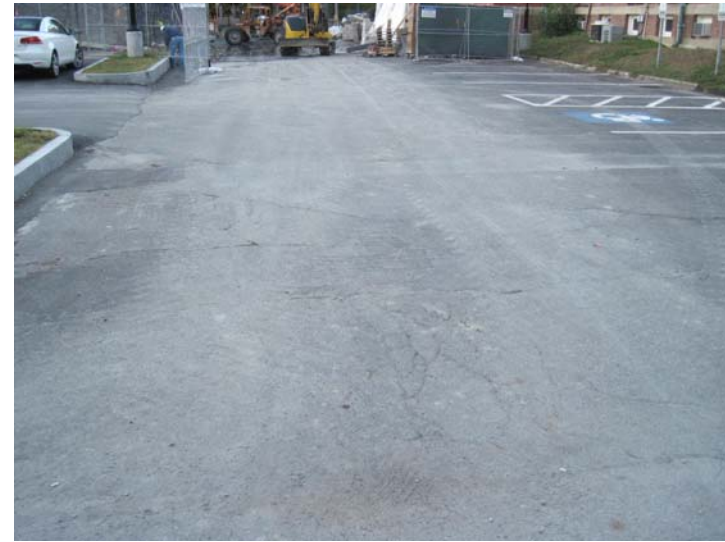
View of the rear parking lot asphalt surface conditions. Also to be resurfaced in 2016.

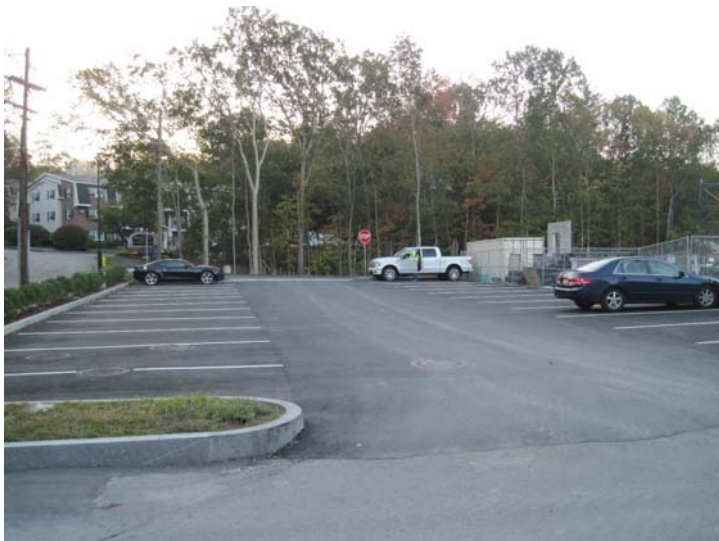
View of the new parking lot adjacent to the original rear lot. Installed in 2016.

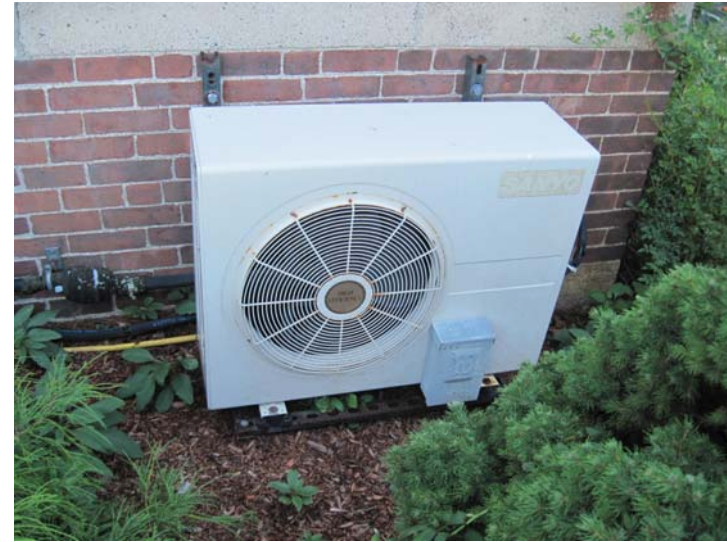
A 1.5-ton Sanyo mini-split A/C unit cools the first floor Town Clerk/Registrars Office.

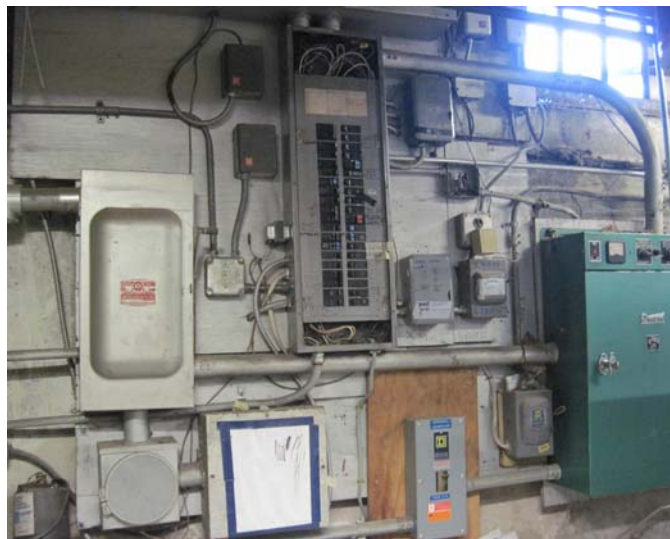
View of the aging electrical distribution equipment and wiring with open-panel electrical load center. All in need of near term modernization.

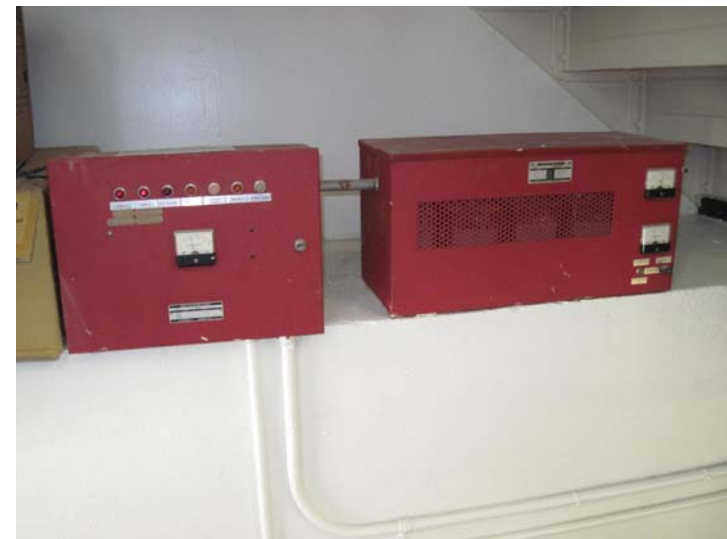
The aging zone-type fire alarm control box and outdated peripherals have far surpassed their expected useful service lives. All are in need of near term replacement.

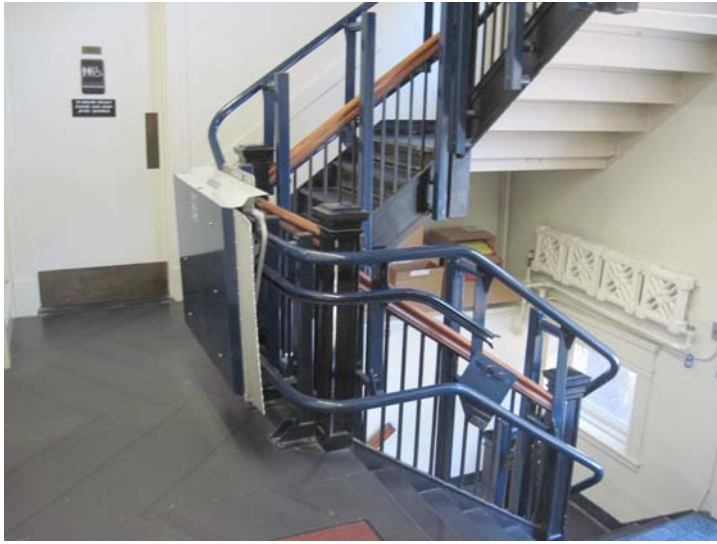
View of one of two stair rail-mounted wheelchair lifts. One provides access from the basement and entrance levels up to the first floor. The second provides access from the first floor to the second. Replacement with a new, single continuous system is planned for 2017.

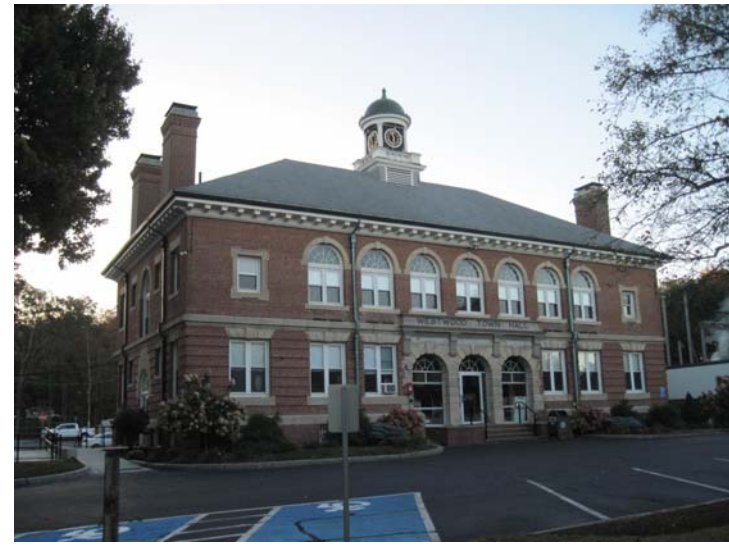
View of the building front (west) elevation with mix of face-brick; cast-stone lintels, sills, and trim elements; recently repainted wood dentil block soffits, older three-tab asphalt shingle roof, and copper-domed cupola with four-sided clock.

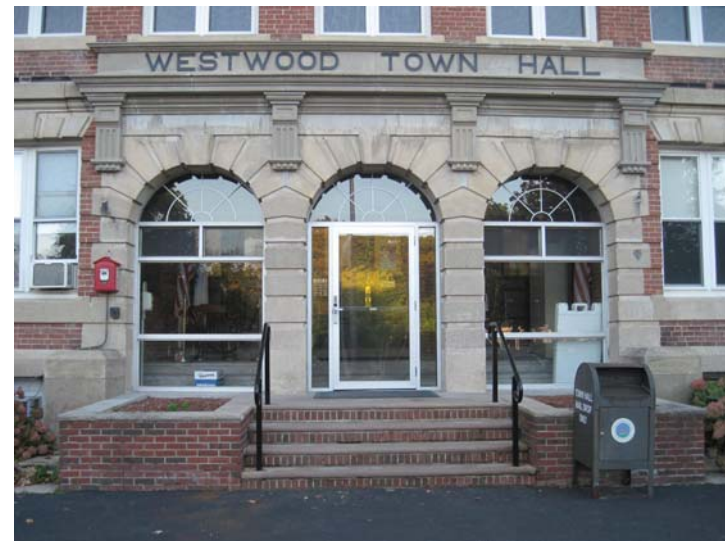
The front entrance and north elevation accessible entrance aluminum-framed glass doors were both recently replaced in 2016.

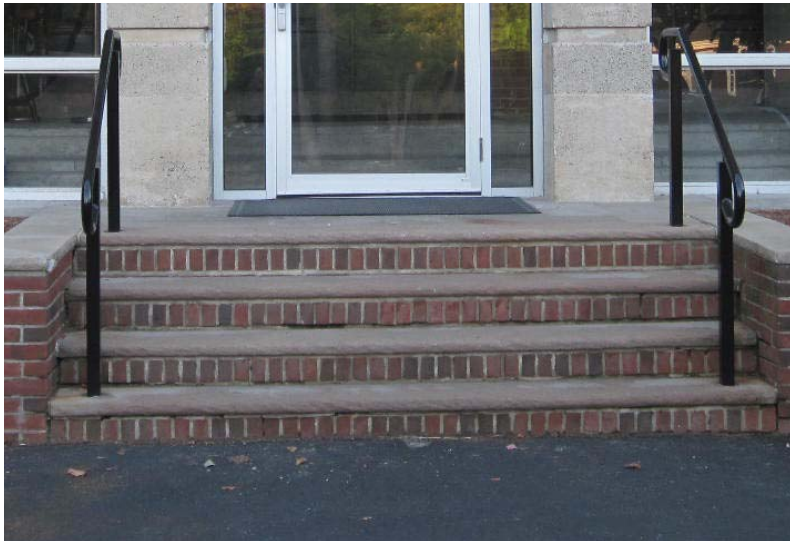
The front steps and adjacent brick planters are in need of near term repointing and brick repair/replacement.

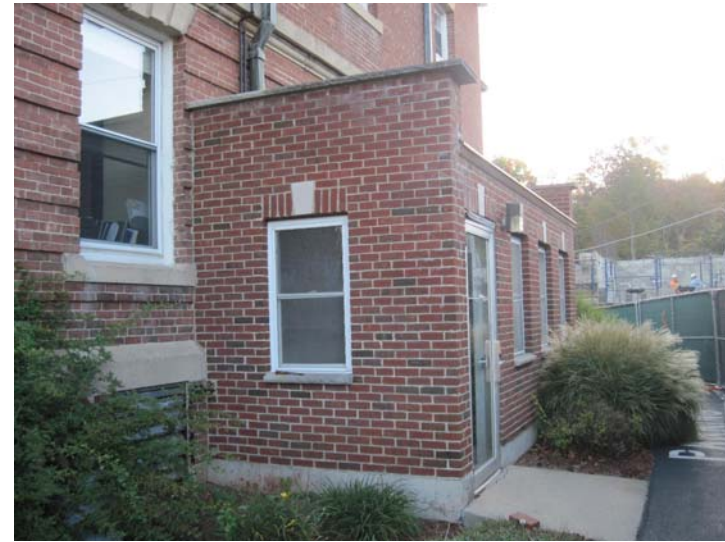
View of the south end-elevation addition, constructed at an unknown later date.

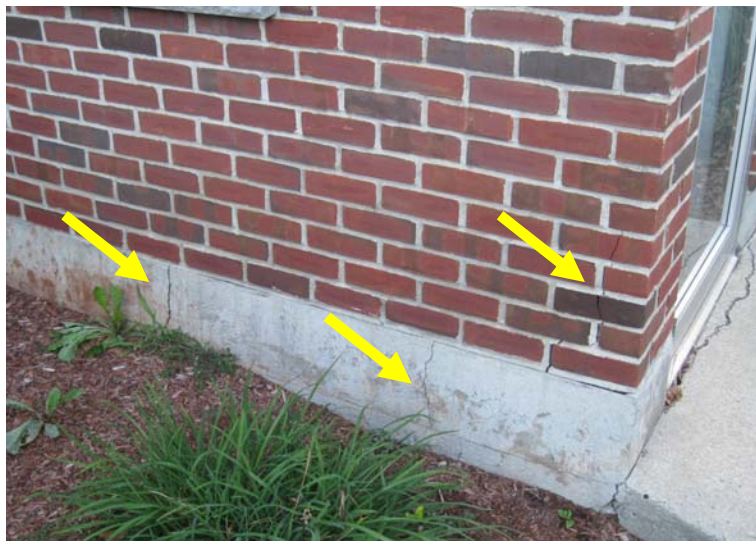
Close-up of visible cracking within the brickwork and foundation at the south elevation addition. In need of near term repair.

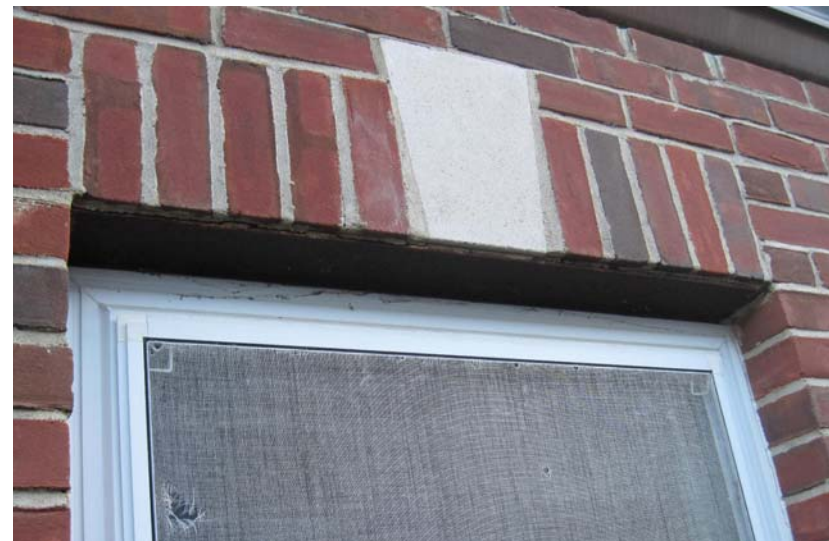
The aging corroding lintels at the five extension windows are in need of near-term replacement to avoid rust-jacking damage to the surround brick.

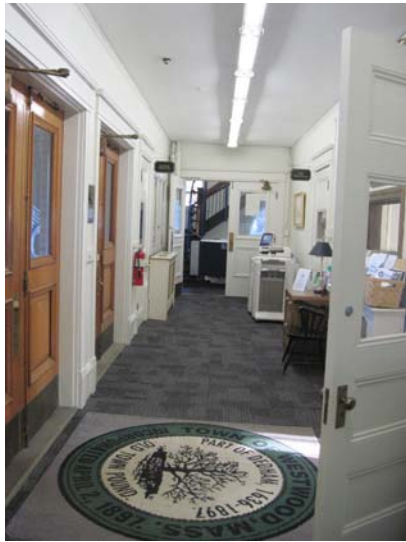
View of the front lobby with painted walls and ceilings and recently (2015) installed carpet tile flooring.

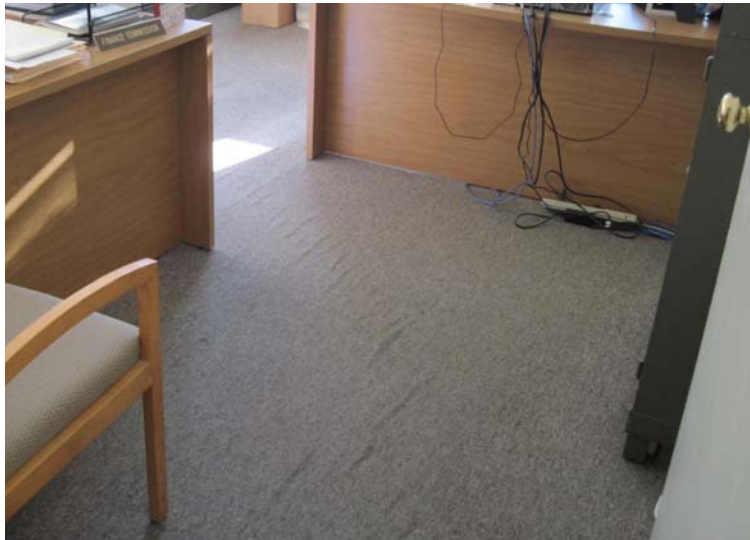
The aging, wrinkling carpet in the second floor Finance Commission office is in need of near term replacement.

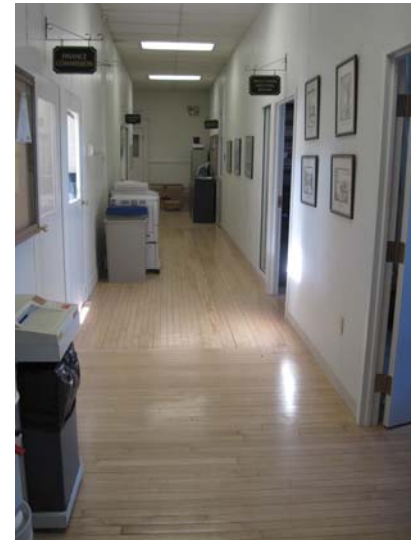
The second floor hallway features hardwood flooring in generally good condition.

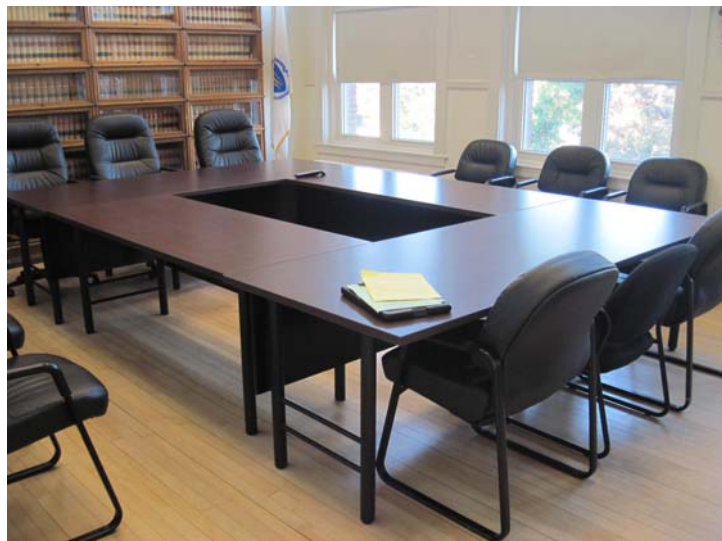
The hardwood floor within the second floor Selectmen Meeting Room was recently refinished in 2014.

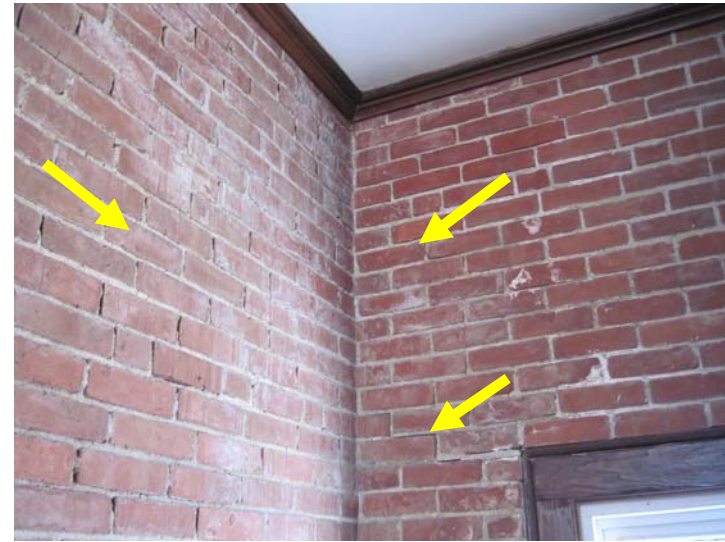
View of step-cracking and visible mortar loss noted within the egress stairwell exterior walls.

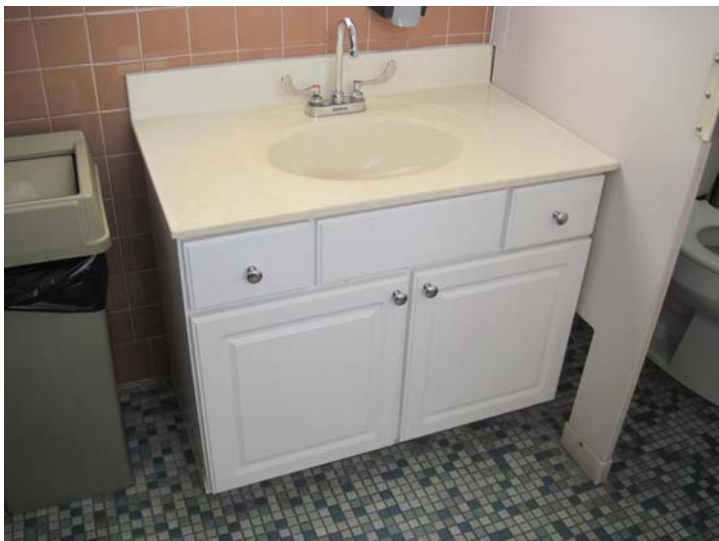
View of older fixtures and finishes within the first floor women's restroom.

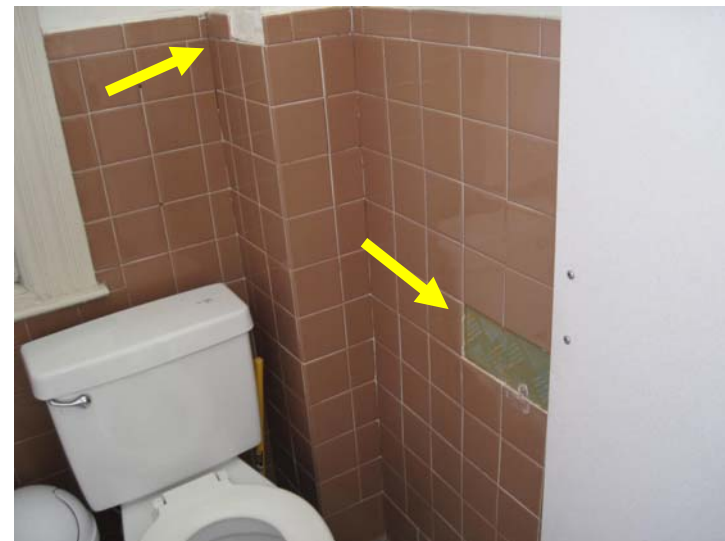
View of damaged and missing tilework within the first floor restroom. In need of near-term updating and remodeling to accessibility standards.

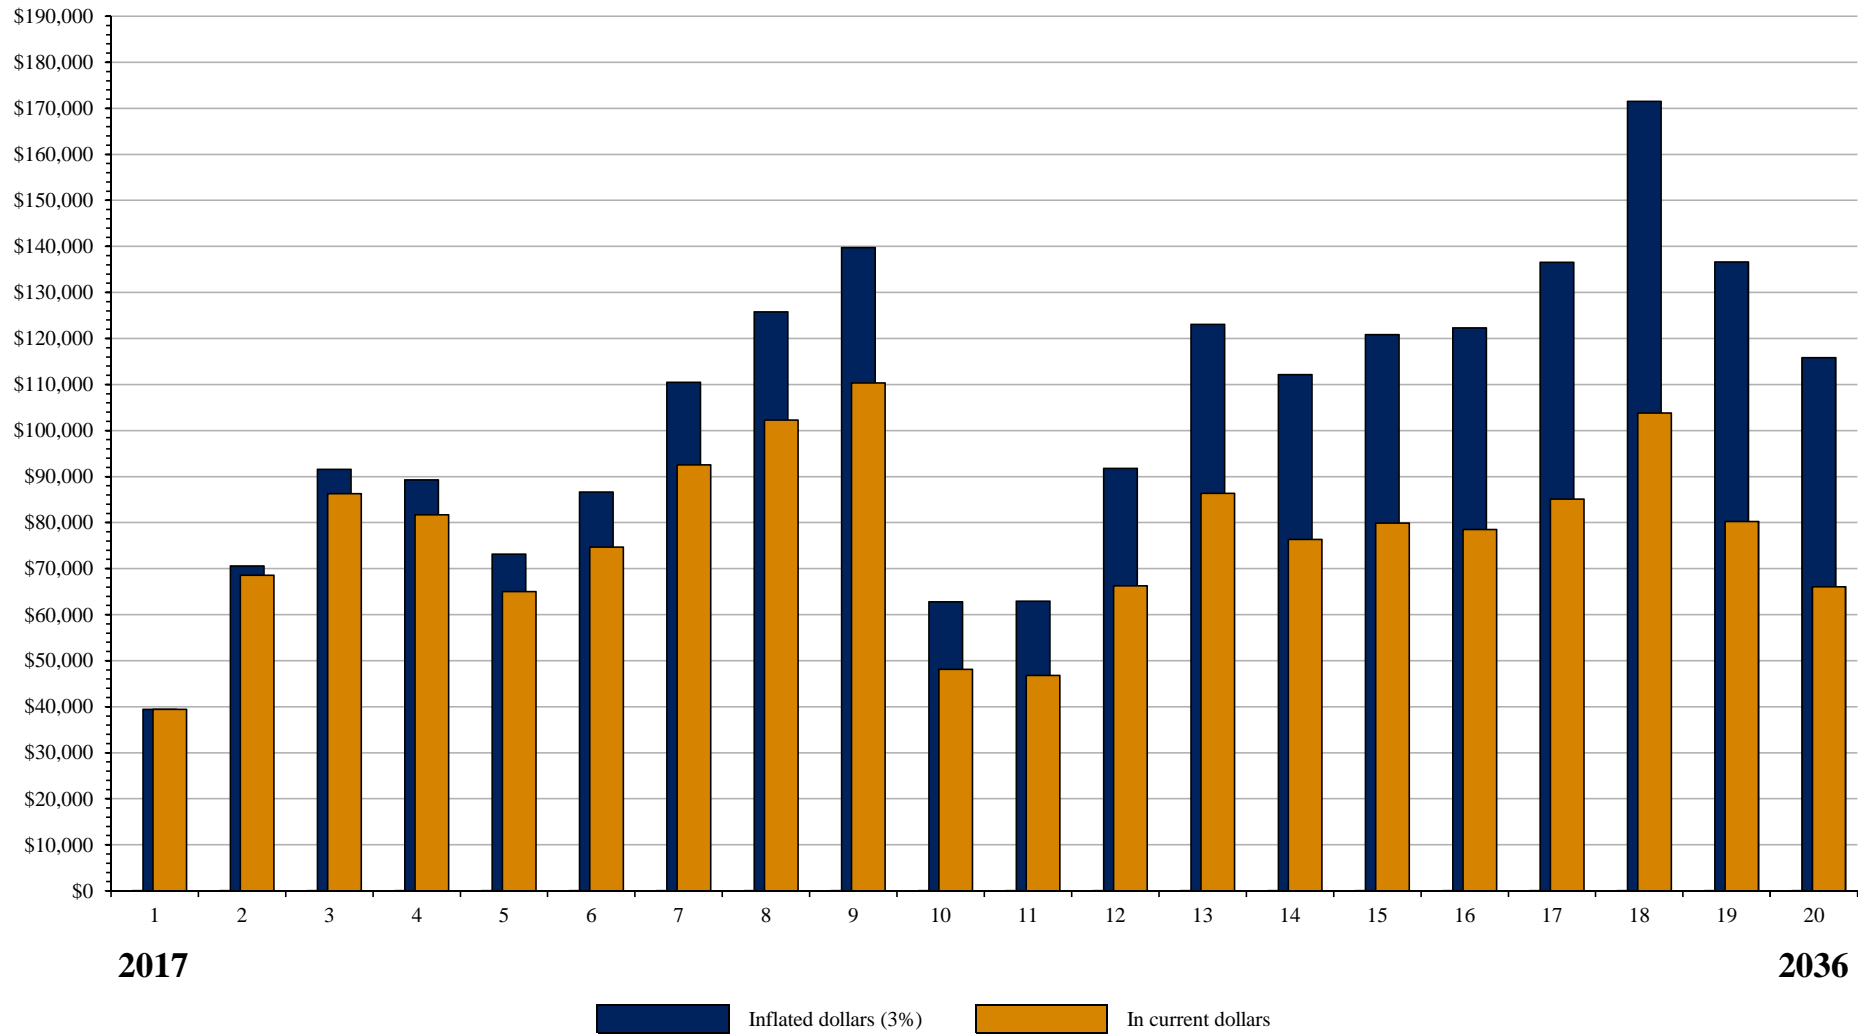
**Reported Reserve Balance as of 10/14/2016 :** \$0      At the end of Year One, Reserve Balances are projected to be: **\$39,454**  
**Estimated Reserve Balance as of 01/01/2017 :** \$0      At the end of Year 20, Reserve Balances are projected to be: **\$115,805**  
**Current annual contributions to reserves :** \$0      *All projected capital needs are met throughout the plan*
