Manhole Inspection Reports

Manhole Inspection Report

July 2023

Westwood, MA

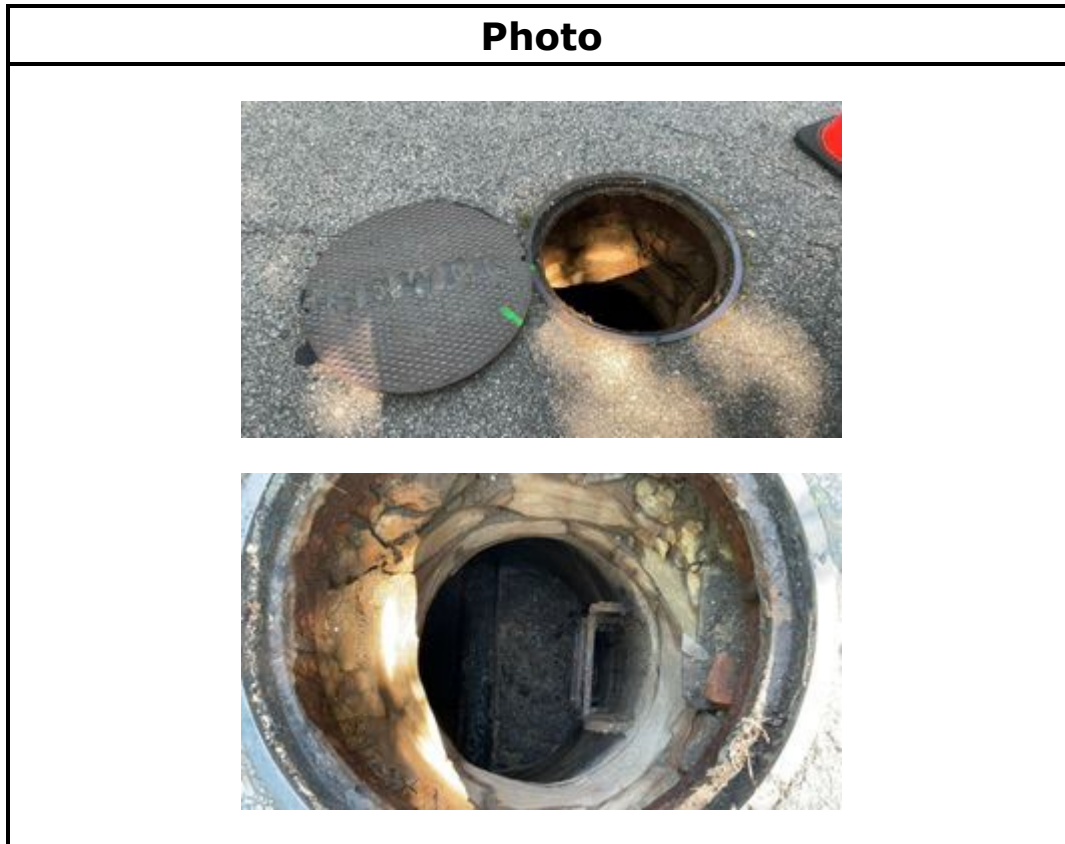
Westwood, MA Manhole Inspections
Manhole ID: 15/073
Westwood, MA

Manhole Information			
Cover Material	Cast Iron	Holes In Cover	Yes
Cover Condition	Sound	Number of Holes	2
Cover Defects		Hole Size (inches)	0.75
Cover Size (inches)	26	Grade	At Grade
Clear Opening Diameter	24	Surface Materials	Paved
Drainage Area (sqft)	4	Cracked Pavement Surrounding Frame	Yes
Cover Comments

Internal Manhole Observations						
Item	Material	Condition	Infiltration?	Infiltration (GPM)	Defects	Comments
Frame	Cast Iron	Sound	No			
Chimney	Brick, Parged	Defective	No		MML, MB, HSV	
Cone	Precast	Sound	No			
Walls	Precast, Parged	Sound	No			
Steps	Present? Yes	# of Steps: 4		Material: Metal		
Bench	Brick, Parged	Sound	No			
	Bench Debris Depth (Inches): 3			Bench Debris: Sediment		
Channel	Brick, Parged	Sound	No			
	Channel Debris Depth (Inches): 2			Channel Debris: Sediment		
Surcharge from Invert Evident? No				Currently:		Marks To:
Additional Comments:

Line Conditions												
In/Out	Compass Direction	Pipe Size	Pipe Material	Rim to Invert Depth	Condition	Flow Depth	Defects	Infiltration	Infiltration (GPM)	Debris	Debris Depth	Debris Material
Out	15/072	8"	ACP	7'7"	Sound	0	No	No	N/A	Yes	0.5"	Sediment
Additional Comments:

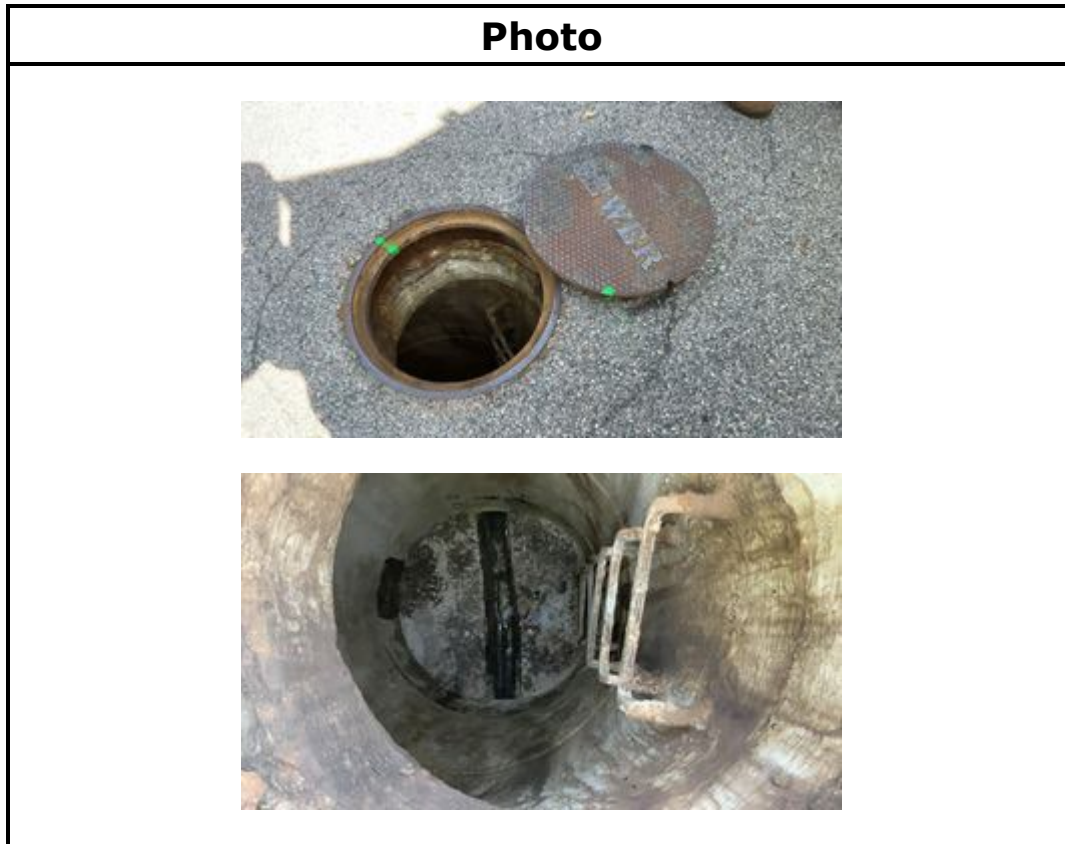
Manhole Information			
Cover Material	Cast Iron	Holes In Cover	Yes
Cover Condition	Sound	Number of Holes	2
Cover Defects		Hole Size (inches)	0.75
Cover Size (inches)	24	Grade	At Grade
Clear Opening Diameter	22	Surface Materials	Paved
Drainage Area (sqft)	4	Cracked Pavement Surrounding Frame	Yes
Cover Comments

Internal Manhole Observations						
Item	Material	Condition	Infiltration?	Infiltration (GPM)	Defects	Comments
Frame	Cast Iron	Sound	No			
Chimney	Brick, Parged	Defective	No		MML, MB, HSV	
Cone	Parged	Sound	No			
Walls	Parged	Sound	No			
Steps	Present? Yes	# of Steps: 7		Material: Metal		
Bench	Parged	Sound	No			
	Bench Debris Depth (Inches):			Bench Debris:		
Channel	Brick	Sound	No			
	Channel Debris Depth (Inches): 0.5			Channel Debris: Sanitary		
Surcharge from Invert Evident? No				Currently:	Marks To:	
Additional Comments:

Line Conditions												
In/Out	Compass Direction	Pipe Size	Pipe Material	Rim to Invert Depth	Condition	Flow Depth	Defects	Infiltration	Infiltration (GPM)	Debris	Debris Depth	Debris Material
Out	15/071	8"	ACP	10'10"	Sound	0.1"	No	No	N/A	No	N/A	N/A
In	Northwest	8"	ACP	9'11"	Sound	0.1"	No	No	N/A	No	N/A	N/A
Additional Comments:

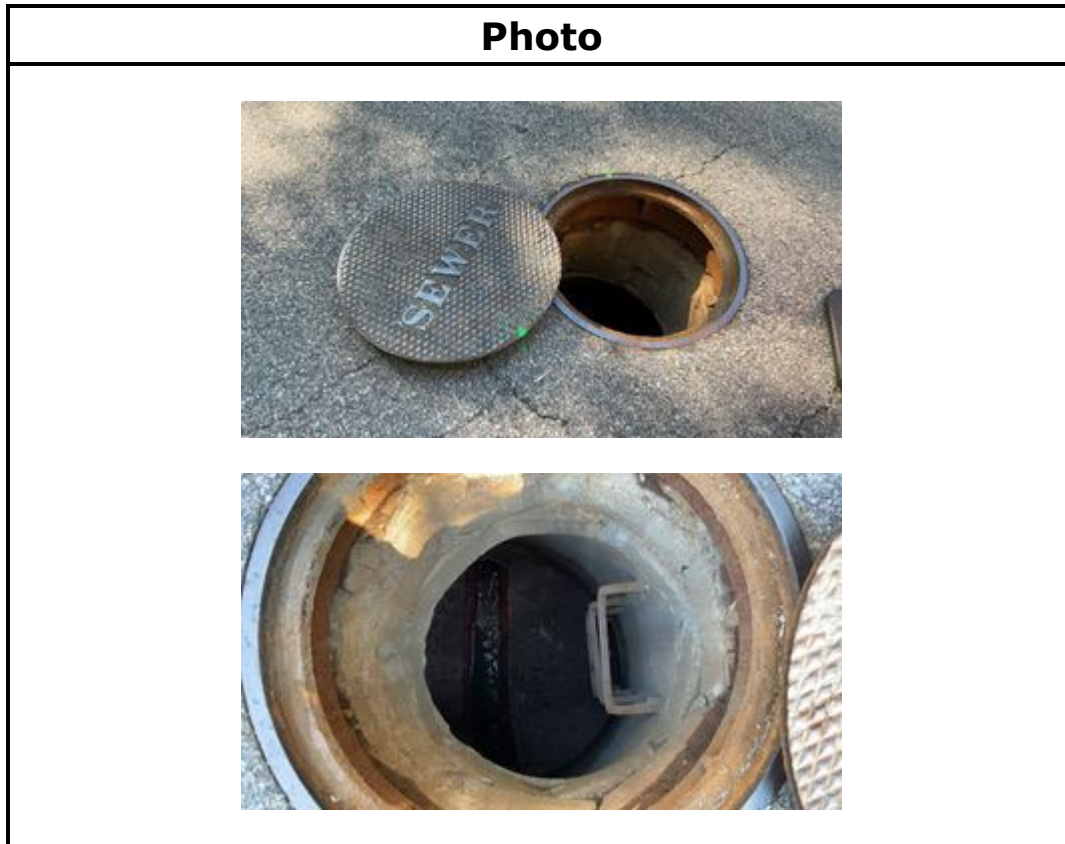
Manhole Information			
Cover Material	Cast Iron	Holes In Cover	No
Cover Condition	Sound	Number of Holes	
Cover Defects		Hole Size (inches)	
Cover Size (inches)	24	Grade	At Grade
Clear Opening Diameter	22	Surface Materials	Paved
Drainage Area (sqft)	4	Cracked Pavement Surrounding Frame	Yes
Cover Comments

Internal Manhole Observations						
Item	Material	Condition	Infiltration?	Infiltration (GPM)	Defects	Comments
Frame	Cast Iron	Sound	No			
Chimney	Brick, Block	Defective	No		MML	
Cone	Precast	Defective	No		Lift holes missing mortar	
Walls	Precast	Sound	No			
Steps	Present? Yes	# of Steps: 4		Material: Metal		
Bench	Brick	Sound	No			
	Bench Debris Depth (Inches): 1			Bench Debris: Sediment		
Channel	Brick	Sound	No			
	Channel Debris Depth (Inches):			Channel Debris:		
Surcharge from Invert Evident? No				Currently:	Marks To:	
Additional Comments:

Line Conditions												
In/Out	Compass Direction	Pipe Size	Pipe Material	Rim to Invert Depth	Condition	Flow Depth	Defects	Infiltration	Infiltration (GPM)	Debris	Debris Depth	Debris Material
Out	15/076	8"	ACP	7'3"	Sound	0.5"	No	No	N/A	No	N/A	N/A
In	15/074	8"	ACP	7'2"	Sound	0.5"	No	No	N/A	No	N/A	N/A
Additional Comments:

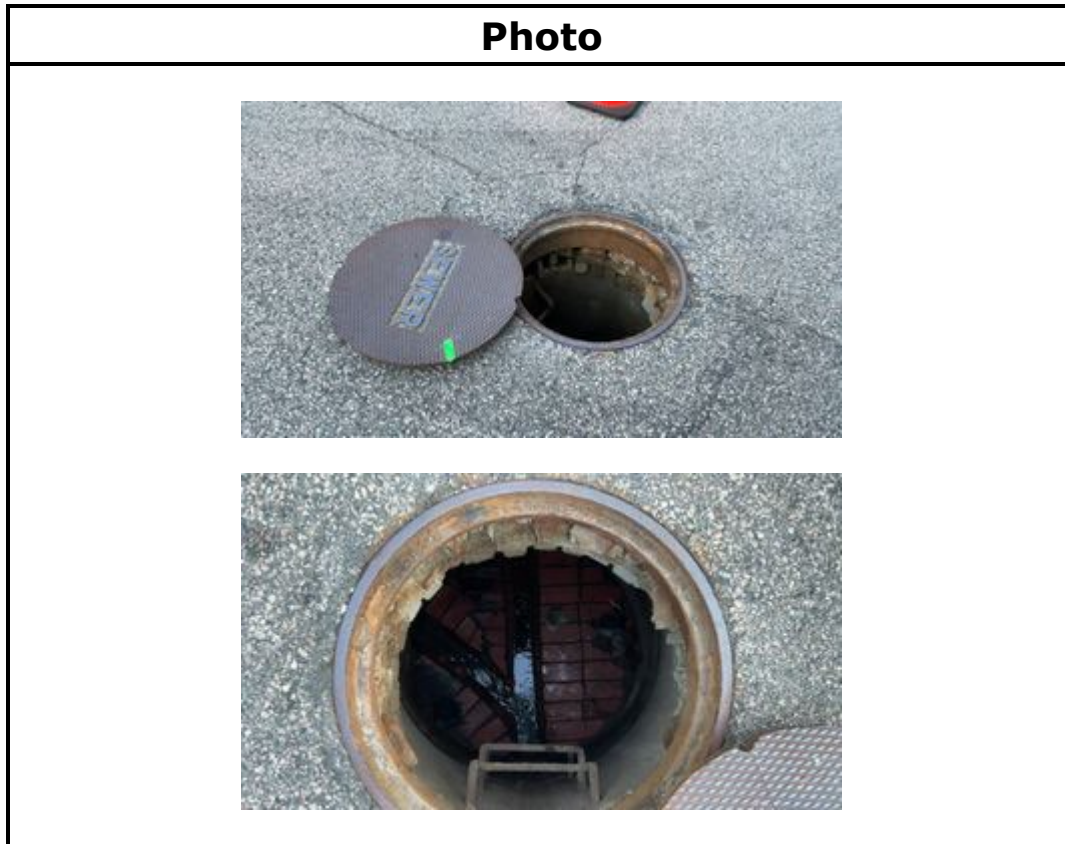
Manhole Information			
Cover Material	Cast Iron	Holes In Cover	Yes
Cover Condition	Sound	Number of Holes	2
Cover Defects		Hole Size (inches)	0.75
Cover Size (inches)	26	Grade	At Grade
Clear Opening Diameter	24	Surface Materials	Paved
Drainage Area (sqft)	4	Cracked Pavement Surrounding Frame	Yes
Cover Comments

Internal Manhole Observations						
Item	Material	Condition	Infiltration?	Infiltration (GPM)	Defects	Comments
Frame	Cast Iron	Sound	No			
Chimney	Brick	Defective	No		MML, MB, HSV	
Cone	Precast	Sound	No			
Walls	Precast	Sound	No			
Steps	Present? Yes	# of Steps: 3		Material: Metal		
Bench	Brick	Sound	No			
	Bench Debris Depth (Inches): 2			Bench Debris: Sanitary, Sediment		
Channel	Brick	Sound	No			
	Channel Debris Depth (Inches):			Channel Debris:		
Surcharge from Invert Evident? No				Currently:		Marks To:
Additional Comments:

Line Conditions												
In/Out	Compass Direction	Pipe Size	Pipe Material	Rim to Invert Depth	Condition	Flow Depth	Defects	Infiltration	Infiltration (GPM)	Debris	Debris Depth	Debris Material
Out	15/061	8"	ACP	6'0"	Sound	2"	No	No	N/A	No	N/A	N/A
In	15/077	8"	ACP	5'11"	Sound	1.5"	No	No	N/A	No	N/A	N/A
In	15/079	8"	ACP	5'11"	Sound	0.5"	No	No	N/A	No	N/A	N/A
Additional Comments:

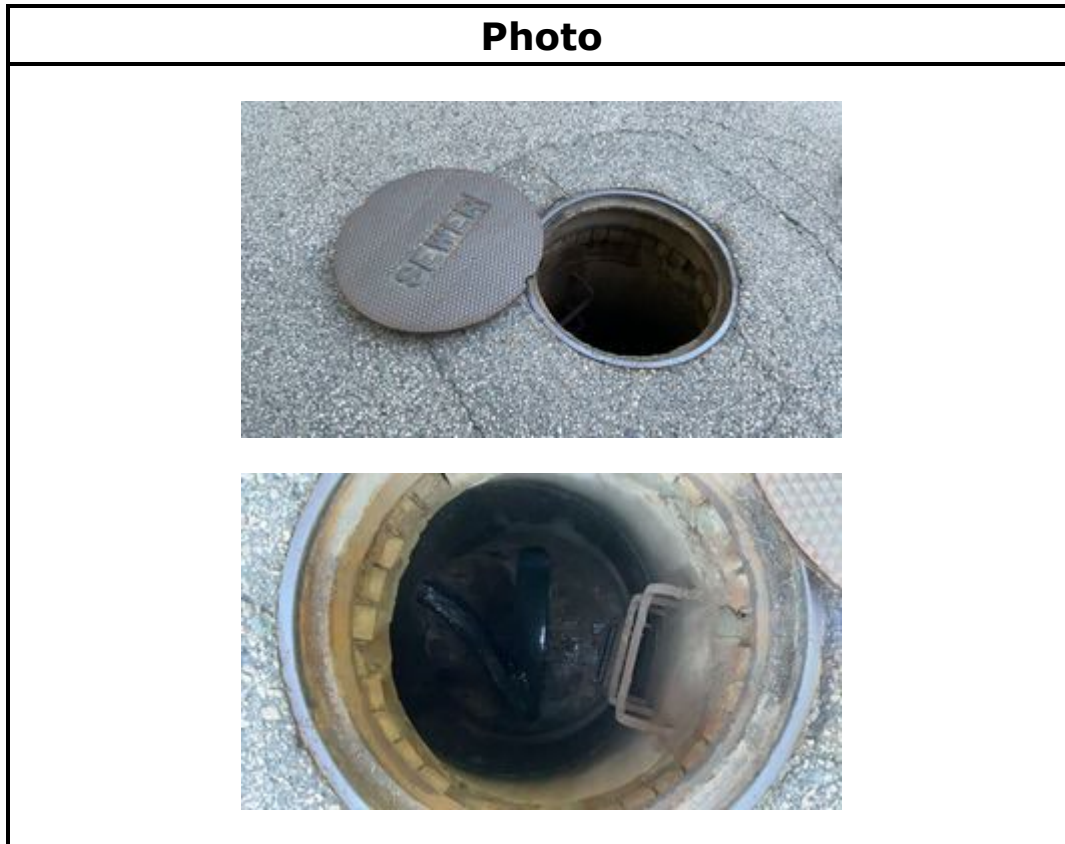
Manhole Information			
Cover Material	Cast Iron	Holes In Cover	Yes
Cover Condition	Sound	Number of Holes	2
Cover Defects		Hole Size (inches)	0.75
Cover Size (inches)	26	Grade	At Grade
Clear Opening Diameter	24	Surface Materials	Paved
Drainage Area (sqft)	4	Cracked Pavement Surrounding Frame	Yes
Cover Comments

Internal Manhole Observations						
Item	Material	Condition	Infiltration?	Infiltration (GPM)	Defects	Comments
Frame	Cast Iron	Sound	No			
Chimney	Brick, Block	Defective	No		MML, MB	
Cone	Precast	Sound	No			
Walls	Precast	Sound	No			
Steps	Present? Yes	# of Steps: 6		Material: Metal		
Bench	Brick, Parged	Sound	No			
	Bench Debris Depth (Inches):			Bench Debris:		
Channel	Brick, Parged	Sound	No			
	Channel Debris Depth (Inches):			Channel Debris:		
Surcharge from Invert Evident? No				Currently:	Marks To:	
Additional Comments:

Line Conditions												
In/Out	Compass Direction	Pipe Size	Pipe Material	Rim to Invert Depth	Condition	Flow Depth	Defects	Infiltration	Infiltration (GPM)	Debris	Debris Depth	Debris Material
Out	15/092	8"	ACP	8'8"	Sound	3.5"	No	No	N/A	No	N/A	N/A
In	15/078	8"	ACP	7'6"	Sound	1"	No	No	N/A	No	N/A	N/A
In	15/060	8"	ACP	8'7"	Sound	2.5"	No	No	N/A	No	N/A	N/A
Additional Comments:

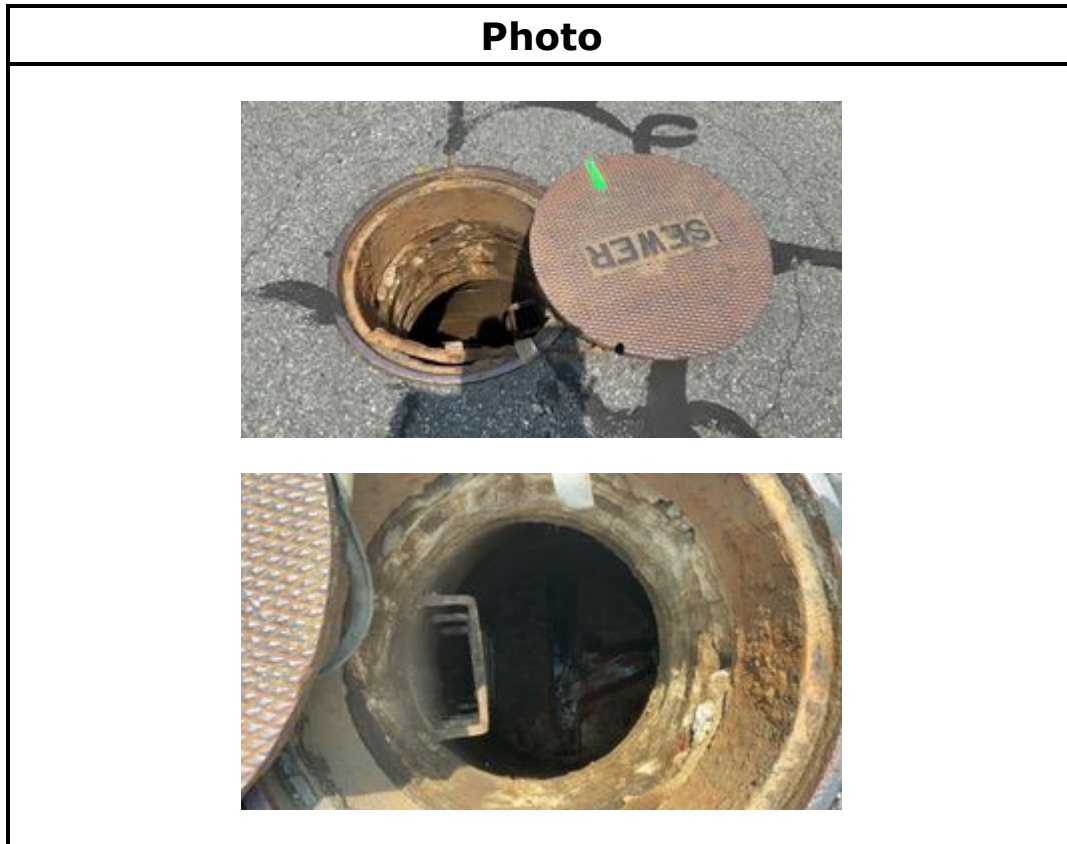
Manhole Information			
Cover Material	Cast Iron	Holes In Cover	Yes
Cover Condition	Sound	Number of Holes	2
Cover Defects		Hole Size (inches)	0.75
Cover Size (inches)	26	Grade	At Grade
Clear Opening Diameter	24	Surface Materials	Paved
Drainage Area (sqft)	4	Cracked Pavement Surrounding Frame	No
Cover Comments

Internal Manhole Observations						
Item	Material	Condition	Infiltration?	Infiltration (GPM)	Defects	Comments
Frame	Cast Iron	Sound	No			
Chimney	Brick, Parged	Sound	No			
Cone	Precast	Defective	No		lift holes missing mortar	
Walls	Precast	Sound	No			
Steps	Present? Yes	# of Steps: 6		Material: Metal		
Bench	Brick, Parged	Sound	No			
	Bench Debris Depth (Inches): 0.5			Bench Debris: Sediment		
Channel	Brick	Defective	No		DAGS	
	Channel Debris Depth (Inches): 2			Channel Debris: Other Grease		
Surcharge from Invert Evident? No				Currently:		Marks To:
Additional Comments:

Line Conditions												
In/Out	Compass Direction	Pipe Size	Pipe Material	Rim to Invert Depth	Condition	Flow Depth	Defects	Infiltration	Infiltration (GPM)	Debris	Debris Depth	Debris Material
Out	15/034	8"	ACP	9'2"	Sound	0.5"	No	No	N/A	No	N/A	N/A
In	Northwest	6"	PVC	9'0"	Sound	0.5"	No	No	N/A	No	N/A	N/A
Additional Comments:

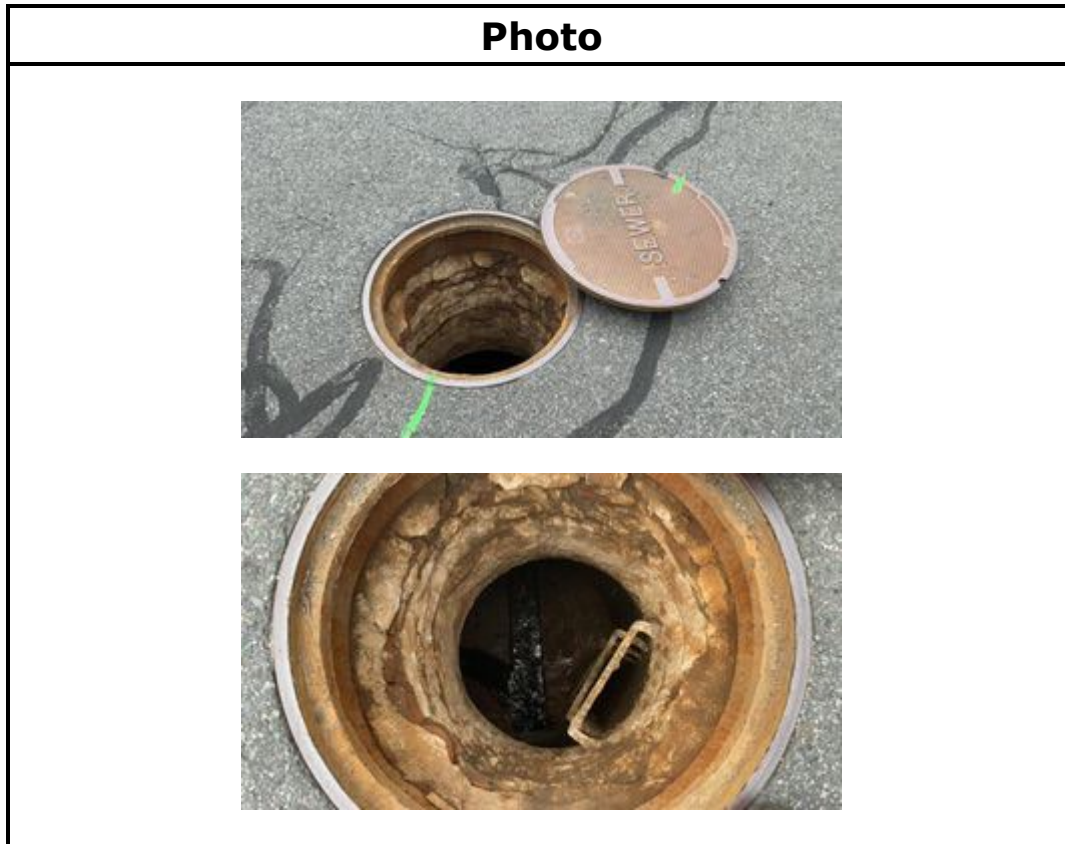
Manhole Information			
Cover Material	Cast Iron	Holes In Cover	Yes
Cover Condition	Sound	Number of Holes	2
Cover Defects		Hole Size (inches)	0.75
Cover Size (inches)	26	Grade	At Grade
Clear Opening Diameter	24	Surface Materials	Paved
Drainage Area (sqft)	4	Cracked Pavement Surrounding Frame	Yes
Cover Comments

Internal Manhole Observations						
Item	Material	Condition	Infiltration?	Infiltration (GPM)	Defects	Comments
Frame	Cast Iron	Sound	No			
Chimney	Brick, Parged	Defective	No		MMM	
Cone	Precast	Sound	No			
Walls	Precast	Sound	No			
Steps	Present? Yes	# of Steps: 6		Material: Metal		
Bench	Brick, Parged	Sound	No			
	Bench Debris Depth (Inches):			Bench Debris:		
Channel	Brick	Sound	No			
	Channel Debris Depth (Inches): 0.5			Channel Debris: Sediment		
Surcharge from Invert Evident? No				Currently:	Marks To:	
Additional Comments:

Line Conditions												
In/Out	Compass Direction	Pipe Size	Pipe Material	Rim to Invert Depth	Condition	Flow Depth	Defects	Infiltration	Infiltration (GPM)	Debris	Debris Depth	Debris Material
Out	15/036	8"	ACP	9'4"	Sound	4"	No	No	N/A	No	N/A	N/A
In	15/035	8"	ACP	9'3"	Sound	0.5"	No	No	N/A	Yes	0.5"	Sediment
In	15/033	8"	ACP	9'3"	Sound	3.5"	No	No	N/A	No	N/A	N/A
Additional Comments:

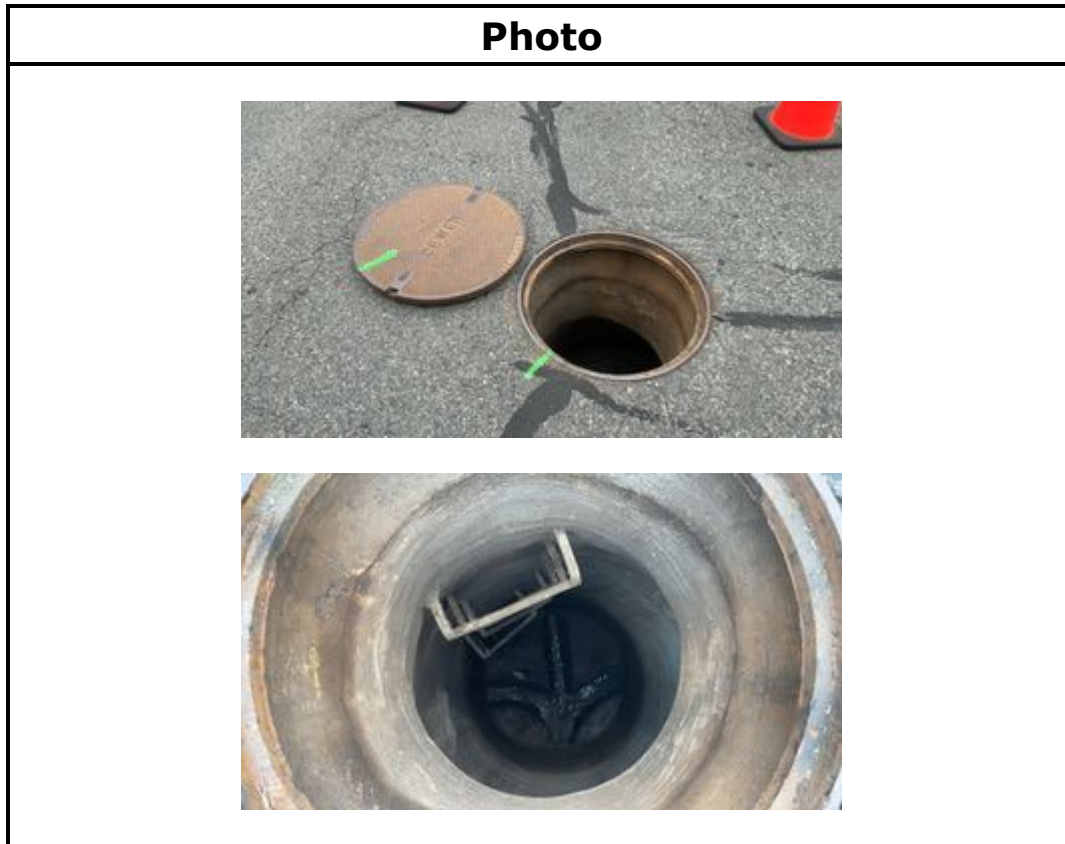
Manhole Information			
Cover Material	Cast Iron	Holes In Cover	No
Cover Condition	Sound	Number of Holes	2
Cover Defects		Hole Size (inches)	0.75
Cover Size (inches)	24	Grade	At Grade
Clear Opening Diameter	22	Surface Materials	Paved
Drainage Area (sqft)	4	Cracked Pavement Surrounding Frame	No
Cover Comments	Blind flange cover

Internal Manhole Observations						
Item	Material	Condition	Infiltration?	Infiltration (GPM)	Defects	Comments
Frame	Cast Iron	Sound	No			
Chimney	Parged	Sound	No			
Cone	Precast, Parged	Sound	No			
Walls	Precast, Parged	Sound	No			
Steps	Present? Yes	# of Steps: 9		Material: Metal		
Bench	Parged	Sound	No			
	Bench Debris Depth (Inches):			Bench Debris:		
Channel	Parged	Sound	No			
	Channel Debris Depth (Inches):			Channel Debris:		
Surcharge from Invert Evident? No				Currently:	Marks To:	
Additional Comments:

Line Conditions												
In/Out	Compass Direction	Pipe Size	Pipe Material	Rim to Invert Depth	Condition	Flow Depth	Defects	Infiltration	Infiltration (GPM)	Debris	Debris Depth	Debris Material
Out	15/034	8"	ACP	12'2"	Sound	3"	No	No	N/A	No	N/A	N/A
In	15/048	8"	ACP	6'3"	Sound	1.5"	No	No	N/A	No	N/A	N/A
In	15/032	8"	ACP	6'8"	Sound	0.5"	No	No	N/A	No	N/A	N/A
In	15/024	8"	ACP	12'1"	Sound	2"	No	No	N/A	No	N/A	N/A
Additional Comments: In (15/048) is an outside drop. In (15/032) is an outside drop.

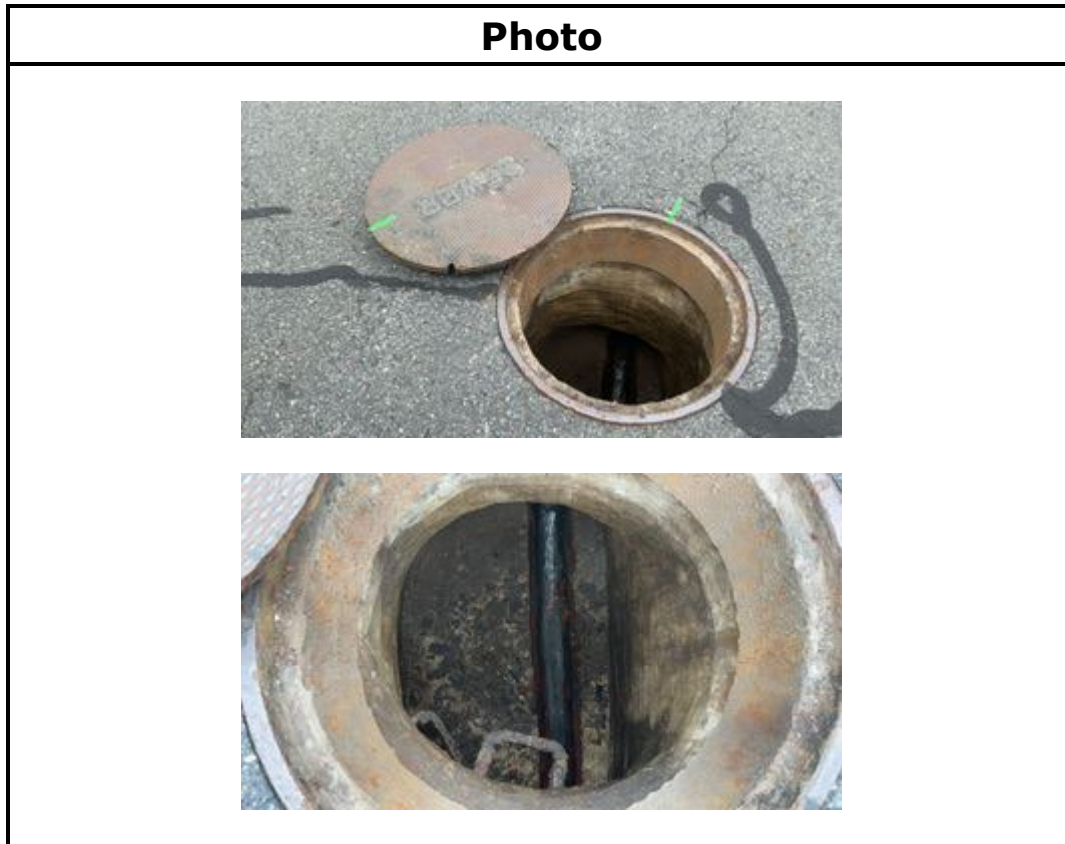
Manhole Information			
Cover Material	Cast Iron	Holes In Cover	Yes
Cover Condition	Sound	Number of Holes	2
Cover Defects		Hole Size (inches)	0.75
Cover Size (inches)	26	Grade	At Grade
Clear Opening Diameter	24	Surface Materials	Paved
Drainage Area (sqft)	4	Cracked Pavement Surrounding Frame	Yes
Cover Comments

Internal Manhole Observations						
Item	Material	Condition	Infiltration?	Infiltration (GPM)	Defects	Comments
Frame	Cast Iron	Sound	No			
Chimney	Brick, Parged	Sound	No			
Cone	Brick, Parged	Sound	No			
Walls	Brick, Parged	Sound	No			
Steps	Present? Yes	# of Steps: 2		Material: Metal		
Bench	Brick, Parged	Sound	No			
	Bench Debris Depth (Inches): 0.25			Bench Debris: Sediment		
Channel	Brick	Sound	No			
	Channel Debris Depth (Inches):			Channel Debris:		
Surcharge from Invert Evident? No				Currently:		Marks To:
Additional Comments:

Line Conditions												
In/Out	Compass Direction	Pipe Size	Pipe Material	Rim to Invert Depth	Condition	Flow Depth	Defects	Infiltration	Infiltration (GPM)	Debris	Debris Depth	Debris Material
Out	15/033	8"	ACP	6'4"	Sound	0.25"	No	No	N/A	No	N/A	N/A
In	15/031	8"	ACP	5'6"	Sound	0.25"	No	No	N/A	No	N/A	N/A
Additional Comments:

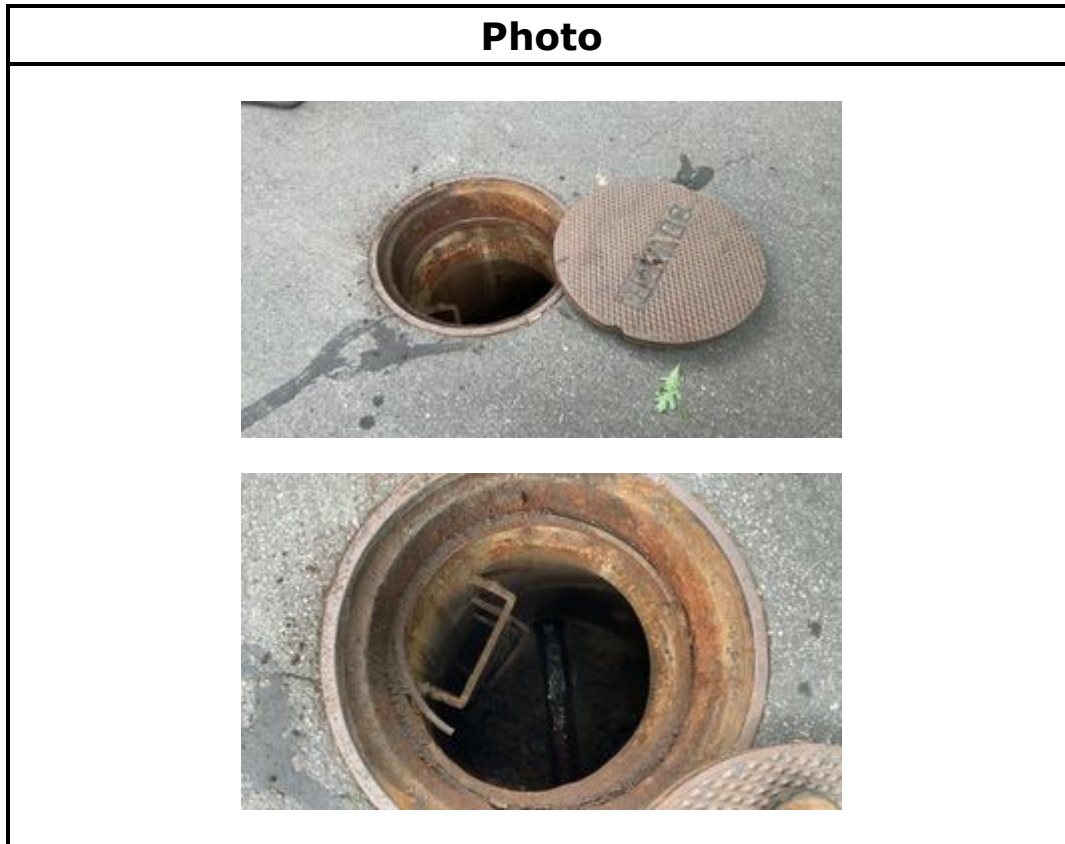
Manhole Information			
Cover Material	Cast Iron	Holes In Cover	Yes
Cover Condition	Sound	Number of Holes	2
Cover Defects		Hole Size (inches)	0.75
Cover Size (inches)	26	Grade	At Grade
Clear Opening Diameter	24	Surface Materials	Paved
Drainage Area (sqft)	4	Cracked Pavement Surrounding Frame	No
Cover Comments

Internal Manhole Observations												
Item	Material	Condition	Infiltration?	Infiltration (GPM)	Defects	Comments						
Frame	Cast Iron	Sound	No			Frame accommodates a flood cover however no flood cover installed						
Chimney	Brick, Precast, Parged	Sound	No									
Cone	Precast, Parged	Sound	No									
Walls	Precast, Parged	Sound	No									
Steps	Present? Yes	# of Steps: 5		Material: Metal								
Bench	Brick, Parged	Sound	No									
	Bench Debris Depth (Inches):			Bench Debris:								
Channel	Brick	Sound	No									
	Channel Debris Depth (Inches): 0.25			Channel Debris: Sanitary								
Surcharge from Invert Evident? No				Currently:				Marks To:				
Additional Comments:

Line Conditions												
In/Out	Compass Direction	Pipe Size	Pipe Material	Rim to Invert Depth	Condition	Flow Depth	Defects	Infiltration	Infiltration (GPM)	Debris	Debris Depth	Debris Material
Out	15/031	8"	ACP	7'11"	Sound	0.25"	No	No	N/A	No	N/A	N/A
In	15/029	8"	ACP	7'9"	Sound	0.25"	No	No	N/A	No	N/A	N/A
Additional Comments:

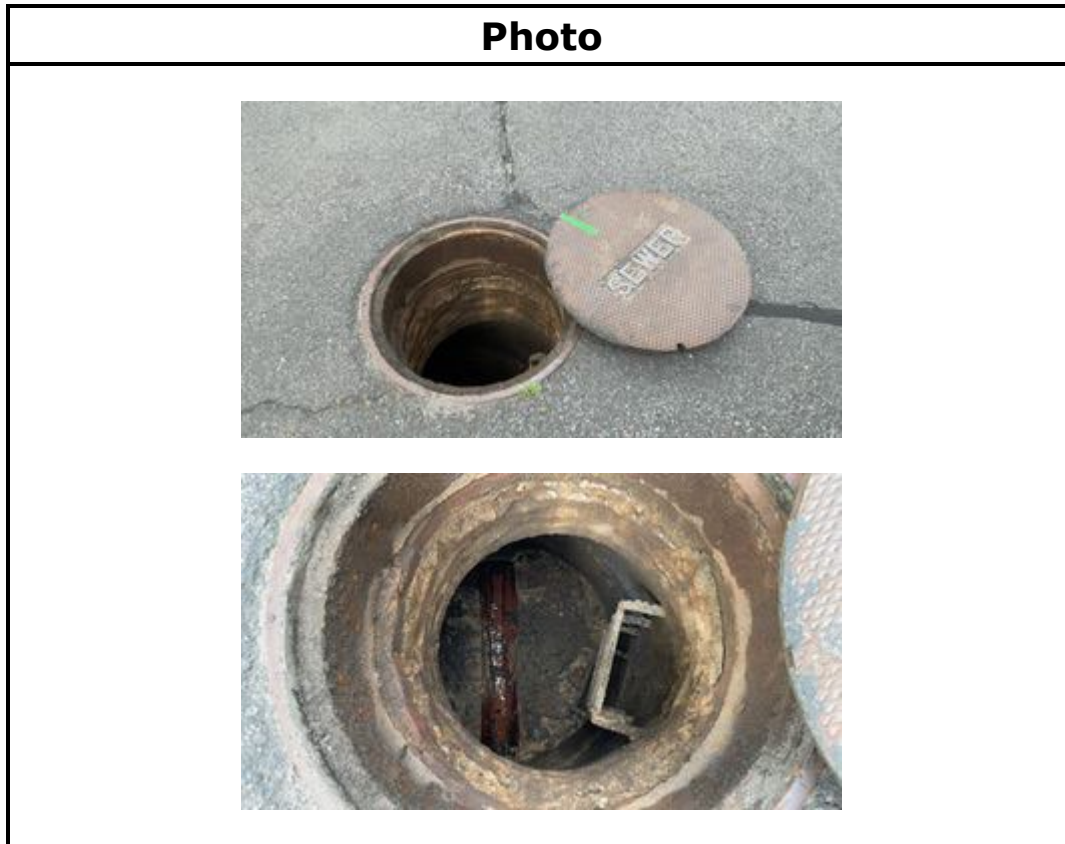
Manhole Information			
Cover Material	Cast Iron	Holes In Cover	Yes
Cover Condition	Sound	Number of Holes	2
Cover Defects		Hole Size (inches)	0.75
Cover Size (inches)	26	Grade	At Grade
Clear Opening Diameter	24	Surface Materials	Paved
Drainage Area (sqft)	4	Cracked Pavement Surrounding Frame	Yes
Cover Comments

Internal Manhole Observations						
Item	Material	Condition	Infiltration?	Infiltration (GPM)	Defects	Comments
Frame	Cast Iron	Sound	No			
Chimney	Brick, Precast, Parged	Sound	No			
Cone	Precast, Parged	Sound	No			
Walls	Precast, Parged	Sound	No			
Steps	Present? Yes	# of Steps: 4		Material: Metal		
Bench	Brick, Parged	Sound	No			
	Bench Debris Depth (Inches):			Bench Debris:		
Channel	Brick	Sound	No			
	Channel Debris Depth (Inches):			Channel Debris:		
Surcharge from Invert Evident? No				Currently:		Marks To:
Additional Comments:

Line Conditions												
In/Out	Compass Direction	Pipe Size	Pipe Material	Rim to Invert Depth	Condition	Flow Depth	Defects	Infiltration	Infiltration (GPM)	Debris	Debris Depth	Debris Material
Out	15/030	8"	ACP	7'7"	Sound	0.25"	No	No	N/A	No	N/A	N/A
In	15/028	8"	ACP	7'5"	Sound	0.25"	No	No	N/A	No	N/A	N/A
Additional Comments:

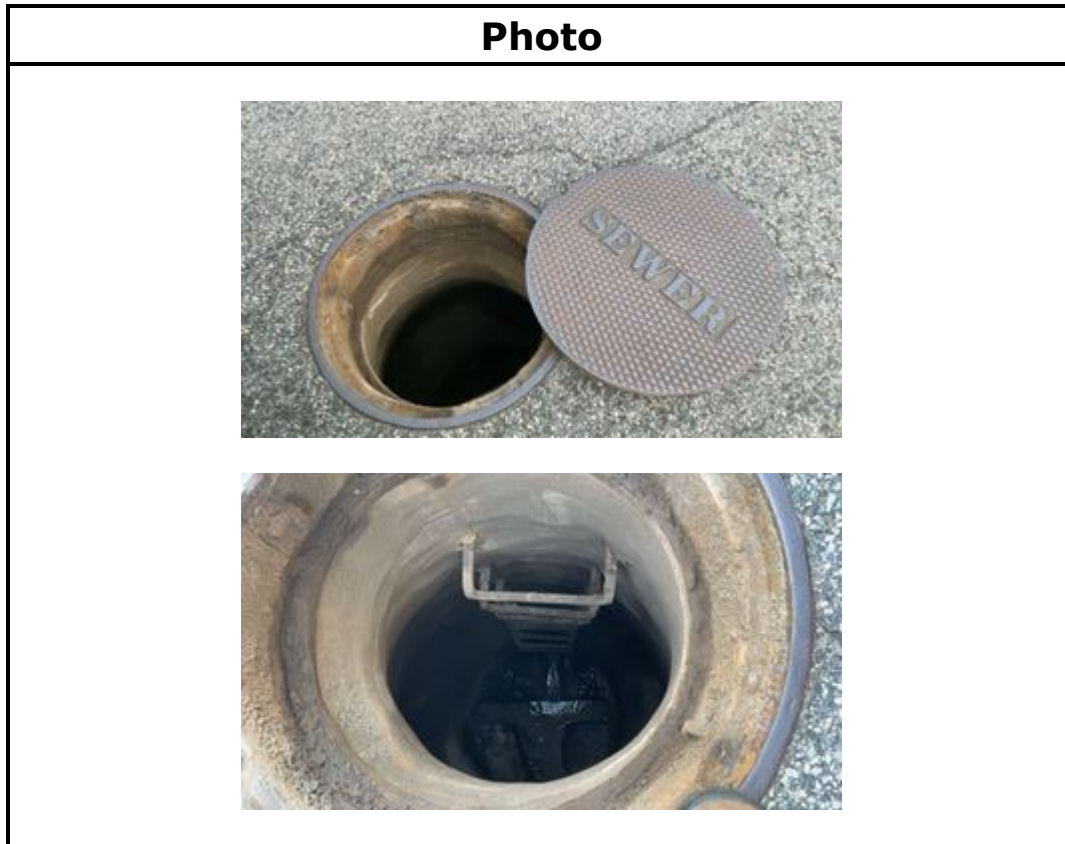
Manhole Information			
Cover Material	Cast Iron	Holes In Cover	Yes
Cover Condition	Sound	Number of Holes	2
Cover Defects		Hole Size (inches)	0.75
Cover Size (inches)	26	Grade	At Grade
Clear Opening Diameter	24	Surface Materials	Paved
Drainage Area (sqft)	4	Cracked Pavement Surrounding Frame	Yes
Cover Comments

Internal Manhole Observations						
Item	Material	Condition	Infiltration?	Infiltration (GPM)	Defects	Comments
Frame	Cast Iron	Sound	No			
Chimney	Parged	Sound	No			
Cone	Parged	Sound	No			
Walls	Parged	Sound	No			
Steps	Present? Yes	# of Steps: 7		Material: Metal		
Bench	Parged	Sound	No			
	Bench Debris Depth (Inches):			Bench Debris:		
Channel	Parged	Sound	No			
	Channel Debris Depth (Inches): 1			Channel Debris: Sediment		
Surcharge from Invert Evident? No				Currently:	Marks To:	
Additional Comments:

Line Conditions												
In/Out	Compass Direction	Pipe Size	Pipe Material	Rim to Invert Depth	Condition	Flow Depth	Defects	Infiltration	Infiltration (GPM)	Debris	Debris Depth	Debris Material
Out	15/018	8"	ACP	11'7"	Sound	1"	No	No	N/A	Yes	0.5"	Sediment
In	15/004	8"	ACP	11'6"	Sound	0.75"	No	No	N/A	Yes	0.25"	Sediment
In	15/112	8"	PVC	10'10"	Sound	0.25"	No	No	N/A	No	N/A	N/A
In	15/006	8"	ACP	11'5"	Sound	0.5"	No	No	N/A	Yes	0.25"	Sediment
Additional Comments:

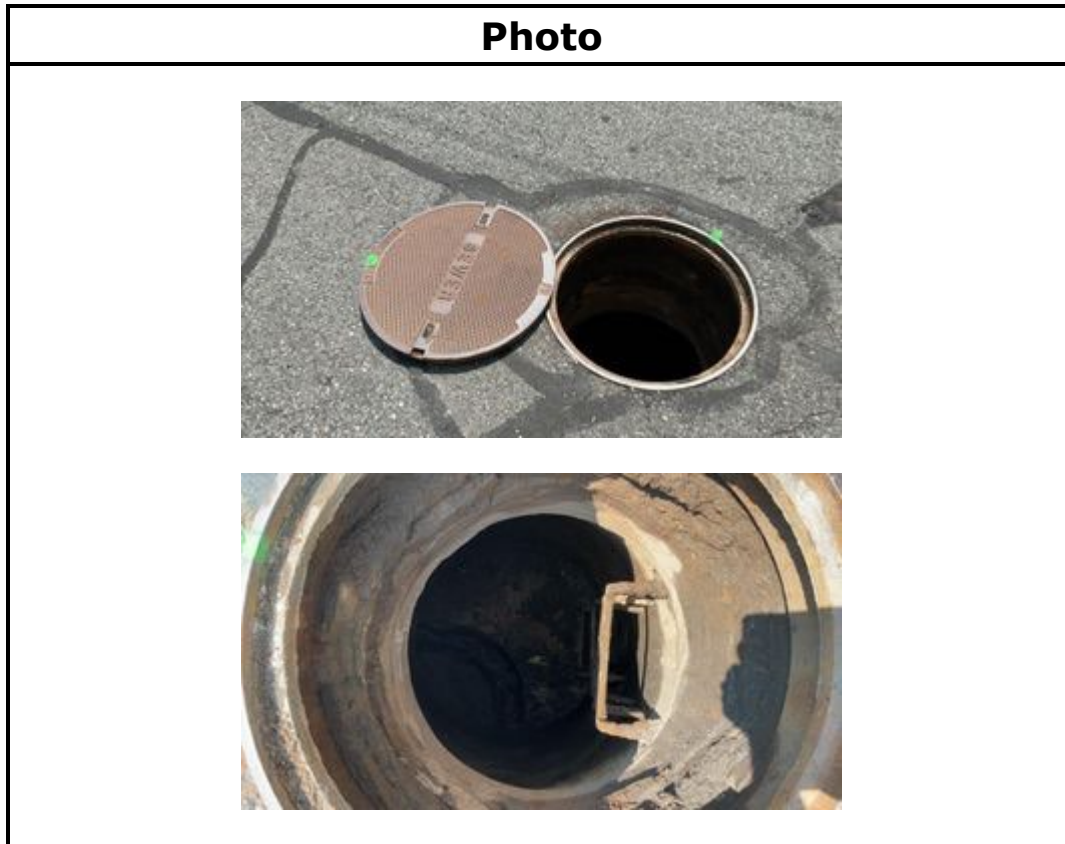
Manhole Information			
Cover Material	Cast Iron	Holes In Cover	No
Cover Condition	Sound	Number of Holes	2
Cover Defects		Hole Size (inches)	0.75
Cover Size (inches)	24	Grade	At Grade
Clear Opening Diameter	22	Surface Materials	Paved
Drainage Area (sqft)	4	Cracked Pavement Surrounding Frame	No
Cover Comments

Internal Manhole Observations						
Item	Material	Condition	Infiltration?	Infiltration (GPM)	Defects	Comments
Frame	Cast Iron	Sound	No			
Chimney	Brick, Parged	Defective	No		MMM	
Cone	Precast	Sound	No			
Walls	Precast	Sound	No			
Steps	Present? Yes	# of Steps: 5		Material: Metal		
Bench	Parged	Sound	No			
	Bench Debris Depth (Inches):			Bench Debris:		
Channel	Brick	Sound	No			
	Channel Debris Depth (Inches): 0.5			Channel Debris: Sanitary, Sediment		
Surcharge from Invert Evident? No				Currently:		Marks To:
Additional Comments:

Line Conditions												
In/Out	Compass Direction	Pipe Size	Pipe Material	Rim to Invert Depth	Condition	Flow Depth	Defects	Infiltration	Infiltration (GPM)	Debris	Debris Depth	Debris Material
Out	15/051	8"	ACP	9'7"	Sound	0	No	No	N/A	Yes	0.25"	Sanitary, Sediment
In	15/049	8"	ACP	9'5"	Sound	0	No	No	N/A	Yes	0.25"	Sanitary, Sediment
In	Southwest	8"	VCP	6'8"	Sound	0	No	No	N/A	No	N/A	N/A
Additional Comments:
