# Public Works Department - Carby Street Offices

## Town of Westwood ADA Transition Plan

May 2023

Institute for Human Centered Design

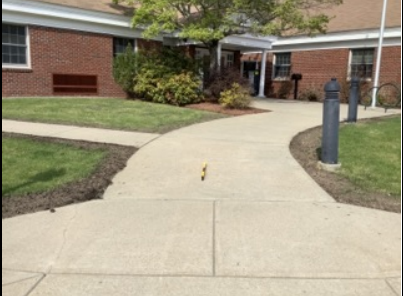
Running slope > 1:20 (5.00%)	8.7%	Reduce running slope to be no steeper than 1:20 (5.00%).	1	-	-
<div style="border: 1px solid black; padding: 2px;">Curb Ramp</div>												
2	Parking Lot	Ext.		Curb Ramp	Perpendicular

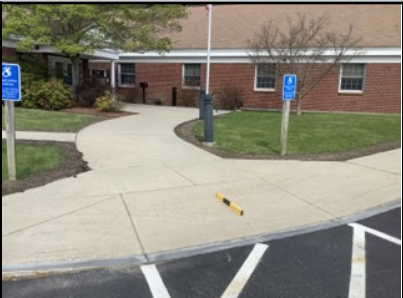
Running slope is > 1:12 (8.33%) Transition from curb ramp to street not flush	10% -	Reduce running slope to be no steeper than 1:12 (8.33%). Ensure transition from curb ramp to street is flush or free of changes in level.	1	3640	\$3640
											<b>3640</b>	
<div style="border: 1px solid black; padding: 2px;">Off-Street Parking Lot or Garage</div>

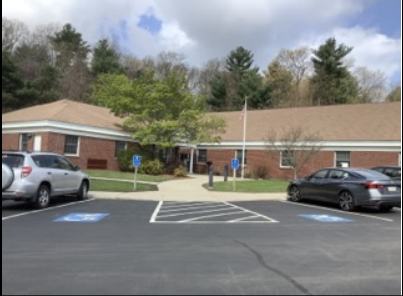
3	Parking Lot	Ext.		Off-Street Parking Lot or Garage	Visitor

Total # of parking Total # of designated car accessible parking spaces Total # of designated van accessible spaces Sign does not have the designation "Van Accessible" Sign bottom < 60" above finished grade International Symbol of Acc. not compliant	31 2 0 - 43" -	Convert one car accessible parking space into a van accessible parking space. Add the designation "Van Accessible" to the sign located at the van accessible space. Locate sign with the bottom of the sign 60" above the ground. Ensure that all three parking identification signs contains the required International Symbol of Accessibility (ISA).	1	650 650 Labor	\$1300
											<b>1300</b>	
<div style="border: 1px solid black; padding: 2px;">Access to Goods and Services</div>												
<div style="border: 1px solid black; padding: 2px;">Means of Egress</div>

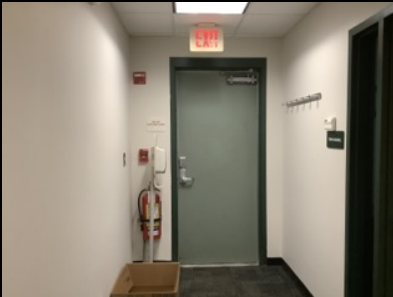
ID	Location	Floor	Room	Element	Type	Photo	Issues	Current Measure	Recommendations	Quantity	Price	Cost Estimation
<b>Doors, Doorways, &amp; Gates</b>												
10	North Egress Door by Town Council	1		Doors, Doorways, & Gates	Emergency Egress

Maneuvering clearance(s) not provided	-	Relocate the hand sanitizer dispenser to provide 12" min. of maneuvering clearance at the push-side of the door.	1	Labor	Labor
11	Champagne Meeting Room	1	10	Doors, Doorways, & Gates	Meeting Room

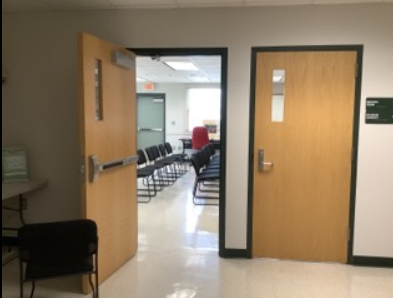
Door requires > 5 lbs. of force to open	10 lbs.	Adjust closers so doors do not require more than 5 pounds of force to open.	2	Labor	Labor
12	Men's Multi-User Toilet Room	1		Doors, Doorways, & Gates	Toilet Room

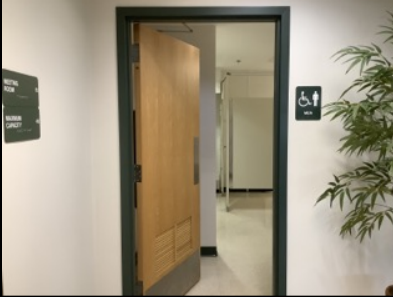
Door requires > 5 lbs. of force to open	10 lbs.	Adjust closers so doors do not require more than 5 pounds of force to open.	1	Labor	Labor
13	Women's Multi-User Toilet Room	1		Doors, Doorways, & Gates	Toilet Room

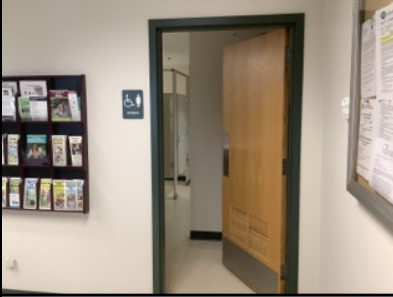
Door requires > 5 lbs. of force to open	11 lbs	Adjust closers so doors do not require more than 5 pounds of force to open.	1	Labor	Labor

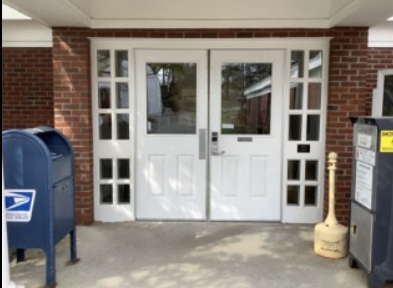
14	Main Entrance	Ext.		Doors, Doorways, & Gates	Main Entrance

Closing speed not compliant	2 sec.	Adjust door closer so that from an open position of 90 degrees, the time required to move the door to a position of 12 degrees from the latch is 5 seconds min.	1	Labor	Labor

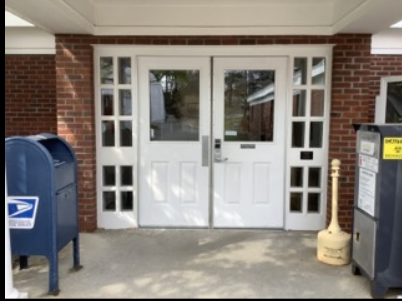
ID	Location	Floor	Room	Element	Type	Photo	Issues	Current Measure	Recommendations	Quantity	Price	Cost Estimation
<b>Signage</b>												
15	Main Entrance	Ext.		Signage	Designation

Signage is not provided	-	Locate compliant signage with raised characters and braille alongside the door on the latch side.	1	450	\$450
											<b>450</b>	
16	Champagne Meeting Room	1	10	Signage	Designation

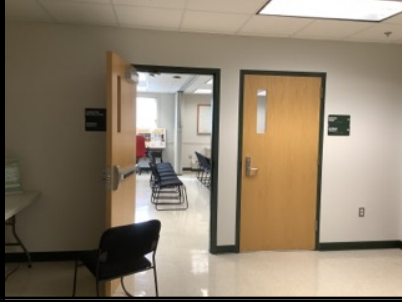
Raised characters < 48" or > 60" above ground	62" -	Mount the signs so that the baseline of the lowest tactile character is 48" min. above finished floor and the baseline of the highest tactile character is 60" max. above the finished floor.	2	Labor	Labor
17	Egress Doors, Champagne Meeting Room	1	10	Signage	Egress

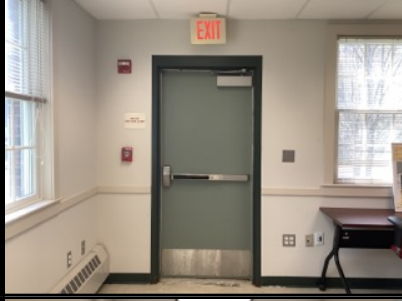
Raised characters < 48" or > 60" above ground	62"	Mount the sign so that the baseline of the lowest tactile character is 48" min. above finished floor and the baseline of the highest tactile character is 60" max. above the finished floor.	2	Labor	Labor

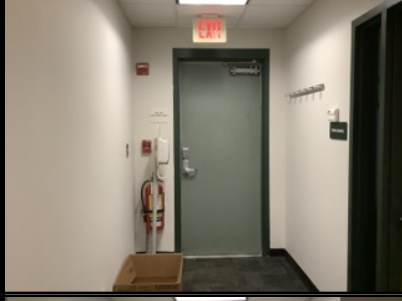
18	North Egress Door by Town Council	1		Signage	Egress

Raised characters < 48" or > 60" above ground	61"	Mount the sign so that the baseline of the lowest tactile character is 48" min. above finished floor and the baseline of the highest tactile character is 60" max. above the finished floor.	1	Labor	Labor
19	Northwest Egress Door by Planning, Zoning, Community and Economic Development	1		Signage	Egress

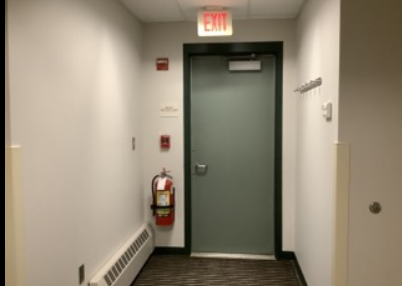
Raised characters < 48" or > 60" above ground	62"	Mount the sign so that the baseline of the lowest tactile character is 48" min. above finished floor and the baseline of the highest tactile character is 60" max. above the finished floor.	1	Labor	Labor

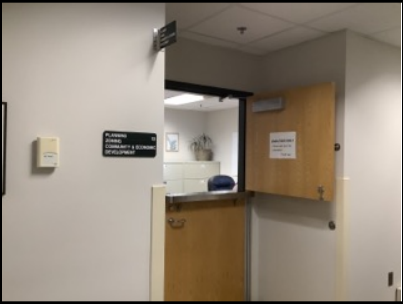
ID	Location	Floor	Room	Element	Type	Photo	Issues	Current Measure	Recommendations	Quantity	Price	Cost Estimation
20	Planning, Zoning, Community and Economic Development	1	13	Signage	Designation

Braille not provided on sign	-	Provide braille on the sign.	1	302	\$302
21	Conference Room	1	18	Signage	Designation

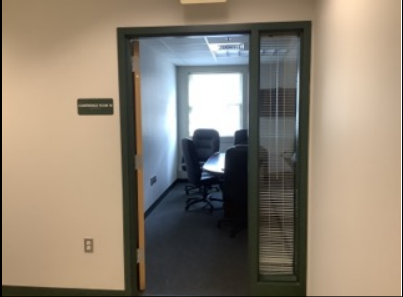
Sign not located on the latch side of the door	-	Locate the sign at permanent rooms alongside the door on the latch side.	1	Labor	Labor
<b>Operable Parts / Reach Range</b>												
22	Building Department	1	11	Operable Parts / Reach Range	Filers

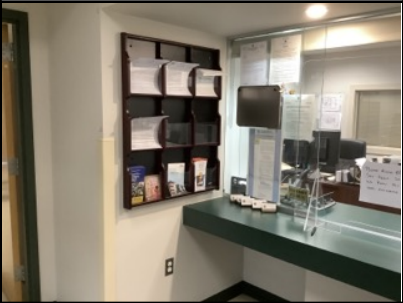
Side reach > 54"	68"	Relocate the informational fliers so that they are between 15" - 48" above the finished floor.	1	333	\$333
23	By Men's and Women's Multi-User Toilet Rooms	1		Operable Parts / Reach Range	Other

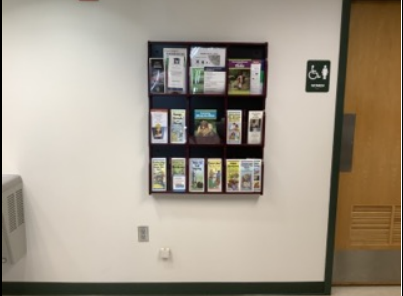
Side reach > 54"	62"	Relocate the informational fliers so that they are between 15" - 48" above the finished floor.	1	333	\$333

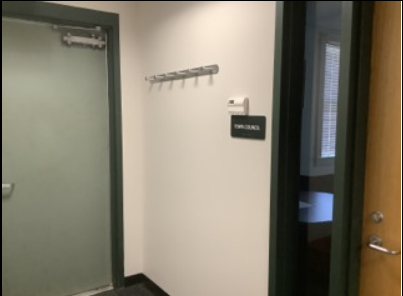
24	By North Egress Door by Town Council	1		Operable Parts / Reach Range	Clothes Rod/Hooks

Side reach > 54"	68"	Relocate the coat hooks so that they are between 15" - 48" above the finished floor.	1	333	\$333

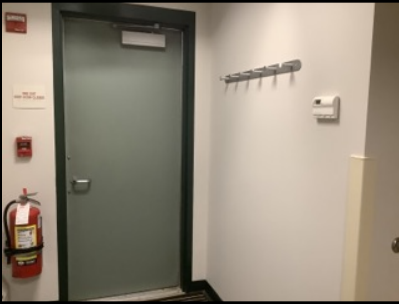
ID	Location	Floor	Room	Element	Type	Photo	Issues	Current Measure	Recommendations	Quantity	Price	Cost Estimation
25	By Northwest Egress Door by Planning, Zoning, Community and Economic Development	1		Operable Parts / Reach Range	Clothes Rod/Hooks

Side reach > 54"	68"	Relocate the coat hooks so that they are between 15" - 48" above the finished floor.	1	333	\$333
26	Women's Multi-User Toilet Room	1		Operable Parts / Reach Range	Clothes Rod/Hooks

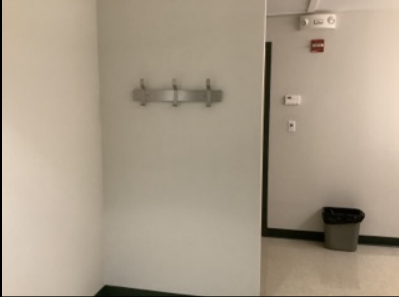
Side reach > 54"	57.5"	Relocate the coat hooks so that they are between 15" - 48" above the finished floor.	1	333	\$333
<div style="border: 1px solid gray; padding: 2px; margin-bottom: 5px;">Toilet &amp; Bathing Rooms</div> <div style="border: 1px solid gray; padding: 2px;">Toilet Compartment</div>												
27	Women's Multi-User Toilet Room	1		Toilet Compartment	Accessible Compartment

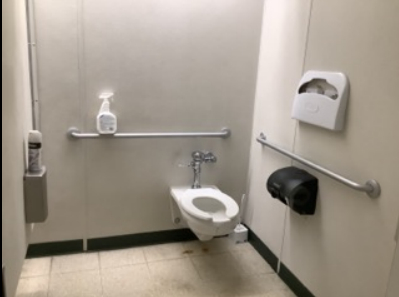
Noncompliant toilet cover dispenser Side grab bar < 54" from back wall	- 48.75"	Relocate toilet cover dispenser so that it is not located over the grab bar. Provide a side wall grab bar that is 42" long min. located 12" max. from the rear wall.	1	333 333	\$666

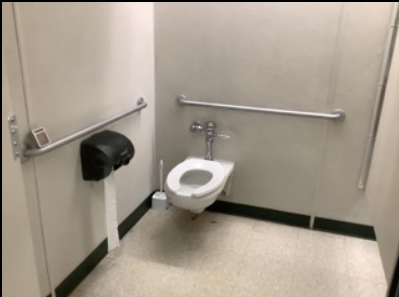
28	Men's Multi-User Toilet Room	1		Toilet Compartment	Accessible Compartment

Clearance at toilet < 72" clear depth (MAAB) Side grab bar < 54" from back wall	68.25" 51"	Relocate or rebuild the partition to the compartment to provide a wheelchair accessible compartment that is 60" wide and 72" deep. Provide a side wall grab bar that is 42" long min. located 12" max. from the rear wall.	1	8037	\$8037
29	Men's Multi-User Toilet Room	1		Toilet Compartment	Accessible Compartment

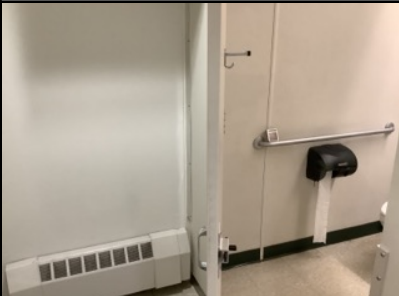
Door pull not provided	-	Provide a door pull on each side of the door between 34" to 48" above the finished floor that does not require tight grasping, pinching or twisting of the wrist.	1	91	\$91

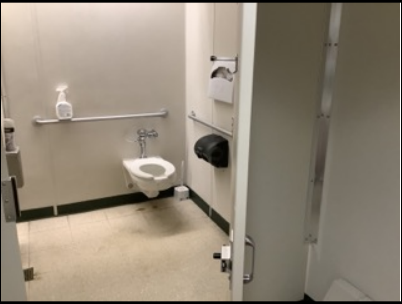
ID	Location	Floor	Room	Element	Type	Photo	Issues	Current Measure	Recommendations	Quantity	Price	Cost Estimation
30	Women's Multi-User Toilet Room	1		Toilet Compartment	Accessible Compartment

Door pull not provided	-	Provide a door pull on each side of the door between 34" to 48" above the finished floor that does not require tight grasping, pinching or twisting of the wrist.	1	91	\$91
<div style="border: 1px solid gray; padding: 2px;">Additional Access</div> <div style="border: 1px solid gray; padding: 2px; margin-top: 5px;">Sink</div>												
31	By Mechanical Room	1		Sink	N/A

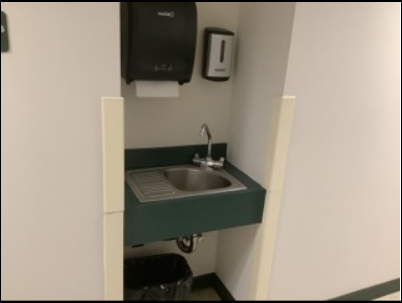
Clear floor space not provided at sink Exposed plumbing underneath sink	27.25" -	Provide a 30" by 48" clear floor space positioned for a forward approach. Insulate or otherwise configure pipes at sink. * Cost requires further analysis.	1	-	-
<div style="border: 1px solid gray; padding: 2px;">Best Practice</div> <div style="border: 1px solid gray; padding: 2px; margin-top: 5px;">Doors, Doorways, &amp; Gates</div>
