# Westwood Fire Department – Main Fire Station

## Town of Westwood ADA Transition Plan

May 2023

Institute for Human Centered Design

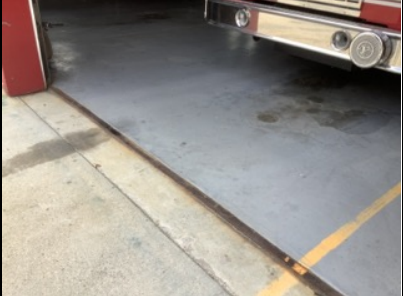
Surface openings > 1/2"	1.5"	Repair the surface opening to be 1/2" max. wide at the transition from the exterior to the apparatus bays.	1	-	-
2	East Parking Lot to Main Entrance	Ext.		Exterior Access Route	Walkway

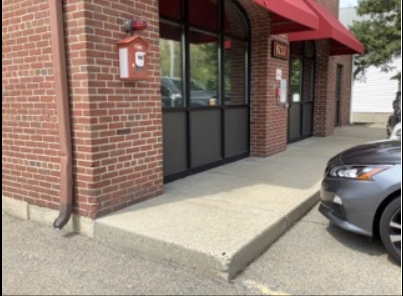
Accessible route not provided	-	Ensure an accessible route is provided to the main entrance from the parking lot. Cost estimate is for a curb ramp.	1	3640	\$3640
											<b>3640</b>	
<div style="border: 1px solid black; padding: 2px;">Off-Street Parking Lot or Garage</div>												
3	East Parking Lot	Ext.		Off-Street Parking Lot or Garage	Visitor

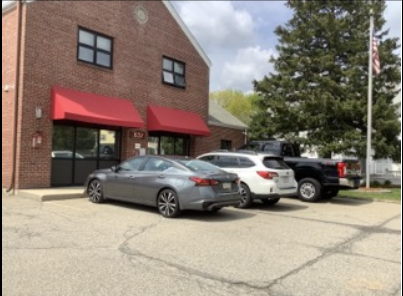
Total # of parking Total # of designated car accessible parking spaces Total # of designated van accessible spaces Van space < 132" or <96" wide Access aisle not provided Sign with the International Symbol of Acc. not provided Sign does not have the designation "Van Accessible"	3 0 0 - - -	Provide a van accessible space and marked access aisle that are both at least 96" wide. Provide a sign with the International Symbol of Accessibility (ISA) with the bottom of the sign 60" min. above the ground and the top 96" max. above the ground. Add the designation "Van Accessible" to the sign located at the van accessible space.	1	2405	\$2405

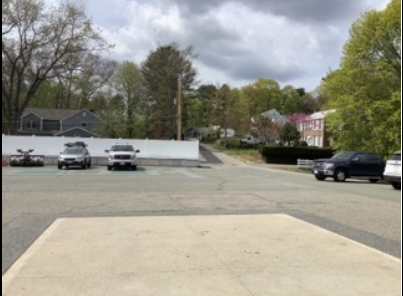
Total # of parking Total # of designated car accessible parking spaces Total # of designated van accessible spaces Van space < 132" or <96" wide Access aisle not provided Sign with the International Symbol of Acc. not provided Sign does not have the designation "Van Accessible"	10 0 0 - - -	Provide a van accessible space and marked access aisle that are both at least 96" wide. Provide a sign with the International Symbol of Accessibility (ISA) with the bottom of the sign 60" min. above the ground and the top 96" max. above the ground. Add the designation "Van Accessible" to the sign located at the van accessible space.	1	2405	\$2405
											<b>2405</b>

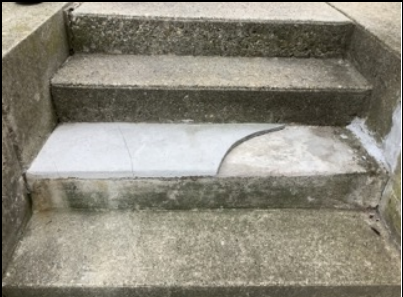
Not maintained in operable working condition	-	Repair the crack and missing portion of the stair tread to ensure stairs are maintained in operable working condition.	1	-	-
6	North Exterior Stair	Ext.		Exterior Stair	N/A

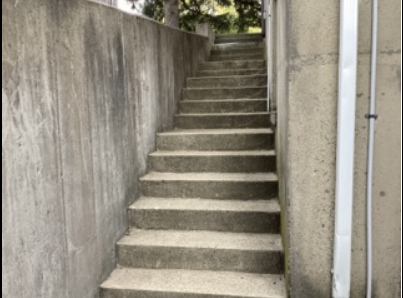
Handrails not provided	-	Provide handrails on both sides of the stair.	2	2886	\$5772
											<b>5772</b>	
<b>Access to Goods and Services</b>												
<b>Means of Egress</b>												
7	Main Egress Door	1		Means of Egress	N/A

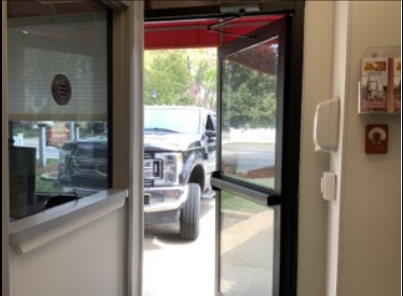
Tactile exit sign not provided Illuminated ISA symbol not provided (MAAB)	- -	Ensure that a tactile exit sign with raised characters and braille is provided at the exit door. Mount the sign between 48" - 60" above the finished floor located on the latch side of the door. When or if an illuminated exit sign is provided, provide an illuminated sign with the International Symbol of Accessibility (ISA).	1	302 -	\$302

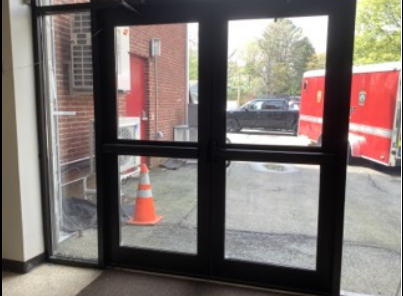
Tactile exit sign not provided Illuminated ISA symbol not provided (MAAB)	-	Ensure that a tactile exit sign with raised characters and braille is provided at the exit door. Mount the sign between 48" - 60" above the finished floor located on the latch side of the door. When or if an illuminated exit sign is provided, provide an illuminated sign with the International Symbol of Accessibility (ISA).	1	302 -	\$302
											<b>302</b>	
9	Northwest Egress Door	B		Means of Egress	N/A

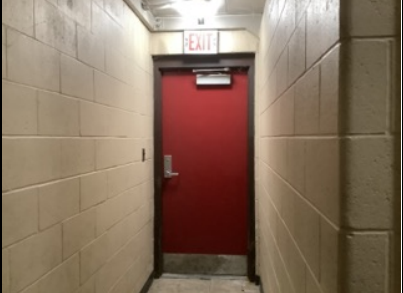
Tactile exit sign not provided Directional sign to accessible emergency exit not provided	- -	Ensure that a tactile exit sign with raised characters and braille is provided at the exit door. Mount the sign between 48" - 60" above the finished floor located on the latch side of the door. Provide a directional sign indicating the location of the nearest accessible emergency exit.	1	302 302	\$604

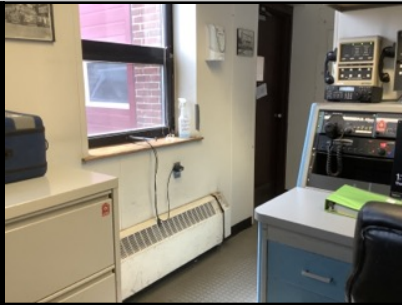
Route < 36" wide	24.5"	Relocate the tan cabinet to ensure that a clear width of 36" min. is maintained at the accessible route.	1	Labor	Labor
11	To Fire Prevention/ Basement			Interior Access Route	N/A

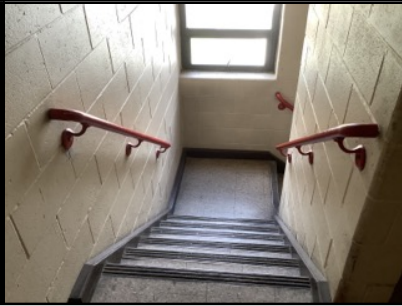
Accessible vertical route not provided	-	To achieve program access, IHCD recommends that staff from offices in the basement meet with members of the public on the first floor.	1	-	-
<b>Doors, Doorways, &amp; Gates</b>												
12	Main Egress Door	1		Doors, Doorways, & Gates	Emergency Egress

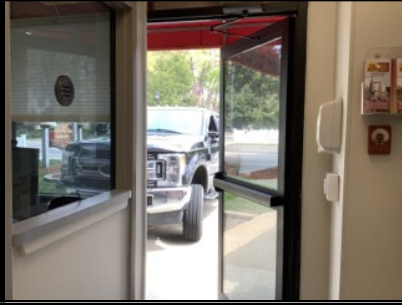
Maneuvering clearance(s) not provided	-	Provide an automatic door opener.	1	3978 -	\$3978
											<b>3978</b>	
13	Dispatch to Apparatus Bay (Truck Bay)	1		Doors, Doorways, & Gates	Toilet Room

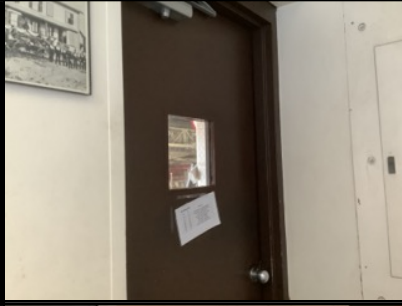
Hardware not compliant		Provide hardware that can be operable with one hand and not require tight grasping, pinching, or twisting of the wrist.	1	629	\$629

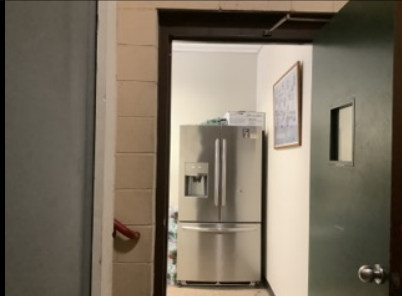
Hardware not compliant	-	Provide hardware that can be operable with one hand and not require tight grasping, pinching, or twisting of the wrist.	1	629	\$629
											<b>629</b>

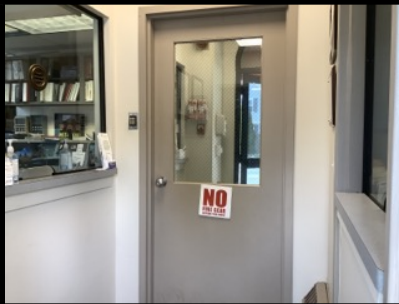
Maneuvering clearance(s) not provided Hardware not compliant	10" -	Reverse the swing of the door to provide maneuvering clearance. Provide hardware that can be operable with one hand and not require tight grasping, pinching, or twisting of the wrist.	1	2449 629	\$3078
											<b>3078</b>	
16	Single-User Toilet Room	1		Doors, Doorways, & Gates	Toilet Room

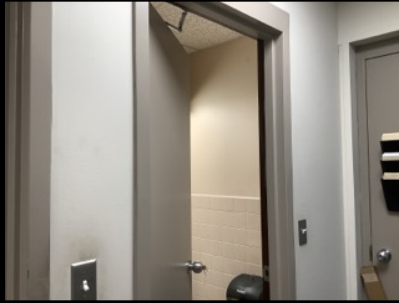
Clear width at door < 32" Threshold > 1/2" high Hardware not compliant Door requires > 5 lbs. of force to open	27" 0.75" - 13 lbs	Widen the door so that there is 32" min. clear width. Alter the threshold to be 1/2" high max. Provide hardware that can be operable with one hand and not require tight grasping, pinching, or twisting of the wrist. Adjust closers so doors do not require more than 5 pounds of force to open.	1	4376 195 629 Labor	\$5200

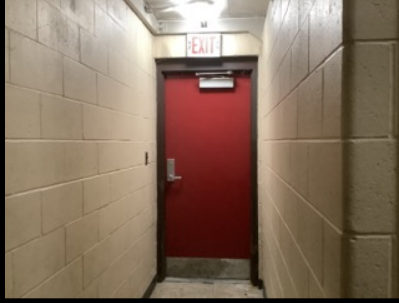
Door requires > 5 lbs. of force to open	-	Adjust closers so doors do not require more than 5 pounds of force to open.	1	Labor	Labor
18	Apparatus Bay (Truck Bay) to Stair	1		Doors, Doorways, & Gates	Circulation

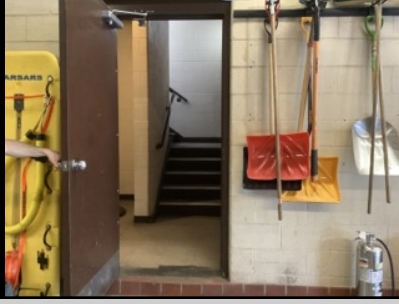
Threshold > 1/2" high Hardware not compliant Door requires > 5 lbs. of force to open	4.75" - 14 lbs	Rather than altering the threshold, the fire department can achieve program access by having fire department staff from the basement offices meet with the public in an accessible area on the first floor. Provide hardware that can be operable with one hand and not require tight grasping, pinching, or twisting of the wrist. Adjust closers so doors do not require more than 5 pounds of force to open.	1	629 Labor	\$629
											<b>629</b>	
<b>Stairways</b>												
19	Staircase			Stairways	Egress

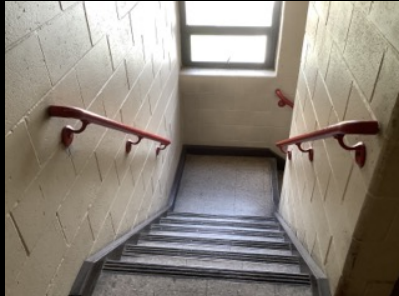
Handrail height < 34" or > 38" Handrails do not extend 12" from stairs Handrails not continuous where required	39" - -	Alter so the handrails are 34"- 38" high above the floor. Top: Ensure handrails extend horizontally above the landing for 12" min. beginning above the first riser nosing. Bottom: Ensure handrails extend at least 12" plus the width of one tread depth beyond the last riser. Provide continuous handrails.	2	Labor 2886	\$5772

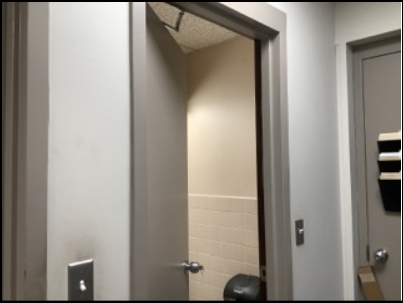
Signage is not provided	-	Locate compliant signage with raised characters and braille alongside the door on the latch side. After the single-user toilet room is brought into full compliance, provide a sign with the International Symbol of Accessibility.	1	302	\$302
											<b>302</b>	
21	Assistant Chiefs Office	B		Signage	Designation

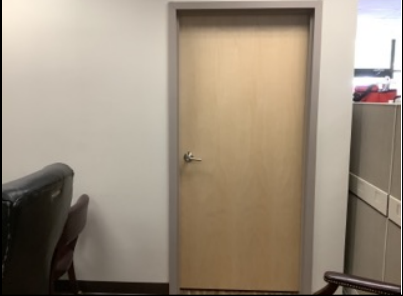
Signage is not provided	-	Locate compliant signage with raised characters and braille alongside the door on the latch side.	1	302	\$302
											<b>302</b>	
22	Main Entrance	Ext.		Signage	Designation

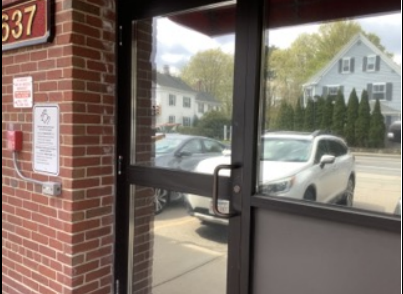
Signage is not provided	-	Locate compliant signage with raised characters and braille alongside the door on the latch side.	1	450	\$450
											<b>450</b>	
23	West Secondary Entrance and Northwest Egress Door	Ext.		Signage	Designation

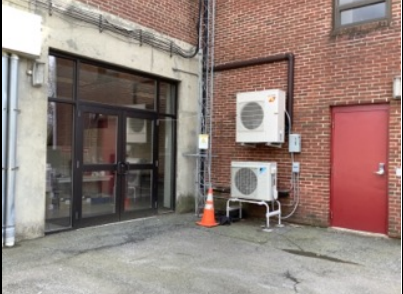
Signage is not provided	-	Locate compliant signage with raised characters and braille alongside the door on the right side of the double doors.	1	450	\$450

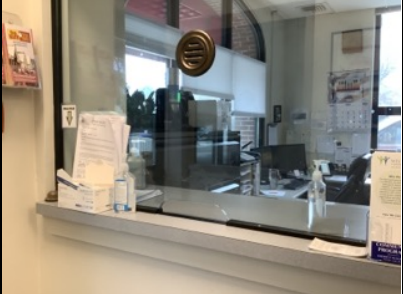
Counter > 36" high	44.5"	Provide a counter that is 36" max. above the finished floor.	1	880	\$880
											<b>880</b>	
<b>Toilet &amp; Bathing Rooms</b>

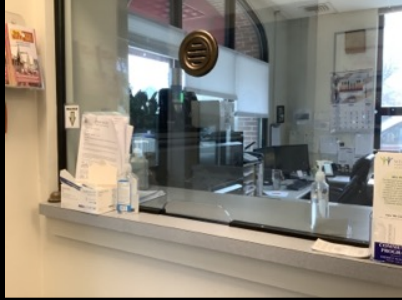
64.5"	Recommend providing an additional speak-through hole at a lower height for wheelchair users and persons of short stature.	1	-	-
<b>Stairs</b>												
30	North Exterior Stair	Ext.		Stairs	Exterior

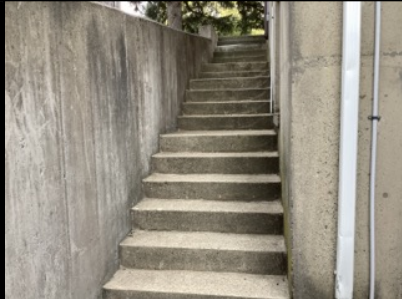
-	Recommend providing contrast strips on the treads of the exterior stair.	1	-	-
