Westwood Town Hall

Town of Westwood ADA Transition Plan

June 2023

Institute for Human Centered Design

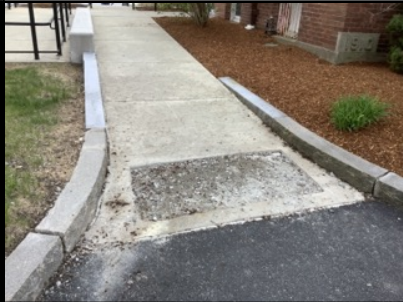
Route not maintained in operable working condition	-	Ensure the detectable warning at the curb ramp is replaced to ensure it is maintained in operable working condition. Cost estimate is for a new detectable warning.	1	468	\$468
											468	
<div style="border: 1px solid black; padding: 2px;">Off-Street Parking Lot or Garage</div>												
2	East Parking Lot	Ext.		Off-Street Parking Lot or Garage	Visitor

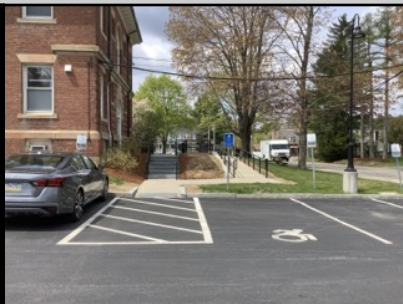
Total # of parking Total # of designated car accessible parking spaces Total # of designated van accessible spaces Access aisle < 96" wide at van space Sign does not have the designation "Van Accessible" International Symbol of Acc. not compliant	38 1 0 94" - -	Ensure that one van accessible parking space is provided in this parking lot. Provide a marked access aisle that is at least 96" wide. Add the designation "Van Accessible" to the sign located at the van accessible space. Ensure that the sign contains the required International Symbol of Accessibility (ISA).	1	390 650 650	\$1690

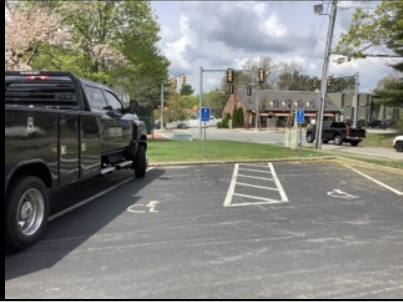
Total # of parking Total # of designated car accessible parking spaces Total # of designated van accessible spaces Access aisle < 96" wide at van space Sign does not have the designation "Van Accessible" International Symbol of Acc. not compliant	9 2 0 49" - -	Re-stripe the right-most parking space to provide one van accessible parking space and marked access aisle that are both 96" wide min. in this parking lot. Add the designation "Van Accessible" to the sign located at the van accessible space. Ensure that both signs contain the required International Symbol of Accessibility (ISA).	1	390 650 650	\$1690
											1690	
<div style="border: 1px solid black; padding: 2px;">Exterior Ramp</div>												
4	East Parking Lot to North Secondary Entrance	Ext.		Exterior Ramp	N/A

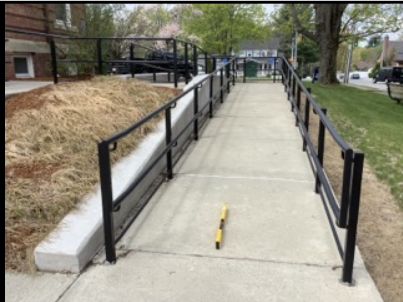
Running slope > 1:12 (8.33%) Landing < 60" min. long Edge protection < 4" high	8.7% 53" -	Reduce running slope to be no steeper than 1:12 (8.33%). Rebuild the ramp to provide a 60" min. deep landing at the top of the ramp. Provide edge protection that prevents the passage of a 4" diameter sphere, where any portion of the sphere is within 4" of the finished floor or ground surface.(Cost estimated for a new 30' long straight concrete ramp and landing.)	1	46025	\$46025

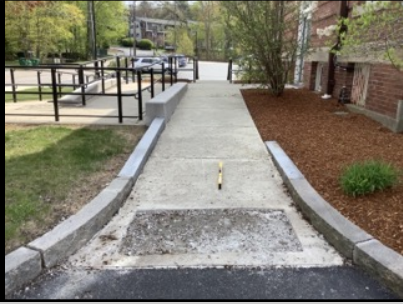
No top or bottom landing provided Handrails are not provided	- -	Provide landing at the top and bottom of ramp. (Cost estimated for two 4' x 5' wide concrete landings.) Provide handrails with 1-1/4" to 1-1/2" circular cross sections on each side of the ramp. (Approx. 25' in length of handrails are estimated based on the measured distance.)	1	416 416 1850 1850	\$4532
Exterior Stair												
6	Main Entrance	Ext.		Exterior Stair	N/A

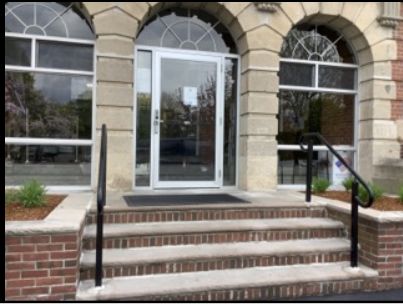
Handrails do not extend 12" from stair	4"	Bottom: Ensure handrails extend to at least 12" plus the width of one tread beyond the bottom riser.	2	822	\$1644
Entrance												
7	Secondary Entrance	Ext.		Entrance	Secondary Entrance

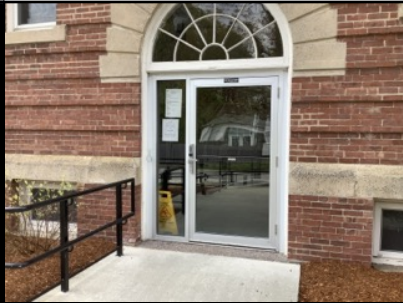
Directional sign to accessible entrance not provided	-	Provide a directional sign indicating the location of the nearest accessible entrance when an accessible entrance is built.	1	450	\$450

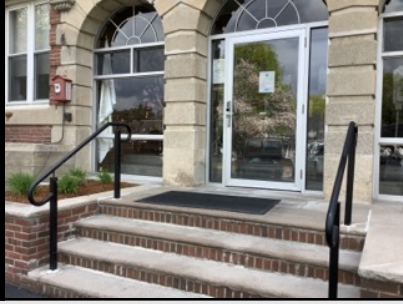
8	West Main Entrance	1		Entrance	Main Entrance

Directional sign to accessible entrance not provided Door requires > 15 lbs. of force to open	- 20 lbs	Provide a directional sign indicating the location of the nearest accessible entrance when an accessible entrance is built. Adjust closers so doors do not require more than 15 pounds of opening force.	1	450 Labor	\$450
Access to Goods and Services

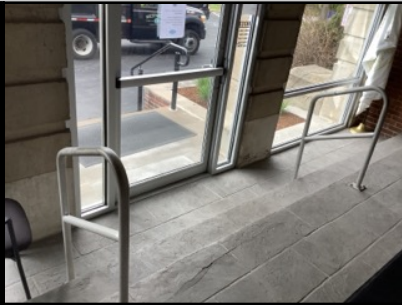
Handrail height < 34" or > 38" Handrails do not extend 12" from stairs	39" -	Alter so the handrails are 34"- 38" high above the floor. Top: Ensure handrails extend horizontally above the landing for 12" min. beginning above the first riser nosing. Bottom: Ensure handrails extend to at least 12" plus the width of one tread beyond the bottom riser.	2	822	\$1644
											1644	
20	North Stair	2		Stairways	Egress

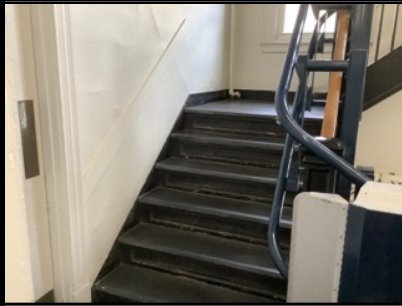
Handrail not provided on both sides	-	Provide handrails on each side. Refer to Record ID #21 for total costs for handrails at this staircase.	2	-	-
21	North Stair	2		Stairways	Egress

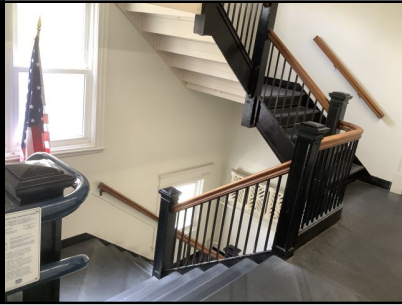
Handrails do not extend 12" from stairs Handrails not continuous where required	- -	Top: Ensure handrails extend horizontally above the landing for 12" min. beginning above the first riser nosing. Bottom: Ensure handrails extend to at least 12" plus the width of one tread beyond the bottom riser. Provide continuous handrails. (Cost estimate is for providing handrails on both sides between the first and second floor).	2	1716	\$3432

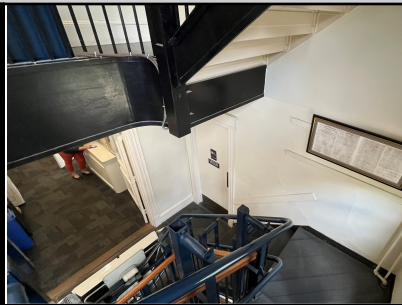
Accessibility issues include lack of an accessible entrance and lack of an accessible route between the first floor, and second floor. Although an inclined lift is provided, it is not in operable working condition and the headroom clearance of the lift does not comply with ASME A18.1. Due to this issue, IHCD recommends that the Town research the feasibility of installing a limited use limited application (LULA) elevator and an accessible entrance. Additionally, the Town can choose to relocate programs to an accessible location. The current practice of meeting members of the public who cannot negotiate stairs in the parking lot is not an integrated setting or an appropriate solution.

Not maintained in operable working condition Headroom clearance does not comply with ASME A18.1	- 72.75"	As the headroom clearance does not comply with ASME A18.1, look into providing a limited use limited application (LULA) elevator and an accessible entrance to provide access between the exterior, first floor and second floor. Ensure that accessible features are maintained in operable working condition. (Cost estimate is for installing a LULA elevator.)	1	89296	\$89296
											89296	
Signage												
23	West Main Entrance	1		Signage	Designation

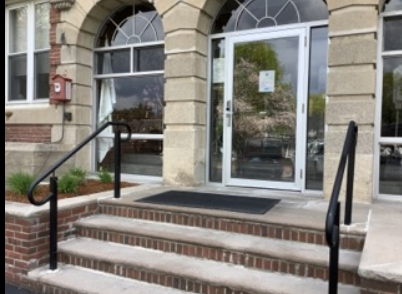
Signage is not provided	-	Locate compliant signage with raised characters and braille alongside the door on the latch side.	1	302	\$302
											302

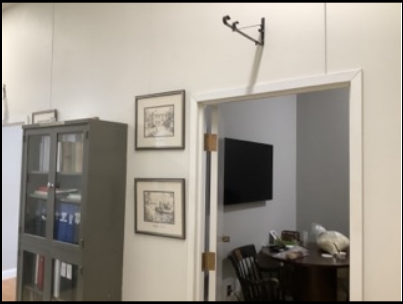
Signage is not provided	-	Locate compliant signage with raised characters and braille alongside the door on the latch side.	1	302	\$302
											302	
25	Finance Director	1		Signage	Designation

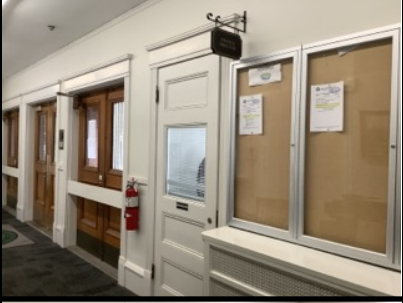
Raised characters not provided on sign Braille not provided on sign Sign not located on the latch side of the door	- - -	Provide text with raised characters duplicated in braille on the sign. Locate the sign at permanent rooms alongside the door on the latch side.	1	302 Labor	\$302
											302	
26	Town Administrator	2		Signage	Designation

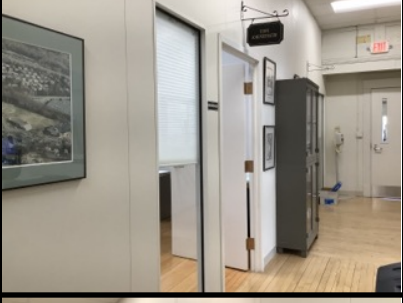
Raised characters not provided on sign Braille not provided on sign Sign not located on the latch side of the door	- - -	Provide text with raised characters duplicated in braille on the sign. Locate the sign at permanent rooms alongside the door on the latch side.	1	302 Labor	\$302

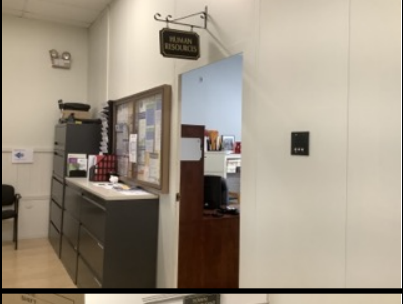
Raised characters not provided on sign Braille not provided on sign Sign not located on the latch side of the door	- - -	Provide text with raised characters duplicated in braille on the sign. Locate the sign at permanent rooms alongside the door on the latch side.	1	302 Labor	\$302
											302	
28	Town Accountant	2		Signage	Designation

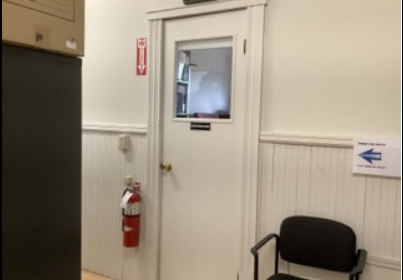
Raised characters not provided on sign Braille not provided on sign Sign not located on the latch side of the door Signage lacks 18" by 18" clear floor space	- - - -	Provide text with raised characters duplicated in braille on the sign. Provide braille on the sign. Locate the sign at permanent rooms alongside the door on the latch side. Relocate fire extinguisher to provide a clear floor space of 18" min. by 18" min. at the sign.	1	302 Labor	\$302
											302

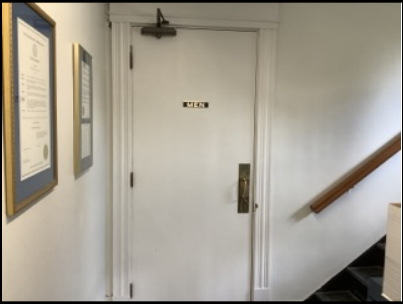
<ul style="list-style-type: none"> Raised characters not provided on sign Braille not provided on sign Sign not located on the latch side of the door Directional sign to access. toilet not provided 	-	<ul style="list-style-type: none"> Provide text with raised characters duplicated in braille on the sign. Locate the sign at permanent rooms alongside the door on the latch side. Install a sign indicating the location of the nearest accessible toilet room (the women's toilet room that we recommend converting into a single-user toilet room). 	1	302 302 Labor	\$604
30	Women's Multi-User Toilet Room	2		Signage	Designation

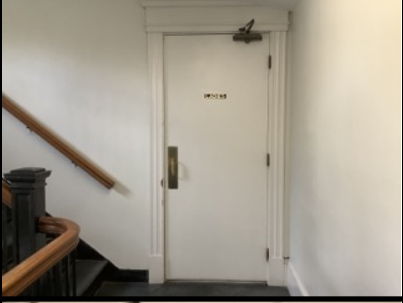
<ul style="list-style-type: none"> Raised characters not provided on sign Braille not provided on sign Sign not located on the latch side of the door International Symbol of Acc. not provided 	-	<ul style="list-style-type: none"> Provide text with raised characters duplicated in braille on the sign. Recommend changing this toilet room into an all gender single-user toilet room. Locate the sign at permanent rooms alongside the door on the latch side. Provide a sign containing the International Symbol of Accessibility (ISA) after the toilet room is brought into compliance. 	1	302 Labor	\$302

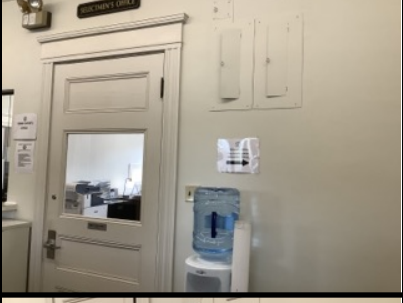
31	Selectman's Office	1		Signage	Designation

<ul style="list-style-type: none"> Raised characters not provided on sign Braille not provided on sign Signage lacks 18" by 18" clear floor space 	-	<ul style="list-style-type: none"> Provide text with raised characters duplicated in braille on the sign. Provide braille on the sign. Relocate the furniture to provide a clear floor space of 18" min. by 18" min. and ensure the sign is located on the latch side of the door. 	1	302 Labor	\$302
32	By Town Clerk and Registrar's Office	1		Signage	Directional

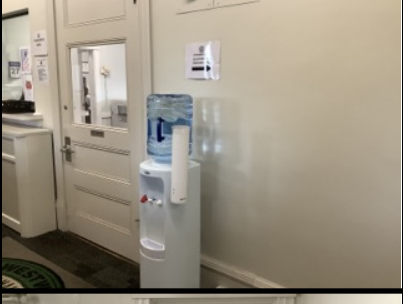
<ul style="list-style-type: none"> Non-glare finish and contrast not provided on sign 	-	<ul style="list-style-type: none"> Install a sign with a non-glare finish. 	1	302	\$302
33	Women's Multi-User Toilet Room	1		Signage	Designation

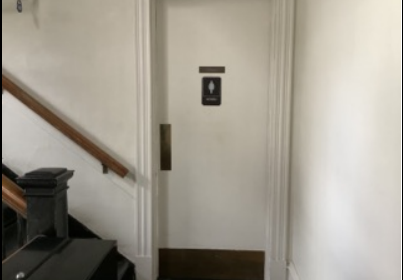
<ul style="list-style-type: none"> Directional sign to access. toilet not provided 	-	<ul style="list-style-type: none"> Install a sign indicating the location of the nearest accessible toilet room. 	1	302	\$302

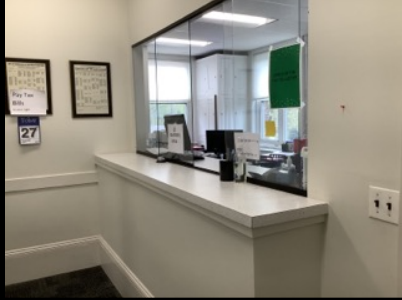
Counter > 36" high	42.75"	Provide a counter that is 36" max. above the finished floor.	1	880	\$880
											880	
35	Assessor's Department and Town Clerk and Registrar's Offices	1		Service Counter	N/A

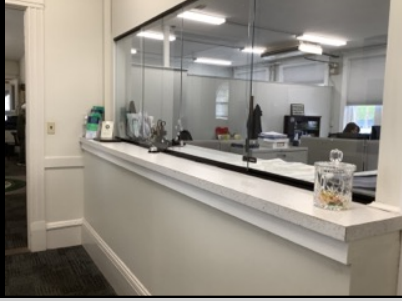
Counter > 36" high	42.75"	Provide a counter that is 36" max. above the finished floor.	2	880	\$1760
											1760	
Operable Parts / Reach Range												
36	Secondary Entrance Door Bell	Ext.		Operable Parts / Reach Range	Door Bell

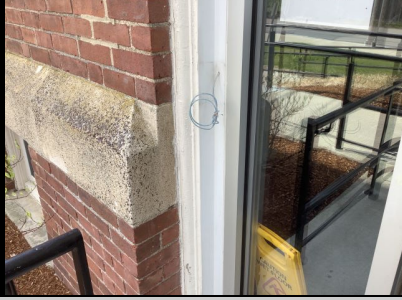
Not in operable working condition	-	This is loose wiring for a bell that the public can ring to alert the Town Hall when assistance is needed to enter. Staff will either meet outside with the public or on the first floor. Recommend repairing or replacing the bell, ensuring that there is 30" min. by 48" min. in front of the bell, and providing signage at the bell with directions for the public until an accessible route is provided throughout the building.	1	Labor 450	\$450

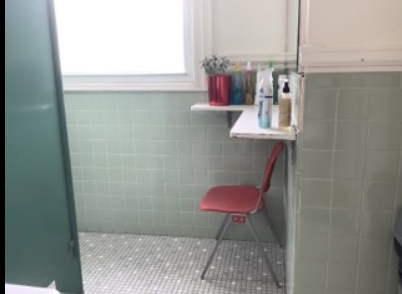
Top of dining/work surface < 28" or > 34"	41.5"	Lower the work surface so that the top is between 28"- 34" above the floor and there is 27" clear height underneath.	1	459	\$459
											459

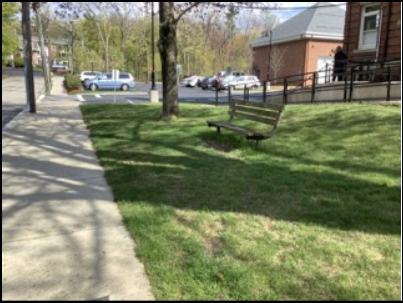
No accessible route to one bench in area	-	Provide an accessible route to one bench in this area.	1	-	-
Toilet & Bathing Rooms												
Overall Access												
39	Women's Multi-User Toilet Room	2		Overall Access	Toilet Room

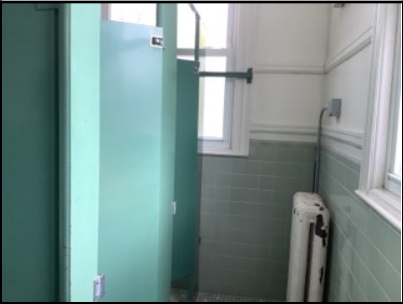
Accessible plumbing fixtures or stalls not provided Audible and visible alarm not provided	- -	Renovate the toilet room to an accessible single-user toilet room. When fire system is updated, ensure that a visible and audible fire alarm is installed.	1	31985 -	\$31985
											31985	
40	Single-User Toilet Room	1		Overall Access	Toilet Room

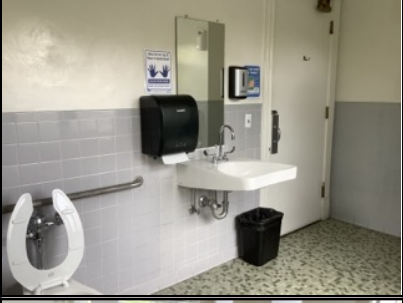
Audible and visible alarm not provided	-	When fire system is updated, ensure that a visible and audible fire alarm is installed.	1	-	-

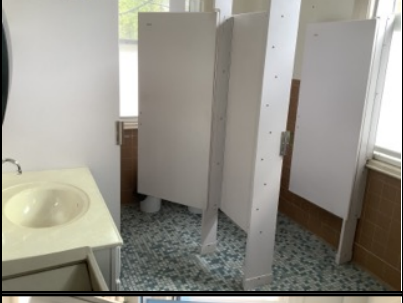
41	Women's Multi-User Toilet Room	1		Overall Access	Toilet Room

Audible and visible alarm not provided	-	When fire system is updated, ensure that a visible and audible fire alarm is installed.	1	-	-
42	Men's Multi-User Toilet Room	2		Overall Access	Toilet Room

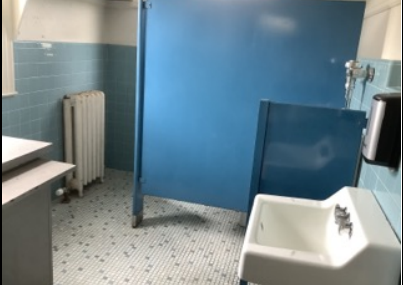
Audible and visible alarm not provided	-	When fire system is updated, ensure that a visible and audible fire alarm is installed.	1	Labor	Labor

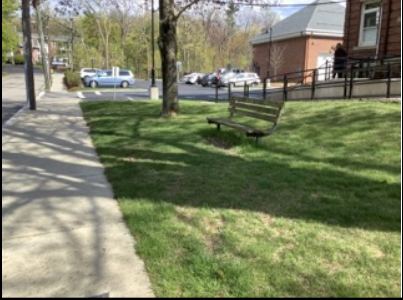
-	Recommend providing a 36" min. by 48" min. stable, firm and slip-resistant surface adjacent to at least one bench in a manner that is substantially similar to what is shown in the narrative report.	1	-	-
<div style="border: 1px solid gray; padding: 2px;">Signage</div>												
49	To West Main Entrance	Ext.		Signage	Directional

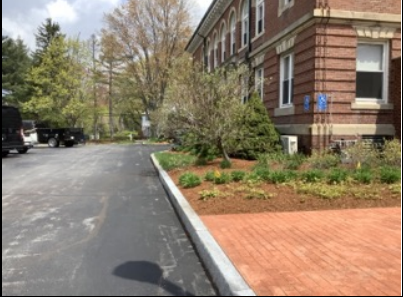
-	Recommend providing a bigger directional sign with a larger International Symbol of Accessibility (ISA), to ensure it can be identified from a distance.	1	-	-
<div style="border: 1px solid gray; padding: 2px;">Stairways</div>												
50	Stair to West Main Egress	1		Stairways	N/A

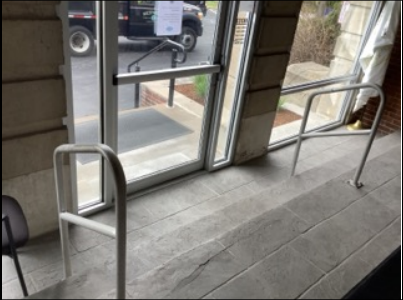
-	Recommend providing contrasting strips on all interior and exterior stair treads.	1	-	-
