# Wentworth Hall – Islington Branch Library

## Town of Westwood ADA Transition Plan

August 2023

Institute for Human Centered Design

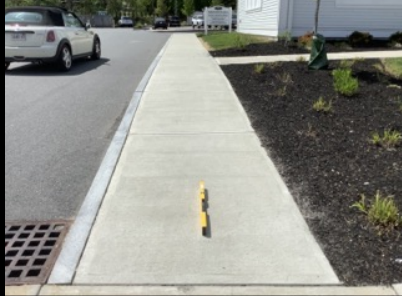
ID	Location	Floor	Room	Element	Type	Photo	Issues	Current Measure	Recommendations	Quantity	Price	Cost Estimation
<div style="border: 1px solid black; padding: 2px;">Approach and Entrance</div>												
<div style="border: 1px solid black; padding: 2px;">Exterior Access Route</div>												
1	Secondary Entrance to Main Entrance	Ext.		Exterior Access Route	Walkway

Running slope > 1:20 (5.00%)	7.9%	Reduce running slope to be no steeper than 1:20 (5.00%).	1	-	-
<div style="border: 1px solid black; padding: 2px;">Off-Street Parking Lot or Garage</div>												
2	West Parking Lot	Ext.		Off-Street Parking Lot or Garage	Visitor

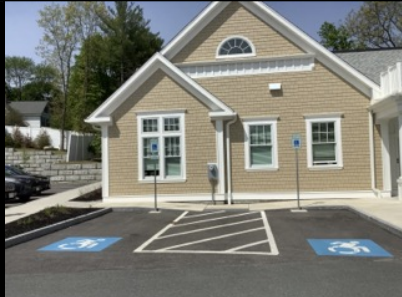
Total # of parking Total # of designated car accessible parking spaces Total # of designated van accessible spaces Sign does not have the designation "Van Accessible"	35 2 0 -	Add the designation "Van Accessible" to the sign located at the left-most van accessible space.	1	650	\$650

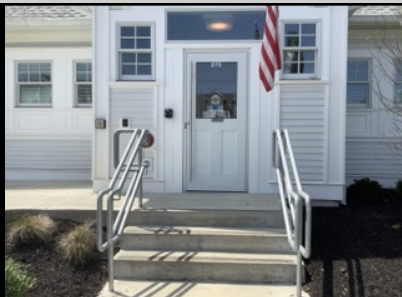
Handrail height < 34" or > 38"	40.5"	Alter so the handrails are 34"- 38" high above the finished floor or ground.	1	Labor	Labor
<div style="border: 1px solid black; padding: 2px;">Entrance</div>												
4	Secondary Entrance, West Egress	Ext.		Entrance	Secondary Entrance

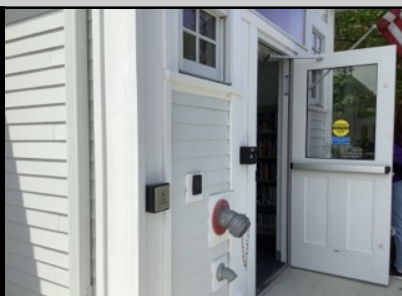
Door requires > 15 lbs. of force to open	18 lbs	Adjust closers so doors do not require more than 15 pounds of opening force.	1	Labor	Labor
<div style="border: 1px solid black; padding: 2px;">Access to Goods and Services</div>

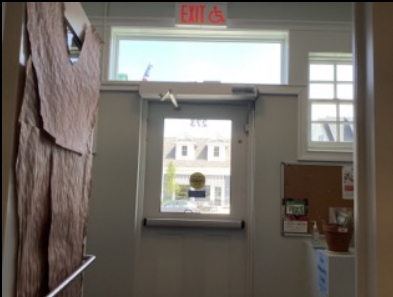
Tactile exit sign not provided	-	Ensure that a tactile exit sign with raised characters and braille is provided at the exit door. Mount the sign between 48" - 60" above the finished floor located on the latch side of the door.	1	302	\$302
											<b>302</b>	
6	North Egress Door, Stair 1	1		Means of Egress	N/A

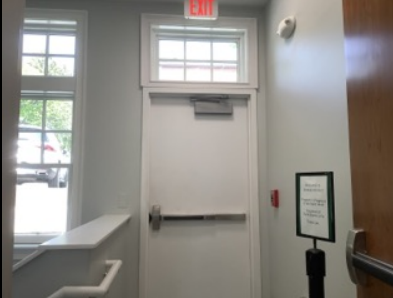
Tactile exit sign not provided Directional sign to accessible emergency exit not provided	- -	Ensure that a tactile exit sign with raised characters and braille is provided at the exit door. Mount the sign between 48" - 60" above the finished floor located on the latch side of the door. Provide a directional sign indicating the location of the nearest accessible emergency exit.	1	302 302	\$604

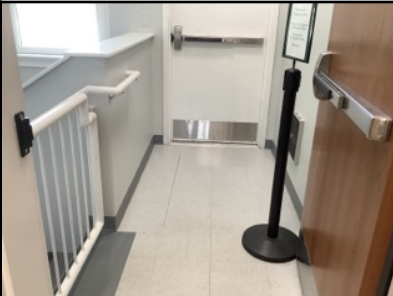
Route < 36" wide	31"	Relocate the stanchion pole to ensure that a clear width of 36" min. is maintained at the accessible route.	1	Labor	Labor
8	Stair 1	1		Interior Access Route	N/A

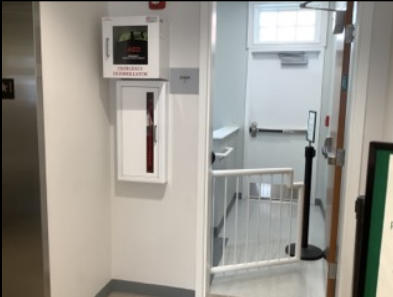
Obstructed by protruding objects	8.75"	Provide a cane-detectable barrier underneath the automatic external defibrillator (AED).	1	398	\$398
											<b>398</b>	
9	Library	1	102	Interior Access Route	N/A

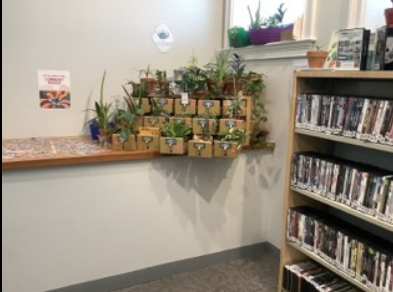
Obstructed by protruding objects	11.5"	Relocate the plant container or provide a cane-detectable barrier underneath it.	1	Labor	Labor

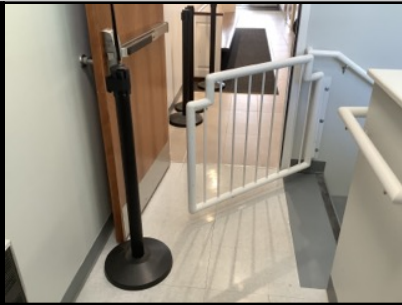
Maneuvering clearance(s) not provided	44"	Relocate the stanchion to provide 48" clear floor space at the gate.	1	Labor	Labor
11	Office	1	110	Doors, Doorways, & Gates	Office

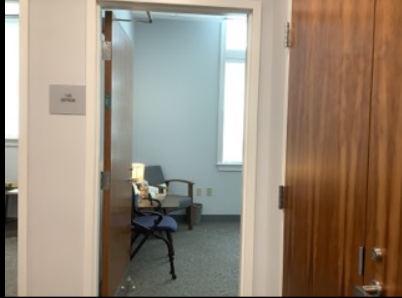
Maneuvering clearance(s) not provided	5"	Provide an automatic door opener.	1	3978	\$3978
											<b>3978</b>	
12	Office	1	110	Doors, Doorways, & Gates	Office

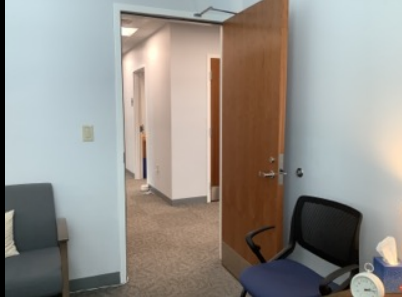
Maneuvering clearance(s) not provided	-	Relocate the dark blue chair to provide clear floor space at the doorway.	1	Labor	Labor
13	Stair 1	1		Doors, Doorways, & Gates	Circulation

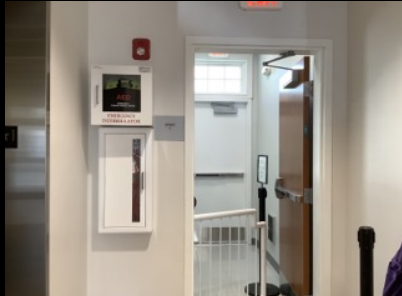
Maneuvering clearance(s) not provided Door requires > 5 lbs. of force to open	10.25" 10 lbs	Relocate the fire extinguisher to provide 12" min. of maneuvering clearance at the push side of the door. Adjust closers so doors do not require more than 5 pounds of force to open.	1	333 Labor	\$333

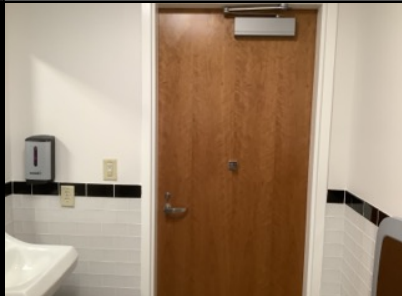
Door requires > 5 lbs. of force to open	10 lbs	Adjust closers so doors do not require more than 5 pounds of force to open.	1	Labor	Labor

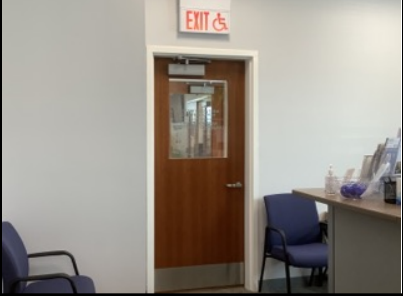
Door requires > 5 lbs. of force to open	10 lbs	Adjust closers so doors do not require more than 5 pounds of force to open.	1	Labor	Labor
16	Secondary Entrance, West Egress	1	123	Doors, Doorways, & Gates	Emergency Egress

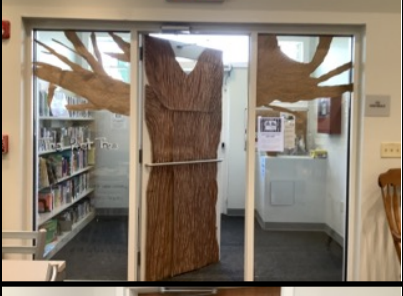
Door requires > 5 lbs. of force to open	15 lbs	Adjust closers so doors do not require more than 5 pounds of force to open.	1	Labor	Labor
17	Single-User Toilet Room	B		Doors, Doorways, & Gates	Toilet Room

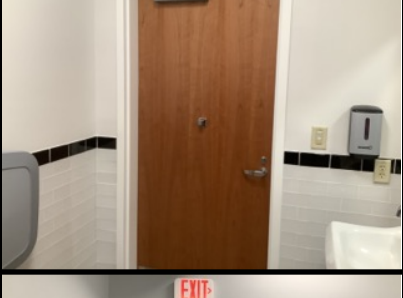
Door requires > 5 lbs. of force to open	10 lbs	Adjust closers so doors do not require more than 5 pounds of force to open.	1	Labor	Labor
18	Stair 2, Large Meeting Room	B		Doors, Doorways, & Gates	Other

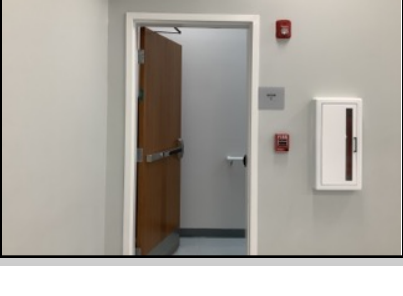
Door requires > 5 lbs. of force to open	11 lbs	Adjust closers so doors do not require more than 5 pounds of force to open.	1	Labor	Labor

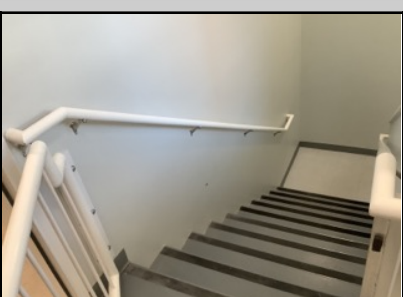
Handrail height < 34" or > 38"	39"	Alter so the handrails are 34"- 38" high above the floor.	2	Labor	Labor

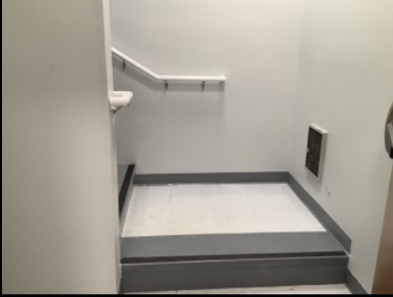
Handrail not provided on both sides Handrails do not extend 12" from stairs	- -	Provide handrails on both sides. Bottom: Ensure handrails extend at least 12" plus the width of one tread beyond the bottom riser. Alternatively, continue the extension by wrapping it around the corner of the wall.	1	1716 260	\$1976
<b>Elevator</b>												
21	Elevator	B		Elevator	Interior

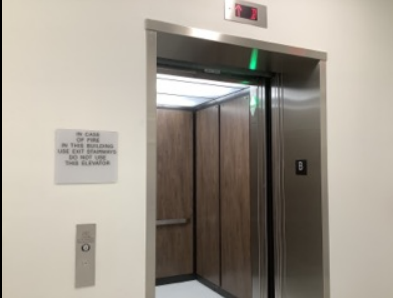
Audible & visible car position indicators not provided	-	Install audible car position indicators inside the elevator cabin.	1	2210	\$2210
<b>Signage</b>												
22	Main Egress	Ext.		Signage	Designation

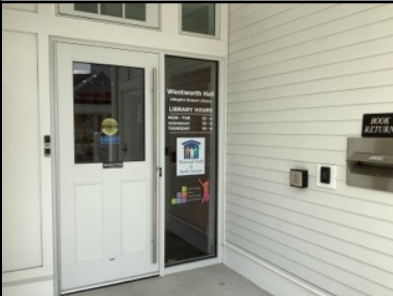
Signage is not provided	-	Provide a designation sign, located on the latch side of the door, that includes text with raised characters duplicated in braille on the sign.	1	450	\$450

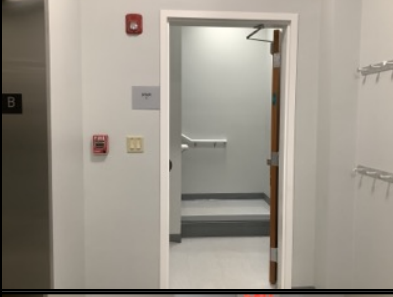
Raised characters < 48" or > 60" above ground	62"	Mount the sign so that the baseline of the lowest tactile character is 48" min. above finished floor and the baseline of the highest tactile character is 60" max. above the finished floor.	1	Labor	Labor
24	Stair 1	1		Signage	Designation

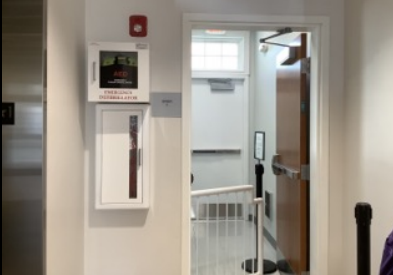
Raised characters < 48" or > 60" above ground Braille misplaced on sign	62" -	Mount the sign so that the baseline of the lowest tactile character is 48" min. above finished floor and the baseline of the highest tactile character is 60" max. above the finished floor. Position the braille below the corresponding text. If text is multi-lined place braille below the entire text.	1	Labor 302	\$302
<b>302</b>

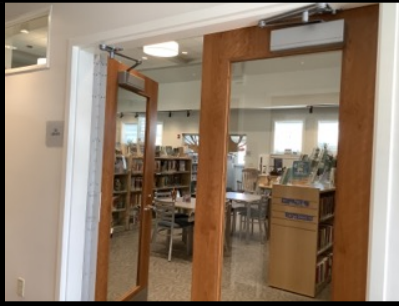
Raised characters < 48" or > 60" above ground Braille misplaced on sign	- -	Mount the sign so that the baseline of the lowest tactile character is 48" min. above finished floor and the baseline of the highest tactile character is 60" max. above the finished floor. Position the braille below the corresponding text. If text is multi-lined place braille below the entire text.	1	Labor 302	\$302
26	Youth and Family Services and Early Childhood Departments	1	108	Signage	Designation

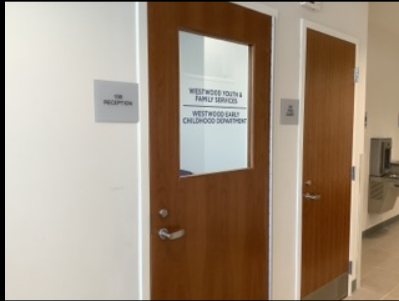
Raised characters < 48" or > 60" above ground Braille misplaced on sign Designation sign is incorrect	62" - -	Mount the sign so that the baseline of the lowest tactile character is 48" min. above finished floor and the baseline of the highest tactile character is 60" max. above the finished floor. Position the braille below the corresponding text. If text is multi-lined place braille below the entire text. Provide a sign with the correct room designation.	1	Labor 302	\$302

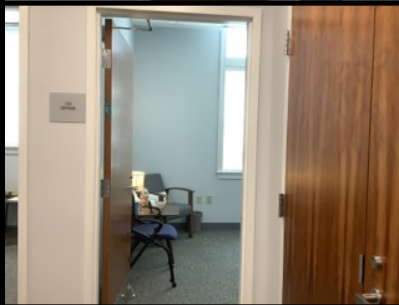
Raised characters < 48" or > 60" above ground Sign not located on the latch side of the door	61" -	Mount the sign so that the baseline of the lowest tactile character is 48" min. above finished floor and the baseline of the highest tactile character is 60" max. above the finished floor. Locate the sign at permanent rooms alongside the door on the latch side.	1	Labor	Labor
28	Stair 2, Large Meeting Room	B		Signage	Designation

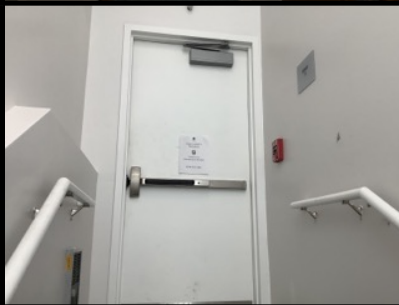
Raised characters < 48" or > 60" above ground Sign not located on the latch side of the door	62" -	Mount the sign so that the baseline of the lowest tactile character is 48" min. above finished floor and the baseline of the highest tactile character is 60" max. above the finished floor. Locate the sign at permanent rooms alongside the door on the latch side.	1	Labor	Labor
29	Large Meeting Room	B		Signage	Designation

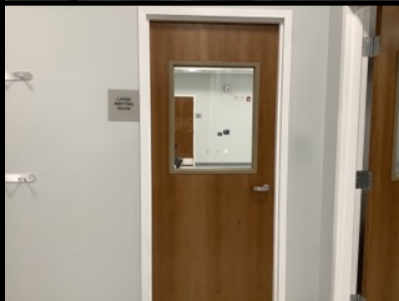
Sign not located on the latch side of the door	-	Locate the sign at permanent rooms alongside the door on the latch side.	1	Labor	Labor

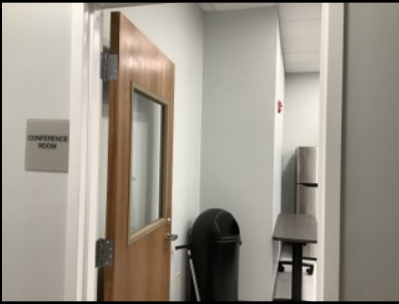
Sign not located on the latch side of the door	-	Locate the sign at permanent rooms alongside the door on the latch side.	1	Labor	Labor
31	Main Egress	Ext.		Signage	Informational

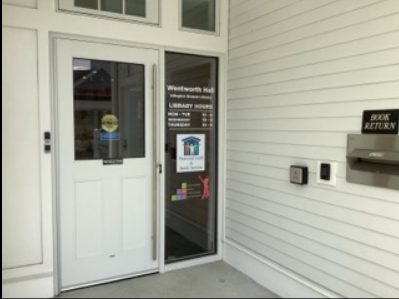
Non-glare finish and contrast not provided on sign	-	Install a sign with a non-glare finish.	1	450	\$450
											<b>450</b>	
32	Single-User Toilet Rooms	1		Signage	Designation

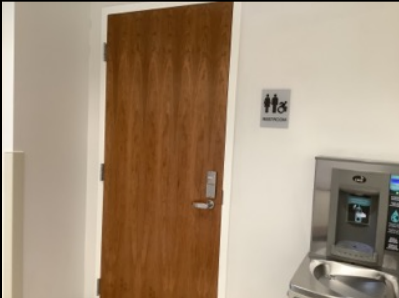
International Symbol of Acc. not compliant	-	Provide a sign with the required International Symbol of Accessibility (ISA).	2	302	\$604
											<b>604</b>	
<b>Service Counter</b>												
33	Lobby, Youth and Family Services and Early Childhood Departments	1	110	Service Counter	N/A

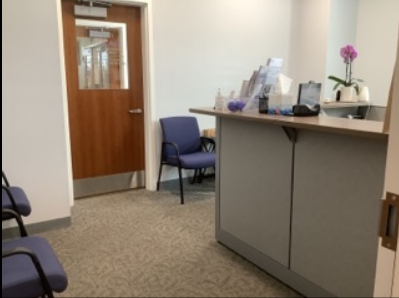
Counter > 36" high	43"	Provide a counter that is 36" max. above the ground or finished floor.	1	880	\$880

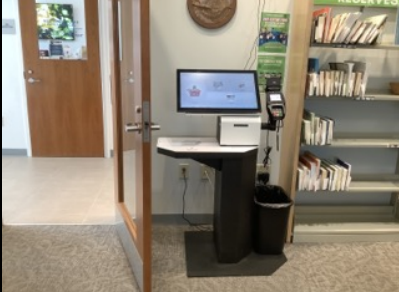
Clear floor space is not provided	-	Relocate the self-checkout kiosk to ensure a 30" min. by 48" min. clear floor space is provided.	1	Labor	Labor

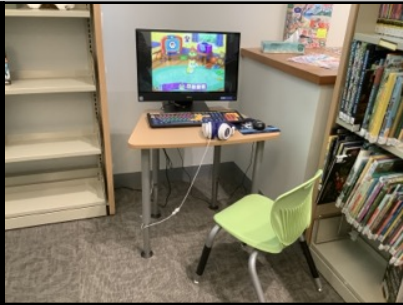
Knee or toe clearance not provided	19.5"	For children, provide at least one work surface with 24" min. high knee and toe clearance.	1	910	\$910
											<b>910</b>	
<b>Toilet &amp; Bathing Rooms</b>												
<b>Lavatory</b>												
36	Single-User Toilet Room	1		Lavatory	N/A

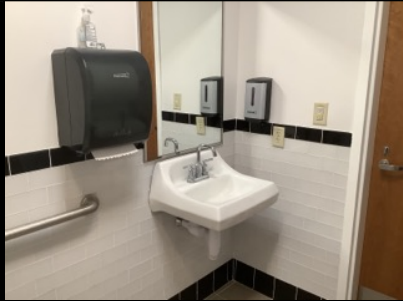
Toe or knee clearances not provided	26"	Provide at least one lavatory with knee and toe clearance positioned for a forward approach.	1	2192	\$2192
											<b>2192</b>	
<b>Single-User Toilet</b>												
37	Single-User Toilet Room	B		Single-User Toilet	N/A

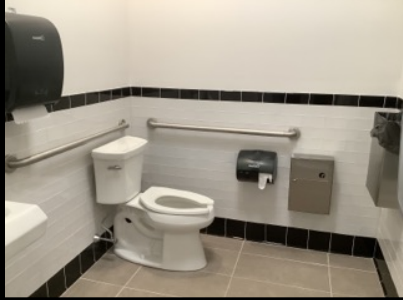
Side grab bar < 54" from back wall < 42" clear deep in front of toilet (MAAB) Item mounted over grab bar (MAAB)	49.75" 37" -	Provide a side wall grab bar that is 42" long min. located 12" max. from the rear wall. Relocate the mounted trash can to ensure that there is 42" clear deep min. in front of the toilet bowl. Relocate paper towel dispenser so that it is not mounted over the grab bar.	1	1167 459 459	\$2085

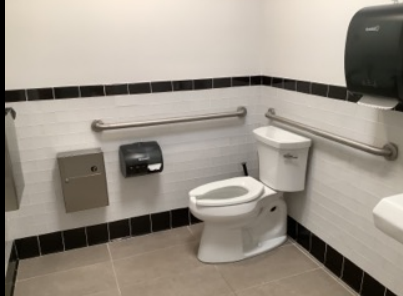
Side grab bar < 54" from back wall < 42" clear deep in front of toilet (MAAB) Item mounted over grab bar (MAAB)	49.75" 37" -	Provide a side wall grab bar that is 42" long min. located 12" max. from the rear wall. Relocate the mounted trash can to ensure that there is 42" clear deep min. in front of the toilet bowl. Relocate the paper towel dispenser so that it is not mounted over the grab bar.	1	1167 459 459	\$2085
											<b>2085</b>

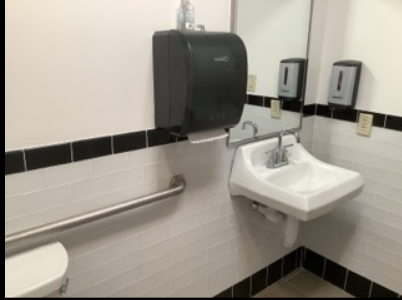
Dispenser acts as a protruding object	9.75"	When relocating the paper towel dispenser out of the circulation path, ensure a cane-detectable barrier, like a trash can, is placed underneath it.	1	Labor	Labor
40	Single-User Toilet Room	B		Dispensers	Paper Towel Dispenser

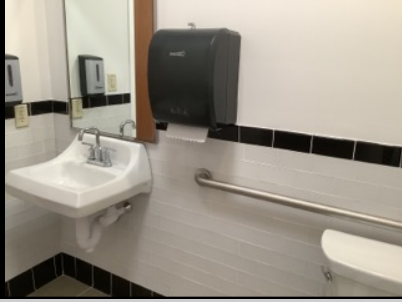
Dispenser acts as a protruding object	9.5"	When relocating the paper towel dispenser out of the circulation path, ensure a cane-detectable barrier, like a trash can, is placed underneath it.	1	Labor	Labor
<b>Baby Changing Table</b>												
41	Single-User Toilet Room	1		Baby Changing Table	N/A

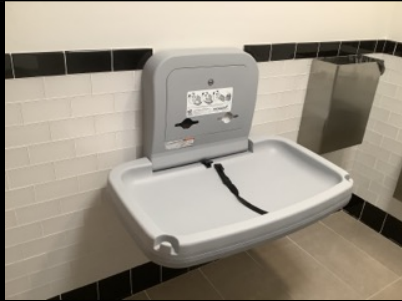
Changing table lacks 27" high knee clearance	24"	Ensure that the baby changing table surface has 27" high min. knee and toe clearance positioned for a forward approach.	1	459	\$459

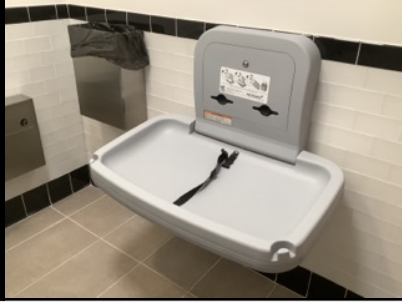
Changing table lacks 27" high knee clearance	22.5"	Ensure that the baby changing table surface has 27" high min. knee and toe clearance positioned for a forward approach.	1	459	\$459
<b>Best Practice</b>

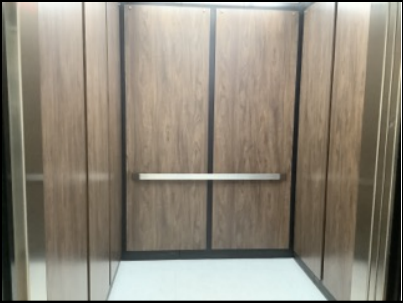
-	Recommend providing a handrail, located between 33"- 36" on all sides of the elevator walls.	2	-	-
<b>Interior Access Route</b>												
44	Elevator	1		Interior Access Route	N/A

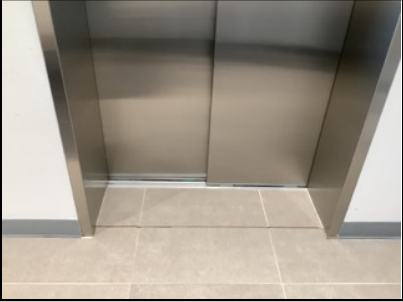
-	Recommend providing a contrast strip to prevent tripping at the compliant change in level.	1	-	-
<b>Parking Lot</b>												
45	West Parking Lot, Electric Vehicle Charging Station	Ext.		Parking Lot	Visitor

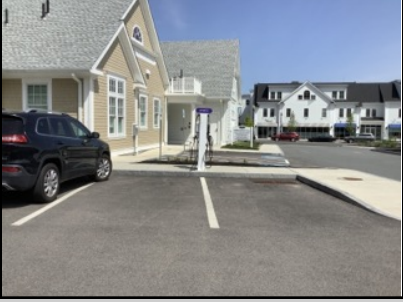
-	The ADA Standards do not include specific provisions for electric vehicle (EV) charging stations. However, it is advisable to address access to EV charging stations so that they are usable by people with disabilities. See <a href="https://www.access-board.gov/tad/ev/">https://www.access-board.gov/tad/ev/</a> for design recommendations.	1	-	-

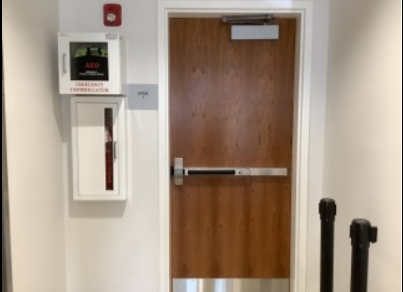
-	Recommend providing a cautionary sign to open the door slowly, as users could be ascending the staircase.	1	-	-
