# Community Tot-Lot

## Town of Westwood ADA Transition Plan

June 2023

Institute for Human Centered Design

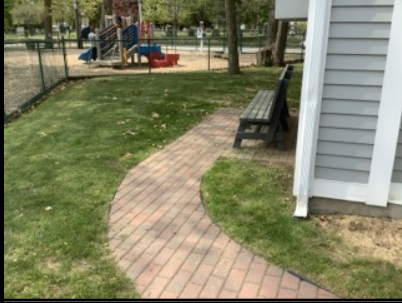
ID	Location	Floor	Room	Element	Type	Photo	Issues	Current Measure	Recommendations	Quantity	Price	Cost Estimation
<div style="border: 1px solid gray; padding: 2px;">Approach and Entrance</div>												
<div style="border: 1px solid gray; padding: 2px;">Exterior Access Route</div>												
1	North Side by Parking	Ext.		Exterior Access Route	Walkway

Exterior route < 36" wide	32"	Ensure that a clear width of 48" min. is maintained at the accessible route.	1	-	-
2	South Entrance From Nahatan Street	Ext.		Exterior Access Route	Exterior

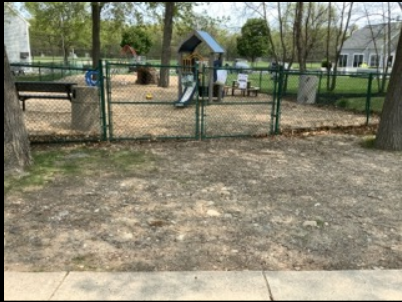
Accessible route not provided	-	Ensure an accessible route is provided to the playground. IHCD recommends an asphalt, stone dust or concrete route.	1	-	-
3	North Side by Parking	Ext.		Exterior Access Route	Exterior

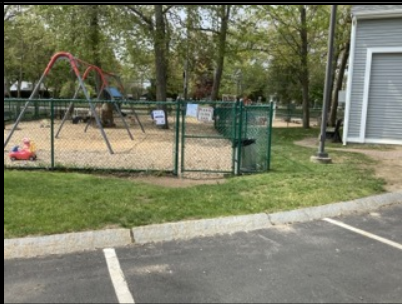
Accessible route not provided	-	Ensure an accessible route is provided to the playground. IHCD recommends an asphalt, stone dust or concrete route.	1	-	-

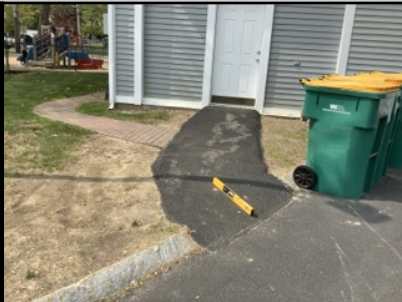
<div style="border: 1px solid gray; padding: 2px;">Curb Ramp</div>												
4	North Side by Parking	Ext.		Curb Ramp	N/A

Running slope is > 1:12 (8.33%)	17.6%	Reduce running slope to be no steeper than 1:12 (8.33%). (Cost estimate for a new curb ramp.)	1	3640	\$3640
											3640	
<div style="border: 1px solid gray; padding: 2px;">Access to Goods and Services</div>

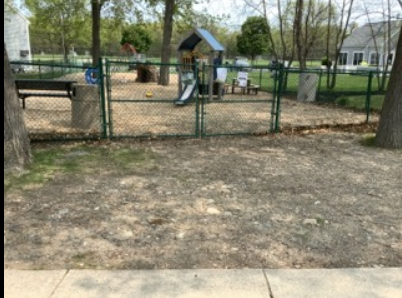
Reach < 15" or > 48"(forward/side approach)	57"	Relocate gate hardware so that controls are between 15"- 48" above the ground.	1	Labor	Labor
<b>Picnic Tables</b>												
6	By the Senior Center	Ext.		Picnic Tables	N/A

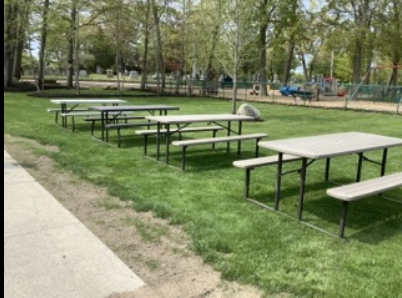
At least 5% accessible spaces not provided Picnic table not on an accessible route	- -	Ensure that at least 5% (minimum one) of picnic tables are accessible. Ensure that the picnic table is connected to an accessible route. (Cost estimate includes the accessible picnic table, not the accessible route to the picnic table if it is located in the same location.)	1	1400	\$1400
7	Southeast Side	Ext.		Picnic Tables	N/A

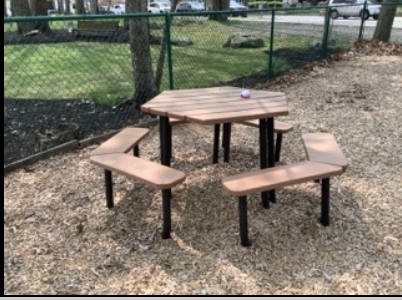
At least 5% accessible spaces not provided Picnic table not on an accessible route	- -	Ensure that at least 5% (minimum one) of picnic tables are accessible. Ensure that the picnic table is connected to an accessible route. (Cost estimate includes the accessible picnic table, not the accessible route to the picnic table if it is located in the same location.)	1	1400	\$1400

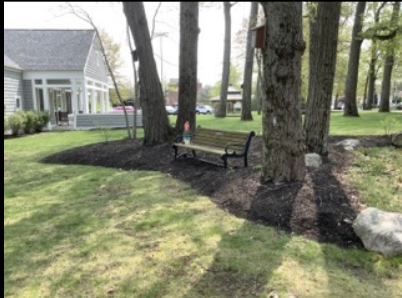
<b>Benches</b>												
8	East of Tot Lot	Ext.		Benches	N/A

No accessible route to one bench in this area		Provide an accessible route to at least one bench in this area or relocate one bench to an accessible route.	1	-	-
<b>Play and Sport Areas</b>

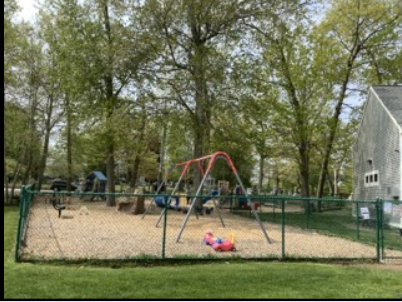
<ul style="list-style-type: none"> <li>Accessible route not provided around playground</li> <li>Accessible route not provided at play components</li> <li>Surface not stable, firm, and slip-resistant</li> </ul>	<ul style="list-style-type: none"> <li>-</li> <li>-</li> <li>-</li> </ul>	<ul style="list-style-type: none"> <li>Install an accessible route to and around the playground.</li> <li>Provide a compliant impact-attenuating surface under and around the play components.</li> <li>Repair the surface and ensure that surface is firm, stable and slip-resistant (to areas under and around play components).</li> </ul>	1	-	-
<b>Best Practice</b>												
<b>Benches</b>												
10	East Side	Ext.		Benches	N/A

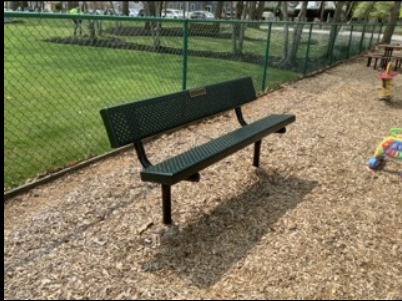
<ul style="list-style-type: none"> <li>Recommend providing a 36" by 48" firm, stable and slip-resistant area alongside one bench in each area where benches are provided so that a person using a wheelchair or other mobility device is able to sit alongside someone seated on the bench with their shoulders aligned.</li> </ul>	1	-	-

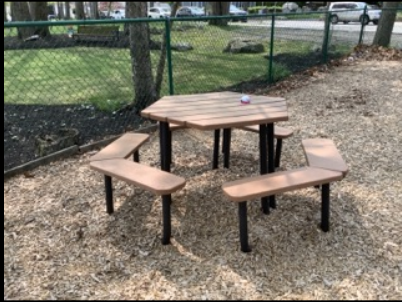
<b>Picnic Tables</b>												
11	Southeast Side	Ext.		Picnic Tables	N/A

<ul style="list-style-type: none"> <li>Recommend providing a stable, firm and slip-resistant surface that is 48" clear on all sides of the accessible picnic tables.</li> </ul>	1	-	-
