# June Street Playground

## Town of Westwood ADA Transition Plan

June 2023

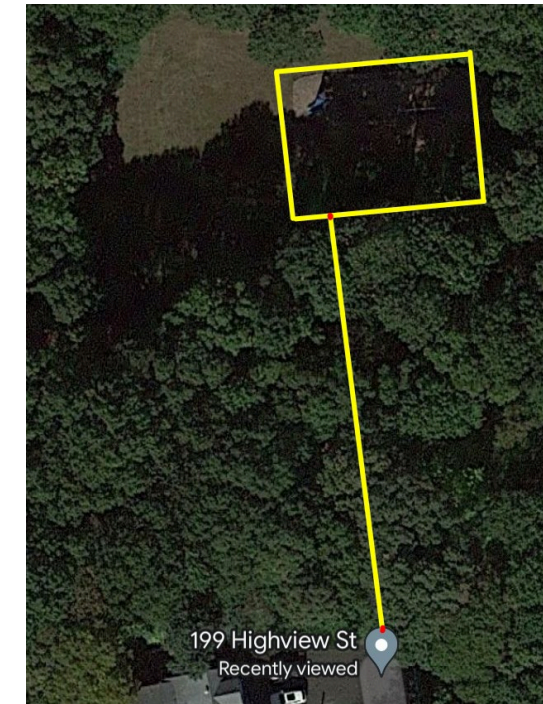
Figure 1: The following image uses a yellow line to indicate the approximate suggested location for a 48" wide min. stable, firm and slip-resistant accessible route connecting park entry points to and around the playground.

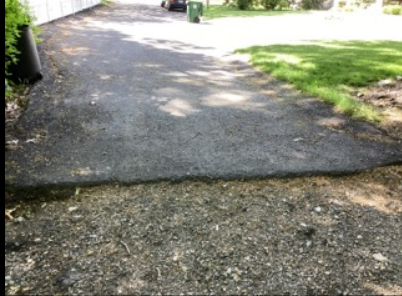
Accessibility issues include routes with excessive level changes. Additionally, there is only a dirt route that is not stable, firm, and slip-resistant provided from the park entrance to one (1) bench, and one (1) picnic table.

ID	Location	Floor	Room	Element	Type	Photo	Issues	Current Measure	Recommendations	Quantity	Price	Cost Estimation
<b>Approach and Entrance</b>												
<b>Exterior Access Route</b>												
1	Route to Park	Ext.		Exterior Access Route	Exterior

Level changes > 1/4" Accessible route not provided	1.5" -	Alter the change in level to be 1/4" high max. Ensure an accessible route is provided to all program areas, including the playground.	1	-	-
<b>Access to Goods and Services</b>												
<b>Picnic Tables</b>												
2	Near Playground	Ext.		Picnic Tables	N/A

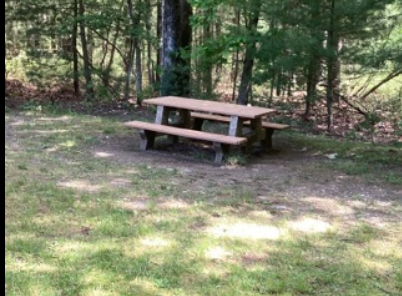
- Lack of an accessible picnic table near the playground.

At least 5% accessible spaces not provided Picnic table not on an accessible route Knee clearance less than 19" deep	- - -	Ensure that at least 5% (minimum one) of picnic tables are accessible. Ensure that the accessible picnic table is connected to an accessible route. Provide at least one picnic table with knee clearance that is 19" deep min.	1	1400	\$1400

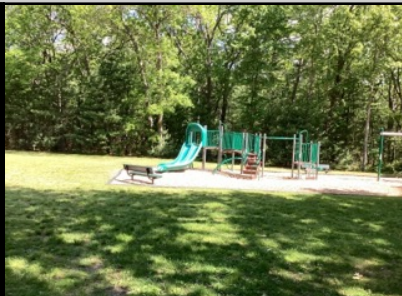
Accessibility issues include lack of a compliant impact-attenuating surface under and around the play components, and an accessible route to and around the playground.

Accessible route not provided around playground Accessible route not provided at play components	- -	Install an accessible route to and around the playground. Provide a compliant impact-attenuating surface under and around the play components.	1	-	-
