Morrison Park

Town of Westwood ADA Transition Plan

July 2023

Institute for Human Centered Design

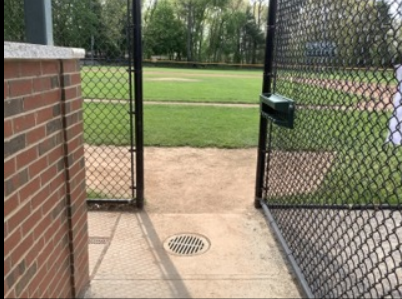
Route obstructed by protruding objects	6"	Relocate the batting caddy inside the team seating area, to ensure it is not located within the accessible route.	1	-	-
Curb Ramp												
2	Route to Parking Lot From Concession Stand	Ext.		Curb Ramp	N/A

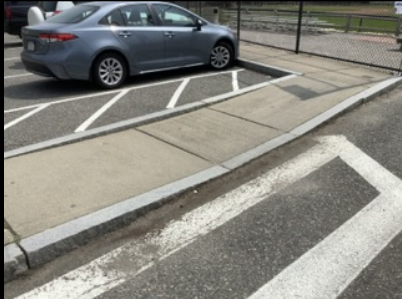
Transition from curb ramp to street not flush	1"	Ensure transition from curb ramp to street is flush or free of changes in level.	1	-	-
Off-Street Parking Lot or Garage												
3	Parking Lot	Ext.		Off-Street Parking Lot or Garage	Visitor

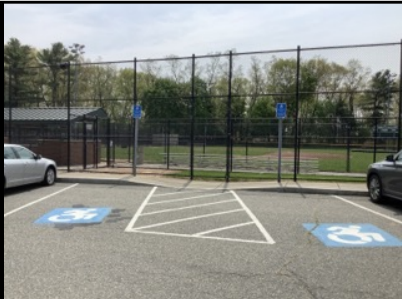
Total # of parking Total # of designated car accessible parking spaces Total # of designated van accessible spaces Sign does not have the designation "Van Accessible" Sign top > 96" above finished grade (MAAB) International Symbol of Acc. not compliant	31 2 0 - 106" -	Add the designation "Van Accessible" to the sign located at the van accessible space. Locate both signs with the top of the signs no higher than 96" above the ground. Ensure that both signs contain a compliant International Symbol of Accessibility (ISA).	2	650	\$1300

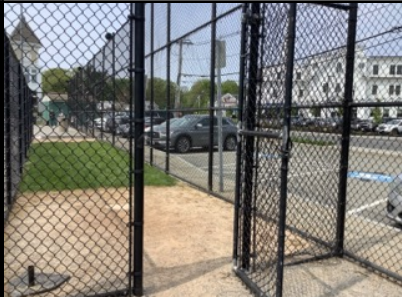
Clear width at door < 32"	30.5"	Widen the gate so that there is 32" min. clear width. (Cost needs further study.)	1	Cost needs further study	Cost needs further study

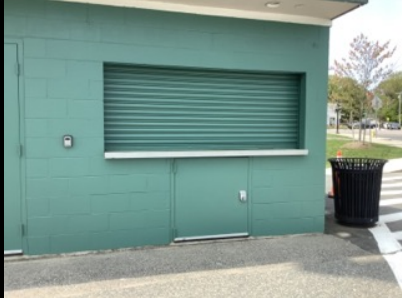
Counter > 36" high	43.3"	Provide a counter that is 36" max. above the ground.	1	880	\$880
											880	
Picnic Tables												
6	By Baseball Field	Ext.		Picnic Tables	N/A

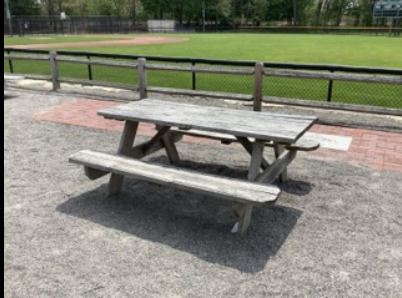
At least 5% accessible spaces not provided Toe or knee clearance at tables not provided Knee clearance less than 19" deep	25.5" 12"	Ensure that at least 5% (minimum one) of picnic tables are accessible. Provide at least 1 picnic table (or ensure that 5% of picnic tables) have toe and knee clearance. Knee clearance should be 27" min. high and 19" deep min.	1	1400	\$1400
											1400	
Toilet & Bathing Rooms												
Portable Toilet												
7	By Concession Stand	Ext.		Portable Toilet	N/A

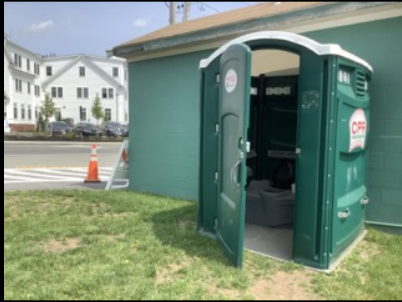
Not located on an accessible route Accessible portable toilets not provided	10.8% -	Locate portable toilet on an accessible route. Ensure that at least 5% of portable toilets (with a minimum of one) are accessible. (Cost estimate is for an accessible portable toilet.)	1	- 5980	\$5980

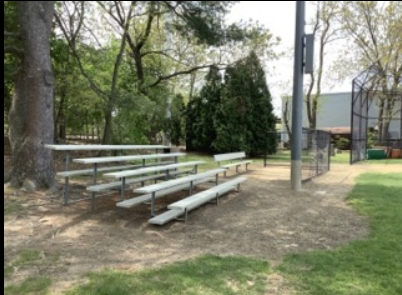
Accessible spaces are not provided at team seating Accessible spaces not provided at sidelines seating Not connected to an accessible-route	- - -	Provide a 30" x 48" stable, firm and slip resistant clear floor space at team seating. Provide a 36" x 60" stable, firm and slip resistant clear floor space alongside each side of the sideline seating. Provide an accessible route to the team seating and sidelines seating areas.	1	-	-

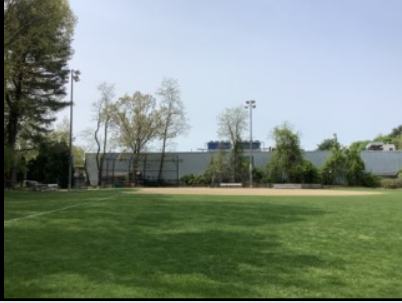
Not connected to an accessible-route No accessible route to all areas of sport activity	- -	Provide an accessible route to the softball field. Install an accessible route between all areas of sports activity.	1	-	-
<div style="border: 1px solid #ccc; padding: 5px; margin-bottom: 5px;"> Best Practice ▼ </div> <div style="border: 1px solid #ccc; padding: 5px; margin-bottom: 5px;"> Exterior Access Route </div>												
10	Baseball Field	Ext.		Exterior Access Route	Fencing

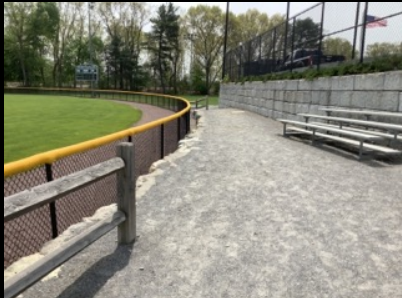
-	Recommend continuing the fencing along the drop-off between the accessible route and the baseball field.	1	-	-
