# Westwood High School

## Town of Westwood ADA Transition Plan

October 2023

Institute for Human Centered Design

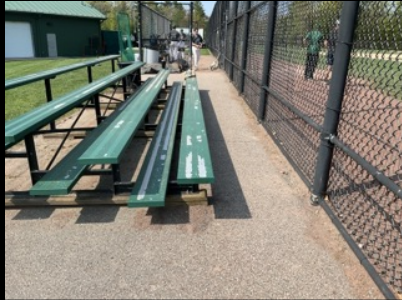
Exterior route < 36" wide	31"	Ensure that a clear width of 36" min. is maintained at the accessible route. Move the bench bleacher back to ensure that even when a wheelchair user is seated shoulder to shoulder with a companion seated on the bleacher that there is a circulation path that is no less than 36" wide min., 48" wide preferred.	1	Labor	Labor
2	Sideline Seating Near Baseball Field First Base Side Team Seating	Ext.		Exterior Access Route	Exterior

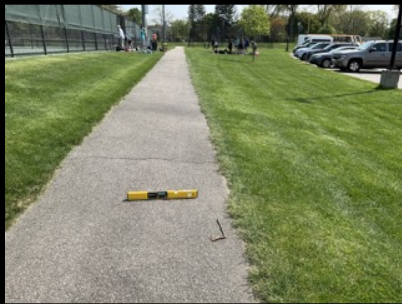
ID	Location	Floor	Room	Element	Type	Photo	Issues	Current Measure	Recommendations	Quantity	Price	Cost Estimation
6	Route Between Parking and Softball Field	Ext.		Exterior Access Route	Walkway

Cross slope > 1:50 (2.00%)	3%	Reduce cross slope to be no steeper than 1:50 (2.00%).	1	-	-
7	Path From Parking Past Tennis Courts To Baseball and Softball Field	Ext.		Exterior Access Route	Exterior

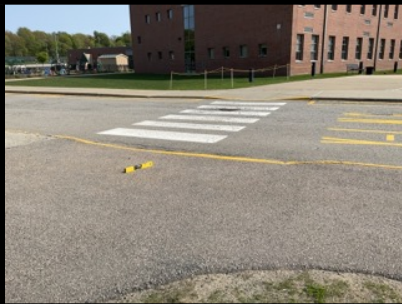
ID	Location	Floor	Room	Element	Type	Photo	Issues	Current Measure	Recommendations	Quantity	Price	Cost Estimation
11	Parking by Main Entrance North Side of School	Ext.		Exterior Access Route	Exterior

Running slope > 1:20 (5.00%)	9%	Reduce running slope to be no steeper than 1:20 (5.00%).	1	-	-
12	Route Between Parking and Tennis Court/Softball Field	Ext.		Exterior Access Route	Walkway

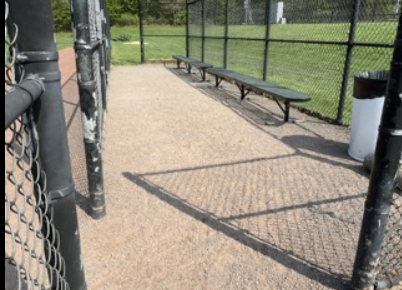
Surface is not stable, firm, and slip-resistant	-	Repair surface to be firm, stable and slip-resistant.	2	-	-

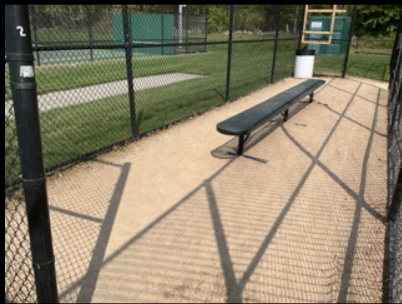
ID	Location	Floor	Room	Element	Type	Photo	Issues	Current Measure	Recommendations	Quantity	Price	Cost Estimation
16	Softball Field Third Base and First Base Team Seating Areas	Ext.		Exterior Access Route	Team Seating Area

Surface is not stable, firm, and slip-resistant Accessible route not provided	- -	Repair the surface to be firm, stable and slip-resistant. Ensure an accessible route is provided to the third base team seating area.	2	-	-
17	Around Football Field	Ext.		Exterior Access Route	Walkway

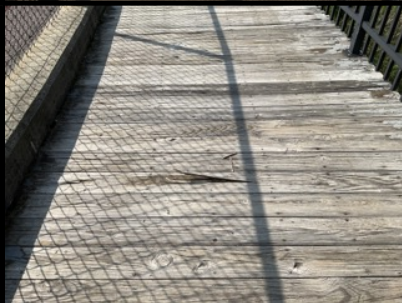
Route not maintained in operable working condition	-	Ensure the accessible route is maintained in operable working condition.	1	-	-
18	Pitching Practice Area Near Baseball Field, First Base Side Team Seating	Ext.		Exterior Access Route	Exterior

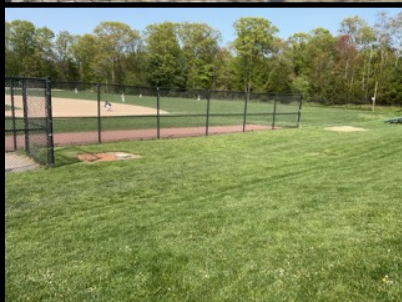
Accessible route not provided	-	Provide an accessible route to the practice pitching mound and team seating that is firm, stable and slip-resistant.	1	-	-

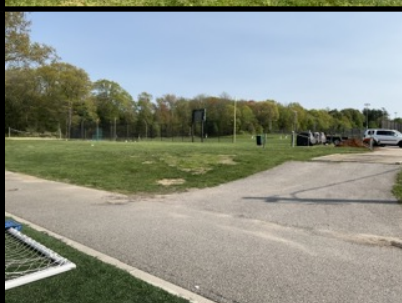
Accessible route not provided	-	Provide an accessible route to the soccer field, volleyball court and batting cage that is firm, stable and slip-resistant.	1	-	-

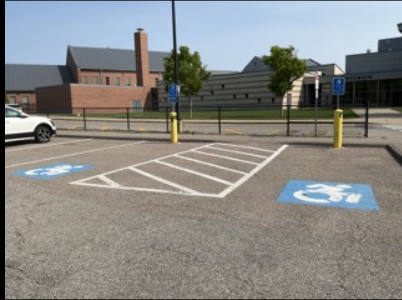
ID	Location	Floor	Room	Element	Type	Photo	Issues	Current Measure	Recommendations	Quantity	Price	Cost Estimation
26	North Lot by Football Field	Ext.		Off-Street Parking Lot or Garage	N/A

Total # of parking Total # of designated car accessible parking spaces Total # of designated van accessible spaces	337 3 3	Provide 2 car accessible spaces.  Recommend these accessible spaces be located on the east side of the north lot by the multipurpose field as there are no accessible parking spaces in this location.	2	2405	\$4810
											<b>4810</b>	
27	North Lot by Football Field	Ext.		Off-Street Parking Lot or Garage	N/A

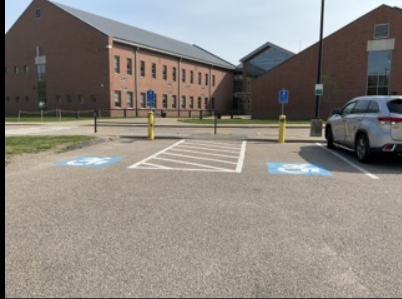
Sign bottom < 60" above finished grade	52"	Ensure all signs for the van accessible space is located with the bottom of the sign 60" above the ground.	1	Labor	Labor
28	North Lot by Football Field	Ext.		Off-Street Parking Lot or Garage	N/A

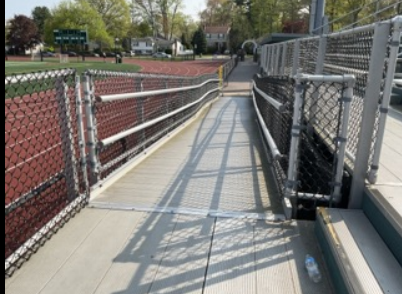
Handrails do not extend 12" past top & bottom	-	Alter handrails to extend horizontally above the landing for 12" min. beyond the top of ramp runs.	2	185	\$370
											<b>370</b>

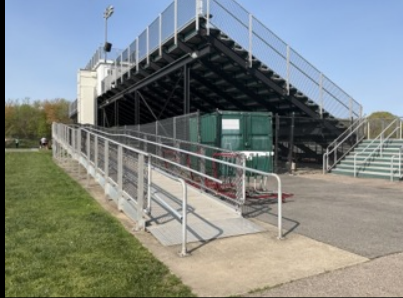
ID	Location	Floor	Room	Element	Type	Photo	Issues	Current Measure	Recommendations	Quantity	Price	Cost Estimation
31	Football Field, Ramp To Press Box	Ext.		Exterior Ramp	N/A

Lower right handrail does not extend 12" past bottom	-	Replace lower right handrail to extend horizontally above the landing for 12" min. beyond the bottom of ramp run.  Cost estimate based on a 30' long metal railing.	1	2886	\$2886
											<b>2886</b>	
32	Football Field, Ramp to Press Box	Ext.		Exterior Ramp	N/A

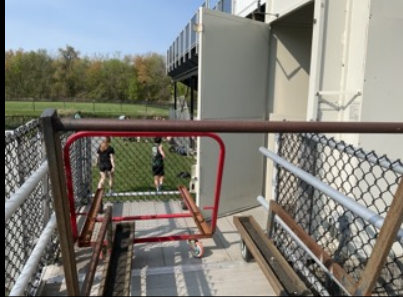
Left top handrail does not extend 12" past top landing	-	Alter left handrail to extend horizontally above the landing for 12" min. beyond the top of ramp runs.	1	185	\$185
											<b>185</b>	
<div style="border: 1px solid black; padding: 2px; margin-bottom: 5px;">Access to Goods and Services <span style="float: right;">▼</span></div> <div style="border: 1px solid black; padding: 2px;">Means of Egress</div>

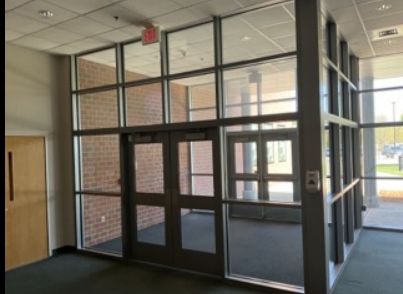
Tactile exit sign not provided Illuminated ISA symbol not provided (MAAB)	- -	Ensure that a tactile exit sign with raised characters and braille is provided at the exit door. Since each door has an active leaf, the sign must be located to the right of the doors mounted between 48"- 60" above the finished floor.  When the illuminated exit sign is repaired or replaced, provide an illuminated sign with the International Symbol of Accessibility (ISA).	1	302	\$302

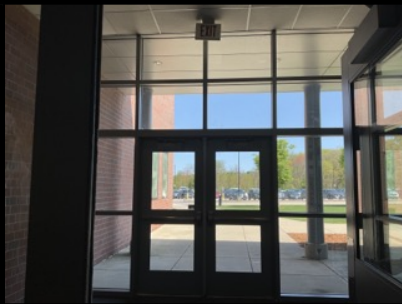
ID	Location	Floor	Room	Element	Type	Photo	Issues	Current Measure	Recommendations	Quantity	Price	Cost Estimation
36	Door 13 Inside Vestibule, Auditorium Entrance Lobby	1		Means of Egress	N/A

Tactile exit sign not provided	- -	Ensure that a tactile exit sign with raised characters and braille is provided at the exit door. Since each door has an active leaf, the sign must be located to the right of the doors mounted between 48"- 60" above the finished floor.	1	302	\$302
											<b>302</b>	
37	Door 21	1		Means of Egress	N/A

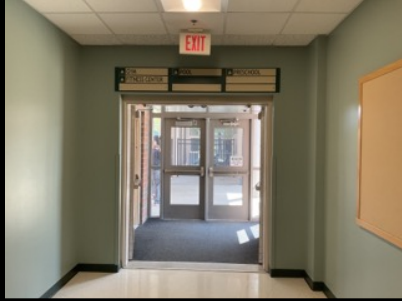
Tactile exit sign not provided Illuminated ISA symbol not provided (MAAB)	- -	Ensure that a tactile exit sign with raised characters and braille is provided at the exit door. Mount the sign between 48"- 60" above the finished floor located on the right side of the double doors. When the illuminated exit sign is repaired or replaced, provide an illuminated sign with the International Symbol of Accessibility (ISA).	1	302	\$302

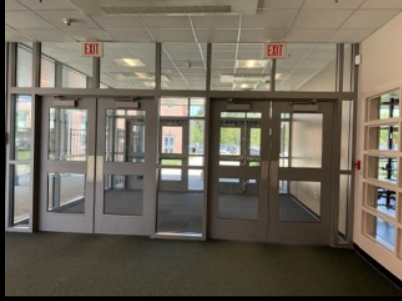
Tactile exit sign not provided Illuminated ISA symbol not provided (MAAB)	- -	Ensure that a tactile exit sign with raised characters and braille is provided at the exit door. Since each door has an active leaf, the sign must be located to the right of the doors mounted between 48"- 60" above the finished floor. When the illuminated exit sign is repaired or replaced, provide an illuminated sign with the International Symbol of Accessibility (ISA).	2	302	\$604
											<b>604</b>	
39	Gymnasium Leads to Door 28	1		Means of Egress	N/A

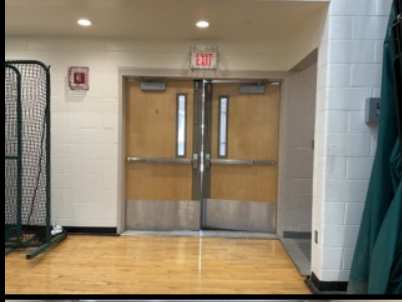
Tactile exit sign not provided Illuminated ISA symbol not provided (MAAB)	- -	Ensure that a tactile exit sign with raised characters and braille is provided at the exit door. Mount the sign between 48"- 60" above the finished floor located on the adjacent wall on the right side of the right hand door. When the illuminated exit sign is repaired or replaced, provide an illuminated sign with the International Symbol of Accessibility (ISA).	1	302	\$302

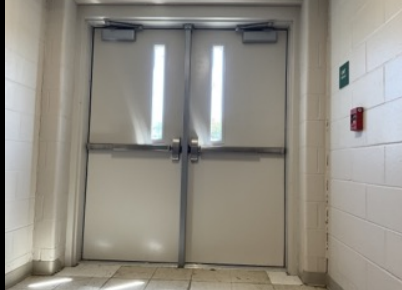
Tactile exit sign not provided	-	Ensure that a tactile exit sign with raised characters and braille is provided at the exit door. Mount the sign between 48"- 60" above the finished floor located on the adjacent wall on the right side of the right hand door.	1	302	\$302
											<b>302</b>

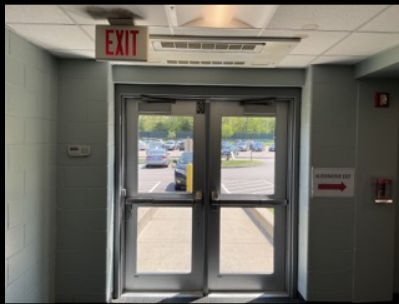
ID	Location	Floor	Room	Element	Type	Photo	Issues	Current Measure	Recommendations	Quantity	Price	Cost Estimation
41	Recreation Department, Door 30	1		Means of Egress	N/A

Tactile exit sign not provided Illuminated ISA symbol not provided (MAAB)	- -	Ensure that a tactile exit sign with raised characters and braille is provided at the exit door. Mount the sign between 48"- 60" above the finished floor located on the adjacent wall on the right side of the right hand door. When the illuminated exit sign is repaired or replaced, provide an illuminated sign with the International Symbol of Accessibility (ISA).	1	302	\$302
42	Pool Lounge, Door 31 (Two Doors)	1		Means of Egress	N/A

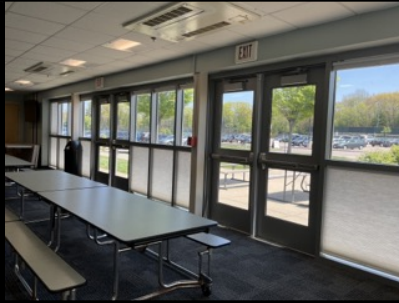
Tactile exit sign not provided Illuminated ISA symbol not provided (MAAB)	- -	Ensure that a tactile exit sign with raised characters and braille is provided at both exit doors. Since each door has an active leaf, the sign must be located to the right of the door mounted between 48"- 60" above the finished floor. When the illuminated exit sign is repaired or replaced, provide an illuminated sign with the International Symbol of Accessibility (ISA).	2	302	\$604

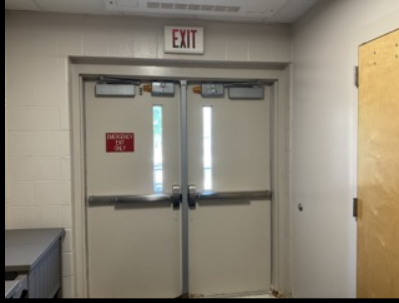
Tactile exit sign not provided Directional sign to accessible emergency exit not provided	- -	Ensure that a tactile exit sign with raised characters and braille is provided at the exit door. The sign must be located to the right of the door mounted between 48"- 60" above the finished floor. Provide a directional sign indicating the location of the nearest accessible emergency exit.	1	302 302	\$604
44	Gymnasium, Leads to Door 61	1		Means of Egress	N/A

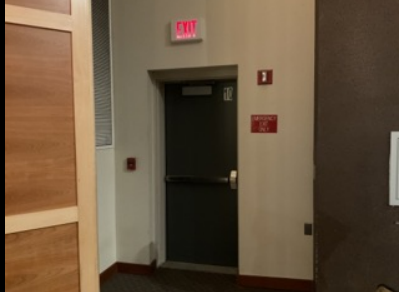
Tactile exit sign not provided Directional sign to accessible emergency exit not provided	- -	Ensure that a tactile exit sign with raised characters and braille is provided at the exit door. Mount the sign between 48"- 60" above the finished floor located on the latch side of the door. Provide a directional sign indicating the location of the nearest accessible emergency exit.	1	302 302	\$604

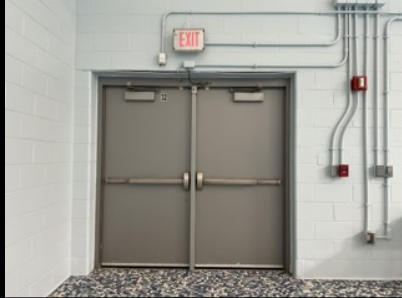
ID	Location	Floor	Room	Element	Type	Photo	Issues	Current Measure	Recommendations	Quantity	Price	Cost Estimation
46	Door 32	1		Means of Egress	N/A

Tactile exit sign not provided Illuminated ISA symbol not provided (MAAB)	- -	Ensure that a tactile exit sign with raised characters and braille is provided at the exit door. Since each door is an active leaf, the sign must be located to the right of the door mounted between 48"- 60" above the finished floor. When the illuminated exit sign is repaired or replaced, provide an illuminated sign with the International Symbol of Accessibility (ISA).	1	302	\$302
47	Door 11	1	B118	Means of Egress	N/A

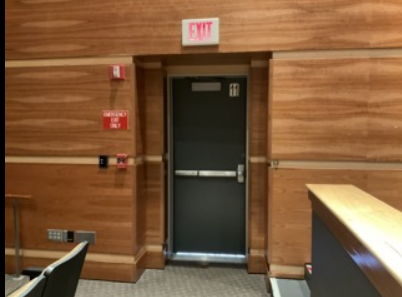
Tactile exit sign not provided Illuminated ISA symbol not provided (MAAB)	- -	Ensure that a tactile exit sign with raised characters and braille is provided at the exit door. Mount the sign between 48"- 60" above the finished floor located on the nearest adjacent wall. When the illuminated exit sign is repaired or replaced, provide an illuminated sign with the International Symbol of Accessibility (ISA).	1	302	\$302

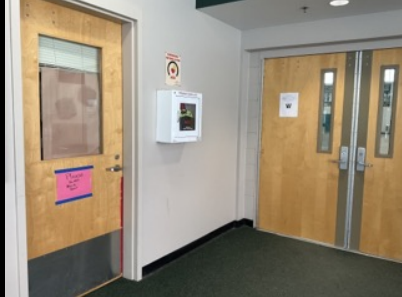
Obstructed by protruding objects	7"	Provide a cane-detectable barrier underneath the defibrillator.	1	398	\$398
49	Auxiliary Theater, "Little Theater"	1	B116	Interior Access Route	N/A

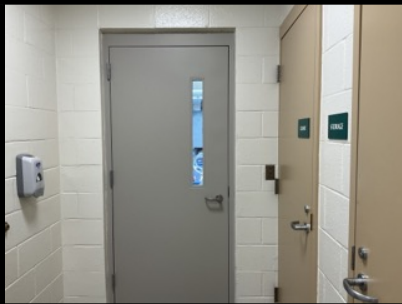
ID	Location	Floor	Room	Element	Type	Photo	Issues	Current Measure	Recommendations	Quantity	Price	Cost Estimation
56	From Family Changing Rooms to Pool	1	C147	Doors, Doorways, & Gates	Circulation

Maneuvering clearance(s) not provided Door requires > 5 lbs. of force to open	9" 13 lbs	Provide an automatic door opener./Reverse the swing of the door to provide maneuvering clearance. Adjust closers so doors do not require more than 5 pounds of force to open.	1	3978 Labor	\$3978
57	Men's Gym Locker Room	1		Doors, Doorways, & Gates	Toilet Room

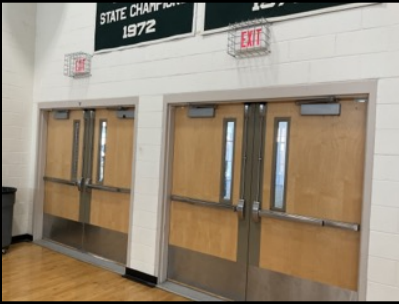
ID	Location	Floor	Room	Element	Type	Photo	Issues	Current Measure	Recommendations	Quantity	Price	Cost Estimation
61	Gymnasium	1		Doors, Doorways, & Gates	Assembly Space

Door requires > 5 lbs. of force to open	15 lbs	Adjust closers so doors do not require more than 5 pounds of force to open.	4	Labor	Labor
62	From Gym to Recreation Department	1		Doors, Doorways, & Gates	Assembly Space

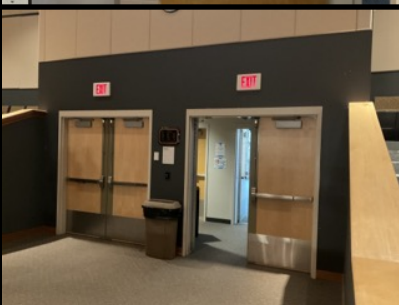
Door requires > 5 lbs. of force to open	15 lbs	Adjust closers so doors do not require more than 5 pounds of force to open.	4	Labor	Labor

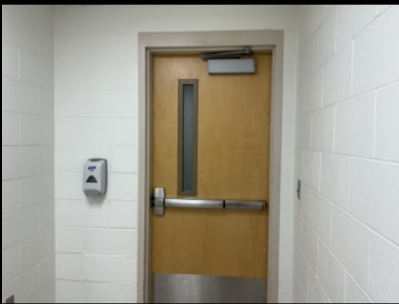
ID	Location	Floor	Room	Element	Type	Photo	Issues	Current Measure	Recommendations	Quantity	Price	Cost Estimation
66	Women's Locker Room	1	C149	Doors, Doorways, & Gates	Toilet Room

Door requires > 5 lbs. of force to open	16 lbs	Adjust closers so doors do not require more than 5 pounds of force to open.	1	Labor	Labor
67	Doors From Pool to Pool Lounge	1	C160	Doors, Doorways, & Gates	Circulation

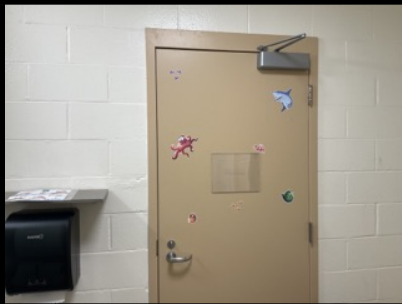
ID	Location	Floor	Room	Element	Type	Photo	Issues	Current Measure	Recommendations	Quantity	Price	Cost Estimation
71	Family Changing Room B by the Pool	1	C147	Doors, Doorways, & Gates	Toilet Room

Maneuvering clearance(s) not provided Door requires > 5 lbs. of force to open Door closes faster than 5 seconds	10" 10 lbs 2 sec	Relocate the paper towel dispenser. Adjust closers so doors do not require more than 5 pounds of force to open. Adjust door closers and gate closers so that from an open position of 90 degrees, the time required to move the door to a position of 12 degrees from the latch is 5 seconds minimum.	1	Labor	Labor
72	Women's Locker Room	1	C149	Doors, Doorways, & Gates	Toilet Room

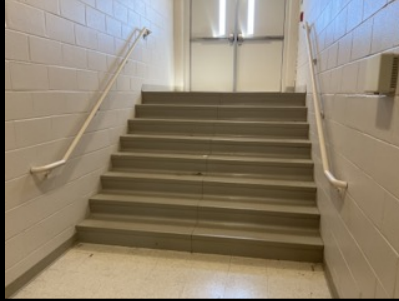
ID	Location	Floor	Room	Element	Type	Photo	Issues	Current Measure	Recommendations	Quantity	Price	Cost Estimation
<b>Stairways</b>												
81	Gymnasium, Stair 61	1		Stairways	Egress

Handrail height < 34" or > 38"	30"	Alter so the handrails are 34"- 38" high above the floor.	2	Labor	Labor
82	Auditorium, Stage Right Stairs On Side of Stage	1	B118	Stairways	Interior

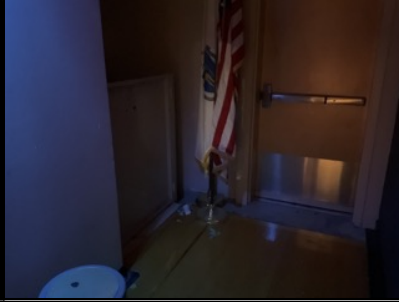
-	Recommend installing lights that are brighter than 10 foot candles in front of the lift.	1	-	-
85	Auditorium, Lift to Stage	1	B118	Platform Lift	N/A

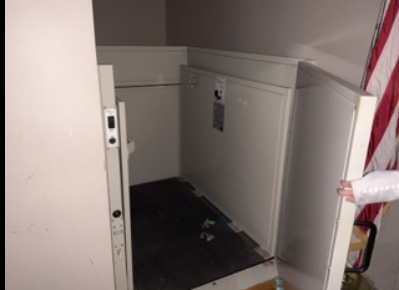
Lift with door on narrow end is < 36" x 54"	29"	Further study will be needed to determine whether it is technically feasible to bring the lift into full compliance with the ADA Standards and 521 CMR.	1	-	-

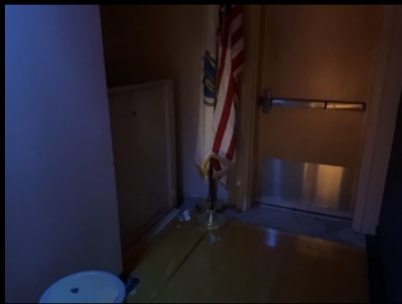
ID	Location	Floor	Room	Element	Type	Photo	Issues	Current Measure	Recommendations	Quantity	Price	Cost Estimation
86	Auditorium, Lift to Stage	1	B118	Platform Lift	N/A

Controls lack clear floor space Not maintained in operable working condition	- -	Ensure that controls have a 30" min. by 48" min. clear floor space. Relocate flags to ensure clear floor space. Ensure that the lift is maintained in operating working condition.	1	Labor	Labor
87	Lift From Recreation Department to Pool	1		Platform Lift	N/A

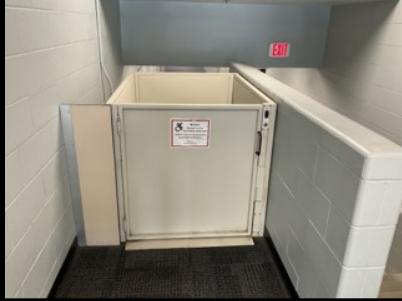
Lift with door on narrow end is < 36" x 54" End door < 32" wide	30.5" 30.5"	Further study will be needed to determine whether it is technically feasible to bring the lift into full compliance with the ADA Standards and 521 CMR.	1	-	-
88	Lift From Recreation Department to Pool	1		Platform Lift	N/A

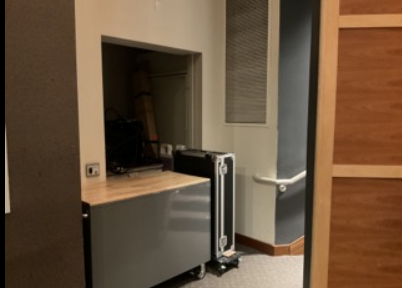
Not maintained in operable working condition	-	Ensure that the lift is maintained in operating working condition. Clear storage in this area.	1	Labor	Labor

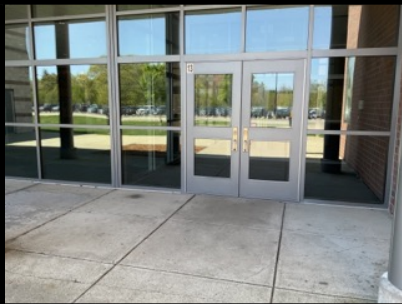
ID	Location	Floor	Room	Element	Type	Photo	Issues	Current Measure	Recommendations	Quantity	Price	Cost Estimation
96	Auditorium Entrance - Door 13	Ext.		Signage	Designation

Signage is not provided	-	Locate a compliant designation signage with raised characters and braille alongside the door on the latch side.	1	450	\$450
											<b>450</b>	
97	Gymnasium Main Entrance, Door 22	Ext.		Signage	Designation

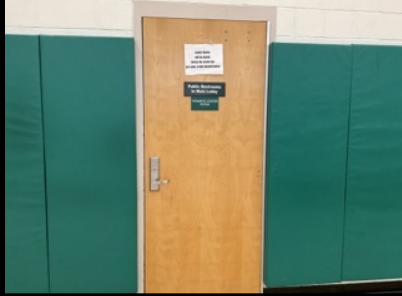
ID	Location	Floor	Room	Element	Type	Photo	Issues	Current Measure	Recommendations	Quantity	Price	Cost Estimation
101	Women's Gym Locker Room	1		Signage	Designation

Raised characters < 48" or > 60" above ground Sign not located on the latch side of the door	61" -	Mount the sign so that the baseline of the lowest tactile character is 48" min. above finished floor and the baseline of the highest tactile character is 60" max. above the finished floor. Locate the sign at permanent rooms alongside the door on the latch side.	1	Labor	Labor
102	Gym Entrance From Recreation Department	1		Signage	Designation

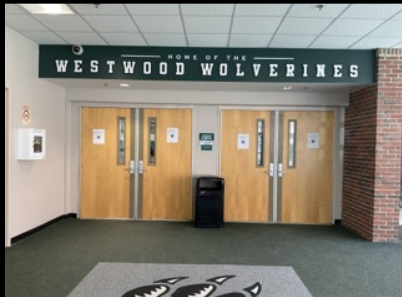
Signage is not provided Signage lacks 18" by 18" clear floor space	- -	Locate compliant signage with raised characters and braille alongside the right adjacent wall for the right double doors. Relocate the trash can to provide a clear floor space of 18" min. by 18" min. for the existing sign in on the right side of the left double doors.	1	302	\$302
											<b>302</b>	
											<b>302</b>

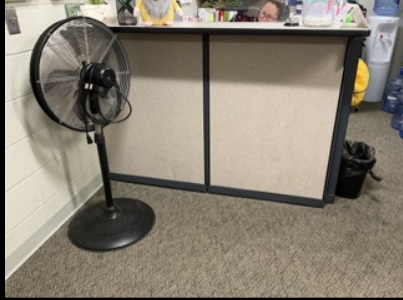
ID	Location	Floor	Room	Element	Type	Photo	Issues	Current Measure	Recommendations	Quantity	Price	Cost Estimation
<b>Service Counter</b>												
106	Recreation Department	1	C145	Service Counter	N/A

Counter > 36" high	39.5"	Provide a counter that is 36" max. above the finished floor.	1	1144	\$1144
											1144	
<b>Operable Parts / Reach Range</b>												
107	Auditorium, Retractable Armrests	1		Operable Parts / Reach Range	N/A

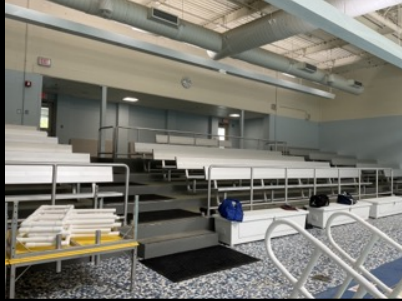
ID	Location	Floor	Room	Element	Type	Photo	Issues	Current Measure	Recommendations	Quantity	Price	Cost Estimation
Assembly Area												
110	Pool	1	C160	Assembly Area	Bleacher

Number of seats Number of designated wheelchair spaces Minimum # wheelchair spaces not provided	275 2 -	Three additional wheelchair spaces are needed. Recommend providing the 3 additional wheelchair spaces that are needed by moving the bench seating at the front of the seating and putting companion seating next to spaces.	3	Labor	Labor
111	Auxiliary Theater, "Little Theater"	1	B116	Assembly Area	N/A

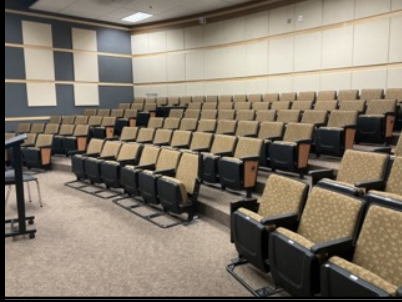
Number of seats Minimum # wheelchair spaces not provided	107 0	Provide 4 wheelchair spaces with companion seating. In row seating, companion seats must be located to provide shoulder alignment with adjacent wheelchair spaces.	4	Cost needs further analysis	Cost needs further analysis
112	Auditorium	1		Assembly Area	N/A

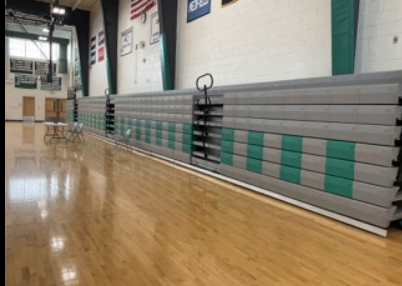
Number of seats Minimum # wheelchair spaces not provided	1000 -	When bleachers are replaced, provide bleachers that include accessible seating with companion spaces located on an accessible route based on Table 221.2.1 in the 2010 ADA Standards. (In the mean time, consider constructing some temporary accessible seating and companion spaces at an accessible locations around the gym.)	10	Cost needs further analysis	Cost needs further analysis

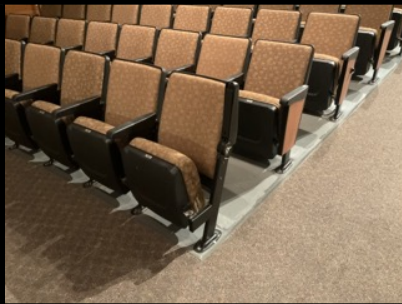
ID	Location	Floor	Room	Element	Type	Photo	Issues	Current Measure	Recommendations	Quantity	Price	Cost Estimation
115	Auditorium	1		Assembly Area	N/A

Assistive listening devices not provided	-	If audible communication is integral to the use of the space, provide an assistive listening system.  24 receivers will be needed, of which 6 need to be hearing aid compatible.  Cost estimate based on assistive listening devices for a capacity of 600. Actual capacity was 660 seats.	1	8125	\$8125
116	Gymnasium	1		Assembly Area	N/A

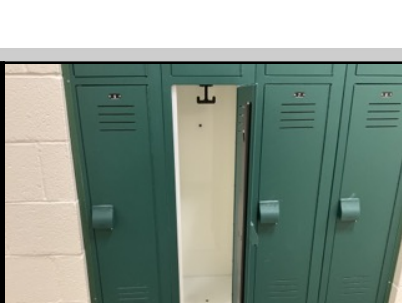
5% of lockers are not accessible	-	Provide at least one accessible locker (or ensure 5% of all lockers are accessible) .	1	-	-

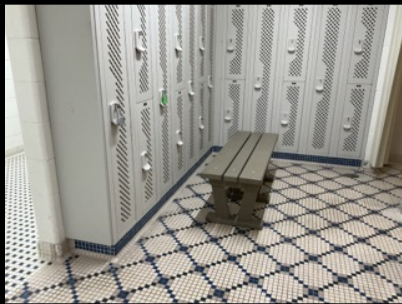
ID	Location	Floor	Room	Element	Type	Photo	Issues	Current Measure	Recommendations	Quantity	Price	Cost Estimation
120	Men's Locker Room	1	C151	Locker Room	Men's

Back support not provided at bench Bench < 24" deep Bench < 48" long	- 15" -	Provide at least one bench with back support or that is affixed to a wall with room on the side to transfer that is at least 24" deep and 48" long.	1	260	\$260
											<b>260</b>	
121	Women's Locker Room	1	C149	Locker Room	Women's

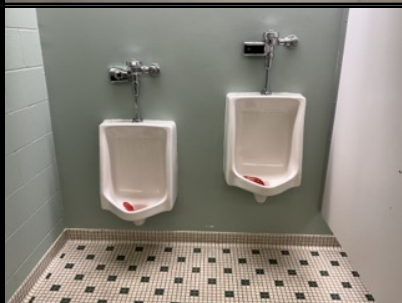
Element is not maintained in operable condition	-	Ensure that the flush controls are maintained in operable working condition. The motion sensor control was broken on the day of survey.	1	Labor	Labor

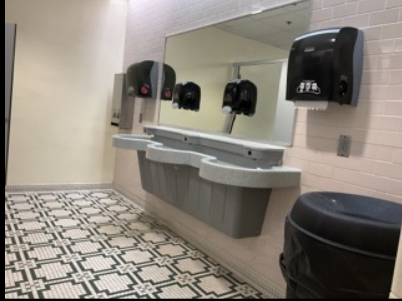
ID	Location	Floor	Room	Element	Type	Photo	Issues	Current Measure	Recommendations	Quantity	Price	Cost Estimation
<b>Lavatory</b>												
125	Men's and Women's Gym Locker Rooms and Toilet Rooms by the Auditorium (4 Total)	1		Lavatory	N/A

Lavatory acts as a protruding object	10"	Place cane-detectable barriers such as panels or barrier skirts on each side of the lavatory.	8	398	\$3184
											<b>3184</b>	
126	Men's Multi-User Toilet Room Near Auditorium	1		Lavatory	N/A

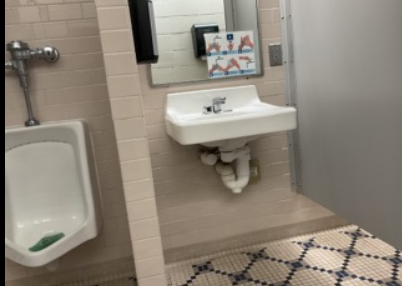
Toe or knee clearances not provided	21.5"	Replace lavatory with one that has knee and toe clearance positioned for a forward approach.	1	2192	\$2192
											<b>2192</b>

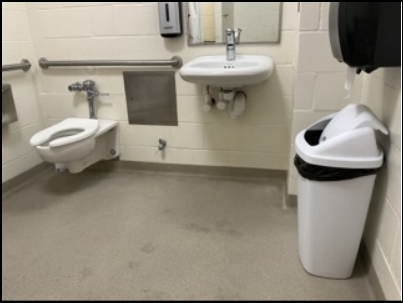
ID	Location	Floor	Room	Element	Type	Photo	Issues	Current Measure	Recommendations	Quantity	Price	Cost Estimation
<b>Single-User Toilet</b>												
130	Family Changing Rooms A and B by the Pool	1	C147	Single-User Toilet	N/A

Toilet seat < 17" or > 19" high Centerline < or > 18" (MAAB) Side grab bar < 54" from back wall Side or rear grab bar < 33" or > 36" high Clearance at toilet < 60" clear width Soap dispenser mounted over grab bar dispenser is not compliant Toe or knee clearances not provided	12 14.5 42" 30" 58" - 24.6"	Renovate the changing room to ensure that there is 60" wide min. clear floor space at the toilet by relocating the sink. Ensure the sink has 27" high knee clearance. Relocate the soap dispenser. Relocate the toilet so that the centerline is 18" from the side wall. Locate the toilet seat between 17" and 19" high. Relocate the grab bars.	2	2816 3676 459 459 459 4022	\$23782

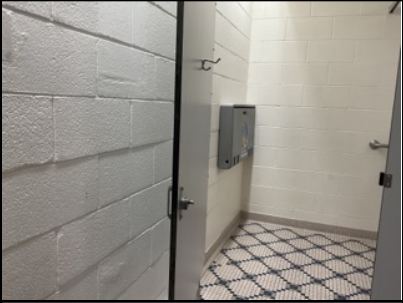
Door has malfunctioning self-closing hinge Coat hook > 48" (2010 ADA) Door pull not provided	- 54.5" -	Repair hinge. Locate the coat hook no higher than 48" above the finished floor. Provide a door pull on each side of the door between 34" to 48" above the finished floor that does not require tight grasping, pinching or twisting of the wrist.	1	Labor 91	\$91
132	Women's Locker Room	1	C149	Toilet Compartment	Accessible Compartment

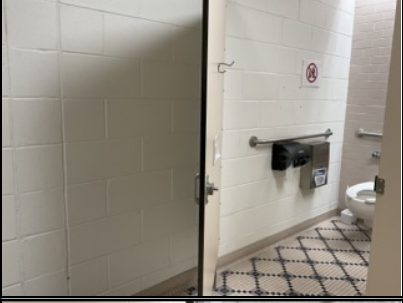
Door has malfunctioning self-closing hinge Door pull not provided	- -	Repair hinge. Provide a door pull on each side of the door between 34" to 48" above the finished floor that does not require tight grasping, pinching or twisting of the wrist.	1	Labor 91	\$91
133	Women's Multi-User Toilet Room Near Pool Lounge	1		Toilet Compartment	Accessible Compartment

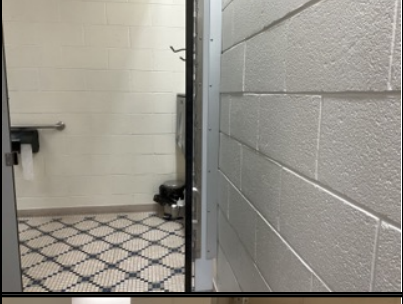
Door has malfunctioning self-closing hinge Door pull not provided	- -	Repair hinge. Provide a door pull on each side of the door between 34" to 48" above the finished floor that does not require tight grasping, pinching or twisting of the wrist.	1	Labor 91	\$91

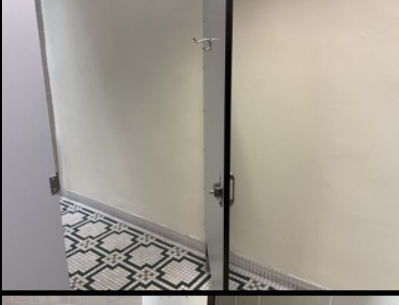
Door has malfunctioning self-closing hinge Door pull not provided	- -	Repair hinge. Provide a door pull on each side of the door between 34" to 48" above the finished floor that does not require tight grasping, pinching or twisting of the wrist.	1	Labor 91	\$91

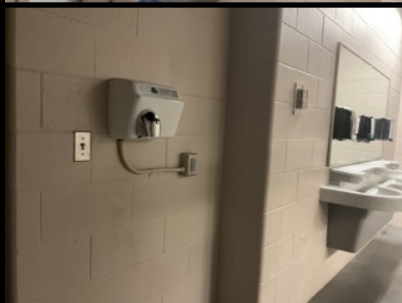
Dispenser acts as a protruding object	8"	Provide a hand dryer that is 4" max. deep.	1	793	\$793
											<b>793</b>
