Municipal Capital Needs Assessment and Replacement Reserve Analysis

Prepared for:

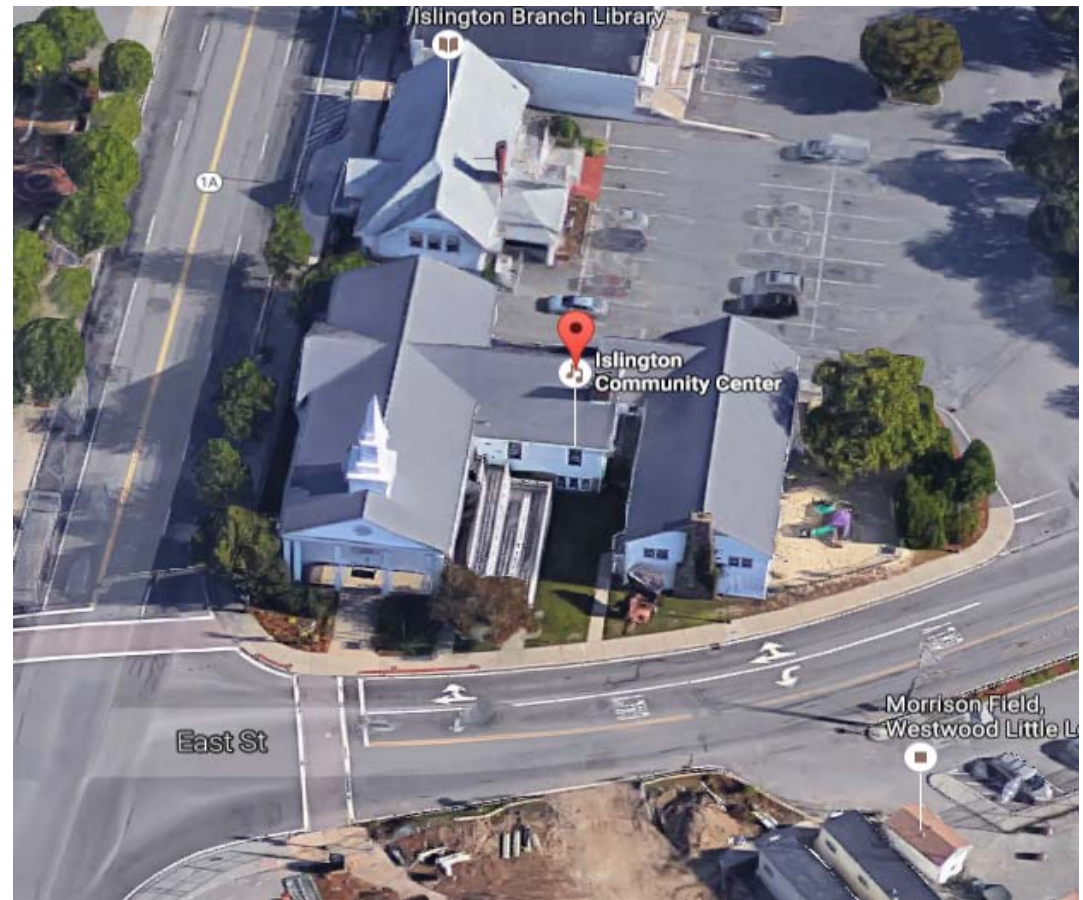
Property Description:

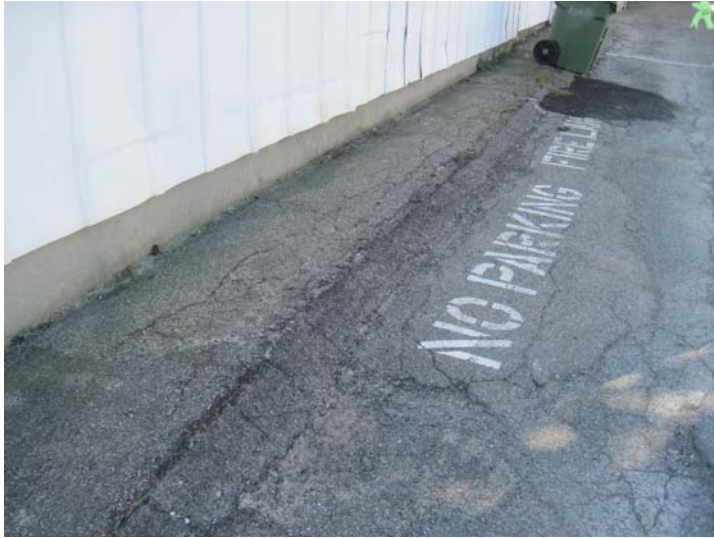
Limited site-related elements include an aging asphalt-paved apron along the north elevation of the building that continues into an asphalt walkway adjacent to the east property border

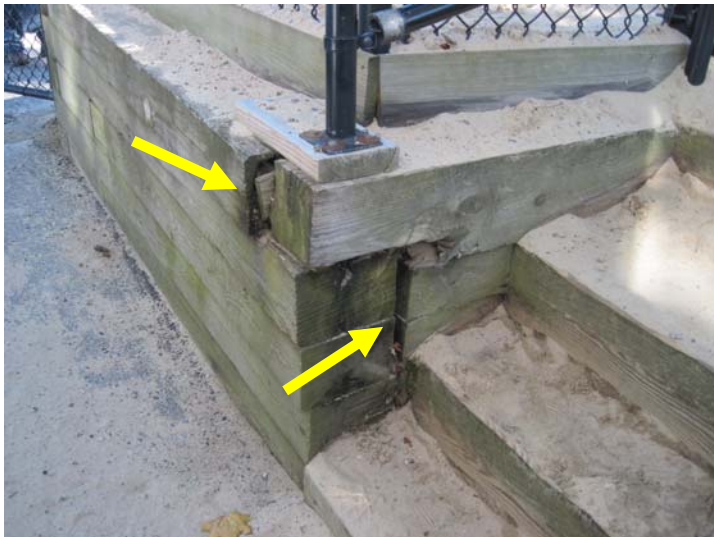
The west facing leg of the timber retaining wall is also damaged with visible outward movement.

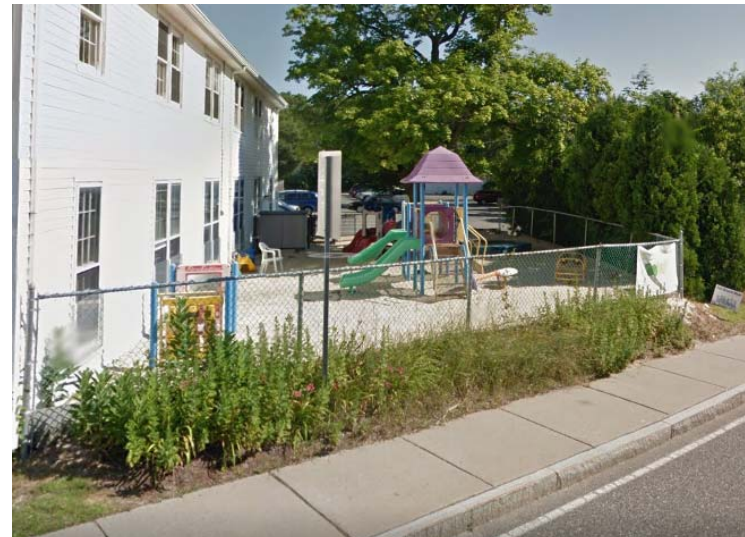
View of the chain link fencing surrounding the playground. All elements within the chain link fencing are the responsibility of the nursery school.

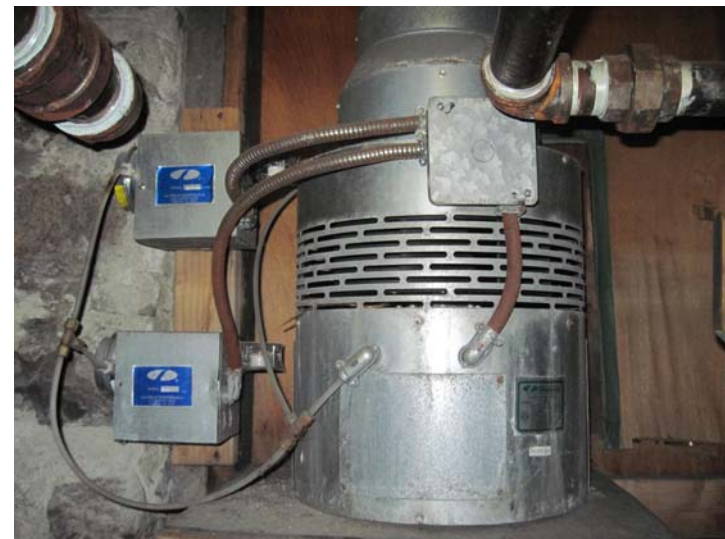
A Field Controls CAS-6 thermostatically controlled "Fan-in-a-Drum" combustion air system automatically draws combustion air into the boiler room when needed and sends a signal to the burners when ok to fire.

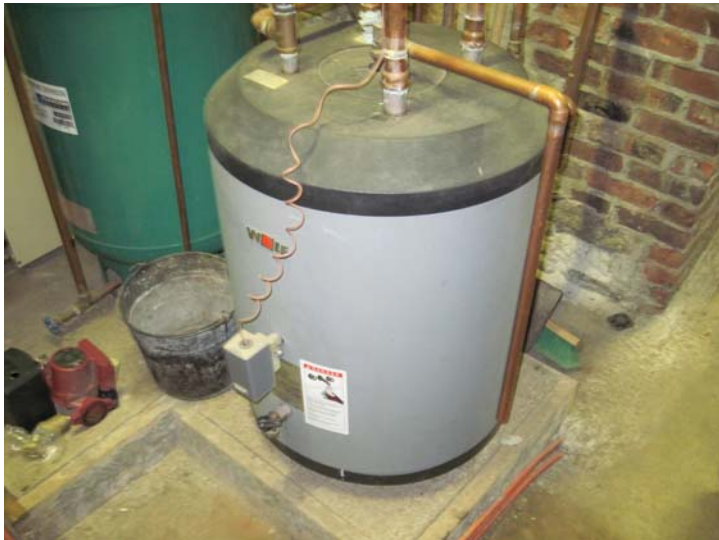
Domestic hot water is produced by a Wolf 30-gallon lowboy indirect-fired hot water storage tank with internal water to water heat exchanger.

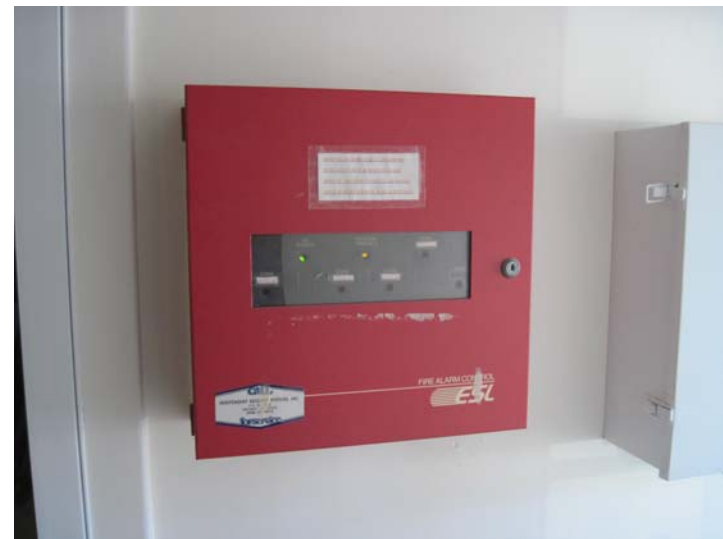
The aging ESL zone-type fire alarm control panel is reportedly greater than twenty years old and in need of near term replacement.

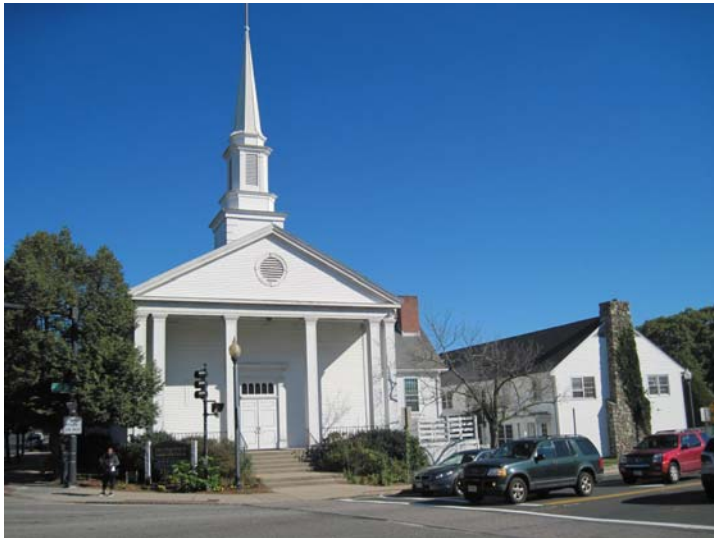
View of the building front (south) elevation. Original church structure at left with original painted-wood gutters and trim elements; and the 1960 addition at right with aluminum gutters and trim elements.

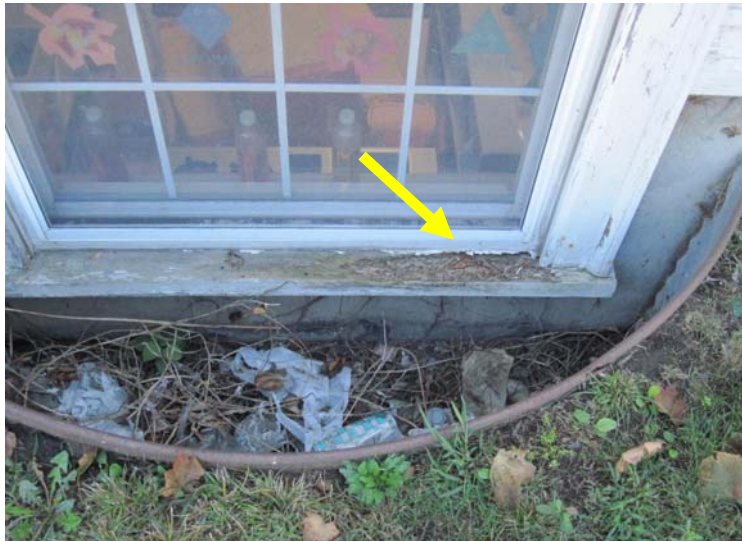
Rotting wood window sills at the sub-grade basement-level windows along the west elevation are all in need of near term replacement

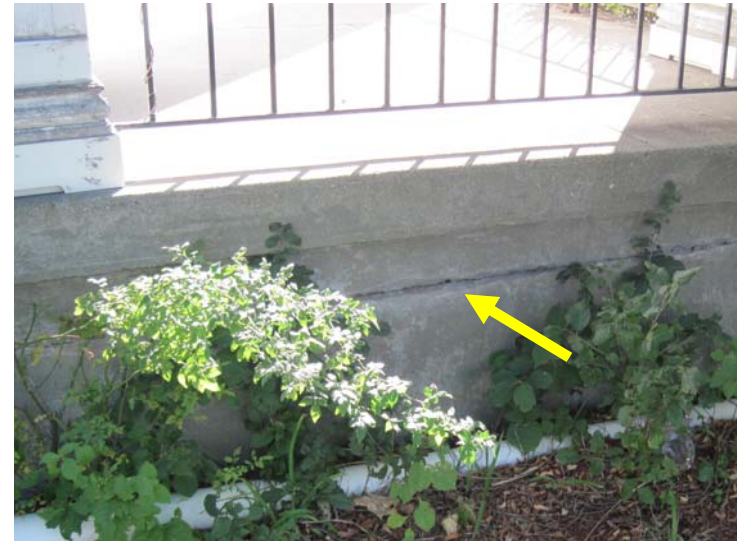
View of exposed cold joint at the sanctuary front entrance porch, in need of near term patching/repair.

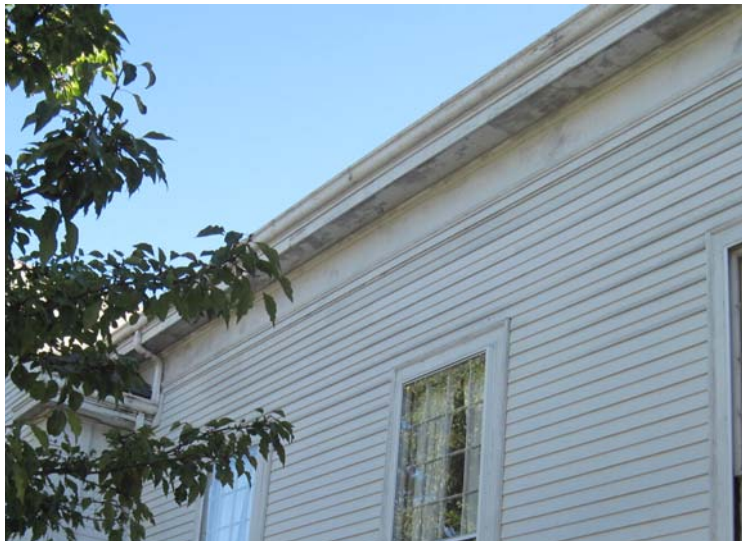
View of failing soffit paint and aging, damaged original wood gutters, in need of near term replacement.

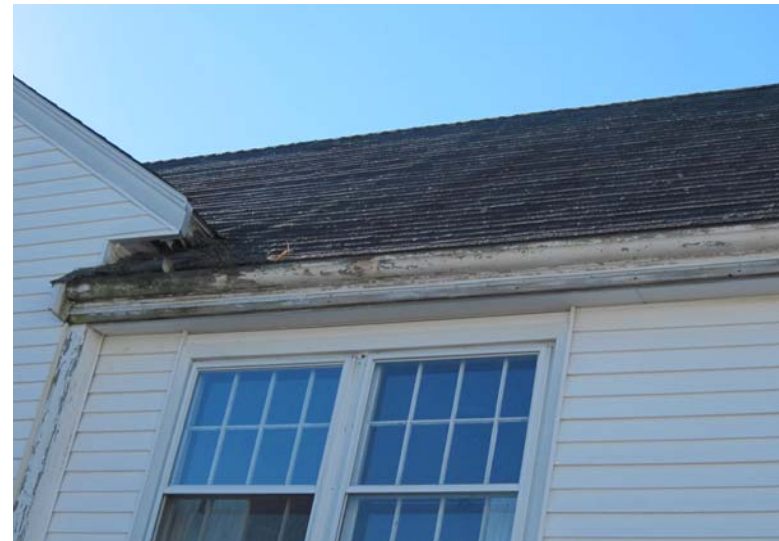
View of rotting wood gutters and aging 3-tab asphalt shingle roofing at the north elevation.

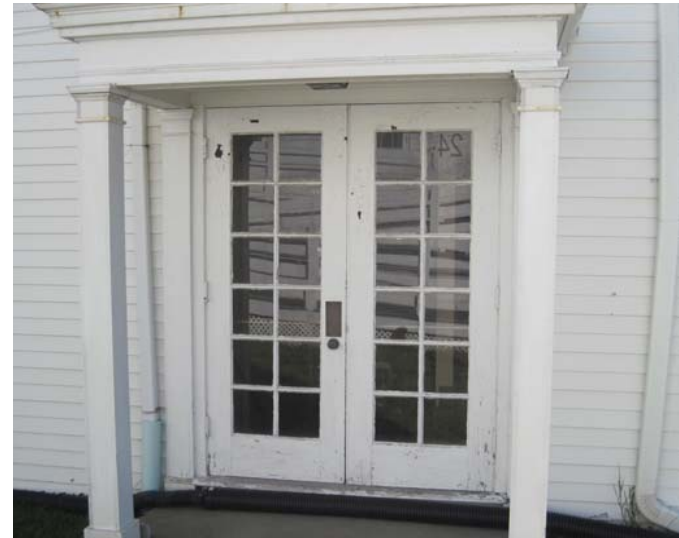
The aging double leaf wood French doors at the 1960's addition west elevation entrance are in need of near term replacement.

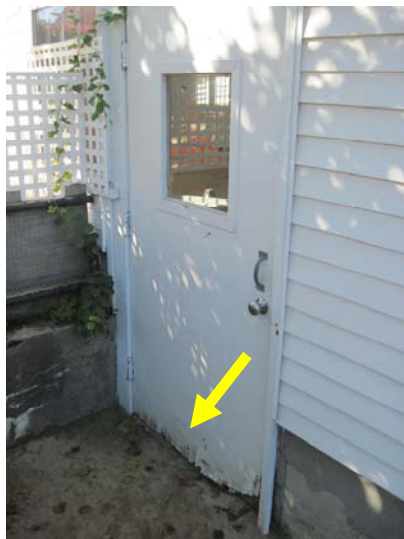
The east elevation egress door from the nursery school auditorium out to the playground exhibits significant base rot and is in need of near term replacement.

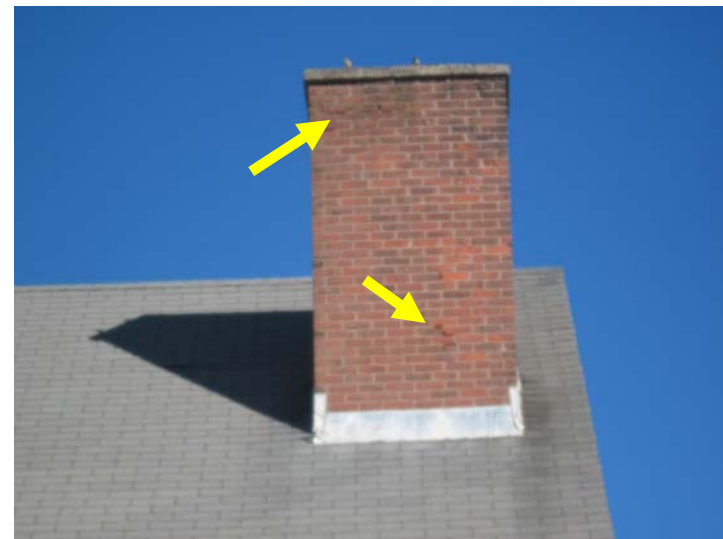
Visible mortar loss within the chimney is in need of near term repair and repointing.

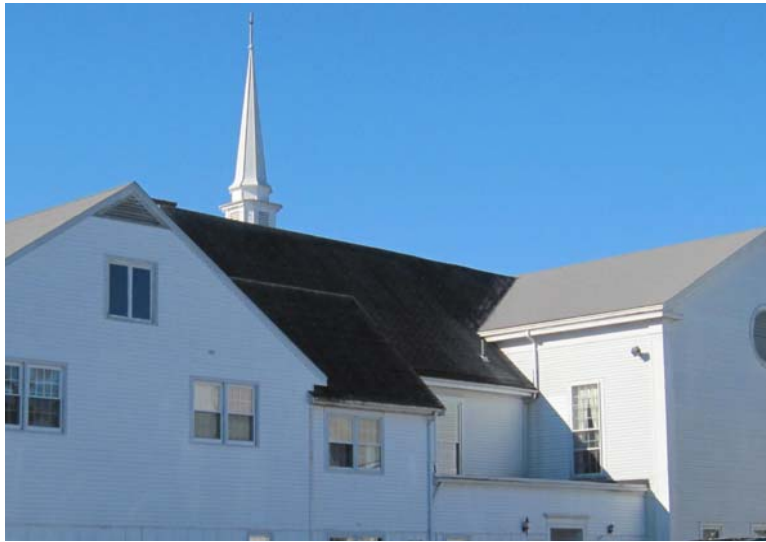
The 3-tab asphalt shingle roofing exhibits mixed conditions with the most severe aging visible along the north elevation over the main entrance.

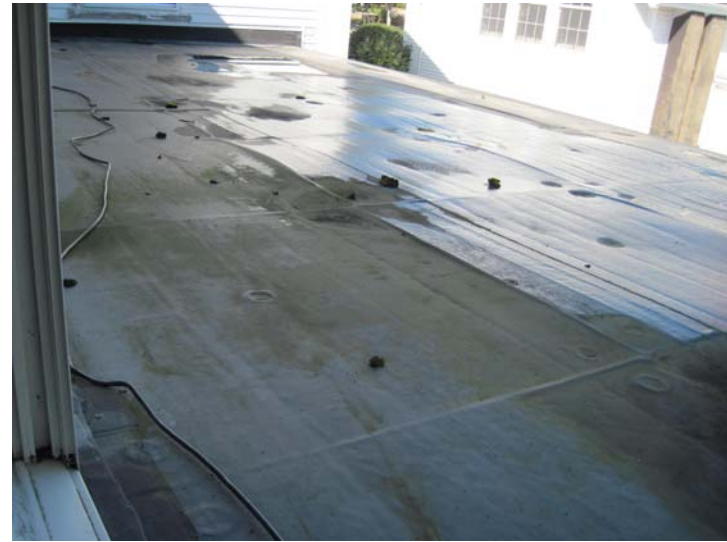
View of the aging mechanically fastened EPDM rubber membrane over the main entrance flat roof structure.

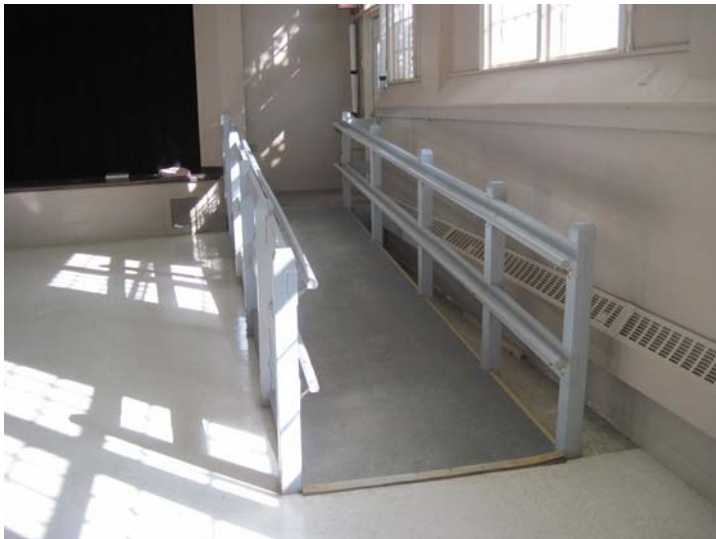
The aging accessible ramp does not meet current requirements and is in need of near term replacement.

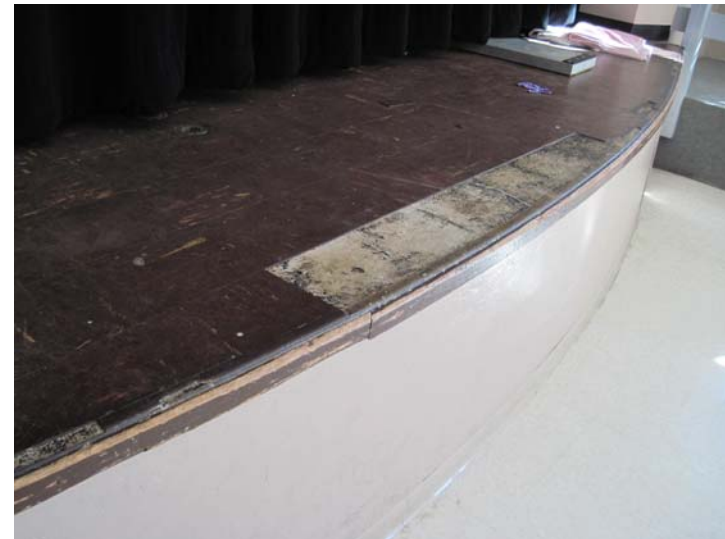
View of the original aging damaged auditorium stage tiles. Tiles are 9"x9" in dimension and could possibly be constructed of asbestos containing material (ACM).

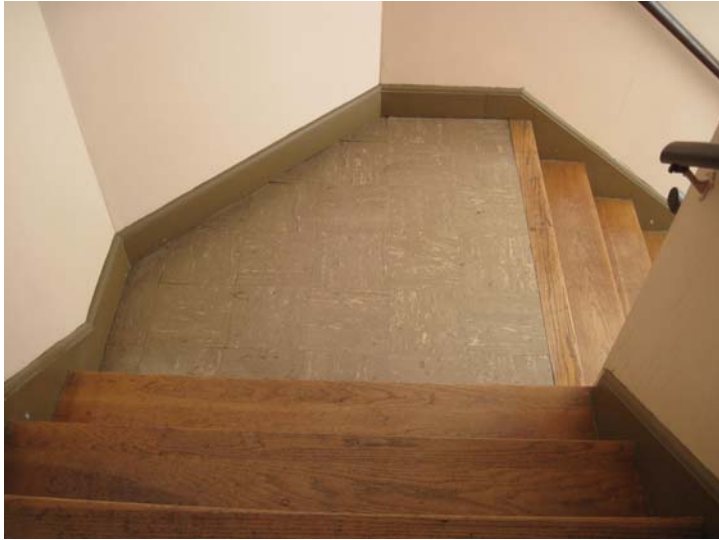
View of the aging wood stair treads and suspected ACM tile landings at the south elevation of the auditorium leading up to the 2nd Floor classrooms.

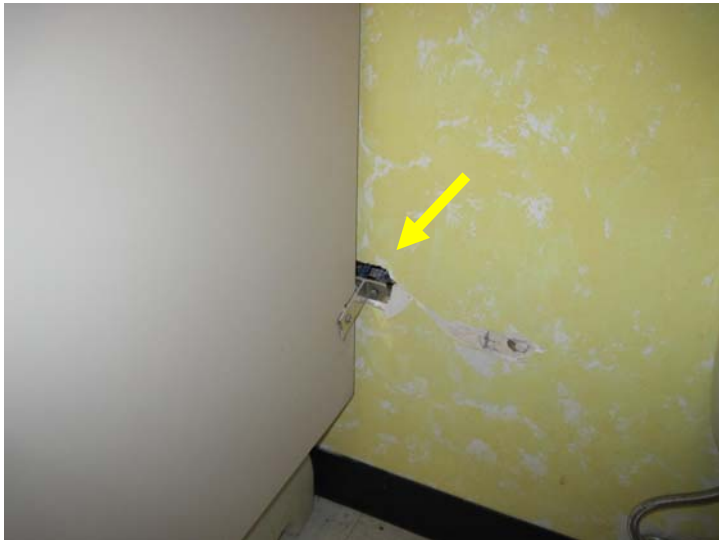
View of damaged partition wall anchor. Both bathrooms are in need of near term renovation.

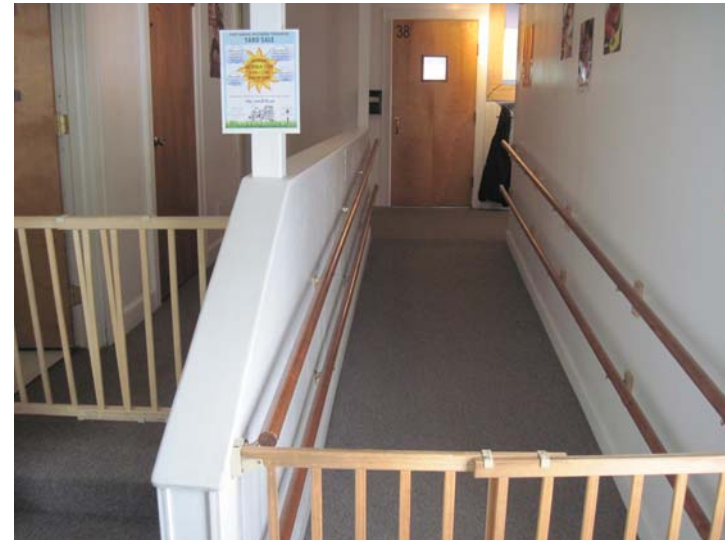
View of typical second floor hallway finishes with painted drywall walls and carpeted flooring.

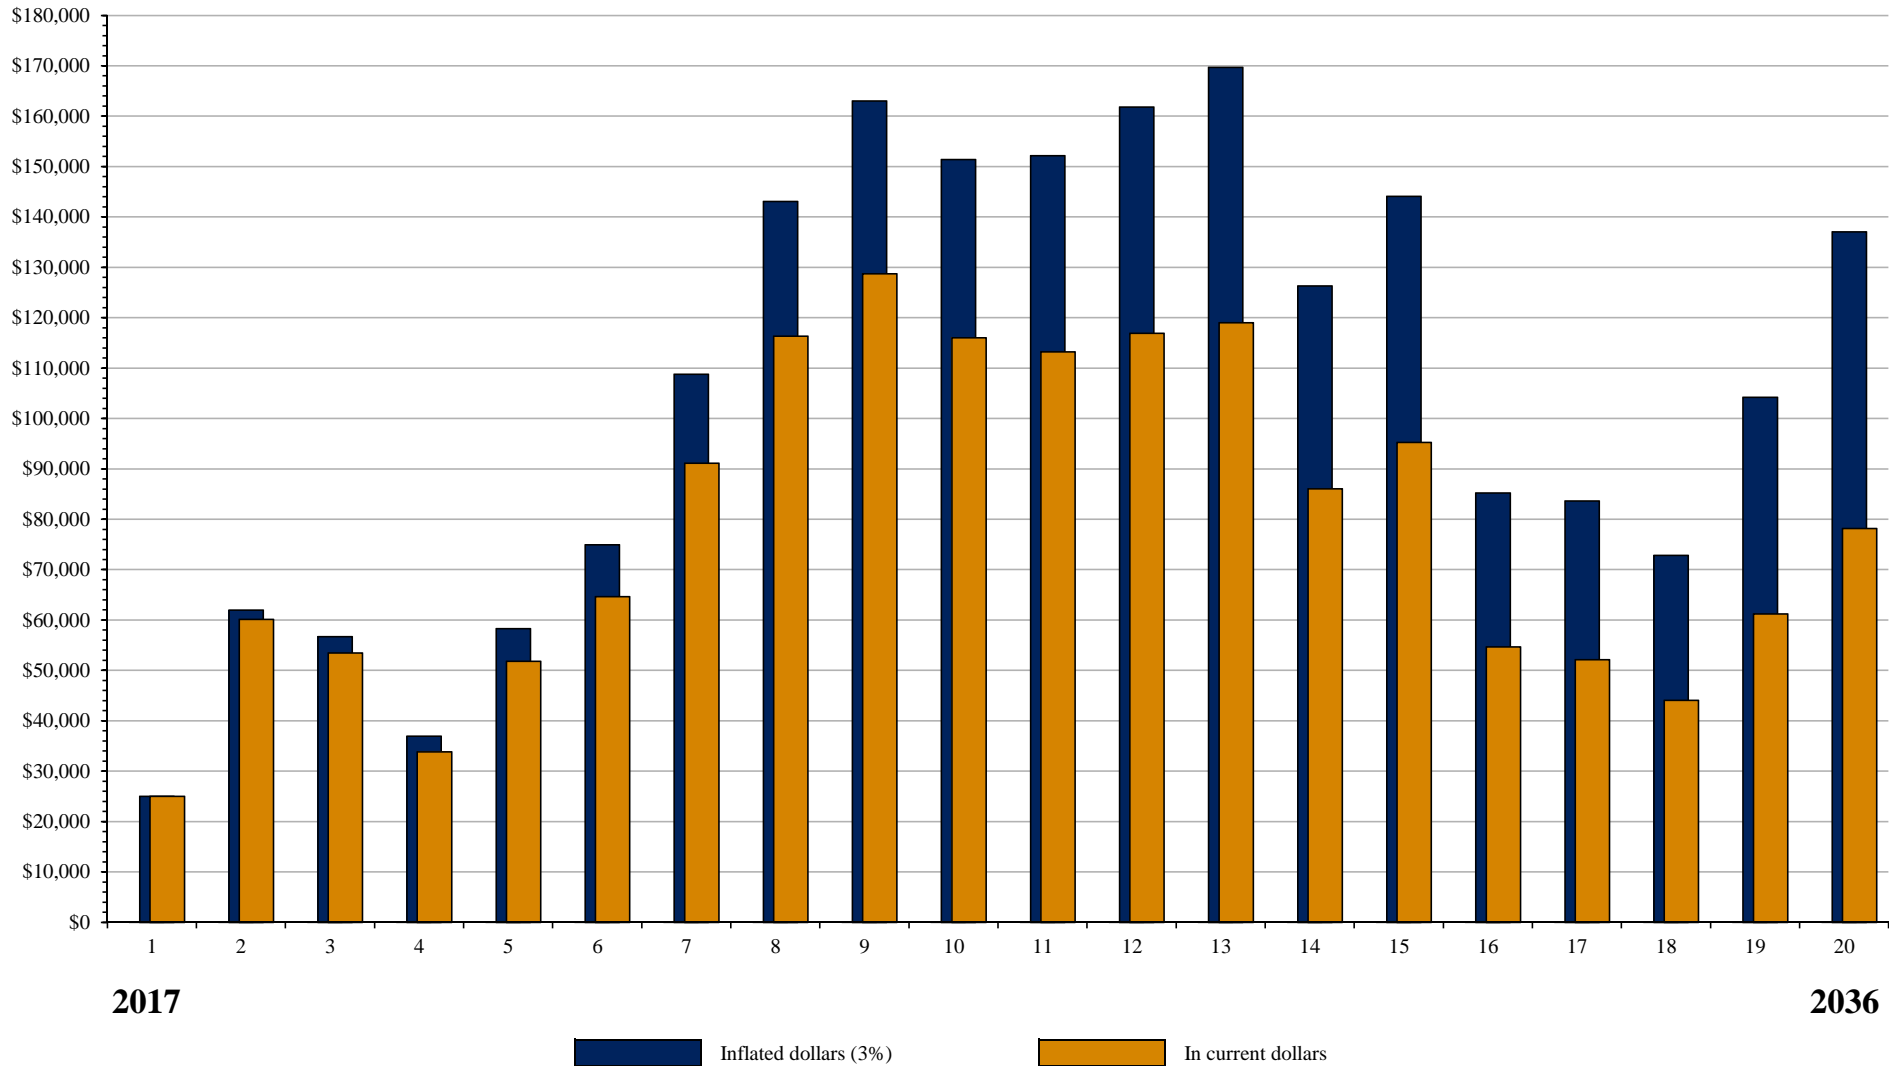
<i>Reported Reserve Balance as of 10/12/2016</i> : \$0	At the end of Year One, Reserve Balances are projected to be: \$24,988
<i>Estimated Reserve Balance as of 01/01/2016</i> : \$0	At the end of Year 20, Reserve Balances are projected to be: \$137,034
<i>Current annual contributions to reserves</i> : \$0	<i>All projected capital needs are met throughout the plan</i>
