Municipal Capital Needs Assessment and Replacement Reserve Analysis

Prepared for:

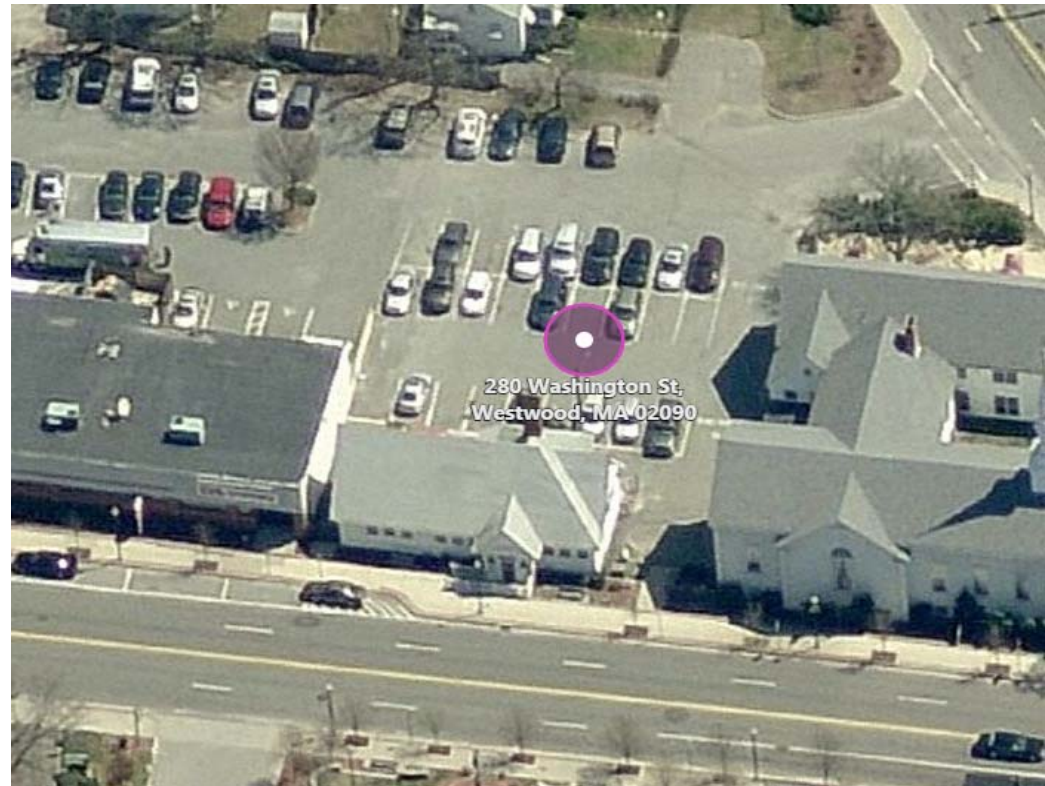
Property Description:

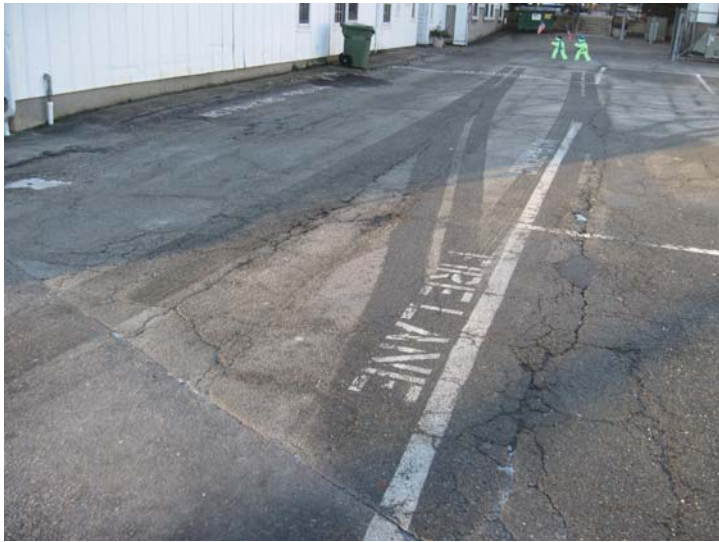
View of the ageing, deteriorating parking lot and fire-lane asphalt surface conditions.

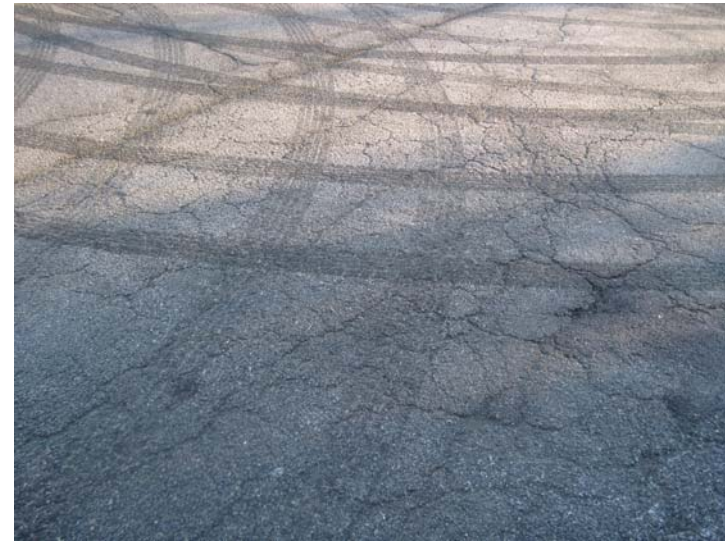
Significant cracking and alligating of the entire asphalt surface is beyond repair. Near term complete resurfacing is recommended.

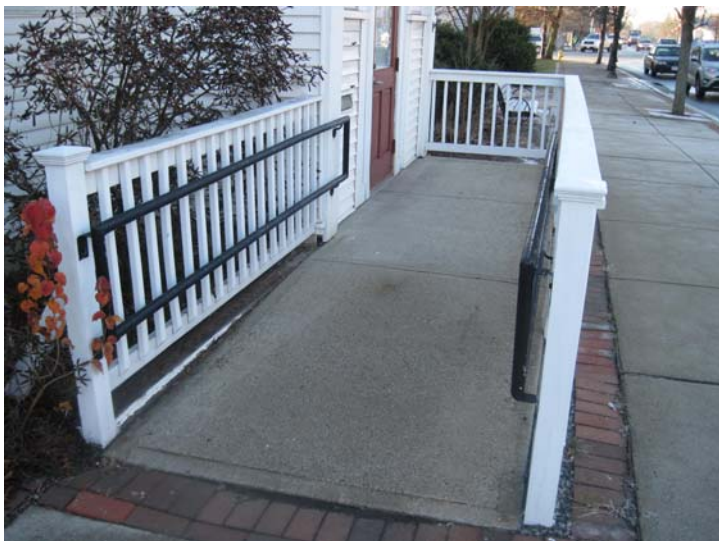
Concrete surfaces are limited to the front entrance ramp, two side elevation steps, and the exterior heating/cooling unit housekeeping pad. All in generally good observable condition.

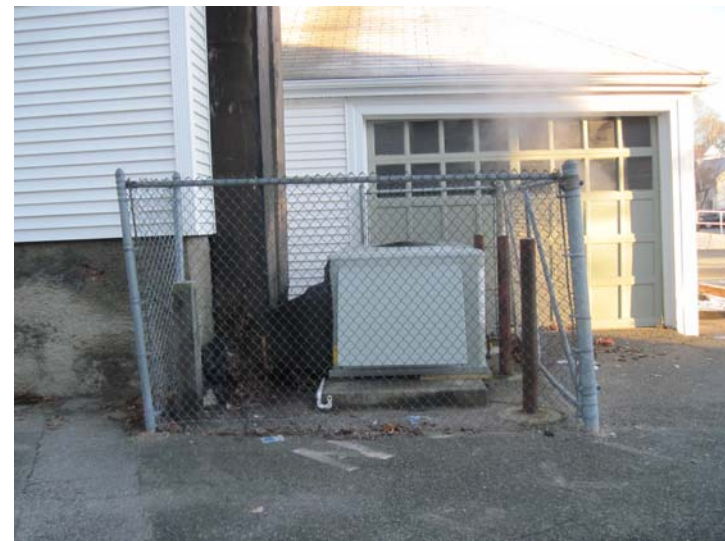
Fencing is limited to the chain link enclosure at the exterior pad-mounted heating/cooling unit. The posts are out of plumb due to vehicle impact and/or snow removal efforts and are in need of repair/re-setting.

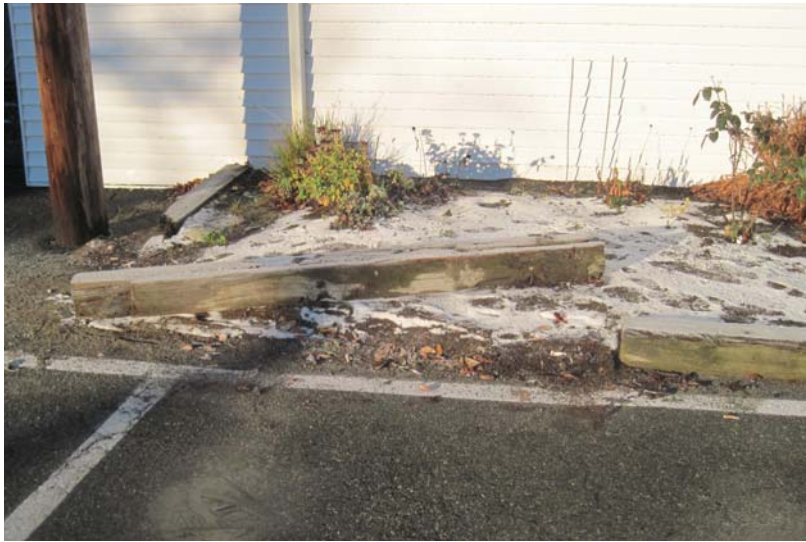
The aging, rotting, damaged rear-elevation landscaping timbers are in need of replacement.

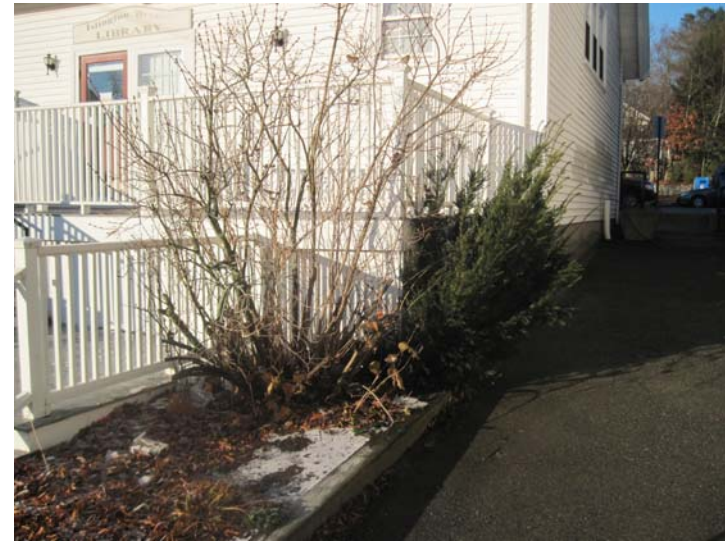
Overgrown shrubs adjacent to the rear-elevation deck are in need of trimming or removal.

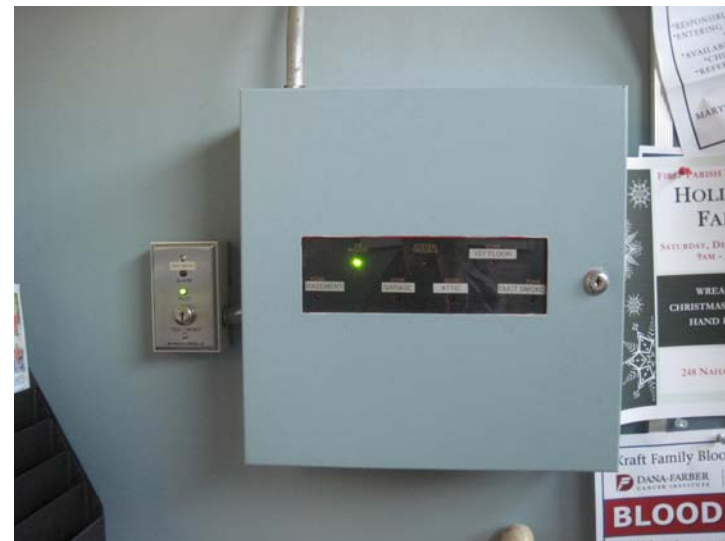
The aging zone-type fire alarm control panel has surpassed its twenty-year expected useful service life and is in need of near-term replacement.

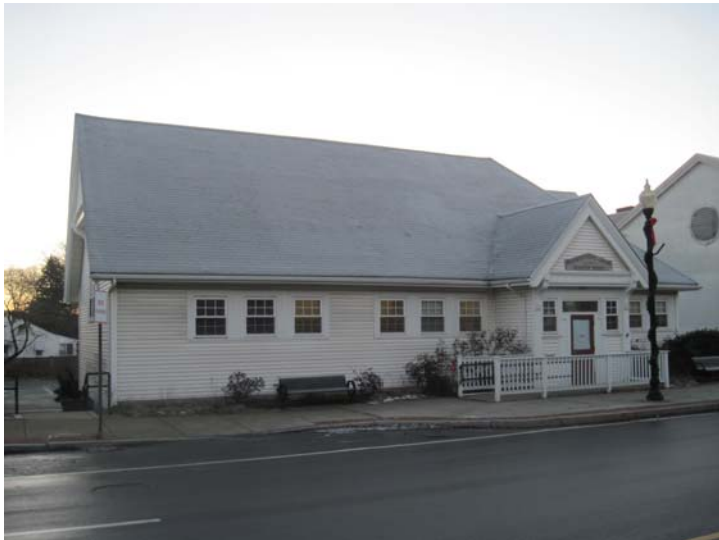
View of the building front (west) elevation with clapboard-profile vinyl siding and aging three-tab asphalt-shingle roof.

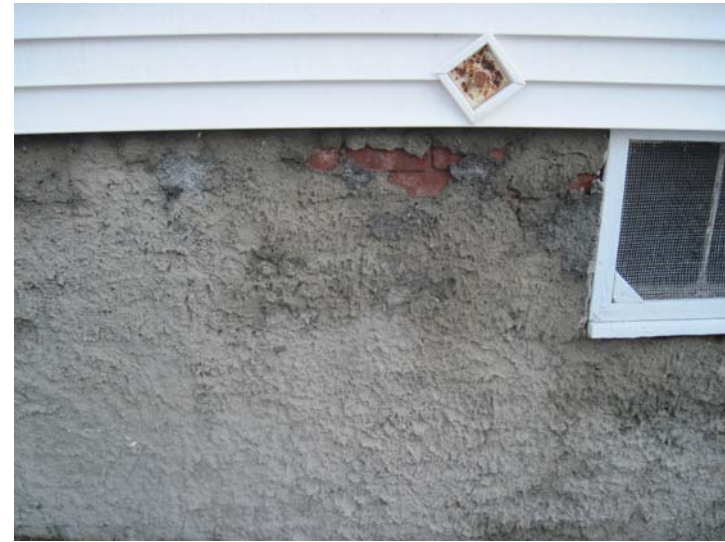
View of the aging, delaminating parging over the original brick foundation at the south end-elevation of the building. In need of near-term removal, as-needed repointing, and complete re-parging.

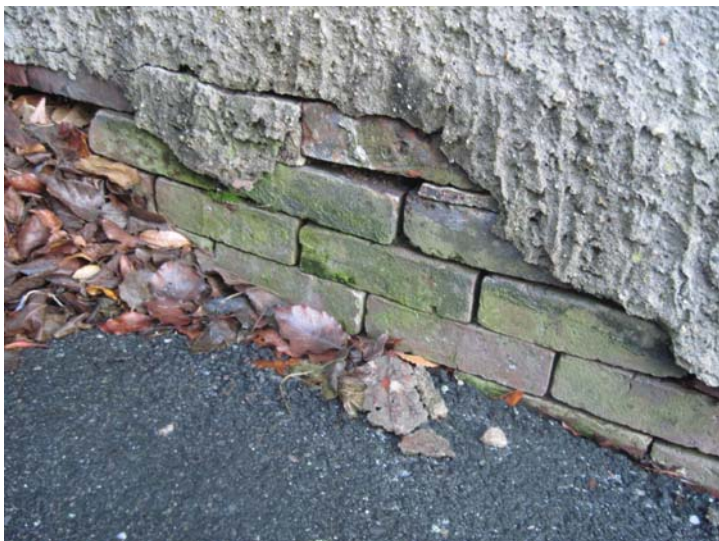
Close-up of complete mortar loss visible at the exposed brick foundation at the south end-elevation. In need of near-term removal, repointing, and re-parging.

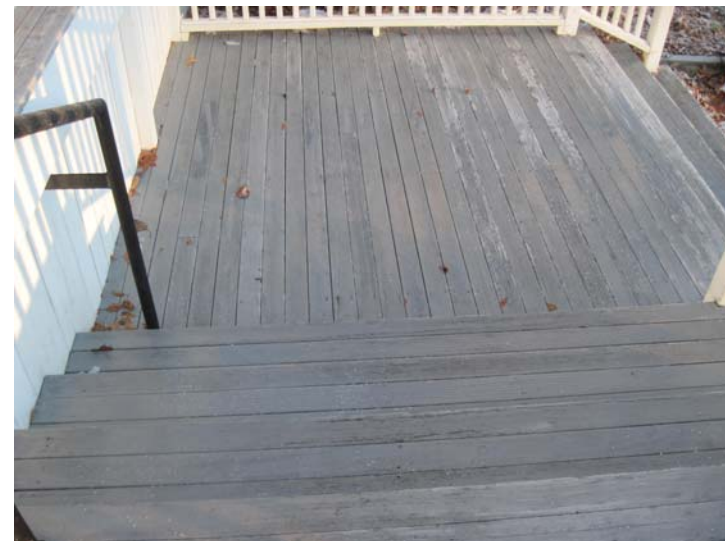
View of aging wood decking boards at the rear-elevation entrance deck structure.

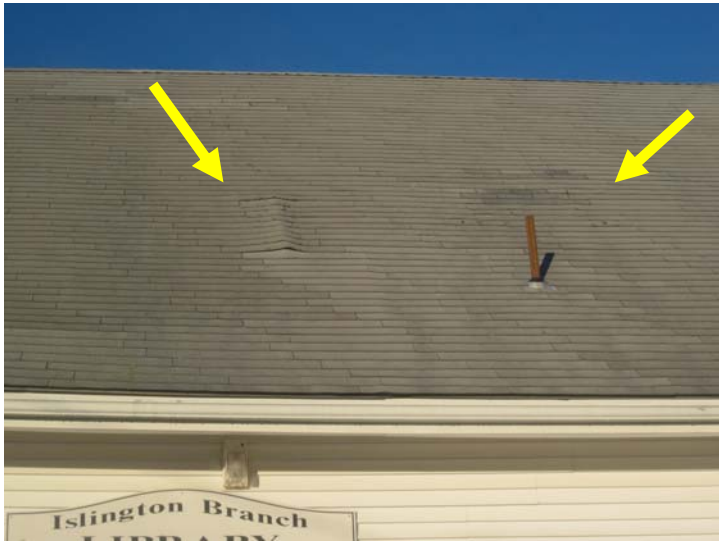
The ageing roof shingles are lifting in several spots providing an access for wind driven rain which has resulted in visible interior moisture damage.

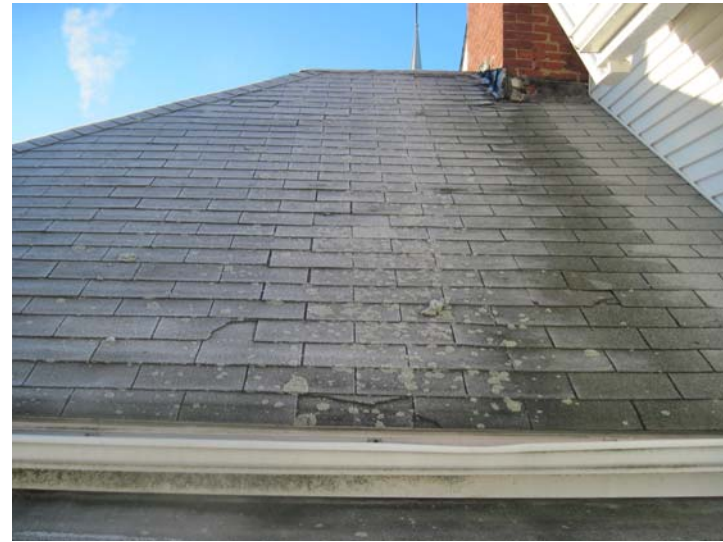
View of significant organic growth and shingle damage at the garage extension roof.

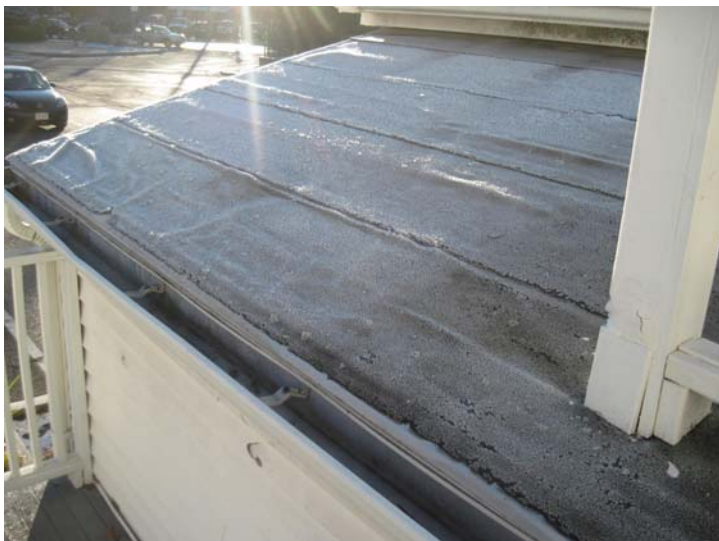
A small section of asphalt roll roofing over the garage structure is also ageing, deteriorating and in need of near-term replacement.

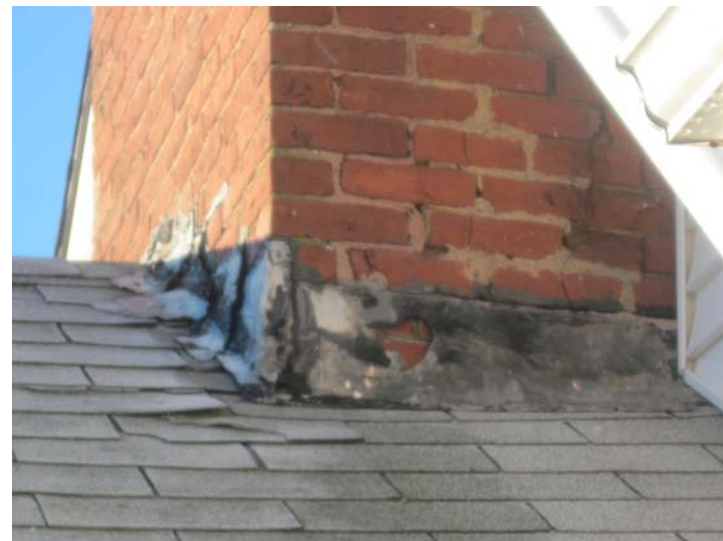
Close-up of deteriorating flashing, cracked bricks, mortar loss, and lifting shingles at the north and east sides of the chimney providing access for wind-driven rain and moisture damage.

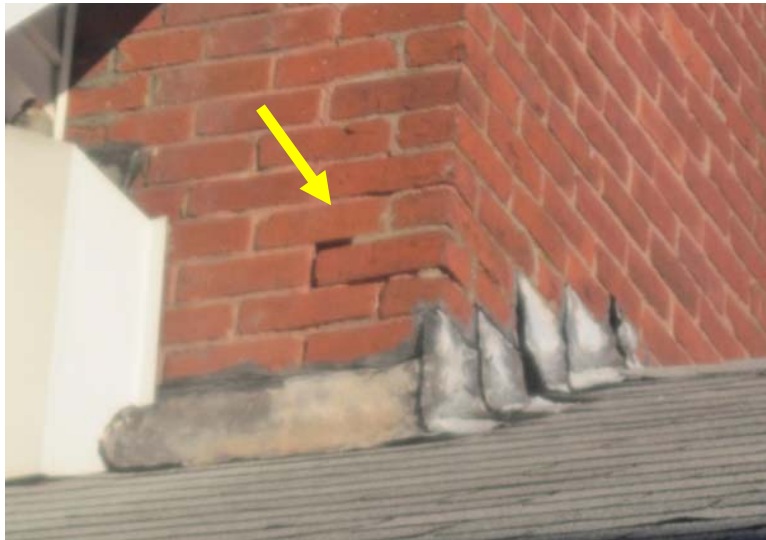
View of visible mortar loss at the chimney's south side.

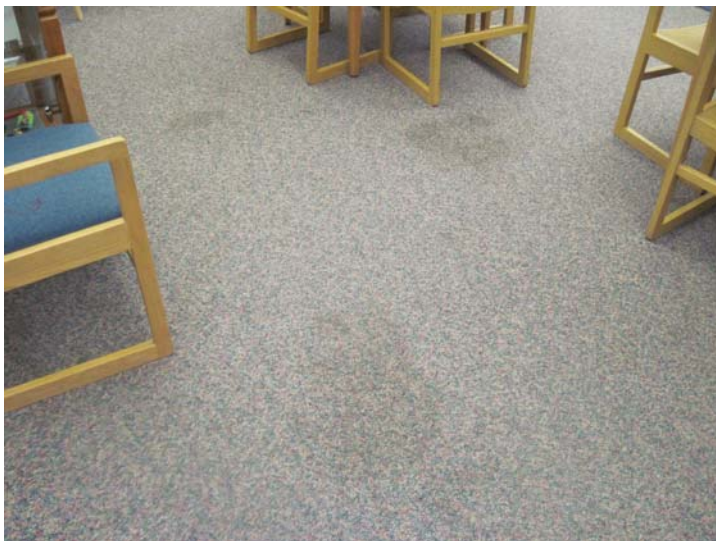
Age and use-related carpet staining and wear is visible throughout the room. Presumed to date to the 1996 renovations and in need of near term full replacement.

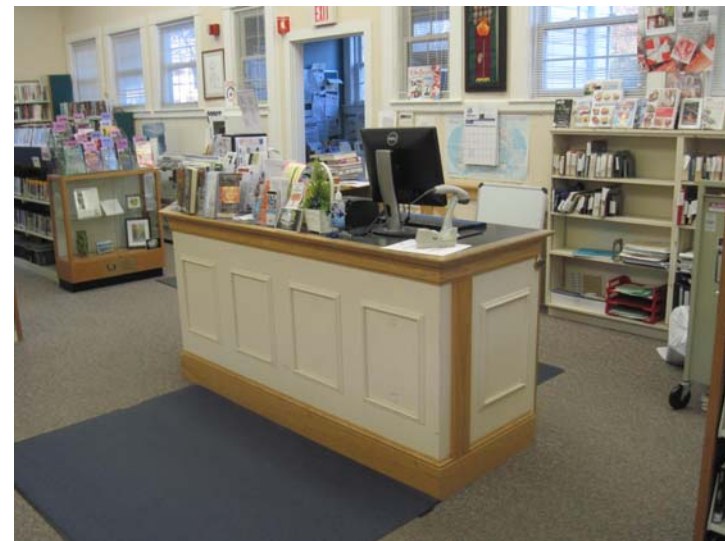
View of the librarian's desk and front entrance vestibule just beyond.

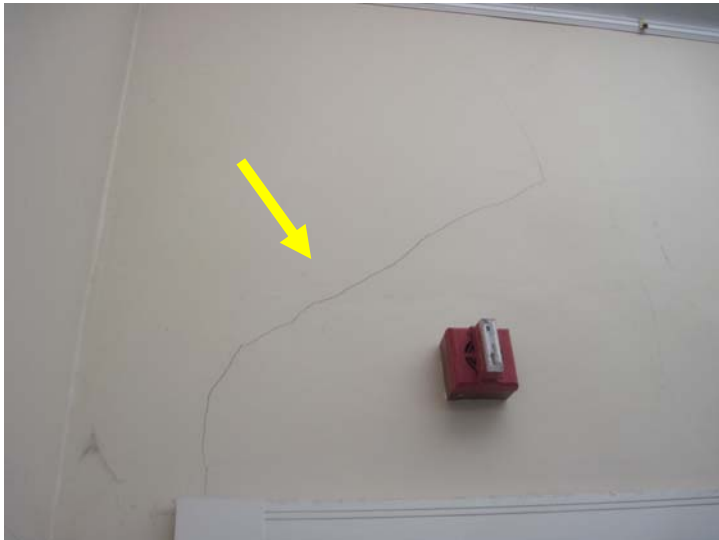
View of cracking wall plaster visible above the rear entrance door.

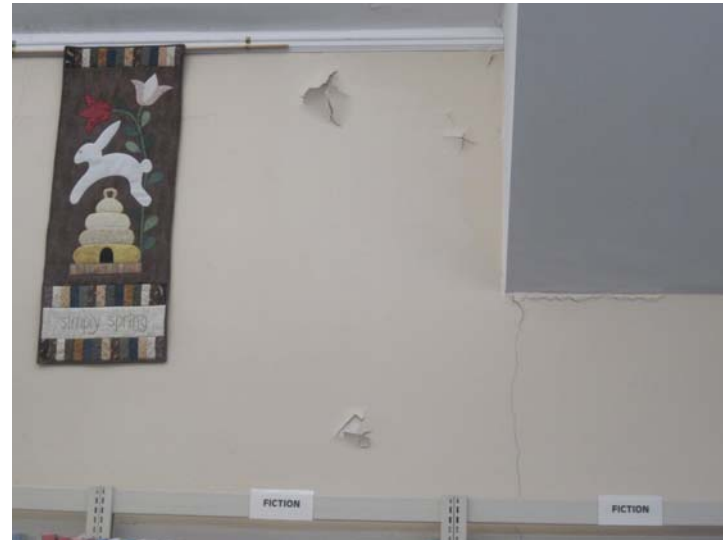
View of moisture-related paint failure and cracking visible along the east-elevation wall.

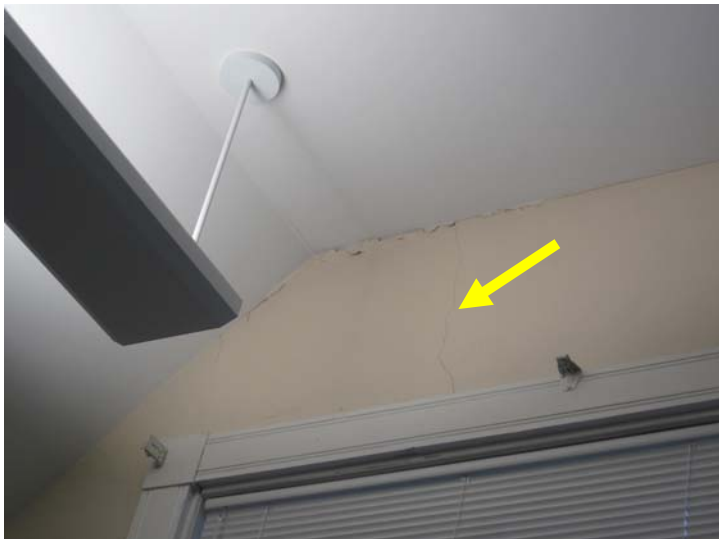
View of wall cracking and paint failure visible at the south-elevation wall.

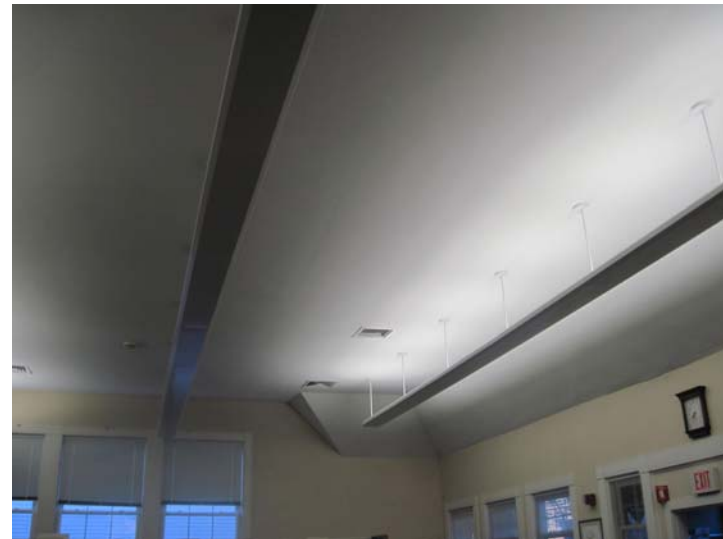
Diffused lighting fixtures were installed during the 1996 renovations.

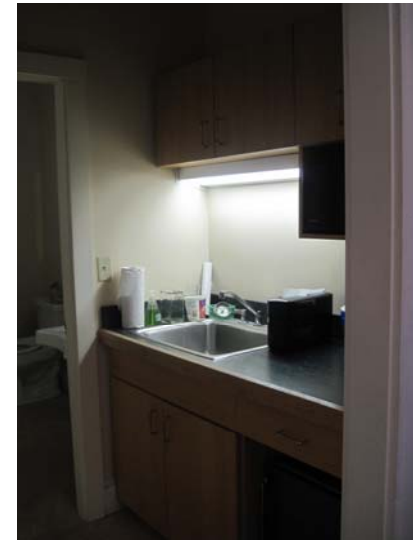
A small kitchenette with wood cabinets, plastic-laminate countertop, inset stainless-steel sink, mini-refrigerator, and small point-of-use water heater, is located at the northeast corner.

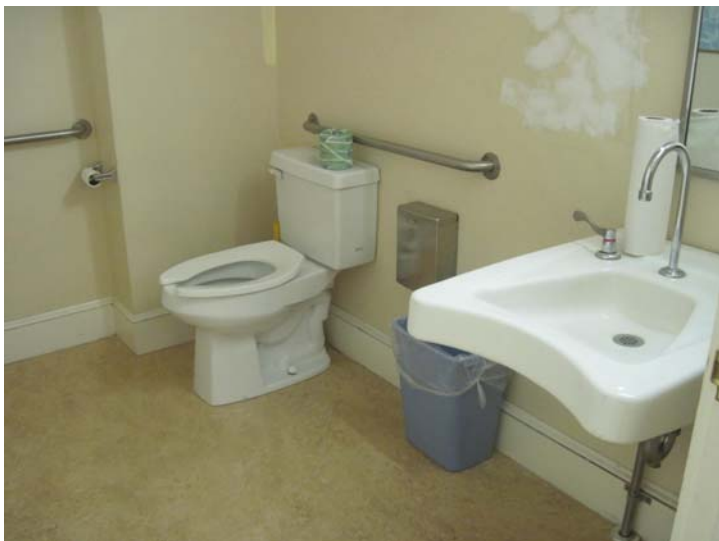
A fully-accessible bathroom is located just through the kitchen area. New vinyl sheet flooring was recently installed throughout the kitchen and bathroom in 2016.
