Conservation Land Management Plan

Town of Westwood Conservation Commission

March 2024

Prepared by: BETA GROUP, INC.

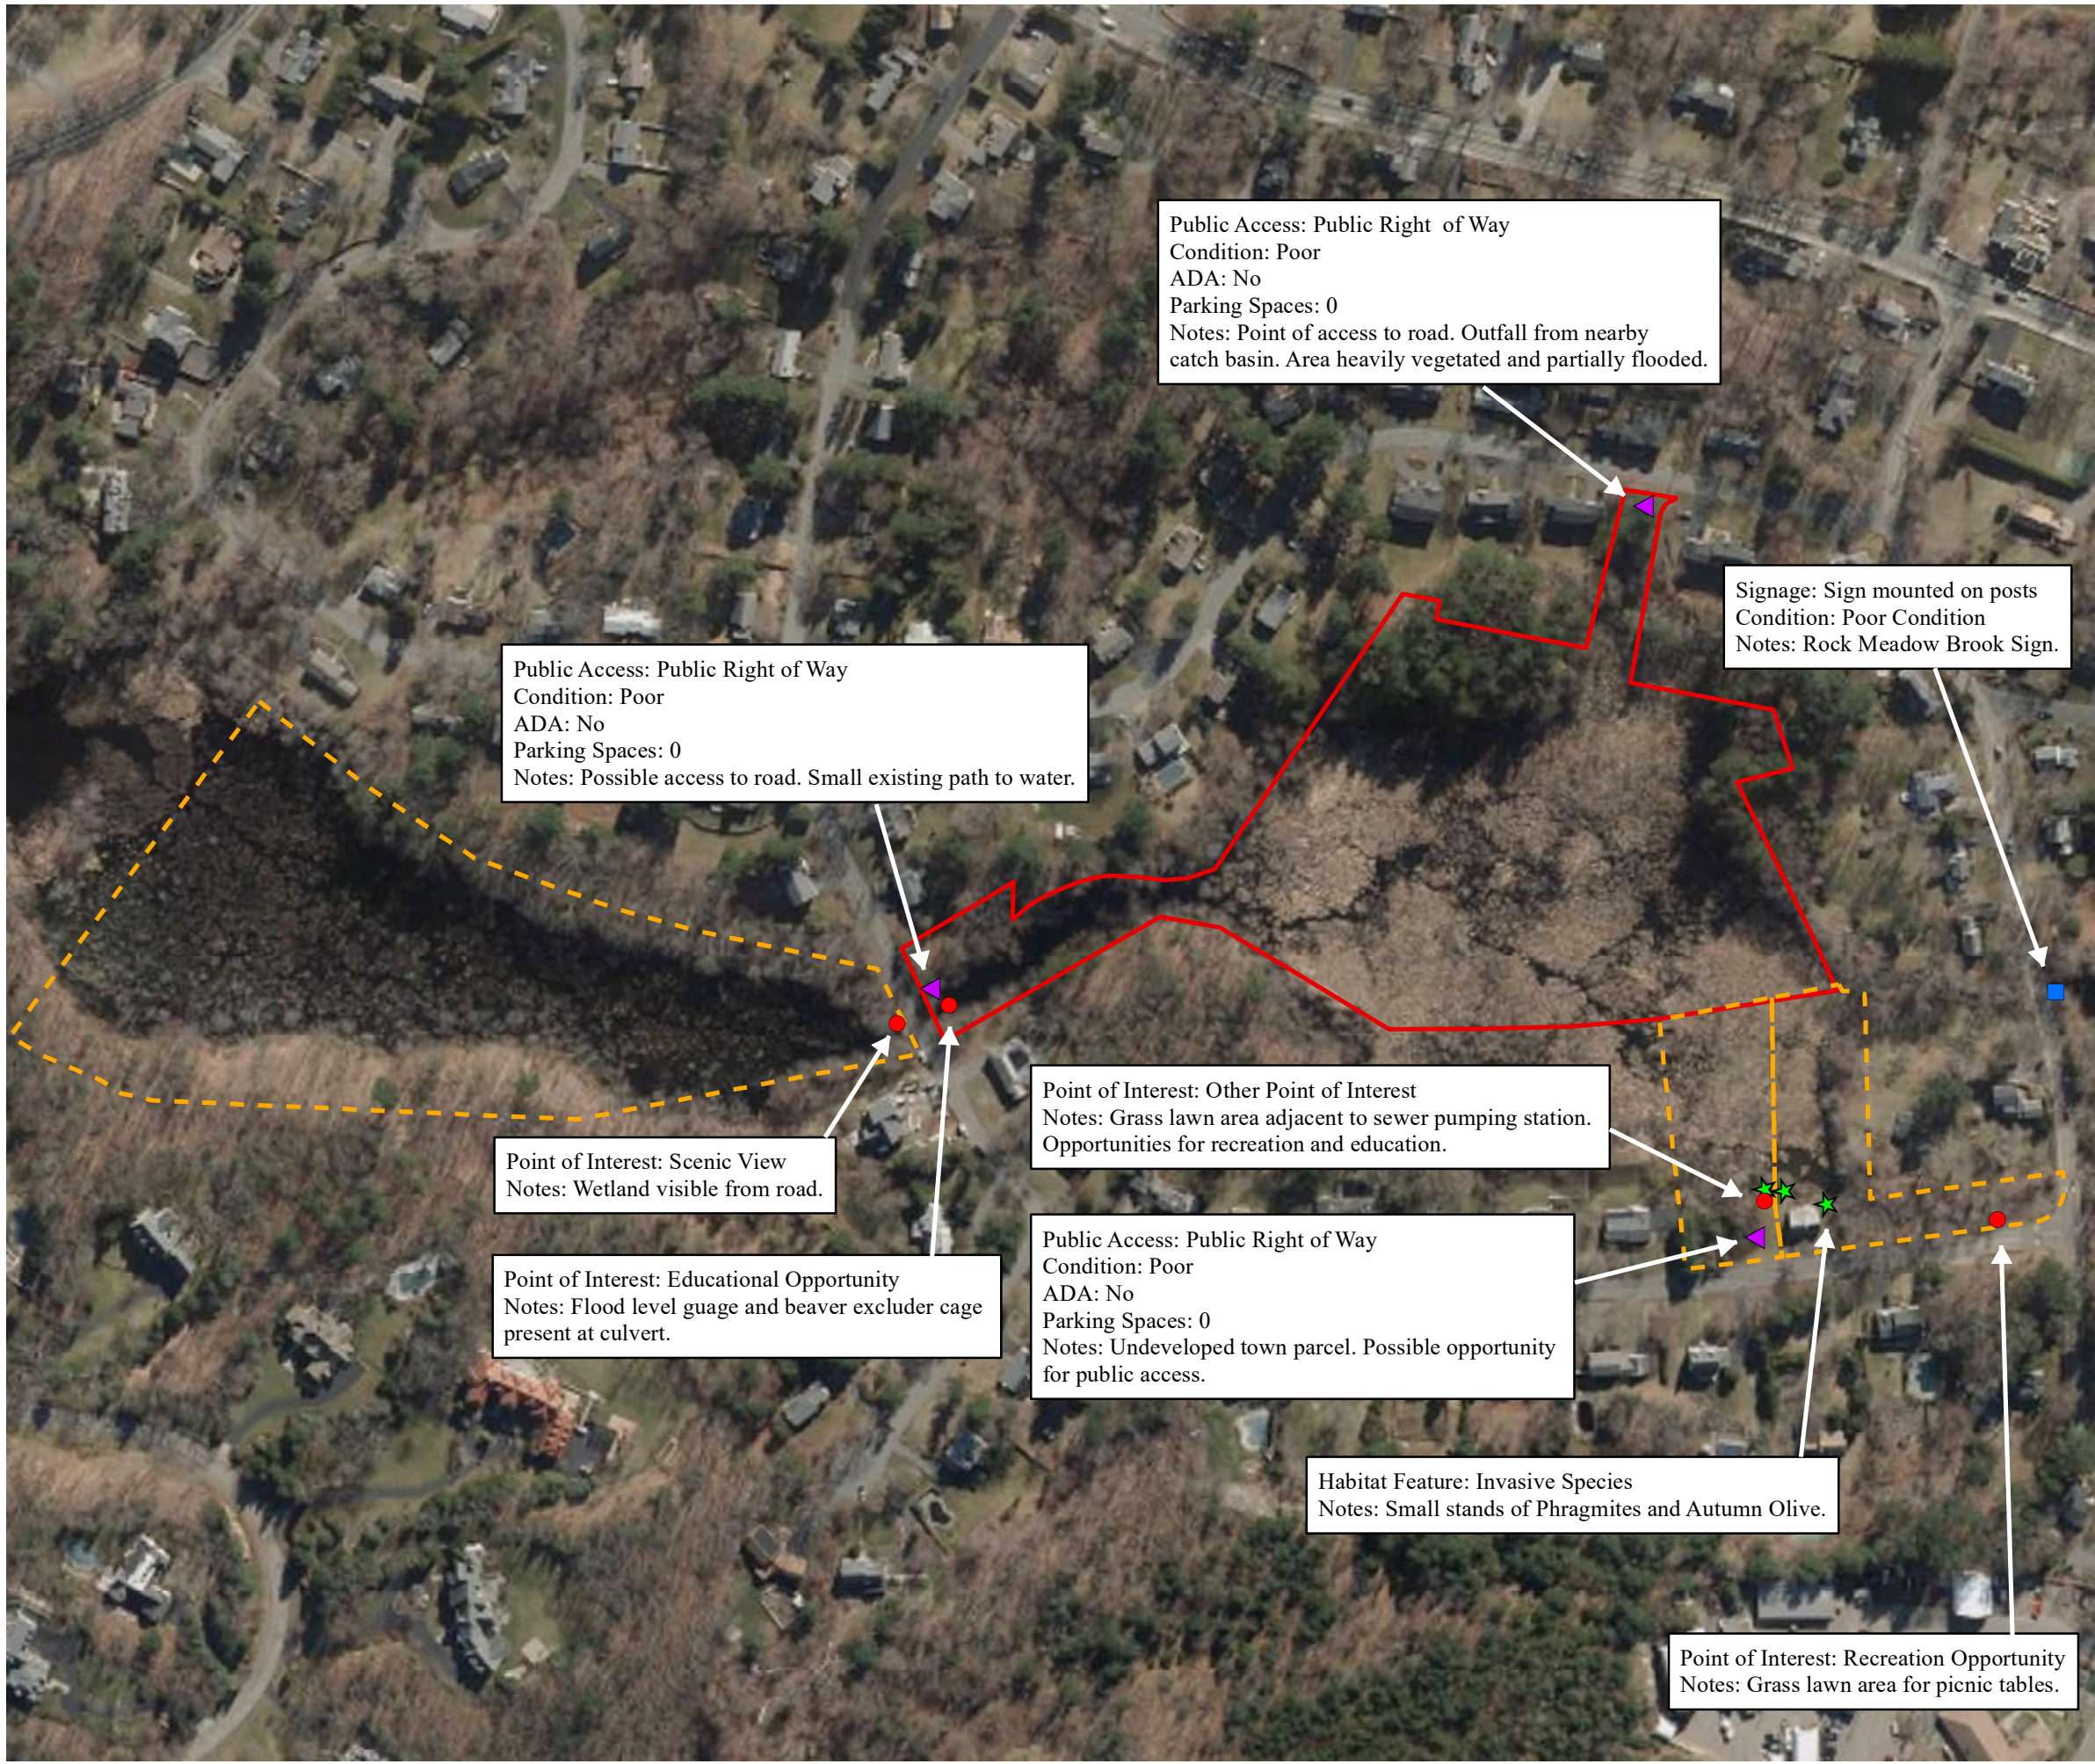
**Property Assessment Map
Rock Meadow Brook Conservation Area
Westwood, MA**

Public Access: Public Right of Way
Condition: Poor
ADA: No
Parking Spaces: 0
Notes: Point of access to road. Outfall from nearby catch basin. Area heavily vegetated and partially flooded.

Public Access: Public Right of Way
Condition: Poor
ADA: No
Parking Spaces: 0
Notes: Possible access to road. Small existing path to water.

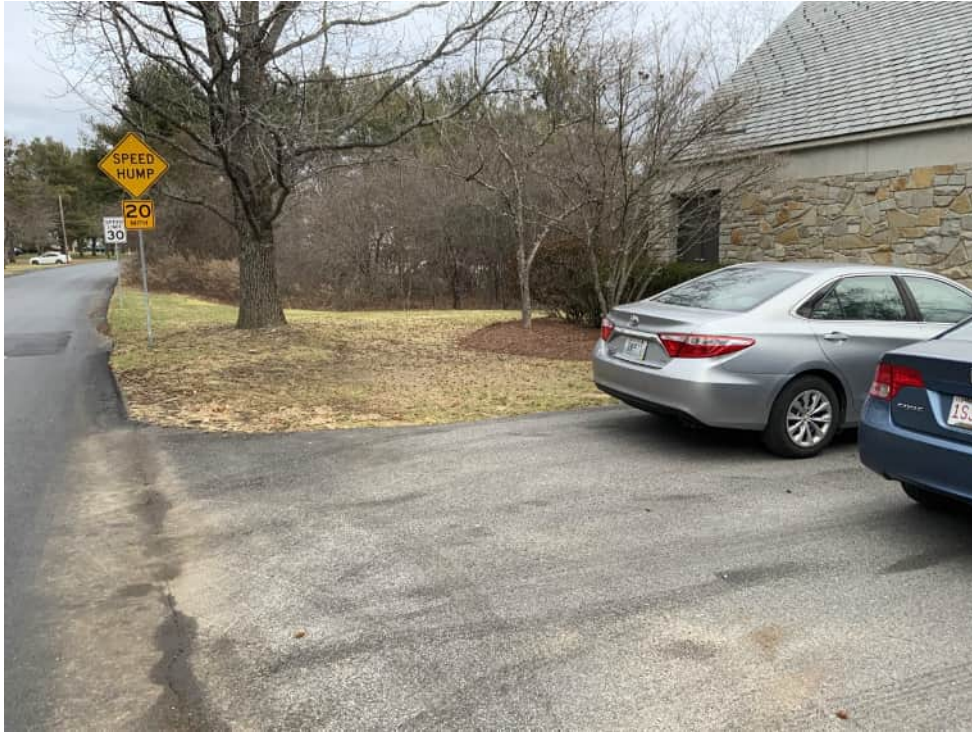
Photo 1

The potential public access point at the Conant Road pump station contains space for around two vehicles, while the potential access point at the Lorraine Road easement is heavily wooded and inaccessible. Due to the site’s inaccessibility and wetland habitat, no recreational development is recommended onsite.

View of the Pumping station access and parking along Conant Road—facing north

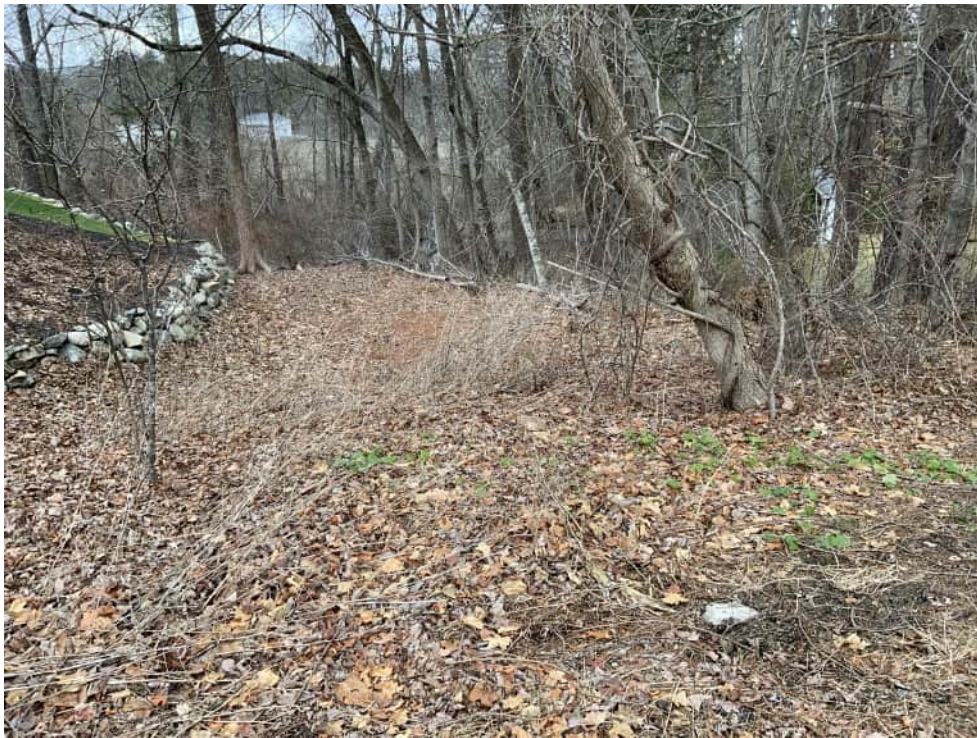
Photo 2

View of the Lorraine Road Right-of-Way—facing northwest

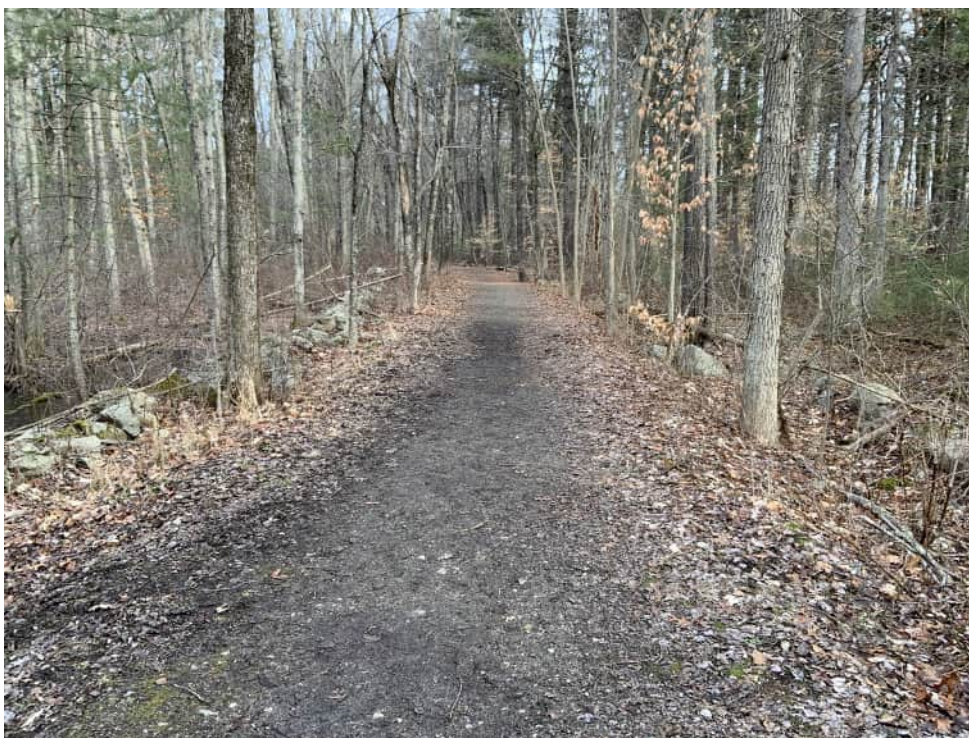
Photo 8

Sandy Valley Road is a trail extension of the approach road to the Lowell Woods properties and is therefore named the same as the road. Sandy Valley Road is the most well-maintained trail, with a wide flat path along the duration of the trail. Several offshoots along Sandy Valley Road connect the other trails with some signage. Images in Appendix D: Photo Documentation showcase the need for replacement or restoration of several of these signs.

View of Sandy Valley Road—facing north

Key access improvements are needed to achieve those enhanced recreational and educational opportunities at Lowell Woods. The approach to the site along Sandy Valley Road should be paved to improve the overall condition of the road and the experience of arriving at the properties. Additional signage along Gay Street where it intersects with Sandy Valley Road identifying the direction of the Lowell Woods properties and highlighting the biking and hiking trails would help increase visibility and potentially increase visitation. Similarly, the addition of sidewalks along Gay Street and Sandy Valley Road could increase the number of neighborhoods in walkable distance to Lowell Woods. The parking area itself could be expanded to accommodate larger vehicles such as school buses or accessible vans. The signage within the parking area can be improved with a larger map and more informational resources about the site.

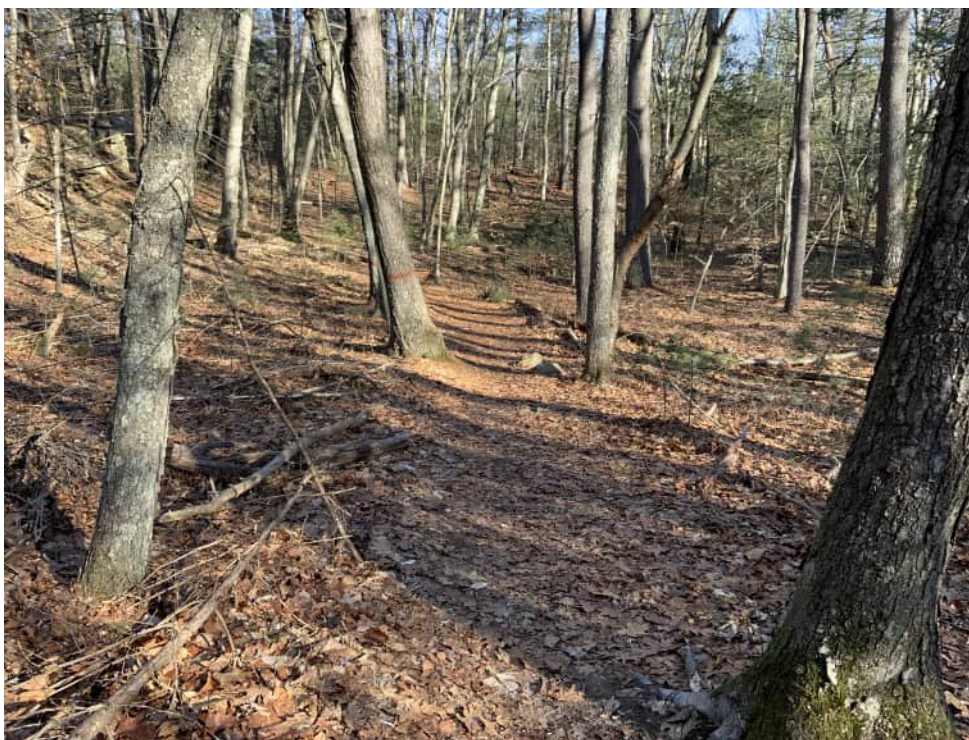
Photo 14

Krissy's Trail runs close to Route I-95 without any fencing or other physical barrier separating the trail from the roadway. The trail itself is well-kept with several downed trees.

View of Krissy's Trail—facing north

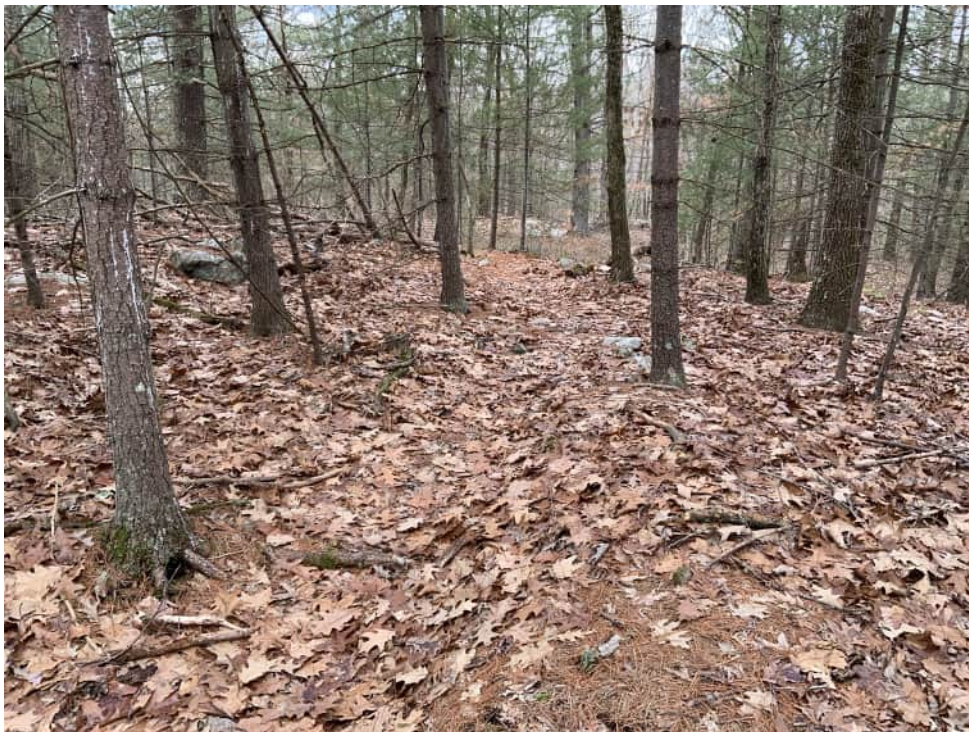
Photo 15

Scout Trail is a difficult trail to traverse for hikers, and likely serves primarily as a mountain biking route. The trail is poorly defined along some of its length, it is hilly, and the path itself is thin and winding. Markers along the trail keep bikers aware that they are still on Scout Trail.

View Scout's Trail—facing west

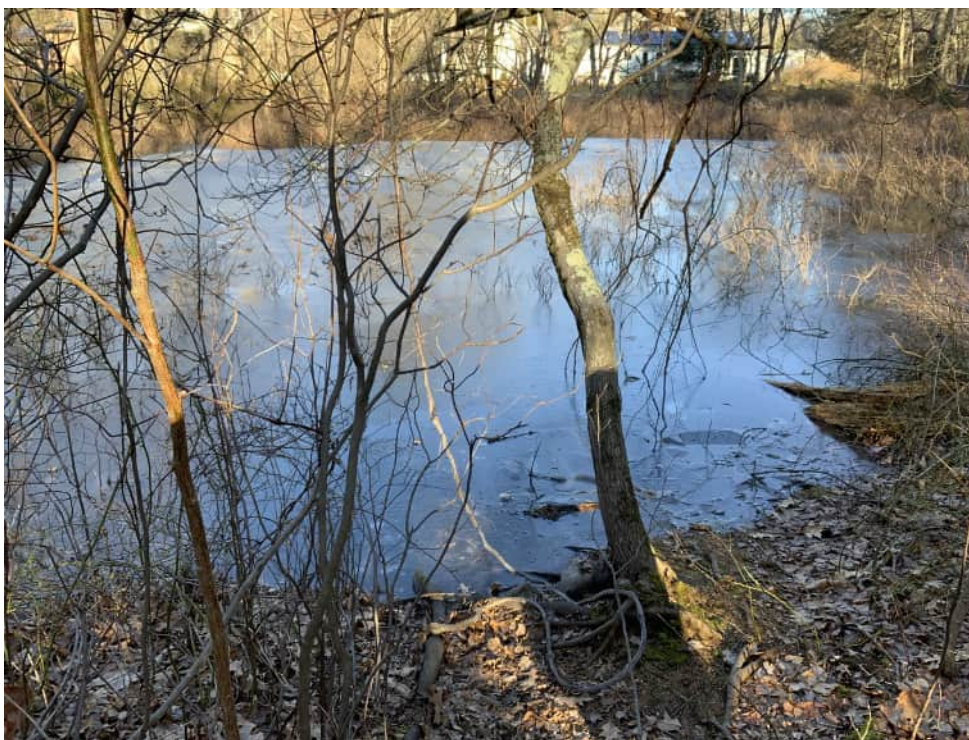
Photo 16

View of a potential vernal pool along Blue Trail—facing north

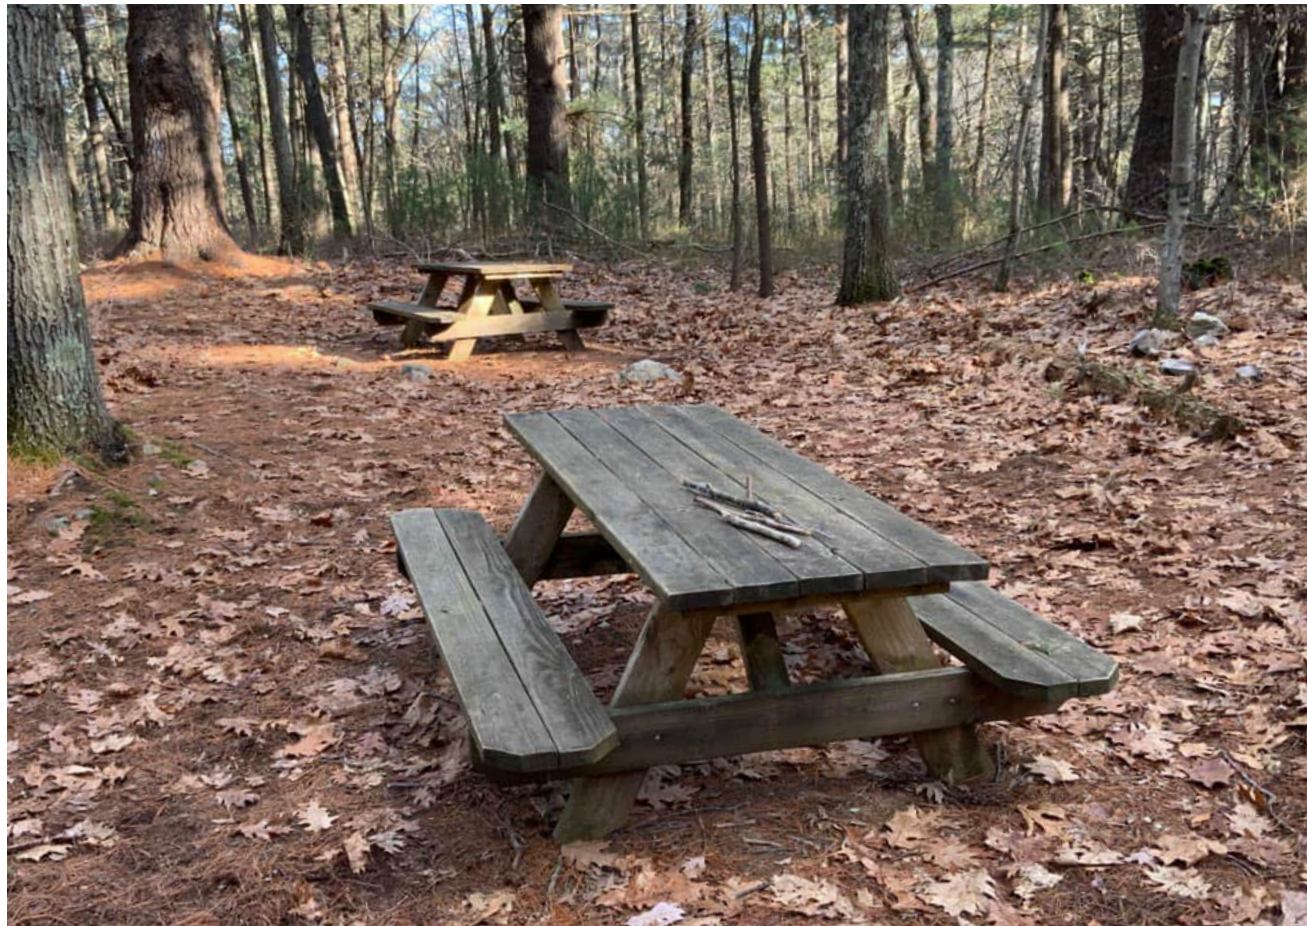
Existing Picnic Area

A picnic and camping area from a 2016 Eagle Scout project exist at the intersection of Lowell Road and Fox Meadow Trail. The area contains several picnic tables and tent platforms in poor or weathered condition. Along the far edge of the area down a dead-end trail are several fire pits – either formally or informally constructed. The trail in the surrounding area also needs maintenance. Development of an accessible access trail to this area would greatly expand recreational opportunity.

Efforts to improve recreation at Lowell Woods have already been made, specifically in the 2016 Boy Scout project at Lowell Road. However, due to deterioration from exposure, weather, and wildlife, the project needs repair. This presents an opportunity to greatly improve recreation facilities along Lowell Road in the form of new picnic tables, protected fire pits, strong tent platforms and trail maintenance.
