Westwood Fire Station 2 - Islington

Town of Westwood ADA Transition Plan

July 2023

Westwood Fire Station 2, also known as Islington Station is located at 300 Washington Street and is a one (1) story building. Outside the facility, there is a parking lot and a memorial located on the north side.

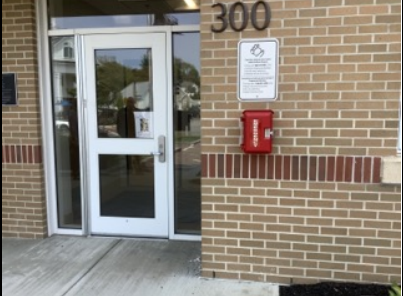
Obstructed by protruding objects	7.5"	Provide a cane-detectable barrier underneath the fire alarm pull box.	1	398	\$398
											398	
2	Parking Lot to the Memorial	Ext.		Exterior Access Route	N/A

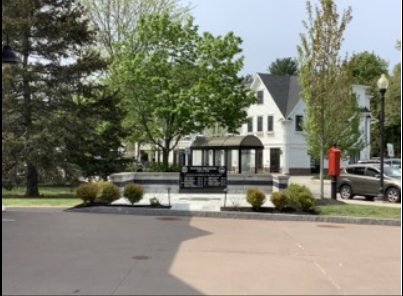
Accessible route not provided	-	Ensure an accessible route is provided to the memorial.	1	-	-
<div style="border: 1px solid black; padding: 2px;">Off-Street Parking Lot or Garage</div>												
3	Parking Lot	Ext.		Off-Street Parking Lot or Garage	Visitor

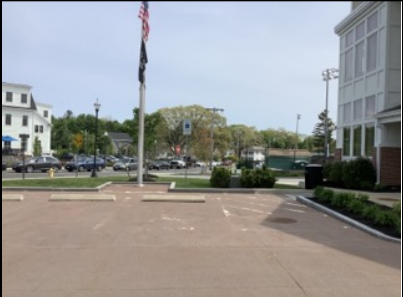
Total # of parking Total # of designated car accessible parking spaces Total # of designated van accessible spaces Sign top > 96" above finished grade	3 - 1 103"	Locate sign a the van accessible parking space with the top of the sign 96" above the ground.	1	Labor	Labor

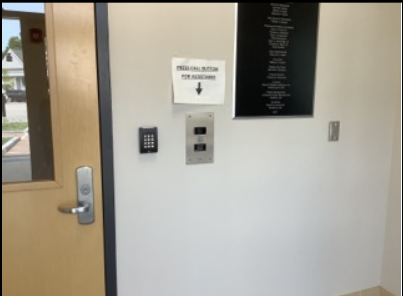
<div style="border: 1px solid black; padding: 2px;">Access to Goods and Services</div>												
<div style="border: 1px solid black; padding: 2px;">Means of Egress</div>												
4	Main Egress Door	1		Means of Egress	N/A

Two-way emergency communication sign not provided	-	Ensure a sign with raised tactile characters and braille, for the two-way communication system is provided.	1	302	\$302
											302

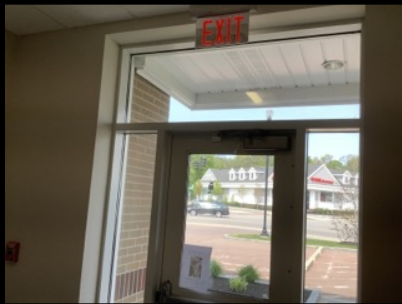
ID	Location	Floor	Room	Element	Type	Photo	Issues	Current Measure	Recommendations	Quantity	Price	Cost Estimation
5	Main Egress Door	Ext.		Means of Egress	N/A

Tactile exit sign not provided Illuminated ISA symbol not provided (MAAB)	-	Ensure that a tactile exit sign with raised characters and braille is provided at the exit door. Mount the sign between 48" - 60" above the finished floor located on the latch side of the door. When the illuminated exit sign is repaired or replaced, provide an illuminated sign with the International Symbol of Accessibility (ISA).	1	302 -	\$302
Doors, Doorways, & Gates												
6	Single-User Toilet Room	1		Doors, Doorways, & Gates	Toilet Room

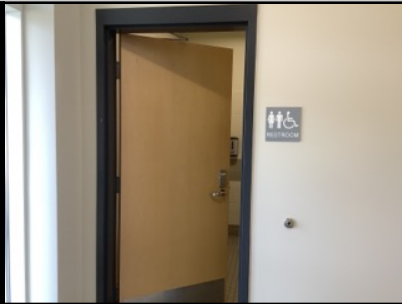
Door requires > 5 lbs. of force to open	10 lbs	Adjust closers so doors do not require more than 5 pounds of force to open.	1	Labor	Labor
Signage												
7	Main Entrance	Ext.		Signage	Designation

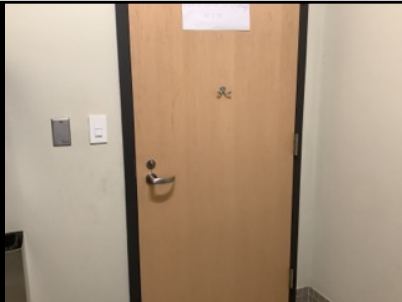
Toilet & Bathing Rooms												
Single-User Toilet												
8	Single-User Toilet Room	1		Single-User Toilet	N/A

Hook located > 48" high (2010 ADA)	54"	Locate the coat hook no higher than 48" above the finished floor.	1	150	\$150

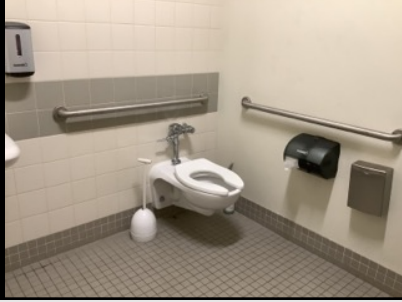
ID	Location	Floor	Room	Element	Type	Photo	Issues	Current Measure	Recommendations	Quantity	Price	Cost Estimation
9	Single-User Toilet Room	1		Single-User Toilet	N/A

Clearance at toilet < 60" clear width	-	Relocate the plunger to ensure that there is 60" wide min. clear floor space at the toilet.	1	Labor	Labor
<div style="border: 1px solid gray; padding: 5px; margin-bottom: 5px;"> Best Practice ▼ </div> <div style="border: 1px solid gray; padding: 5px;"> Speak-Through Hole </div>												
10	Lobby	1		Speak-Through Hole

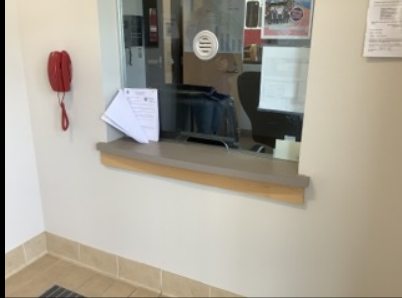
-	Recommend providing an additional speak-through hole at a lower height for wheelchair users and persons of short stature.	1	-	-

- At the service counter in the lobby, recommend providing an additional speak-through hole at a lower height for wheelchair users and persons of short stature.
