# Westwood Police Station

## Town of Westwood ADA Transition Plan

June 2023

Institute for Human Centered Design

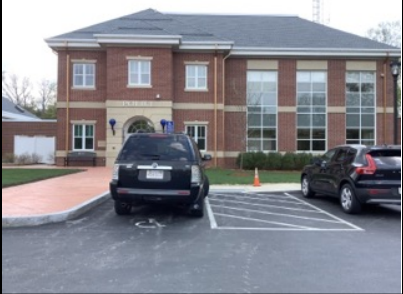
Total # of parking Total # of designated car accessible parking spaces Total # of designated van accessible spaces Sign top > 96" above finished grade	15 0 1 97.5	Locate sign with the top of the sign 96" max. above the ground.	1	Labor	Labor
<div style="border: 1px solid black; padding: 2px;">Entrance</div>												
2	Main Egress Door	1	151	Entrance	Main Entrance

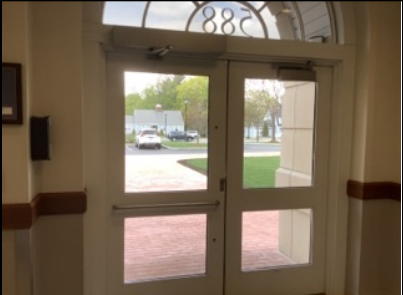
Door requires > 15 lbs. of force to open	18 lbs	Adjust closers so doors do not require more than 15 pounds of opening force.	1	Labor	Labor
<div style="border: 1px solid black; padding: 2px;">Access to Goods and Services</div> <div style="border: 1px solid black; padding: 2px;">Means of Egress</div>

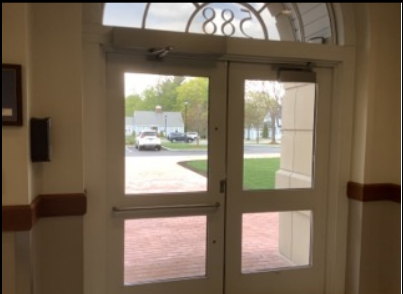
3	Main Egress Door	1	151	Means of Egress	N/A

Tactile exit sign not provided Illuminated ISA symbol not provided (MAAB)	-	Ensure that a tactile exit sign with raised characters and braille is provided at the exit door. Mount the sign between 48" - 60" above the finished floor located on the latch side of the door.  When or if an illuminated exit sign is provided, provide an illuminated sign with the International Symbol of Accessibility (ISA).	1	302	\$302
4	Stair 2 to Egress	1		Means of Egress	N/A

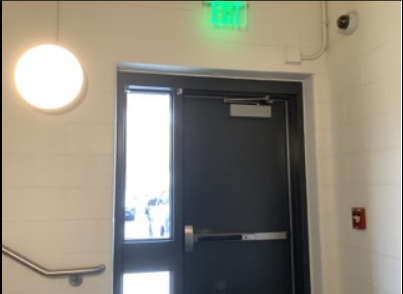
Tactile exit sign not provided Illuminated ISA symbol not provided (MAAB)	-	Ensure that a tactile exit sign with raised characters and braille is provided at the exit door. Mount the sign between 48" - 60" above the finished floor located on the latch side of the door.  Provide an illuminated sign with the International Symbol of Accessibility (ISA).	1	302	\$562
											<b>302</b>	<b>562</b>

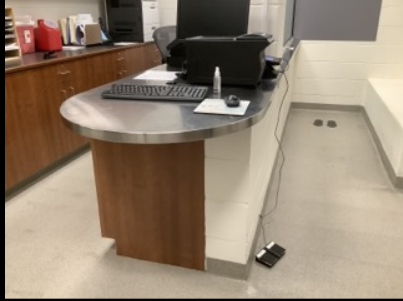
ID	Location	Floor	Room	Element	Type	Photo	Issues	Current Measure	Recommendations	Quantity	Price	Cost Estimation
<b>Interior Access Route</b>												
5	Booking	1		Interior Access Route	N/A

Obstructed by protruding objects	16"	Provide a cane-detectable barrier underneath the counter. Recommend locating the cane detectable barrier at 27" exactly so that the counter is still usable by wheelchair users.	1	398	\$398
											<b>398</b>	
<b>Doors, Doorways, &amp; Gates</b>												
6	Single-User Toilet Room	1	151	Doors, Doorways, & Gates	Toilet Room

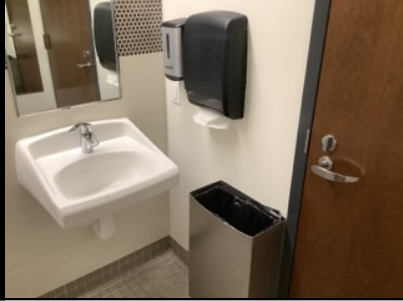
Maneuvering clearance(s) not provided Door requires > 5 lbs. of force to open	- 16 lbs	Relocate the trash can to provide 18" min. of pull-side maneuvering clearance on the latch side of the door. (Cost is for relocating a bolted item.) Adjust closers so doors do not require more than 5 pounds of force to open.	1	333 Labor	\$333
											<b>333</b>

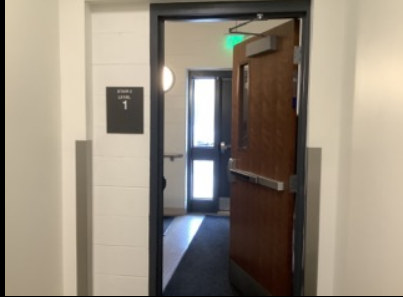
7	Stair 2 to Egress	1		Doors, Doorways, & Gates	Circulation

Door requires > 5 lbs. of force to open	15 lbs	Adjust closers so doors do not require more than 5 pounds of force to open.	1	Labor	Labor
<b>Signage</b>												
8	Main Entrance	1	151	Signage	Designation

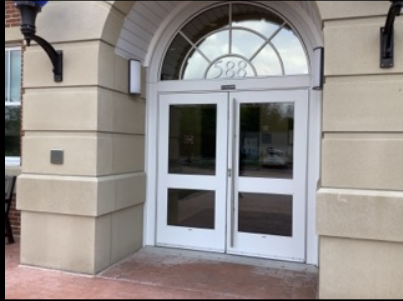
Signage is not provided	-	Locate compliant signage with raised characters and braille alongside the door on the latch side.	1	450	\$450
											<b>450</b>	
9	Booking, Juvenile Holding Cell	1	120	Signage	Designation

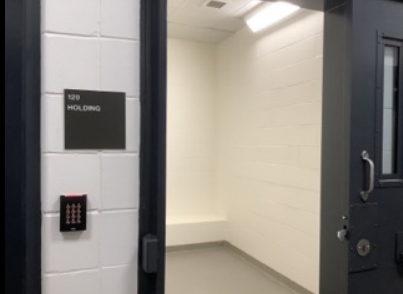
Raised characters < 48" or > 60" above ground Braille not provided on sign	62" -	Mount the sign so that the baseline of the lowest tactile character is 48" min. above finished floor and the baseline of the highest tactile character is 60" max. above the finished floor. Provide braille on the sign. Braille is not provided under the room number. Braille must be located below the corresponding text.	1	Labor 302	\$302

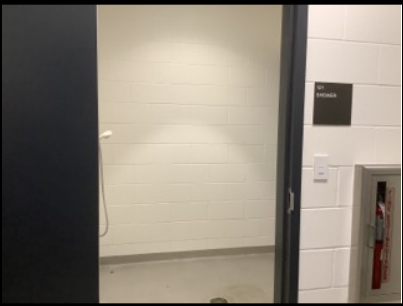
ID	Location	Floor	Room	Element	Type	Photo	Issues	Current Measure	Recommendations	Quantity	Price	Cost Estimation
10	Booking, Shower Room	1	121	Signage	Designation

Raised characters < 48" or > 60" above ground Braille not provided on sign	62" -	Mount the sign so that the baseline of the lowest tactile character is 48" min. above finished floor and the baseline of the highest tactile character is 60" max. above the finished floor. Provide braille on the sign. Braille is not provided under the room number. Braille must be located below the corresponding text.	1	Labor 302	\$302
11	Lobby	1	151	Signage	Designation

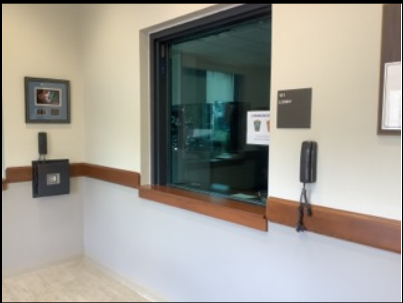
Raised characters < 48" or > 60" above ground Braille not provided on sign	61.75" -	Mount the sign so that the baseline of the lowest tactile character is 48" min. above finished floor and the baseline of the highest tactile character is 60" max. above the finished floor. Provide braille on the sign. Braille is not provided under the room number. Braille must be located below the corresponding text.	1	Labor 302	\$302

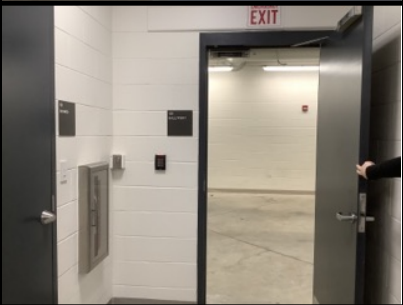
12	Sallyport	1	129	Signage	Designation

Raised characters < 48" or > 60" above ground Braille not provided on sign	62" -	Mount the sign so that the baseline of the lowest tactile character is 48" min. above finished floor and the baseline of the highest tactile character is 60" max. above the finished floor. Provide braille on the sign. Braille is not provided under the room number. Braille must be located below the corresponding text.	1	Labor 302	\$302
13	Booking, Men's Holding Cell 3	1	120	Signage	Designation

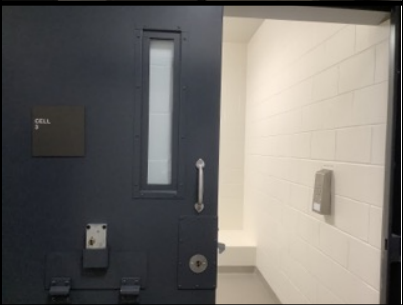
Raised characters < 48" or > 60" above ground Sign not located on the latch side of the door	62" -	Mount the sign so that the baseline of the lowest tactile character is 48" min. above finished floor and the baseline of the highest tactile character is 60" max. above the finished floor. Locate the sign at permanent rooms alongside the door on the latch side.	1	Labor	Labor
14	Booking, Women's Holding Cell 6	1	115	Signage	Designation

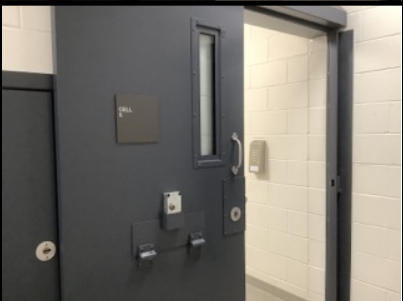
Raised characters < 48" or > 60" above ground Sign not located on the latch side of the door	61.5" -	Mount the sign so that the baseline of the lowest tactile character is 48" min. above finished floor and the baseline of the highest tactile character is 60" max. above the finished floor. Locate the sign at permanent rooms alongside the door on the latch side.	1	Labor	Labor

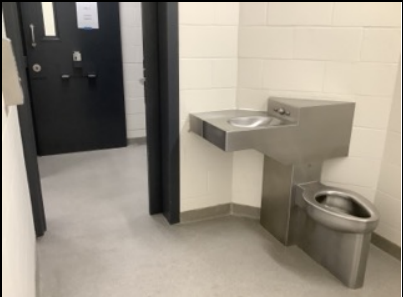
ID	Location	Floor	Room	Element	Type	Photo	Issues	Current Measure	Recommendations	Quantity	Price	Cost Estimation
<b>Detention Facilities</b>												
20	Booking, Male Holding Cell 3	1	120	Detention Facilities	Men's

Mobility cell lacks 60" turning space Mobility cell lacks clear floor space alongside bed	58.75" -	The Town can achieve program access by making arrangements to transfer men, women and juveniles who need a mobility accessible holding cell to another Town or County holding cell that is accessible.	1	-	-
21	Booking, Women's Holding Cell 6	1	115	Detention Facilities	Women's

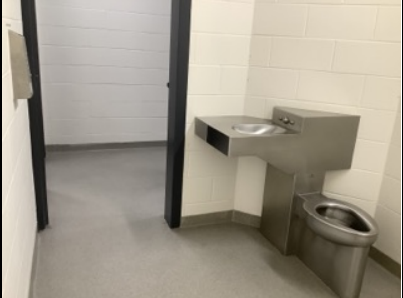
Mobility cell lacks 60" turning space Mobility cell lacks clear floor space alongside bed	59" -	The Town can achieve program access by making arrangements to transfer men, women and juveniles who need a mobility accessible holding cell to another Town or County holding cell that is accessible.	1	-	-
22	Booking, Juvenile Holding Cell	1	120	Detention Facilities	Juvenile

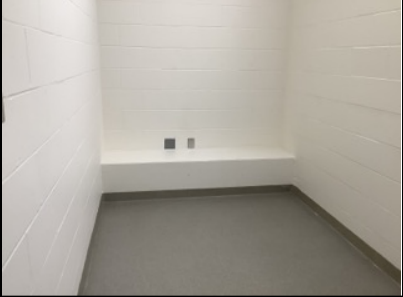
Mobility cell lacks clear floor space alongside bed Mobility cell lacks access to accessible toilet/lavatory	- -	The Town can achieve program access by making arrangements to transfer men, women and juveniles who need a mobility accessible holding cell to another Town or County holding cell that is accessible.	1	-	-

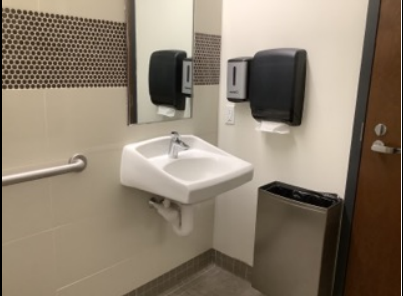
<b>Toilet &amp; Bathing Rooms</b>												
<b>Lavatory</b>												
23	Single-User Toilet Room	1	151	Lavatory	N/A

Mirror above lavatory w/reflective surface > 40"	41.5"	Lower mirror so that the bottom surface is at 40" max. above the finished floor.	1	333	\$333
											333

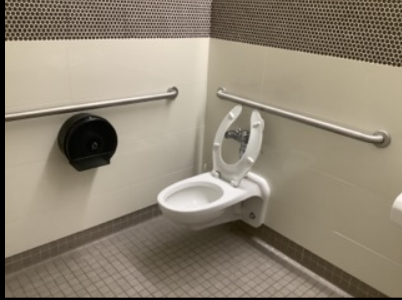
ID	Location	Floor	Room	Element	Type	Photo	Issues	Current Measure	Recommendations	Quantity	Price	Cost Estimation
<b>Single-User Toilet</b>												
24	Single-User Toilet Room	1	151	Single-User Toilet	N/A

Clearance at toilet < 60" clear width	58"	Renovate the toilet room to ensure that there is 60" wide min. clear floor space at the toilet. (Cost estimate to relocate the lavatory.)	1	2192	\$2192
											<b>2192</b>	
25	Single-User Toilet Room	1	151	Single-User Toilet	N/A

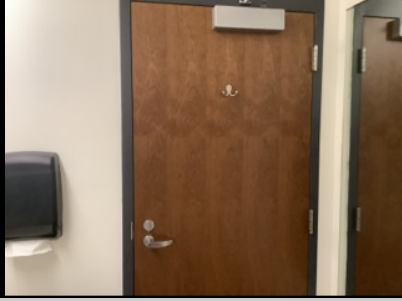
Hook located > 48" high (2010 ADA)	68"	Locate the coat hook no higher than 48" above the finished floor.	1	150	\$150
											<b>150</b>	
<b>Shower Compartment</b>												
26	Booking Shower	1		Shower Compartment	Roll-In Type

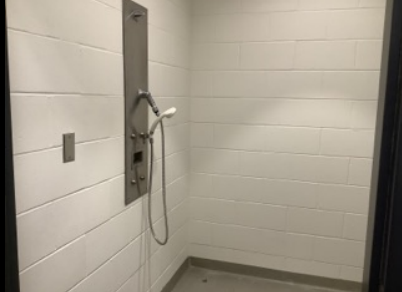
Grab bars not provided Control height < 38" or > 48"	- 49"	The Town can achieve program access by making arrangements to transfer men, women and juveniles who need a mobility accessible holding cell to another Town or County holding cell that is accessible.	1	-	-
