Lodge Soccer Field

Town of Westwood ADA Transition Plan

June 2023

Background

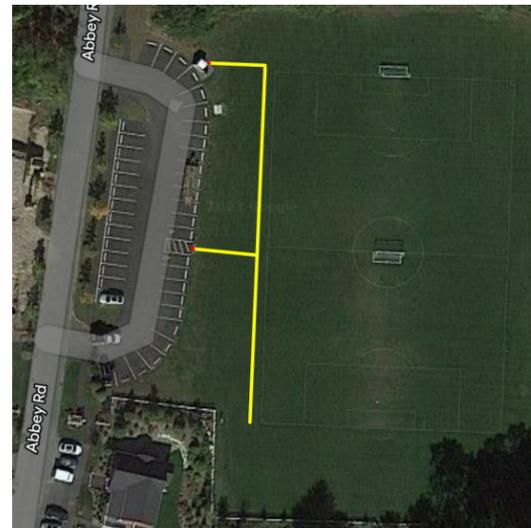
Accessibility issues include lack of an accessible route to the edge of sport activity at the soccer field.

Figure 1: The image below uses a yellow line to indicate the approximate suggested location for a 48” wide min. stable, firm and slip-resistant accessible route connecting park entry points to the boundary of sport activities and the portable toilet.

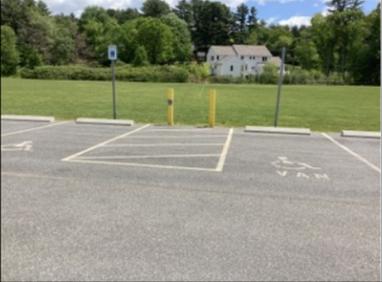
ID	Location	Floor	Room	Element	Type	Photo	Issues	Current Measure	Recommendations	Quantity	Price	Cost Estimation
Approach and Entrance												
Off-Street Parking Lot or Garage												
1	Parking	Ext.	Off-Street Parking Lot or Garage	Visitor

Total # of parking Total # of designated car accessible parking spaces Total # of designated van accessible spaces Sign with the International Symbol of Acc. not provided Sign does not have the designation "Van Accessible"	38 1 1 - -	Provide a sign with the International Symbol of Accessibility (ISA) with the bottom of the sign 60" min. above the ground and the top 96" max. above the ground and ensure that the sign contains the designation "Van Accessible."	1	650	\$650	
											650	
Access to Goods and Services												
Bike Racks												
2	By Soccer	Ext.	Bike Racks	N/A

Accessibility issues include lack of an identification sign with the International Symbol of Accessibility (ISA) and the designation “Van Accessible” at the van accessible parking space.

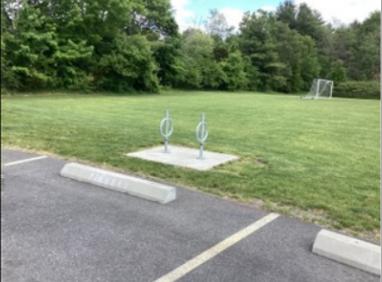
Bike rack is not connected to an accessible route	-	Ensure bike racks are connected to an accessible route.	1	-	-

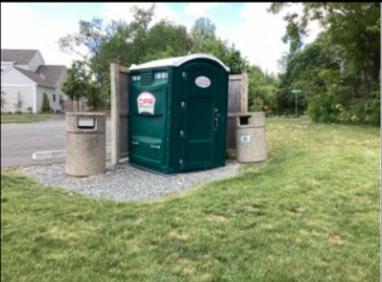
Trash / Recycling												
3	By Soccer	Ext.	Trash / Recycling	N/A

Trash container not connected to an accessible route	-	Ensure that the trash container is located on an accessible route.	1	-	-	
Toilet & Bathing Rooms												
Portable Toilet												
4	By Soccer	Ext.	Portable Toilet	N/A

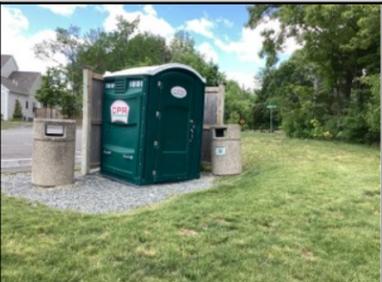
Not located on an accessible route 60" by 72" clear space not provided	- 60"	Locate portable toilet on an accessible route. Provide an accessible portable toilet that has 60" wide and 72" deep at the toilet. (Cost estimate is for an accessible portable toilet.)	1	5980	\$5980	
											5980

Accessibility issues include lack of clear space provided at the toilet.

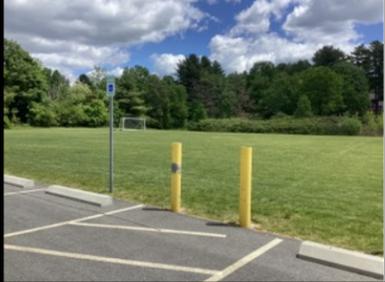
No accessible route to all areas of sport activity	-	Install an accessible route between all areas of sports activity.	1	-	-
