APPENDIX C

CCTV Reports

Project Name:		Town of Westwood MA WE 4-9-21						
US MH	DS MH	Pipe ID	Date	Street	Material	Size	Total	Insp
08-126	08-126A	08-126_08-126A	4/8/2021	Washington Street	Asbestos Cement	6	39	39
08-127	08-127A	08-127_08-127A	4/8/2021	Washington Street	Asbestos Cement	6	36	36
08-128	08-128A	08-128_08-128A	4/8/2021	Washington Street	Asbestos Cement	6	40	40
08-129	08-129A	08-129_08-129A	4/8/2021	Washington Street	Asbestos Cement	6	40	40

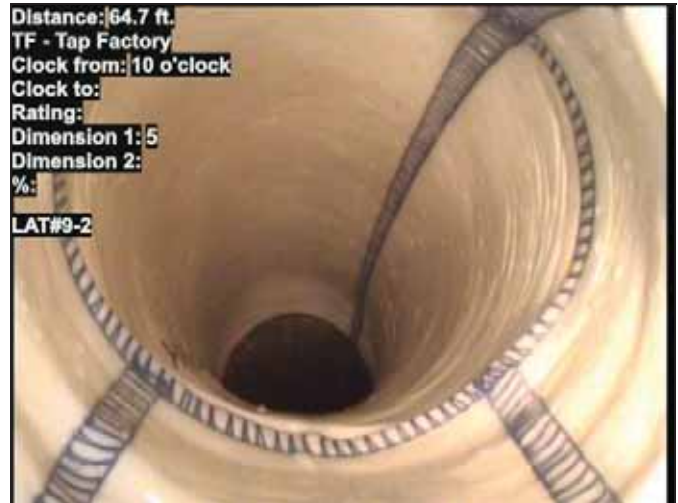
Photo: 10_078-10_079-20191226-140625-141103.JPG
At: 64.7 ft. 10/. TF - Tap Factory
Joint: No LAT#9-2

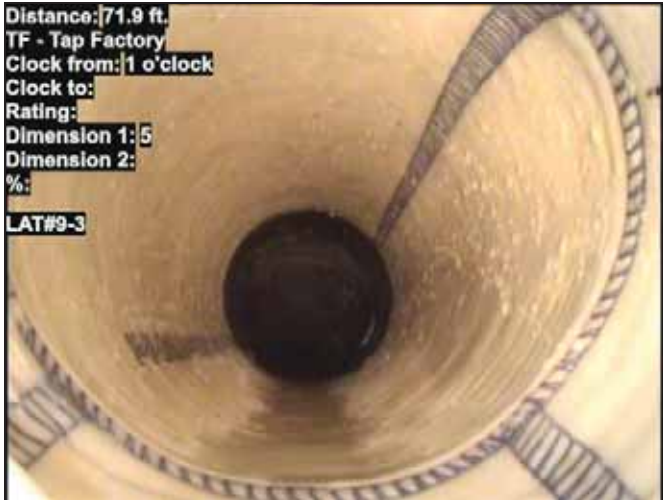
Photo: 10_078-10_079-20191226-140625-141144.JPG
At: 71.9 ft. 1/. TF - Tap Factory
Joint: No LAT#9-3

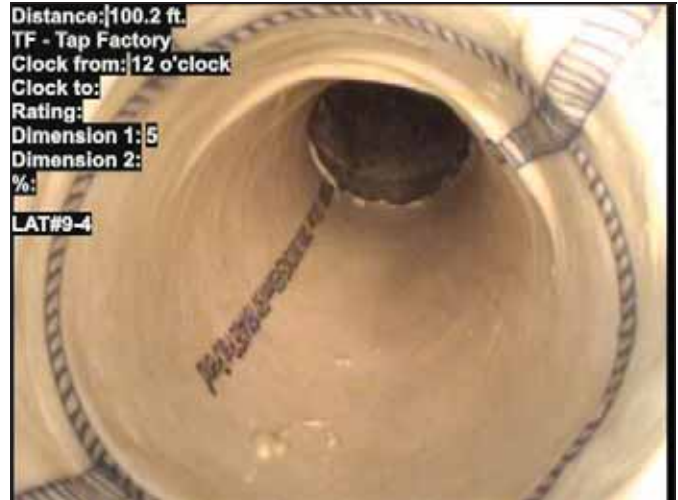
Photo: 10_078-10_079-20191226-140625-141303.JPG
At: 100.2 ft. 12/. TF - Tap Factory
Joint: No LAT#9-4

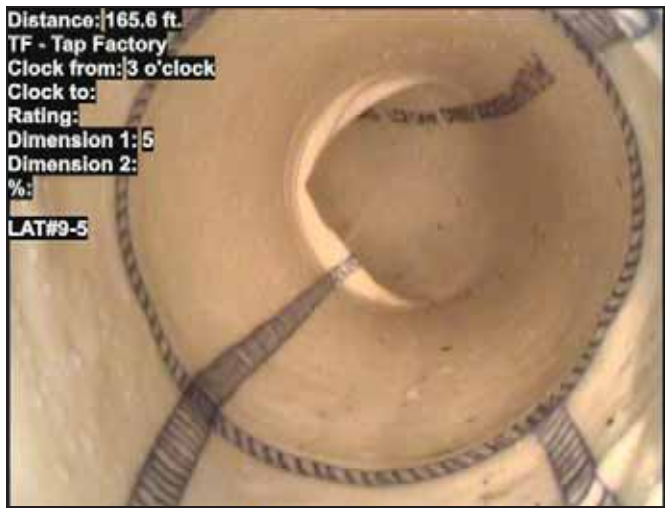
Photo: 10_078-10_079-20191226-140625-141524.JPG
At: 165.6 ft. 3/. TF - Tap Factory
Joint: No LAT#9-5

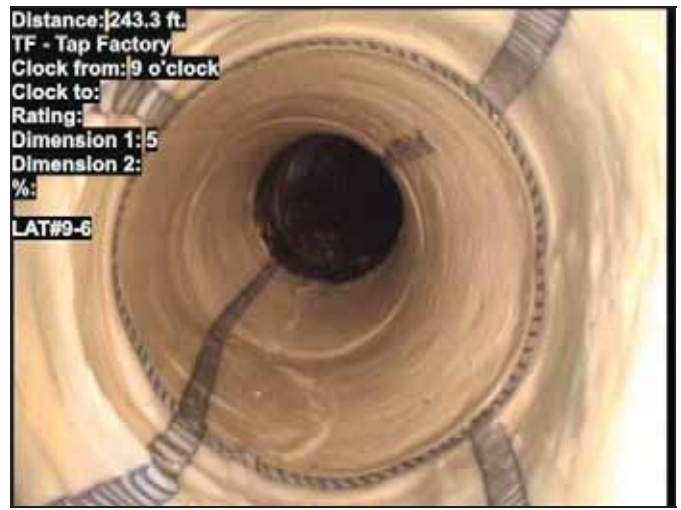
Photo: 10_078-10_079-20191226-140625-141827.JPG
At: 243.3 ft. 9/. TF - Tap Factory
Joint: No LAT#9-6

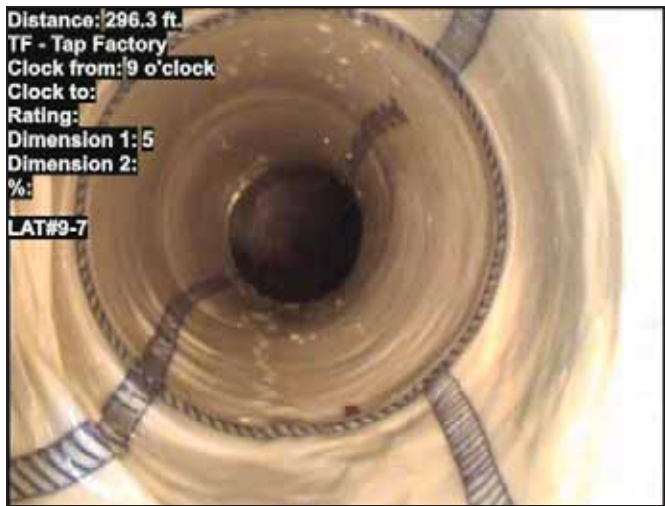
Photo: 10_078-10_079-20191226-140625-142044.JPG
At: 296.3 ft. 9/. TF - Tap Factory
Joint: No LAT#9-7

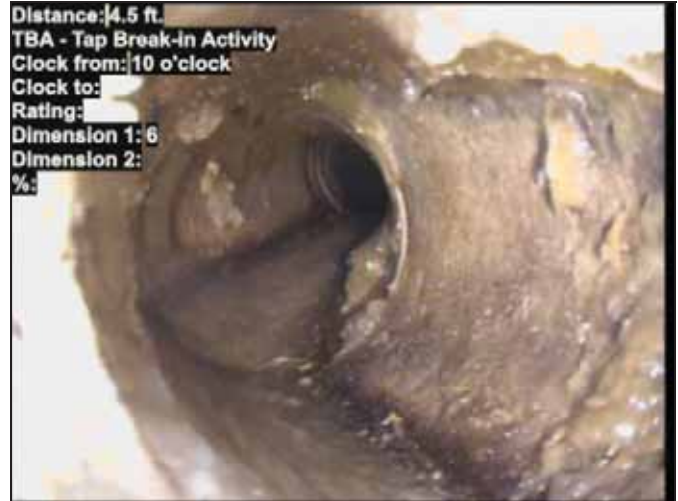
Photo: 10_078-10_079-04292020-TBA-4.5 ft.-120745.JPG
At: 4.451 ft. 10/. TBA - Tap Break-in Activity
Joint: No

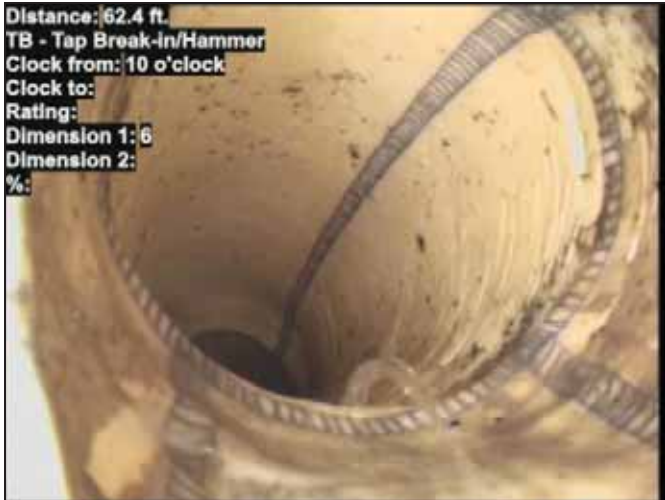
Photo: 10_078-10_079-04292020-TB-62.4 ft.-120950.JPG
At: 62.413 ft. TB - Tap Break-in/Hammer
10/.
Joint: No

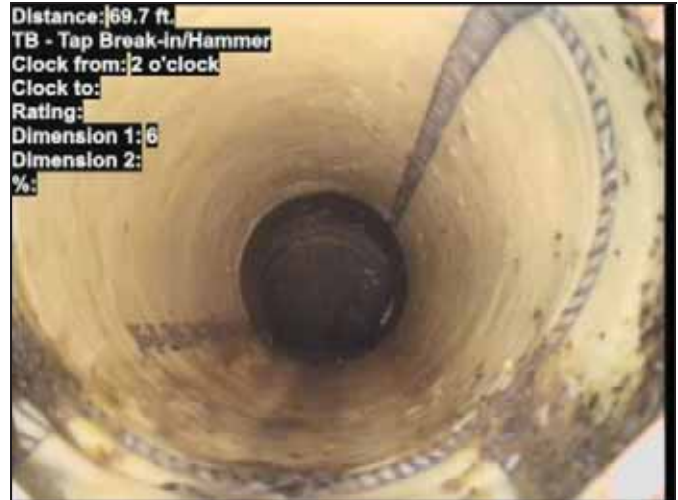
Photo: 10_078-10_079-04292020-TB-69.7 ft.-121327.JPG
At: 69.733 ft. 2/. TB - Tap Break-in/Hammer
Joint: No

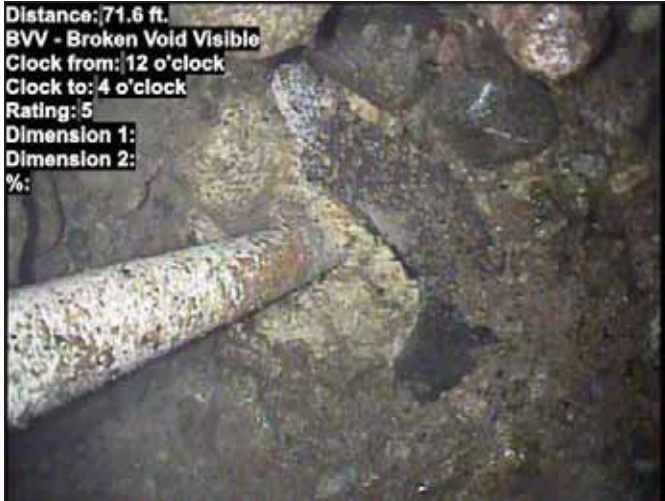
Photo: 14_071-14_013-20181116-090045.JPG
At: 71.6 ft. 12/4 BVV - Broken Void Visible
Joint: No

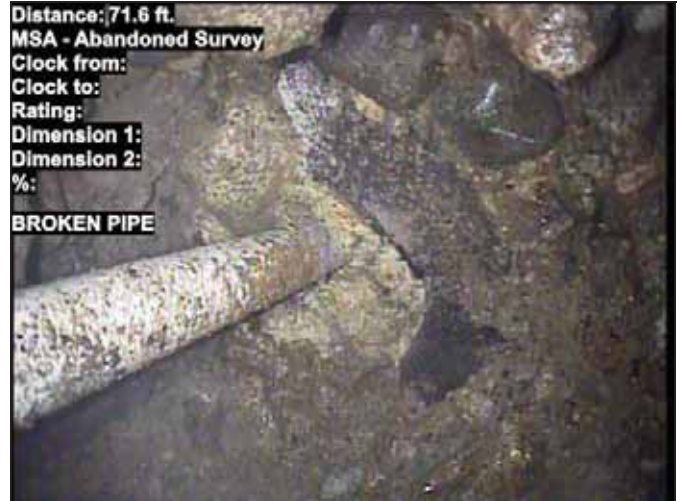
Photo: 14_071-14_013-20181116-090119.JPG
At: 71.6 ft. MSA - Abandoned Survey
Joint: No **BROKEN PIPE**

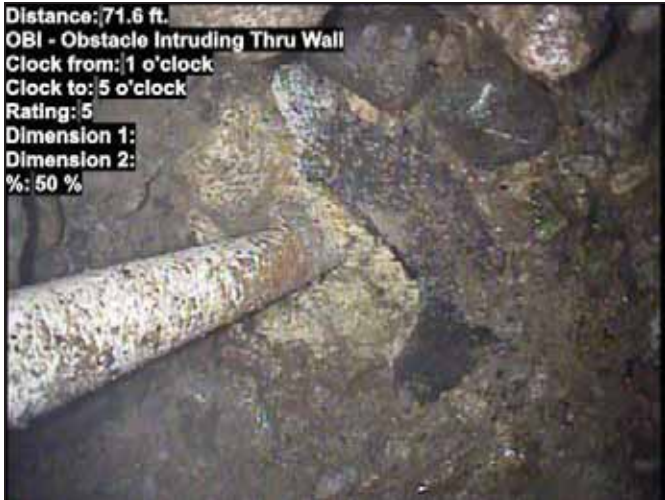
Photo: 14_071-14_013-20181116-090054.JPG
At: 71.6 ft. 1/5 OBI - Obstacle Intruding Thru Wall
Joint: No 50 %

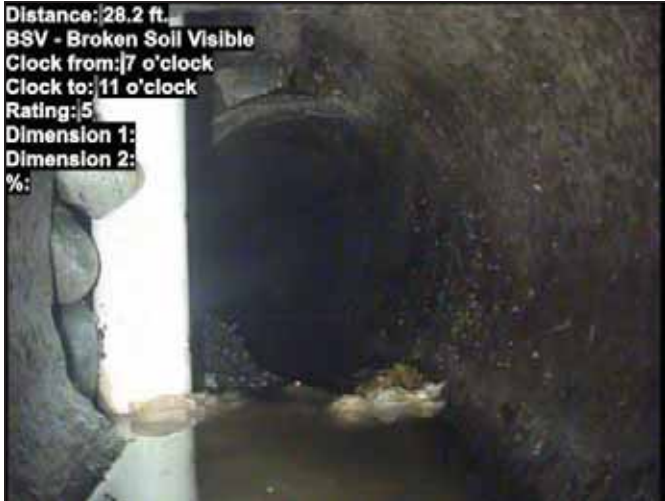
Photo: 14_071-14_013-20181116-120243.JPG
At: 28.2 ft. 7/11 BSV - Broken Soil Visible
Joint: No

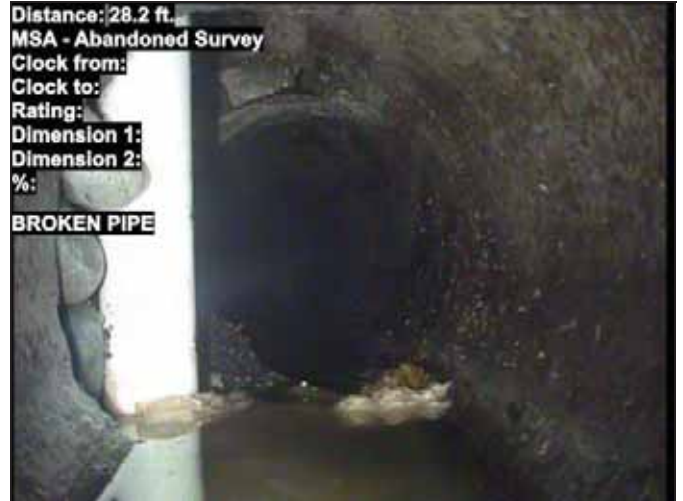
Photo: 14_071-14_013-20181116-120319.JPG
At: 28.2 ft. MSA - Abandoned Survey
Joint: No BROKEN PIPE

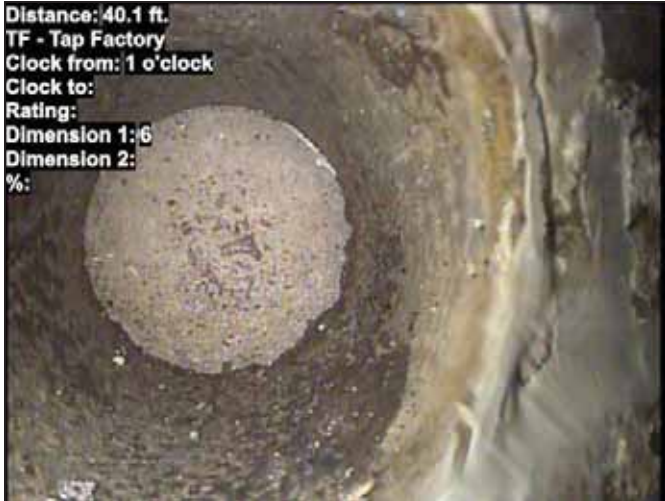
Photo: 14_013-14_017-20181116-090913.JPG
At: 40.1 ft. 1/. TF - Tap Factory
Joint: No

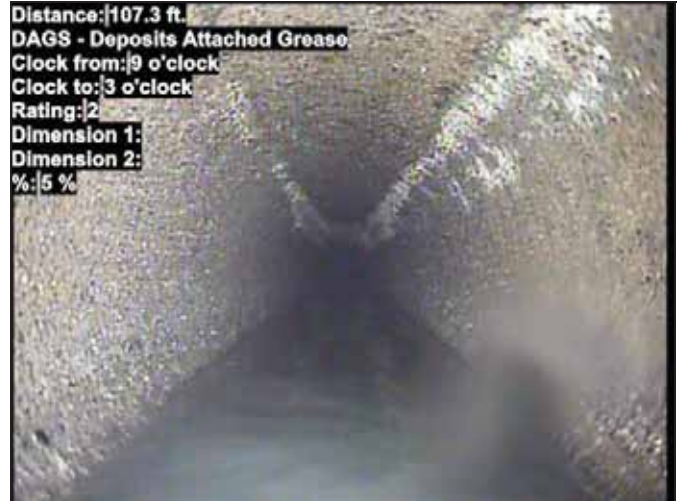
Photo: 14_013-14_017-20181116-091123.JPG
At: 107.3 ft. 9/3 DAGS - Deposits Attached Grease
Joint: Yes 5 %

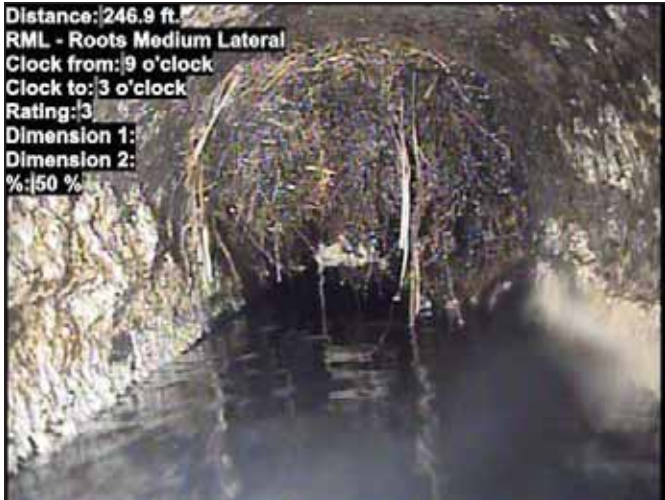
Photo: 14_013-14_017-20181116-091541.JPG
At: 246.9 ft. 9/3 RML - Roots Medium Lateral
Joint: No 50 %

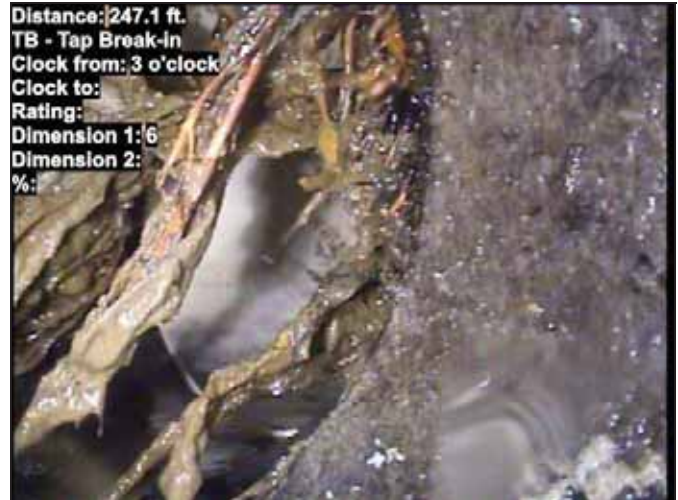
Photo: 14_013-14_017-20181116-093734.JPG
At: 247.1 ft. 3/. TB - Tap Break-in
Joint: No

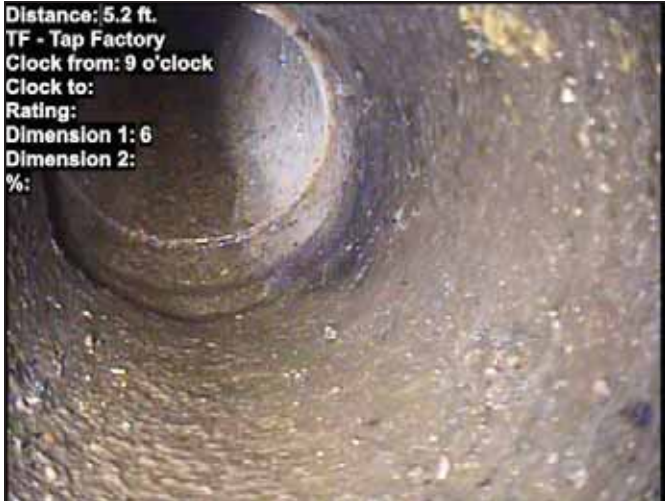
Photo: 14_070-14_071-20181116-115427.JPG
At: 5.2 ft. 9/. TF - Tap Factory
Joint: No

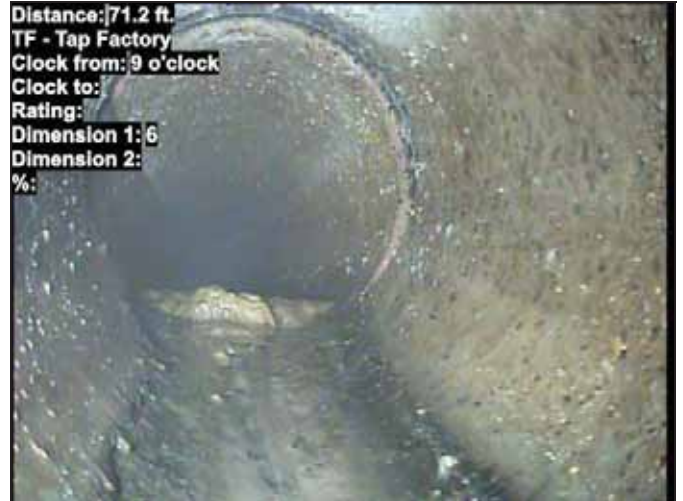
Photo: 14_070-14_071-20181116-115613.JPG
At: 71.2 ft. 9/. TF - Tap Factory
Joint: No

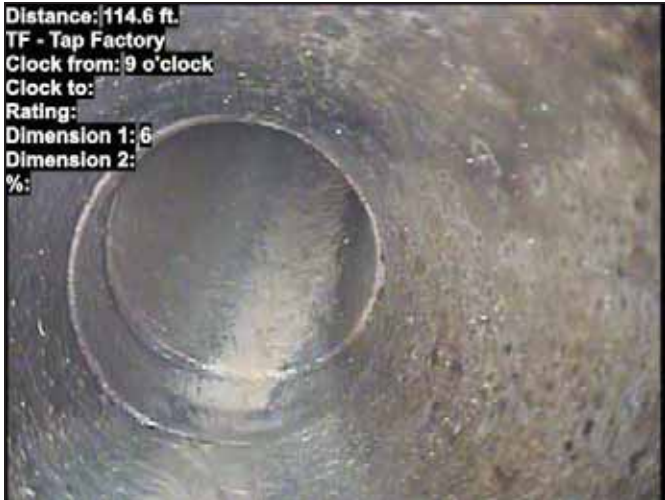
Photo: 14_070-14_071-20181116-115742.JPG
At: 114.6 ft. 9/. TF - Tap Factory
Joint: No

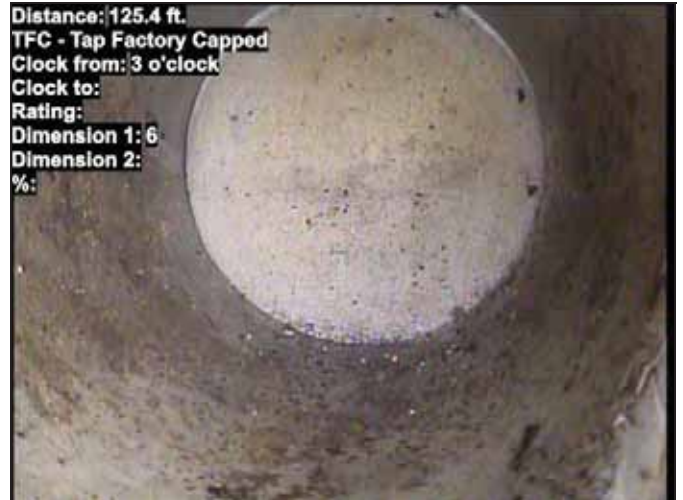
Photo: 14_070-14_071-20181116-115817.JPG
At: 125.4 ft. 3/. TFC - Tap Factory Capped
Joint: No

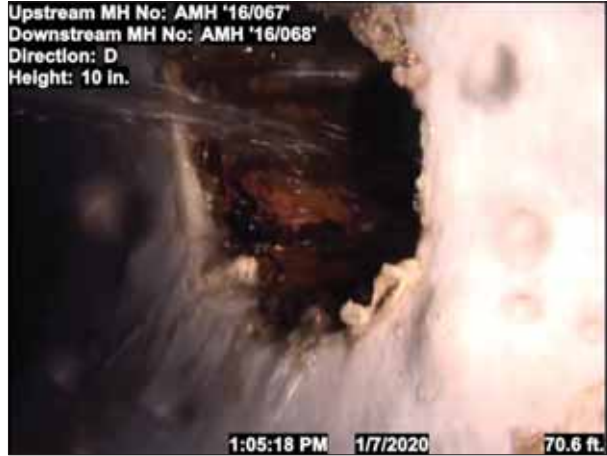
Photo: 1_1_2_24012020_080123_A.jpg, VCR No.: 123
72FT, Tap Factory Made, at 12 o'clock, 6", within 8 inches of joint: NO-GROUT ONLY

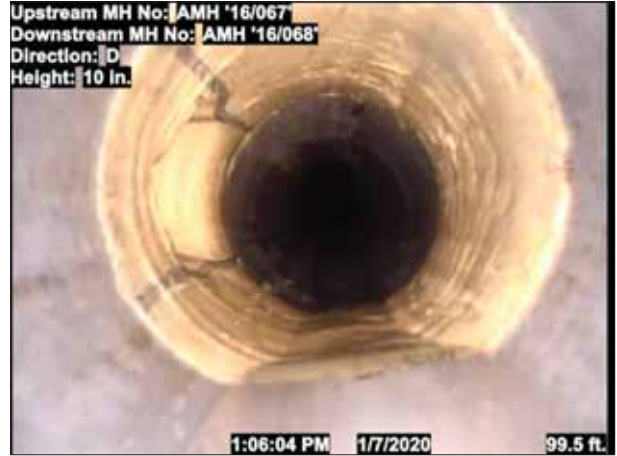
Photo: 1_1_3_24012020_080248_A.jpg, VCR No.: 123
102FT, Tap Factory Made, at 09 o'clock, 6", within 8 inches of joint: NO-LAT 15-2 2' LCR INSTALLED

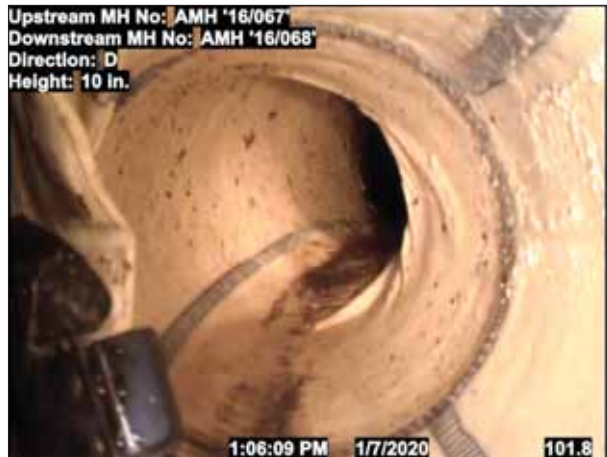
Photo: 1_1_3_24012020_080259_B.jpg, VCR No.: 123
102FT, Tap Factory Made, at 09 o'clock, 6", within 8 inches of joint: NO-LAT 15-2 2' LCR INSTALLED

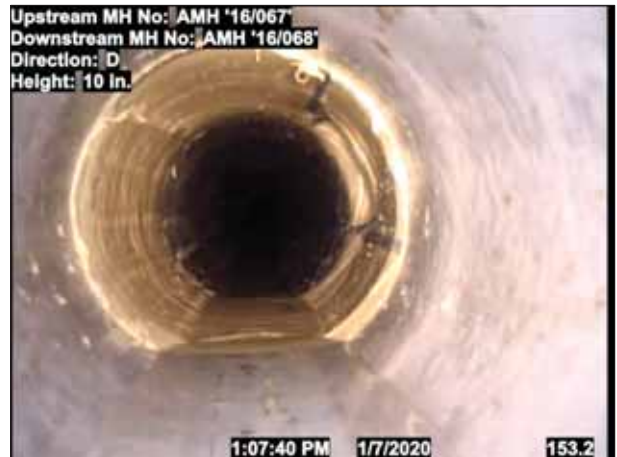
Photo: 1_1_4_24012020_080410_A.jpg, VCR No.: 123
155FT, Tap Factory Made, at 03 o'clock, 6", within 8 inches of joint: NO LAT 15-3 2' LCR INSTALLED

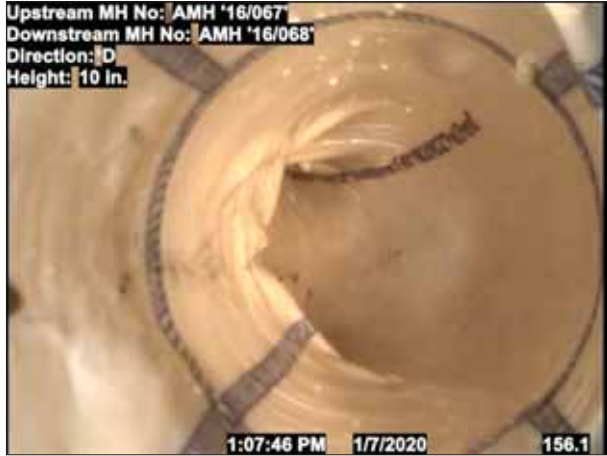
Photo: 1_1_4_24012020_080422_B.jpg, VCR No.: 123
155FT, Tap Factory Made, at 03 o'clock, 6", within 8 inches of joint: NO LAT 15-3 2' LCR INSTALLED

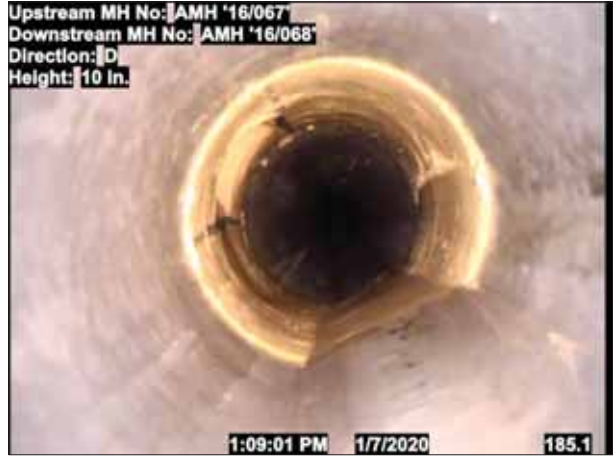
Photo: 1_1_5_24012020_080523_A.jpg, VCR No.: 123
189FT, Tap Factory Made, at 10 o'clock, 6", within 8 inches of joint: NO

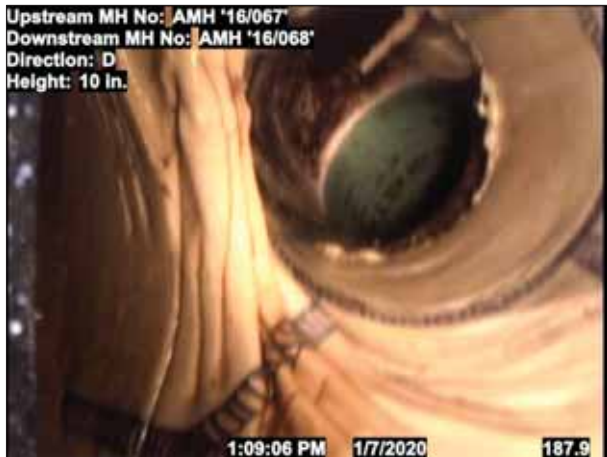
Photo: 1_1_5_24012020_080534_B.jpg, VCR No.: 123
189FT, Tap Factory Made, at 10 o'clock, 6", within 8 inches of joint: NO

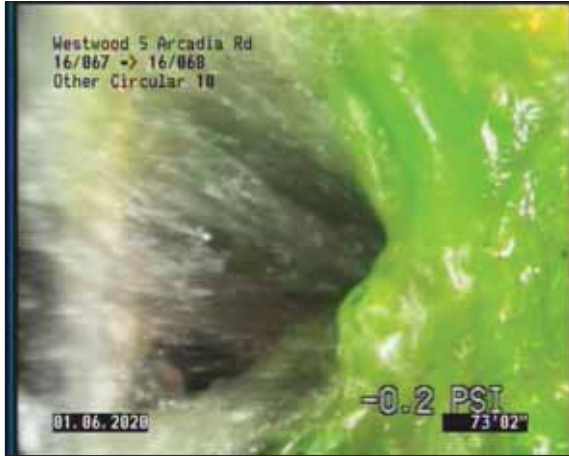
Photo: 3_3_2_06012020_153433_A.JPG, 00:00:00
Lateral Tested Failed Grouted (GAL), Retested Passed

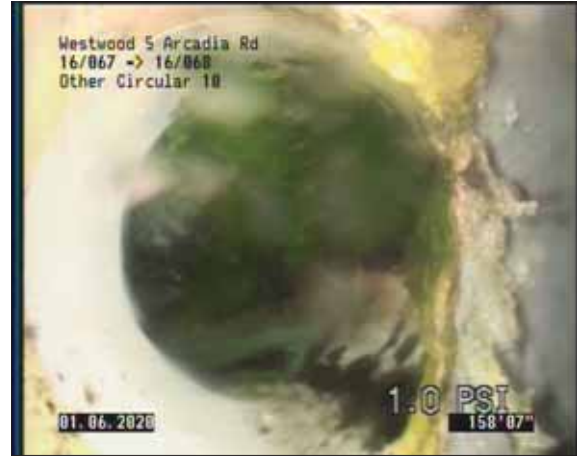
Photo: 3_3_3_06012020_160128_A.JPG, 00:00:00
Lateral Tested Failed Grouted (GAL), Retested Passed

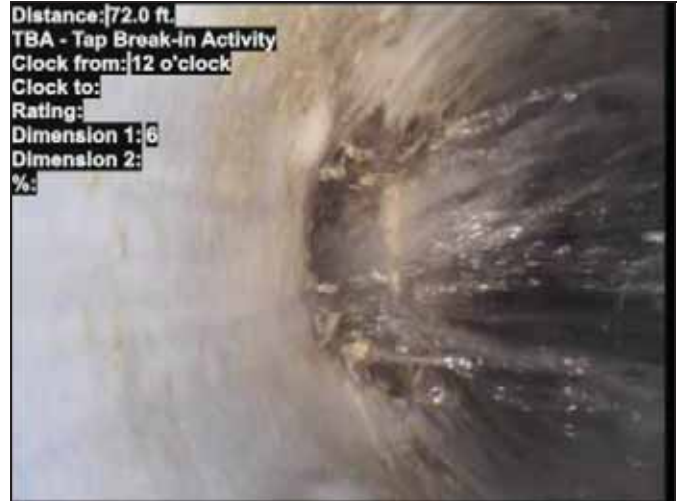
Photo: 16_067-16_068-04302020-TBA-72.0 ft.-112123.JPG
At: 72.008 ft. TBA - Tap Break-in Activity
Joint: No 12/.

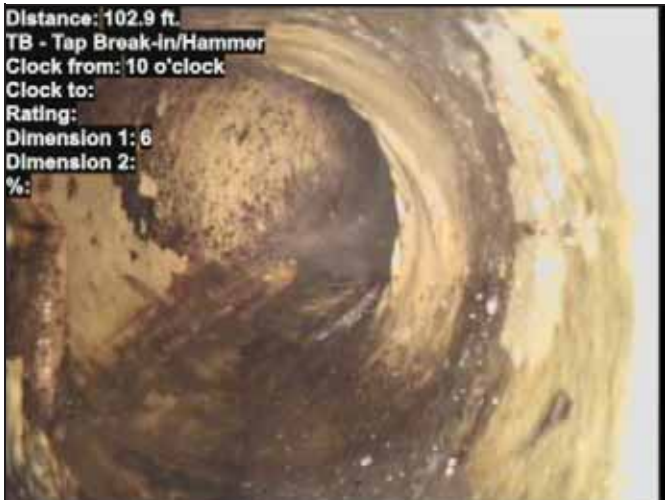
Photo: 16_067-16_068-04302020-TB-102.9 ft.-112235.JPG
At: 102.868 ft. TB - Tap Break-in/Hammer
Joint: No 10/.

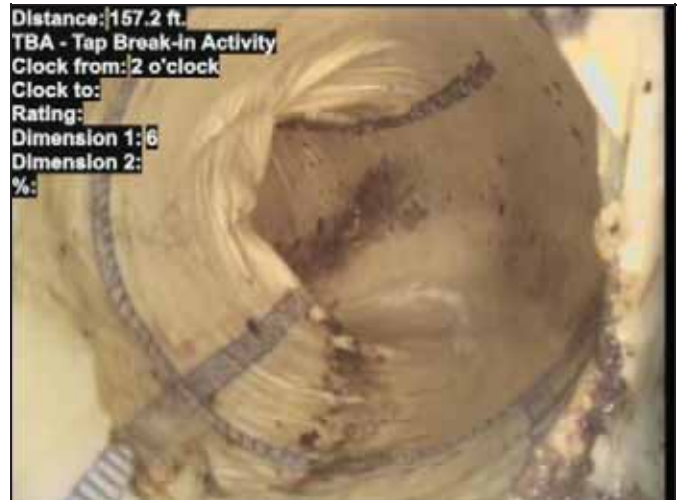
Photo: 16_067-16_068-04302020-TBA-157.2 ft.-112414.JPG
At: 157.171 ft. TBA - Tap Break-in Activity
Joint: No 2/.
