APPENDIX D

Manhole Inspection Reports

Westwood Manhole Inspections

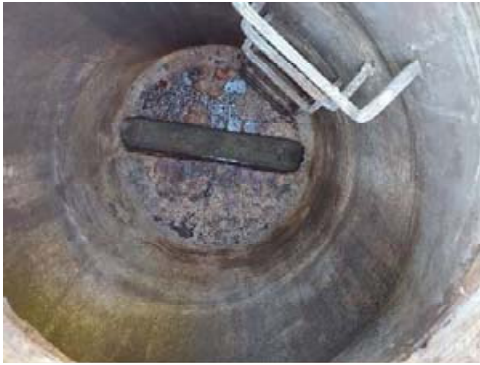
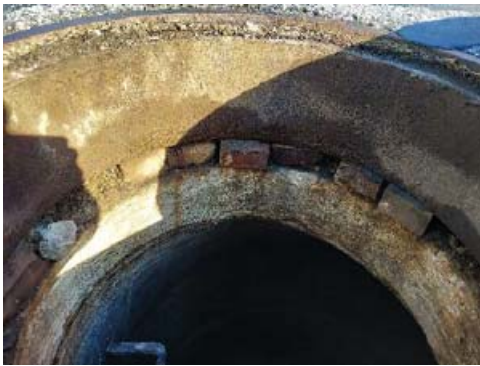
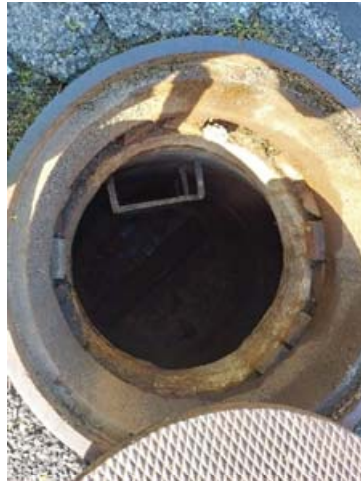
06-091 Photos

Manhole ID	<u>06/091</u>	Rim to Invert	<u>93"</u>
Street	<u>Loring St.</u>	Inner Diameter	<u>4'</u>
Date	<u>5/11/2021</u>	Material	<u>Concrete</u>
Time	<u>8:15</u>	Cover	<u>Good</u>
Inspector	<u>Maria George</u>	Frame	<u>Good</u>

Defects	Depth	Clock Position	Comments
Missing Brick		12-12

Pavement cracking around cover

8" AC, Inv.=93"

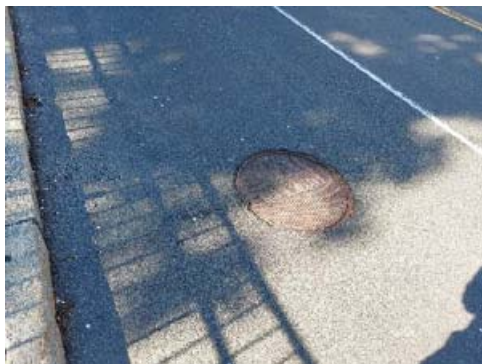
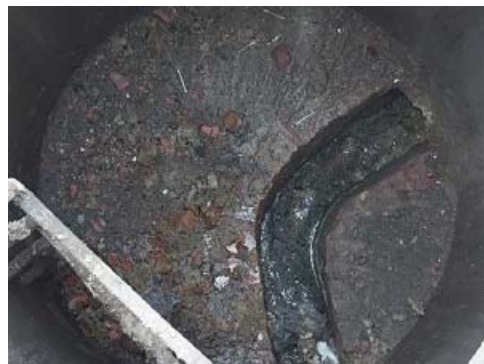
06-095 Photos

Manhole ID	<u>06/095</u>	Rim to Invert	<u>94.5"</u>
Street	<u>Washington St.</u>	Inner Diameter	<u>4'</u>
Date	<u>5/11/2021</u>	Material	<u>Concrete</u>
Time	<u>8:30</u>	Cover	<u>Good - Drain</u>
Inspector	<u>Maria George</u>	Frame	<u>Good</u>

Defects	Depth	Clock Position	Comments
Missing Brick		12-12	Chimney
Construction Debris	90"	6-12	On bench
Solids in Channel	94.5"	5-7

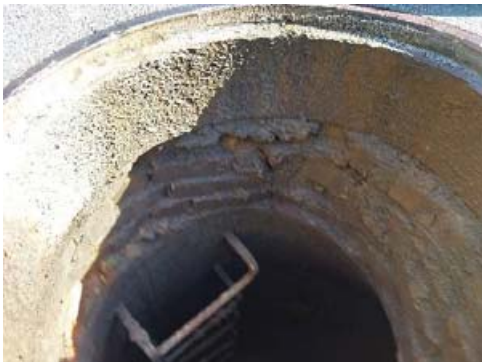
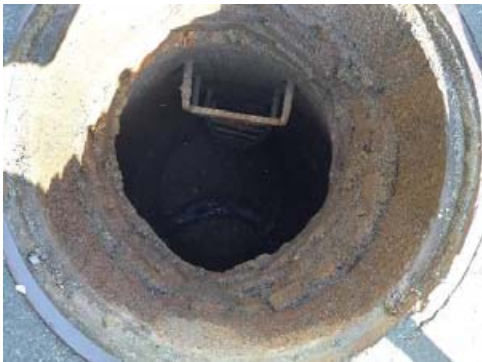
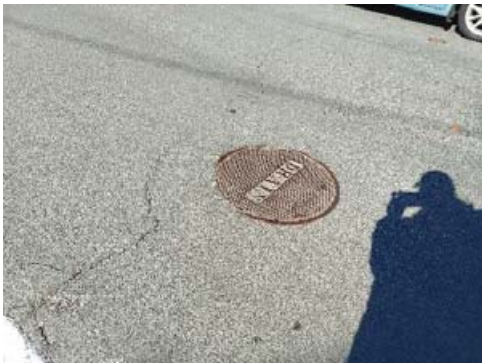
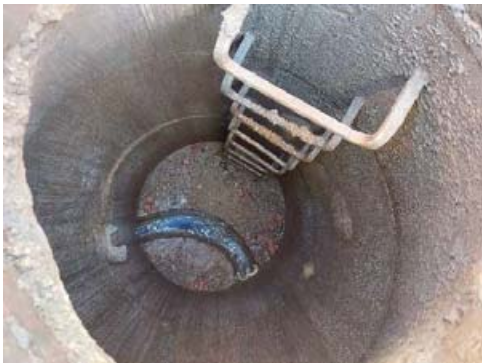
06-096 Photos

Manhole ID	<u>06/096</u>	Rim to Invert	<u>124"</u>
Street	<u>Washington @ Lull</u>	Inner Diameter	<u>4'</u>
Date	<u>5/11/2021</u>	Material	<u>Concrete</u>
Time	<u>8:35</u>	Cover	<u>Good - Drain</u>
Inspector	<u>Maria George</u>	Frame	<u>Good - 1" Offset</u>

Defects	Depth	Clock Position	Comments
Missing Mortar	8"-23"	12-12	Chimney
Construction Debris	117"	12-12	On bench
Infiltration Stain	23"	12-12	Chimney
Infiltration Dripper	117"	5-6	On bench

The top of the external drop connection has a small break on the bottom of the pipe.

Drop pipe has a small break

External Drop Connection
 Top Inv. = 84"
 Bottom Inv. = 124"
 8" AC

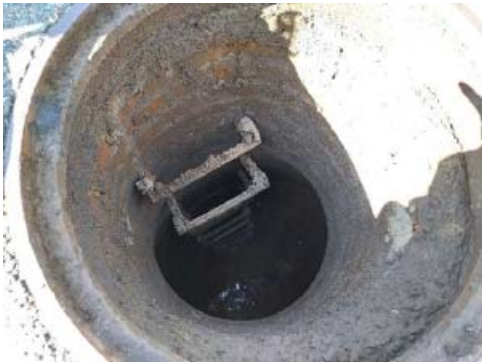
06-112 Photos

Manhole ID	<u>06/112</u>	Rim to Invert	<u>185"</u>
Street	<u>Lull St.</u>	Inner Diameter	<u>4'</u>
Date	<u>5/11/2021</u>	Material	<u>Concrete</u>
Time	<u>8:45</u>	Cover	<u>Good</u>
Inspector	<u>Maria George</u>	Frame	<u>Good - 1" Offset</u>

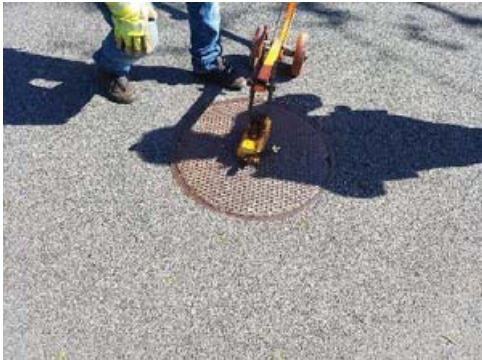
Manhole ID	<u>06/111</u>	Rim to Invert	<u>67"</u>
Street	<u>Croft Regis Rd.</u>	Inner Diameter	<u>4'</u>
Date	<u>5/11/2021</u>	Material	<u>Concrete</u>
Time	<u>9:00</u>	Cover	<u>Good</u>
Inspector	<u>Maria George</u>	Frame	<u>Good</u>

Defects	Depth	Clock Position	Comments
Construction Debris	59"		On bench
Encrustation	67"		In channel
Infiltration Stain	17"	12-12	Below chimney

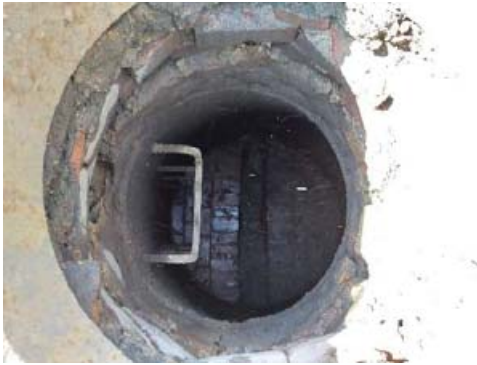
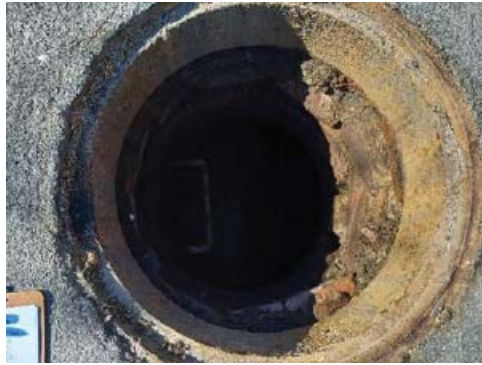
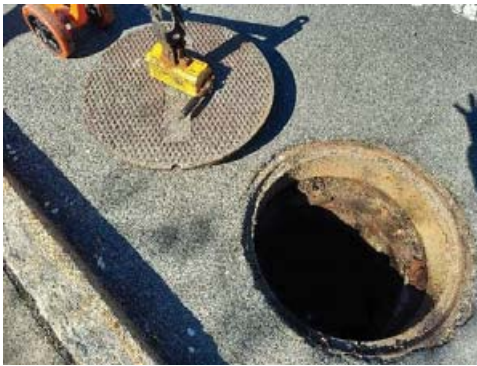
08-047 Photos

Manhole ID	<u>08/047</u>	Rim to Invert	<u>Approximately 88"</u>
Street	<u>Washington St.</u>	Inner Diameter	<u>4'</u>
Date	<u>5/11/2021</u>	Material	<u>Concrete</u>
Time	<u>9:10</u>	Cover	<u>Good - Drain</u>
Inspector	<u>Maria George</u>	Frame	<u>Good</u>

Defects	Depth	Clock Position	Comments
Missing Mortar	8"-26.5"	12-12	
Displaced Brick	8"-26.5"	12-12

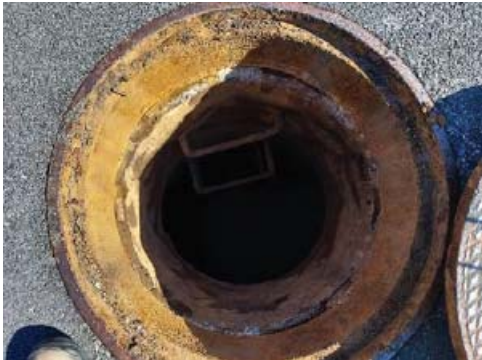
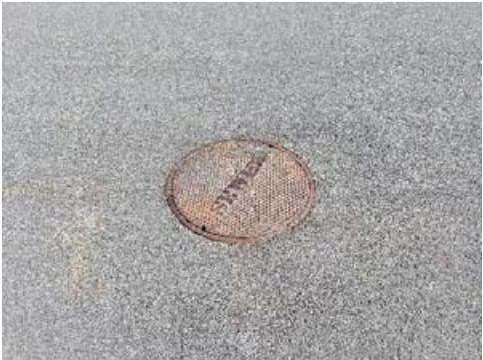
08-050 Photos

Manhole ID	<u>08/050</u>	Rim to Invert	<u>91"</u>
Street	<u>Cobleigh St.</u>	Inner Diameter	<u>4'</u>
Date	<u>5/11/2021</u>	Material	<u>Concrete</u>
Time	<u>9:20</u>	Cover	<u>Good</u>
Inspector	<u>Maria George</u>	Frame	<u>Good</u>

Defects	Depth	Clock Position	Comments
Missing Mortar	8.5"-12"	6-12	Small
Infiltration Stain	29"	5-7

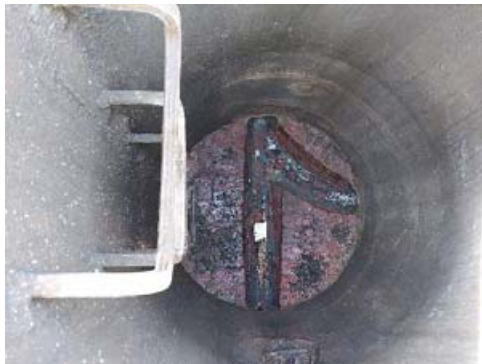
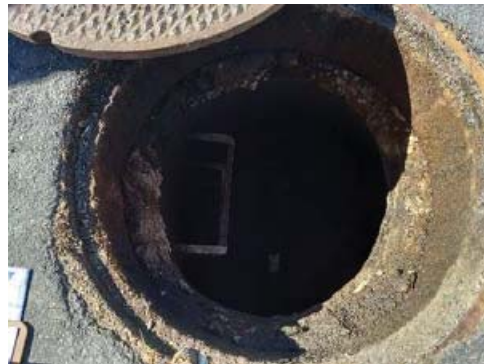
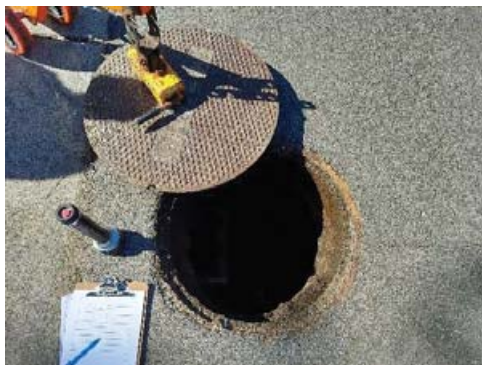
08-048 Photos

Manhole ID	<u>08/048</u>	Rim to Invert	<u>97"</u>
Street	<u>Washington @ Cobleigh</u>	Inner Diameter	<u>4'</u>
Date	<u>5/11/2021</u>	Material	<u>Concrete</u>
Time	<u>9:20</u>	Cover	<u>Good</u>
Inspector	<u>Maria George</u>	Frame	<u>Good</u>

Defects	Depth	Clock Position	Comments
Missing Mortar	8"-16"	12-12	
Displaced Brick	8"-16"	12-12

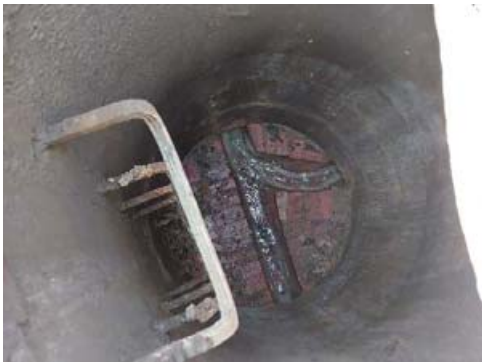
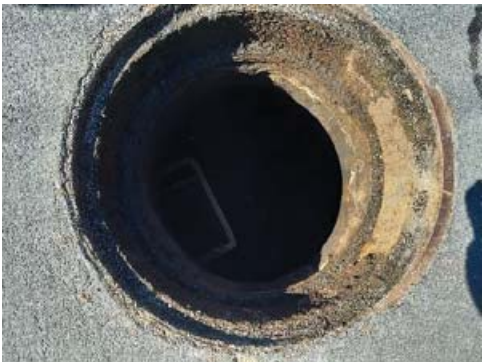
08-086 Photos

Manhole ID	<u>08/086</u>	Rim to Invert	<u>101"</u>
Street	<u>Washington @ Hooper</u>	Inner Diameter	<u>4'</u>
Date	<u>5/11/2021</u>	Material	<u>Concrete</u>
Time	<u>9:50</u>	Cover	<u>Good</u>
Inspector	<u>Maria George</u>	Frame	<u>Good</u>

Defects	Depth	Clock Position	Comments
Concrete Debris	95"	2-5

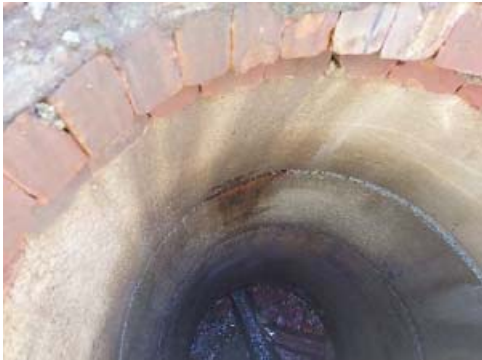
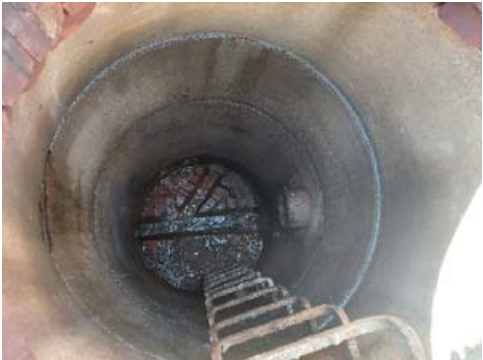
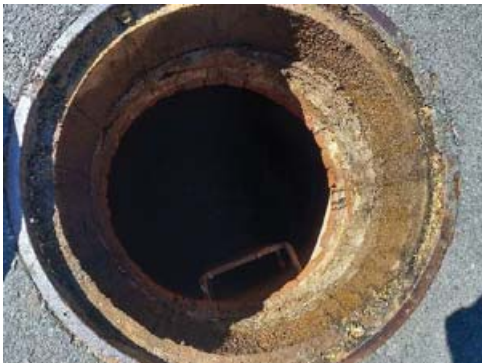
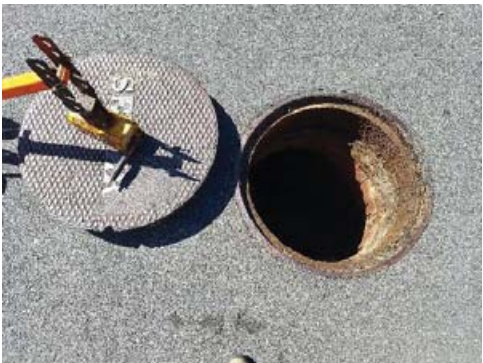
08-078 Photos

Manhole ID	<u>08/078</u>	Rim to Invert	<u>143"</u>
Street	<u>Hooper St.</u>	Inner Diameter	<u>4'</u>
Date	<u>5/11/2021</u>	Material	<u>Concrete</u>
Time	<u>10:00</u>	Cover	<u>Good</u>
Inspector	<u>Maria George</u>	Frame	<u>Good</u>

Defects	Depth	Clock Position	Comments
Infiltration Stain	51"	5-6	Partially patched at joint

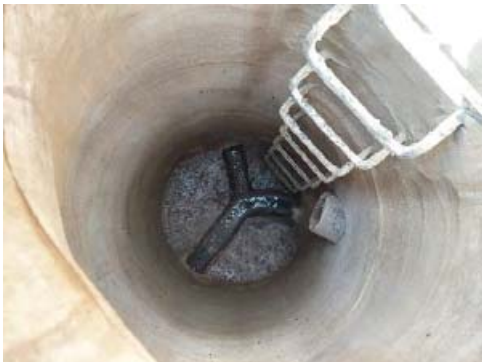
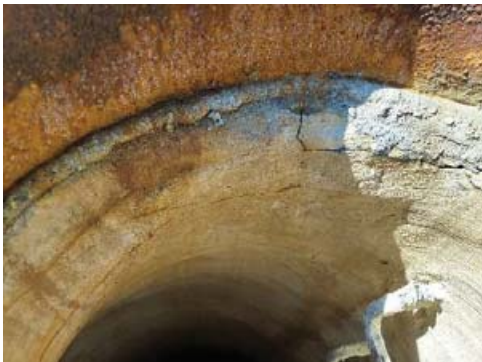
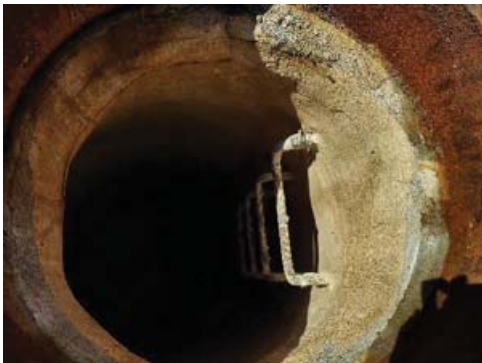
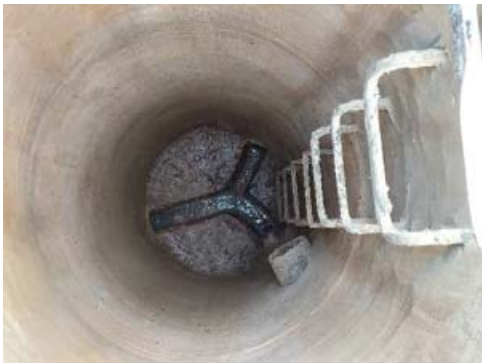
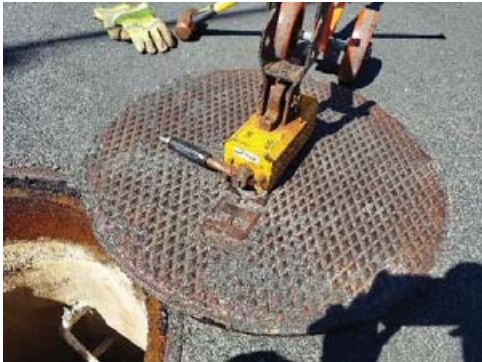
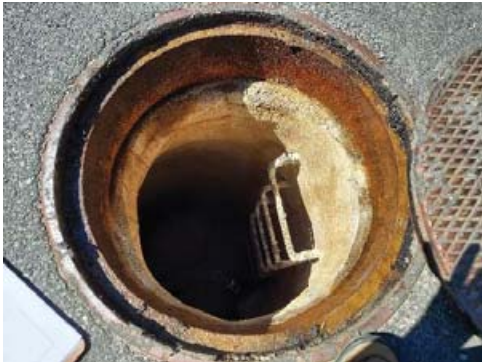
Manhole ID	<u>08/077</u>	Rim to Invert	<u>125"</u>
Street	<u>Hooper @ Webster</u>	Inner Diameter	<u>4'</u>
Date	<u>5/11/2021</u>	Material	<u>Cement Lined</u>
Time	<u>10:05</u>	Cover	<u>Good</u>
Inspector	<u>Maria George</u>	Frame	<u>Good</u>

Defects	Depth	Clock Position	Comments
Small Crack	8"-16"	9-11

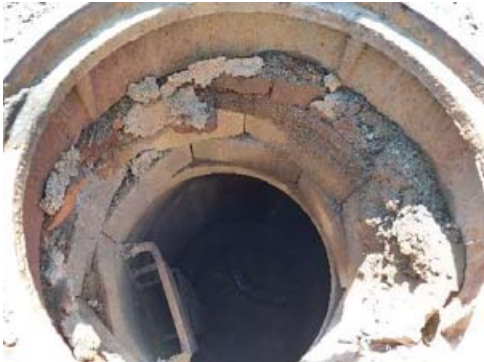
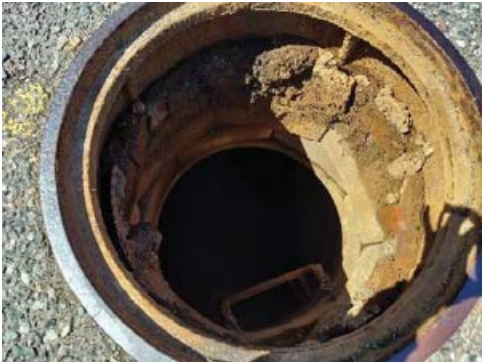
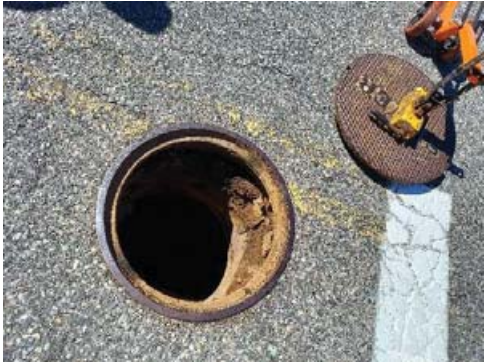
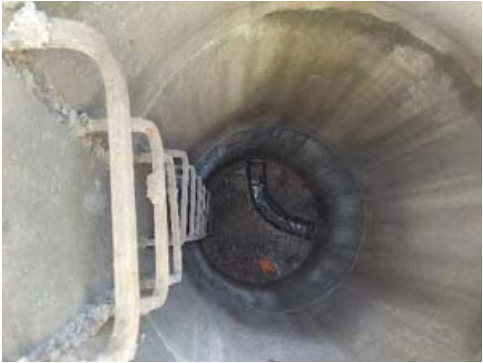
08-087 Photos

Defects	Depth	Clock Position	Comments
Missing Mortar	7"-25"	12-12	
Displaced Brick	7"-25"	12-12	
Infiltration Stain	106"	12-12

153" to bench

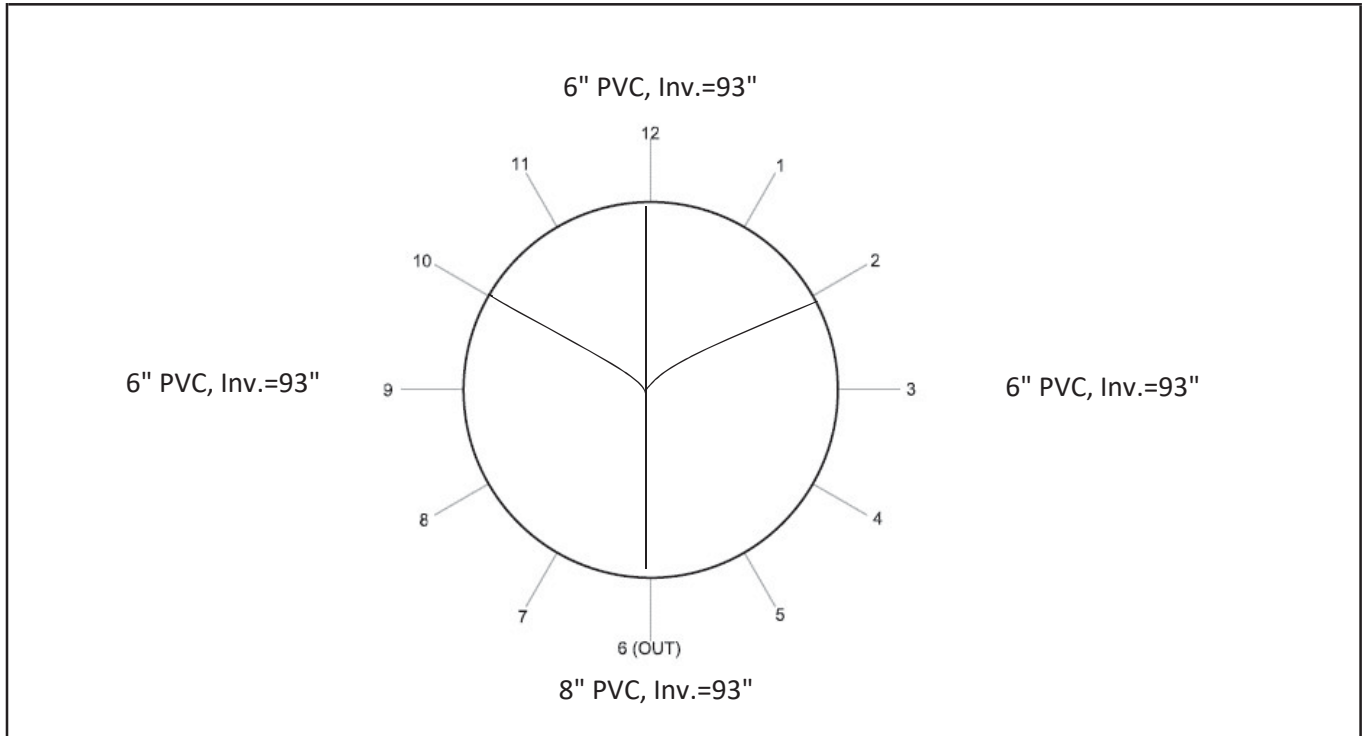
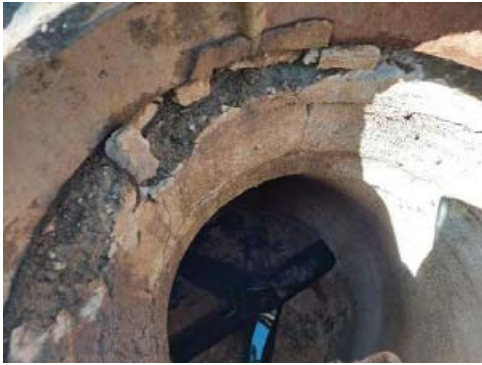
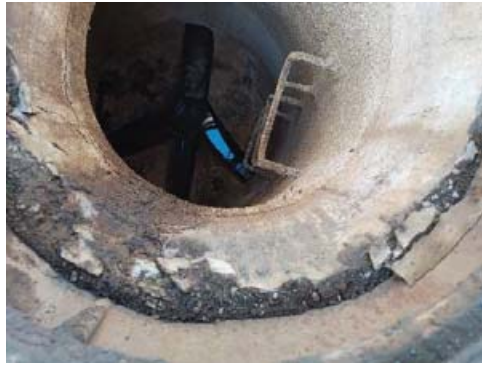
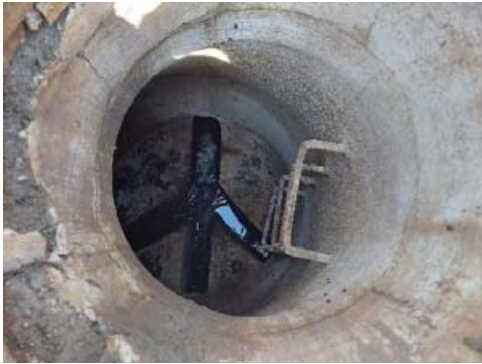
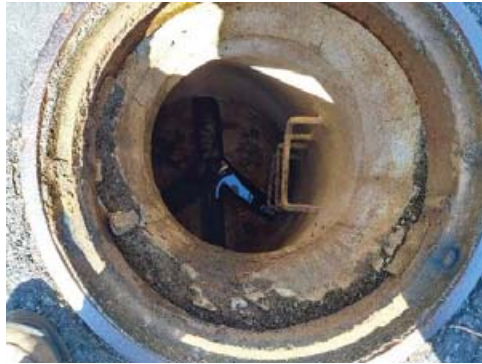
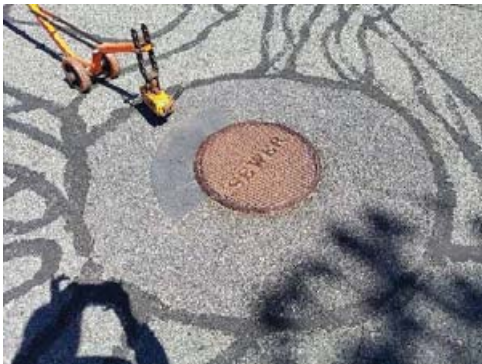
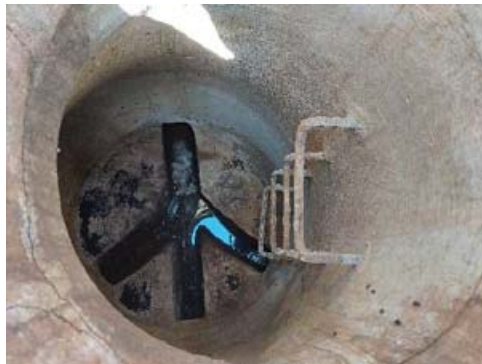
Manhole ID	<u>08/088</u>	Rim to Invert	<u>93"</u>
Street	<u>Alcott Ln.</u>	Inner Diameter	<u>4'</u>
Date	<u>5/11/2021</u>	Material	<u>Concrete - Cement Lined</u>
Time	<u>10:30</u>	Cover	<u>Good</u>
Inspector	<u>Maria George</u>	Frame	<u>Good - Offest 3"</u>

Defects	Depth	Clock Position	Comments
Minor Cracks	8"-20"	12-12	Circumferential
Infiltration Stain	8"-20"	12-12	
Missing Mortar	8"-20"

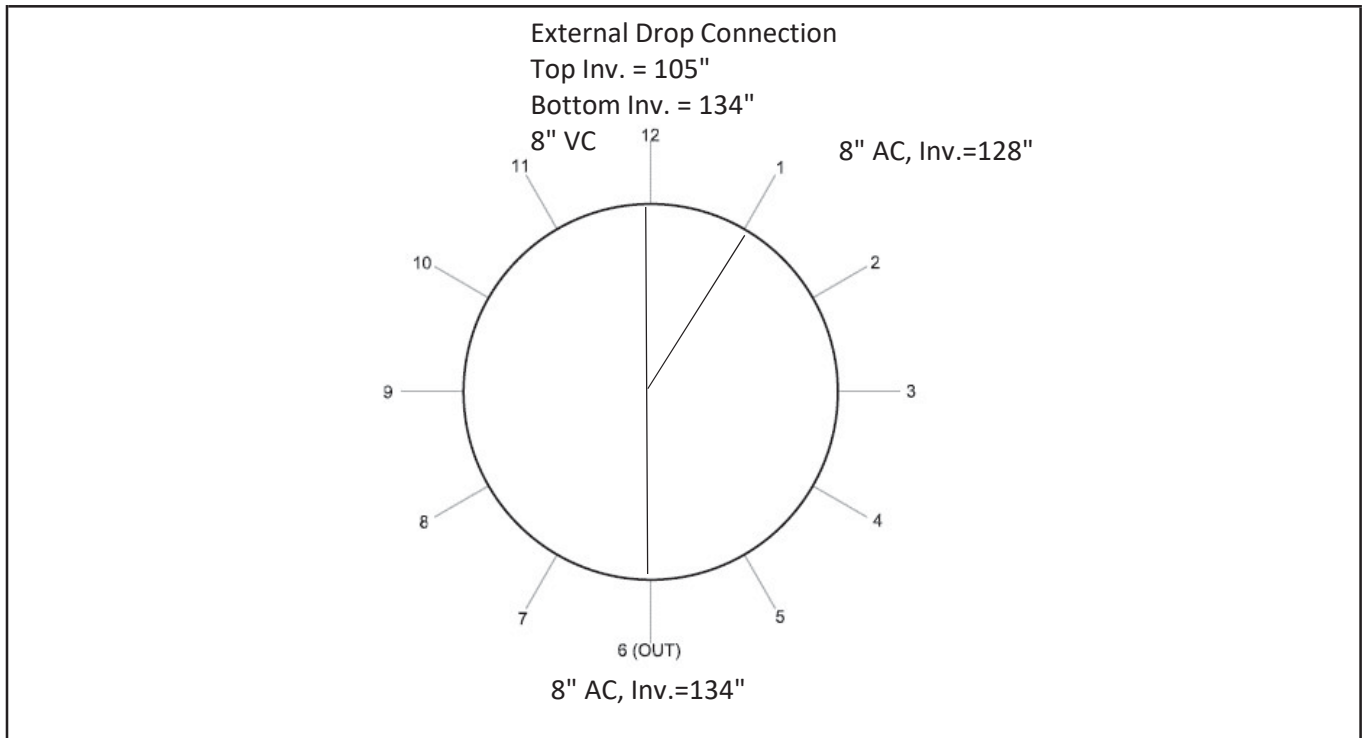
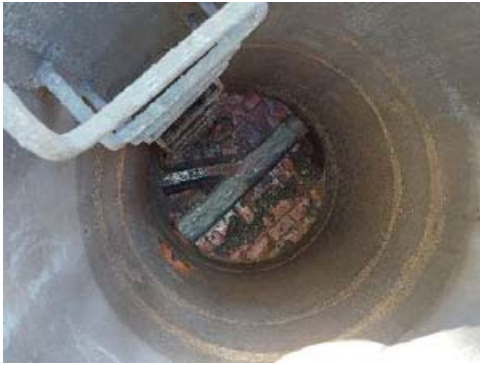
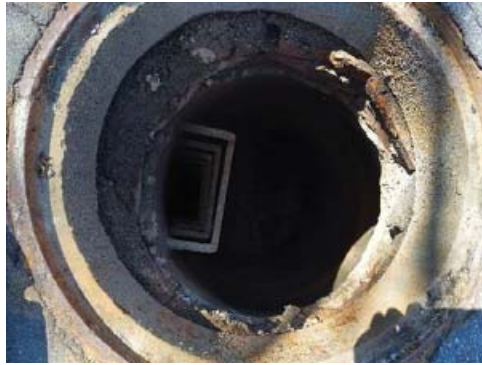
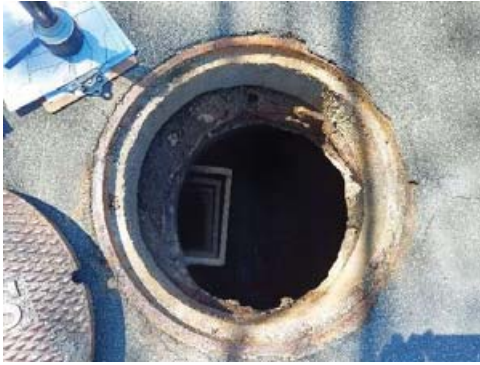
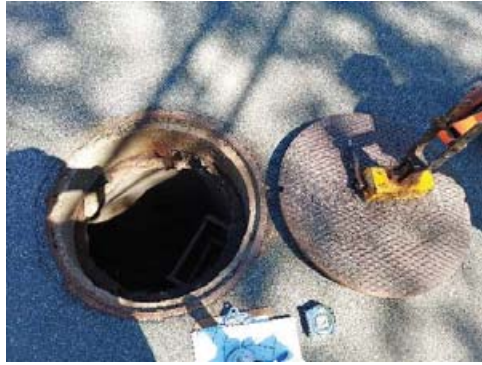
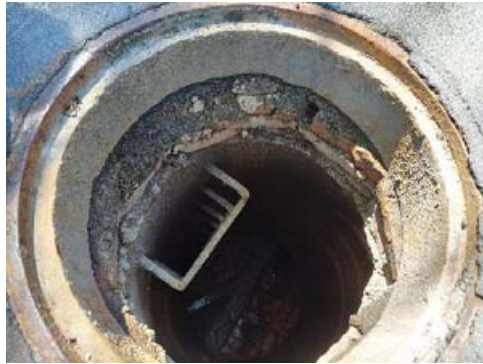
Manhole ID	<u>08/089</u>	Rim to Invert	<u>134"</u>
Street	<u>Washington @ Alcott</u>	Inner Diameter	<u>4'</u>
Date	<u>5/11/2021</u>	Material	<u>Concrete</u>
Time	<u>10:40</u>	Cover	<u>Good</u>
Inspector	<u>Maria George</u>	Frame	<u>Good - Offset 3"</u>

Defects	Depth	Clock Position	Comments
Missing Mortar	9"-18"	12-12	
Displaced Brick	9"-18"	12-12

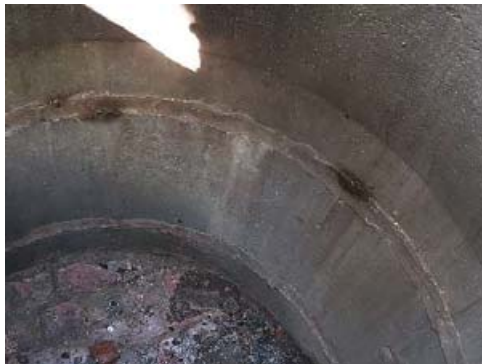
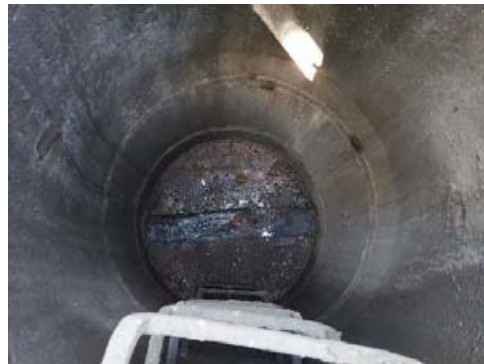
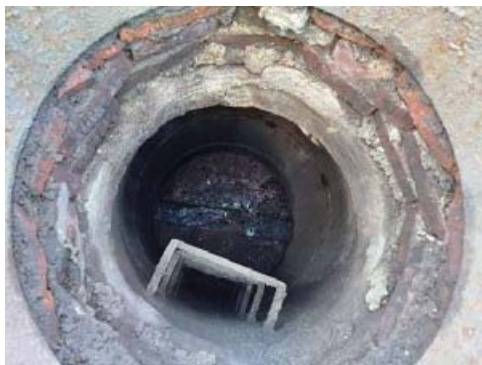
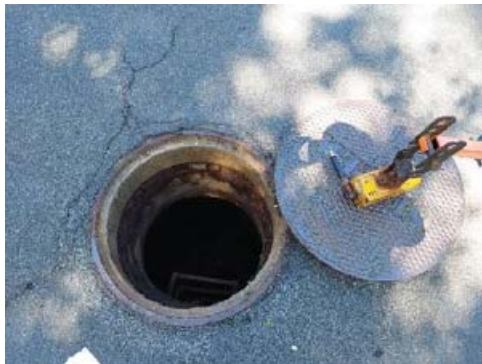
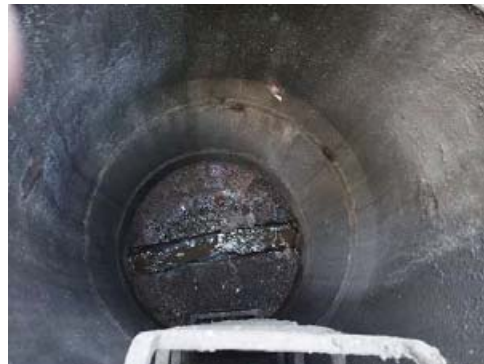
Manhole ID	<u>08/090</u>	Rim to Invert	<u>118"</u>
Street	<u>Washington @ Wentworth</u>	Inner Diameter	<u>4'</u>
Date	<u>5/11/2021</u>	Material	<u>Concrete</u>
Time	<u>10:50</u>	Cover	<u>Good</u>
Inspector	<u>Maria George</u>	Frame	<u>Good</u>

Defects	Depth	Clock Position	Comments
Infiltration Stain	73"	10, 11	
Missing Mortar		12-12

Brick in invert - removed by DPW

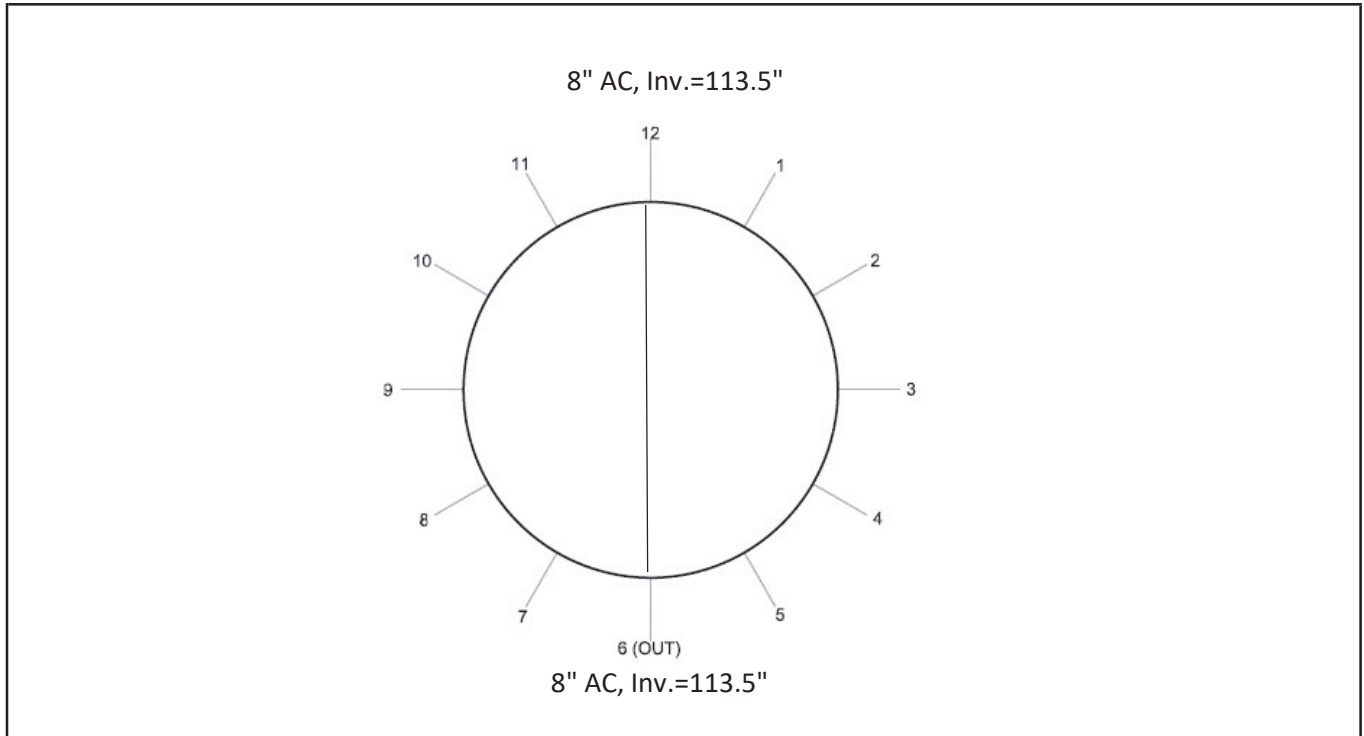
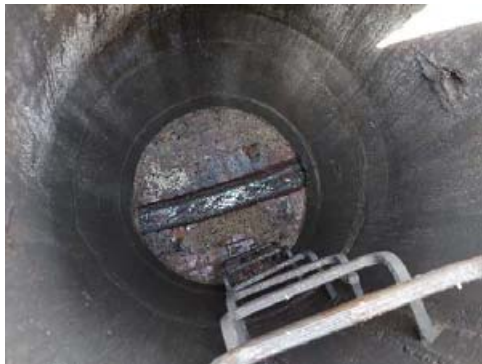
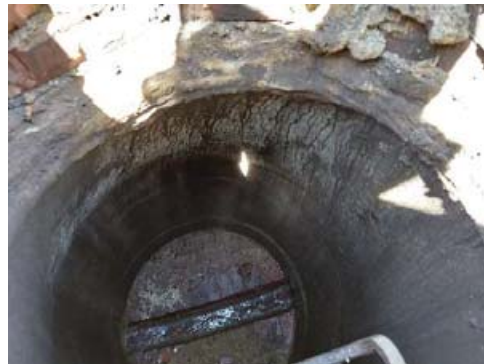
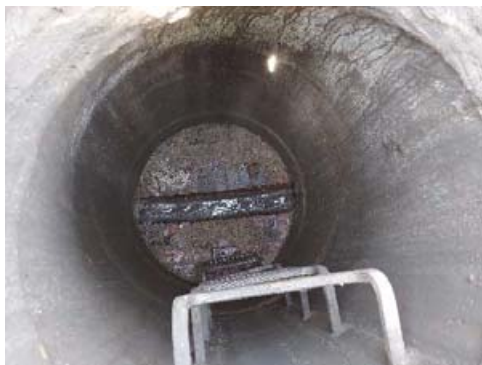
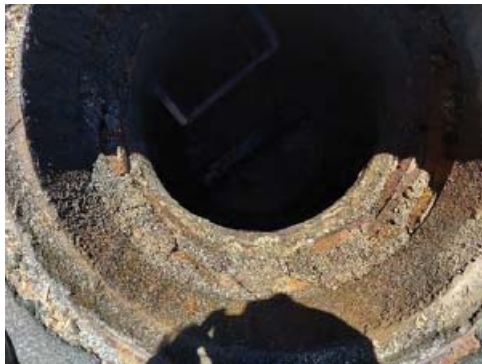
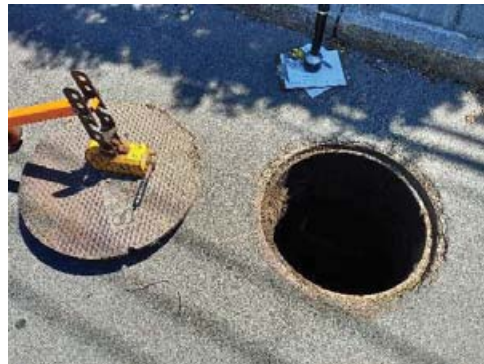
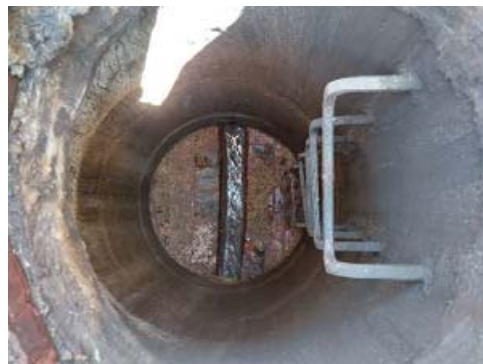
08-091 Photos

Defects	Depth	Clock Position	Comments
Missing Mortar	8.5"-15"	12-12	Chimney
Displaced Brick	8.5"-15"	12-12	Chimney
Infiltration Stain	15"	12-12	Chimney

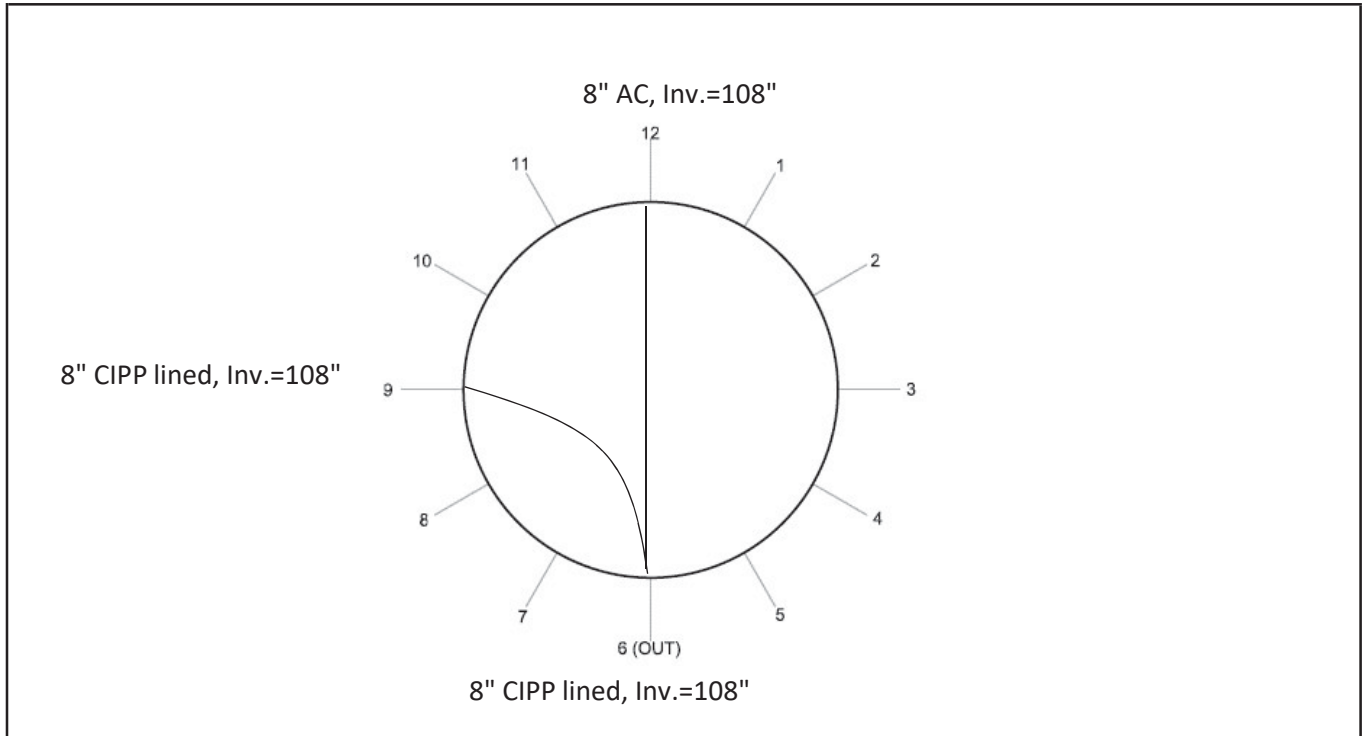
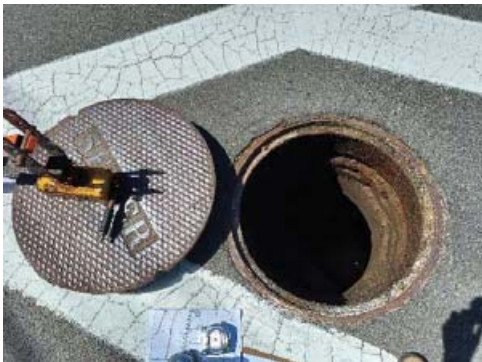
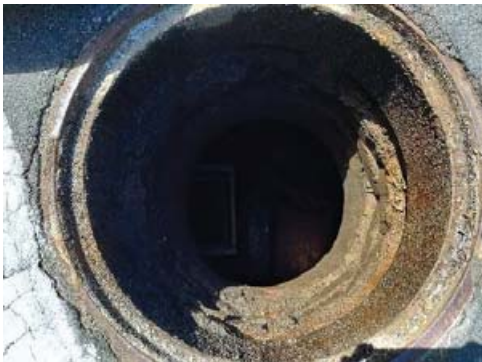
08-092 Photos

Defects	Depth	Clock Position	Comments
Missing Mortar	8.5"-18"	12-12	
Debris	101"	12-6	On bench

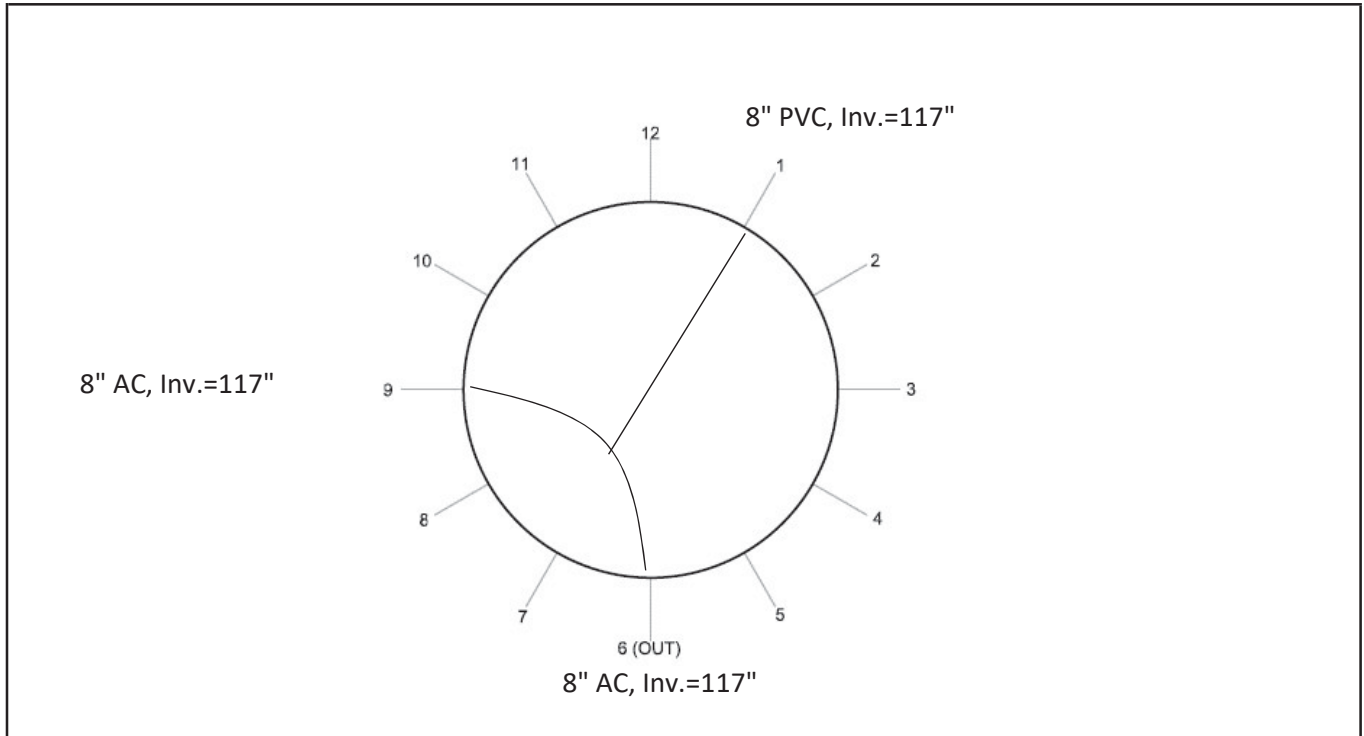
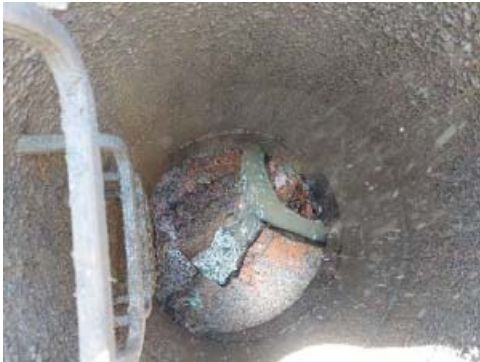
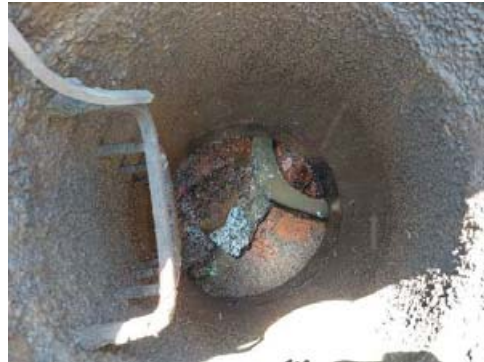
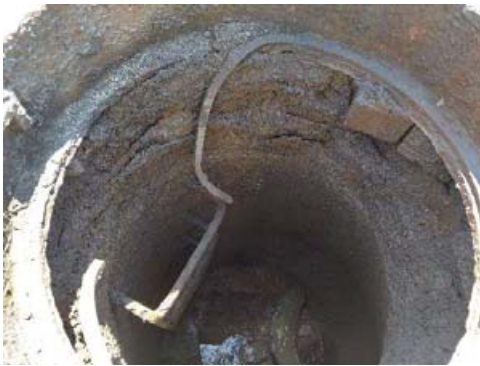
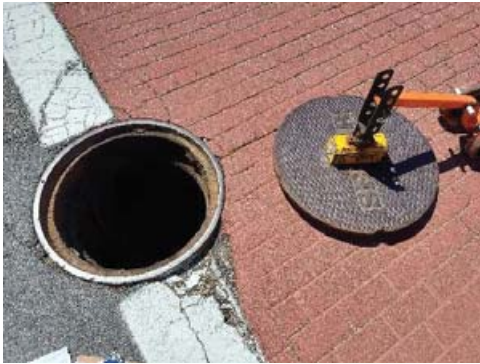
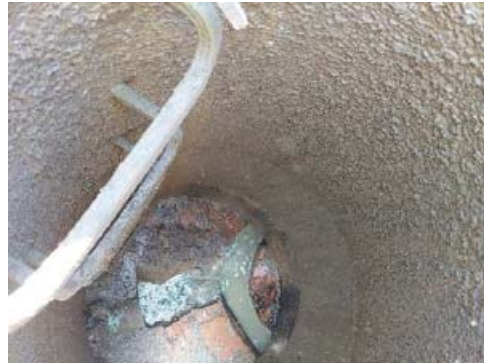
08-101 Photos

Defects	Depth	Clock Position	Comments
Infiltration Runner	109"	7-8	On bench
Cut Gasket

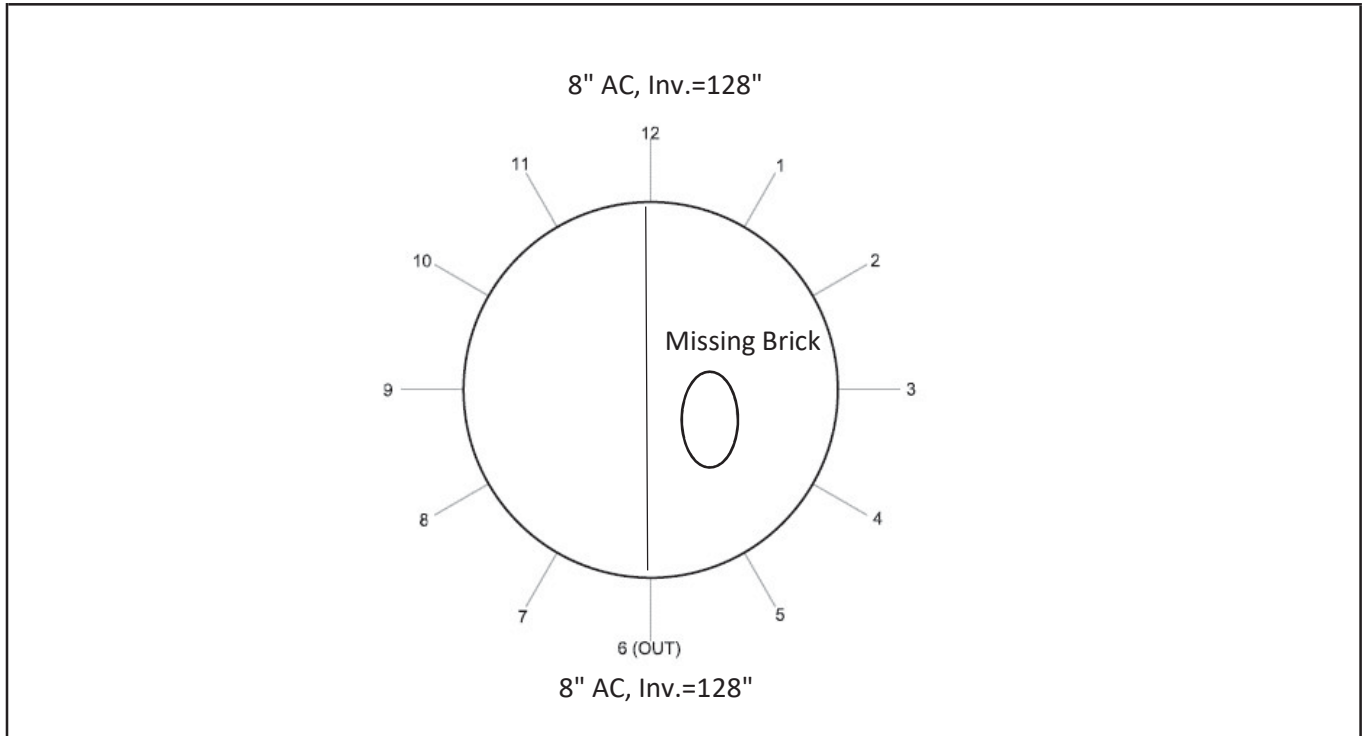
08-099 Photos

Defects	Depth	Clock Position	Comments
Missing Brick	119"	2-4	On bench
Infiltration Stain	64"	2, 8

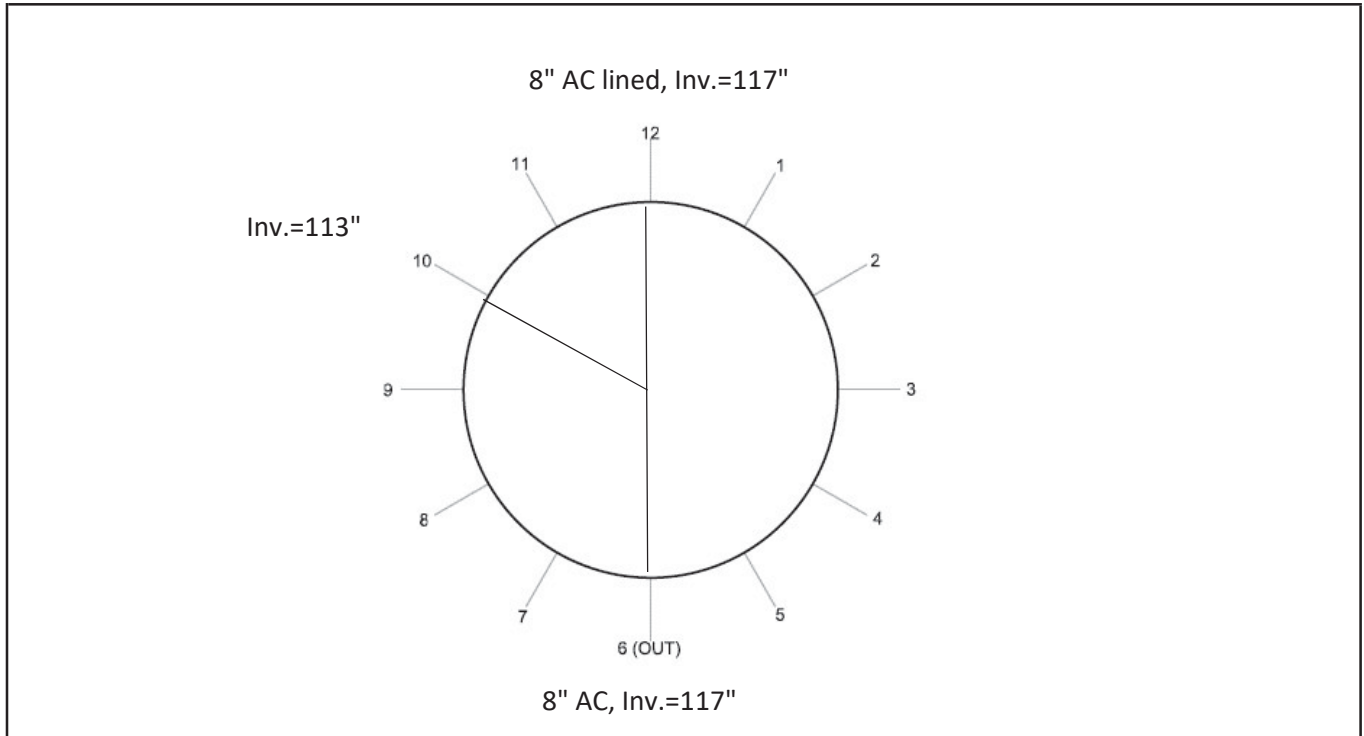
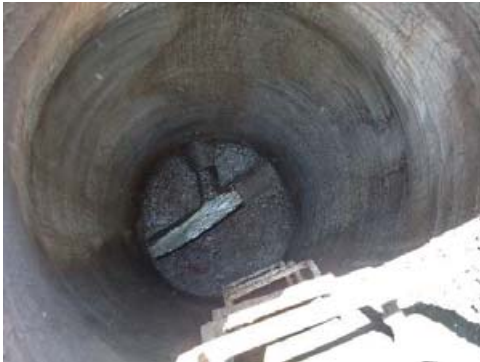
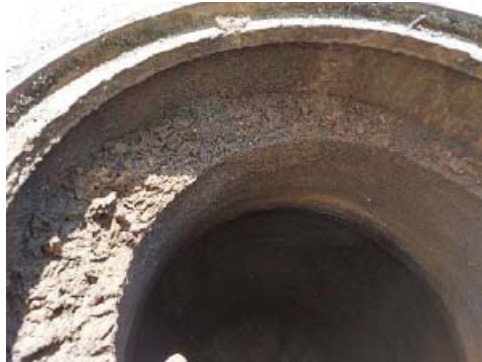
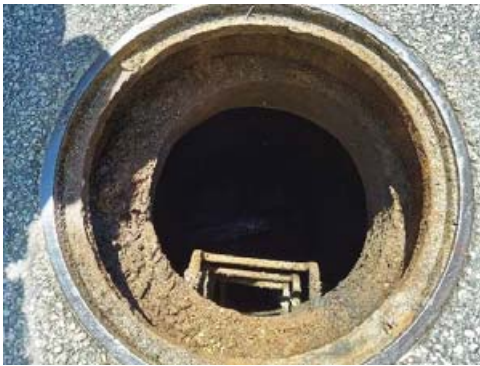
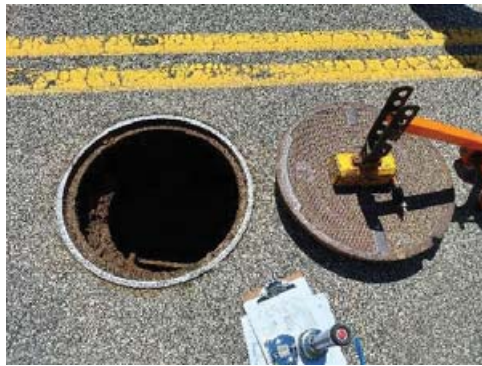
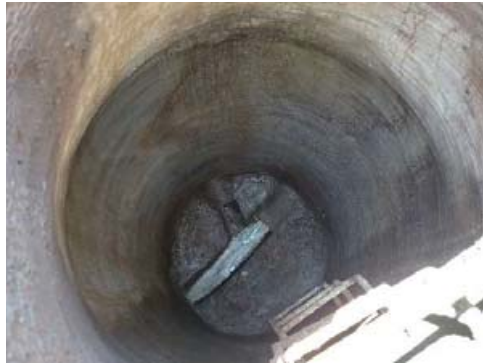
08-139 Photos

Defects	Depth	Clock Position	Comments
Infiltration Stain	43"	10-12

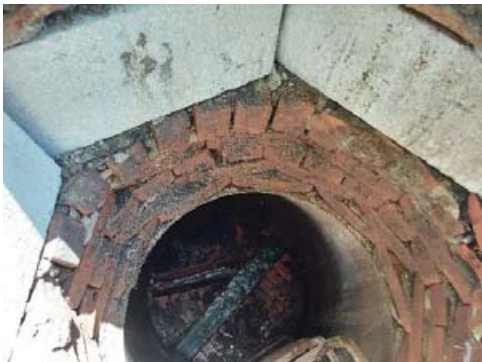
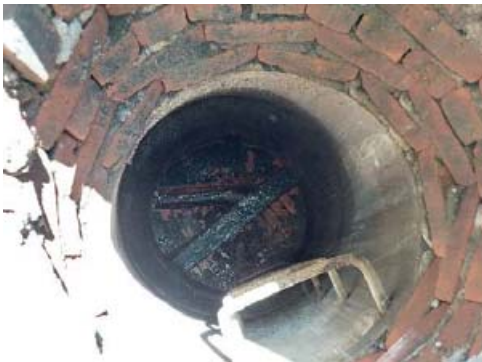
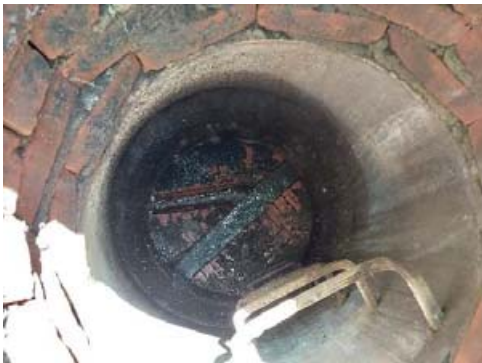
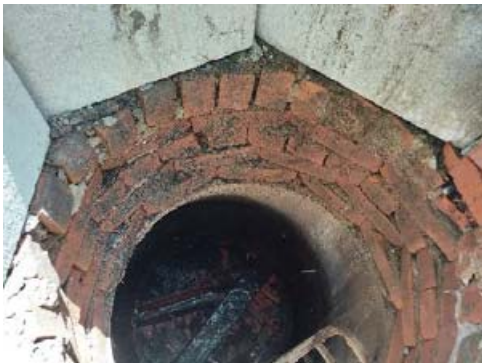
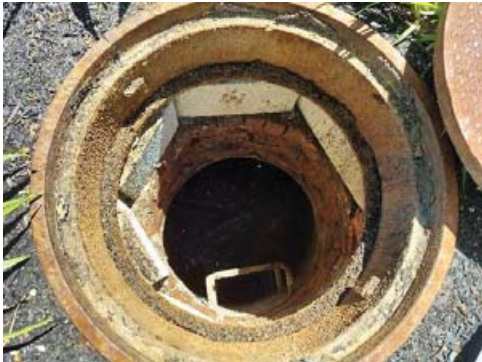
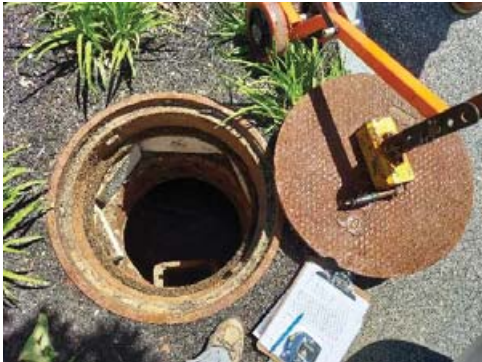
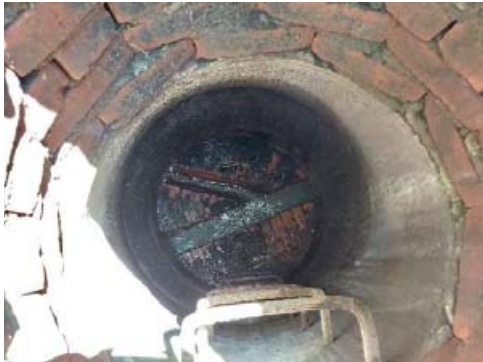
08-102 Photos

Defects	Depth	Clock Position	Comments
Missing Mortar	9"-34"	12-12	
Infiltration Stain	120"	2, 11

SMH located on graden bed near parking lot
Chimney is brick and block

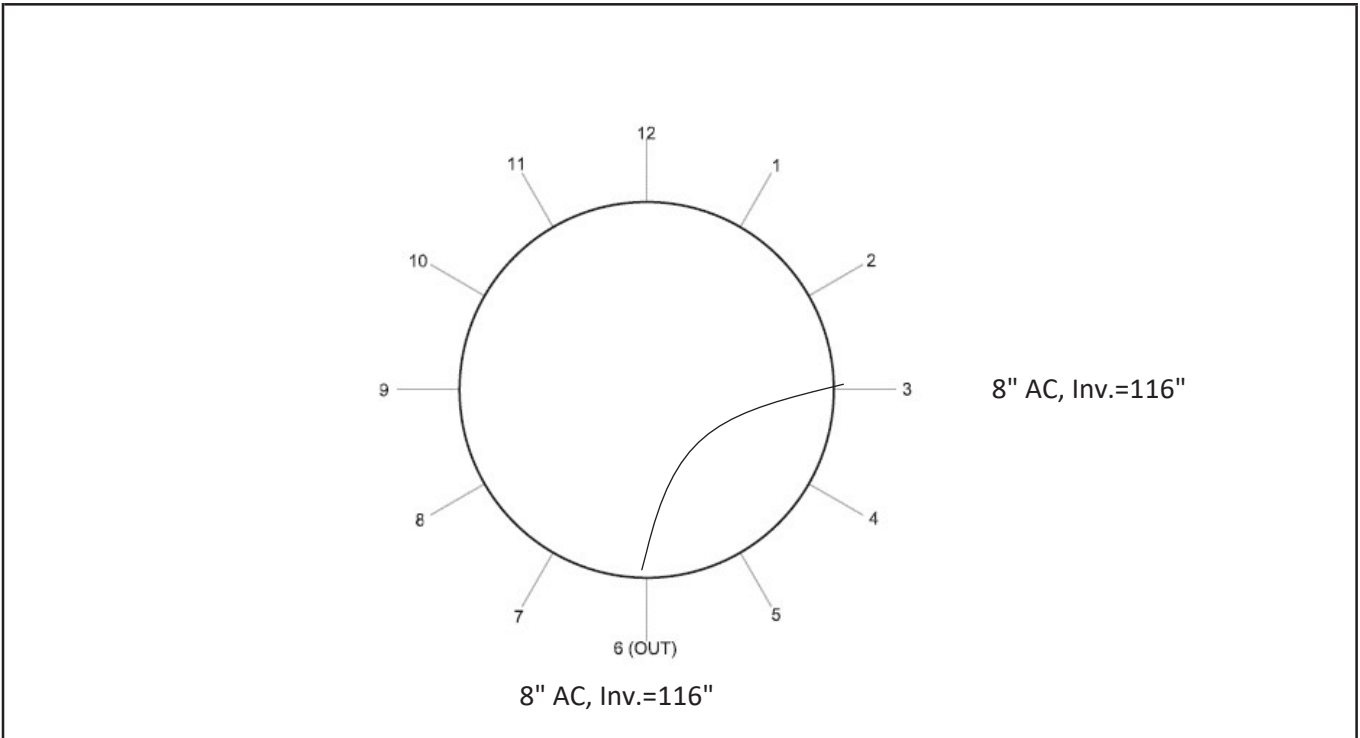
Defects	Depth	Clock Position	Comments
Infiltration Strain	27"	7-8	
Infiltration Dripper	95"	2:30
