APPENDIX D

Manhole Inspection Reports

Westwood Manhole Inspections

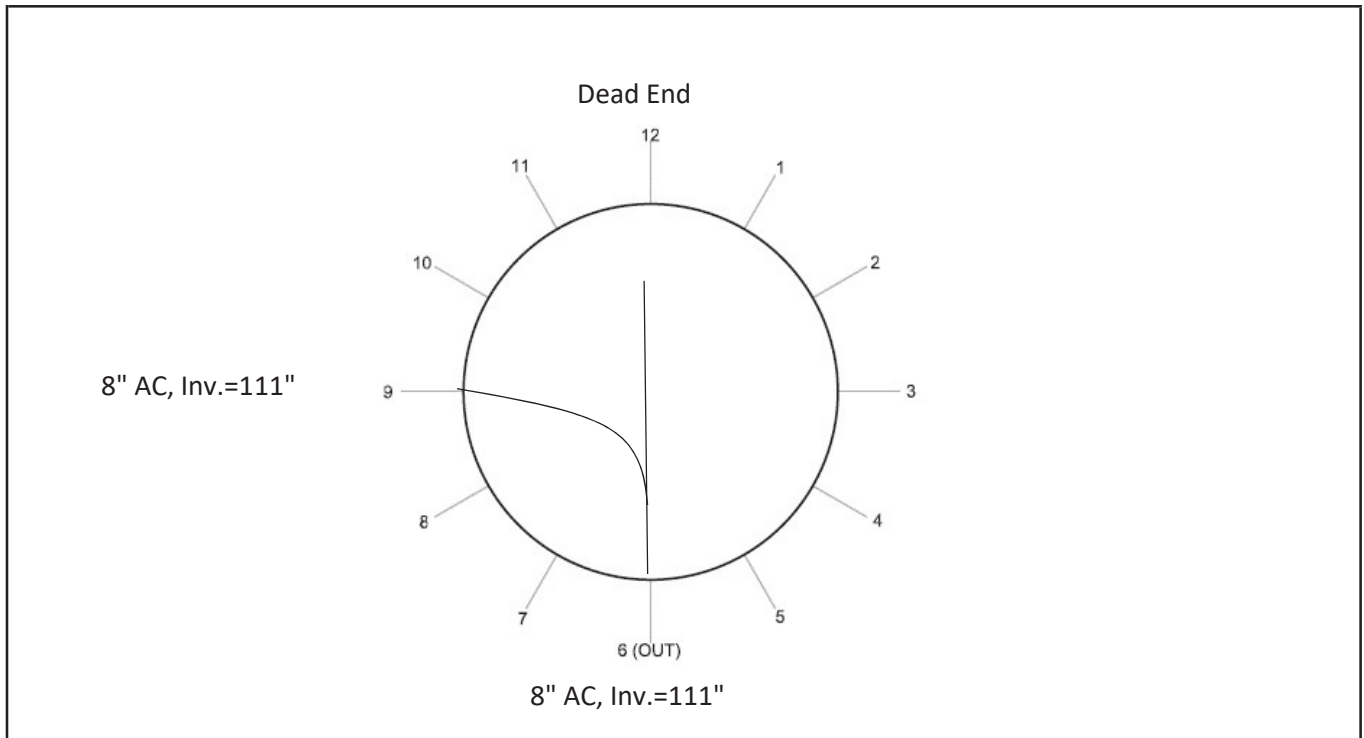
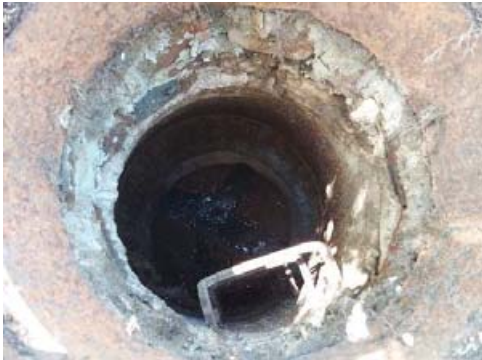
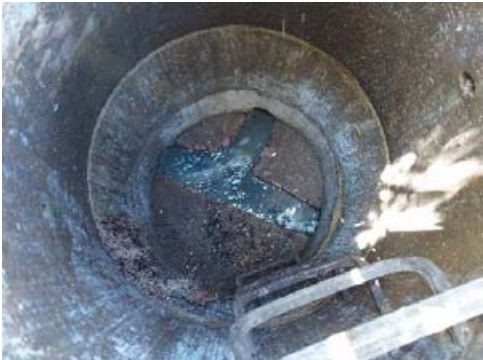
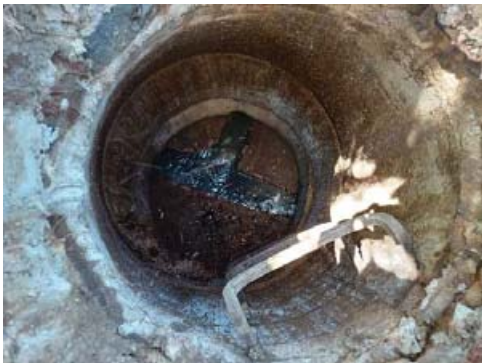
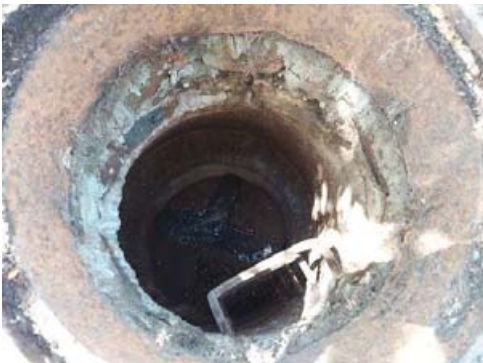
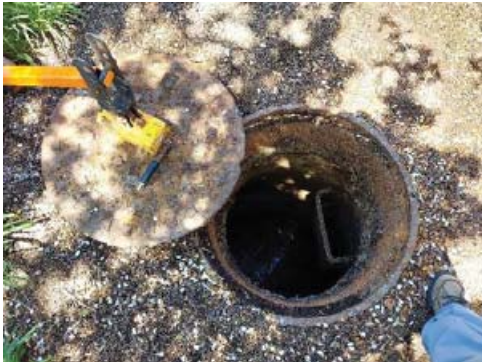
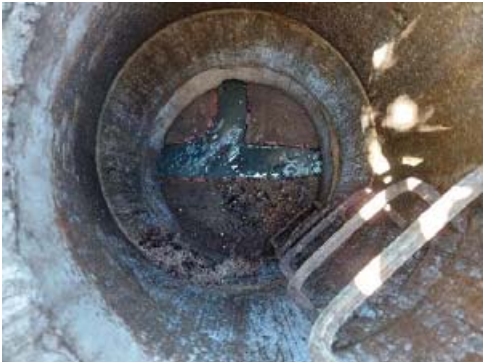
Defects	Depth	Clock Position	Comments
Roots Minor	9"	12-12	Below frame
Root Ball	63"	3-5	At joint
Missing Mortar	9"-20"	12-12	
Infiltration Stain	20"	12-12

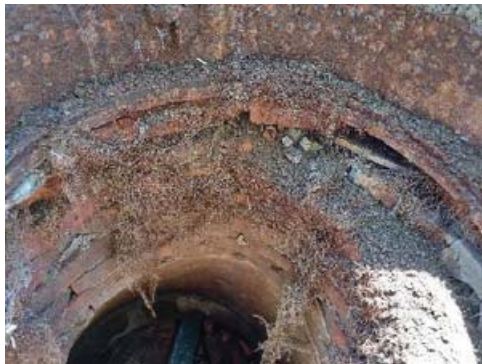
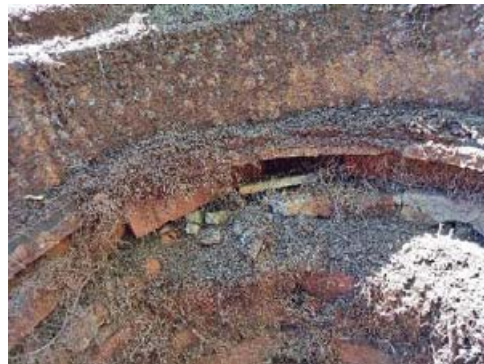
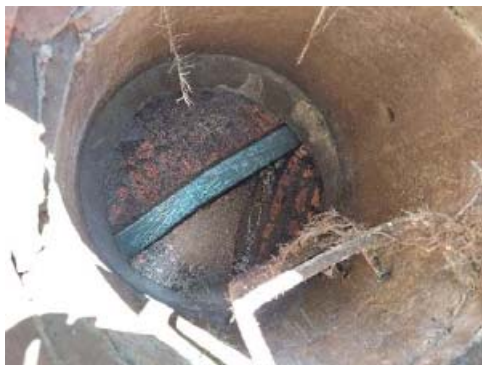
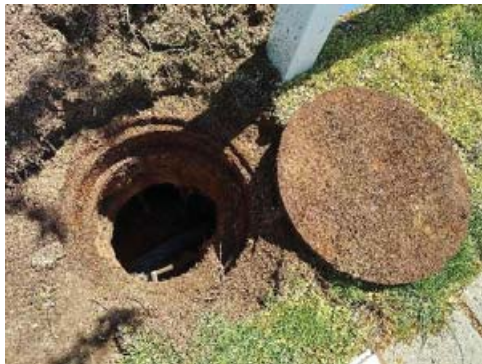
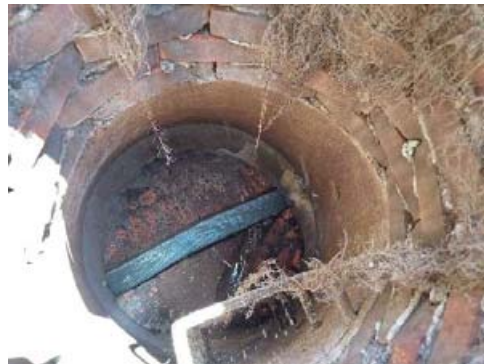
08-105 Photos

Defects	Depth	Clock Position	Comments
Missing Mortar	8"-12"	12-12	
Displaced Brick	8"-12"		
Medium Roots	12"	12-12

Buried 4" under soil near end of fence post

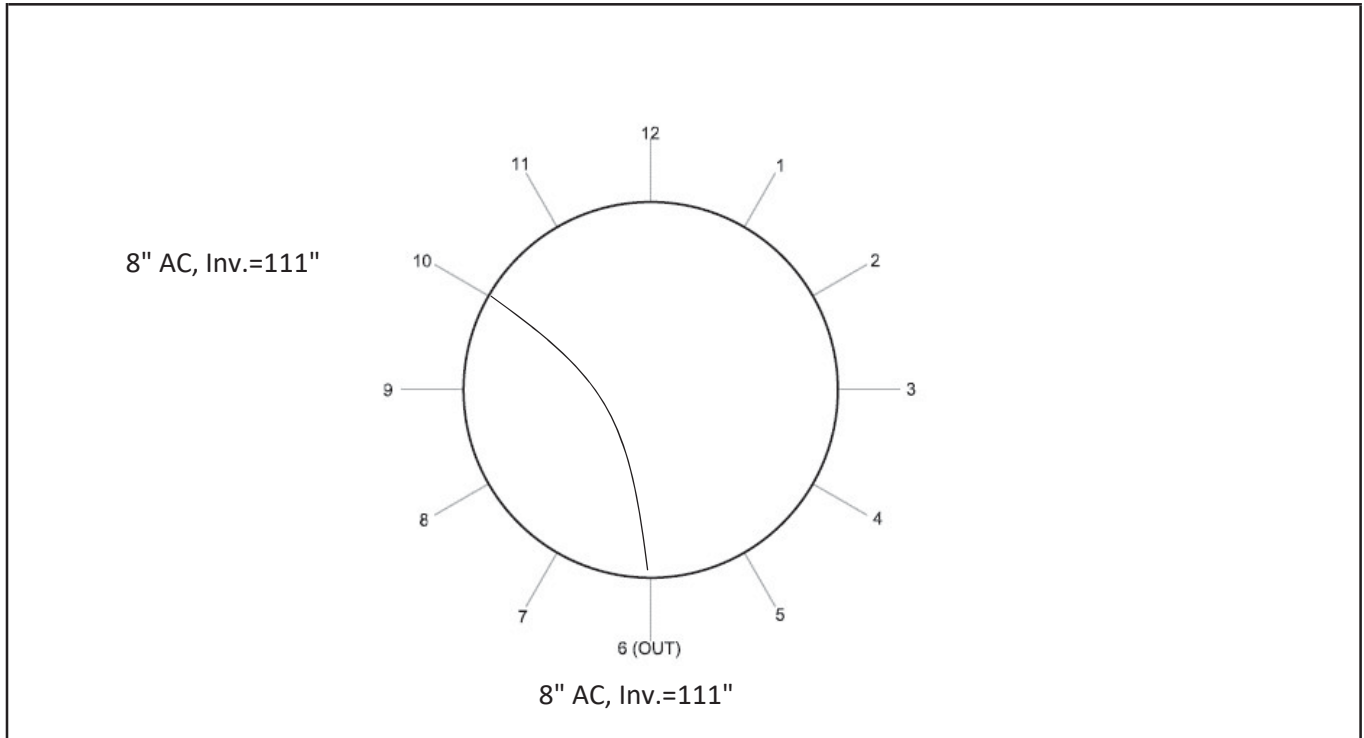
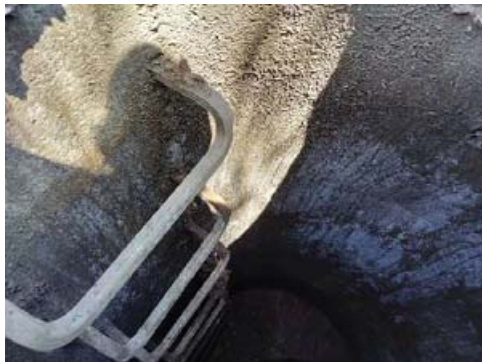
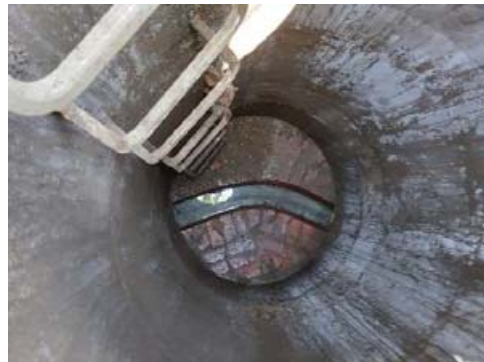
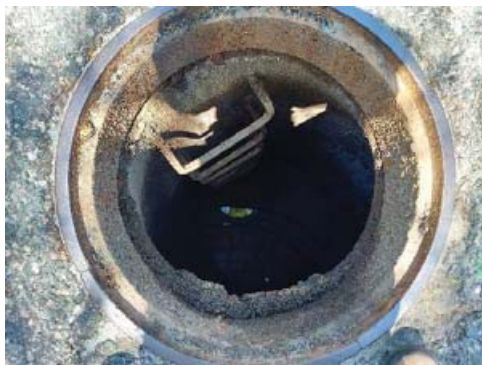
08-120 Photos

Defects	Depth	Clock Position	Comments
Displaced Brick	8"-10"	12-12	
Missing Mortar	8"-10"	12-12	
Infiltration Stain	10"	12-12

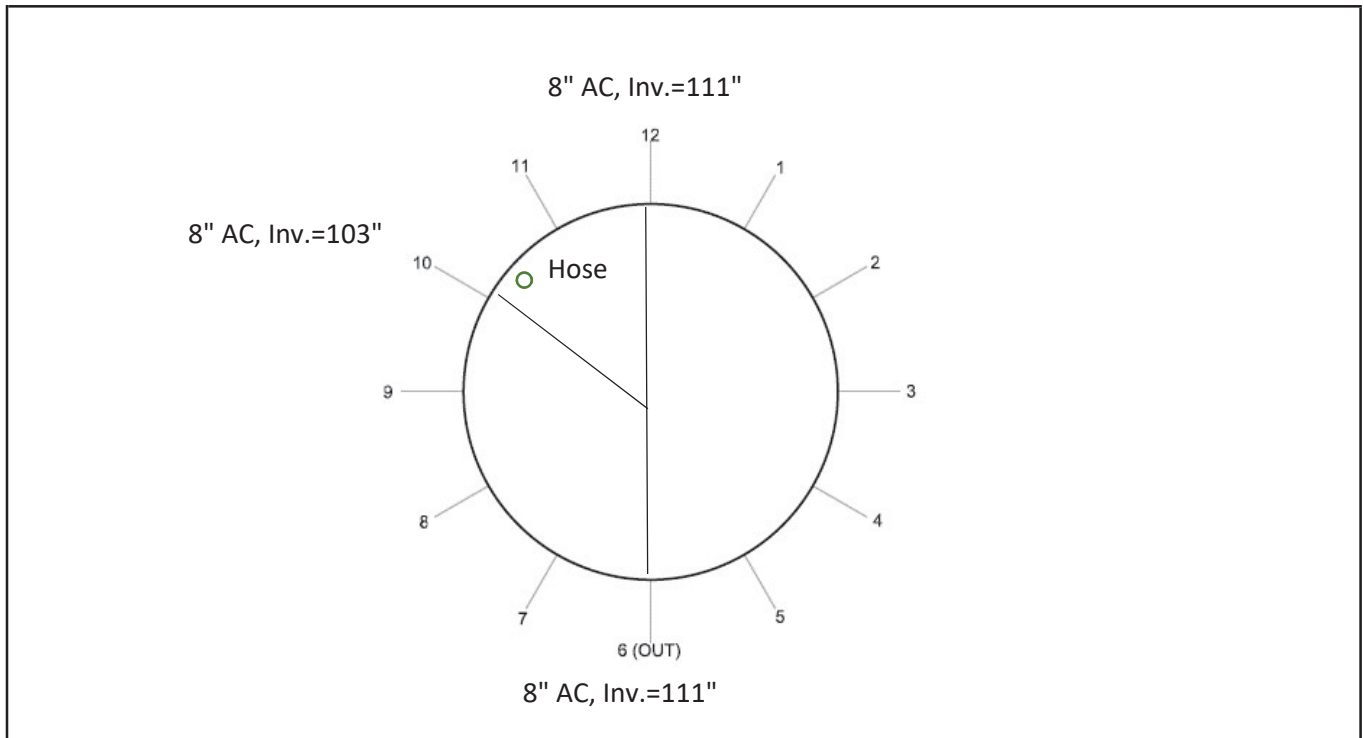
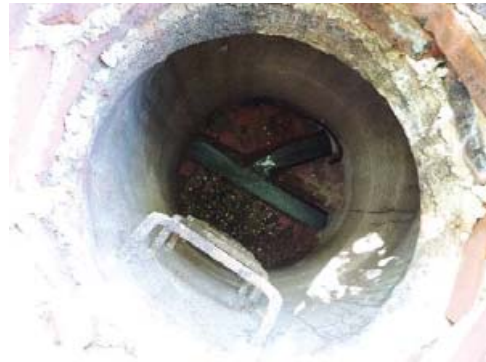
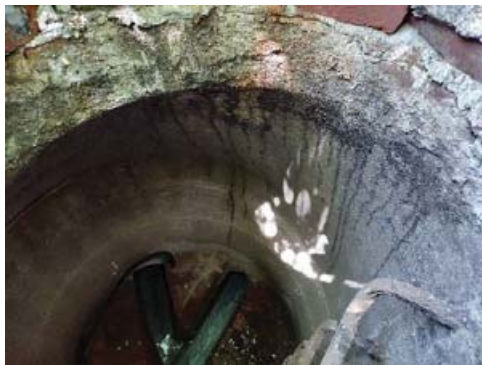
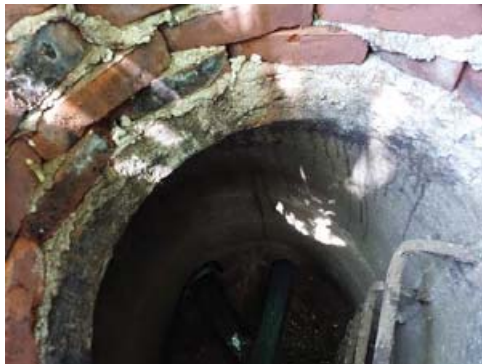
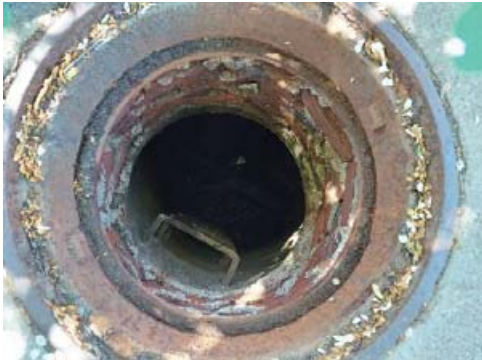
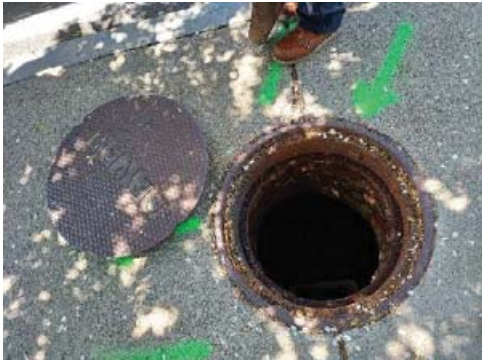
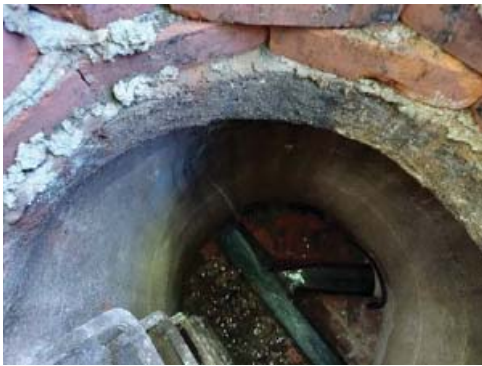
Defects	Depth	Clock Position	Comments
Infiltration Stain	28"	12-2, 6	
Infiltration Stain	~40"	10

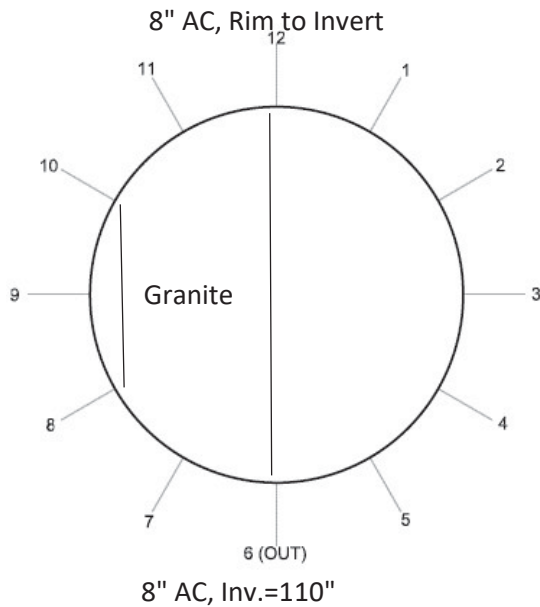
08-122 Photos

Defects	Depth	Clock Position	Comments
Offset Chimney	23"	12-6	7"
Granite in Riser

The granite in the riser is granite curbing that is built into the structure. The clearance access is approximately 24" wide, and is below the granite curb. DPW is concerned that personnel cannot fit through this constricted opening.

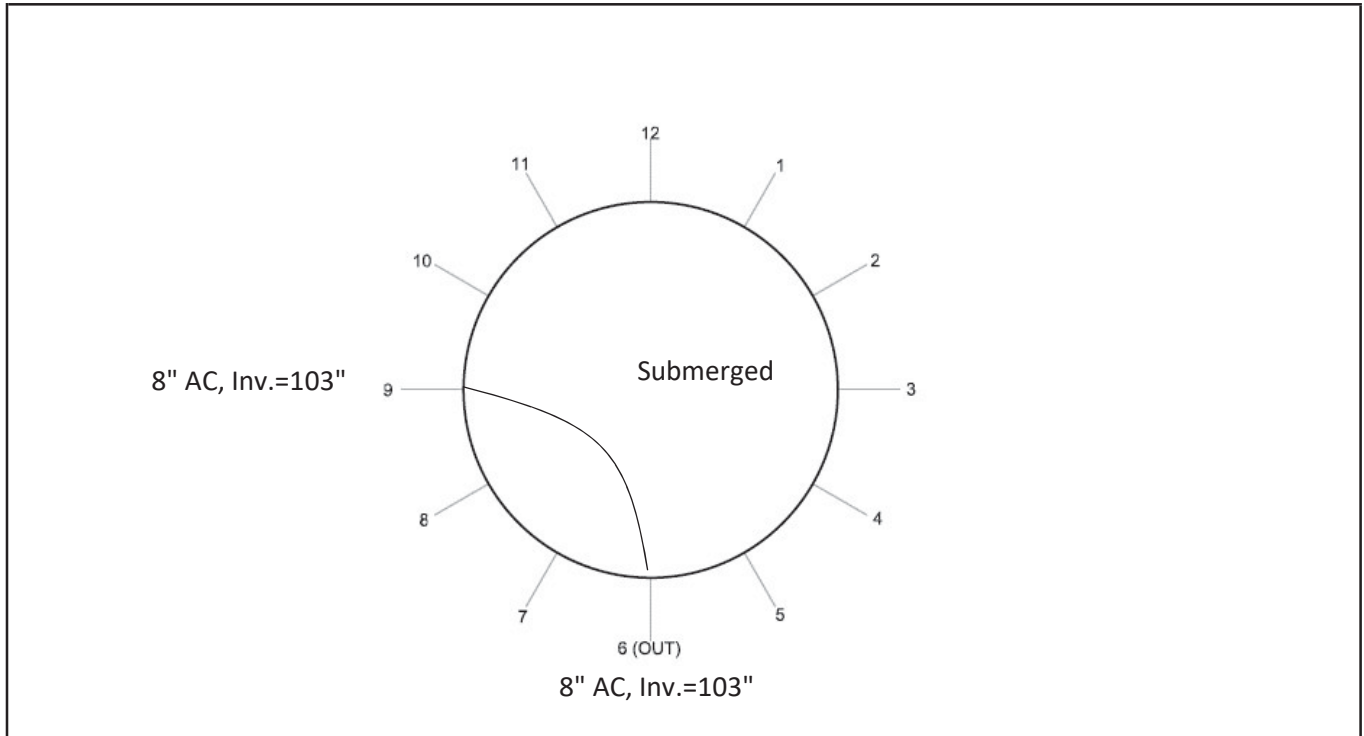
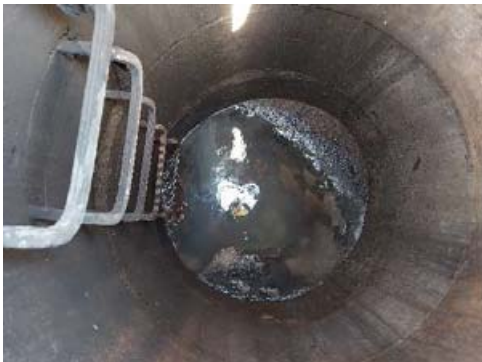
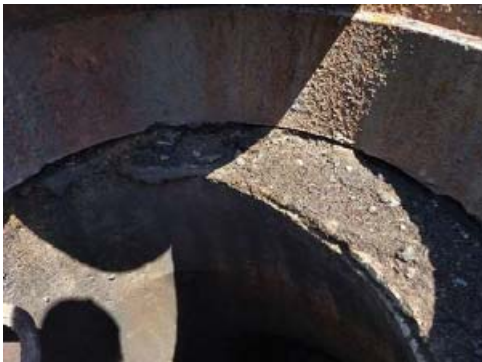
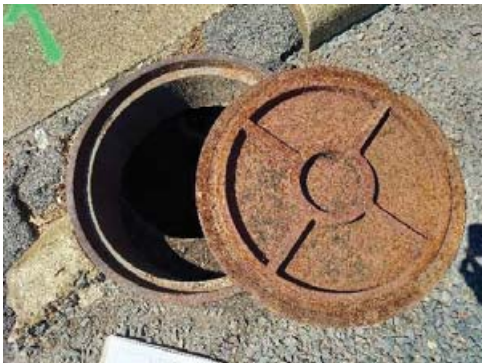
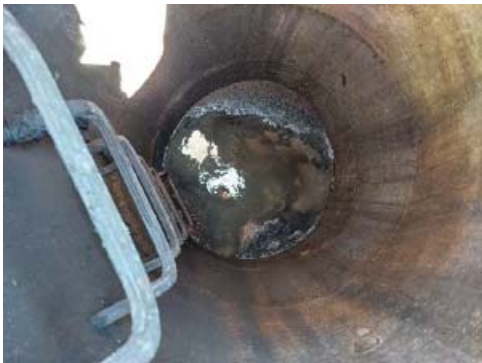
08-140 Photos

Defects	Depth	Clock Position	Comments
Infiltration Runner	99.5"	5:30	
Submerged Bench	99.5"	12-12

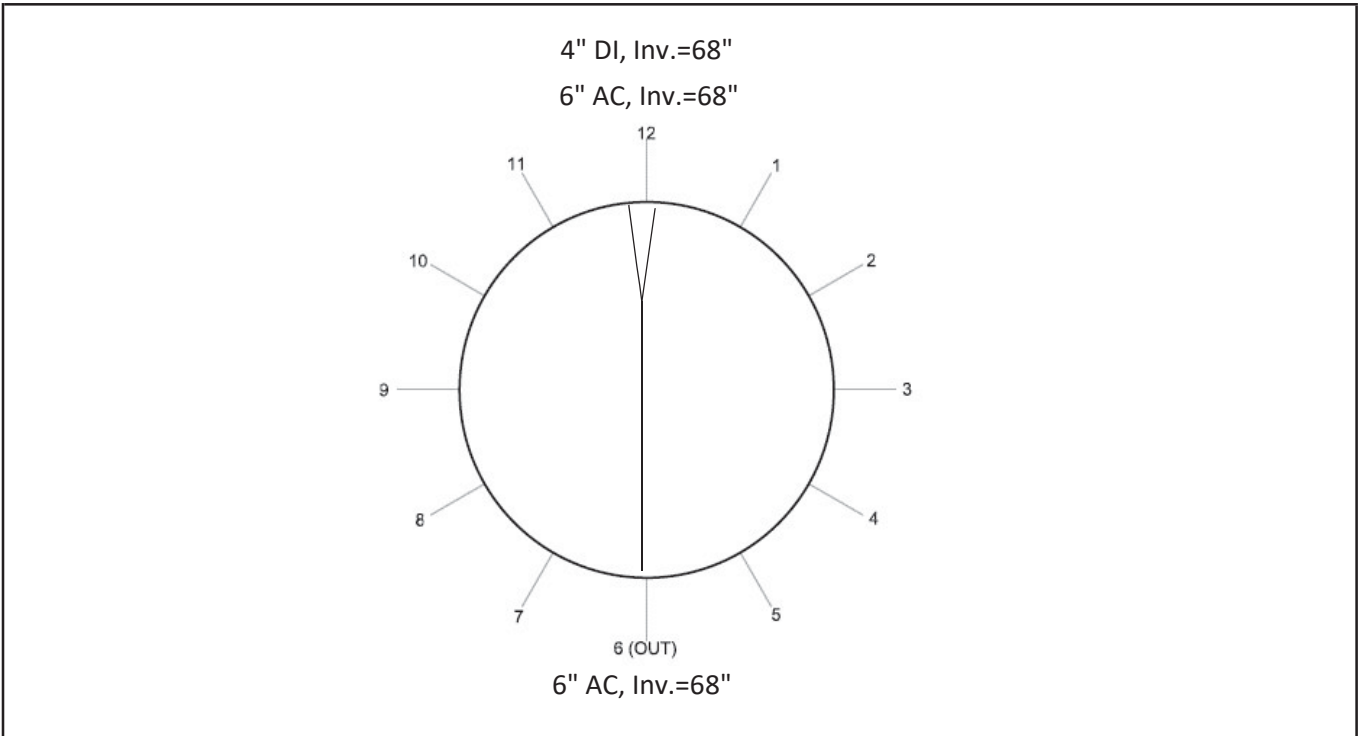
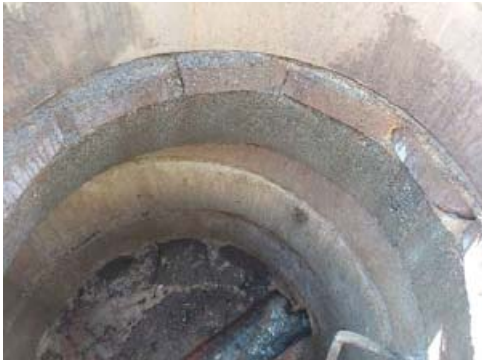
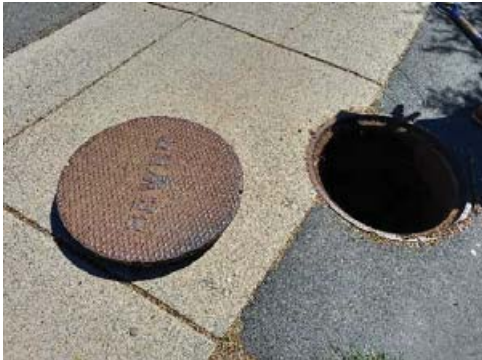
08-126 Photos

Defects	Depth	Clock Position	Comments
Cement/Debris	62"	12-12	On Bench

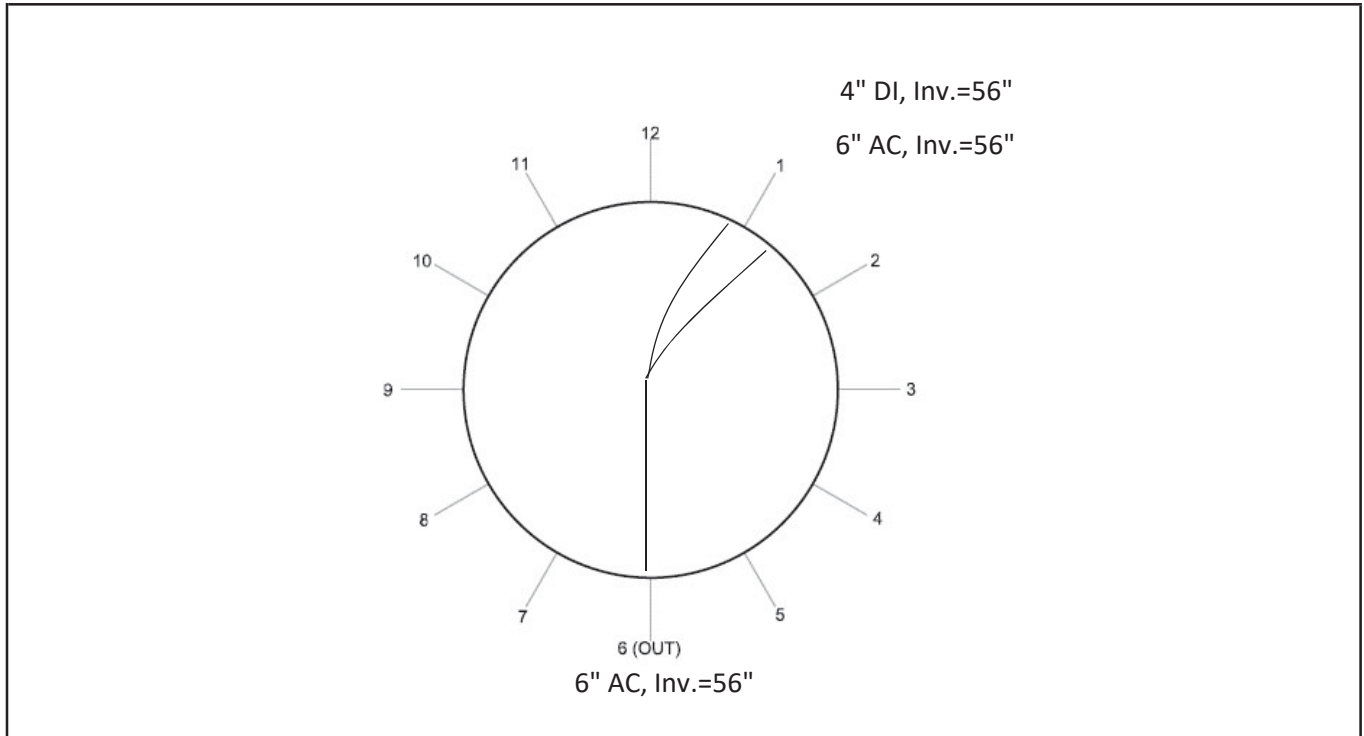
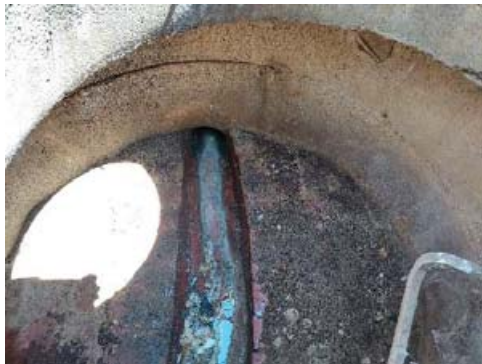
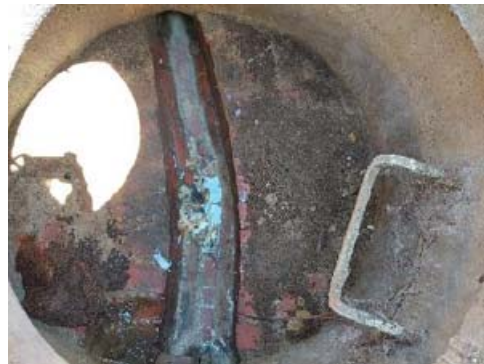
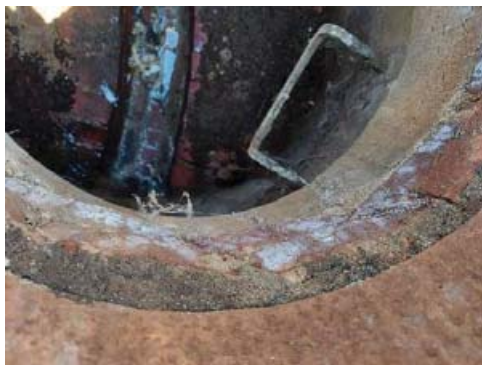
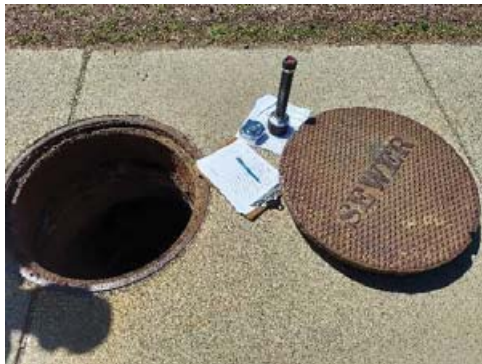
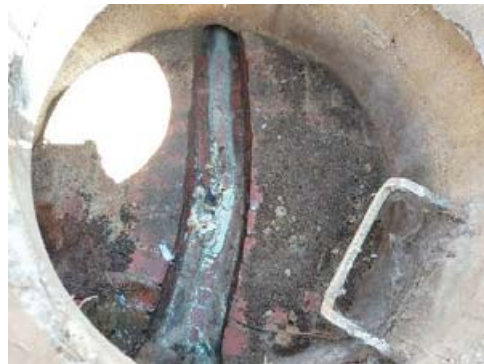
08-127 Photos

Defects	Depth	Clock Position	Comments
Roots Fine	15"	12-2	
Compacted Dirt	49"		On Bench
Roots Fine	34"	12	
Root Ball	49"	2

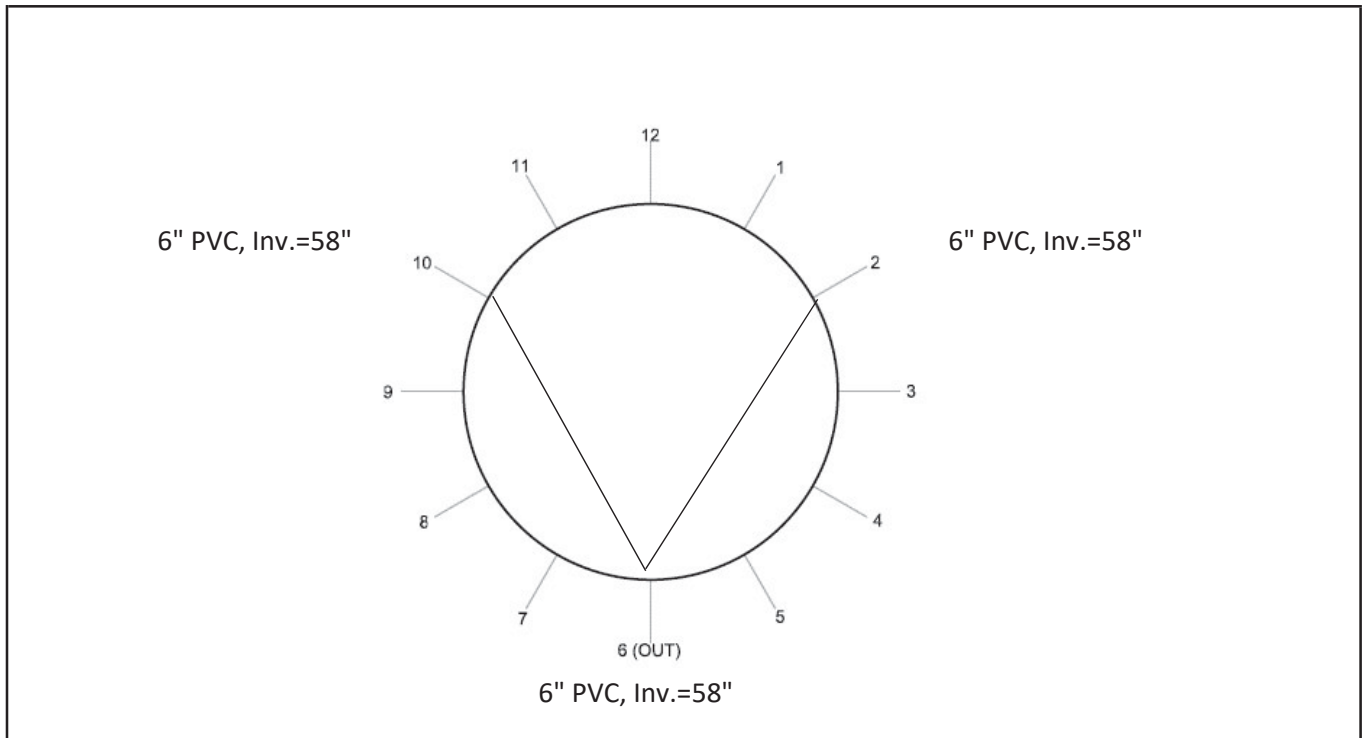
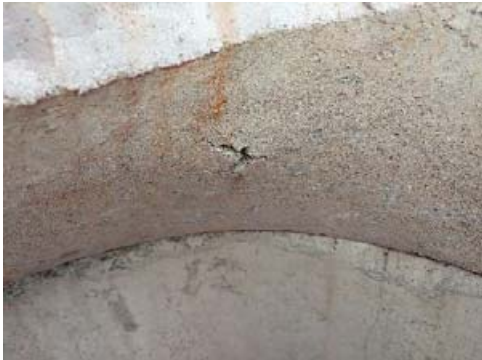
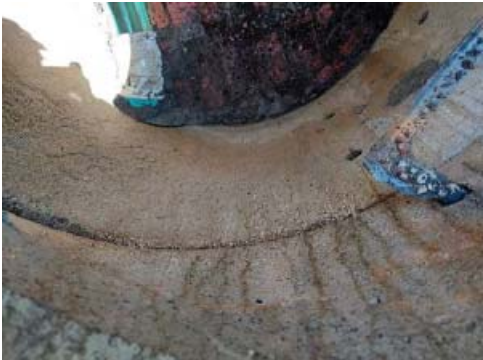
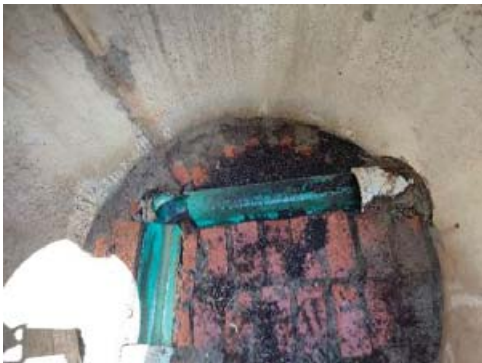
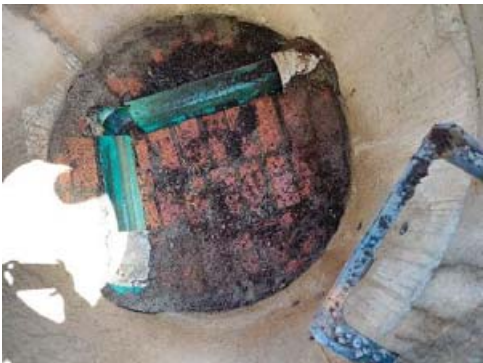
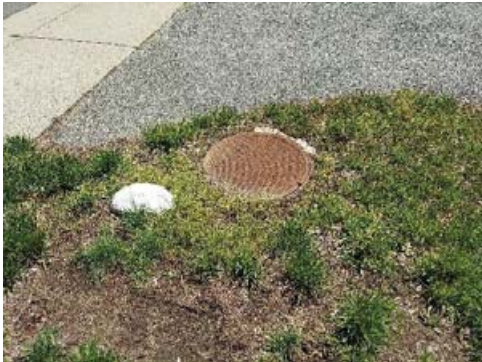
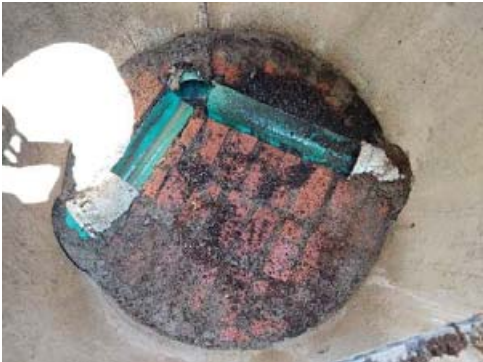
08-131 Photos

Defects	Depth	Clock Position	Comments
Fracture	14"	9	
Roots Fine	24"	1-3	Joint
Missing Mortar	54"	2, 10	At pipe joints
Hole	54"	2, 10	Hole partially filled with mortar

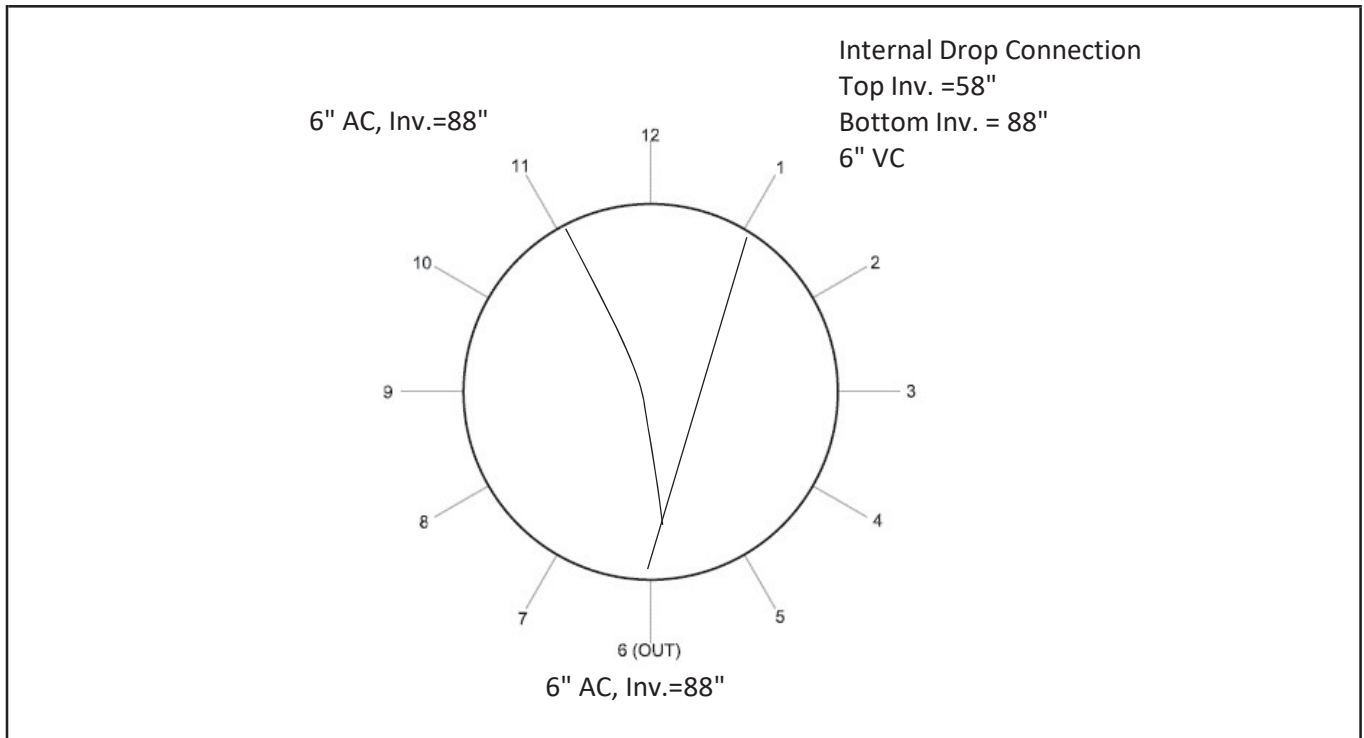
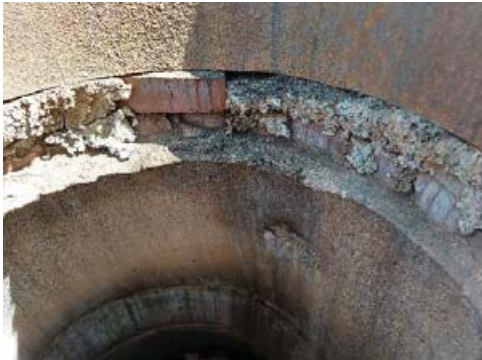
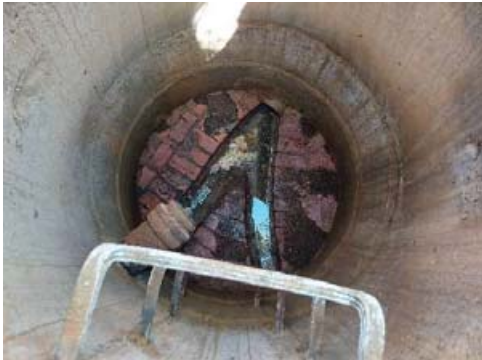
08-128 Photos

Defects	Depth	Clock Position	Comments
Missing Morrtar	8"-13"	12-12	
Displaced brick	8"-13"	12-12	
Infiltration Stain	13"	12-12	Minor
Minor Crack	56"		Joint

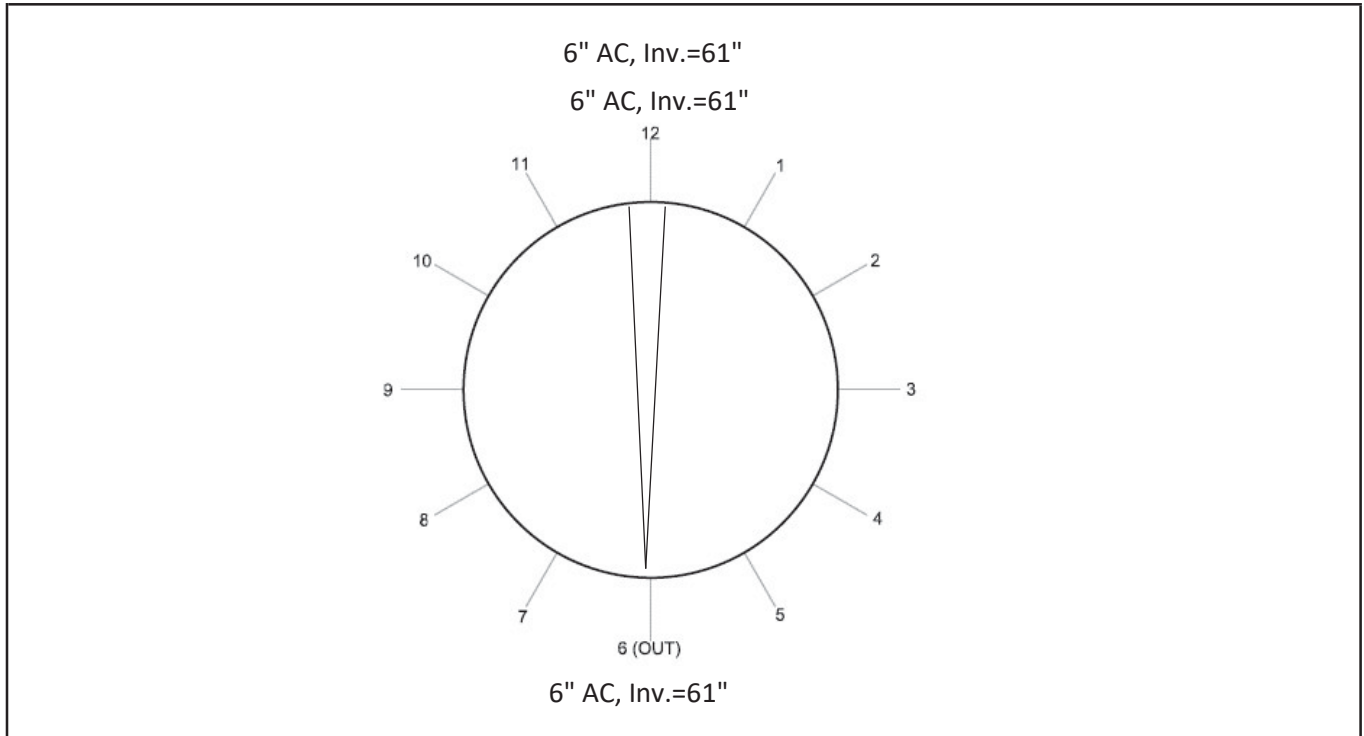
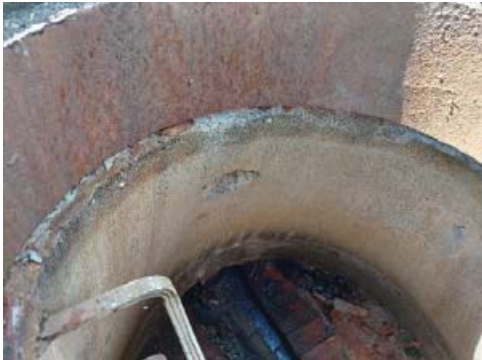
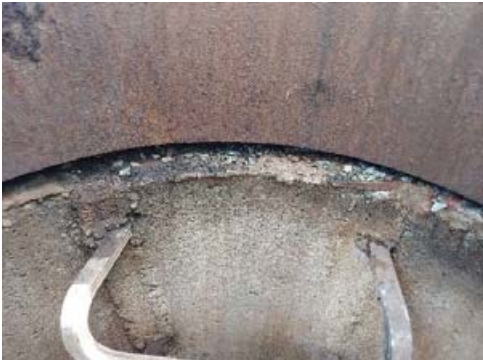
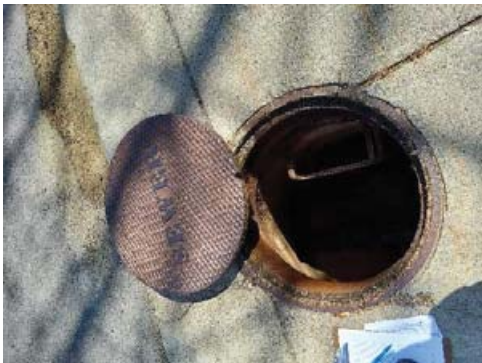
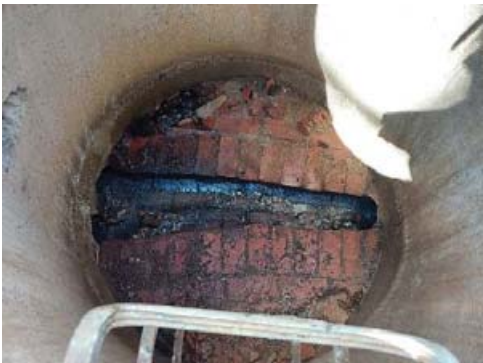
08-129 Photos

Defects	Depth	Clock Position	Comments
Missing Mortar	9"-10"	12-12	Medium
Missing Brick	9"-10"	12-12	
Hole	23"		5" circle, concrete divet
Construction Debris	57"	7-11, 2-5	On bench

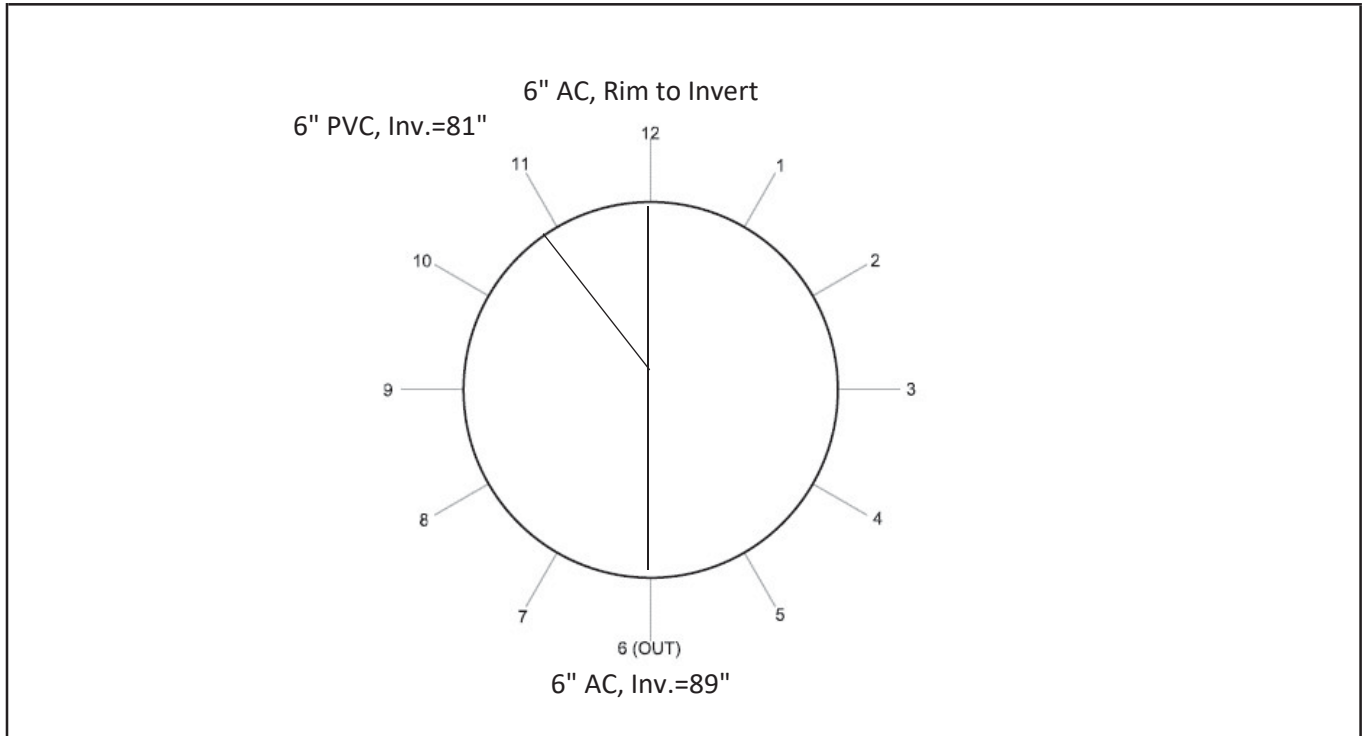
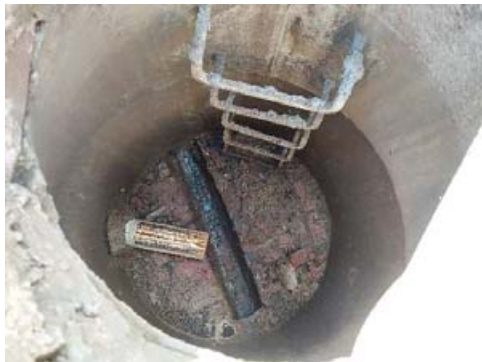
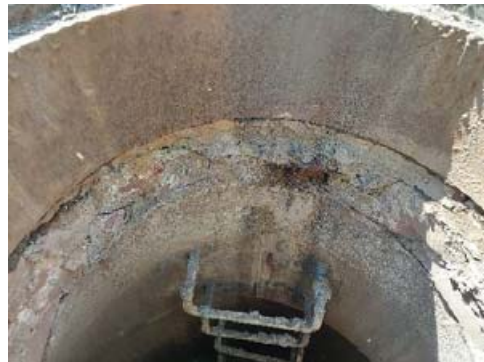
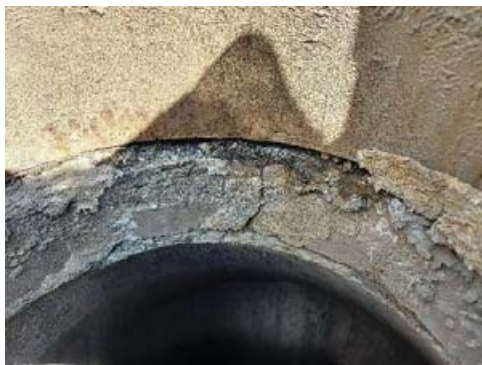
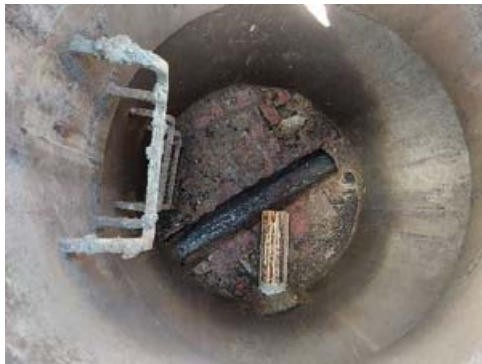
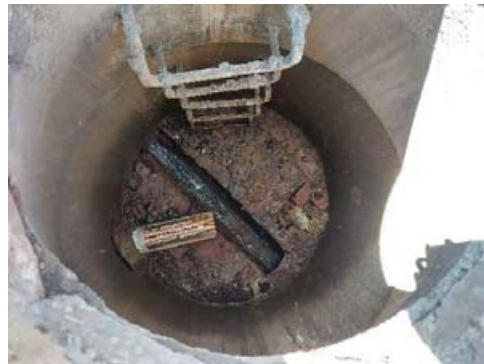
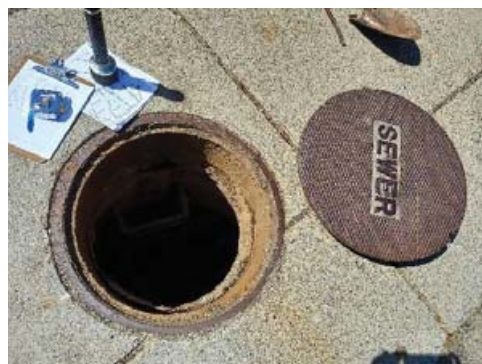
06-094 Photos

Defects	Depth	Clock Position	Comments
Missing Mortar	8"-16"	12-12	Chimney
Cracked	8"-16"	12-12	Chimney
Construction Debris	84"	12-12	Bench

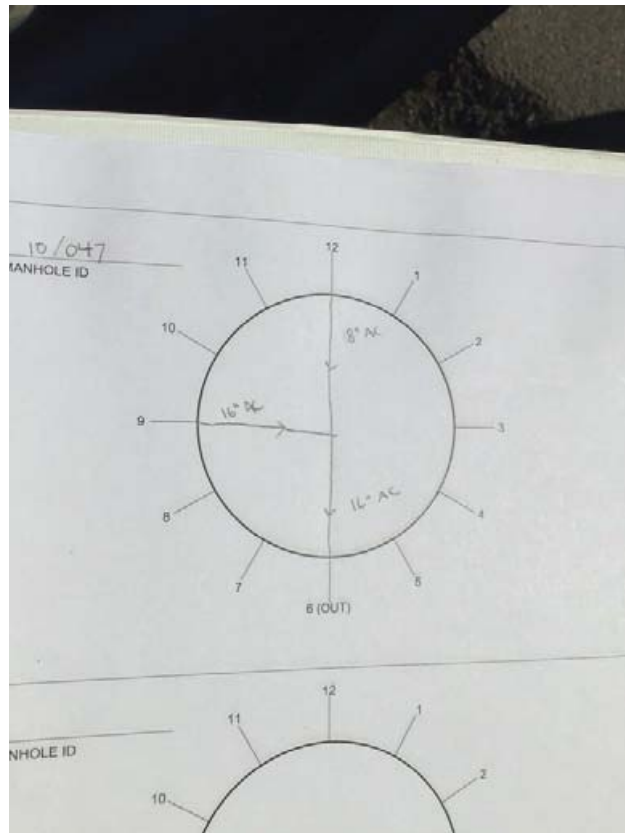
Manhole ID Number	10/047
Street	GAY ST
Address	14 Thatcher St Westwood, MA 02090
Surveyor	Bill Watts
Date	2018-11-30
Time	09:15
Rim to Invert	16.5
Inner Diameter	4
Material	Concrete
Cover Condition	Sound
Frame Condition	Broken

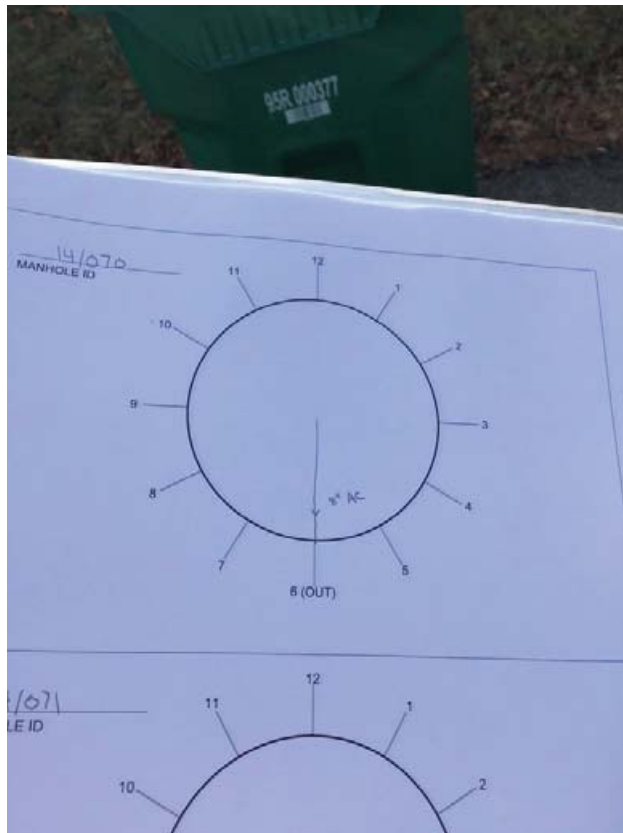
Manhole ID Number	14/070
Street	FISHER ST
Address	2-22 Fisher St Westwood, MA 02090
Surveyor	Bill Watts
Date	2018-11-28
Time	09:50
Rim to Invert	9.83
Inner Diameter	4
Material	Concrete
Cover Condition	Sound
Frame Condition	Cracked
