Manhole Inspection Reports

Manhole Inspection Report

July 2023

Westwood, MA

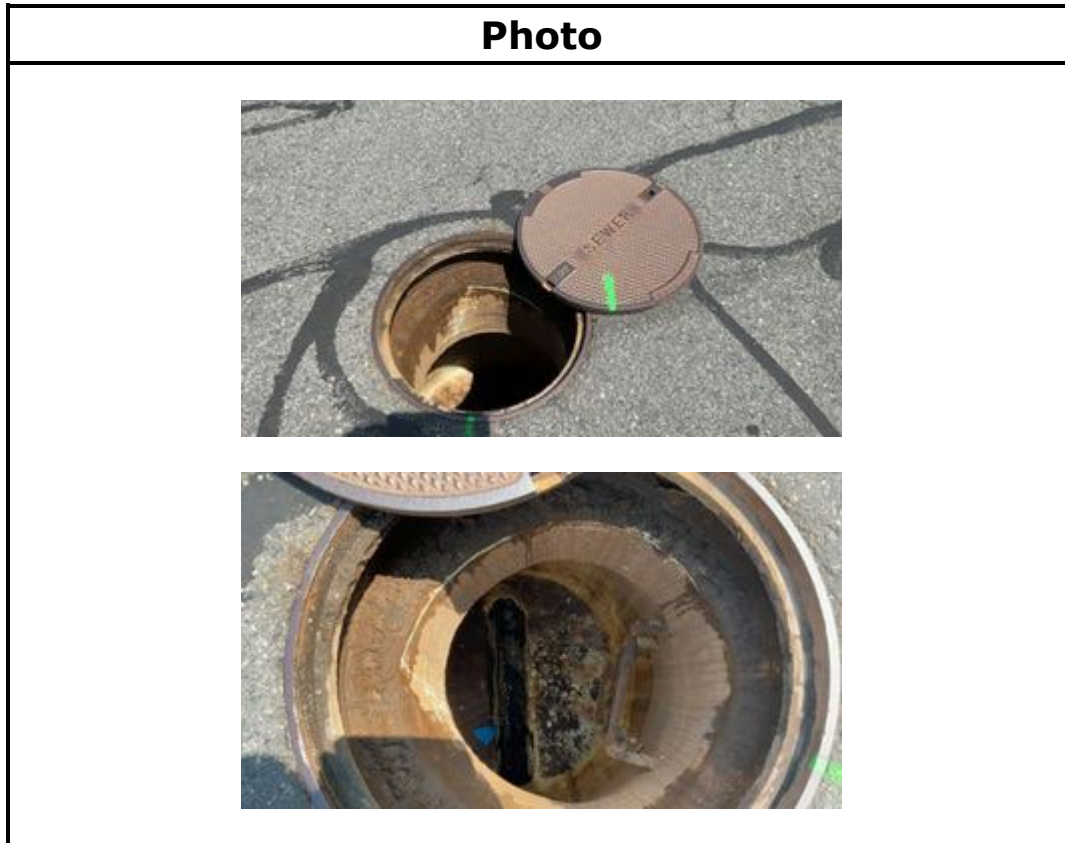
Westwood, MA Manhole Inspections Manhole ID: 15/051 Westwood, MA

Manhole Information			
Cover Material	Cast Iron	Holes In Cover	No
Cover Condition	Sound	Number of Holes	2
Cover Defects		Hole Size (inches)	0.75
Cover Size (inches)	24	Grade	At Grade
Clear Opening Diameter	22	Surface Materials	Paved
Drainage Area (sqft)	4	Cracked Pavement Surrounding Frame	No
Cover Comments	Blind flanged cover

Internal Manhole Observations						
Item	Material	Condition	Infiltration?	Infiltration (GPM)	Defects	Comments
Frame	Cast Iron	Sound	No			
Chimney	Lined	Sound	No			
Cone	Lined	Sound	No			
Walls	Lined	Sound	No			
Steps	Present? Yes	# of Steps: 4		Material: Metal		
Bench	Lined	Sound	No			
	Bench Debris Depth (Inches):			Bench Debris:		
Channel	Lined	Sound	No			
	Channel Debris Depth (Inches):			Channel Debris:		
Surcharge from Invert Evident? No				Currently:		Marks To:
Additional Comments:

Line Conditions												
In/Out	Compass Direction	Pipe Size	Pipe Material	Rim to Invert Depth	Condition	Flow Depth	Defects	Infiltration	Infiltration (GPM)	Debris	Debris Depth	Debris Material
Out	15/052	8"	Lined	7'7"	Sound	0.25"	No	No	N/A	No	N/A	N/A
In	15/050	8"	ACP	7'6"	Sound	0.25"	No	No	N/A	No	N/A	N/A
Additional Comments:

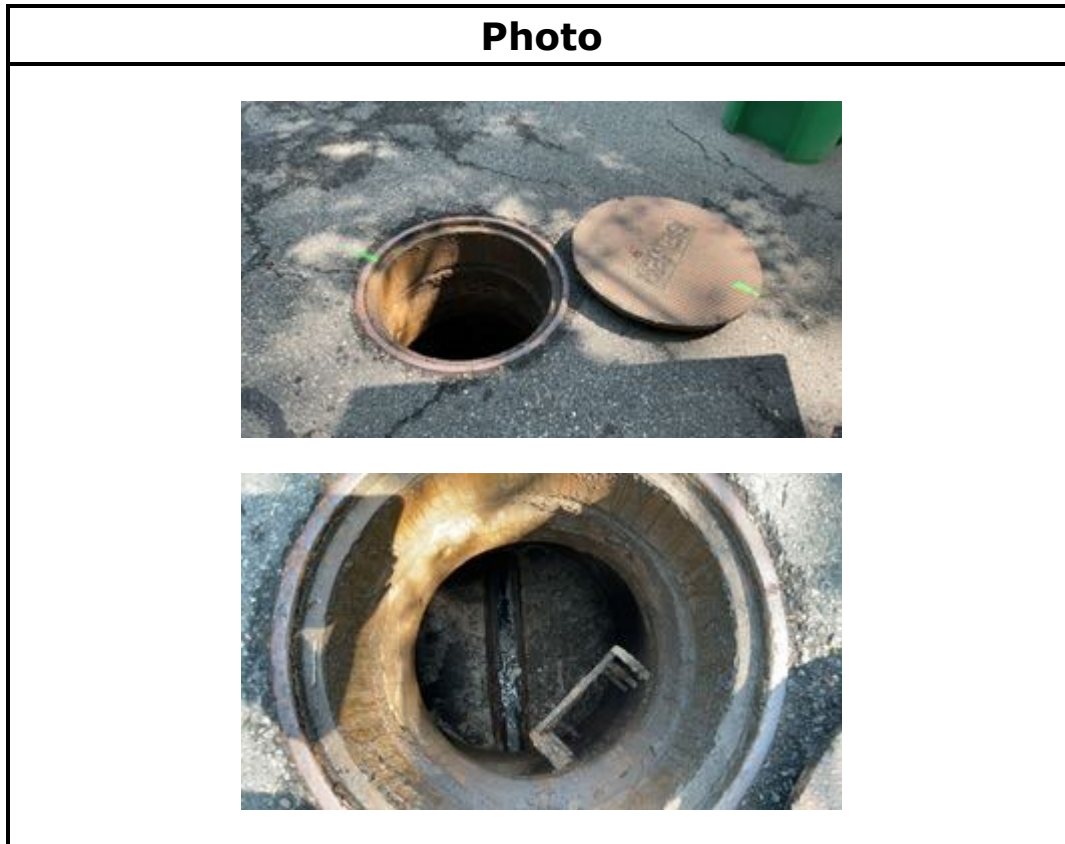
Westwood, MA Manhole Inspections Manhole ID: 15/038 Westwood, MA

Manhole Information			
Cover Material	Cast Iron	Holes In Cover	Yes
Cover Condition	Sound	Number of Holes	2
Cover Defects		Hole Size (inches)	0.75
Cover Size (inches)	26	Grade	At Grade
Clear Opening Diameter	24	Surface Materials	Paved
Drainage Area (sqft)	6	Cracked Pavement Surrounding Frame	Yes
Cover Comments

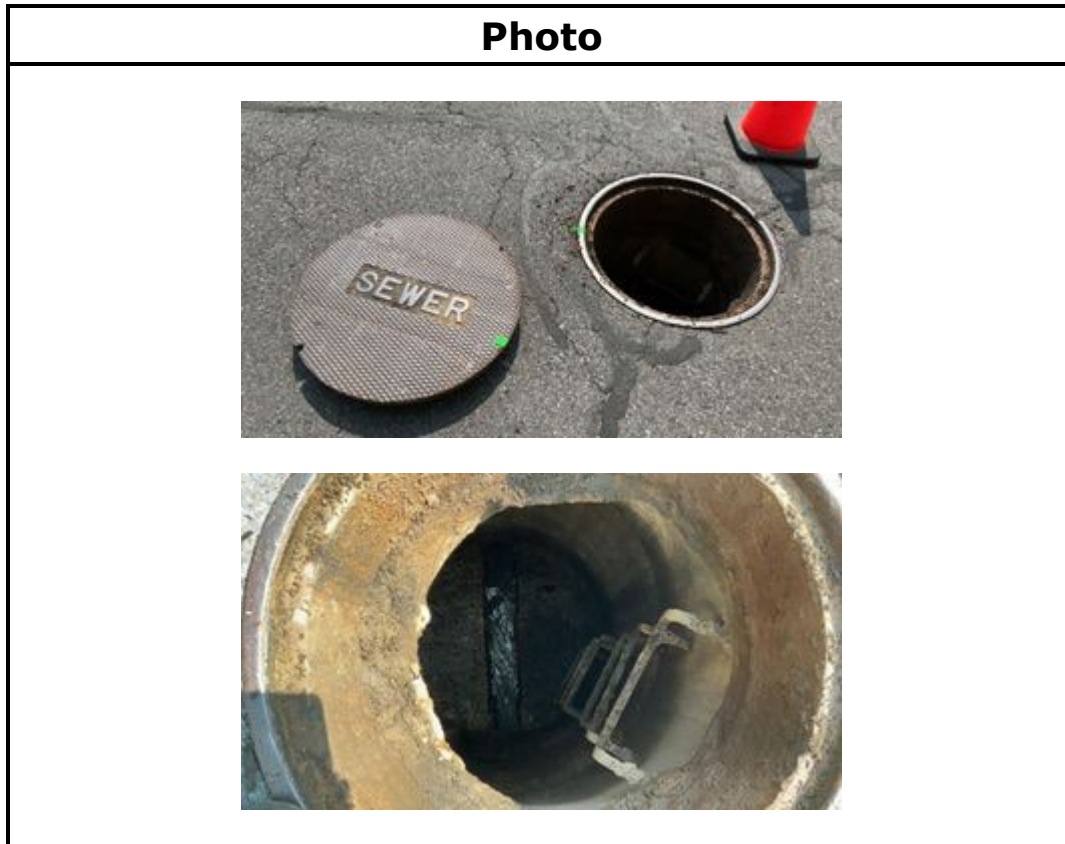
Westwood, MA Manhole Inspections Manhole ID: 15/025 Westwood, MA

Manhole Information			
Cover Material	Cast Iron	Holes In Cover	Yes
Cover Condition	Sound	Number of Holes	2
Cover Defects		Hole Size (inches)	0.75
Cover Size (inches)	26	Grade	At Grade
Clear Opening Diameter	24	Surface Materials	Paved
Drainage Area (sqft)	4	Cracked Pavement Surrounding Frame	Yes
Cover Comments

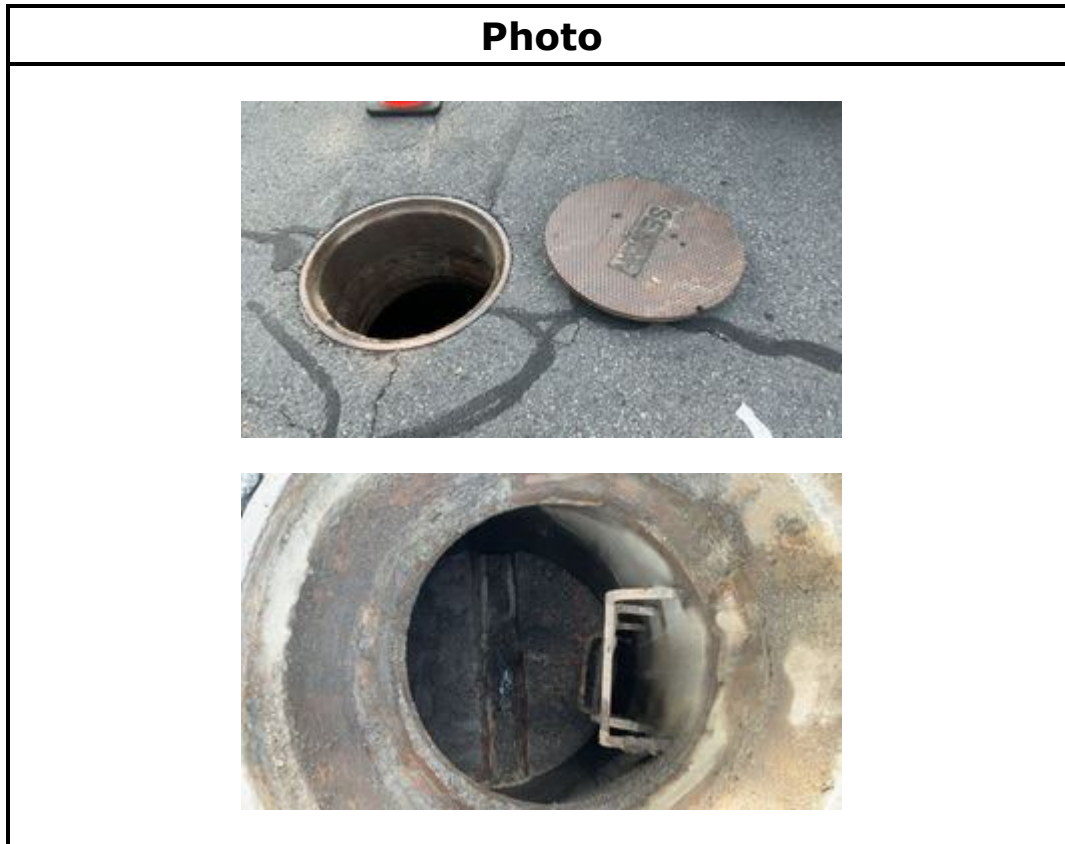
Westwood, MA Manhole Inspections Manhole ID: 15/027 Westwood, MA

Manhole Information			
Cover Material	Cast Iron	Holes In Cover	Yes
Cover Condition	Sound	Number of Holes	2
Cover Defects		Hole Size (inches)	0.5
Cover Size (inches)	26	Grade	At Grade
Clear Opening Diameter	24	Surface Materials	Paved
Drainage Area (sqft)	4	Cracked Pavement Surrounding Frame	Yes
Cover Comments

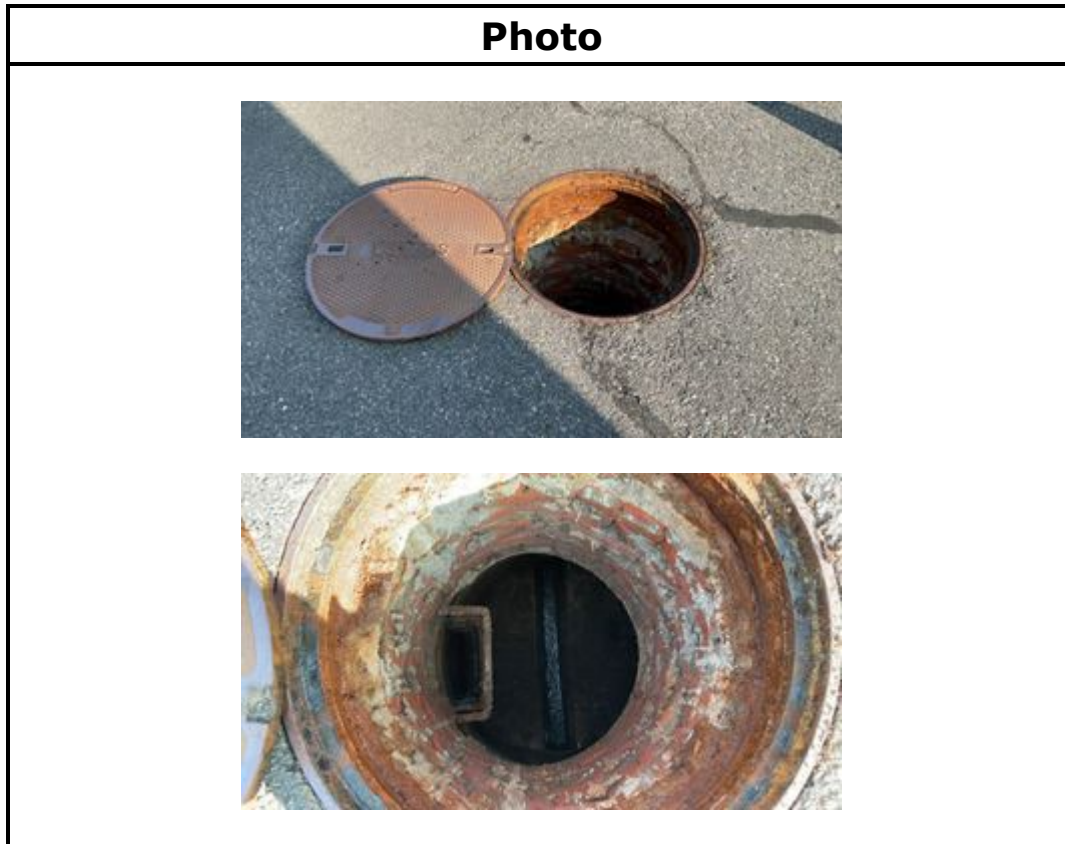
Westwood, MA Manhole Inspections
Manhole ID: 15/023
Westwood, MA

Manhole Information			
Cover Material	Cast Iron	Holes In Cover	No
Cover Condition	Sound	Number of Holes	2
Cover Defects		Hole Size (inches)	0.75
Cover Size (inches)	24	Grade	At Grade
Clear Opening Diameter	22	Surface Materials	Paved
Drainage Area (sqft)	4	Cracked Pavement Surrounding Frame	Yes
Cover Comments	Blind Flange Cover

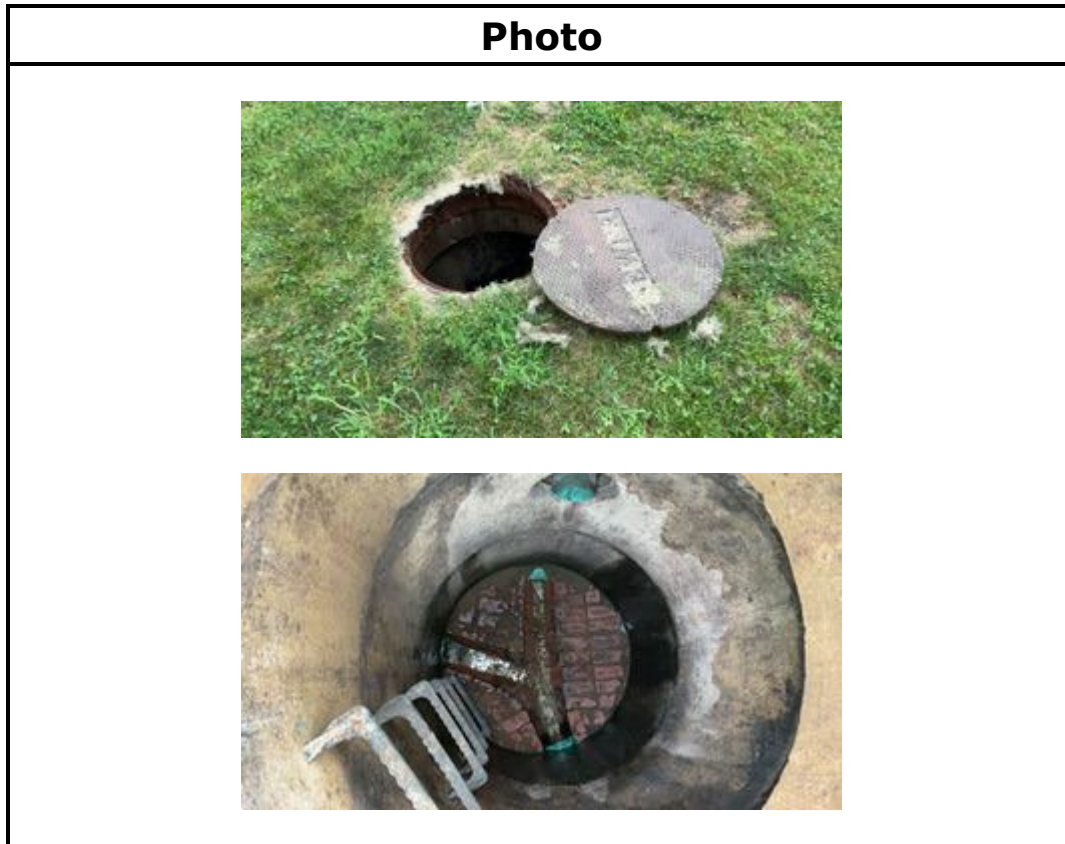
Westwood, MA Manhole Inspections
Manhole ID: 15/111
Westwood, MA

Manhole Information			
Cover Material	Cast Iron	Holes In Cover	Yes
Cover Condition	Sound	Number of Holes	2
Cover Defects		Hole Size (inches)	0.75
Cover Size (inches)	26	Grade	At Grade
Clear Opening Diameter	24	Surface Materials	Grass
Drainage Area (sqft)	4	Cracked Pavement Surrounding Frame	No
Cover Comments

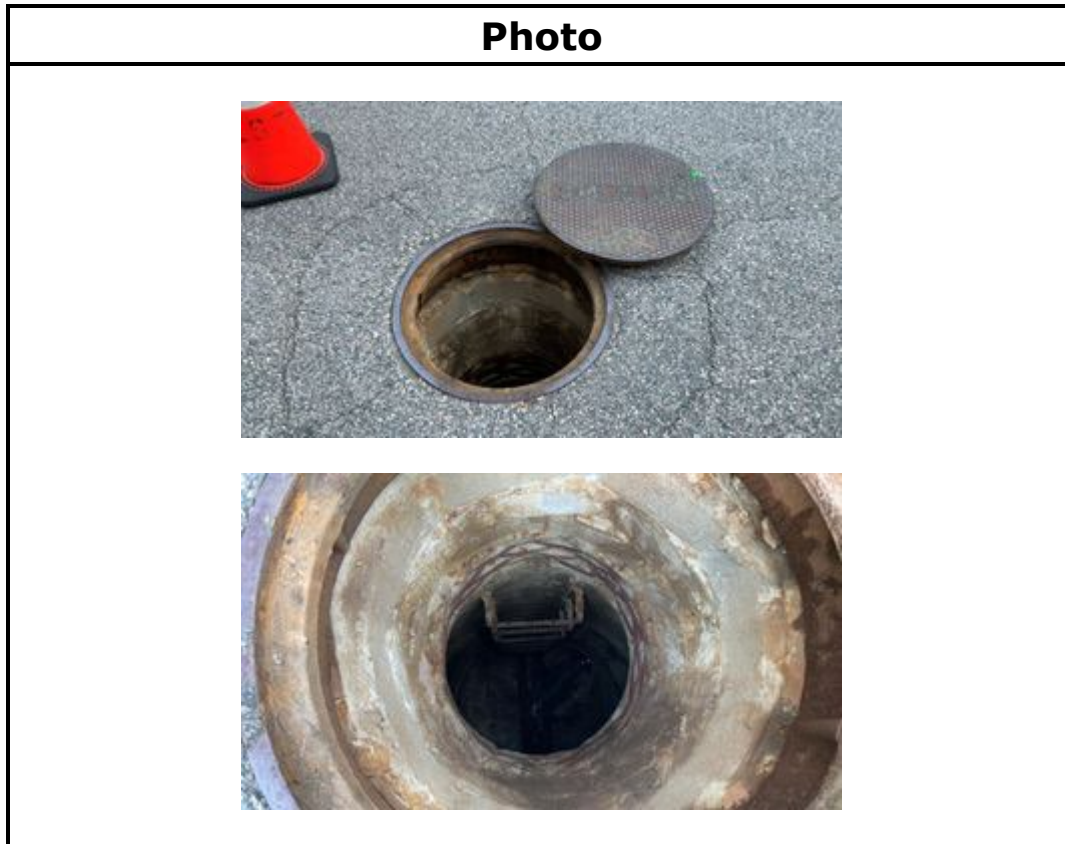
Westwood, MA Manhole Inspections
Manhole ID: 15/072
Westwood, MA

Manhole Information			
Cover Material	Cast Iron	Holes In Cover	No
Cover Condition	Sound	Number of Holes	
Cover Defects		Hole Size (inches)	
Cover Size (inches)	24	Grade	At Grade
Clear Opening Diameter	22	Surface Materials	Paved
Drainage Area (sqft)	4	Cracked Pavement Surrounding Frame	Yes
Cover Comments

Internal Manhole Observations						
Item	Material	Condition	Infiltration?	Infiltration (GPM)	Defects	Comments
Frame	Cast Iron	Sound	No			
Chimney	Brick, Block, Parged	Sound	No			
Cone	Precast	Defective	No		Lift holes missing mortar	
Walls	Precast, Parged	Sound	No			
Steps	Present? Yes	# of Steps: 7		Material: Metal		
Bench	Brick, Parged	Sound	No			
	Bench Debris Depth (Inches):			Bench Debris:		
Channel	Brick	Sound	No			
	Channel Debris Depth (Inches): 0.5			Channel Debris: Sanitary		
Surcharge from Invert Evident? No				Currently:	Marks To:	
Additional Comments:

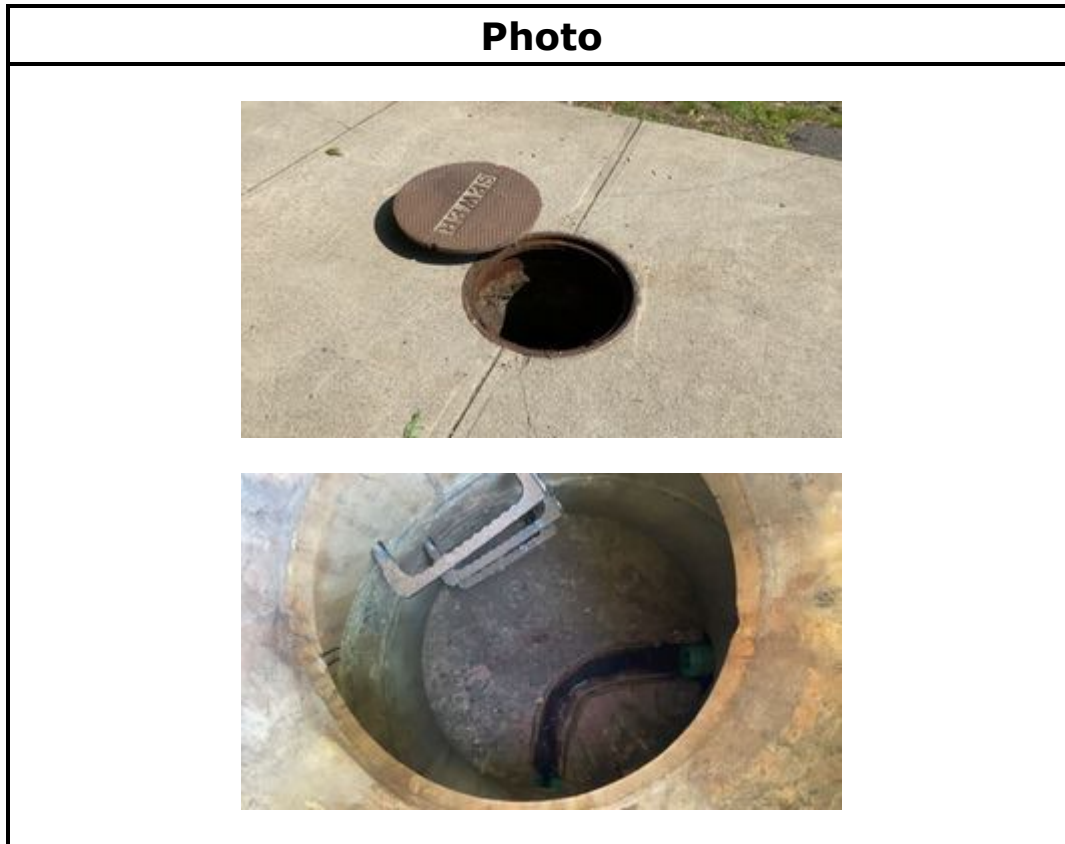
Westwood, MA Manhole Inspections
Manhole ID: 15/114
Westwood, MA

Manhole Information			
Cover Material	Cast Iron	Holes In Cover	Yes
Cover Condition	Sound	Number of Holes	2
Cover Defects		Hole Size (inches)	0.75
Cover Size (inches)	26	Grade	At Grade
Clear Opening Diameter	24	Surface Materials	Paved
Drainage Area (sqft)	4	Cracked Pavement Surrounding Frame	No
Cover Comments

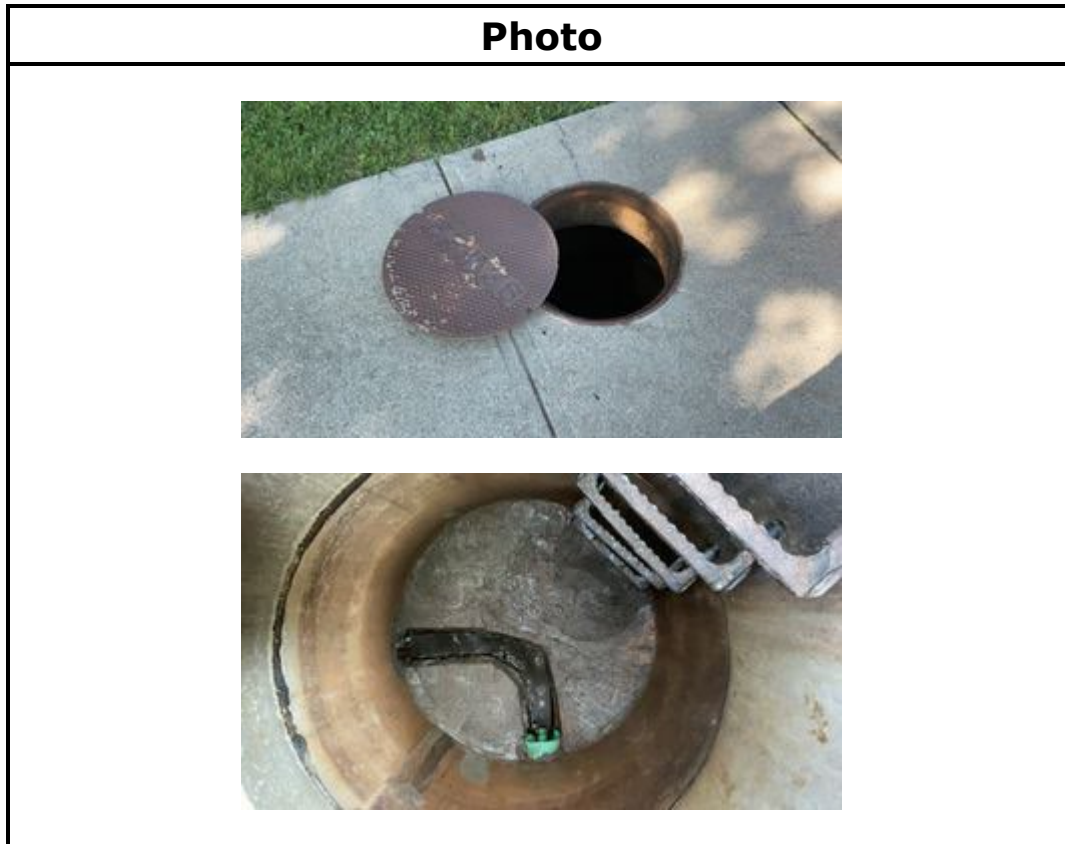
Westwood, MA Manhole Inspections
Manhole ID: 15/115
Westwood, MA

Manhole Information			
Cover Material	Cast Iron	Holes In Cover	Yes
Cover Condition	Sound	Number of Holes	2
Cover Defects		Hole Size (inches)	0.75
Cover Size (inches)	24	Grade	At Grade
Clear Opening Diameter	22	Surface Materials	Paved
Drainage Area (sqft)	4	Cracked Pavement Surrounding Frame	No
Cover Comments

Internal Manhole Observations						
Item	Material	Condition	Infiltration?	Infiltration (GPM)	Defects	Comments
Frame	Cast Iron	Sound	No			
Chimney	Precast	Sound	No			
Cone		None	No			
Walls	Precast	Defective	No		Lift holes missing mortar, IS	
Steps	Present? Yes	# of Steps: 5		Material: Plastic		
Bench	Parged	Sound	No			
	Bench Debris Depth (Inches):			Bench Debris:		
Channel	Brick, Parged	Sound	No			
	Channel Debris Depth (Inches):			Channel Debris:		
Surcharge from Invert Evident? No				Currently:	Marks To:	
Additional Comments:

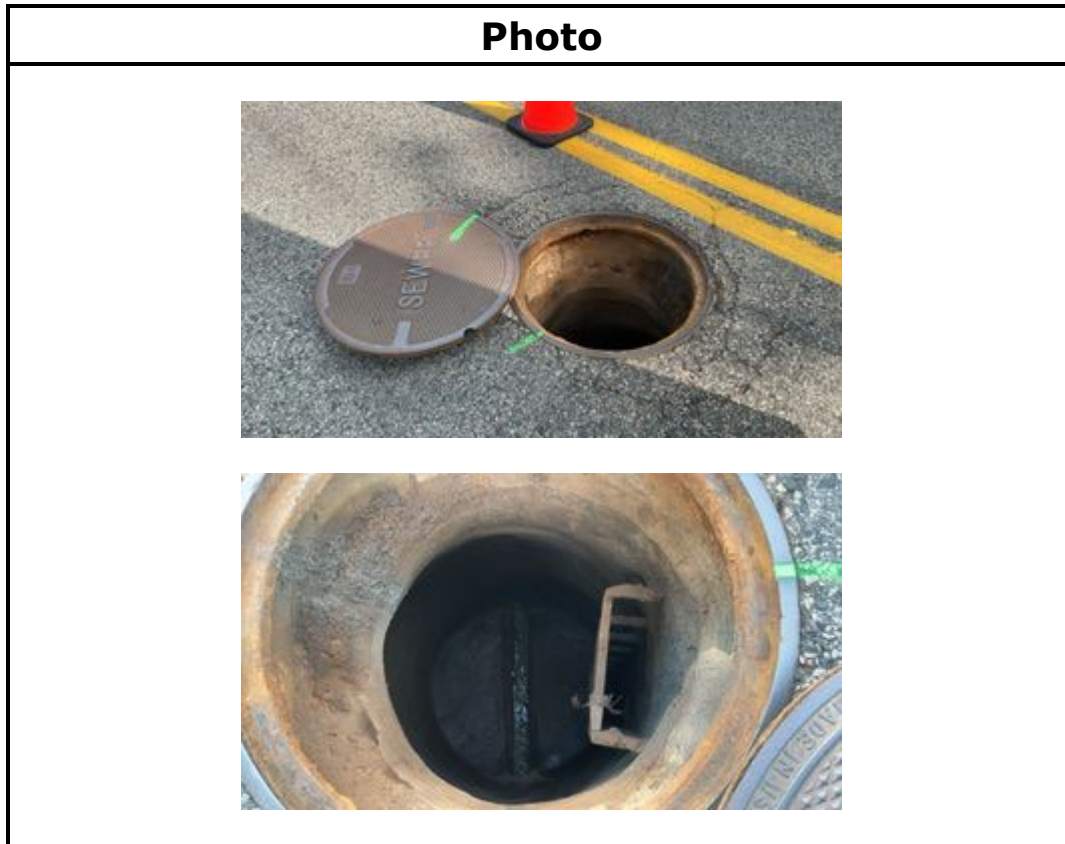
Westwood, MA Manhole Inspections
Manhole ID: 15/009
Westwood, MA

Manhole Information			
Cover Material	Cast Iron	Holes In Cover	Yes
Cover Condition	Sound	Number of Holes	2
Cover Defects		Hole Size (inches)	0.75
Cover Size (inches)	26	Grade	At Grade
Clear Opening Diameter	24	Surface Materials	Paved
Drainage Area (sqft)	4	Cracked Pavement Surrounding Frame	Yes
Cover Comments

Internal Manhole Observations						
Item	Material	Condition	Infiltration?	Infiltration (GPM)	Defects	Comments
Frame	Cast Iron	Defective	No		Chipped	
Chimney	Parged	Sound	No			
Cone	Parged	Sound	No			
Walls	Parged	Sound	No			
Steps	Present? Yes	# of Steps: 7		Material: Metal		
Bench	Parged	Sound	No			
	Bench Debris Depth (Inches):			Bench Debris:		
Channel	ACP	Sound	No			
	Channel Debris Depth (Inches):			Channel Debris:		
Surcharge from Invert Evident? No				Currently:	Marks To:	
Additional Comments:

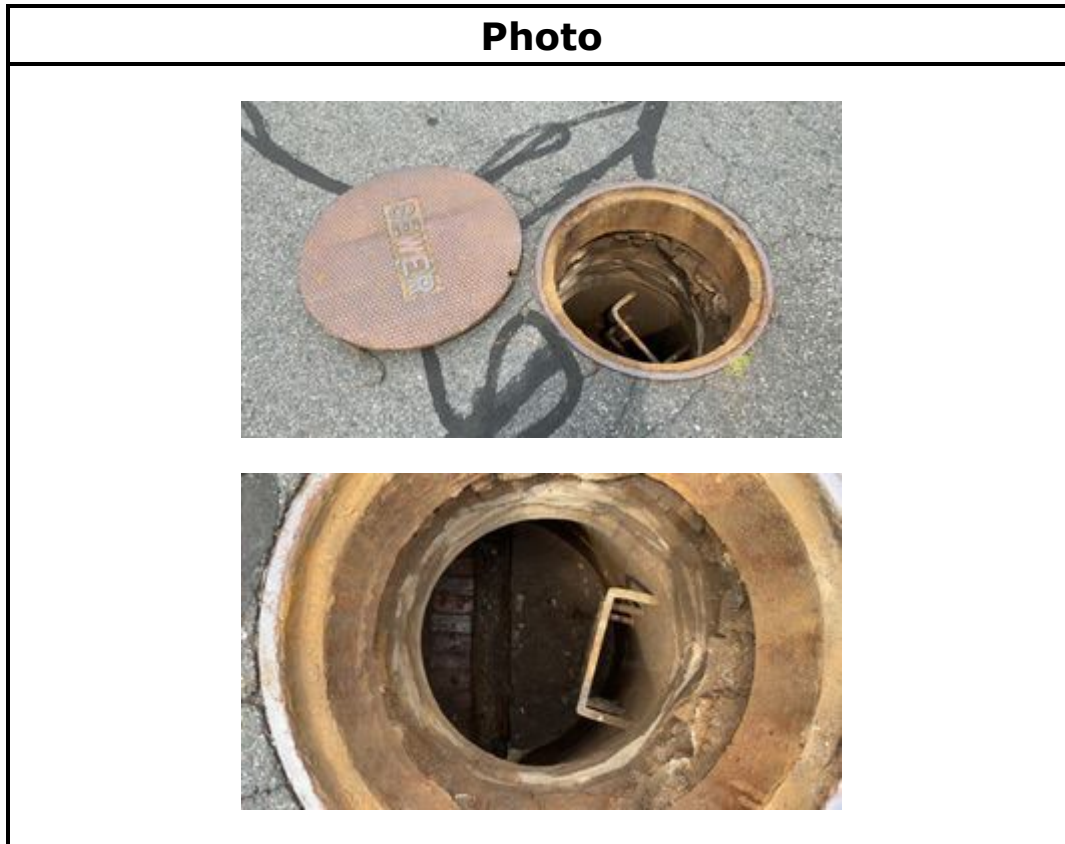
Westwood, MA Manhole Inspections
Manhole ID: 15/028
Westwood, MA

Manhole Information			
Cover Material	Cast Iron	Holes In Cover	Yes
Cover Condition	Sound	Number of Holes	2
Cover Defects		Hole Size (inches)	0.75
Cover Size (inches)	26	Grade	At Grade
Clear Opening Diameter	24	Surface Materials	Paved
Drainage Area (sqft)	4	Cracked Pavement Surrounding Frame	Yes
Cover Comments

Internal Manhole Observations						
Item	Material	Condition	Infiltration?	Infiltration (GPM)	Defects	Comments
Frame	Cast Iron	Sound	No			
Chimney	Brick, Precast	Sound	No			
Cone	Precast	Sound	No			
Walls	Precast	Sound	No			
Steps	Present? Yes	# of Steps: 3		Material: Metal		
Bench	Brick	Sound	No			
	Bench Debris Depth (Inches): 1.5			Bench Debris: Sediment		
Channel	Brick	Sound	No			
	Channel Debris Depth (Inches): 0.5			Channel Debris: Sediment		
Surcharge from Invert Evident? No				Currently:	Marks To:	
Additional Comments:

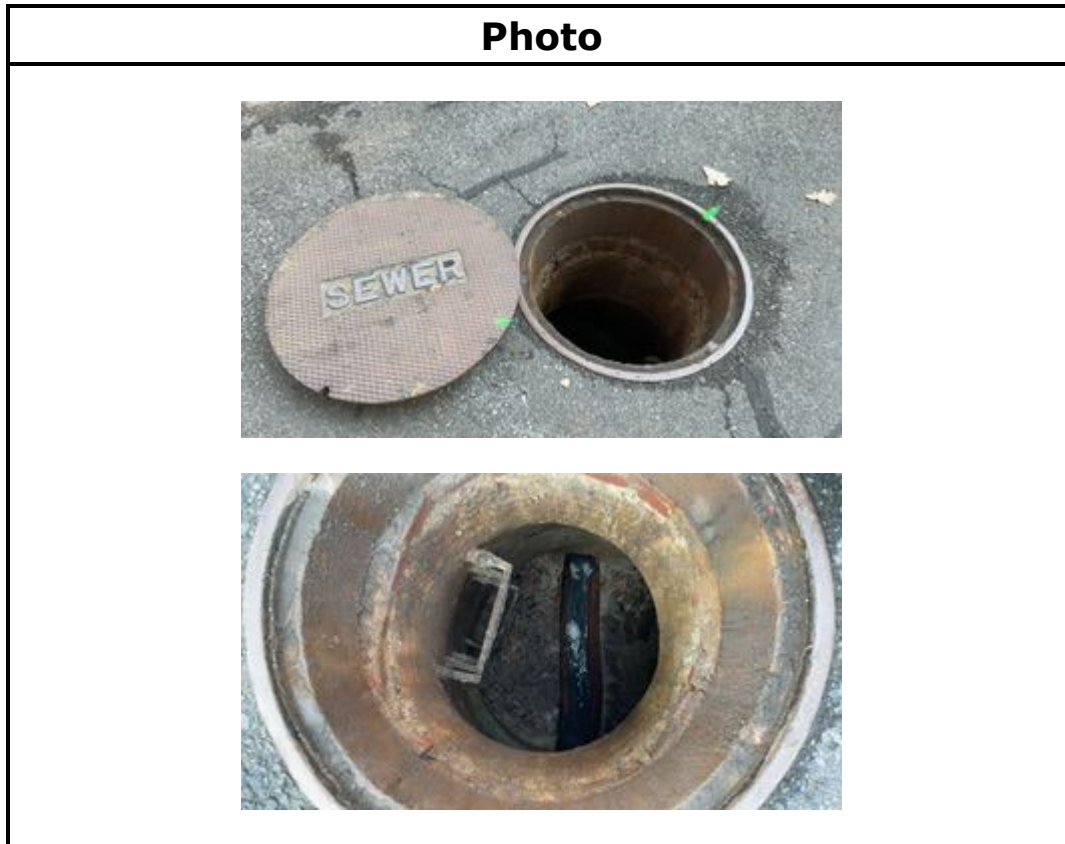
Westwood, MA Manhole Inspections Manhole ID: 15/017 Westwood, MA

Manhole Information			
Cover Material	Cast Iron	Holes In Cover	Yes
Cover Condition	Sound	Number of Holes	2
Cover Defects		Hole Size (inches)	0.75
Cover Size (inches)	26	Grade	At Grade
Clear Opening Diameter	24	Surface Materials	Paved
Drainage Area (sqft)	4	Cracked Pavement Surrounding Frame	Yes
Cover Comments

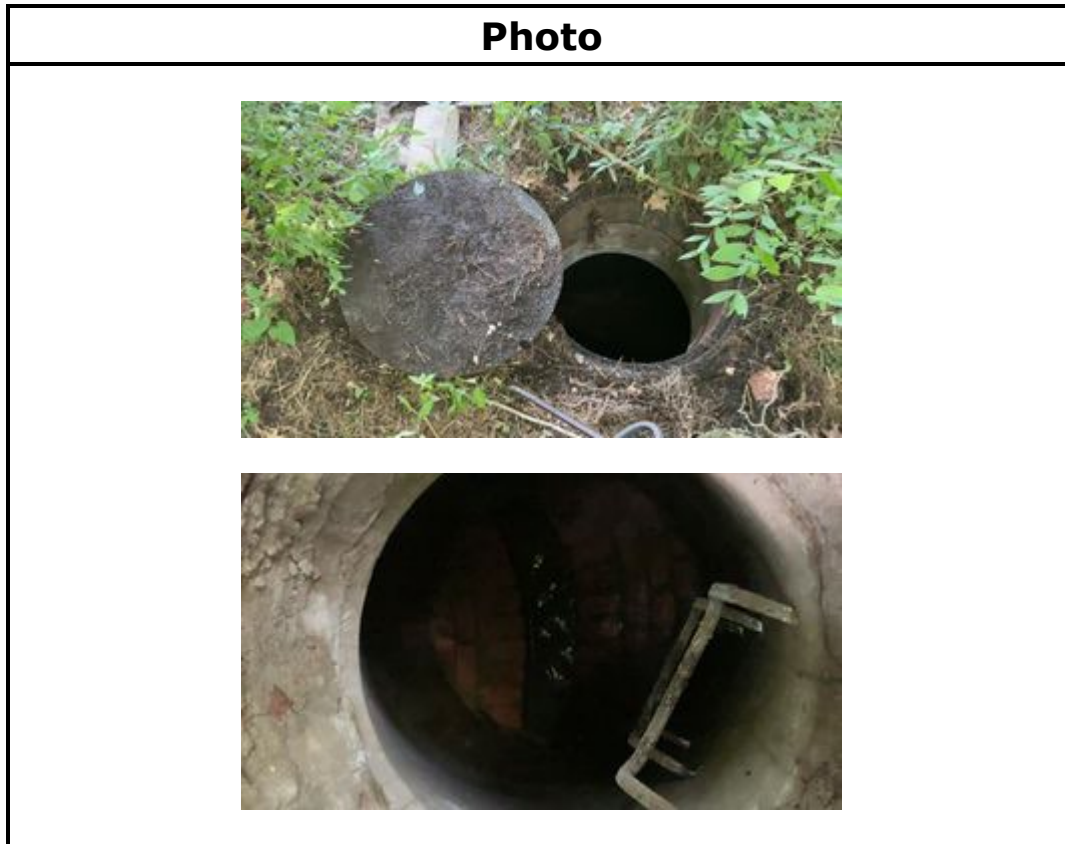
Westwood, MA Manhole Inspections Manhole ID: 15/060 Westwood, MA

Manhole Information			
Cover Material	Cast Iron	Holes In Cover	Yes
Cover Condition	Sound	Number of Holes	2
Cover Defects		Hole Size (inches)	0.75
Cover Size (inches)	26	Grade	Below Grade
Clear Opening Diameter	24	Surface Materials	Dirt
Drainage Area (sqft)	10	Cracked Pavement Surrounding Frame	No
Cover Comments

Internal Manhole Observations						
Item	Material	Condition	Infiltration?	Infiltration (GPM)	Defects	Comments
Frame	Cast Iron	Sound	No			
Chimney	Brick, Parged	Sound	No			
Cone	Precast	Defective	No		Lift holes missing mortar	
Walls	Precast	Sound	No			
Steps	Present? Yes	# of Steps: 4		Material: Metal		
Bench	Brick	Sound	No			
	Bench Debris Depth (Inches):			Bench Debris:		
Channel	Brick	Sound	No			
	Channel Debris Depth (Inches):			Channel Debris:		
Surcharge from Invert Evident? No				Currently:	Marks To:	
Additional Comments:

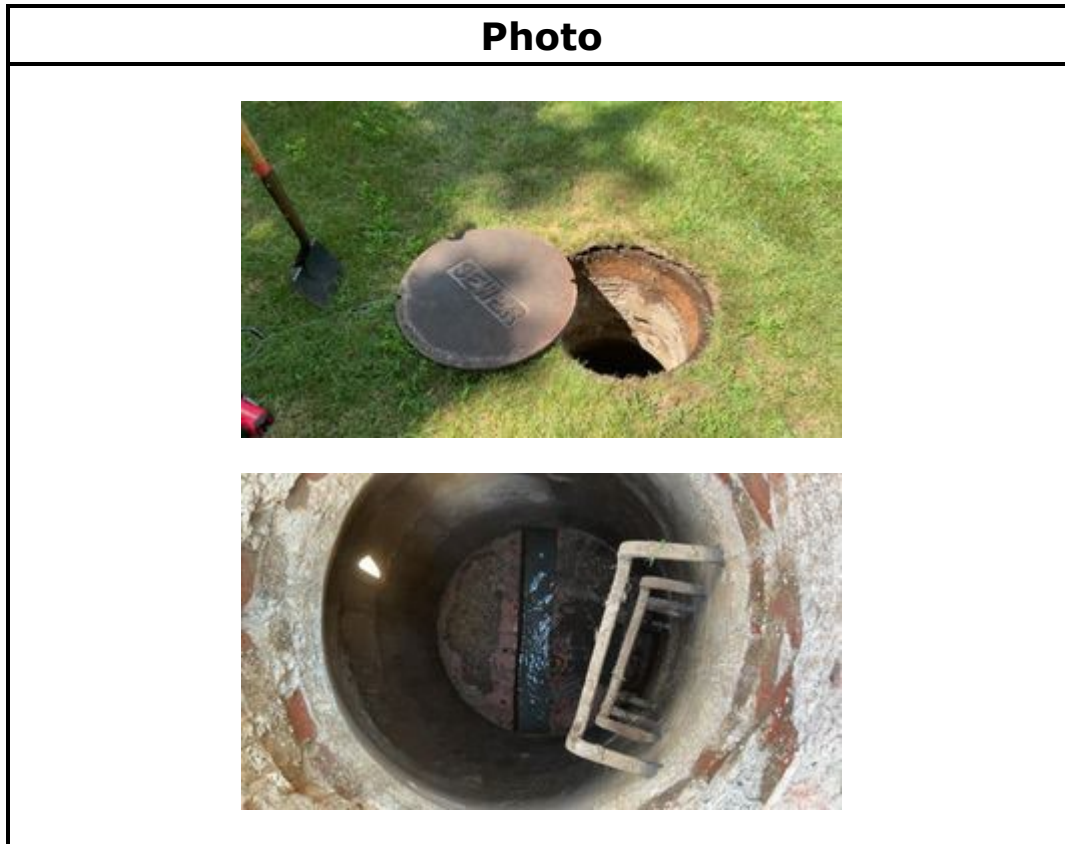
Westwood, MA Manhole Inspections
Manhole ID: 15/092
Westwood, MA

Manhole Information			
Cover Material	Cast Iron	Holes In Cover	Yes
Cover Condition	Sound	Number of Holes	2
Cover Defects		Hole Size (inches)	0.75
Cover Size (inches)	26	Grade	Below Grade
Clear Opening Diameter	24	Surface Materials	Grass
Drainage Area (sqft)	10	Cracked Pavement Surrounding Frame	No
Cover Comments

Internal Manhole Observations						
Item	Material	Condition	Infiltration?	Infiltration (GPM)	Defects	Comments
Frame	Cast Iron	Defective	No		SCP	
Chimney	Brick, Parged	Sound	No			
Cone	Precast	Defective	No		Lift holes missing mortar	
Walls	Precast	Sound	No			
Steps	Present? Yes	# of Steps: 6		Material: Metal		
Bench	Brick	Sound	No			
	Bench Debris Depth (Inches): 1			Bench Debris: Sediment		
Channel	Brick	Sound	No			
	Channel Debris Depth (Inches):			Channel Debris:		
Surcharge from Invert Evident? No				Currently:	Marks To:	
Additional Comments:

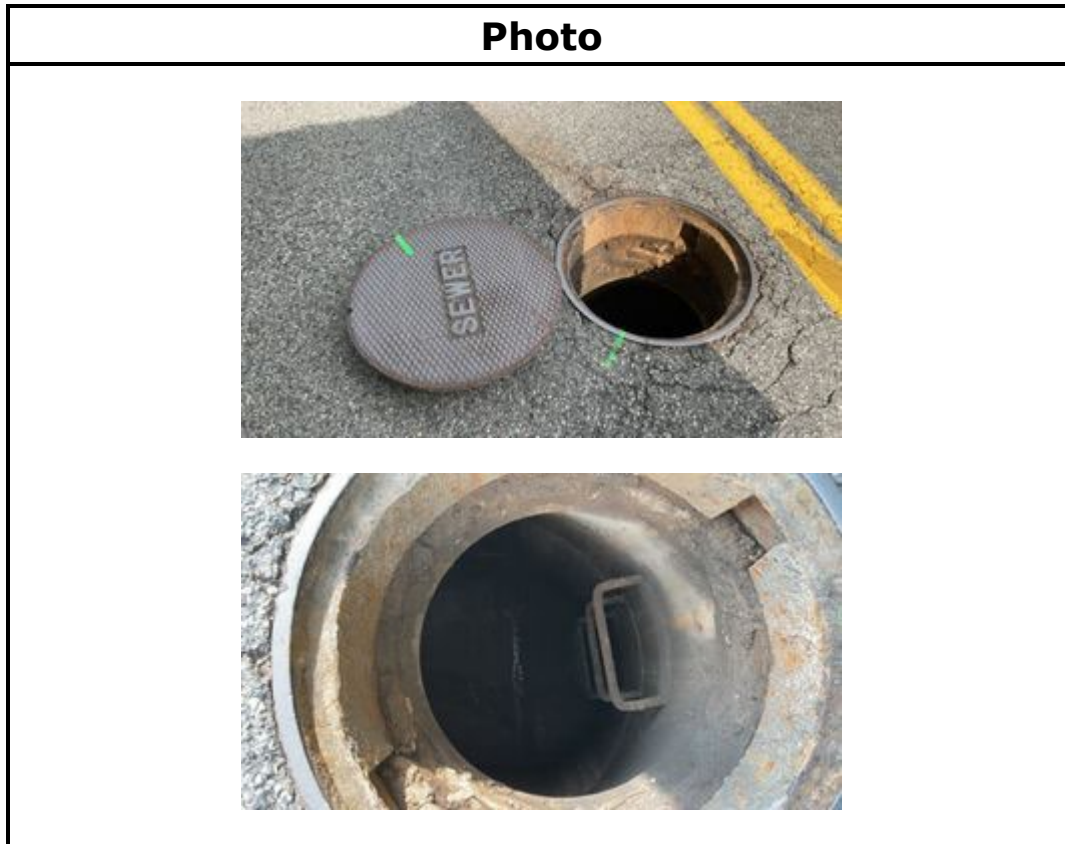
Westwood, MA Manhole Inspections
Manhole ID: 15/009A
Westwood, MA

Manhole Information			
Cover Material	Cast Iron	Holes In Cover	Yes
Cover Condition	Sound	Number of Holes	2
Cover Defects		Hole Size (inches)	0.75
Cover Size (inches)	26	Grade	At Grade
Clear Opening Diameter	24	Surface Materials	Paved
Drainage Area (sqft)	4	Cracked Pavement Surrounding Frame	Yes
Cover Comments

Internal Manhole Observations						
Item	Material	Condition	Infiltration?	Infiltration (GPM)	Defects	Comments
Frame	Cast Iron	Sound	No			
Chimney	Brick	Sound	No			
Cone	Precast	Sound	No			
Walls	Precast	Sound	No			
Steps	Present? Yes	# of Steps: 5		Material: Metal		
Bench	Brick	Sound	No			
	Bench Debris Depth (Inches):			Bench Debris:		
Channel	ACP	Sound	No			
	Channel Debris Depth (Inches):			Channel Debris:		
Surcharge from Invert Evident? No				Currently:	Marks To:	
Additional Comments: Additional MH, not on map. Appears to look like SMH 15/010

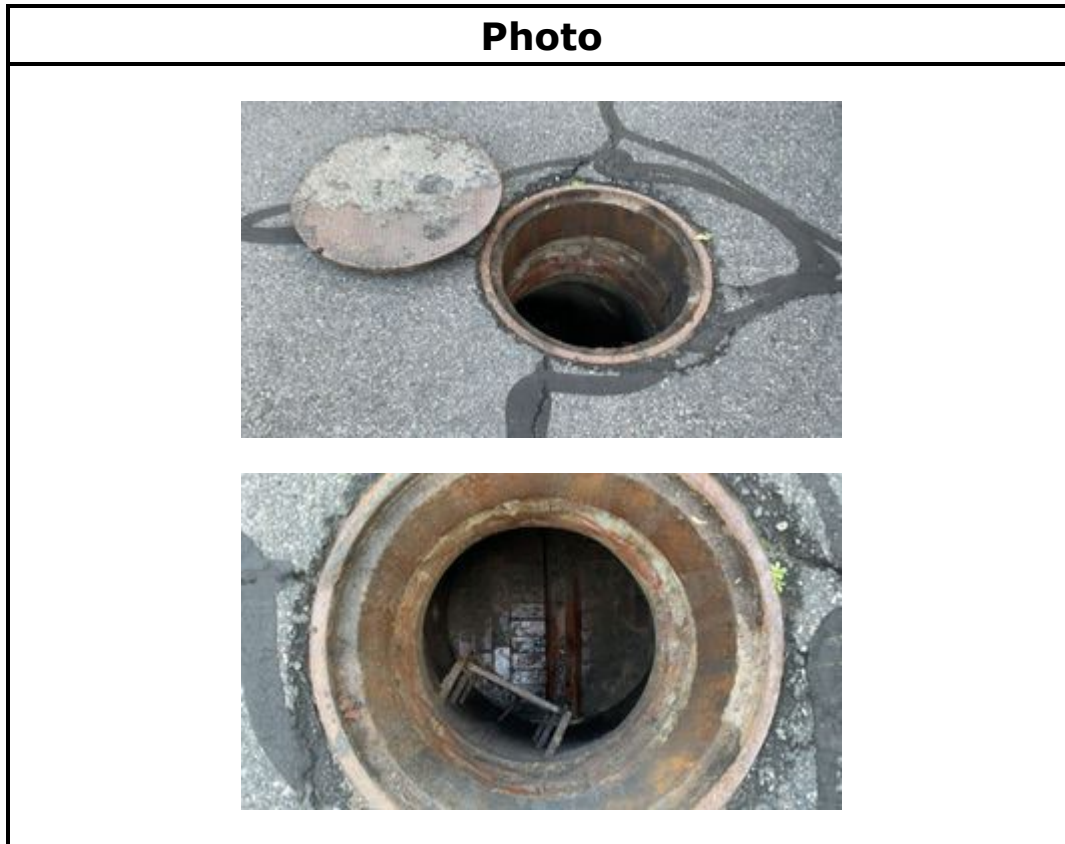
Westwood, MA Manhole Inspections
Manhole ID: 15/020
Westwood, MA

Manhole Information			
Cover Material	Cast Iron	Holes In Cover	Yes
Cover Condition	Sound	Number of Holes	2
Cover Defects		Hole Size (inches)	0.75
Cover Size (inches)	26	Grade	At Grade
Clear Opening Diameter	24	Surface Materials	Paved
Drainage Area (sqft)	8	Cracked Pavement Surrounding Frame	Yes
Cover Comments

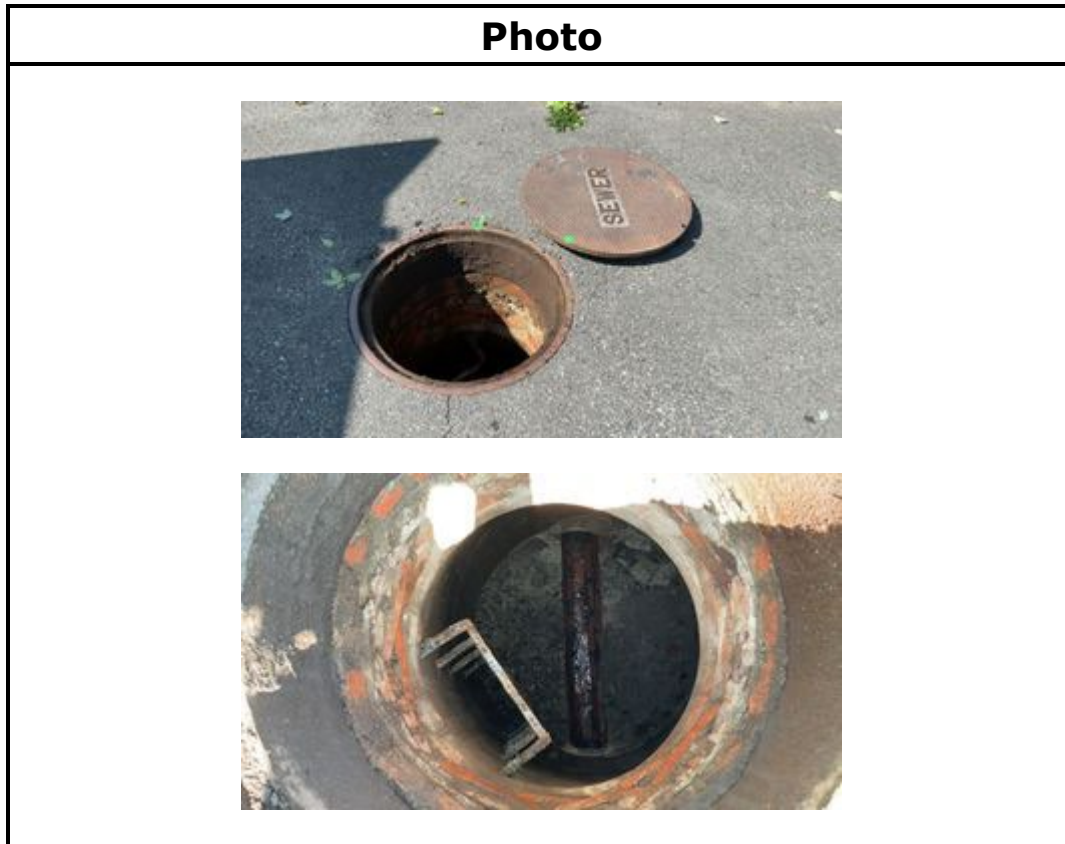
Westwood, MA Manhole Inspections
Manhole ID: 15/047
Westwood, MA

Manhole Information			
Cover Material	Cast Iron	Holes In Cover	Yes
Cover Condition	Sound	Number of Holes	2
Cover Defects		Hole Size (inches)	0.75
Cover Size (inches)	26	Grade	At Grade
Clear Opening Diameter	24	Surface Materials	Paved
Drainage Area (sqft)	4	Cracked Pavement Surrounding Frame	No
Cover Comments

Internal Manhole Observations						
Item	Material	Condition	Infiltration?	Infiltration (GPM)	Defects	Comments
Frame	Cast Iron	Sound	No			
Chimney	Brick, Parged	Sound	No			
Cone	Precast	Defective	No		Lift holes missing mortar	
Walls	Precast	Defective	No		SRV	
Steps	Present? Yes	# of Steps: 4		Material: Metal		
Bench	Parged	Sound	No			
	Bench Debris Depth (Inches): 0.5			Bench Debris: Sediment		
Channel	Brick	Sound	No			
	Channel Debris Depth (Inches):			Channel Debris:		
Surcharge from Invert Evident? No				Currently:		Marks To:
Additional Comments:

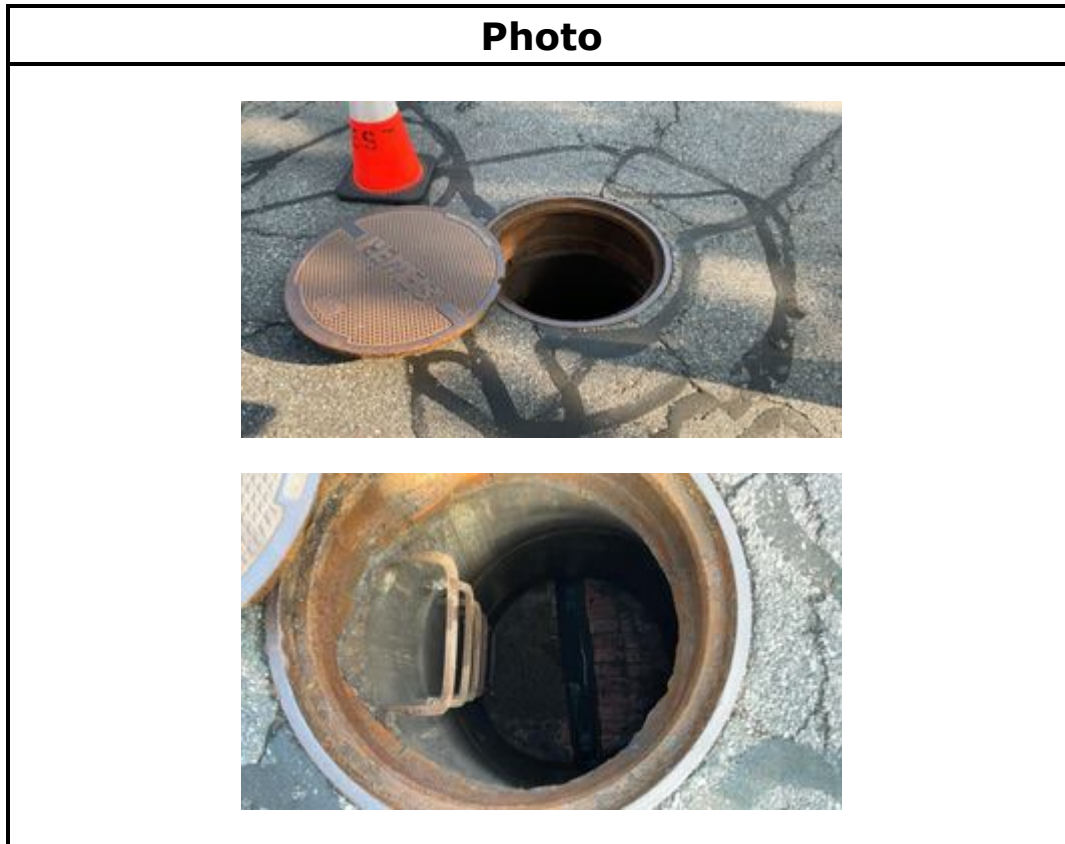
Westwood, MA Manhole Inspections
Manhole ID: 15/022
Westwood, MA

Manhole Information			
Cover Material	Cast Iron	Holes In Cover	Yes
Cover Condition	Sound	Number of Holes	2
Cover Defects		Hole Size (inches)	0.75
Cover Size (inches)	26	Grade	At Grade
Clear Opening Diameter	24	Surface Materials	Paved
Drainage Area (sqft)	4	Cracked Pavement Surrounding Frame	Yes
Cover Comments

Internal Manhole Observations						
Item	Material	Condition	Infiltration?	Infiltration (GPM)	Defects	Comments
Frame	Cast Iron	Sound	No			
Chimney	Brick, Precast	Sound	No			
Cone	Precast	Sound	No			
Walls	Precast	Sound	No			
Steps	Present? Yes	# of Steps: 6		Material: Metal		
Bench	Brick	Sound	No			
	Bench Debris Depth (Inches): 0.25			Bench Debris: Sediment		
Channel	Brick	Sound	No			
	Channel Debris Depth (Inches):			Channel Debris:		
Surcharge from Invert Evident? No				Currently:		Marks To:
Additional Comments:

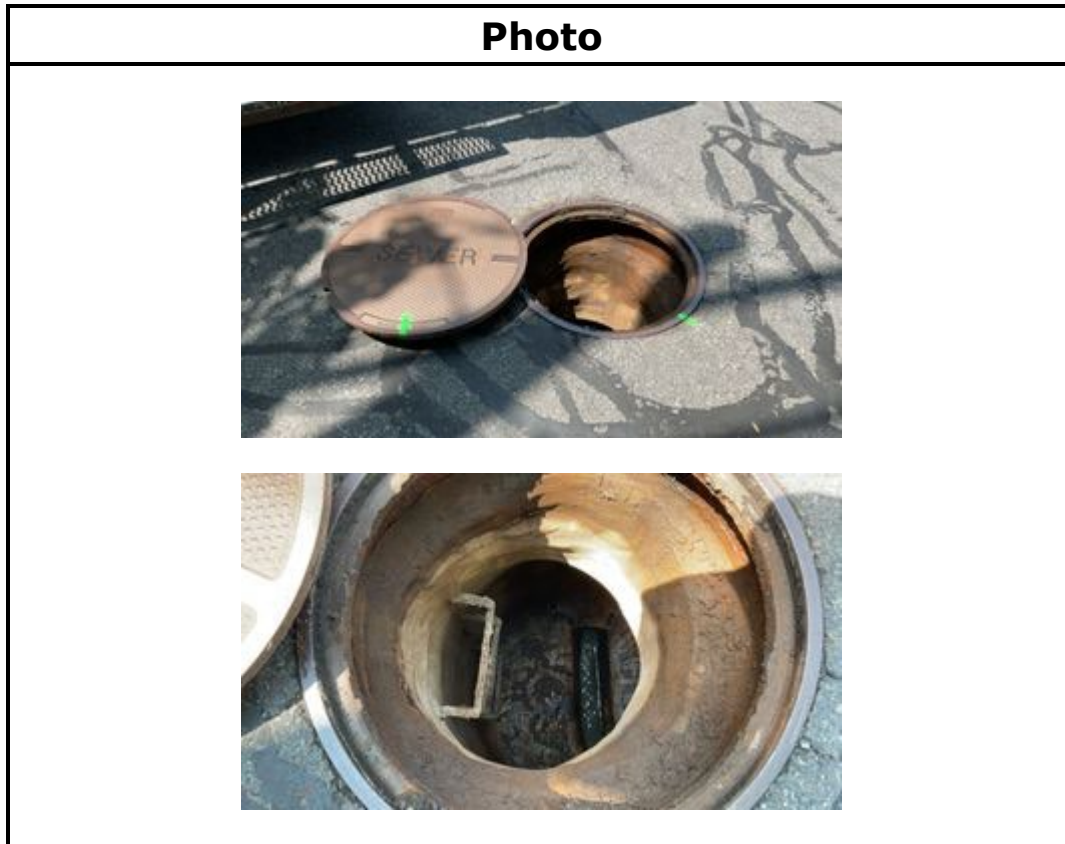
Westwood, MA Manhole Inspections
Manhole ID: 15/053
Westwood, MA

Manhole Information			
Cover Material	Cast Iron	Holes In Cover	Yes
Cover Condition	Sound	Number of Holes	2
Cover Defects		Hole Size (inches)	0.75
Cover Size (inches)	26	Grade	At Grade
Clear Opening Diameter	24	Surface Materials	Paved
Drainage Area (sqft)	4	Cracked Pavement Surrounding Frame	No
Cover Comments

Internal Manhole Observations						
Item	Material	Condition	Infiltration?	Infiltration (GPM)	Defects	Comments
Frame	Cast Iron	Sound	No			
Chimney	Parged	Sound	No			
Cone	Parged	Sound	No			
Walls	Parged	Sound	No			
Steps	Present? Yes	# of Steps: 4		Material: Metal		
Bench	Parged	Sound	No			
	Bench Debris Depth (Inches):			Bench Debris:		
Channel	Parged	Sound	No			
	Channel Debris Depth (Inches):			Channel Debris:		
Surcharge from Invert Evident? No				Currently:	Marks To:	
Additional Comments:

Line Conditions												
In/Out	Compass Direction	Pipe Size	Pipe Material	Rim to Invert Depth	Condition	Flow Depth	Defects	Infiltration	Infiltration (GPM)	Debris	Debris Depth	Debris Material
Out	15/054	8"	Lined	7'10:	Sound	0.75"	No	No	N/A	No	N/A	N/A
In	15/052	8"	Lined	7'9"	Sound	0.75"	No	No	N/A	No	N/A	N/A
Additional Comments:

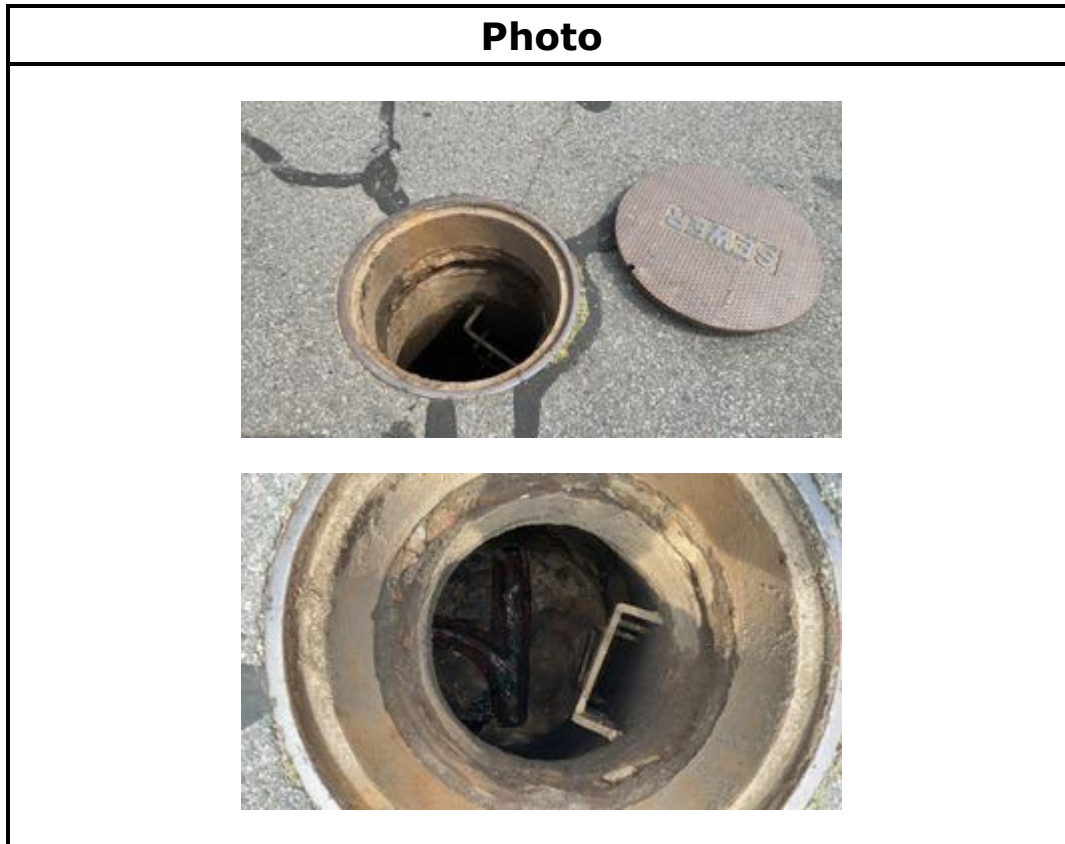
Westwood, MA Manhole Inspections
Manhole ID: 15/046
Westwood, MA

Manhole Information			
Cover Material	Cast Iron	Holes In Cover	Yes
Cover Condition	Sound	Number of Holes	2
Cover Defects		Hole Size (inches)	0.75
Cover Size (inches)	26	Grade	At Grade
Clear Opening Diameter	24	Surface Materials	Paved
Drainage Area (sqft)	4	Cracked Pavement Surrounding Frame	No
Cover Comments

Internal Manhole Observations						
Item	Material	Condition	Infiltration?	Infiltration (GPM)	Defects	Comments
Frame	Cast Iron	Sound	No			
Chimney	Brick, Parged	Defective	No		MMM	
Cone	Precast	Sound	No			
Walls	Precast, Parged	Defective	Yes	0.01	IR	
Steps	Present? Yes	# of Steps: 5		Material: Metal		
Bench	Brick	Sound	No			
	Bench Debris Depth (Inches):			Bench Debris:		
Channel	Brick	Sound	No			
	Channel Debris Depth (Inches):			Channel Debris:		
Surcharge from Invert Evident? No				Currently:	Marks To:	
Additional Comments:

Line Conditions												
In/Out	Compass Direction	Pipe Size	Pipe Material	Rim to Invert Depth	Condition	Flow Depth	Defects	Infiltration	Infiltration (GPM)	Debris	Debris Depth	Debris Material
Out	15/047	8"	ACP	8'4"	Sound	0.5"	No	No	N/A	No	N/A	N/A
In	15/057	8"	ACP	8'2"	Sound	0.25"	No	No	N/A	No	N/A	N/A
In	15/045	8"	ACP	8'0"	Sound	0.25"	No	No	N/A	No	N/A	N/A
Additional Comments:
