Manhole Inspection Reports

Manhole Inspection Report

July 2023

Westwood, MA

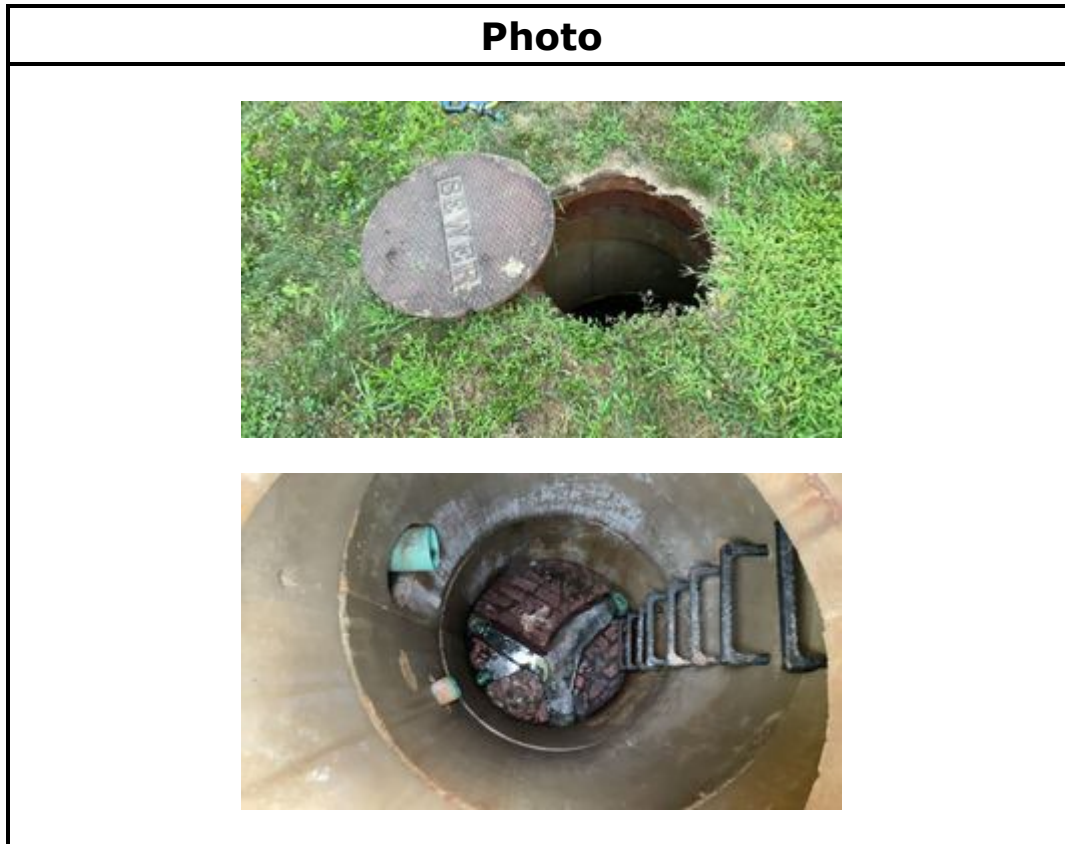
Westwood, MA Manhole Inspections
Manhole ID: 15/108
Westwood, MA

Manhole Information			
Cover Material	Cast Iron	Holes In Cover	Yes
Cover Condition	Sound	Number of Holes	2
Cover Defects		Hole Size (inches)	0.75
Cover Size (inches)	26	Grade	At Grade
Clear Opening Diameter	24	Surface Materials	Grass
Drainage Area (sqft)	4	Cracked Pavement Surrounding Frame	No
Cover Comments

Internal Manhole Observations						
Item	Material	Condition	Infiltration?	Infiltration (GPM)	Defects	Comments
Frame	Cast Iron	Defective	No		SCP	
Chimney	Brick, Precast	Defective	No		H, MML	
Cone		None	No			
Walls	Precast	Defective	No		MML, H	
Steps	Present? Yes	# of Steps: 7		Material: Plastic		
Bench	Brick	Defective	No		MMS	
	Bench Debris Depth (Inches):			Bench Debris:		
Channel	Brick	Sound	No			
	Channel Debris Depth (Inches): 1.5			Channel Debris: Sanitary		
Surcharge from Invert Evident? No				Currently:	Marks To:	
Additional Comments:

Line Conditions												
In/Out	Compass Direction	Pipe Size	Pipe Material	Rim to Invert Depth	Condition	Flow Depth	Defects	Infiltration	Infiltration (GPM)	Debris	Debris Depth	Debris Material
Out	15/112	8"	PVC	11'6"	Defective	0"	Pipe seal missing mortar	No	N/A	Yes	1.5"	Sanitary
In	Northwest 1	4"	PVC	6'11"	Defective	0"	Pipe seal missing mortar	No	N/A	No	N/A	N/A
In	Northwest 2	6"	PVC	11'5"	Defective	0"	Pipe seal missing mortar	No	N/A	No	N/A	N/A
In	North	6"	PVC	5'8"	Defective	0"	Pipe seal missing mortar	No	N/A	No	N/A	N/A
In	15/109	8"	PVC	11'5"	Defective	0.25"	Pipe seal missing mortar	No	N/A	No	N/A	N/A
Additional Comments:

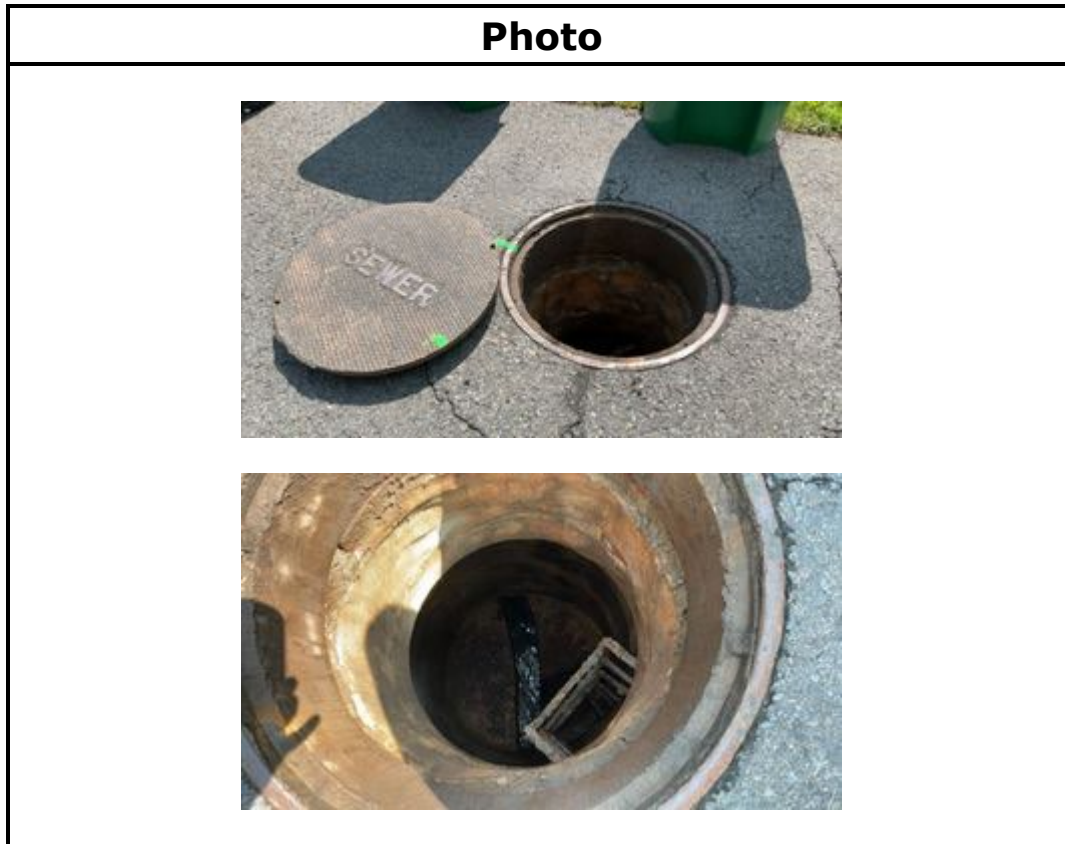
Westwood, MA Manhole Inspections
Manhole ID: 15/041
Westwood, MA

Manhole Information			
Cover Material	Cast Iron	Holes In Cover	Yes
Cover Condition	Sound	Number of Holes	2
Cover Defects		Hole Size (inches)	0.75
Cover Size (inches)	26	Grade	At Grade
Clear Opening Diameter	24	Surface Materials	Paved
Drainage Area (sqft)	4	Cracked Pavement Surrounding Frame	No
Cover Comments

Internal Manhole Observations						
Item	Material	Condition	Infiltration?	Infiltration (GPM)	Defects	Comments
Frame	Cast Iron	Sound	No			
Chimney	Brick, Parged	Defective	No		MMS	
Cone	Precast, Parged	Sound	No			
Walls	Precast, Parged	Sound	No			
Steps	Present? Yes	# of Steps: 7		Material: Metal		
Bench	Brick, Parged	Sound	No			
	Bench Debris Depth (Inches):			Bench Debris:		
Channel	Brick	Sound	No			
	Channel Debris Depth (Inches):			Channel Debris:		
Surcharge from Invert Evident? No				Currently:	Marks To:	
Additional Comments:

Line Conditions												
In/Out	Compass Direction	Pipe Size	Pipe Material	Rim to Invert Depth	Condition	Flow Depth	Defects	Infiltration	Infiltration (GPM)	Debris	Debris Depth	Debris Material
Out	15/042	8"	ACP	10'3"	Sound	4"	No	No	N/A	No	N/A	N/A
In	15/040	8"	ACP	10'1"	Sound	4"	No	No	N/A	No	N/A	N/A
In	Southeast	6"	PVC	4'8"	Sound	0.1"	No	No	N/A	No	N/A	N/A
Additional Comments: In (Southeast) is an outside drop, coming from a patch of woods.

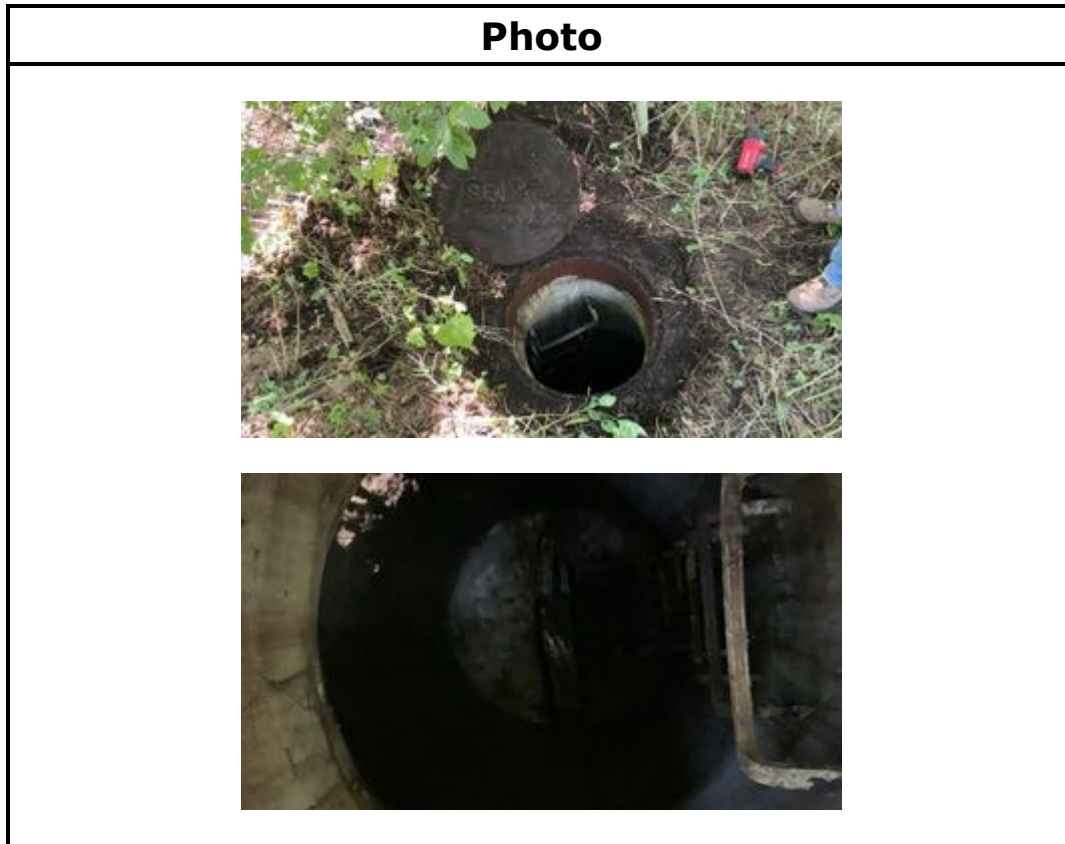
Westwood, MA Manhole Inspections
Manhole ID: 15/058
Westwood, MA

Manhole Information			
Cover Material	Cast Iron	Holes In Cover	No
Cover Condition	Sound	Number of Holes	
Cover Defects		Hole Size (inches)	
Cover Size (inches)	26	Grade	Below Grade
Clear Opening Diameter	24	Surface Materials	Grass
Drainage Area (sqft)	25	Cracked Pavement Surrounding Frame	No
Cover Comments

Internal Manhole Observations						
Item	Material	Condition	Infiltration?	Infiltration (GPM)	Defects	Comments
Frame	Cast Iron	Sound	No			
Chimney	Parged	Sound	No			
Cone	Parged	Sound	No			
Walls	Parged	Sound	No			
Steps	Present? Yes	# of Steps: 6		Material: Metal		
Bench	Brick, Parged	Sound	No			
	Bench Debris Depth (Inches):			Bench Debris:		
Channel	Brick, Lined, Parged	Sound	No			
	Channel Debris Depth (Inches):			Channel Debris:		
Surcharge from Invert Evident? No				Currently:		Marks To:
Additional Comments:

Line Conditions												
In/Out	Compass Direction	Pipe Size	Pipe Material	Rim to Invert Depth	Condition	Flow Depth	Defects	Infiltration	Infiltration (GPM)	Debris	Debris Depth	Debris Material
Out	15/059	8"	ACP	8'8"	Sound	2"	No	No	N/A	No	N/A	N/A
In	15/043	8"	Lined	8'7"	Sound	2"	No	No	N/A	No	N/A	N/A
Additional Comments:

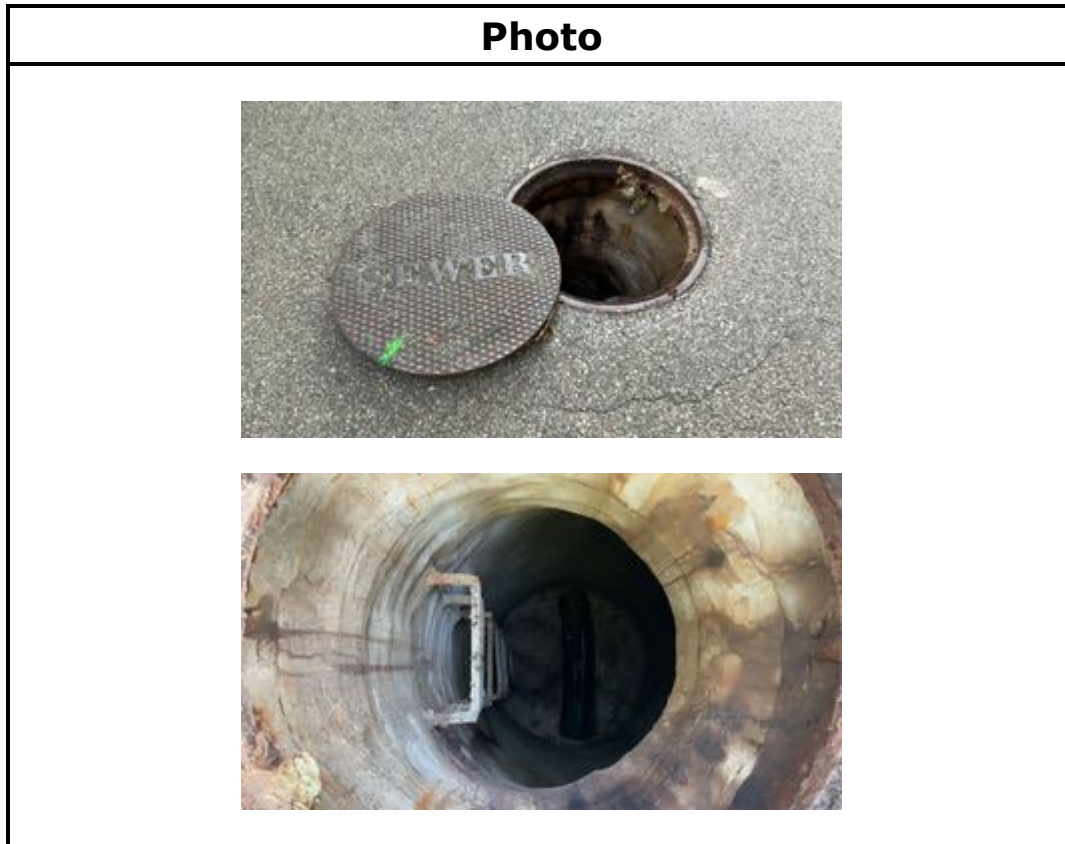
Westwood, MA Manhole Inspections
Manhole ID: 15/071
Westwood, MA

Manhole Information			
Cover Material	Cast Iron	Holes In Cover	No
Cover Condition	Sound	Number of Holes	
Cover Defects		Hole Size (inches)	
Cover Size (inches)	24	Grade	At Grade
Clear Opening Diameter	22	Surface Materials	Paved
Drainage Area (sqft)	4	Cracked Pavement Surrounding Frame	No
Cover Comments

Internal Manhole Observations						
Item	Material	Condition	Infiltration?	Infiltration (GPM)	Defects	Comments
Frame	Cast Iron	Sound	No			
Chimney	Parged	Sound	No			
Cone	Parged	Sound	No			
Walls	Parged	Sound	No			
Steps	Present? Yes	# of Steps: 8		Material: Metal		
Bench	Parged	Sound	No			
	Bench Debris Depth (Inches):			Bench Debris:		
Channel	Parged	Sound	No			
	Channel Debris Depth (Inches):			Channel Debris:		
Surcharge from Invert Evident? No				Currently:		Marks To:
Additional Comments:

Line Conditions												
In/Out	Compass Direction	Pipe Size	Pipe Material	Rim to Invert Depth	Condition	Flow Depth	Defects	Infiltration	Infiltration (GPM)	Debris	Debris Depth	Debris Material
Out	15/072	8"	ACP	11'0"	Sound	0.1"	No	No	N/A	No	N/A	N/A
In	15/070	8"	ACP	10'11"	Sound	0.1"	No	No	N/A	No	N/A	N/A
Additional Comments:

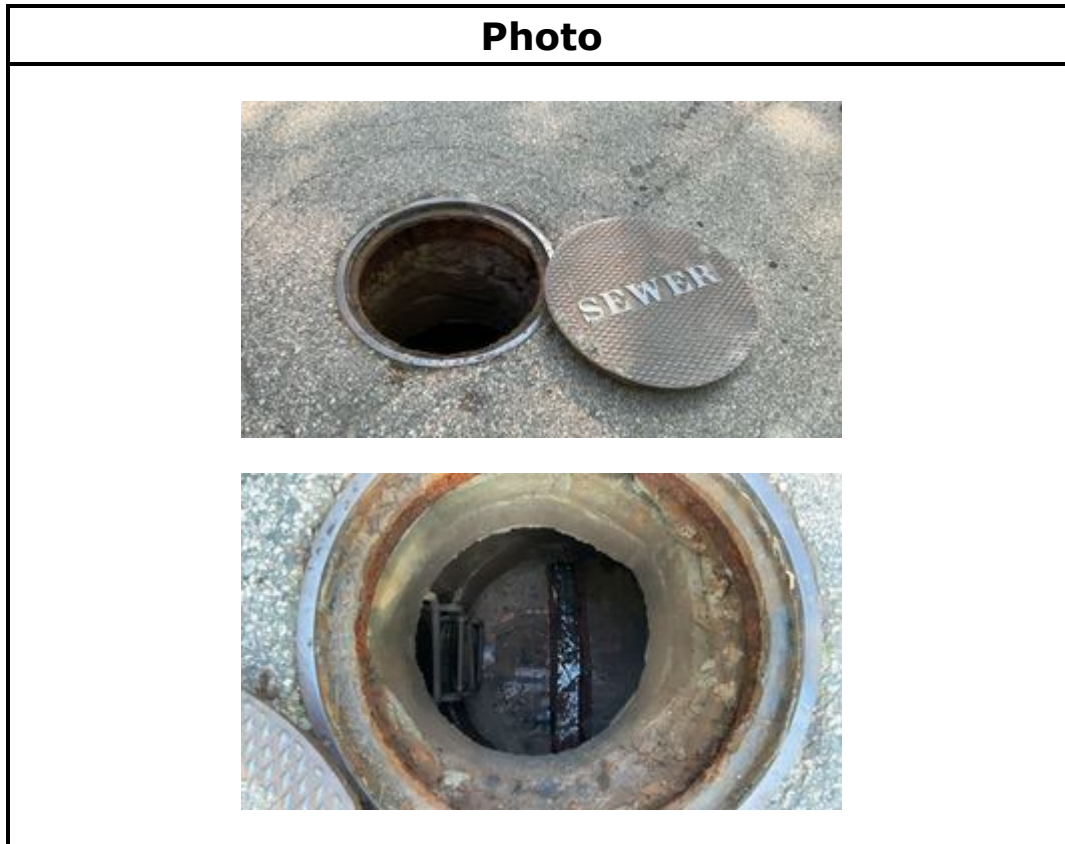
Westwood, MA Manhole Inspections
Manhole ID: 15/074
Westwood, MA

Manhole Information			
Cover Material	Cast Iron	Holes In Cover	No
Cover Condition	Sound	Number of Holes	
Cover Defects		Hole Size (inches)	
Cover Size (inches)	24	Grade	Below Grade
Clear Opening Diameter	22	Surface Materials	Paved
Drainage Area (sqft)	16	Cracked Pavement Surrounding Frame	No
Cover Comments

Internal Manhole Observations						
Item	Material	Condition	Infiltration?	Infiltration (GPM)	Defects	Comments
Frame	Cast Iron	Defective	No		SCP	
Chimney	Brick, Block, Precast	Defective	No		MML, MB	
Cone		None	No			
Walls	Precast	Sound	No			
Steps	Present? Yes	# of Steps: 4		Material: Metal		
Bench	Brick	Sound	No			
	Bench Debris Depth (Inches):			Bench Debris:		
Channel	Brick	Sound	No			
	Channel Debris Depth (Inches):			Channel Debris:		
Surcharge from Invert Evident? No				Currently:	Marks To:	
Additional Comments:

Line Conditions												
In/Out	Compass Direction	Pipe Size	Pipe Material	Rim to Invert Depth	Condition	Flow Depth	Defects	Infiltration	Infiltration (GPM)	Debris	Debris Depth	Debris Material
Out	15/075	8"	ACP	7'4"	Sound	0.75"	No	No	N/A	No	N/A	N/A
In	15/072	8"	ACP	7'3"	Sound	0.75"	No	No	N/A	No	N/A	N/A
Additional Comments:

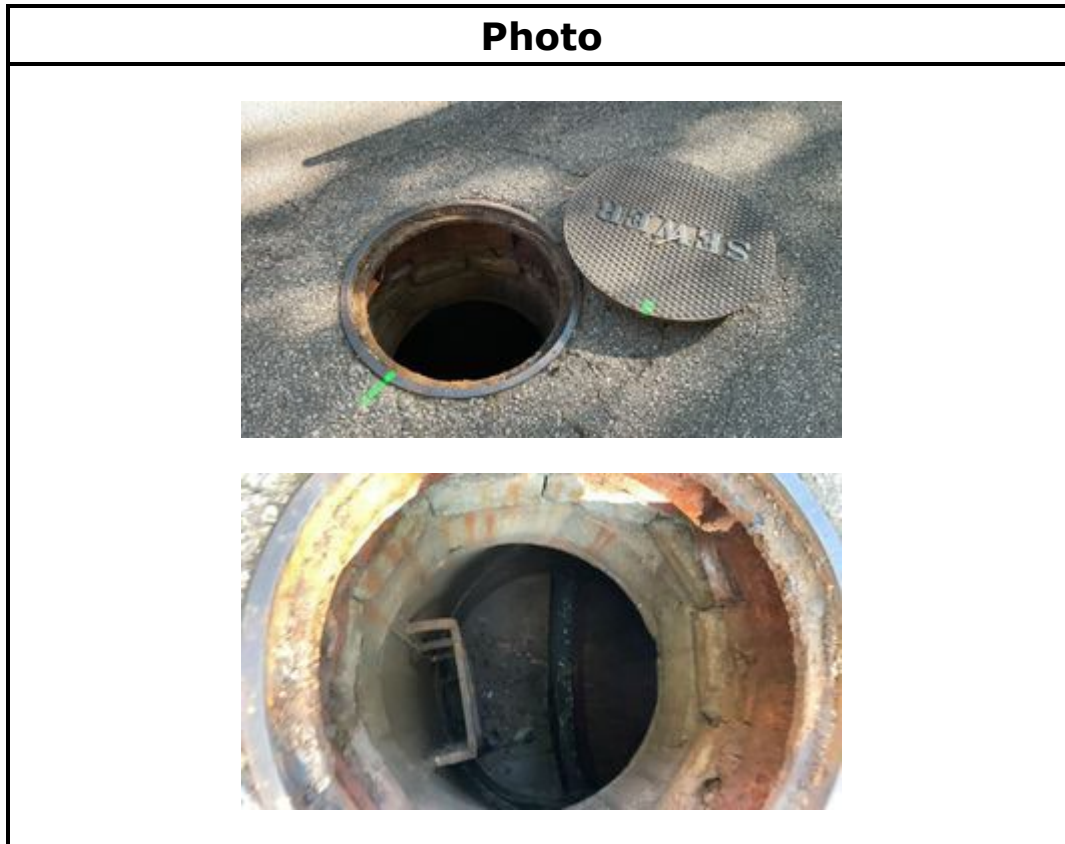
Westwood, MA Manhole Inspections
Manhole ID: 15/076
Westwood, MA

Manhole Information			
Cover Material	Cast Iron	Holes In Cover	No
Cover Condition	Sound	Number of Holes	
Cover Defects		Hole Size (inches)	
Cover Size (inches)	24	Grade	At Grade
Clear Opening Diameter	22	Surface Materials	Paved
Drainage Area (sqft)	4	Cracked Pavement Surrounding Frame	No
Cover Comments

Internal Manhole Observations						
Item	Material	Condition	Infiltration?	Infiltration (GPM)	Defects	Comments
Frame	Cast Iron	Defective	No		SCP	
Chimney	Brick, Block, Precast	Defective	No		MML, MB	
Cone	Precast	Defective	No		Lift holes missing mortar	
Walls	Precast	Sound	No			
Steps	Present? Yes	# of Steps: 4		Material: Metal		
Bench	Brick	Sound	No			
	Bench Debris Depth (Inches): 2.5			Bench Debris: Sediment		
Channel	Brick	Sound	No			
	Channel Debris Depth (Inches): 0.5			Channel Debris: Sanitary		
Surcharge from Invert Evident? No				Currently:	Marks To:	
Additional Comments:

Line Conditions												
In/Out	Compass Direction	Pipe Size	Pipe Material	Rim to Invert Depth	Condition	Flow Depth	Defects	Infiltration	Infiltration (GPM)	Debris	Debris Depth	Debris Material
Out	15/077	8"	ACP	7'5"	Sound	0.75"	No	No	N/A	No	N/A	N/A
In	15/075	8"	ACP	7'4"	Sound	0.75"	No	No	N/A	No	N/A	N/A
Additional Comments:

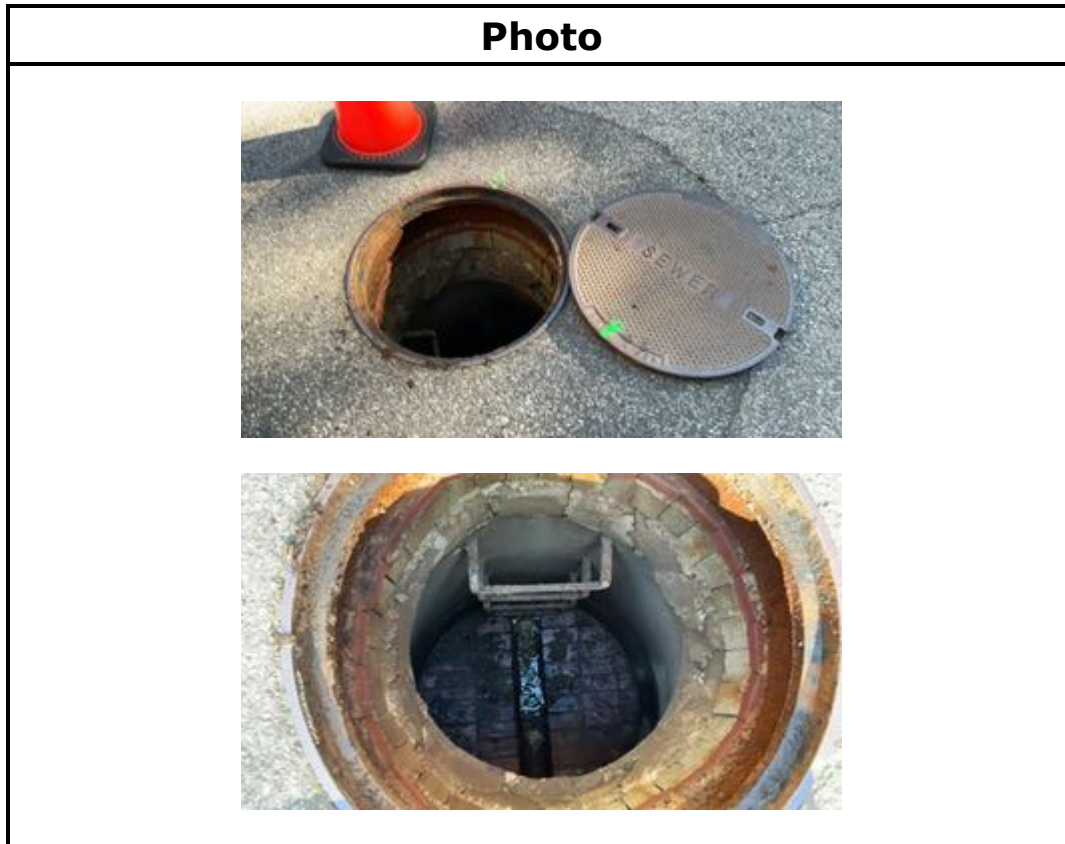
Westwood, MA Manhole Inspections
Manhole ID: 15/077
Westwood, MA

Manhole Information			
Cover Material	Cast Iron	Holes In Cover	No
Cover Condition	Sound	Number of Holes	
Cover Defects		Hole Size (inches)	
Cover Size (inches)	24	Grade	At Grade
Clear Opening Diameter	22	Surface Materials	Paved
Drainage Area (sqft)	4	Cracked Pavement Surrounding Frame	No
Cover Comments	Blind flange

Internal Manhole Observations						
Item	Material	Condition	Infiltration?	Infiltration (GPM)	Defects	Comments
Frame	Cast Iron	Sound	No			
Chimney	Brick, Block	Defective	No		MML	
Cone	Precast	Sound	No			
Walls	Precast	Sound	No			
Steps	Present? Yes	# of Steps: 4		Material: Metal		
Bench	Brick	Sound	No			
	Bench Debris Depth (Inches): 0.25			Bench Debris: Sediment		
Channel	Brick	Sound	No			
	Channel Debris Depth (Inches):			Channel Debris:		
Surcharge from Invert Evident? No				Currently:	Marks To:	
Additional Comments:

Line Conditions												
In/Out	Compass Direction	Pipe Size	Pipe Material	Rim to Invert Depth	Condition	Flow Depth	Defects	Infiltration	Infiltration (GPM)	Debris	Debris Depth	Debris Material
Out	15/078	8"	ACP	7'5"	Sound	0.25"	No	No	N/A	No	N/A	N/A
In	15/076	8"	ACP	7'4"	Sound	0.25"	No	No	N/A	No	N/A	N/A
Additional Comments:

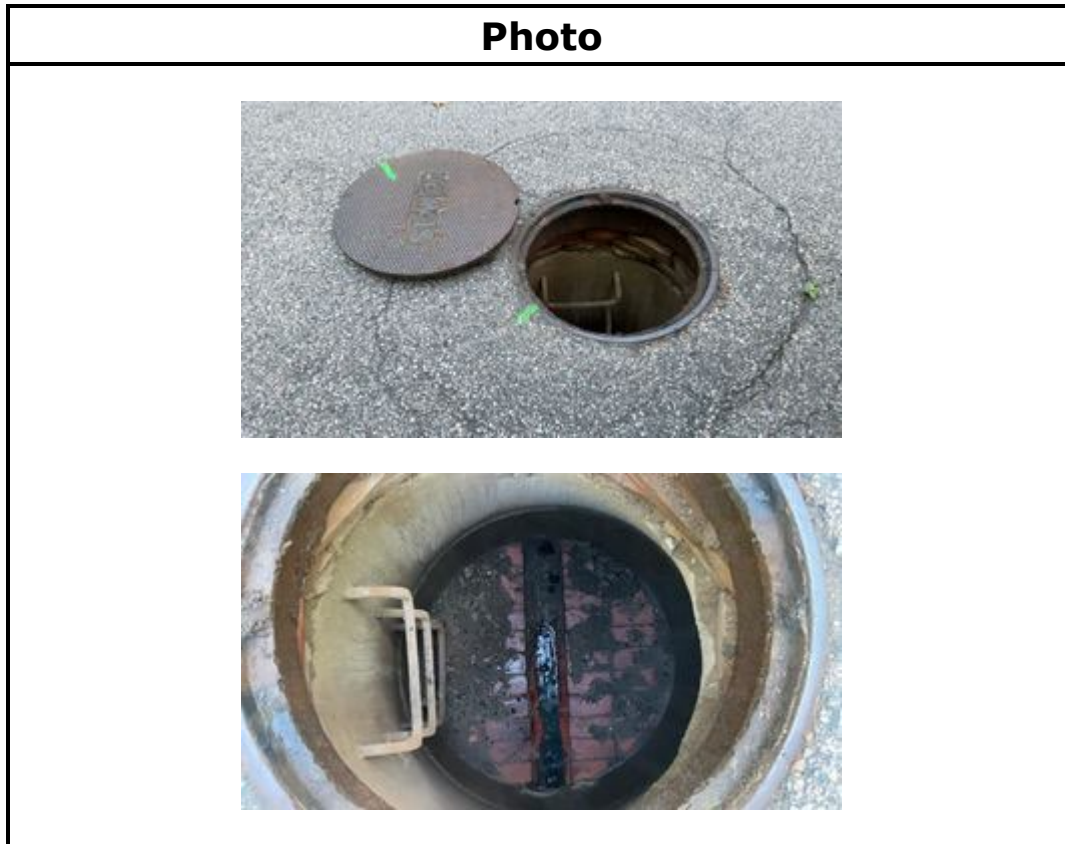
Westwood, MA Manhole Inspections
Manhole ID: 15/080
Westwood, MA

Manhole Information			
Cover Material	Cast Iron	Holes In Cover	Yes
Cover Condition	Sound	Number of Holes	2
Cover Defects		Hole Size (inches)	0.75
Cover Size (inches)	26	Grade	At Grade
Clear Opening Diameter	24	Surface Materials	Paved
Drainage Area (sqft)	4	Cracked Pavement Surrounding Frame	No
Cover Comments

Internal Manhole Observations						
Item	Material	Condition	Infiltration?	Infiltration (GPM)	Defects	Comments
Frame	Cast Iron	Sound	No			
Chimney	Brick	Defective	No		MML, MB, HSV	
Cone	Precast	Sound	No			
Walls	Precast	Sound	No			
Steps	Present? Yes	# of Steps: 4		Material: Metal		
Bench	Brick	Sound	No			
	Bench Debris Depth (Inches): 1			Bench Debris: Sediment		
Channel	Brick	Sound	No			
	Channel Debris Depth (Inches): 1			Channel Debris: Sediment		
Surcharge from Invert Evident? No				Currently:		Marks To:
Additional Comments:

Line Conditions												
In/Out	Compass Direction	Pipe Size	Pipe Material	Rim to Invert Depth	Condition	Flow Depth	Defects	Infiltration	Infiltration (GPM)	Debris	Debris Depth	Debris Material
Out	15/079	8"	ACP	6'4"	Sound	0.1"	No	No	N/A	No	N/A	N/A
Additional Comments:

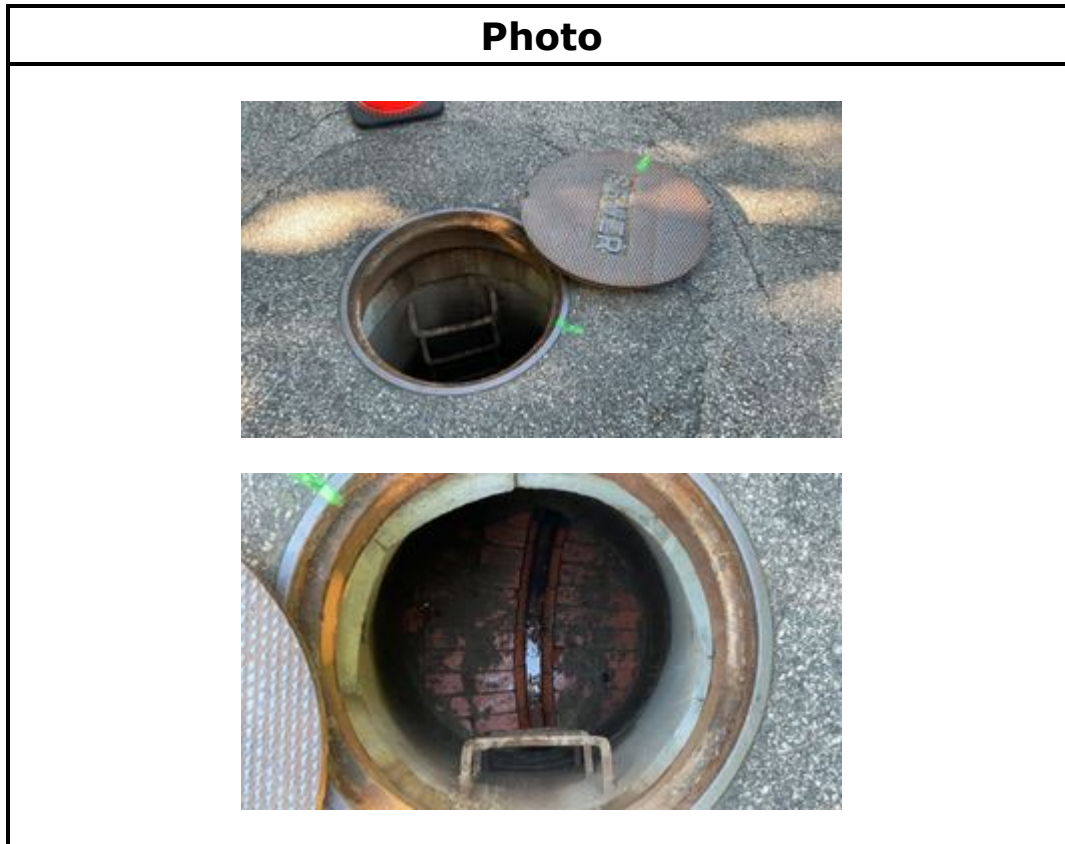
Westwood, MA Manhole Inspections
Manhole ID: 15/079
Westwood, MA

Manhole Information			
Cover Material	Cast Iron	Holes In Cover	Yes
Cover Condition	Sound	Number of Holes	2
Cover Defects		Hole Size (inches)	0.75
Cover Size (inches)	26	Grade	At Grade
Clear Opening Diameter	24	Surface Materials	Paved
Drainage Area (sqft)	4	Cracked Pavement Surrounding Frame	No
Cover Comments

Internal Manhole Observations						
Item	Material	Condition	Infiltration?	Infiltration (GPM)	Defects	Comments
Frame	Cast Iron	Sound	No			
Chimney	Brick, Block	Defective	No		MML	
Cone	Precast	Defective	No		Lift holes missing mortar	
Walls	Precast	Sound	No			
Steps	Present? Yes	# of Steps: 3		Material: Metal		
Bench	Brick	Sound	No			
	Bench Debris Depth (Inches): 0.25			Bench Debris: Sediment		
Channel	Brick	Sound	No			
	Channel Debris Depth (Inches):			Channel Debris:		
Surcharge from Invert Evident? No				Currently:	Marks To:	
Additional Comments:

Line Conditions												
In/Out	Compass Direction	Pipe Size	Pipe Material	Rim to Invert Depth	Condition	Flow Depth	Defects	Infiltration	Infiltration (GPM)	Debris	Debris Depth	Debris Material
Out	15/078	8"	ACP	6'2"	Sound	0.1"	No	No	N/A	No	N/A	N/A
In	15/080	8"	ACP	6'1"	Sound	0.1"	No	No	N/A	No	N/A	N/A
Additional Comments:

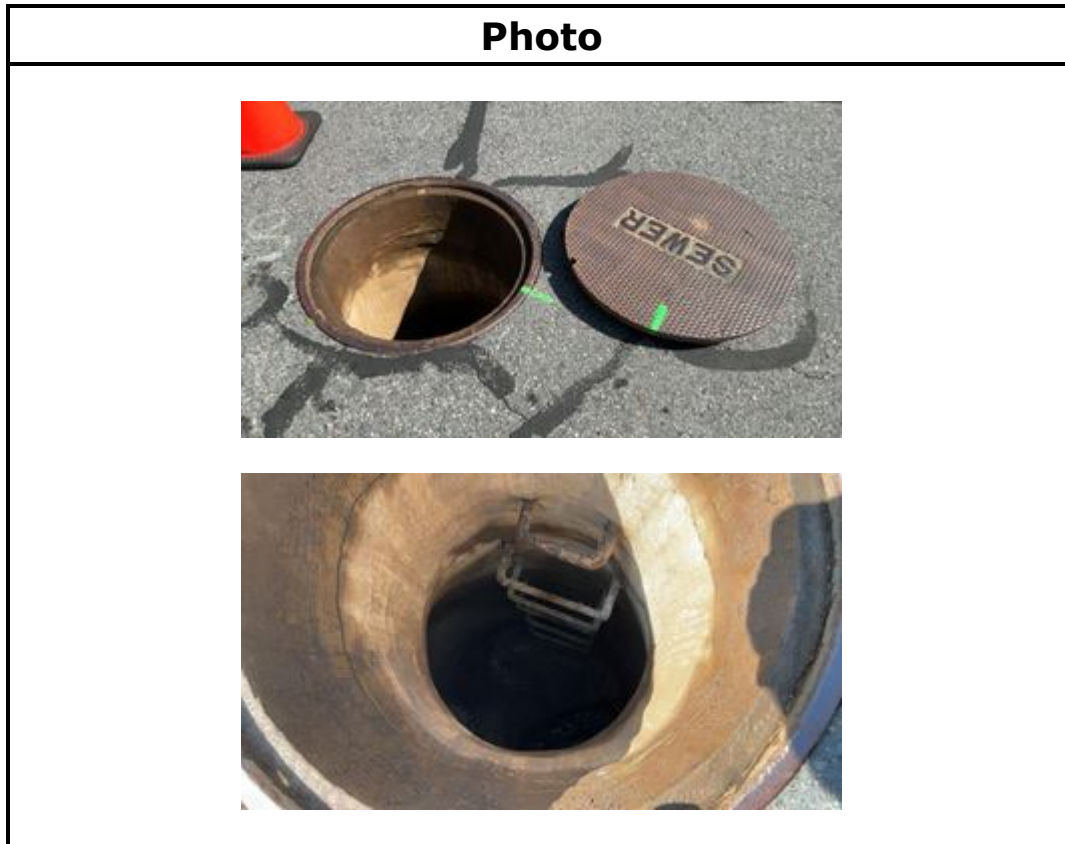
Westwood, MA Manhole Inspections
Manhole ID: 15/048
Westwood, MA

Manhole Information			
Cover Material	Cast Iron	Holes In Cover	Yes
Cover Condition	Sound	Number of Holes	2
Cover Defects		Hole Size (inches)	0.75
Cover Size (inches)	26	Grade	At Grade
Clear Opening Diameter	24	Surface Materials	Paved
Drainage Area (sqft)	4	Cracked Pavement Surrounding Frame	No
Cover Comments

Internal Manhole Observations						
Item	Material	Condition	Infiltration?	Infiltration (GPM)	Defects	Comments
Frame	Cast Iron	Sound	No			
Chimney	Parged	Sound	No			
Cone	Parged	Sound	No			
Walls	Parged	Sound	No			
Steps	Present? Yes	# of Steps: 7		Material: Metal		
Bench	Parged	Sound	No			
	Bench Debris Depth (Inches):			Bench Debris:		
Channel	Parged	Sound	No			
	Channel Debris Depth (Inches):			Channel Debris:		
Surcharge from Invert Evident? No				Currently:	Marks To:	
Additional Comments:

Line Conditions												
In/Out	Compass Direction	Pipe Size	Pipe Material	Rim to Invert Depth	Condition	Flow Depth	Defects	Infiltration	Infiltration (GPM)	Debris	Debris Depth	Debris Material
Out	15/033	8"	ACP	9'11"	Sound	0.5"	No	No	N/A	No	N/A	N/A
In	15/047	8"	ACP	9'8"	Defective	0.5"	Pipe connection leak	Yes	0.25"	No	N/A	N/A
Additional Comments:

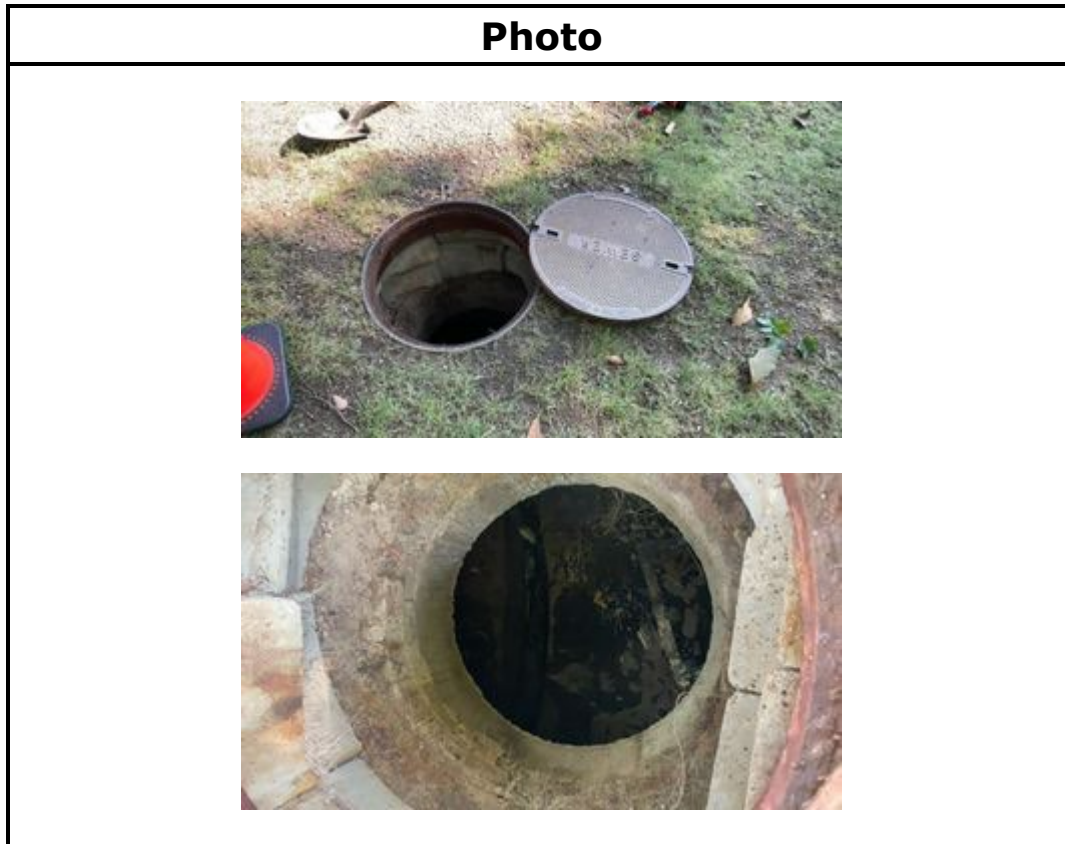
Westwood, MA Manhole Inspections
Manhole ID: 15/113
Westwood, MA

Manhole Information			
Cover Material	Cast Iron	Holes In Cover	No
Cover Condition	Sound	Number of Holes	
Cover Defects		Hole Size (inches)	
Cover Size (inches)	24	Grade	Above Grade
Clear Opening Diameter	22	Surface Materials	Grass, Dirt
Drainage Area (sqft)	4	Cracked Pavement Surrounding Frame	No
Cover Comments	Blind flange cover

Internal Manhole Observations						
Item	Material	Condition	Infiltration?	Infiltration (GPM)	Defects	Comments
Frame	Cast Iron	Sound	No			
Chimney	Block	Defective	No		MML, RFB	
Cone	Precast	Sound	No			
Walls	Precast	Defective	No		RMB	
Steps	Present? Yes	# of Steps: 1		Material: Plastic		
Bench	Parged	Defective	No		RMJ	
	Bench Debris Depth (Inches): 0.25			Bench Debris: Sediment		
Channel	Brick, Parged	Sound	No			
	Channel Debris Depth (Inches):			Channel Debris:		
Surcharge from Invert Evident? No				Currently:		Marks To:
Additional Comments:

Line Conditions												
In/Out	Compass Direction	Pipe Size	Pipe Material	Rim to Invert Depth	Condition	Flow Depth	Defects	Infiltration	Infiltration (GPM)	Debris	Debris Depth	Debris Material
Out	Southwest	6"	PVC	5'7"	Sound	0.1"	No	No	N/A	No	N/A	N/A
In	Northeast	6"	PVC	5'6"	Defective	0.1	RMJ	No	N/A	No	N/A	N/A
Additional Comments:

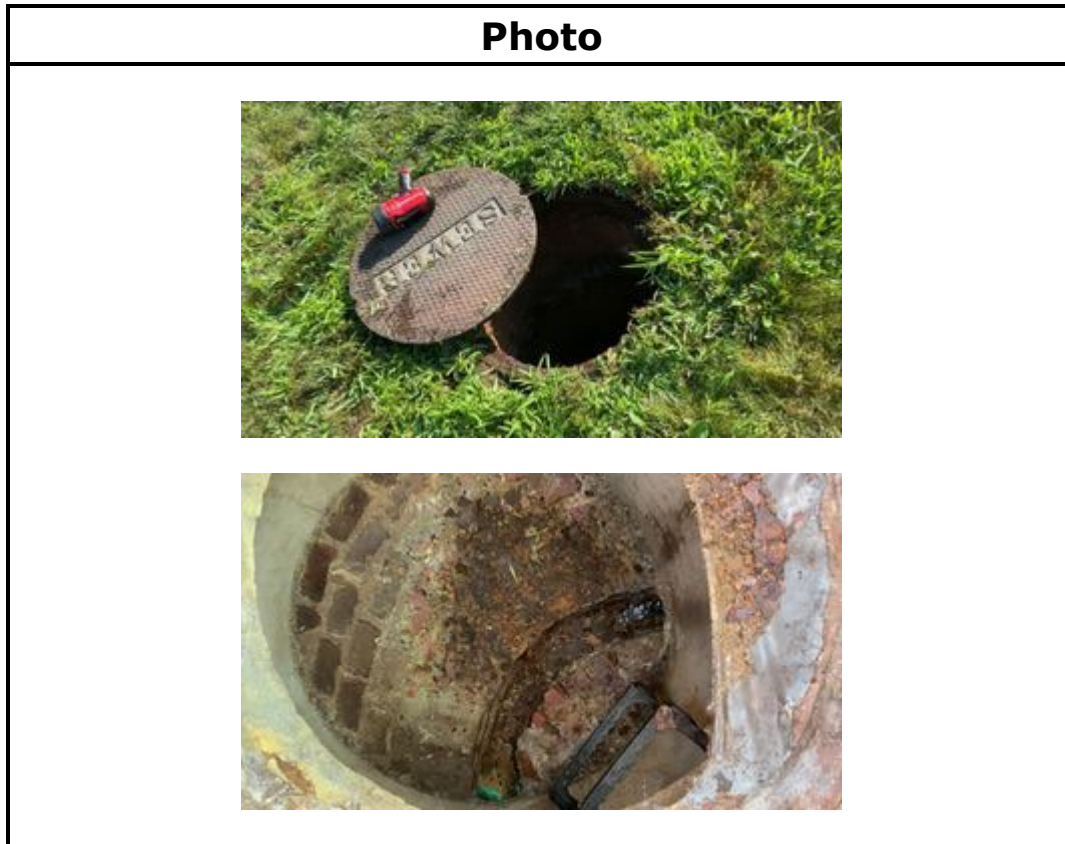
Westwood, MA Manhole Inspections
Manhole ID: 15/107
Westwood, MA

Manhole Information			
Cover Material	Cast Iron	Holes In Cover	Yes
Cover Condition	Sound	Number of Holes	2
Cover Defects		Hole Size (inches)	0.75
Cover Size (inches)	26	Grade	At Grade
Clear Opening Diameter	24	Surface Materials	Grass
Drainage Area (sqft)	4	Cracked Pavement Surrounding Frame	No
Cover Comments

Internal Manhole Observations						
Item	Material	Condition	Infiltration?	Infiltration (GPM)	Defects	Comments
Frame	Cast Iron	Defective	No		SCP	
Chimney	Brick, Precast, Parged	Sound	No			Plastic sheeting around chimney
Cone		None	No			
Walls	Precast	Sound	No			
Steps	Present? Yes	# of Steps: 2		Material: Plastic		
Bench	Brick	Defective	No		MB, MMM	
	Bench Debris Depth (Inches): 2			Bench Debris: Sediment		
Channel	Brick	Sound	No			
	Channel Debris Depth (Inches): 1			Channel Debris: Sediment		
Surcharge from Invert Evident? No				Currently:		Marks To:
Additional Comments:

Line Conditions												
In/Out	Compass Direction	Pipe Size	Pipe Material	Rim to Invert Depth	Condition	Flow Depth	Defects	Infiltration	Infiltration (GPM)	Debris	Debris Depth	Debris Material
Out	15/110	8"	PVC	6'8"	Sound	0"	No	No	N/A	Yes	0.5"	Sediment
In	East	6"	PVC	6'1"	Sound	0"	No	No	N/A	Yes	0.5"	Sediment
Additional Comments:

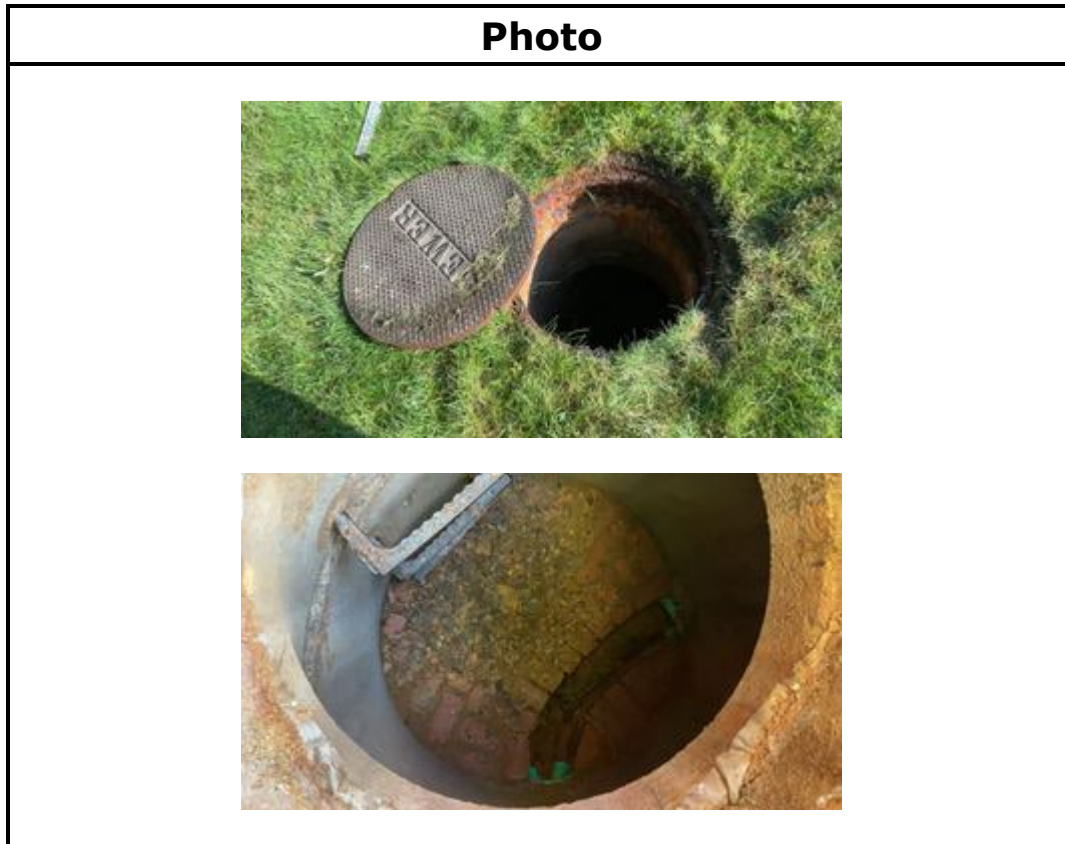
Westwood, MA Manhole Inspections
Manhole ID: 15/110
Westwood, MA

Manhole Information			
Cover Material	Cast Iron	Holes In Cover	Yes
Cover Condition	Sound	Number of Holes	2
Cover Defects		Hole Size (inches)	0.75
Cover Size (inches)	26	Grade	At Grade
Clear Opening Diameter	24	Surface Materials	Grass
Drainage Area (sqft)	4	Cracked Pavement Surrounding Frame	No
Cover Comments

Internal Manhole Observations						
Item	Material	Condition	Infiltration?	Infiltration (GPM)	Defects	Comments
Frame	Cast Iron	Defective	No		SCP	
Chimney	Brick, Block, Precast	Sound	No			
Cone	Precast	Sound	No			
Walls	Precast	Sound	No			
Steps	Present? Yes	# of Steps: 3		Material: Plastic		
Bench	Brick	Sound	No			
	Bench Debris Depth (Inches): 2			Bench Debris: Sediment		
Channel	Brick	Sound	No			
	Channel Debris Depth (Inches):			Channel Debris:		
Surcharge from Invert Evident? No				Currently:		Marks To:
Additional Comments:

Line Conditions												
In/Out	Compass Direction	Pipe Size	Pipe Material	Rim to Invert Depth	Condition	Flow Depth	Defects	Infiltration	Infiltration (GPM)	Debris	Debris Depth	Debris Material
Out	15/111	8"	PVC	7'1"	Sound	0"	No	No	N/A	Yes	0.25"	Sediment
In	15/107	8"	PVC	7'	Sound	0"	No	No	N/A	Yes	0.25"	Sediment
Additional Comments:

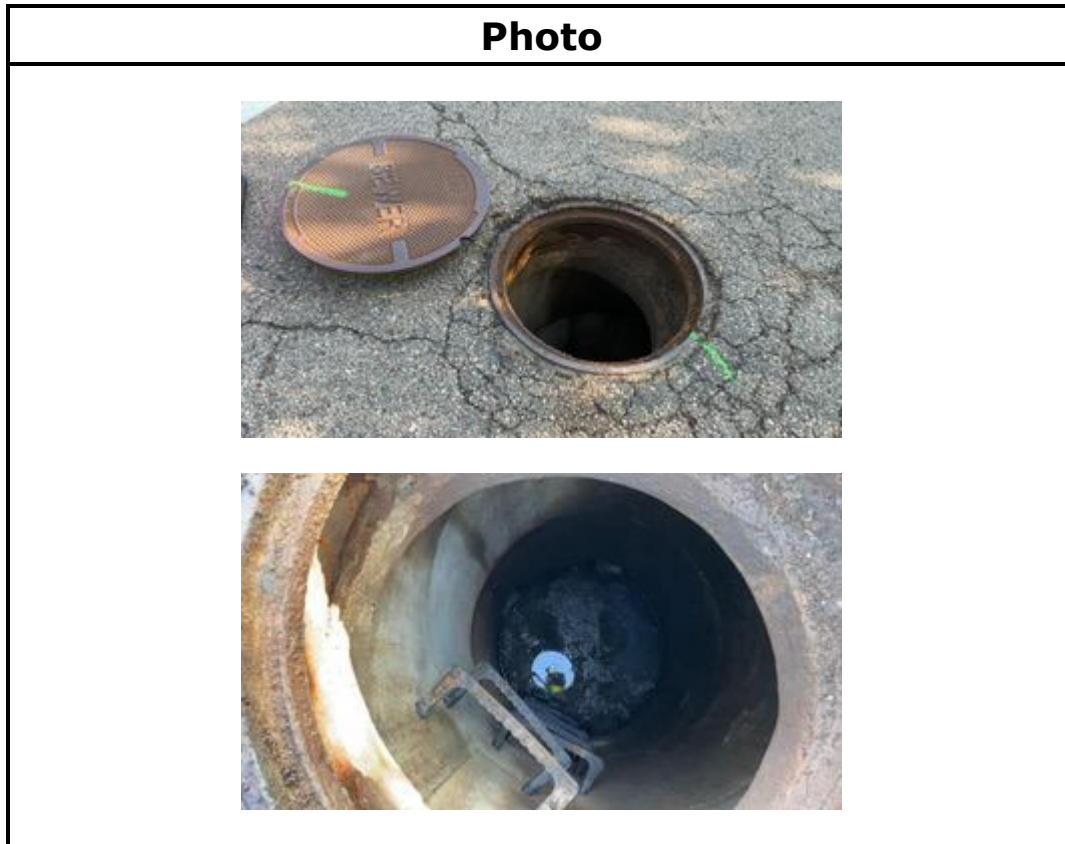
Westwood, MA Manhole Inspections
Manhole ID: 15/112
Westwood, MA

Manhole Information			
Cover Material	Cast Iron	Holes In Cover	Yes
Cover Condition	Sound	Number of Holes	2
Cover Defects		Hole Size (inches)	0.75
Cover Size (inches)	26	Grade	At Grade
Clear Opening Diameter	24	Surface Materials	Paved
Drainage Area (sqft)	4	Cracked Pavement Surrounding Frame	Yes
Cover Comments

Internal Manhole Observations						
Item	Material	Condition	Infiltration?	Infiltration (GPM)	Defects	Comments
Frame	Cast Iron	Defective	No		Offset 3"	
Chimney	Precast	Sound	No			
Cone	Precast	Sound	No			
Walls	Precast	Sound	No			
Steps	Present? Yes	# of Steps: 7		Material: Plastic		
Bench	Poured in place	Sound	No			
	Bench Debris Depth (Inches): 1			Bench Debris: Sanitary, Sediment		
Channel		None	No			
	Channel Debris Depth (Inches):			Channel Debris:		
Surcharge from Invert Evident? No				Currently:	Marks To:	
Additional Comments:

Line Conditions												
In/Out	Compass Direction	Pipe Size	Pipe Material	Rim to Invert Depth	Condition	Flow Depth	Defects	Infiltration	Infiltration (GPM)	Debris	Debris Depth	Debris Material
Out	15/005	8"	PVC	10'3"	Defective	0.1"	Pipe connection missing mortar	No	N/A	Yes	0.25"	Sanitary
In	15/111	8"	PVC	10'1"	Defective	0.1"	Pipe connection missing mortar	No	N/A	No	N/A	N/A
In	15/008	8"	PVC	10'1"	Defective	0.1"	Pipe connection missing mortar	No	N/A	No	N/A	N/A
Additional Comments:

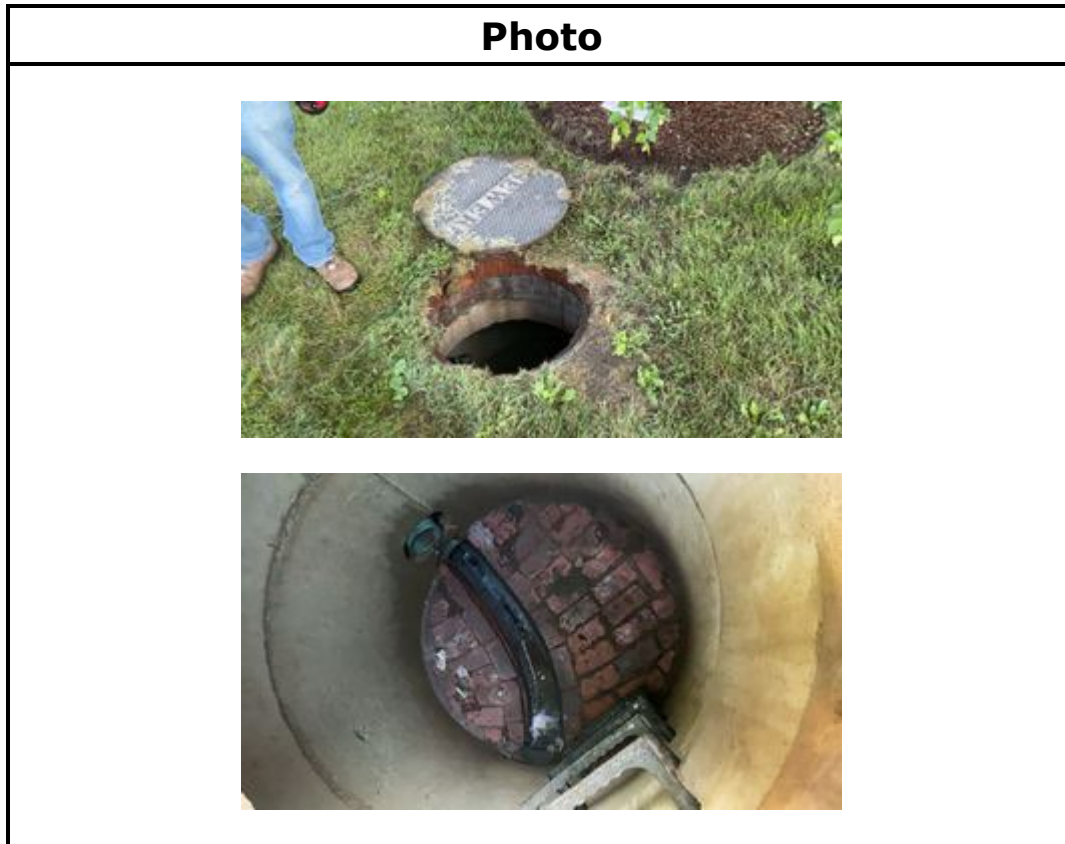
Westwood, MA Manhole Inspections Manhole ID: 15/109 Westwood, MA

Manhole Information			
Cover Material	Cast Iron	Holes In Cover	Yes
Cover Condition	Sound	Number of Holes	2
Cover Defects		Hole Size (inches)	0.5
Cover Size (inches)	26	Grade	At Grade
Clear Opening Diameter	24	Surface Materials	Grass
Drainage Area (sqft)	4	Cracked Pavement Surrounding Frame	No
Cover Comments

Internal Manhole Observations						
Item	Material	Condition	Infiltration?	Infiltration (GPM)	Defects	Comments
Frame	Cast Iron	Sound	No			
Chimney	Brick, Precast	Sound	No			
Cone		None	No			
Walls	Precast	Defective	No		Lift holes missing mortar	
Steps	Present? Yes	# of Steps: 5		Material: Plastic		
Bench	Brick	Sound	No			
	Bench Debris Depth (Inches):			Bench Debris:		
Channel	Brick	Sound	No			
	Channel Debris Depth (Inches):			Channel Debris:		
Surcharge from Invert Evident? No				Currently:		Marks To:
Additional Comments:

Line Conditions												
In/Out	Compass Direction	Pipe Size	Pipe Material	Rim to Invert Depth	Condition	Flow Depth	Defects	Infiltration	Infiltration (GPM)	Debris	Debris Depth	Debris Material
Out	15/108	8"	ACP	8'	Defective	0"	Pipe connection missing mortar	No	N/A	Yes	1"	Sanitary
In	East	6"	PVC	6'11"	Defective	0"	Pipe connection missing mortar	No	N/A	No	N/A	N/A
Additional Comments:

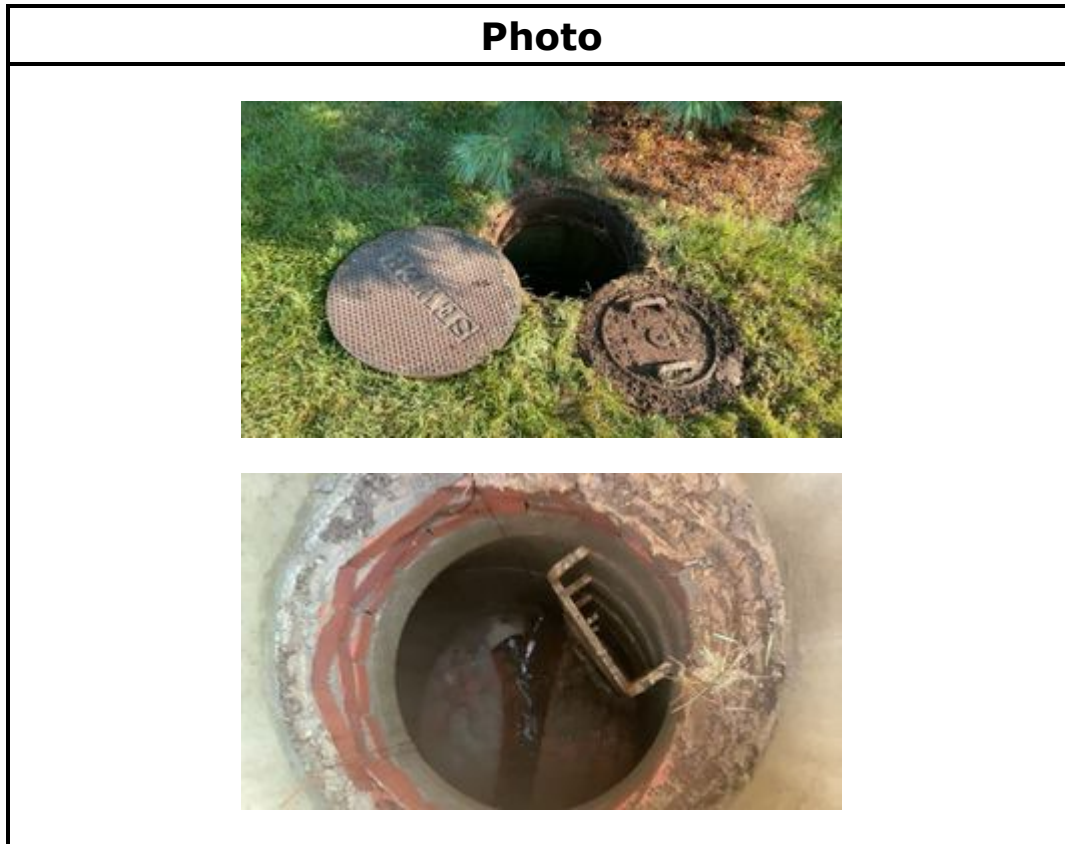
Westwood, MA Manhole Inspections
Manhole ID: 15/007
Westwood, MA

Manhole Information			
Cover Material	Cast Iron	Holes In Cover	Yes
Cover Condition	Sound	Number of Holes	2
Cover Defects	Flood cover installed	Hole Size (inches)	0.5
Cover Size (inches)	26	Grade	At Grade
Clear Opening Diameter	24	Surface Materials	Grass
Drainage Area (sqft)	4	Cracked Pavement Surrounding Frame	No
Cover Comments

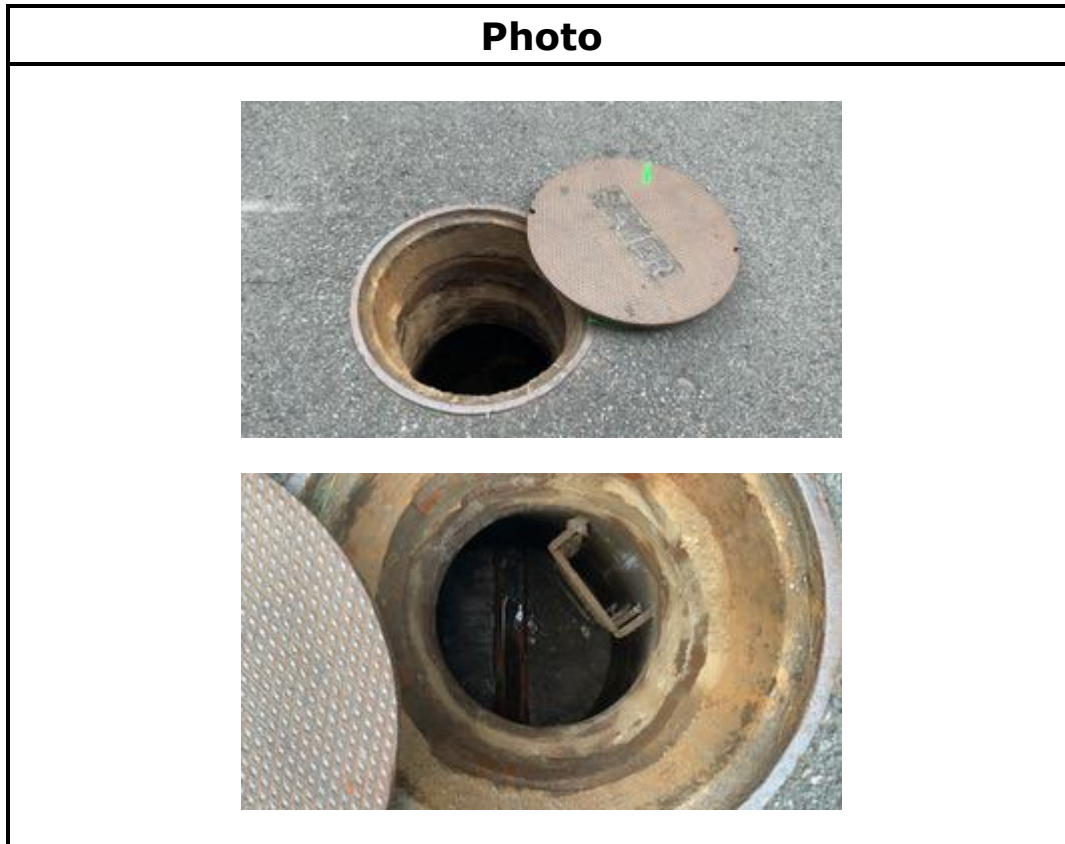
Westwood, MA Manhole Inspections
Manhole ID: 15/044
Westwood, MA

Line Conditions												
In/Out	Compass Direction	Pipe Size	Pipe Material	Rim to Invert Depth	Condition	Flow Depth	Defects	Infiltration	Infiltration (GPM)	Debris	Debris Depth	Debris Material
Out	15/045	8"	ACP	7'10"	Defective	0.1	Pipe connection leak	Yes	0.01"	No	N/A	N/A
Additional Comments:

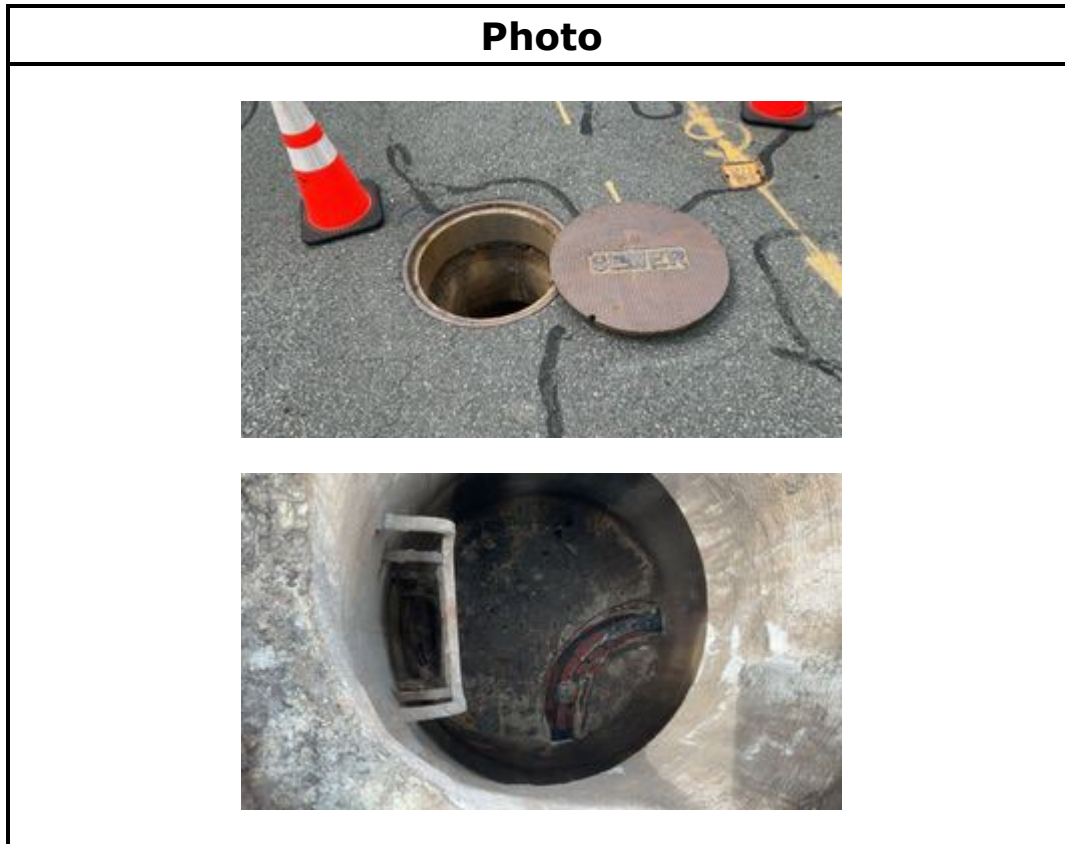
Westwood, MA Manhole Inspections
Manhole ID: 15/057
Westwood, MA

Internal Manhole Observations						
Item	Material	Condition	Infiltration?	Infiltration (GPM)	Defects	Comments
Frame	Cast Iron	Sound	No			
Chimney	Brick, Parged	Defective	No		MMM	
Cone	Precast	Sound	No			
Walls	Precast	Sound	No			
Steps	Present? Yes	# of Steps: 4		Material: Metal		
Bench	Brick, Parged	Sound	No			
	Bench Debris Depth (Inches):			Bench Debris:		
Channel	Brick	Sound	No			
	Channel Debris Depth (Inches):			Channel Debris:		
Surcharge from Invert Evident? No				Currently:	Marks To:	
Additional Comments:
