Manhole Inspection Reports

Manhole Inspection Report

July 2023

Westwood, MA

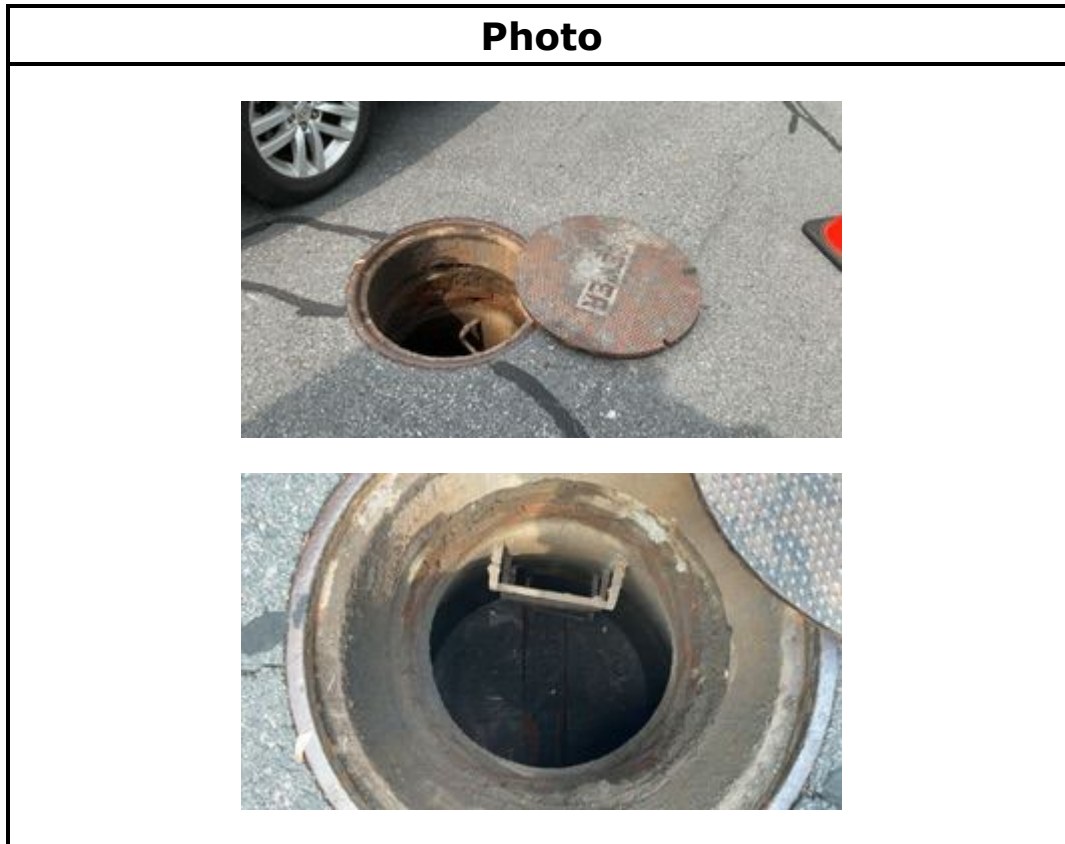
Westwood, MA Manhole Inspections
Manhole ID: 15/056
Westwood, MA

Internal Manhole Observations						
Item	Material	Condition	Infiltration?	Infiltration (GPM)	Defects	Comments
Frame	Cast Iron	Sound	No			
Chimney	Brick, Precast	Defective	No		MMS	
Cone	Precast	Sound	No			
Walls	Precast	Sound	No			
Steps	Present? Yes	# of Steps: 4		Material: Metal		
Bench	Brick	Sound	No			
	Bench Debris Depth (Inches): 0.75			Bench Debris: Sediment		
Channel	Brick	Sound	No			
	Channel Debris Depth (Inches): 0.75			Channel Debris: Sediment		
Surcharge from Invert Evident? No				Currently:	Marks To:	
Additional Comments:

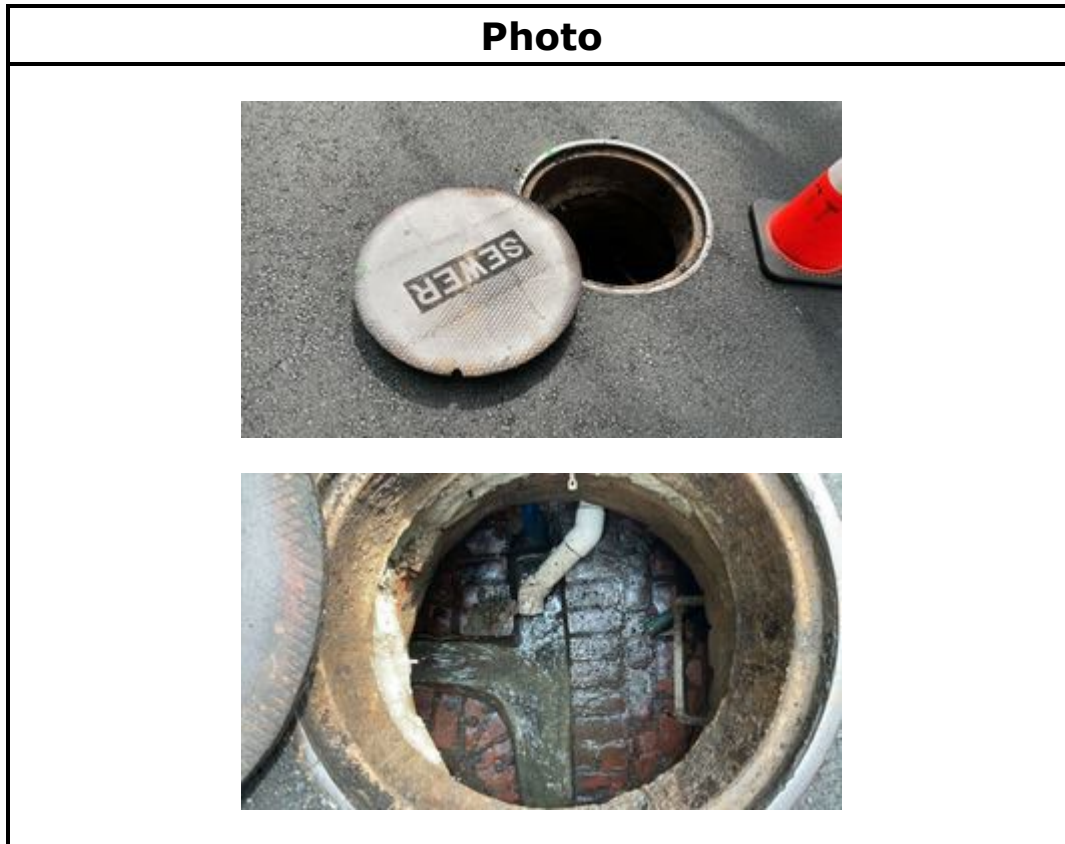
Westwood, MA Manhole Inspections
Manhole ID: 15/081
Westwood, MA

Internal Manhole Observations						
Item	Material	Condition	Infiltration?	Infiltration (GPM)	Defects	Comments
Frame	Cast Iron	Sound	No			
Chimney	Brick	Defective	No		MMM	
Cone	Brick	Defective	No		MMM	
Walls	Brick	Defective	No		MMM	
Steps	Present? Yes	# of Steps: 1		Material: Metal		
Bench	Brick	Sound	No			
	Bench Debris Depth (Inches):			Bench Debris:		
Channel	Brick	Sound	No			
	Channel Debris Depth (Inches):			Channel Debris:		
Surcharge from Invert Evident? No				Currently:	Marks To:	
Additional Comments:

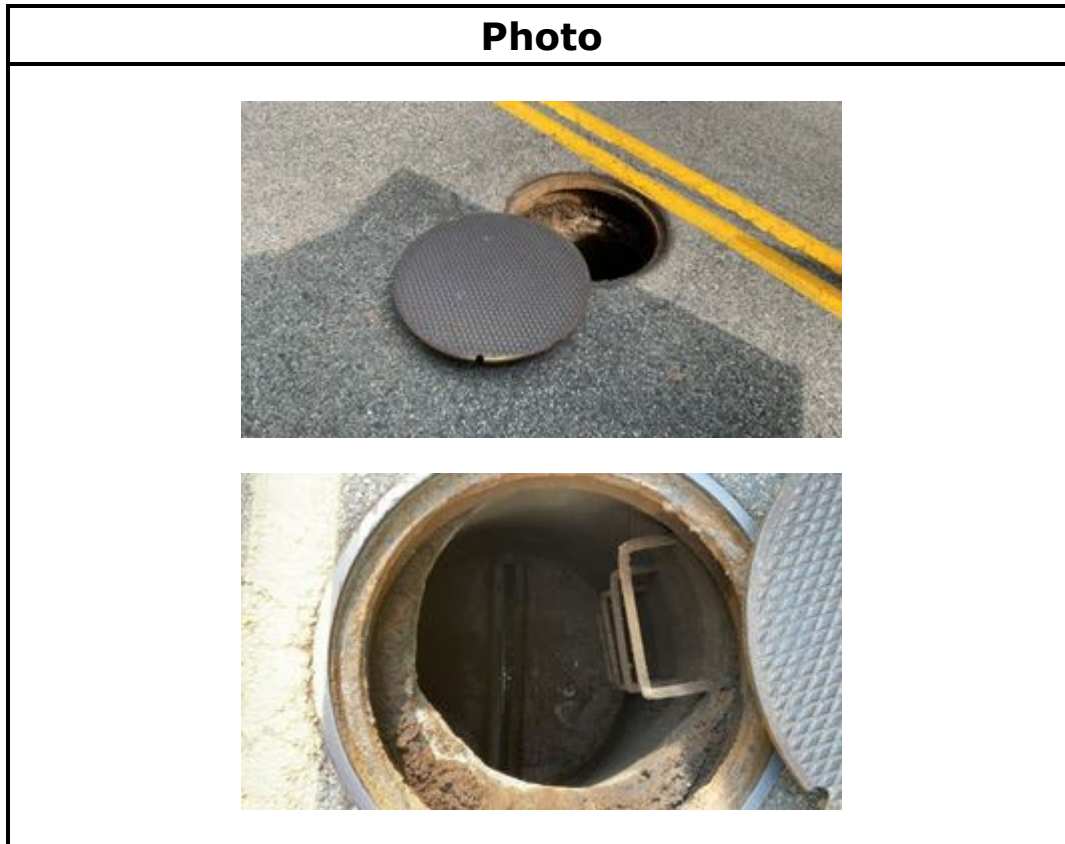
Westwood, MA Manhole Inspections
Manhole ID: 15/012
Westwood, MA

Manhole Information			
Cover Material	Cast Iron	Holes In Cover	Yes
Cover Condition	Sound	Number of Holes	2
Cover Defects		Hole Size (inches)	0.75
Cover Size (inches)	26	Grade	At Grade
Clear Opening Diameter	24	Surface Materials	Paved
Drainage Area (sqft)	4	Cracked Pavement Surrounding Frame	Yes
Cover Comments

Internal Manhole Observations						
Item	Material	Condition	Infiltration?	Infiltration (GPM)	Defects	Comments
Frame	Cast Iron	Defective	No		Offset 2 inches	
Chimney	Precast	Sound	No			
Cone	Precast	Sound	No			
Walls	Precast	Sound	No			
Steps	Present? Yes	# of Steps: 4		Material: Metal		
Bench	Poured in place	Sound	No			
	Bench Debris Depth (Inches): 1			Bench Debris: Sediment		
Channel	ACP	Sound	No			
	Channel Debris Depth (Inches):			Channel Debris:		
Surcharge from Invert Evident? No				Currently:		Marks To:
Additional Comments:

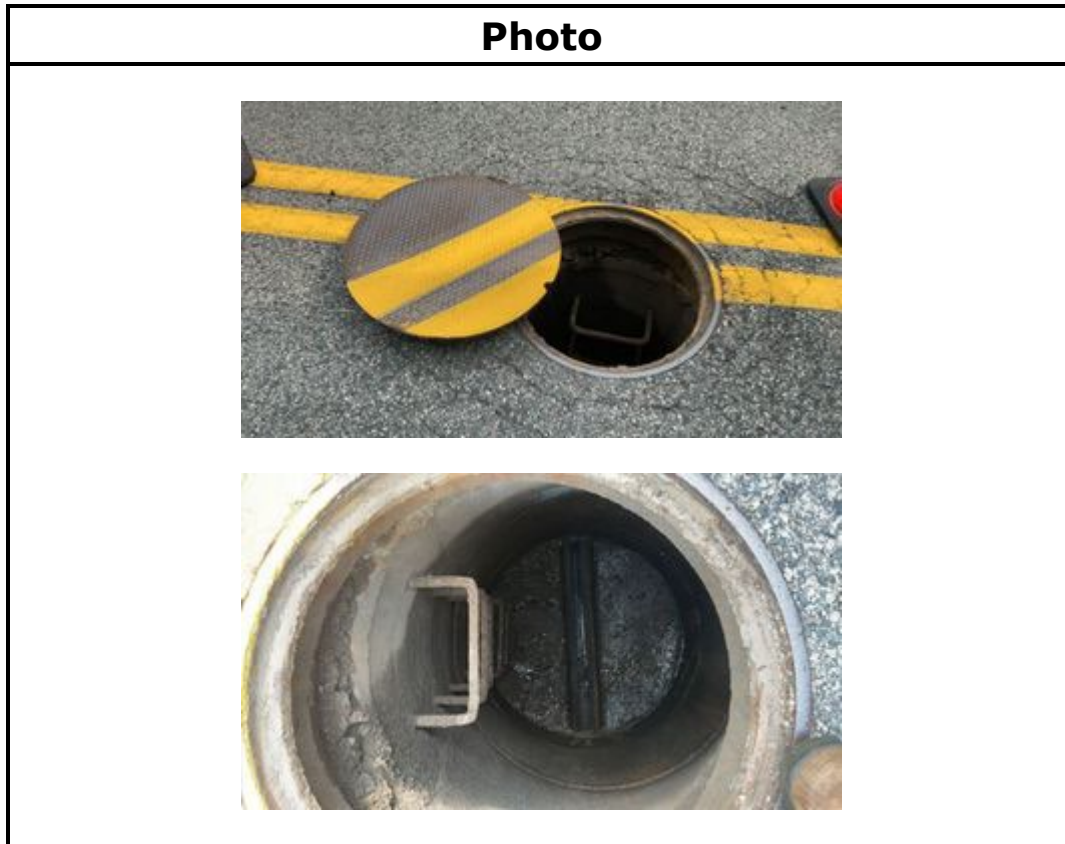
Westwood, MA Manhole Inspections Manhole ID: 15/011 Westwood, MA

Internal Manhole Observations						
Item	Material	Condition	Infiltration?	Infiltration (GPM)	Defects	Comments
Frame	Cast Iron	Sound	No			
Chimney	Precast	Sound	No			
Cone	Precast	Sound	No			
Walls	Precast	Defective	Yes	0.01	IRJ	
Steps	Present? Yes	# of Steps: 5		Material: Metal		
Bench	Poured in place	Sound	No			
	Bench Debris Depth (Inches): 2			Bench Debris: Sediment		
Channel	ACP	Sound	No			
	Channel Debris Depth (Inches):			Channel Debris:		
Surcharge from Invert Evident? No				Currently:		Marks To:
Additional Comments:

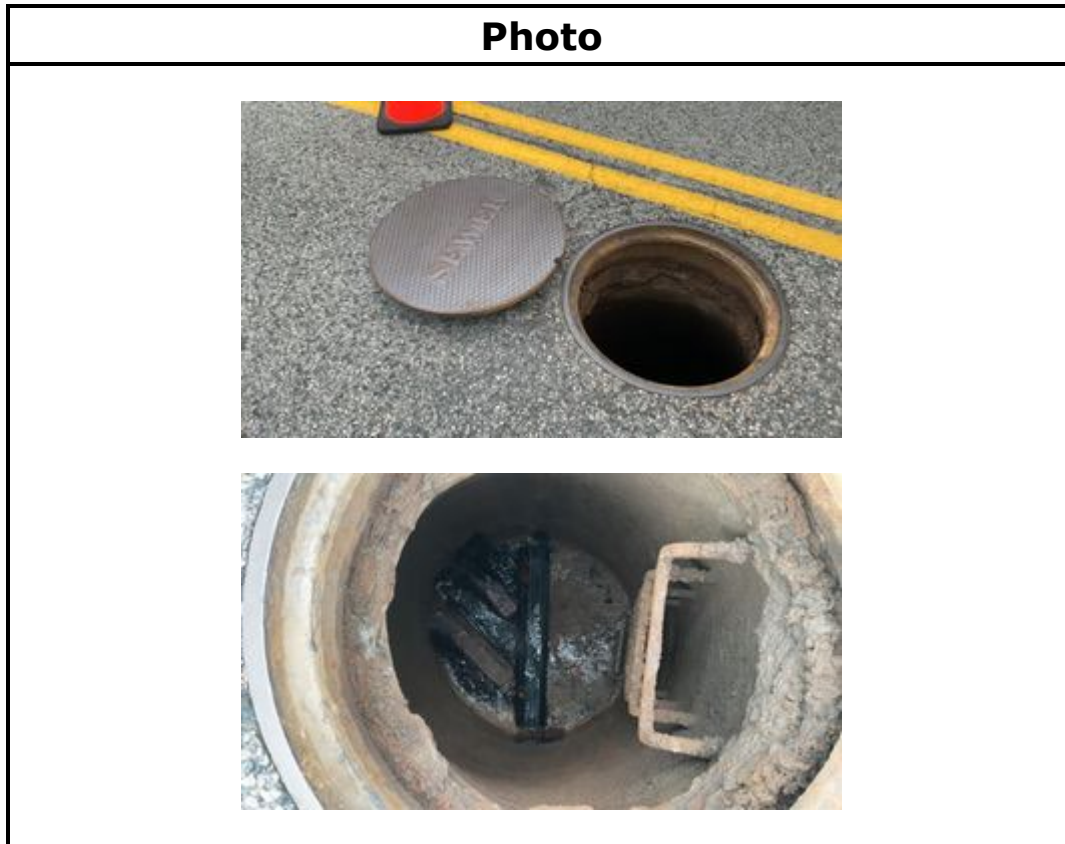
Westwood, MA Manhole Inspections
Manhole ID: 15/006
Westwood, MA

Internal Manhole Observations						
Item	Material	Condition	Infiltration?	Infiltration (GPM)	Defects	Comments
Frame	Cast Iron	Sound	No			
Chimney	Brick, Parged	Sound	No			
Cone	Parged	Sound	No			
Walls	Parged	Defective	Yes	0.01	IR	
Steps	Present? Yes	# of Steps: 6		Material: Metal		
Bench	Parged	Sound	No			
	Bench Debris Depth (Inches):			Bench Debris:		
Channel	Brick, Poured in place	Sound	No			
	Channel Debris Depth (Inches):			Channel Debris:		
Surcharge from Invert Evident? No				Currently:	Marks To:	
Additional Comments:

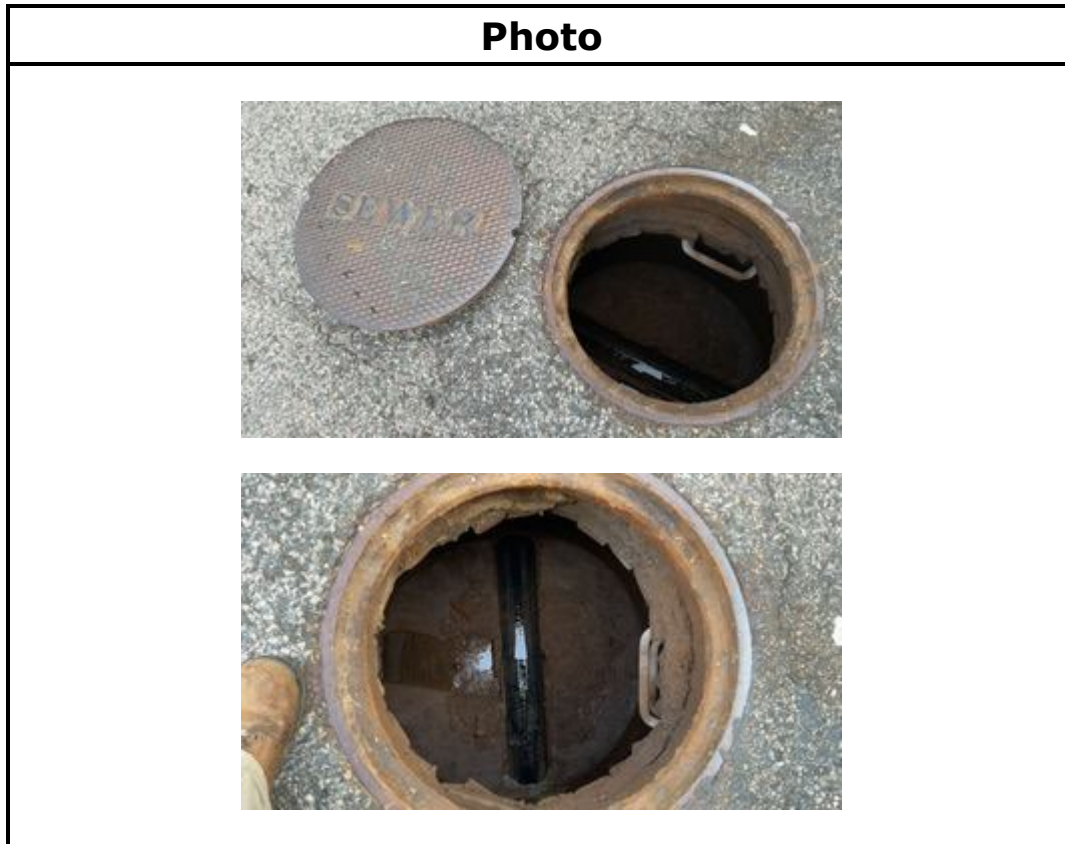
Westwood, MA Manhole Inspections
Manhole ID: 15/002
Westwood, MA

Internal Manhole Observations						
Item	Material	Condition	Infiltration?	Infiltration (GPM)	Defects	Comments
Frame	Cast Iron	Sound	No			
Chimney	Brick	Defective	No		MMM	
Cone	Brick	Sound	No			
Walls	Brick, Precast	Sound	No			
Steps	Present? Yes	# of Steps: 2		Material: Metal		
Bench	Poured in place	Sound	No			
	Bench Debris Depth (Inches):			Bench Debris:		
Channel	ACP	Sound	No			
	Channel Debris Depth (Inches):			Channel Debris:		
Surcharge from Invert Evident? No				Currently:	Marks To:	
Additional Comments:

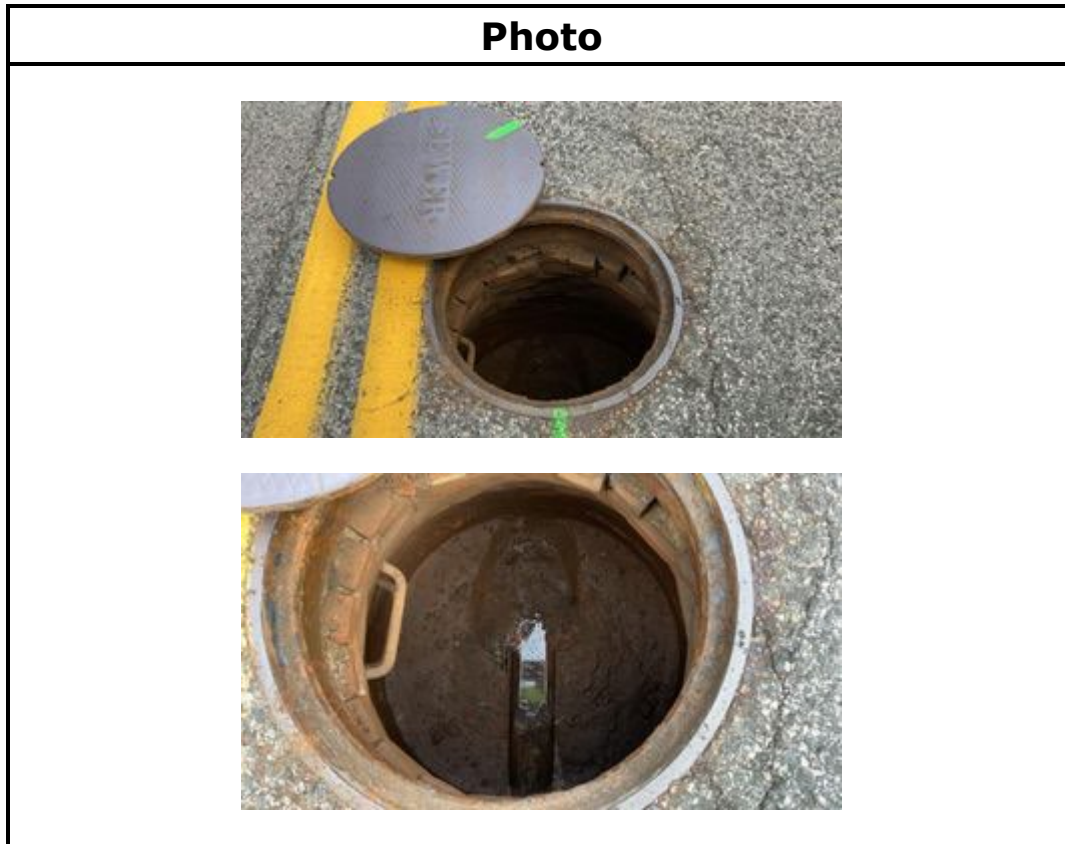
Westwood, MA Manhole Inspections Manhole ID: 15/001 Westwood, MA

Internal Manhole Observations						
Item	Material	Condition	Infiltration?	Infiltration (GPM)	Defects	Comments
Frame	Cast Iron	Sound	No			
Chimney	Brick	Defective	No		MML, MB	
Cone	Brick	Defective	No		MMS	
Walls	Brick, Precast	Sound	No			
Steps	Present? Yes	# of Steps: 2		Material: Metal		
Bench	Poured in place	Sound	No			
	Bench Debris Depth (Inches): 0.5			Bench Debris: Sediment		
Channel	Poured in place, ACP	Sound	No			
	Channel Debris Depth (Inches): 0.75			Channel Debris: Sediment		
Surcharge from Invert Evident? No				Currently:	Marks To:	
Additional Comments:

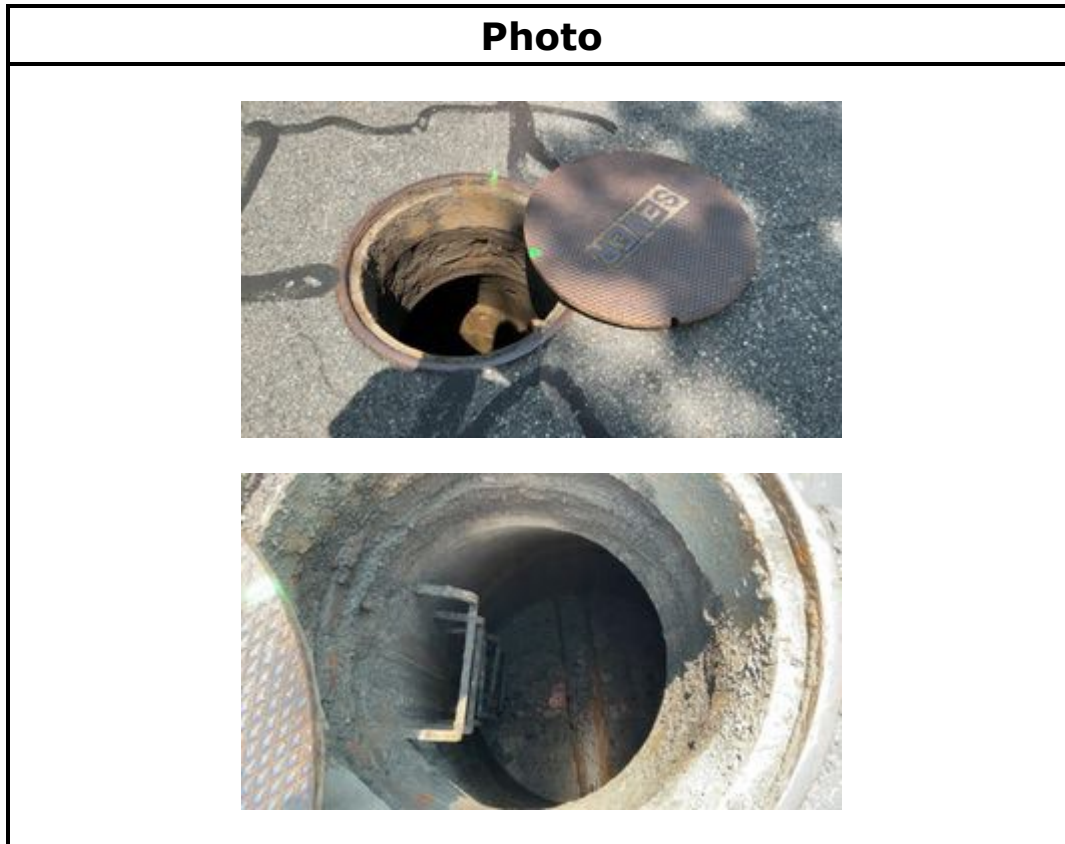
Westwood, MA Manhole Inspections
Manhole ID: 15/049
Westwood, MA

Internal Manhole Observations						
Item	Material	Condition	Infiltration?	Infiltration (GPM)	Defects	Comments
Frame	Cast Iron	Sound	No			
Chimney	Brick	Sound	No			
Cone	Parged	Defective	No		Lift holes missing mortar	
Walls	Precast	Defective	No		Lift holes missing mortar	
Steps	Present? Yes	# of Steps: 5		Material: Metal		
Bench	Brick	Sound	No			
	Bench Debris Depth (Inches): 2			Bench Debris: Sediment		
Channel	Brick	Sound	No			
	Channel Debris Depth (Inches): 0.5			Channel Debris: Sediment		
Surcharge from Invert Evident? No				Currently:		Marks To:
Additional Comments:

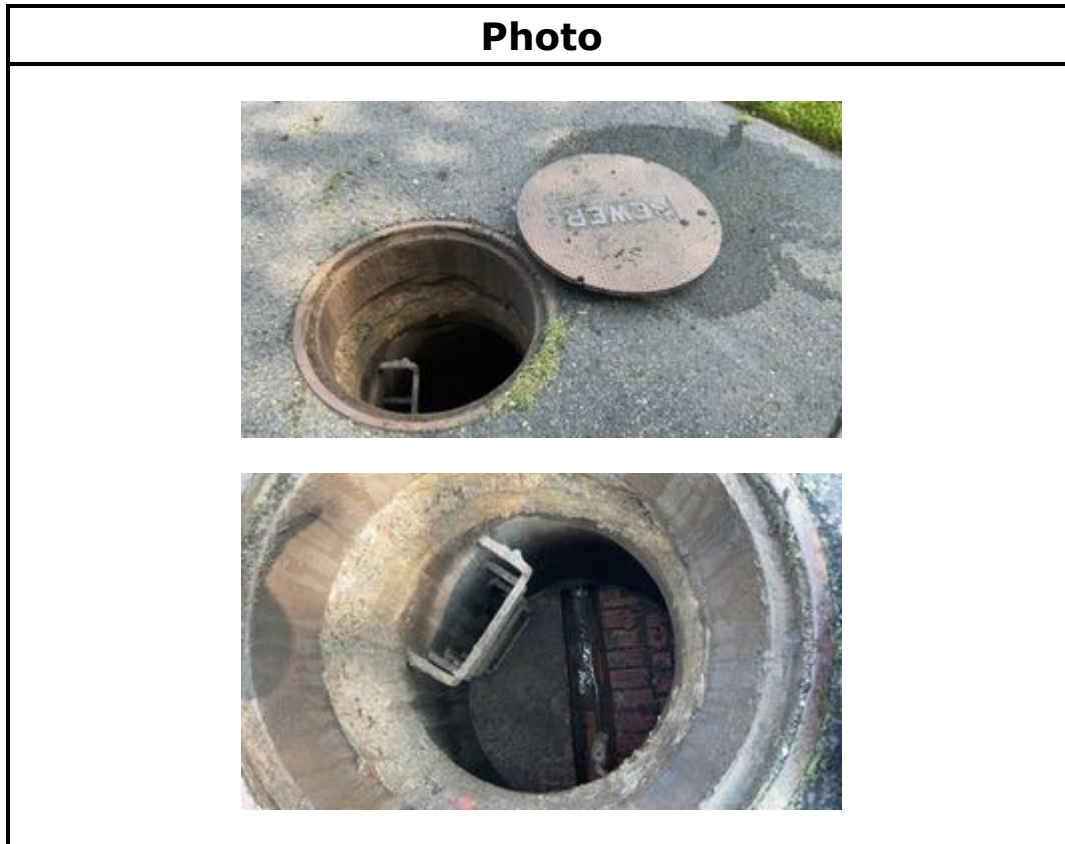
Westwood, MA Manhole Inspections
Manhole ID: 15/039
Westwood, MA

Internal Manhole Observations						
Item	Material	Condition	Infiltration?	Infiltration (GPM)	Defects	Comments
Frame	Cast Iron	Sound	No			
Chimney	Brick, Precast, Parged	Sound	No			
Cone	Precast	Sound	No			
Walls	Precast	Defective	No		MMM	
Steps	Present? Yes	# of Steps: 4		Material: Metal		
Bench	Brick	Sound	No			
	Bench Debris Depth (Inches): 2.5			Bench Debris: Sediment		
Channel	Brick	Sound	No			
	Channel Debris Depth (Inches): 0.5			Channel Debris: Sanitary		
Surcharge from Invert Evident? No				Currently:		Marks To:
Additional Comments:

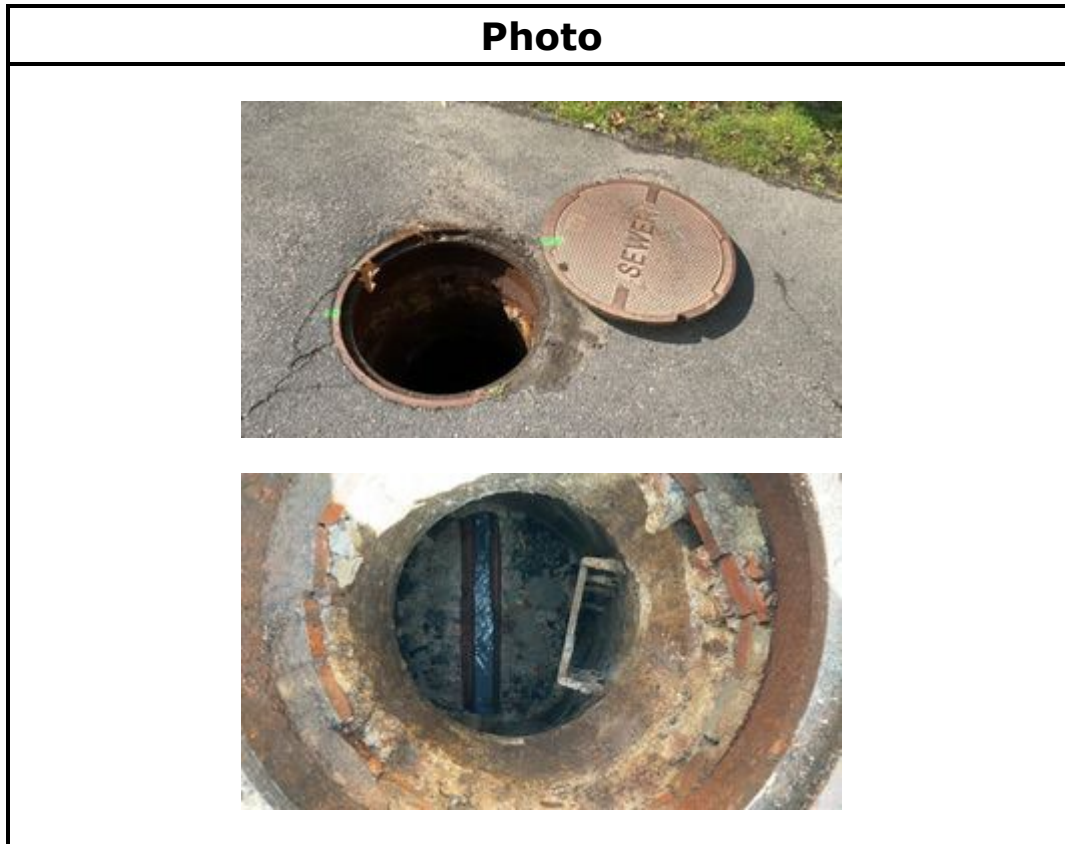
Westwood, MA Manhole Inspections
Manhole ID: 15/016
Westwood, MA

Manhole Information			
Cover Material	Cast Iron	Holes In Cover	Yes
Cover Condition	Sound	Number of Holes	2
Cover Defects		Hole Size (inches)	0.75
Cover Size (inches)	26	Grade	Below Grade
Clear Opening Diameter	24	Surface Materials	Paved
Drainage Area (sqft)	10	Cracked Pavement Surrounding Frame	Yes
Cover Comments

Internal Manhole Observations						
Item	Material	Condition	Infiltration?	Infiltration (GPM)	Defects	Comments
Frame	Cast Iron	Sound	No			
Chimney	Brick	Defective	No		MB, MMS, HSV	
Cone	Parged	Sound	No			
Walls	Parged	Sound	No			
Steps	Present? Yes	# of Steps: 5		Material: Metal		
Bench	Parged	Sound	No			
	Bench Debris Depth (Inches): 2			Bench Debris: Sediment		
Channel	Brick	Sound	No			
	Channel Debris Depth (Inches):			Channel Debris:		
Surcharge from Invert Evident? No				Currently:		Marks To:
Additional Comments:

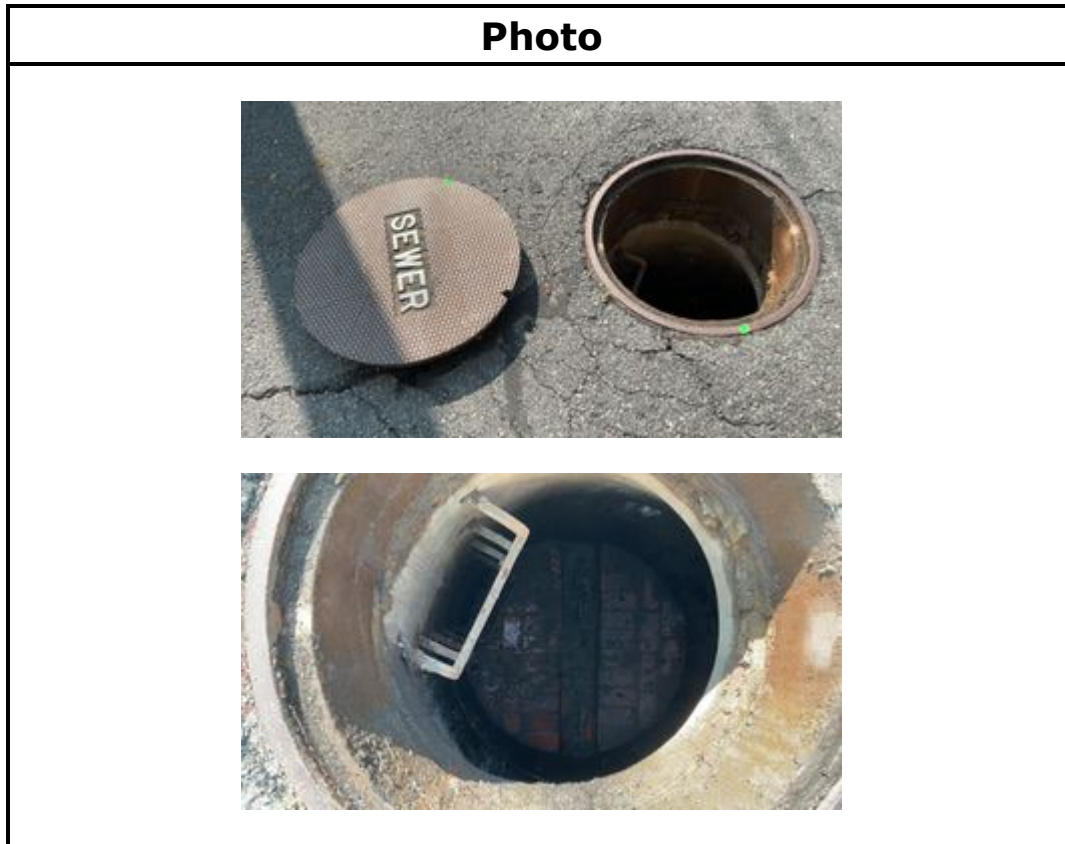
Westwood, MA Manhole Inspections
Manhole ID: 15/019
Westwood, MA

Internal Manhole Observations						
Item	Material	Condition	Infiltration?	Infiltration (GPM)	Defects	Comments
Frame	Cast Iron	Sound	No			
Chimney	Brick, Precast	Sound	No			
Cone	Precast	Sound	No			
Walls	Precast	Sound	No			
Steps	Present? Yes	# of Steps: 5		Material: Metal		
Bench	Brick	Sound	No			
	Bench Debris Depth (Inches):			Bench Debris:		
Channel	Brick	Sound	No			
	Channel Debris Depth (Inches): 0.75			Channel Debris: Sanitary, Sediment		
Surcharge from Invert Evident? No				Currently:		Marks To:
Additional Comments:

Line Conditions												
In/Out	Compass Direction	Pipe Size	Pipe Material	Rim to Invert Depth	Condition	Flow Depth	Defects	Infiltration	Infiltration (GPM)	Debris	Debris Depth	Debris Material
Out	15/018	8"	ACP	7'9"	Sound	0"	No	No	N/A	Yes	0.25"	Sediment
Additional Comments:

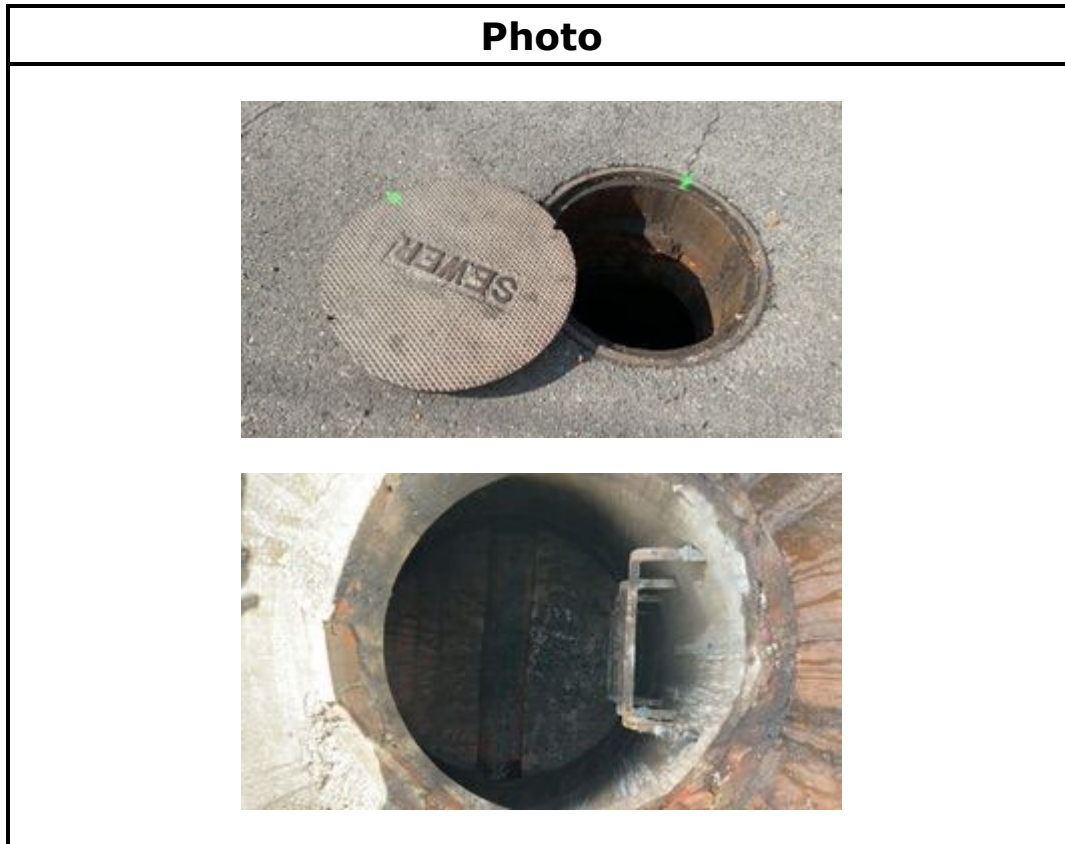
Westwood, MA Manhole Inspections
Manhole ID: 15/037
Westwood, MA

Internal Manhole Observations						
Item	Material	Condition	Infiltration?	Infiltration (GPM)	Defects	Comments
Frame	Cast Iron	Sound	No			
Chimney	Brick, Precast	Defective	No		MMS, HSV	
Cone	Precast	Sound	No			
Walls	Precast	Defective	No		Lift hole missing mortar	
Steps	Present? Yes	# of Steps: 4		Material: Metal		
Bench	Brick	Sound	No			
	Bench Debris Depth (Inches): 1			Bench Debris: Sediment		
Channel	Brick	Sound	No			
	Channel Debris Depth (Inches): 1			Channel Debris: Sediment		
Surcharge from Invert Evident? No				Currently:		Marks To:
Additional Comments:

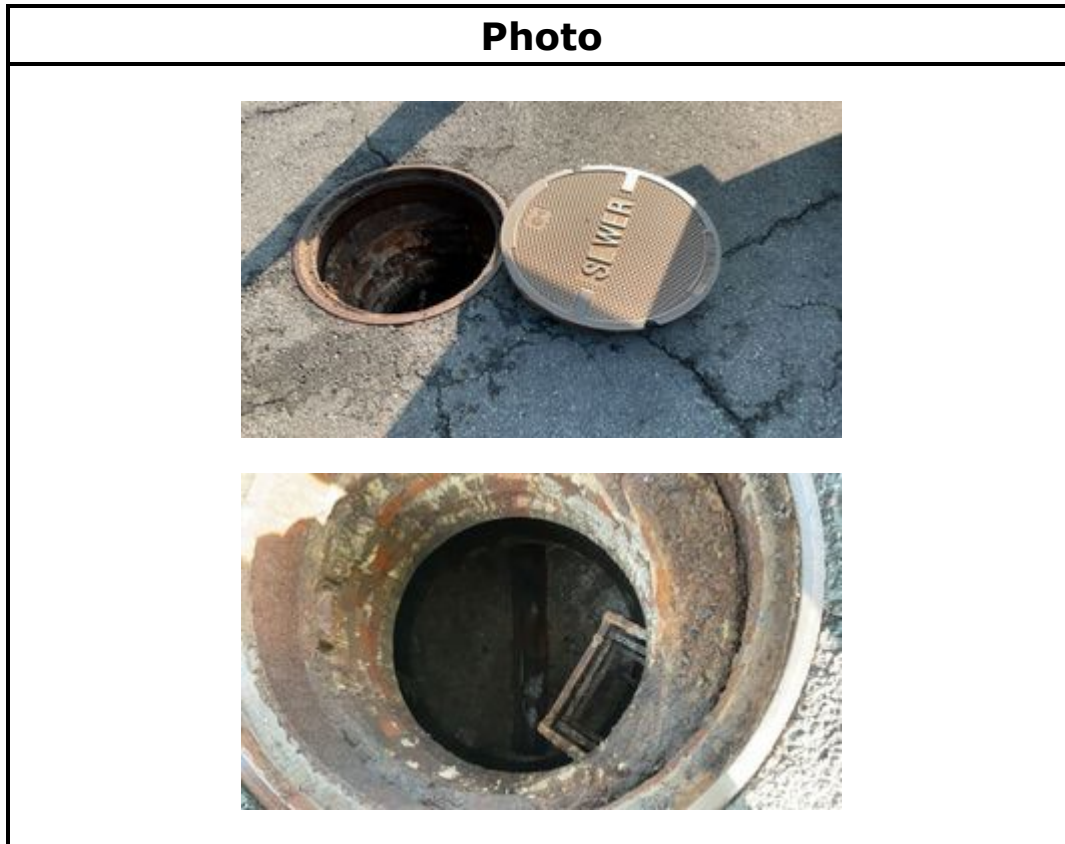
Westwood, MA Manhole Inspections
Manhole ID: 15/021
Westwood, MA

Manhole Information			
Cover Material	Cast Iron	Holes In Cover	Yes
Cover Condition	Sound	Number of Holes	2
Cover Defects		Hole Size (inches)	0.75
Cover Size (inches)	26	Grade	At Grade
Clear Opening Diameter	24	Surface Materials	Paved
Drainage Area (sqft)	6	Cracked Pavement Surrounding Frame	Yes
Cover Comments

Internal Manhole Observations						
Item	Material	Condition	Infiltration?	Infiltration (GPM)	Defects	Comments
Frame	Cast Iron	Defective	No		Offset 4"	
Chimney	Brick, Precast	Sound	No			
Cone	Brick	Sound	No			
Walls	Brick	Sound	No			
Steps	Present? Yes	# of Steps: 4		Material: Metal		
Bench	Brick, Parged	Sound	No			
	Bench Debris Depth (Inches):			Bench Debris:		
Channel	Brick	Sound	No			
	Channel Debris Depth (Inches): 0.5			Channel Debris: Sanitary		
Surcharge from Invert Evident? No				Currently:		Marks To:
Additional Comments:

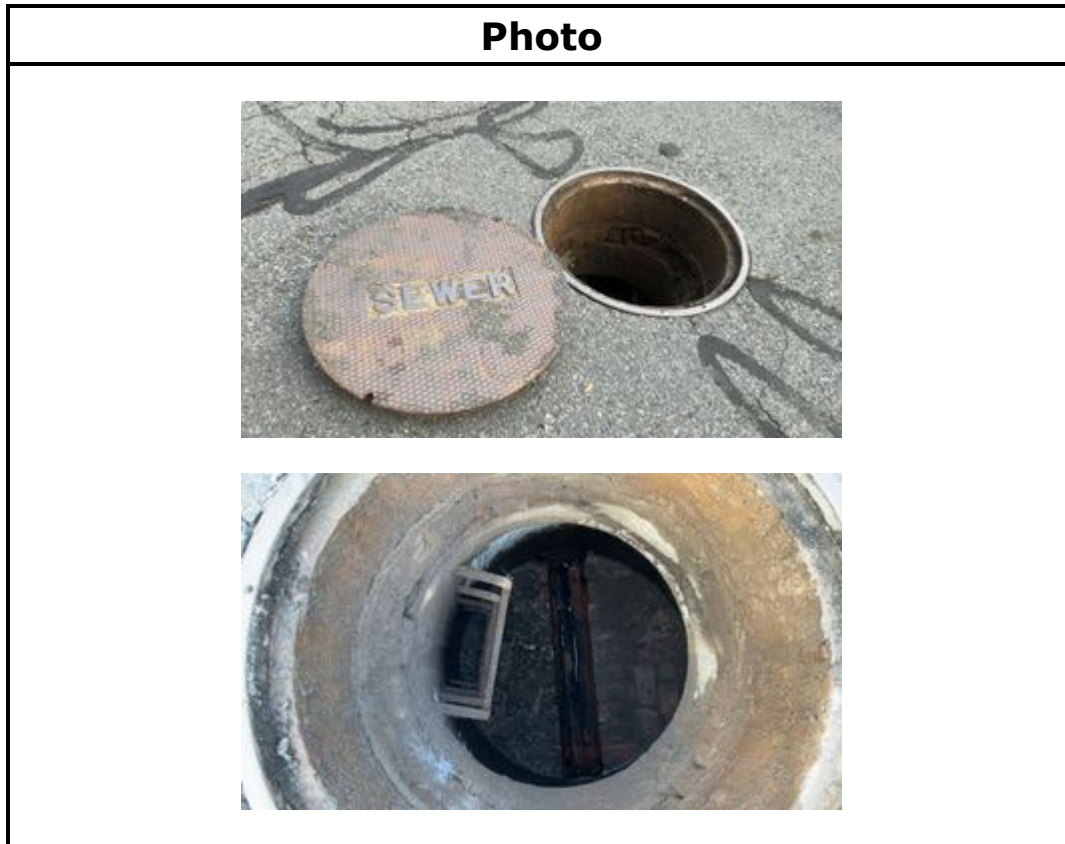
Westwood, MA Manhole Inspections Manhole ID: 15/013 Westwood, MA

Internal Manhole Observations						
Item	Material	Condition	Infiltration?	Infiltration (GPM)	Defects	Comments
Frame	Cast Iron	Sound	No			
Chimney	Brick, Precast	Defective	No		MB, MMM	
Cone	Precast	Sound	No			
Walls	Precast	Sound	No			
Steps	Present? Yes	# of Steps: 4		Material: Metal		
Bench	Brick	Sound	No			Bricks
	Bench Debris Depth (Inches): 0.5			Bench Debris: Sediment, Other		
Channel	Brick	Sound	No			
	Channel Debris Depth (Inches):			Channel Debris:		
Surcharge from Invert Evident? No				Currently:		Marks To:
Additional Comments:
