# June Street Playground

## Town of Westwood ADA Transition Plan

June 2023

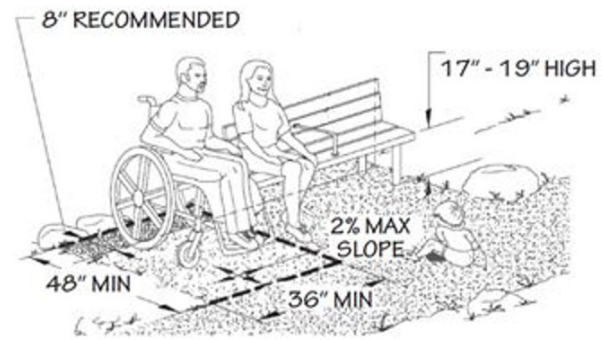
See the following illustration for best practice recommendations for benches:

- Recommend providing a 36" by 48" min. stable, firm and slip-resistant area alongside at least one bench in each distinct area where benches are provided so that a person using a wheelchair or other mobility device is able to sit alongside someone seated on the bench with their shoulders aligned.

Recommend providing a 36" by 48" min. stable, firm and slip-resistant area alongside at least one bench in each distinct area where benches are provided so that a person using a wheelchair or other mobility device is able to sit alongside someone seated on the bench with their shoulders aligned.	1	-	-
<div style="border: 1px solid gray; padding: 2px;">Off-Street Parking Lot or Garage</div>												
6	Route to Park	Ext.		Off-Street Parking Lot or Garage	N/A
