# Westwood High School

## Town of Westwood ADA Transition Plan

October 2023

Institute for Human Centered Design

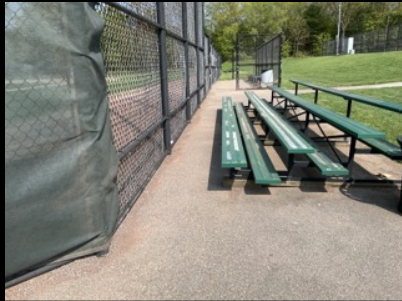
Exterior route < 36" wide	29"	Ensure that a clear width of 36" min. is maintained at the accessible route. Move the bench bleacher back to ensure that even when a wheelchair user is seated shoulder to shoulder with a companion seated on the bleacher that there is a circulation path that is no less than 36" wide min., 48" wide preferred.	1	Labor	Labor

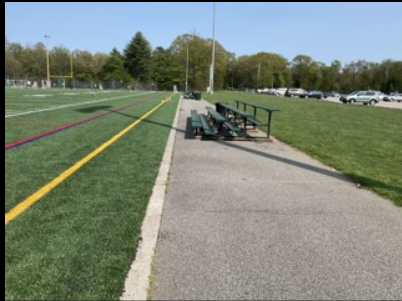
3	Turf Soccer Field (4 Bleachers)	Ext.		Exterior Access Route	Exterior

Exterior route < 36" wide	15"	Ensure that a clear width of 36" min. is maintained at the accessible route. Move the bench bleacher back to ensure that even when a wheelchair user is seated shoulder to shoulder with a companion seated on the bleacher that there is a circulation path that is no less than 36" wide min., 48" wide preferred.	4	Labor	Labor
4	Softball Field First Base Team Seating Area	Ext.		Exterior Access Route	Team Seating Area

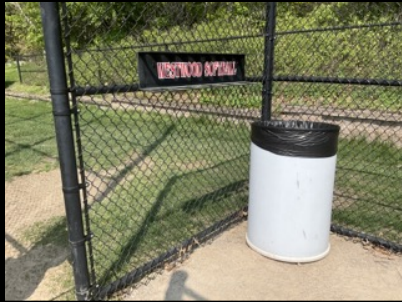
Obstructed by protruding objects	5"	Remove the object mounted on the fence. Alternatively provide a cane-detectable barrier underneath it that is no higher than 27" above the ground.	1	Labor	Labor
5	East Lot by Tennis Court	Ext.		Exterior Access Route	Exterior

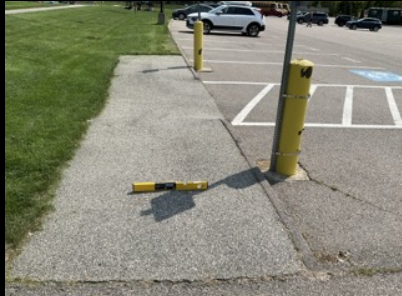
Cross slope > 1:50 (2.00%)	3%	Reduce cross slope to be no steeper than 1:50 (2.00%).	1	-	-

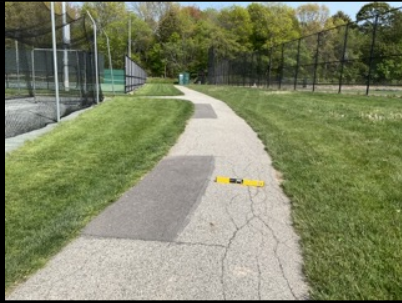
Cross slope > 1:50 (2.00%)	5%	Reduce cross slope to be no steeper than 1:50 (2.00%).	1	-	-
8	To Baseball Field First Base Side Team Seating	Ext.		Exterior Access Route	Exterior

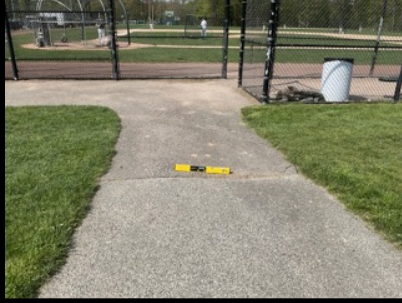
Cross slope > 1:50 (2.00%) Running slope > 1:20 (5.00%)	7.3% 6%	Reduce cross slope to be no steeper than 1:50 (2.00%). Reduce running slope to be no steeper than 1:20 (5.00%).	1	-	-
9	From Nahatan Street to Field	Ext.		Exterior Access Route	Exterior

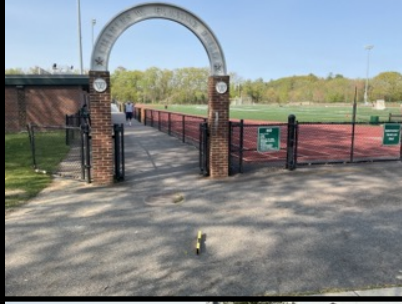
Running slope > 1:20 (5.00%)	8.8%	Reduce running slope to be no steeper than 1:20 (5.00%).	1	-	-

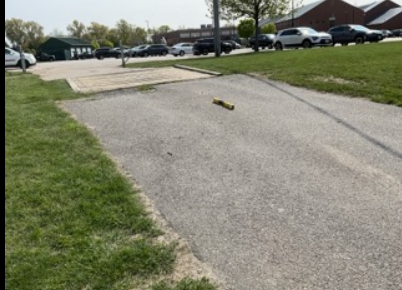
10	Parking to Turf Soccer Field	Ext.		Exterior Access Route	Exterior

Running slope > 1:20 (5.00%)	12%	Reduce running slope to be no steeper than 1:20 (5.00%).	1	-	-

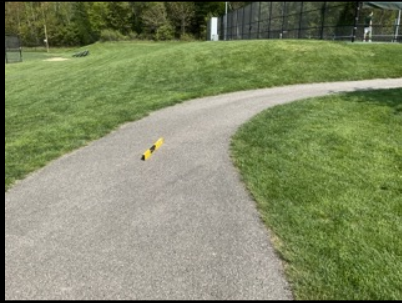
Cross slope > 1:50 (2.00%) Running slope > 1:20 (5.00%)	3% 5.5%	Reduce cross slope to be no steeper than 1:50 (2.00%). Reduce running slope to be no steeper than 1:20 (5.00%).	1	-	-
13	Parking to Turf Soccer Field	Ext.		Exterior Access Route	Exterior

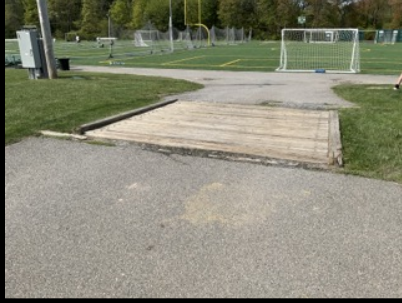
Surface openings > 1/2" Level changes > 1/4"	9" 1"	Ensure that surface openings are 1/2" max. Alter change in level to be 1/4" high max.	2	-	-
14	Around Football Field	Ext.		Exterior Access Route	Walkway

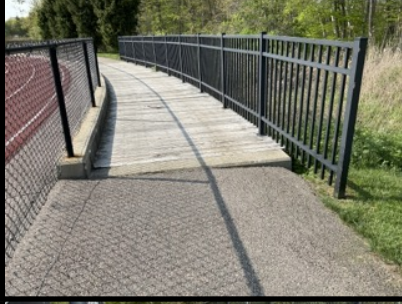
Surface openings > 1/2" Level changes > 1/4"	2" 2"	Ensure that surface openings are 1/2" max. Alter change in level to be 1/4" high max.	1	-	-

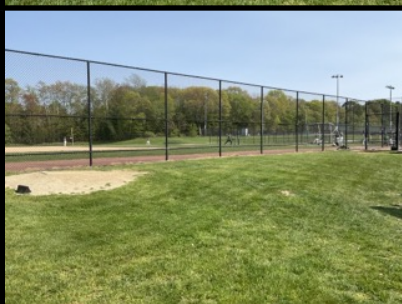
19	Pitching Practice Area Near Baseball Field Third Base Side Team Seating	Ext.		Exterior Access Route	Exterior

Accessible route not provided	-	Provide an accessible route to the practice pitching mound that is firm, stable and slip-resistant.	1	-	-
20	Volleyball Court, Batting Cage, and Soccer Field	Ext.		Exterior Access Route	Exterior

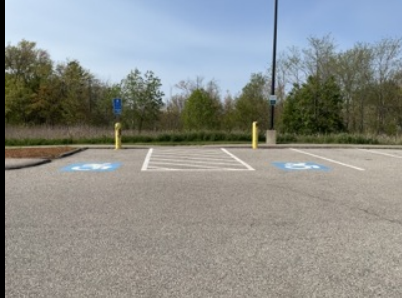
Sign with the International Symbol of Acc. not provided Sign bottom < 60" above finished grade	-	Provide a sign with the International Symbol of Accessibility (ISA) with the bottom of the sign 60" min. above the ground and the top 96" max. above the ground. Locate sign with the bottom of the sign 60" above the ground.	1	650 Labor	\$650

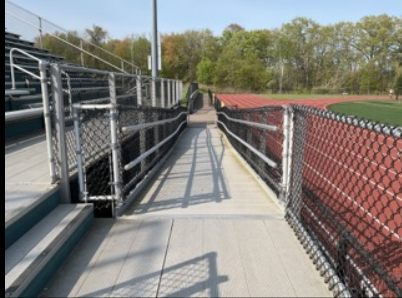
Handrails do not extend 12" past top & bottom	-	Alter handrails to extend horizontally above the landing for 12" min. beyond the top of ramp runs.	2	185	\$370
											<b>370</b>	
30	South Ramp to Bleacher at Football Field	Ext.		Exterior Ramp	N/A

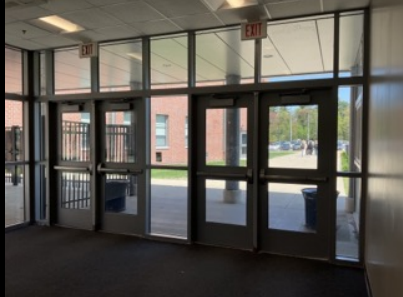
33	Gymnasium, Door 22	1		Means of Egress	N/A

Tactile exit sign not provided	-	Ensure that a tactile exit sign with raised characters and braille is provided at the exit door. Since each door has an active leaf, the sign must be located to the right of the doors mounted between 48"- 60" above the finished floor.	2	302	\$604
											<b>604</b>	
34	Gymnasium, Door 28	1		Means of Egress	N/A

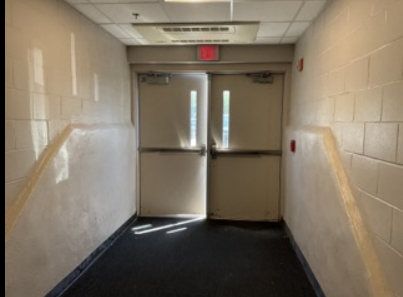
Tactile exit sign not provided	-	Ensure that a tactile exit sign with raised characters and braille is provided at the exit door. Mount the sign between 48"- 60" above the finished floor located on the adjacent wall on the right side of the right hand door.	1	302	\$302
											<b>302</b>	
35	Door 13 From Auditorium Entrance Lobby	1		Means of Egress	N/A

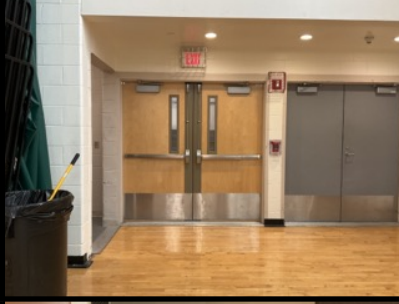
Tactile exit sign not provided Directional sign to accessible emergency exit not provided	- -	Ensure that a tactile exit sign with raised characters and braille is provided at the exit door. Mount the sign between 48"- 60" above the finished floor. Provide a directional sign indicating the location of the nearest accessible emergency exit. Both signs should be located alongside the door on the right side of the right hand door.	1	302 302	\$604

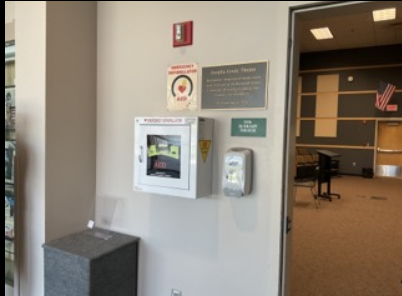
Obstructed by protruding objects	7"	Provide a cane-detectable barrier under the defibrillator.	1	398	\$398
50	Auditorium	1	B118	Interior Access Route	N/A

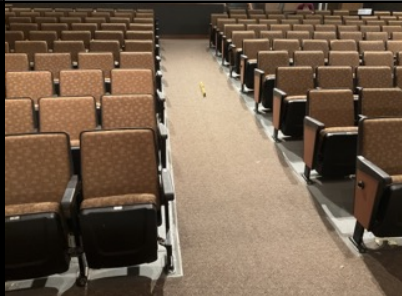
Running slope > 1:12 (8.33)	13.5%	Further study will be needed to determine whether it is technically feasible to bring the route into full compliance with the ADA Standards.	2	-	-

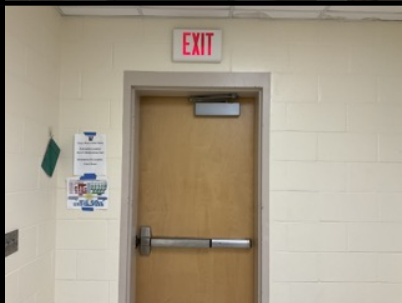
Maneuvering clearance not provided at recess > 6" Door requires > 5 lbs. of force to open	10" 12 lbs	Install an automatic door opener. Adjust closers so doors do not require more than 5 pounds of force to open.	1	3978 Labor	\$3978
58	Auditorium, Door 11	1	B118	Doors, Doorways, & Gates	Emergency Egress

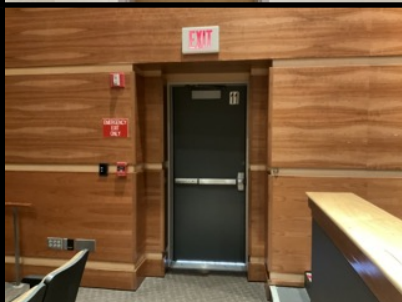
Maneuvering clearance not provided at recess > 6" Door requires > 5 lbs. of force to open	25" 20 lbs	Install an automatic door opener. Adjust closers so doors do not require more than 5 pounds of force to open.	1	3978	\$3978

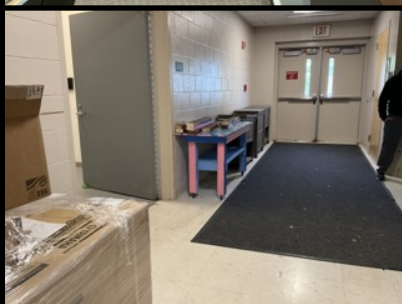
59	Near Door 8	1		Doors, Doorways, & Gates	Emergency Egress

Mat not securely attached	-	Secure the mat.	1	Labor	Labor
60	Auditorium, Door 11	1	B118	Doors, Doorways, & Gates	Emergency Egress

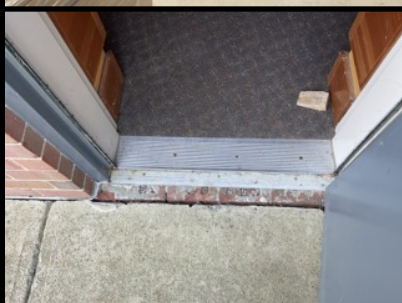
Threshold > 1/2" high	1.5"	Alter the threshold to be 1/2" high max.	1	195	\$195

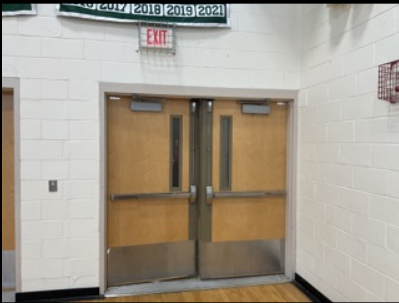
Door requires > 5 lbs. of force to open	15 lbs	Adjust closers so doors do not require more than 5 pounds of force to open.	1	Labor	Labor
63	Women's Multi-User Toilet Room Near Pool Lounge	1		Doors, Doorways, & Gates	Toilet Room

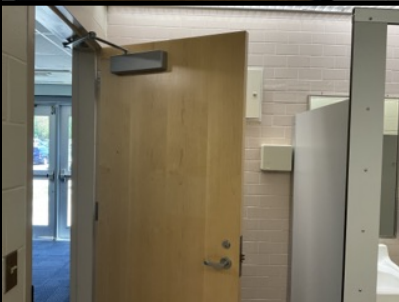
Door requires > 5 lbs. of force to open	13 lbs	Adjust closers so doors do not require more than 5 pounds of force to open.	1	Labor	Labor
64	Men's Multi-User Toilet Room Near Pool Lounge	1		Doors, Doorways, & Gates	Toilet Room

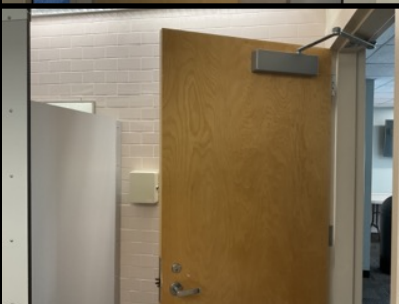
Door requires > 5 lbs. of force to open	12 lbs	Adjust closers so doors do not require more than 5 pounds of force to open.	1	Labor	Labor

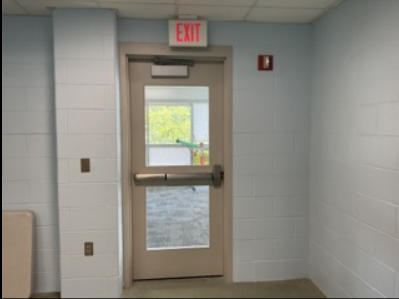
Door requires > 5 lbs. of force to open	15 lbs	Adjust closers so doors do not require more than 5 pounds of force to open.	2	Labor	Labor
68	Men's Multi-User Toilet Room Near Auditorium	1		Doors, Doorways, & Gates	Toilet Room

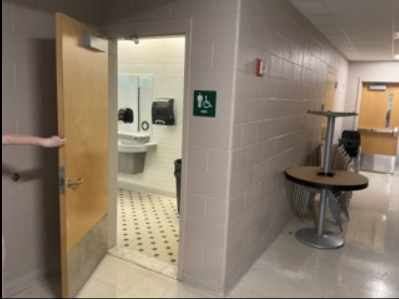
Clear width at door < 32" Door requires > 5 lbs. of force to open	29.5" 13 lbs	Widen the door so that there is 32" min. clear width. Adjust closers so doors do not require more than 5 pounds of force to open.	1	4376 Labor	\$4376
69	Women's Multi-User Toilet Room Near Auditorium	1		Doors, Doorways, & Gates	Toilet Room

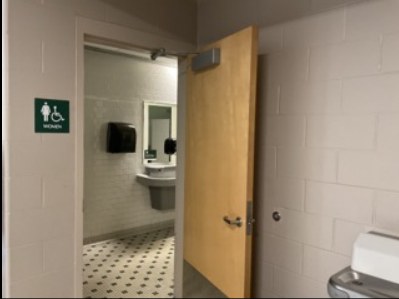
Clear width at door < 32" Door requires > 5 lbs. of force to open	29" 10 lbs	Widen the door so that there is 32" min. clear width. Adjust closers so doors do not require more than 5 pounds of force to open.	1	4376 Labor	\$4376

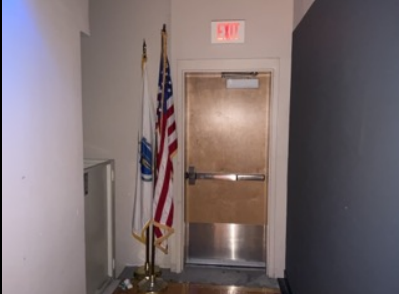
70	Auditorium, Door Next to Lift to Stage	1	B118	Doors, Doorways, & Gates	Circulation

Maneuvering clearance(s) not provided Door requires > 5 lbs. of force to open	- 15 lbs	Relocate flags. Adjust closers so doors do not require more than 5 pounds of force to open.	1	Labor	Labor

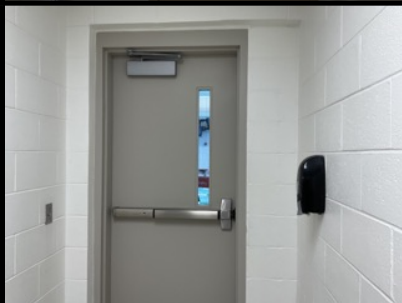
Maneuvering clearance(s) not provided Door requires > 5 lbs. of force to open	10" 10 lbs	Provide an automatic door opener. Adjust closers so doors do not require more than 5 pounds of force to open.	1	3978 Labor	\$3978

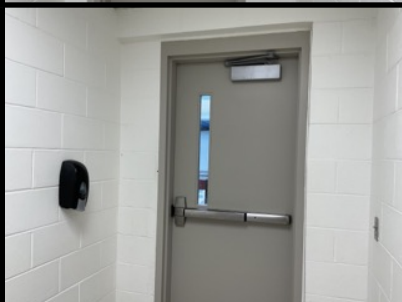
73	Men's Locker Room	1	C151	Doors, Doorways, & Gates	Toilet Room

Maneuvering clearance(s) not provided Door requires > 5 lbs. of force to open	10" 15 lbs	Provide an automatic door opener. Adjust closers so doors do not require more than 5 pounds of force to open.	1	3978 Labor	\$3978
74	Men's Locker Room	1	C151	Doors, Doorways, & Gates	Toilet Room

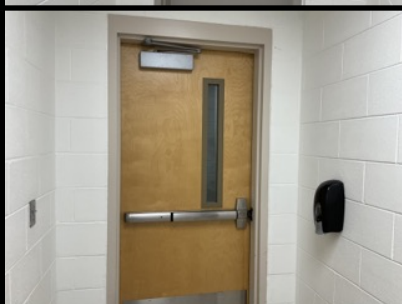
Maneuvering clearance(s) not provided Door requires > 5 lbs. of force to open	10" 10 lbs	Provide an automatic door opener. Adjust closers so doors do not require more than 5 pounds of force to open.	1	3978 Labor	\$3978
75	Women's Gym Locker Room	1		Doors, Doorways, & Gates	Toilet Room

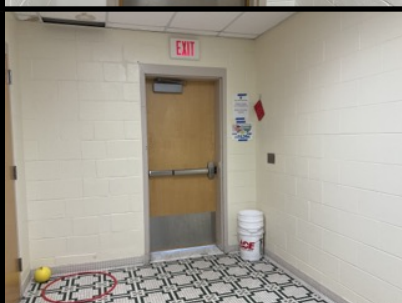
Maneuvering clearance not provided at recess > 6" Door requires > 5 lbs. of force to open	10" 10 lbs	Install an automatic door opener. Adjust closers so doors do not require more than 5 pounds of force to open.	1	3978 Labor	\$3978

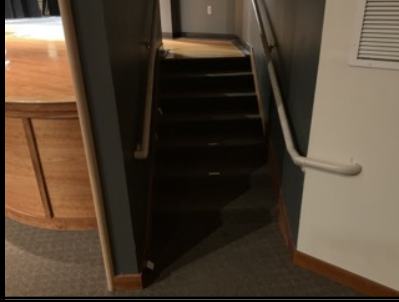
Handrail height < 34" or > 38"	30"	Alter so the handrails are 34"- 38" high above the floor.	2	Labor	Labor
83	To Pool	1	C145	Stairways	Interior

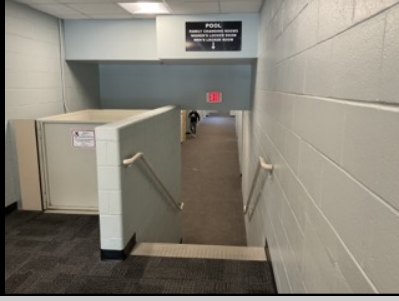
Handrail height < 34" or > 38"	29"	Alter so the handrails are 34"- 38" high above the floor.	2	Labor	Labor
<b>Platform Lift</b>												
84	Lift	1	B118	Platform Lift	N/A

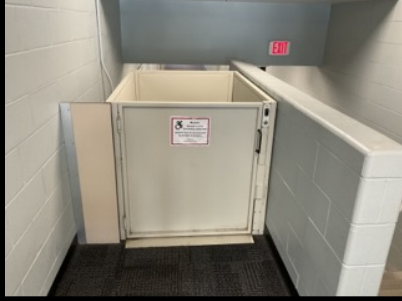
Door lacks maneuvering clearance	-	Provide an automatic door opener.	1	3978	\$3978
											<b>3978</b>

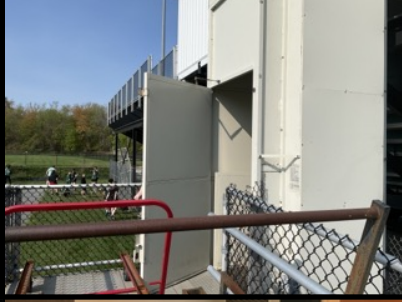
89	Football Field, to Press Box - Lift	Ext.		Platform Lift	N/A

Door lacks maneuvering clearance	-	Provide an automatic door opener.  Note: Lift was unable to be surveyed at the time of survey.	1	3978	\$3978
											<b>3978</b>	
90	Auditorium, Lift to Stage	1	B118	Platform Lift	N/A

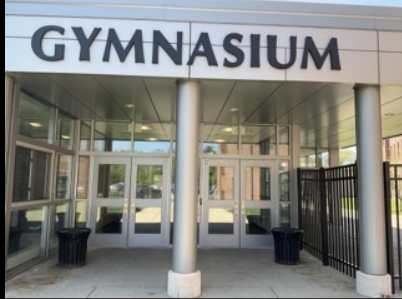
Signage is not provided	-	Locate compliant signage with raised characters and braille alongside each set of doors on the right side.	2	450	\$900
											<b>900</b>	
98	Men's Multi-User Toilet Room Near Pool Lounge	1		Signage	Designation

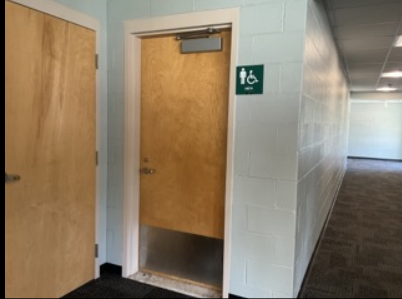
Raised characters < 48" or > 60" above ground	62"	Mount the sign so that the baseline of the lowest tactile character is 48" min. above finished floor and the baseline of the highest tactile character is 60" max. above the finished floor.	1	Labor	Labor

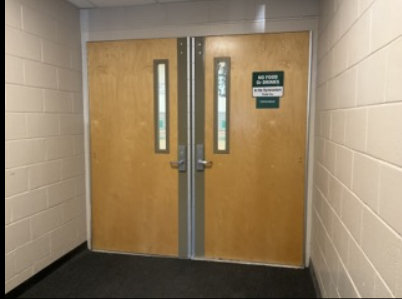
99	Gymnasium, Leading to Door 28	1		Signage	Designation

Raised characters < 48" or > 60" above ground Sign not located properly	55" -	Mount the sign so that the baseline of the lowest tactile character is 48" min. above finished floor and the baseline of the highest tactile character is 60" max. above the finished floor. Locate the sign at permanent rooms alongside the door on right side of the right hand door.	1	Labor	Labor
100	Men's Gym Locker Room (Used for Voting)	1		Signage	Designation

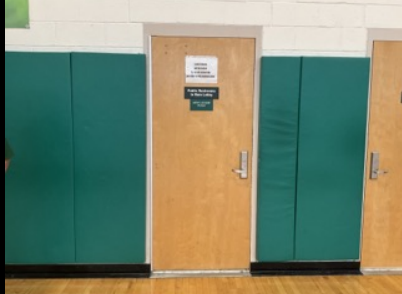
Raised characters < 48" or > 60" above ground Sign not located on the latch side of the door	62" -	Mount the sign so that the baseline of the lowest tactile character is 48" min. above finished floor and the baseline of the highest tactile character is 60" max. above the finished floor. Locate the sign at permanent rooms alongside the door on the latch side.	1	Labor	Labor

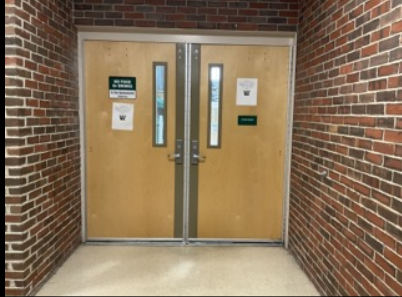
Sign not located on the right side of the door	-	Locate the sign at permanent rooms alongside the door on the adjacent wall on the right side of the right hand door.	1	Labor	Labor
103	Men's and Women's Multi-User Toilet Room Near Football Field	Ext.		Signage	Designation

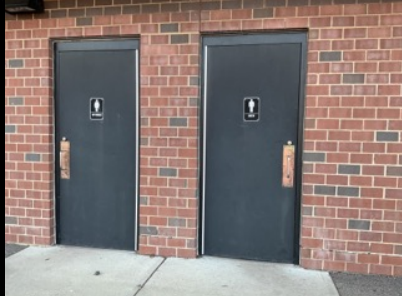
Sign not located on the latch side of the door	-	Locate the sign at permanent rooms alongside the door on the latch side.	2	Labor	Labor

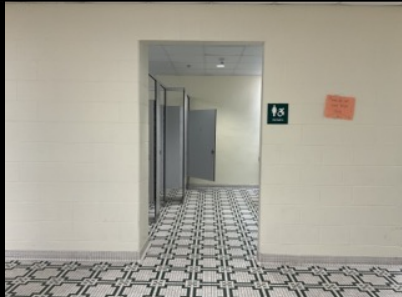
104	Women's Gym Locker Room	1		Signage	Designation

International Symbol of Acc. not compliant	-	Provide a sign with the required International Symbol of Accessibility (ISA).	1	302	\$302
105	Gymnasium	1		Signage	Designation

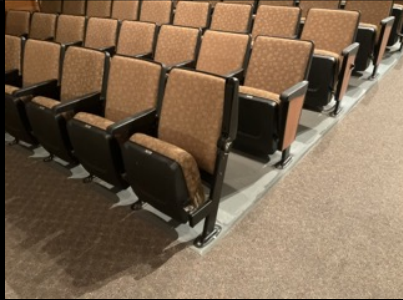
Operable part requires > 5 lbs. of force	10 to 30 lbs	Ensure the the operable part does not require greater than 5 pounds of force to operate.	1	Labor	Labor
108	Auxiliary Theater, "Little Theater", Retractable Armrests	1	B116	Operable Parts / Reach Range	N/A

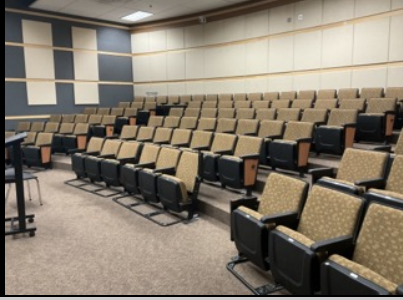
Operable part requires > 5 lbs. of force	16 lbs	Ensure the the operable part does not require greater than 5 pounds of force to operate.	1	-	-
<b>Dining or Work Surfaces</b>												
109	Pool Lounge	1		Dining or Work Surfaces	Dining Surface

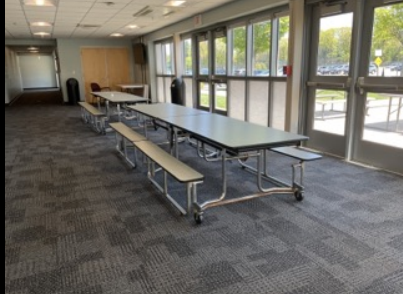
Knee or toe clearance not provided Knee clearance less than 19" deep	20" 17"	Provide at least one dining surface with 27" min. high knee and toe clearance and 19" deep min.	1	1430	\$1430

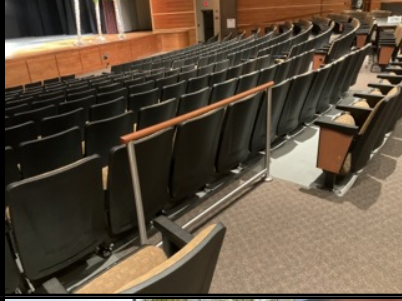
Number of seats Minimum # wheelchair spaces not provided	660 2	Provide 7 wheelchair spaces with companion seating. In row seating, companion seats must be located to provide shoulder alignment with adjacent wheelchair spaces.	7	Cost needs further analysis	Cost needs further analysis

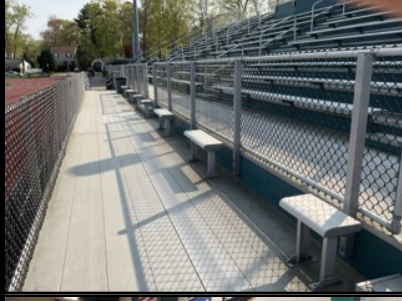
113	Football Field Bleacher	Ext.		Assembly Area	N/A

Number of seats Number of designated wheelchair spaces Wheelchair spaces overlap circulation paths No shoulder alignment at companion & wc spaces	1000 12 -	Ensure that there is proper shoulder alignment between companion and wheelchair spaces.	10	Cost needs further analysis	Cost needs further analysis
114	Gymnasium	1		Assembly Area	N/A

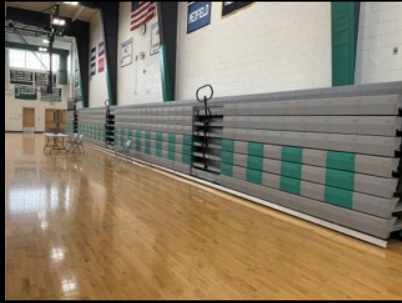
Assistive listening devices not provided	-	If audible communication is integral to the use of the space, provide an assistive listening system.  36 receivers will be needed, of which 9 need to be hearing aid compatible.  Cost estimate based on assistive listening devices for a capacity of 1200. Actual capacity was 1000 seats.	1	12825	\$12825
117	Auxiliary Theater, "Little Theater"	1	B116	Assembly Area	N/A

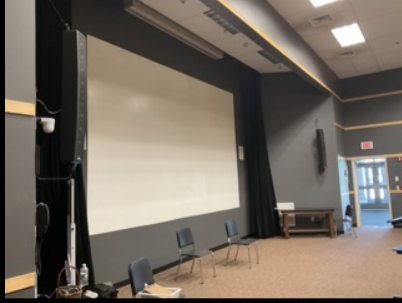
Assistive listening devices not provided	-	If audible communication is integral to the use of the space, provide an assistive listening system.  4 receivers will be needed, of which 2 need to be hearing aid compatible.  Cost estimate based on assistive listening devices for a capacity of 100.	1	2194	\$2194

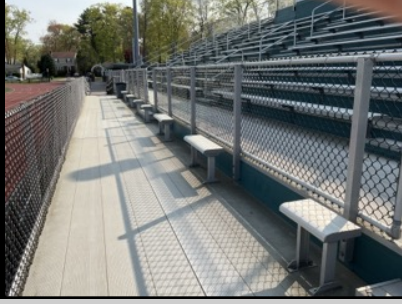
118	Football Field, Bleacher	Ext.		Assembly Area	N/A

Assistive listening devices not provided	-	If audible communication is integral to the use of the space, provide an assistive listening system.  Cost estimate based on assistive listening systems for a capacity of 1200. Actual capacity was 1000 seats.	1	12825	\$12825
<b>Locker Room</b>												
119	Near Family Changing Rooms by the Pool	1	C147	Locker Room	N/A

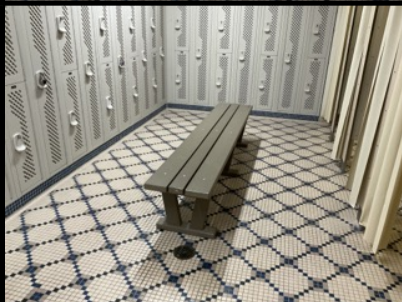
Back support not provided at bench Bench < 24" deep	- 15"	Provide at least one bench with back support or that is affixed to a wall with room on the side to transfer. Provide a bench that is 24" deep.	1	260	\$260
											<b>260</b>	
<div style="border: 1px solid #ccc; padding: 5px; margin-bottom: 5px;"> <b>Toilet &amp; Bathing Rooms</b> </div> <div style="border: 1px solid #ccc; padding: 5px;"> <b>Overall Access</b> </div>

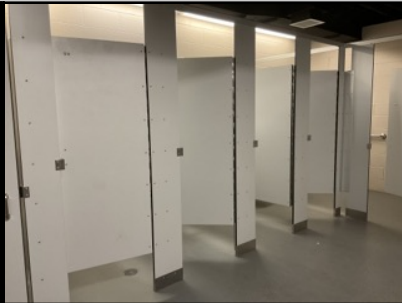
122	Women's Multi-User Toilet Room Near Football Field	Ext.		Overall Access	Toilet Room

Audible and visible alarm not provided		When fire system is updated, ensure that a visible and audible fire alarm is installed.	1	-	-
123	Men's Multi-User Toilet Room Near Football Field	Ext.		Overall Access	Toilet Room

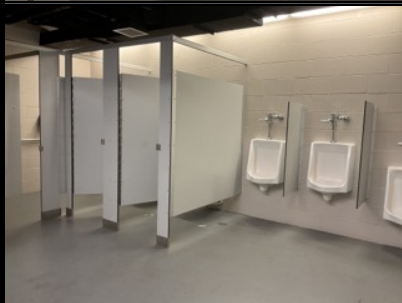
Audible and visible alarm not provided	-	When fire system is updated, ensure that a visible and audible fire alarm is installed.	1	-	-
124	Men's Multi-User Toilet Room Near Auditorium	1		Overall Access	Toilet Room

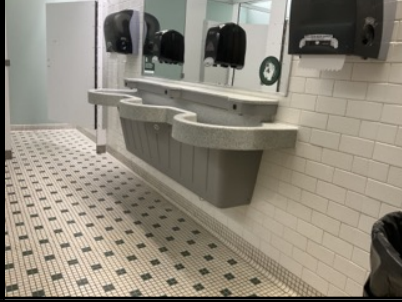
Toe or knee clearances not provided	25.5"	Provide at least one lavatory with knee and toe clearance positioned for a forward approach.	1	2192	\$2192
											<b>2192</b>	
127	Women's Multi-User Toilet Room Near Auditorium	1		Lavatory	N/A

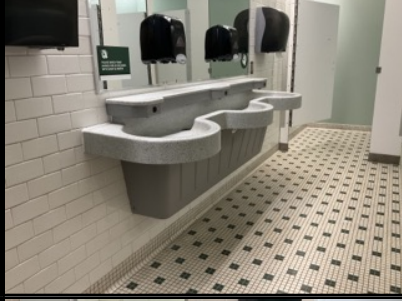
Toe or knee clearances not provided	25"	Provide at least one lavatory with knee and toe clearance positioned for a forward approach.	1	2192	\$2192
											<b>2192</b>	
128	Women's Multi-User Toilet Room Near Pool Lounge	1		Lavatory	N/A

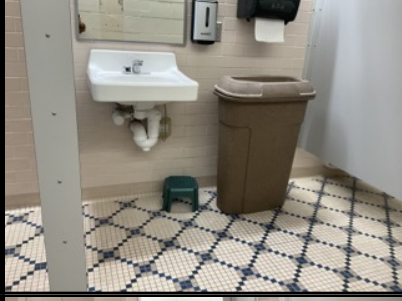
Toe or knee clearances not provided	22"	Provide at least one lavatory with knee and toe clearance positioned for a forward approach.	1	2192	\$2192

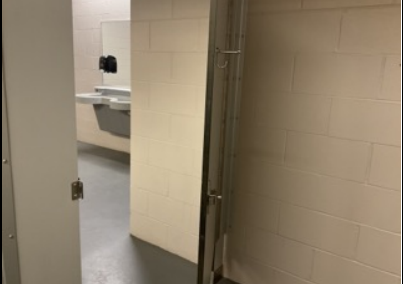
134	Men's Multi-User Toilet Room Near Football Field	Ext		Toilet Compartment	Accessible Compartment

Door has malfunctioning self-closing hinge Door pull not provided	- -	Repair hinge. Provide a door pull on each side of the door between 34" to 48" above the finished floor that does not require tight grasping, pinching or twisting of the wrist.	1	Labor 91	\$91

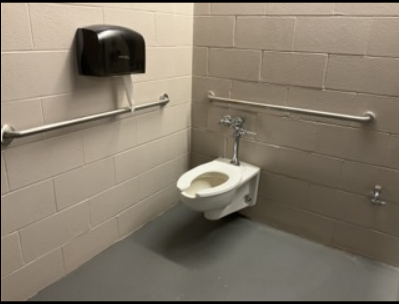
Noncompliant toilet paper dispenser	-	Relocate toilet paper so that it is 24" min. high, located under the grab bar, and between 7" and 9" from the front of the toilet.	1	459	\$459
											<b>459</b>	
136	Men's Multi-User Toilet Room Near Auditorium	1		Toilet Compartment	Accessible Compartment

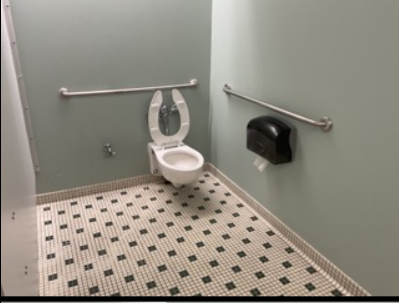
Toilet seat <17" or > 19" high Side or rear grab bar < 33" or >36" high Clearance at toilet < 60" clear width Centerline < or > 18" (MAAB) Side grab bar < 54" from back wall	11.5" 31.5" 55" 14" 50"	Provide a wheelchair accessible compartment that is 60" wide min. Ensure that the toilet seat is located 17" to 19" high and that the centerline of the toilet seat is 18" from the side wall. Locate the grab bars between 33 and 36" above the finished floor and ensure that the side wall grab bar is no less than 54" from the back wall. Provide a door pull on each side of the door between 34" to 48" above the finished floor.	1	8037	\$8037

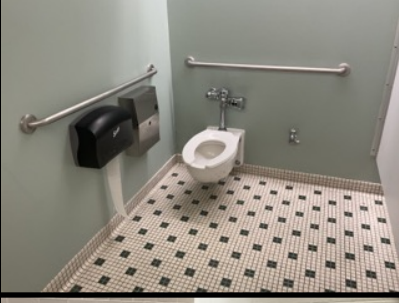
Toilet seat <17" or > 19" high Side or rear grab bar < 33" or >36" high Clearance at toilet < 60" clear width Centerline < or > 18" (MAAB) Side grab bar < 54" from back wall	11.5" 31" 56" 13" 50"	Provide a wheelchair accessible compartment that is 60" wide min. Ensure that the toilet seat is located 17" to 19" high and that the centerline of the toilet seat is 18" from the side wall. Locate the grab bars between 33 and 36" above the finished floor and ensure that the side wall grab bar is no less than 54" from the back wall. Provide a door pull on each side of the door between 34" to 48" above the finished floor.	1	8037	\$8037
											<b>8037</b>	
138	Women's Multi-User Toilet Room Near Pool Lounge	1		Toilet Compartment	Accessible Compartment

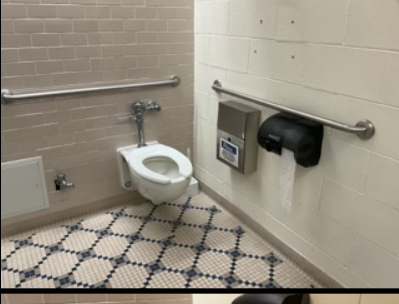
Toilet seat <17" or > 19" high Side or rear grab bar < 33" or >36" high Centerline < or > 18" (MAAB) Side grab bar < 54" from back wall	14" 31.5" 14.5" 50"	Install a toilet with a seat height 17"- 19" above the finished floor. Locate grab bars between 33"- 36" above the finished floor. Relocate toilet so the centerline is 18" from the side wall. Provide a side wall grab bar that is 42" long min. located 12" max. from the rear wall.	1	2816 459 459 3676	\$7410

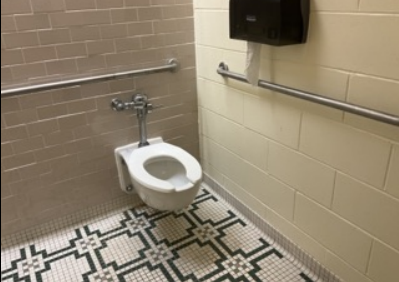
<b>7410</b>	
139	Men's Gym Locker Room	1		Toilet Compartment	Accessible Compartment

Noncompliant toilet paper dispenser	-	Relocate toilet paper so that it is 24" min. high, located under the grab bar, and between 7" and 9" from the front of the toilet.	1	459	\$459
											<b>459</b>

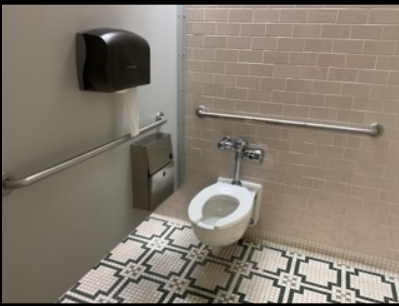
ID	Location	Floor	Room	Element	Type	Photo	Issues	Current Measure	Recommendations	Quantity	Price	Cost Estimation
140	Women's Gym Locker Room	1		Toilet Compartment	Accessible Compartment

Noncompliant toilet paper dispenser	-	Relocate toilet paper so that it is 24" min. high, located under the grab bar, and between 7" and 9" from the front of the toilet.	1	459	\$459
141	Women's Multi-User Toilet Room Near Football Field	Ext		Toilet Compartment	Accessible Compartment

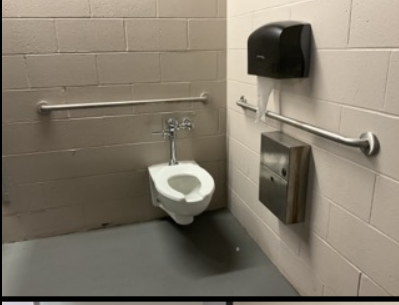
Noncompliant toilet paper dispenser	-	Relocate toilet paper so that it is 24" min. high, located under the grab bar, and between 7" and 9" from the front of the toilet.	1	459	\$459
142	Women's Gym Locker Room	1		Toilet Compartment	Accessible Compartment

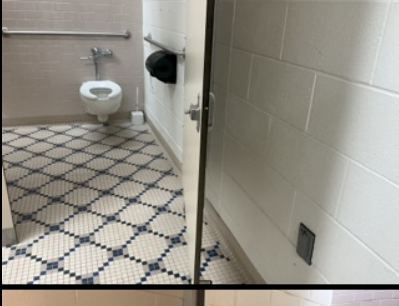
143	Men's Locker Room	1	C151	Toilet Compartment	Accessible Compartment

Door has malfunctioning self-closing hinge Door pull not provided	- -	Repair hinge. Provide a door pull on each side of the door between 34" to 48" above the finished floor that does not require tight grasping, pinching or twisting of the wrist.	1	Labor 91	\$91
144	Men's Gym Locker Room	1		Toilet Compartment	Accessible Compartment

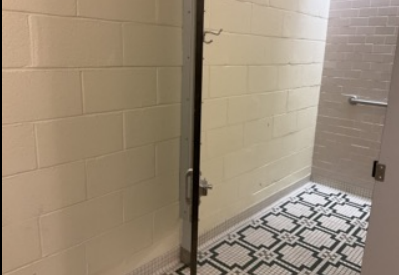
Door has malfunctioning self-closing hinge Door pull not provided	- -	Repair hinge. Provide a door pull on each side of the door between 34" to 48" above the finished floor that does not require tight grasping, pinching or twisting of the wrist.	1	Labor 91	\$91

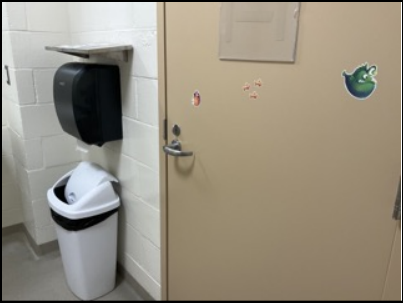
ID	Location	Floor	Room	Element	Type	Photo	Issues	Current Measure	Recommendations	Quantity	Price	Cost Estimation
<b>Dispensers</b>												
145	Family Changing Rooms A and B by the Pool	1	C147	Dispensers	Paper Towel Dispenser

Ensure trash can is permanently located under the paper towel dispenser and the shelf.	2	Labor	Labor
146	Men's Multi-User Toilet Room Near Auditorium	1		Dispensers	Paper Towel Dispenser

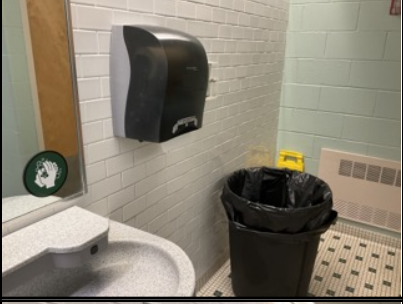
Dispenser acts as a protruding object	5.5"	Ensure a fixed trash can is placed underneath the paper towel dispensers to act as a cane-detectable barrier.	2	Labor	Labor
147	Women's Multi-User Toilet Room Near Auditorium	1		Dispensers	Paper Towel Dispenser

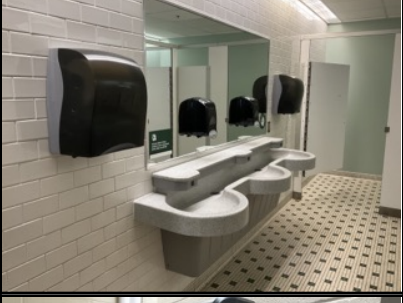
Dispenser acts as a protruding object	6"	Ensure a fixed trash can is placed underneath the paper towel dispensers to act as a cane-detectable barrier.	2	Labor	Labor
148	Men's Multi-User Toilet Room Near Pool Lounge	1		Dispensers	Paper Towel Dispenser

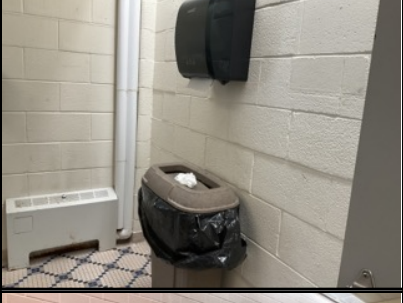
Dispenser acts as a protruding object	9"	Ensure a fixed trash can is placed underneath the paper towel dispenser to act as a cane-detectable barrier.	1	Labor	Labor

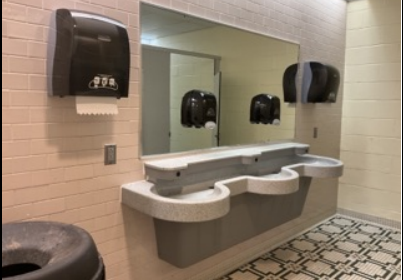
149	Men's and Women's Gym Locker Rooms	1		Dispensers	Paper Towel Dispenser

Dispenser acts as a protruding object	-	Ensure a fixed trash can is placed underneath the paper towel dispenser to act as a cane-detectable barrier.	4	Labor	Labor

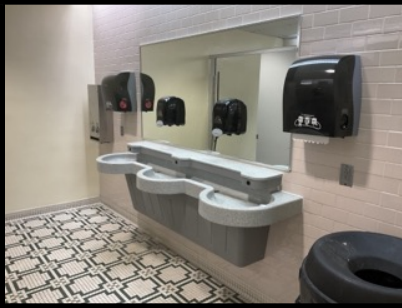
ID	Location	Floor	Room	Element	Type	Photo	Issues	Current Measure	Recommendations	Quantity	Price	Cost Estimation
150	Women's Gym Locker Room	1		Dispensers	Paper Towel Dispenser

Dispenser acts as a protruding object	-	Ensure a fixed trash can is placed underneath the paper towel dispensers to act as a cane-detectable barrier.	3	Labor	Labor
151	Women's Locker Room	1	C149	Dispensers	Paper Towel Dispenser

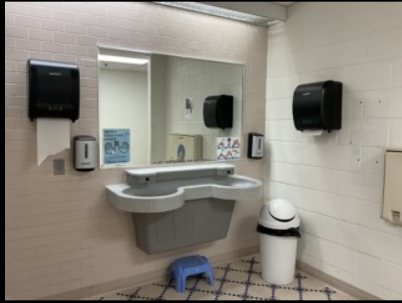
Dispenser acts as a protruding object	8.5"	Ensure a fixed trash can is placed underneath the paper towel dispensers to act as a cane-detectable barrier.	2	Labor	Labor
152	Women's Locker Room	1	C149	Dispensers	Hand Dryer

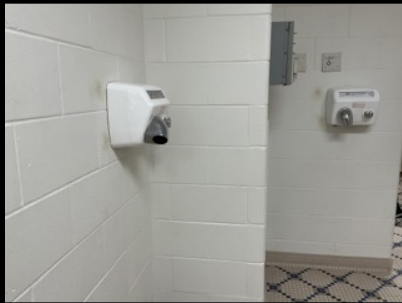
Dispenser acts as a protruding object	8.5"	Provide a hand dryer that is 4" max. deep.	2	793	\$1586
											<b>1586</b>	
153	Men's Locker Room	1	C151	Dispensers	Paper Towel Dispenser

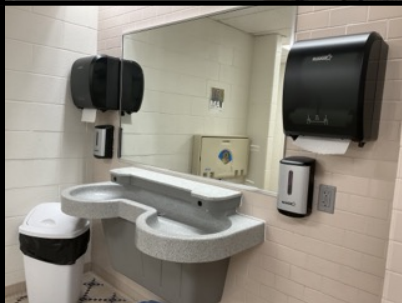
Dispenser acts as a protruding object	9.5"	Ensure a fixed trash can is placed underneath the paper towel dispenser to act as a cane-detectable barrier.	1	Labor	Labor

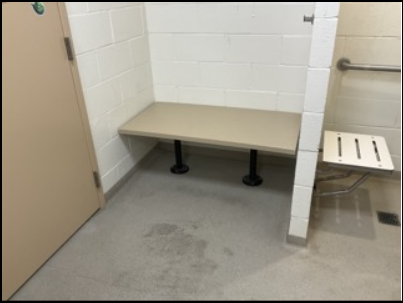
ID	Location	Floor	Room	Element	Type	Photo	Issues	Current Measure	Recommendations	Quantity	Price	Cost Estimation
<b>Changing Rooms</b>												
160	Family Changing Rooms A and B by the Pool	1	C147	Changing Rooms	Other

30" clear not provided alongside bench	-	Ensure that the bench has 30" clear alongside it so that wheelchair users can transfer onto it. (Cost estimate for a new accessible changing room.)	2	7626	\$15252
											<b>15252</b>	
<b>Baby Changing Table</b>												
161	Women's Multi-User Toilet Room Near Pool Lounge	1		Baby Changing Table	N/A

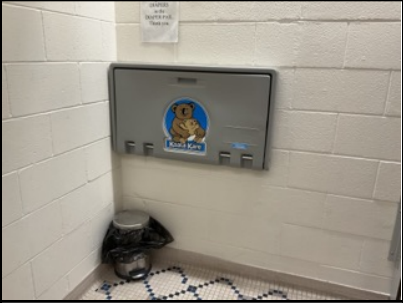
30" x 48" clear floor space not provided	-	Remove the trash can to provide a 30" min. by 48" min. clear floor space positioned for a forward approach	1	Labor	Labor
162	Family Changing Rooms A and B by the Pool	1	C147	Baby Changing Table	N/A

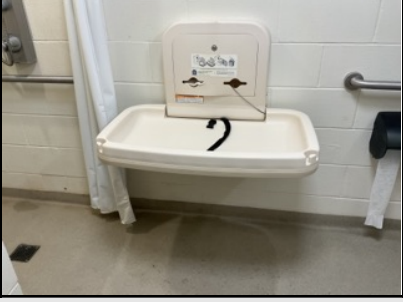
Changing table lacks 27" high knee clearance	21"	Ensure that surface is located between 28" - 34" above the finished floor with 27" high min. knee and toe clearance positioned for a forward approach.	2	459	\$918

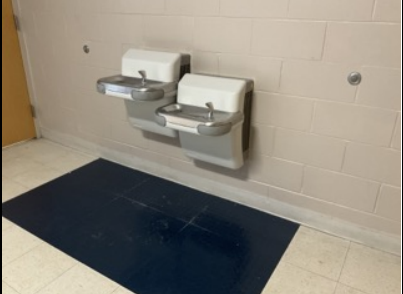
<b>918</b>	
<b>Additional Access</b>												
<b>Drinking Fountains</b>												
163	Near Men's and Women's Toilet Rooms Near Auditorium	1		Drinking Fountains	Hi-Lo

Spout < 38" or > 43" (standing users) Standing height fountain does not have cane protection Knee or toe clearance not provided	33" - 21.5"	Relocate the lower drinking fountain so that the spout is between 38"- 43" above the finished floor or ground and will be for standing users. The current high drinking fountain will serve for seated users. After the drinking fountain is raised, provide a cane-detectable barrier skirt under the high unit.	1	2028 890	\$2918
											<b>2918</b>

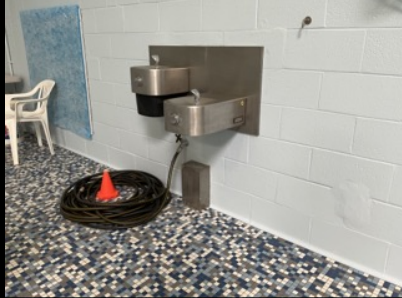
ID	Location	Floor	Room	Element	Type	Photo	Issues	Current Measure	Recommendations	Quantity	Price	Cost Estimation
164	Near Men's Locker Room	1	C151	Drinking Fountains	Hi-Lo

Standing height fountain does not have cane protection	-	Provide a cane-detectable barrier skirt under the high unit.	1	890	\$890
											<b>890</b>	
165	Near Women's Multi-User Toilet Room Near Football Field	Ext		Drinking Fountains	Hi-Lo

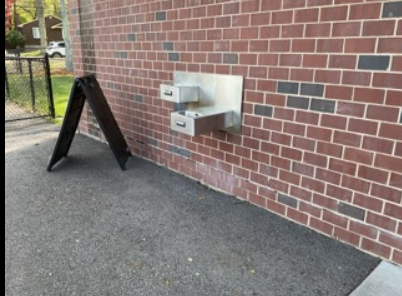
Standing height fountain does not have cane protection	17"	Provide a cane-detectable barrier skirt under the high unit.	1	1157	\$1157
											<b>1157</b>	
166	Women's Gym Locker Room	1		Drinking Fountains	Hi-Lo

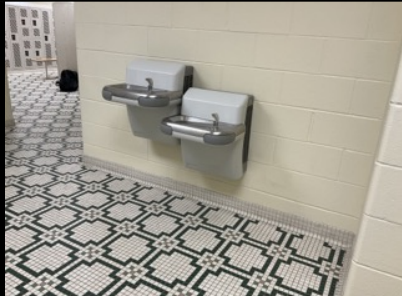
Standing height fountain does not have cane protection Knee or toe clearance not provided	- 25"	Provide a cane-detectable barrier skirt under the high unit. Provide knee and toe clearance, 27" min. high at drinking fountain for seated users.	1	890 2028	\$2918
											<b>2918</b>

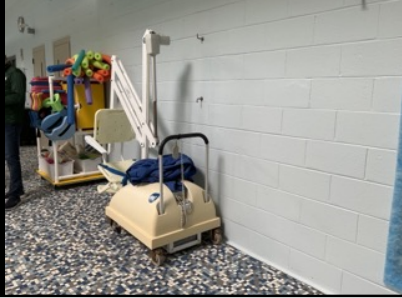
<div style="border: 1px solid gray; padding: 2px; margin-bottom: 5px;"> <b>Play and Sport Areas</b> </div> <div style="border: 1px solid gray; padding: 2px; margin-bottom: 5px;"> <b>Swimming Pool</b> </div>												
167	Pool	1	C160	Swimming Pool	Pool Lift

Lift not independently operated	-	The lift should always be located where the water level is not deeper than 48" and must be independently operable. Clear deck space of a minimum of 36" wide and 48" deep must be provided as an unobstructed area for transfers between a mobility device and the seat. This space must be located on the side of the seat opposite the water.	1	-	-
<div style="border: 1px solid gray; padding: 2px; margin-bottom: 5px;"> <b>Field</b> </div>												
168	Near Softball Field First Base Team Seating Area	Ext.		Field	Softball

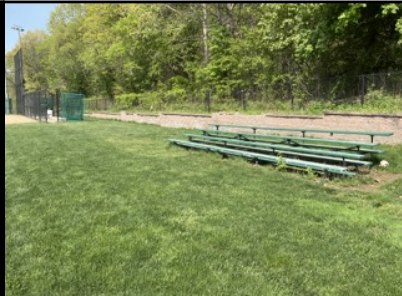
Accessible spaces not provided at sidelines seating Field not connected to an accessible route	- -	Provide an accessible route to the sideline seating that is firm, stable and slip-resistant that is also connected to the field. Provide a 36" by 60" clear floor space that is firm, stable and slip resistant at the sideline seating designated for an accessible space on each side of the bleacher.	1	-	-

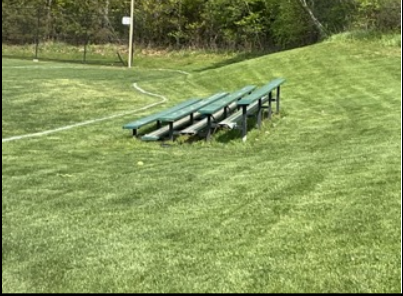
ID	Location	Floor	Room	Element	Type	Photo	Issues	Current Measure	Recommendations	Quantity	Price	Cost Estimation
169	Sideline Seating Near Baseball Field First Base Side Team Seating	Ext.		Field	Baseball

Accessible spaces not provided at sidelines seating No accessible route to sideline seating.	- -	Provide a 36" x 60" clear floor space allow each side of sideline seating. Provide an accessible route to the sideline seating that is firm, stable and slip-resistant.	1	-	-
170	Softball Field Third Base Team Seating Area	Ext.		Field	Softball

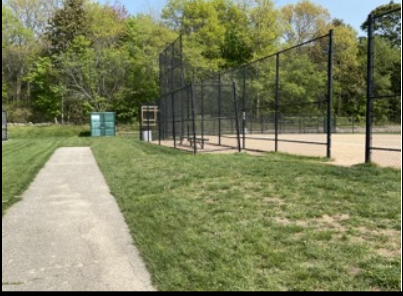
Softball field not connected to an accessible route	-	Provide an accessible route to the softball field.	1	-	-
171	Softball Field Practice Area	Ext.		Field	Softball

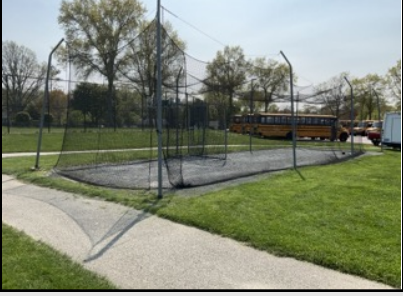
Practice areas are not on an accessible route	-	Provide an accessible route to the practice areas that is firm, stable and slip-resistant.	1	-	-
<div style="border: 1px solid gray; padding: 5px; margin-bottom: 5px;"> <b>Overall Review</b> <span style="float: right;">▼</span> </div> <div style="border: 1px solid gray; height: 20px; width: 100%;"></div>

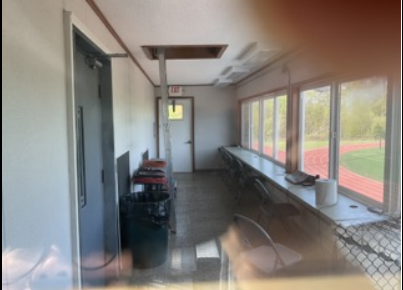
172	Football Field Press Box	Ext.			N/A

Press box was locked and unable to be surveyed.		-	-
<div style="border: 1px solid gray; padding: 5px; margin-bottom: 5px;"> <b>Best Practice</b> <span style="float: right;">▼</span> </div>

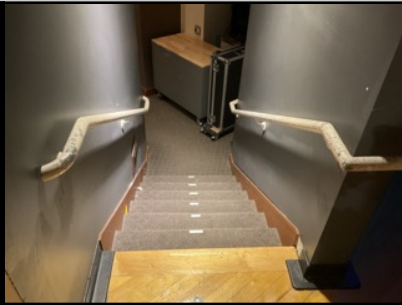
ID	Location	Floor	Room	Element	Type	Photo	Issues	Current Measure	Recommendations	Quantity	Price	Cost Estimation
173	Auditorium, Stairs On Side of Stage	1	B118		N/A

Recommend providing contrast strips along the full tread on both stairs on the sides of the stage.	2	-	-
174	Auditorium, Stage Right Stairs On Side of Stage	1	B118		N/A

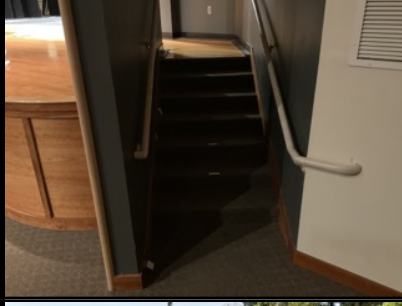
Recommend installing lights at the stair. IHCD recommends providing 10 foot candles in these areas.	1	-	-
175	Turf Soccer Field	Ext.			N/A

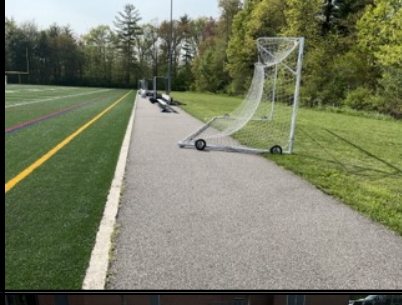
Recommend that the soccer goals to be moved out of the path of circulation, even if there currently exists a 36" clear path.	1	-	-
176	Parking by Main Entrance to Auditorium	Ext.			N/A

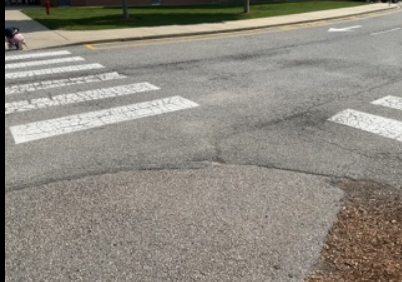
Recommend as best practice to extend the striping so that the crosswalks connect.	1	-	-
