**APPENDIX C**  
CCTV Reports

## NWMCC INSPECTION REPORT

Start date/time: <b>20230725 12:13</b>	Weather: <b>Dry - No precipitation during survey</b>	Surveyed by: <b>C.Arruda</b>	Certificate number: <b>U-910-11364</b>	Pipe segment ref.: <b>15/002 - 15/001</b>	
Owner:	Customer:	Pre-cleaning: <b>Light Cleaning</b>	Date cleaned: <b>20230725</b>	Project name: <b>ENV017-13</b>	
City: <b>WESTWOOD MA</b>	Street: <b>NAHATAN ST</b>	Location code:	Pipe use: <b>Sanitary Sewage Pipe</b>	Drainage area: 	Flow control: 
Upstream MH No: <b>15/001</b>	Downstream MH No: <b>15/002</b>	Direction: <b>U</b>	Total length: <b>304.300 ft.</b>	Length surveyed: <b>304.300 ft.</b>	
Purpose: <b>Maintenance Related</b>	Pipe joint length: 	Height: <b>8 in.</b>	Material: <b>Asbestos Cement</b>	LateralsCounter: 	Additional info:

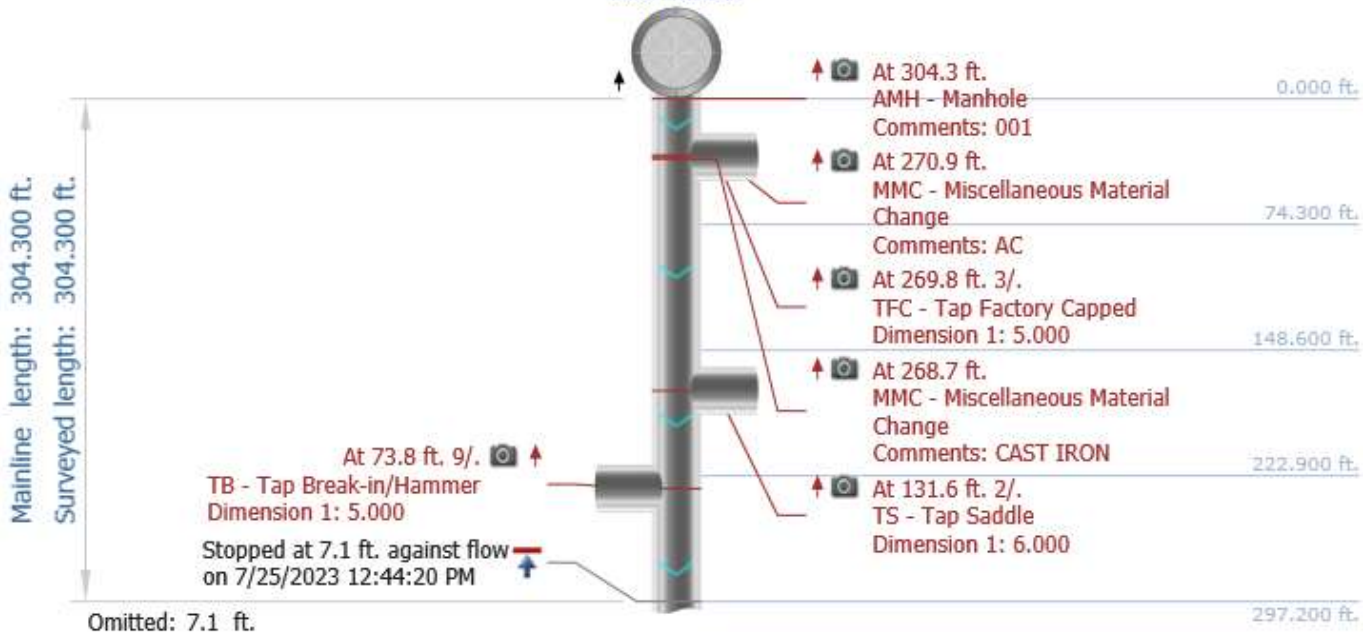
Mainline length: 304.300 ft.  
Surveyed length: 304.300 ft.

Started at 0.0 ft. against flow  
on 7/25/2023 12:13:42 PM

- At 0.0 ft.  
AMH - Manhole  
Comments: 15/002
- At 0.0 ft.  
MWL - Miscellaneous Water  
Level

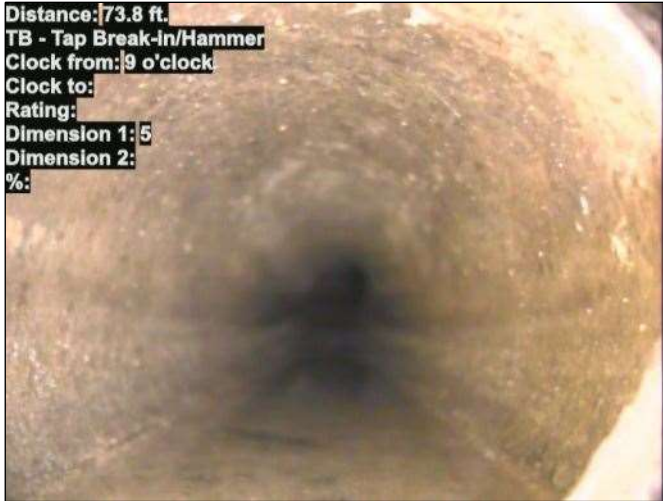
Photo: 15\_001-15\_002-20230725-121926.JPG  
At: 73.8 ft. 9/. TB - Tap Break-in/Hammer  
Joint: No

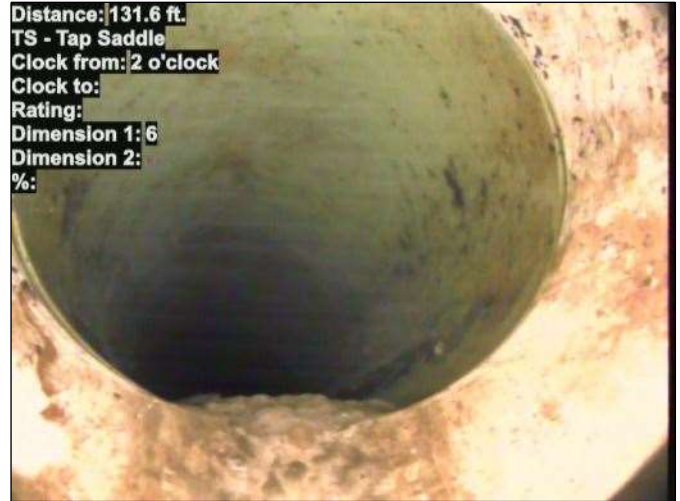
Photo: 15\_001-15\_002-20230725-122140.JPG  
At: 131.6 ft. 2/. TS - Tap Saddle  
Joint: No

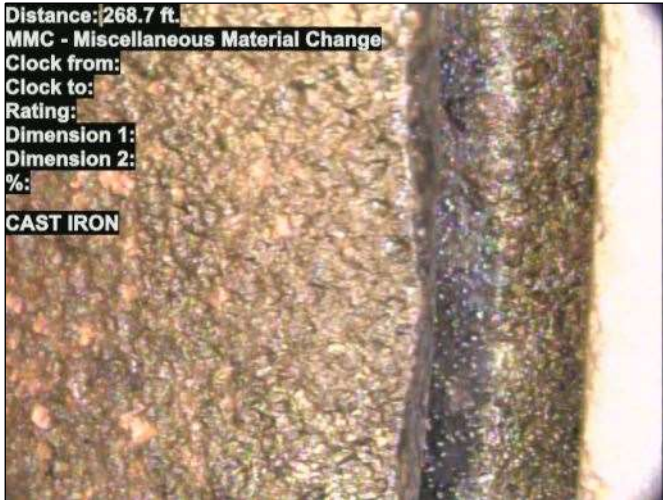
Photo: 15\_001-15\_002-20230725-122534.JPG  
At: 268.7 ft. MMC - Miscellaneous Material Change  
Joint: No CAST IRON

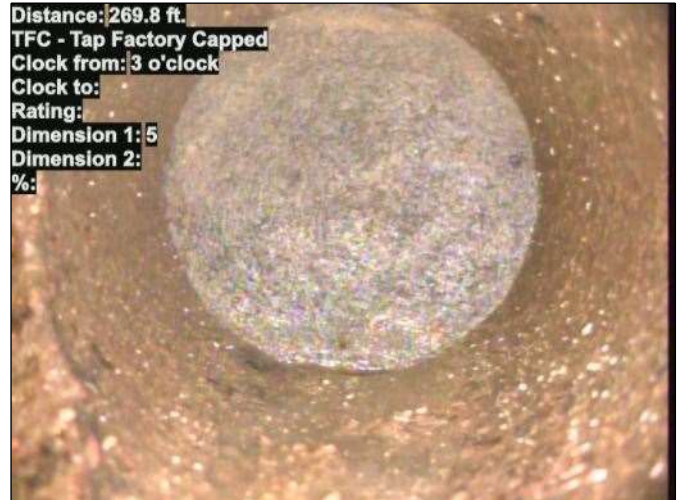
Photo: 15\_001-15\_002-20230725-122554.JPG  
At: 269.8 ft. 3/. TFC - Tap Factory Capped  
Joint: No

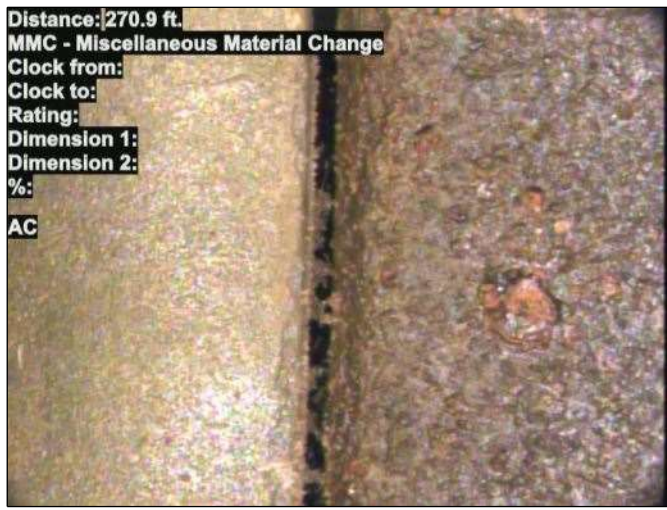
Distance: 270.9 ft.  
MMC - Miscellaneous Material Change  
Clock from:  
Clock to:  
Rating:  
Dimension 1:  
Dimension 2:  
%:  
AC

Photo: 15\_001-15\_002-20230725-122611.JPG  
At: 270.9 ft. MMC - Miscellaneous Material Change  
Joint: No AC

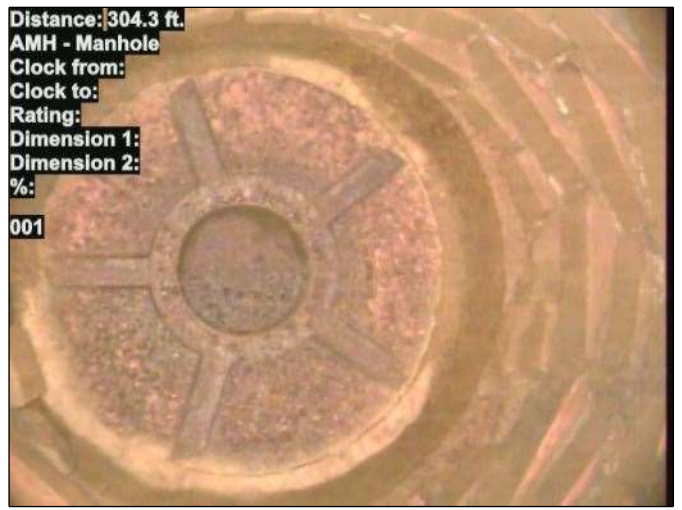
Distance: 304.3 ft.  
AMH - Manhole  
Clock from:  
Clock to:  
Rating:  
Dimension 1:  
Dimension 2:  
%:  
001

Photo: 15\_001-15\_002-20230725-122727.JPG  
At: 304.3 ft. AMH - Manhole  
Joint: No 001

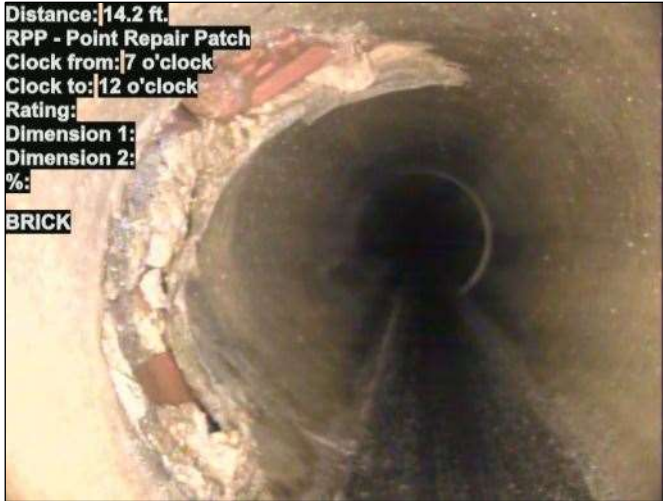
Photo: 15\_002-15\_003-20230725-112219.JPG  
At: 14.2 ft. 7/12 RPP - Point Repair Patch  
Joint: No BRICK

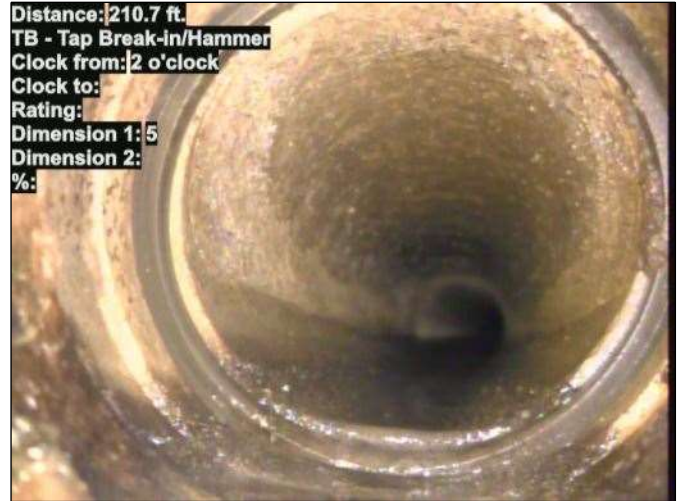
Photo: 15\_002-15\_003-20230725-112822.JPG  
At: 210.7 ft. 2/. TB - Tap Break-in/Hammer  
Joint: No

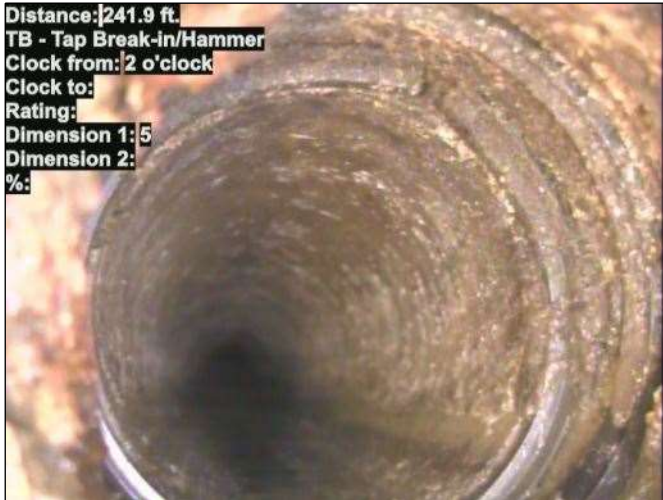
Photo: 15\_002-15\_003-20230725-113040\_1.JPG  
At: 241.9 ft. 2/. TB - Tap Break-in/Hammer  
Joint: No

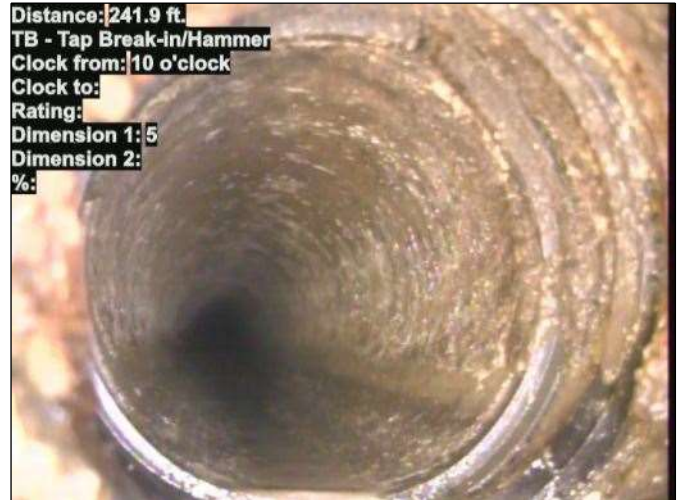
Photo: 15\_002-15\_003-20230725-113040.JPG  
At: 241.9 ft. 2/. TB - Tap Break-in/Hammer  
Joint: No

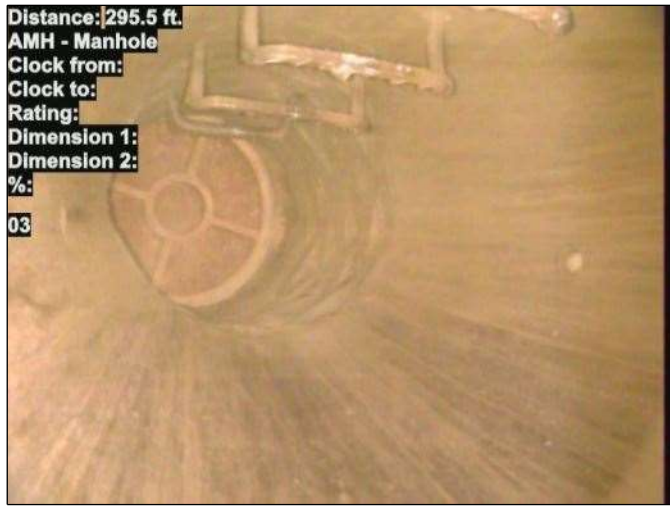
Photo: 15\_002-15\_003-20230725-113231.JPG

At: 295.5 ft. AMH - Manhole

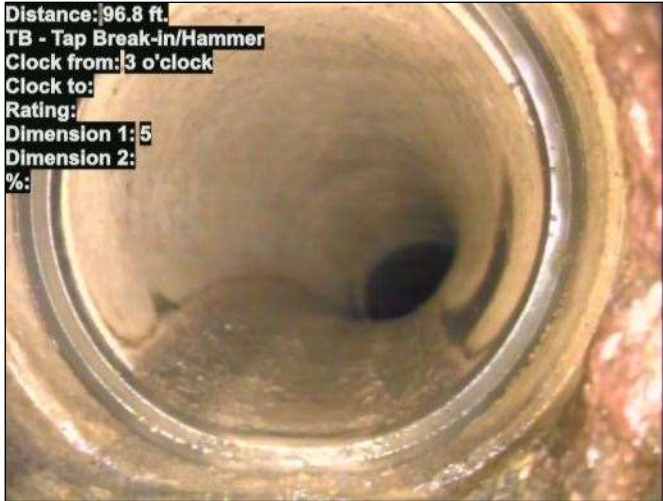
Photo: 15\_003-15\_004-20230725-113833.JPG  
At: 96.8 ft. 3/. TB - Tap Break-in/Hammer  
Joint: No

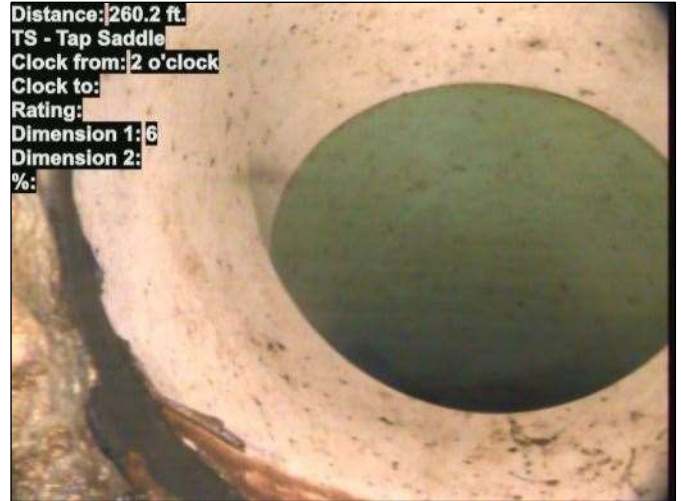
Photo: 15\_003-15\_004-20230725-114418.JPG  
At: 260.2 ft. 2/. TS - Tap Saddle  
Joint: No

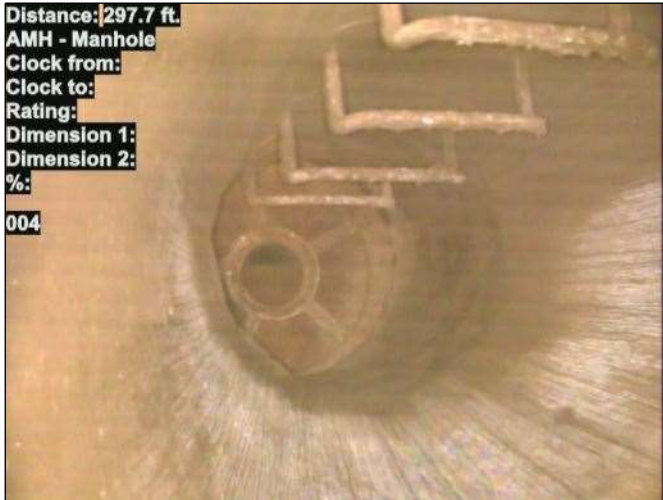
Photo: 15\_003-15\_004-20230725-114559.JPG  
At: 297.7 ft. AMH - Manhole  
Joint: No 004

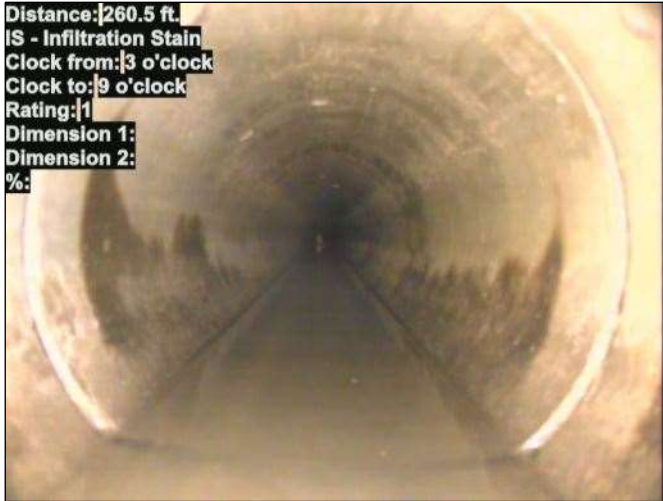
Photo: 15\_004-15\_005-20230725-115813.JPG  
At: 260.5 ft. 3/9 IS - Infiltration Stain  
Joint: No

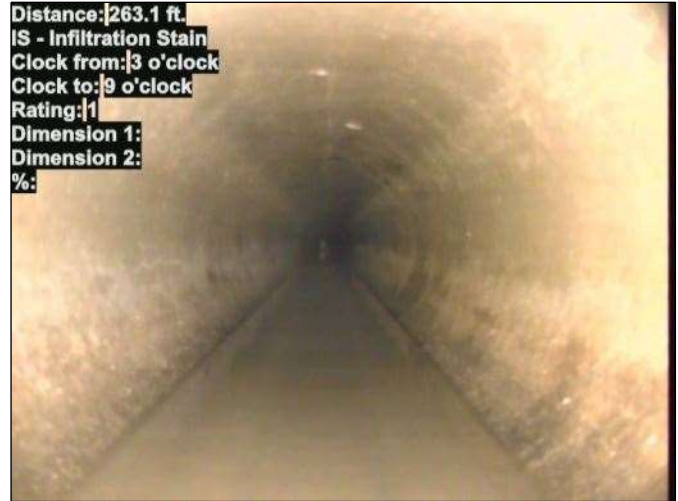
Photo: 15\_004-15\_005-20230725-121258.JPG  
At: 264 ft. 3/9 IS - Infiltration Stain  
Joint: No

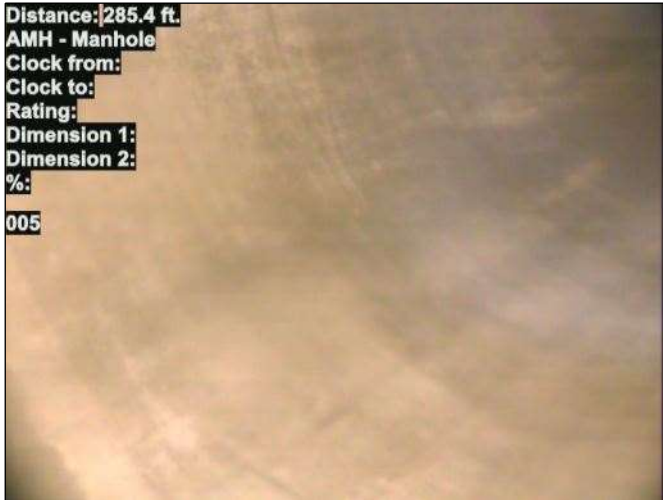
Photo: 15\_004-15\_005-20230725-120135.JPG  
At: 285.4 ft. AMH - Manhole  
Joint: No 005

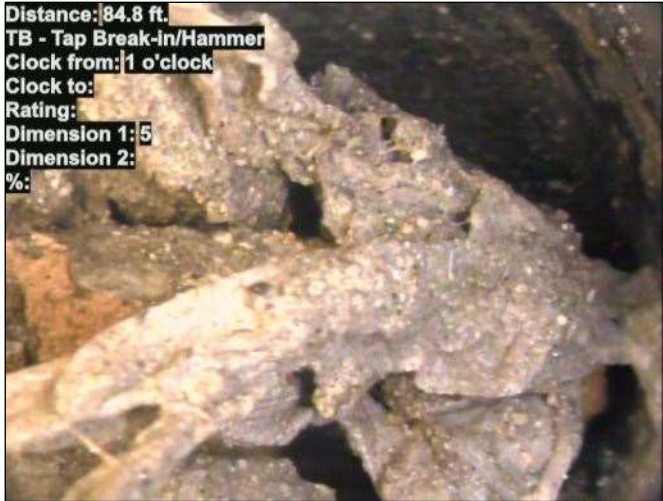
Photo: 15\_005-15\_018-20230801-091542.JPG  
At: 84.8 ft. 1/. TB - Tap Break-in/Hammer  
Joint: No

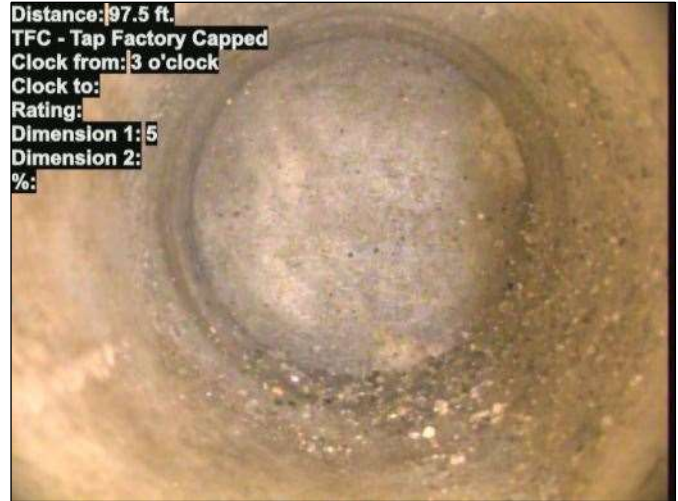
Photo: 15\_005-15\_018-20230801-091651.JPG  
At: 97.5 ft. 3/. TFC - Tap Factory Capped  
Joint: No

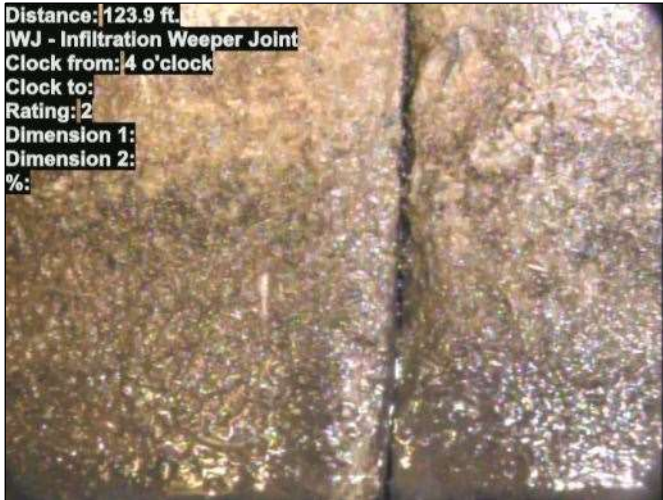
Photo: 15\_005-15\_018-20230801-091813.JPG  
At: 123.9 ft. 4/. IWJ - Infiltration Weeper Joint  
Joint: Yes

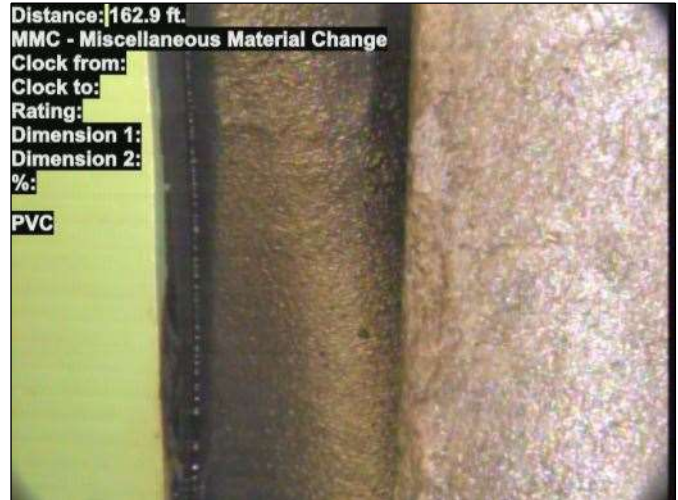
Photo: 15\_005-15\_018-20230801-091958.JPG  
At: 162.9 ft. MMC - Miscellaneous Material Change  
Joint: No PVC

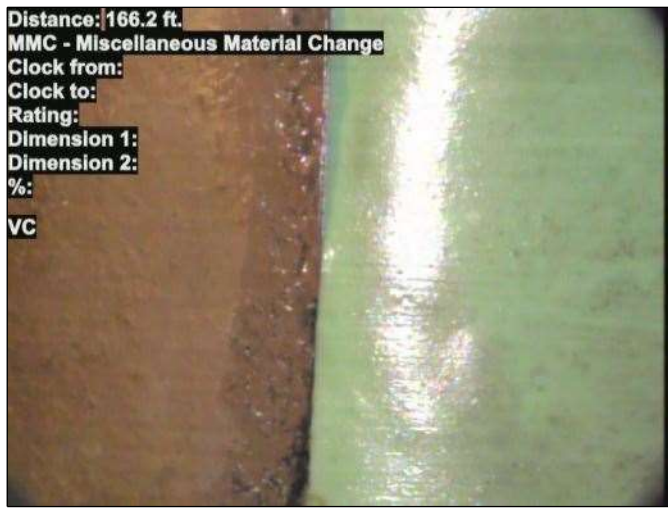
Distance: 166.2 ft.  
MMC - Miscellaneous Material Change  
Clock from:  
Clock to:  
Rating:  
Dimension 1:  
Dimension 2:  
%:  
VC

Photo: 15\_005-15\_018-20230801-092022.JPG  
At: 166.2 ft. MMC - Miscellaneous Material Change  
Joint: No VC

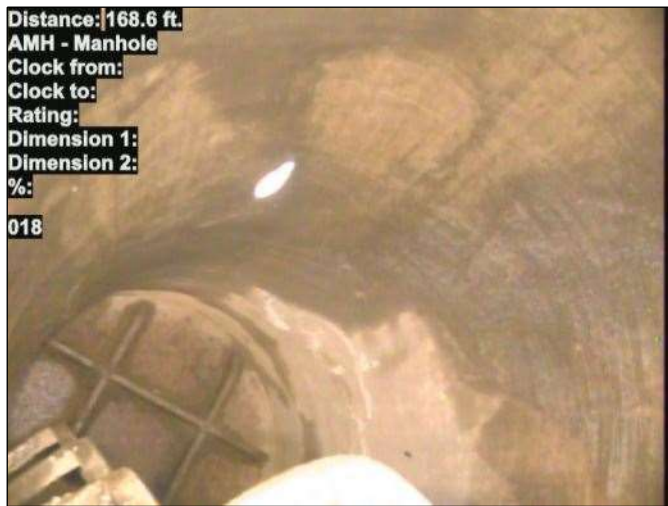
Distance: 168.6 ft.  
AMH - Manhole  
Clock from:  
Clock to:  
Rating:  
Dimension 1:  
Dimension 2:  
%:  
018

Photo: 15\_005-15\_018-20230801-092129.JPG  
At: 168.6 ft. AMH - Manhole  
Joint: No 018

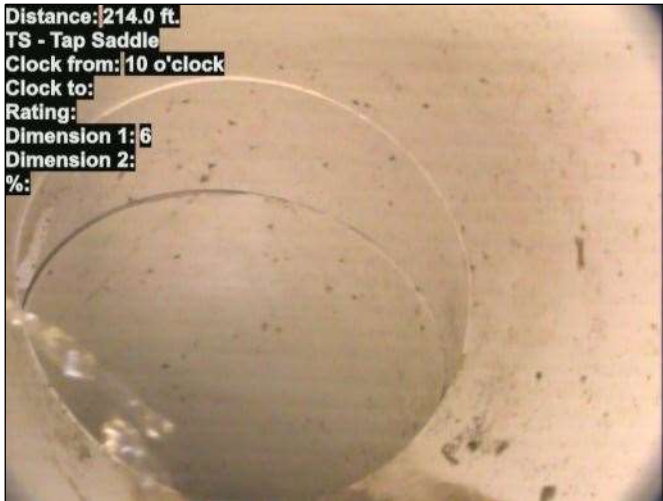
Distance: 214.0 ft.  
TS - Tap Saddle  
Clock from: 10 o'clock  
Clock to:  
Rating:  
Dimension 1: 6  
Dimension 2:  
%:  
Photo: 15\_006-15\_005-20230726-110754.JPG  
At: 214 ft. 10/. TS - Tap Saddle  
Joint: No

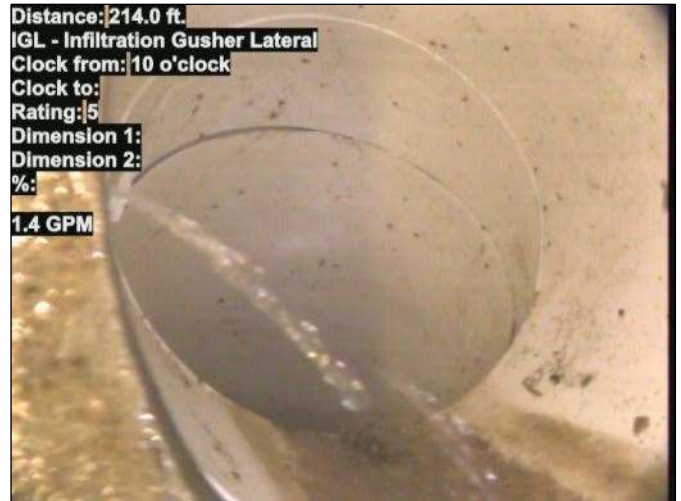
Distance: 214.0 ft.  
IGL - Infiltration Gusher Lateral  
Clock from: 10 o'clock  
Clock to:  
Rating: 5  
Dimension 1:  
Dimension 2:  
%:  
1.4 GPM  
Photo: 15\_006-15\_005-20230726-110809.JPG  
At: 214 ft. 10/. IGL - Infiltration Gusher Lateral  
Joint: No 1.4 GPM

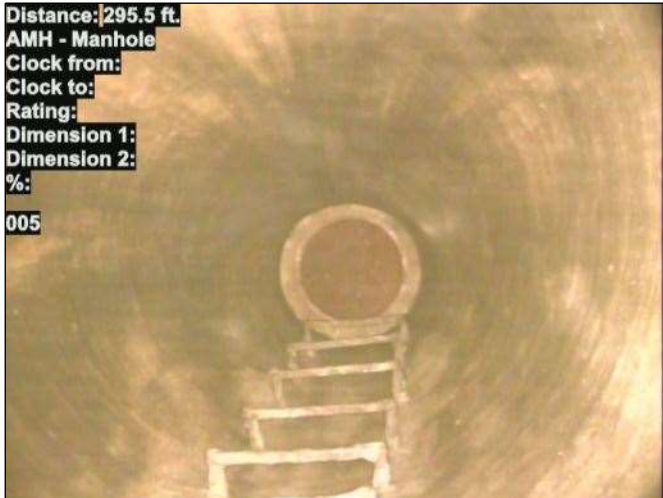
Distance: 295.5 ft.  
AMH - Manhole  
Clock from:  
Clock to:  
Rating:  
Dimension 1:  
Dimension 2:  
%:  
005  
Photo: 15\_006-15\_005-20230726-111157.JPG  
At: 295.5 ft. AMH - Manhole  
Joint: No 005

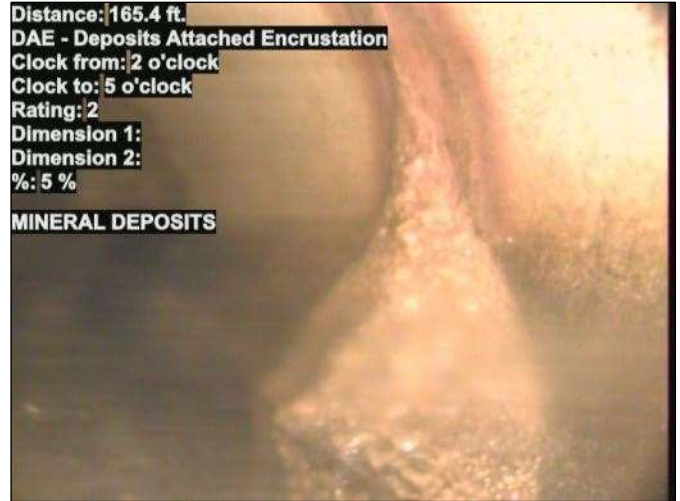
Photo: 15\_007-15\_006-20230726-125205.JPG  
At: 165.4 ft. 2/5 DAE - Deposits Attached Encrustation  
Joint: No 5 % MINERAL DEPOSITS

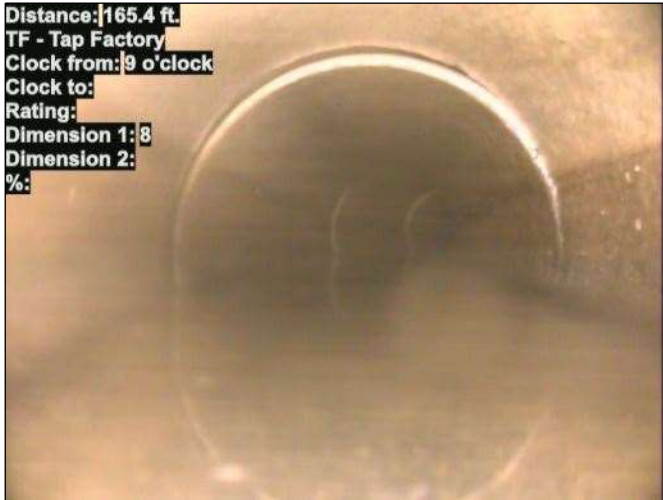
Photo: 15\_007-15\_006-20230726-125145.JPG  
At: 165.4 ft. 9/. TF - Tap Factory  
Joint: No

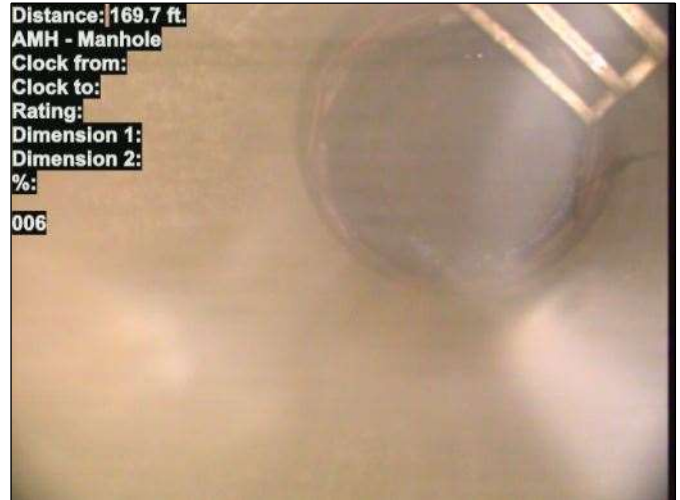
Photo: 15\_007-15\_006-20230726-125310.JPG  
At: 169.7 ft. AMH - Manhole  
Joint: No 006

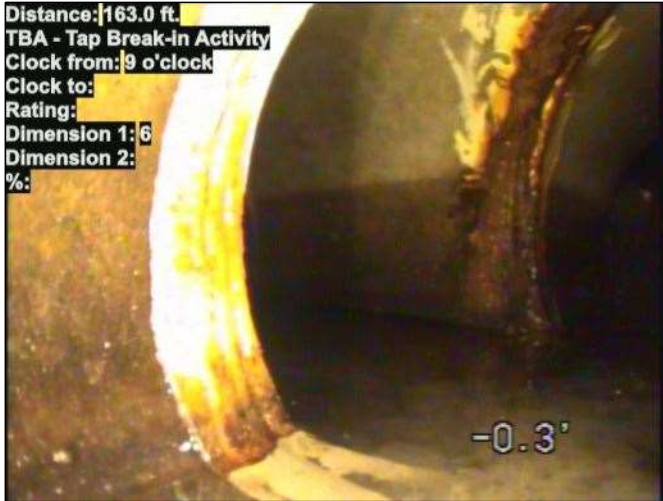
Photo: 15\_007-15\_006-20230807-105714.JPG  
At: 163 ft. 9/. TBA - Tap Break-in Activity  
Joint: No

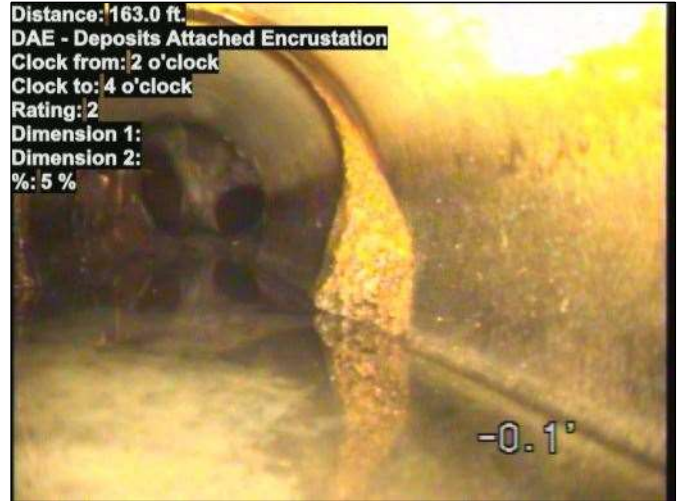
Photo: 15\_007-15\_006-20230807-105737.JPG  
At: 163 ft. 2/4 DAE - Deposits Attached Encrustation  
Joint: No 5 %

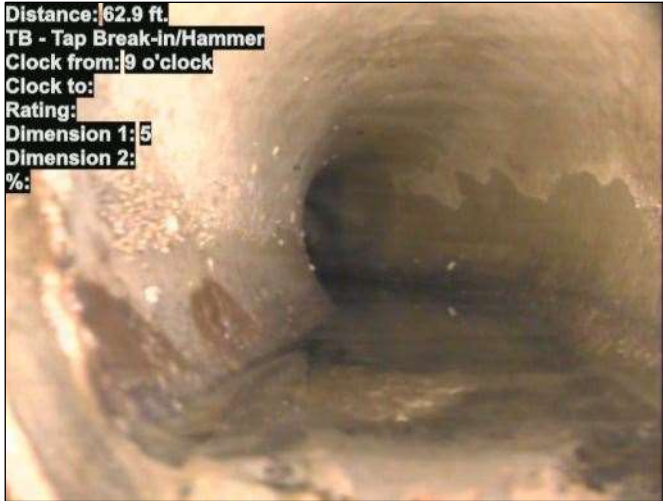
Photo: 15\_009-15\_009A-20230726-103622.JPG  
At: 62.9 ft. 9/. TB - Tap Break-in/Hammer  
Joint: No

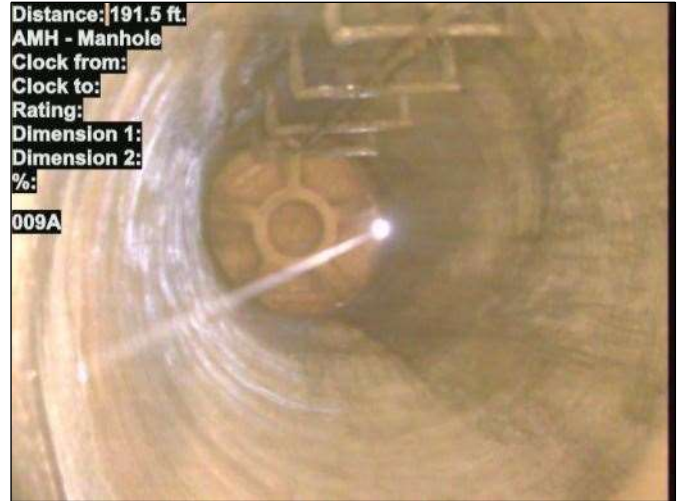
Photo: 15\_009-15\_009A-20230726-104100.JPG  
At: 191.5 ft. AMH - Manhole  
Joint: No 009A

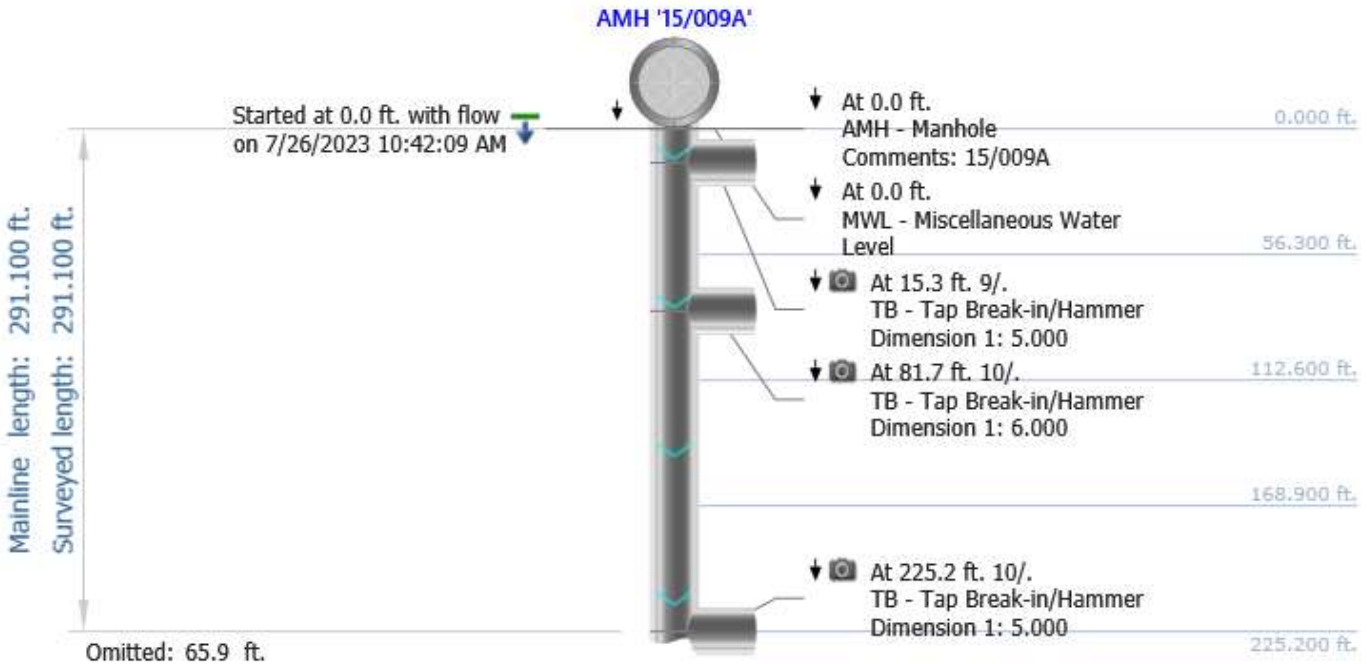
Mainline length: 291.100 ft.  
Surveyed length: 291.100 ft.

Omitted: 225.2 ft.

At 225.2 ft. 9/  
ISL - Infiltration Stain Lateral 225.200 ft.  
Rating: █  
Category: O&M

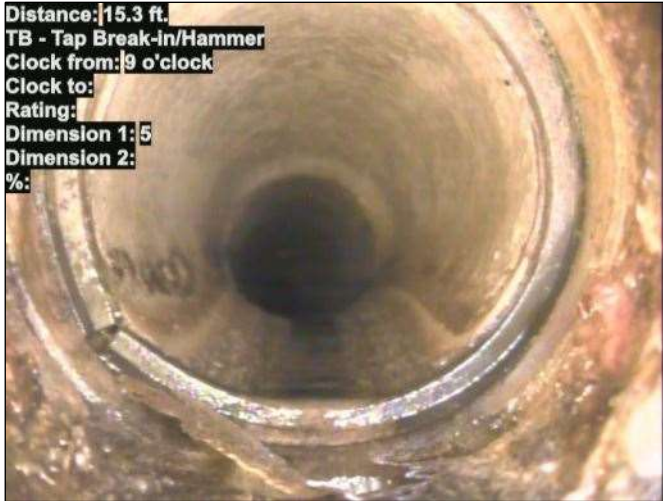
Photo: 15\_009A-15\_006-20230726-104433.JPG  
At: 15.3 ft. 9/. TB - Tap Break-in/Hammer  
Joint: No

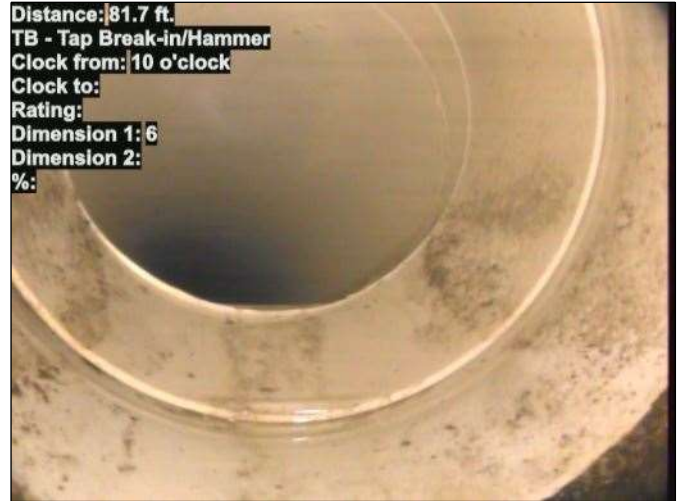
Photo: 15\_009A-15\_006-20230726-104722.JPG  
At: 81.7 ft. 10/. TB - Tap Break-in/Hammer  
Joint: No

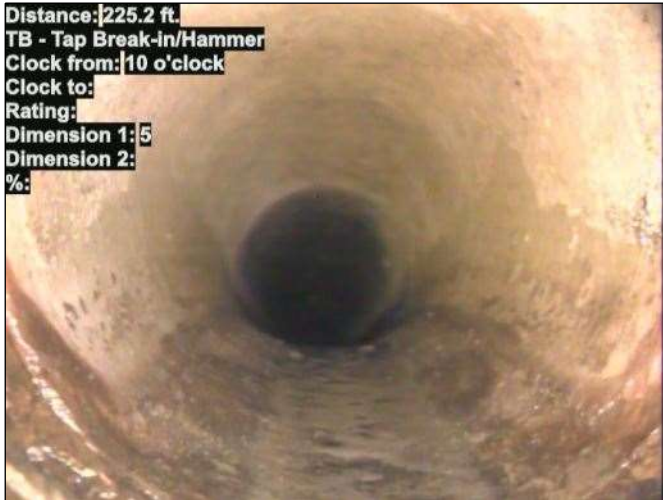
Photo: 15\_009A-15\_006-20230726-105140.JPG  
At: 225.2 ft. 10/. TB - Tap Break-in/Hammer  
Joint: No

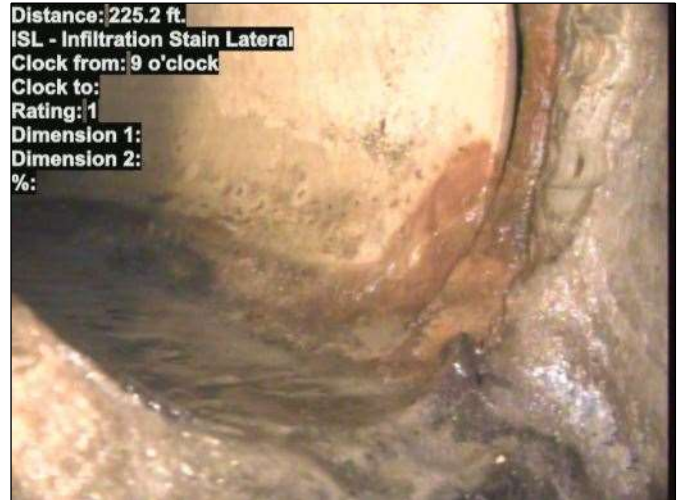
Photo: 15\_009A-15\_006-20230726-105205.JPG  
At: 225.2 ft. 9/. ISL - Infiltration Stain Lateral  
Joint: No

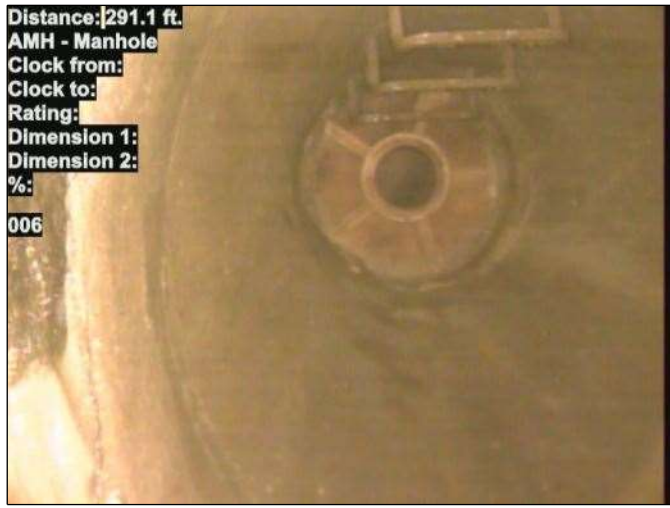
Photo: 15\_009A-15\_006-20230726-105639.JPG

At: 291.1 ft. AMH - Manhole

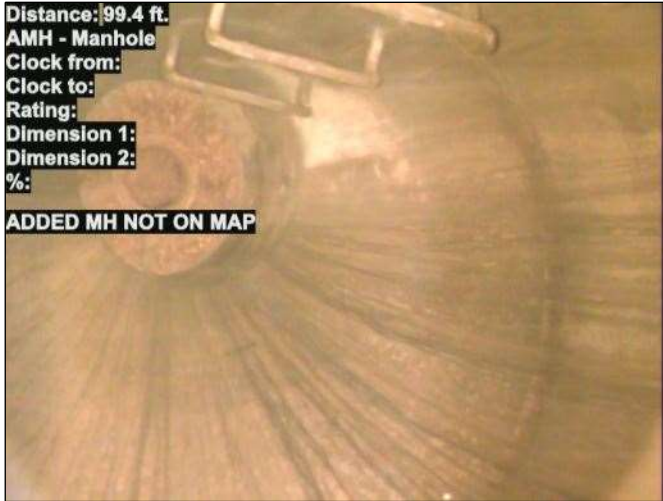
Photo: 15\_011-15\_009-20230726-102622.JPG  
At: 99.4 ft. AMH - Manhole  
Joint: No ADDED MH NOT ON MAP

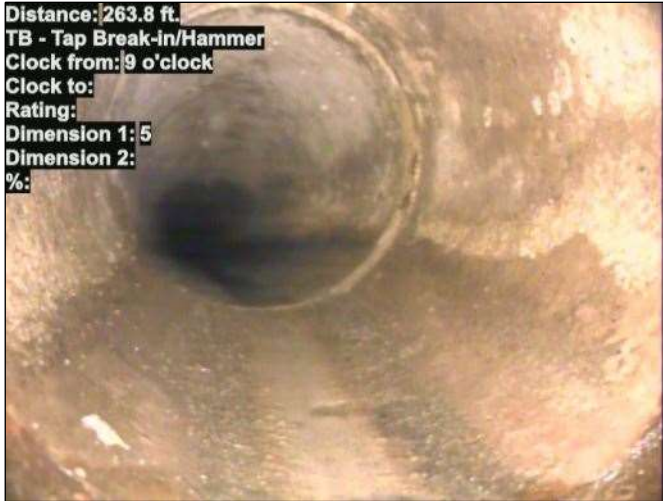
Photo: 15\_012-15\_011-20230726-101745.JPG  
At: 263.8 ft. 9/. TB - Tap Break-in/Hammer  
Joint: No

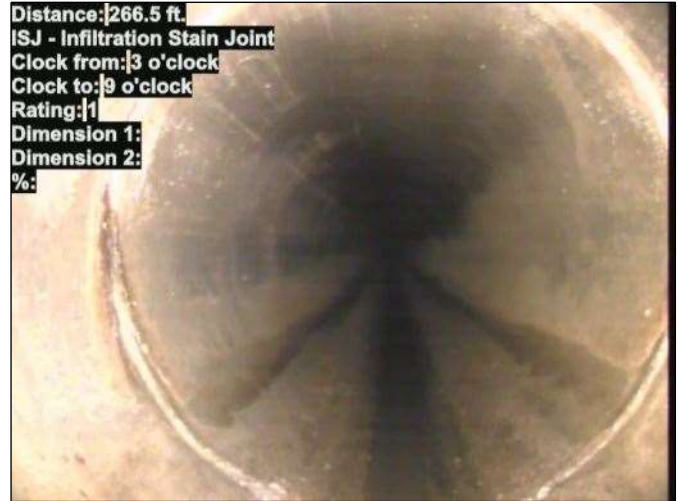
Photo: 15\_012-15\_011-20230726-101829.JPG  
At: 266.5 ft. 3/9 ISJ - Infiltration Stain Joint  
Joint: Yes

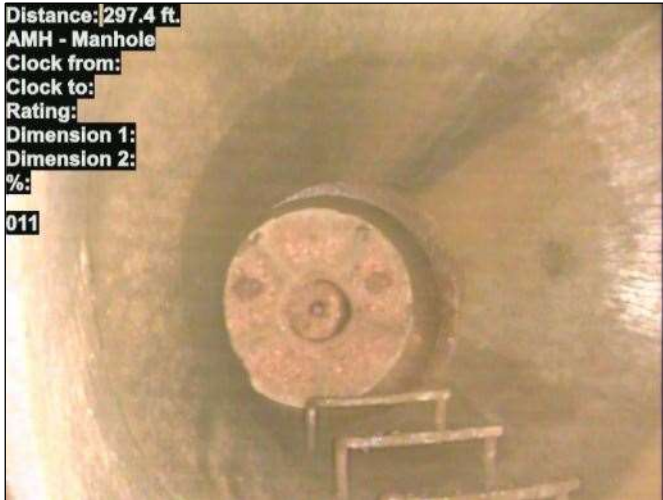
Photo: 15\_012-15\_011-20230726-101942.JPG  
At: 297.4 ft. AMH - Manhole  
Joint: No 011

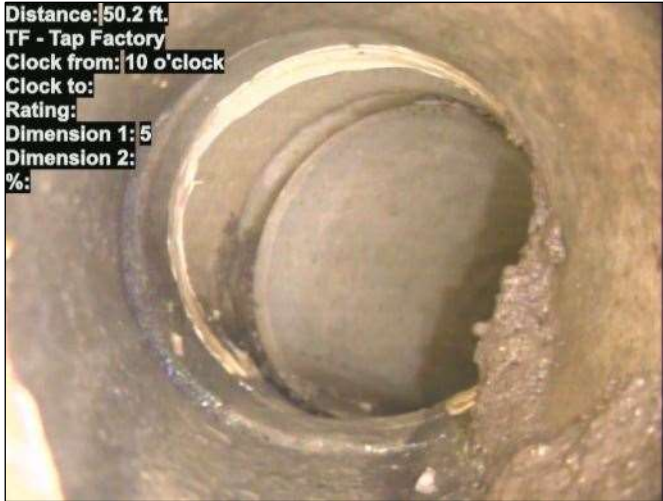
Photo: 15\_013-15\_014-20230725-124802.JPG  
At: 50.2 ft. 10/. TF - Tap Factory  
Joint: No

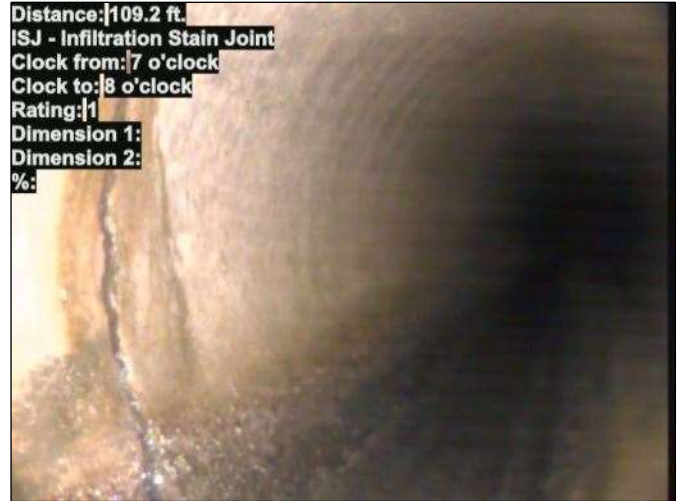
Photo: 15\_013-15\_014-20230725-125038.JPG  
At: 109.2 ft. 7/8 ISJ - Infiltration Stain Joint  
Joint: Yes

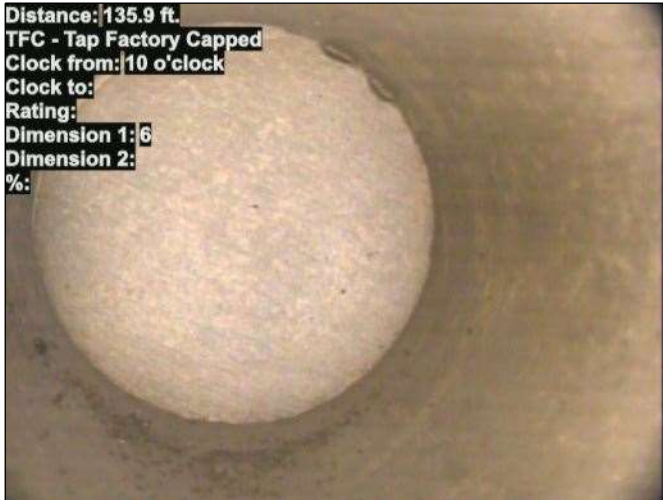
Photo: 15\_013-15\_014-20230725-125150.JPG  
At: 135.9 ft. 10/. TFC - Tap Factory Capped  
Joint: No

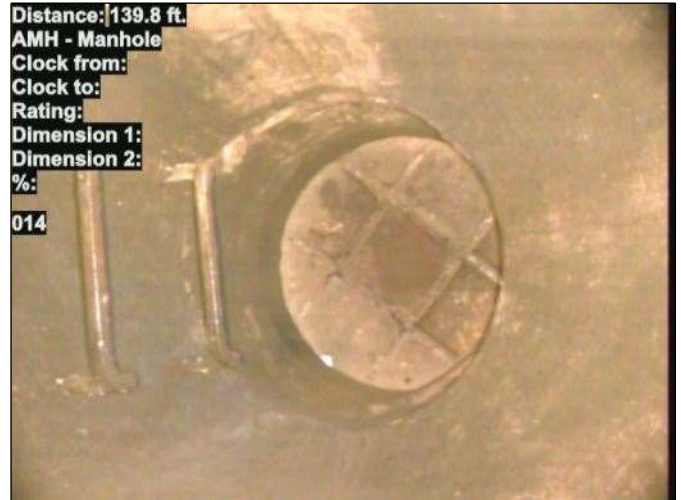
Photo: 15\_013-15\_014-20230725-125220.JPG  
At: 139.8 ft. AMH - Manhole  
Joint: No 014

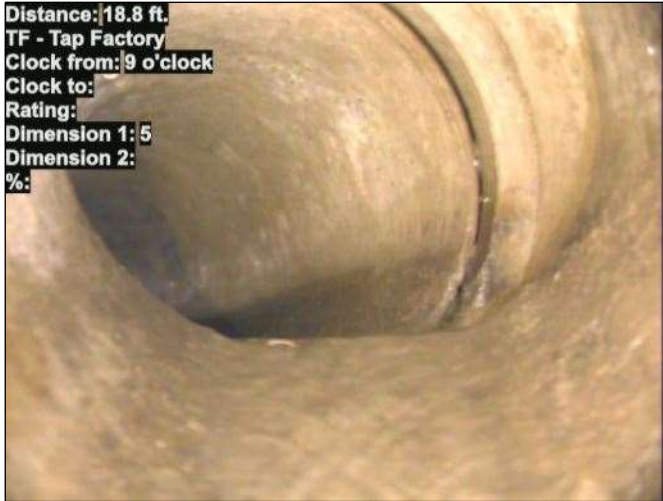
Photo: 15\_014-15\_015-20230724-143457.JPG  
At: 18.8 ft. 9/. TF - Tap Factory  
Joint: No

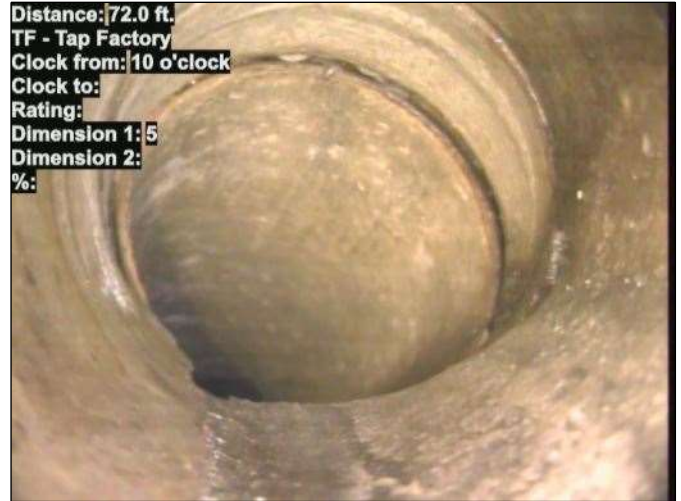
Photo: 15\_014-15\_015-20230724-143650.JPG  
At: 72 ft. 10/. TF - Tap Factory  
Joint: No

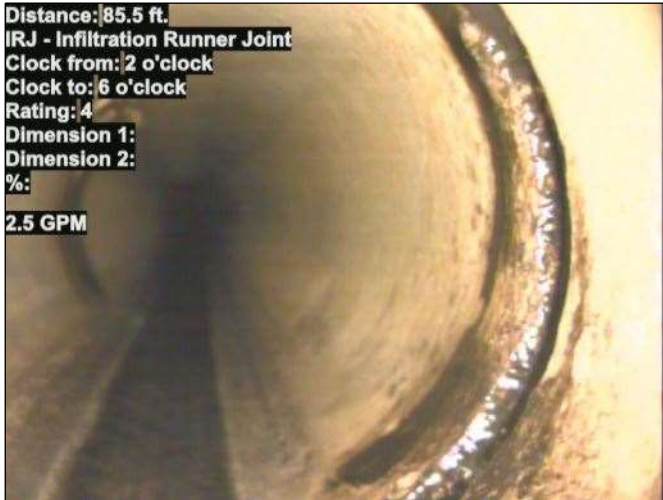
Photo: 15\_014-15\_015-20230724-143735.JPG  
At: 85.5 ft. 2/6 IRJ - Infiltration Runner Joint  
Joint: Yes 2.5 GPM

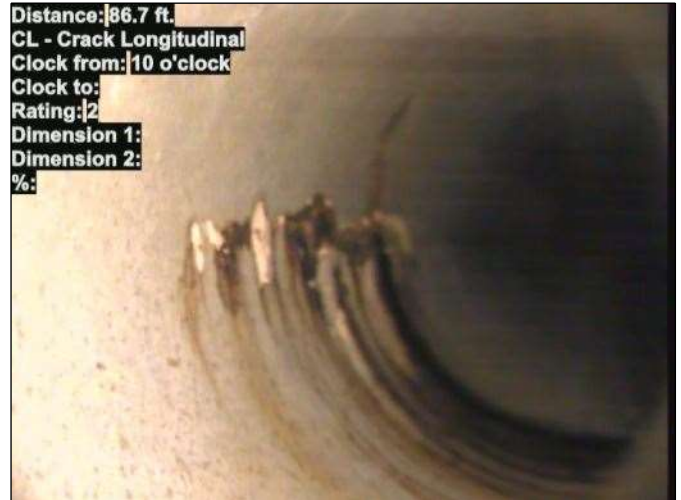
Photo: 15\_014-15\_015-20230724-143819.JPG  
At: 86.7 ft. 10/. CL - Crack Longitudinal  
Joint: No

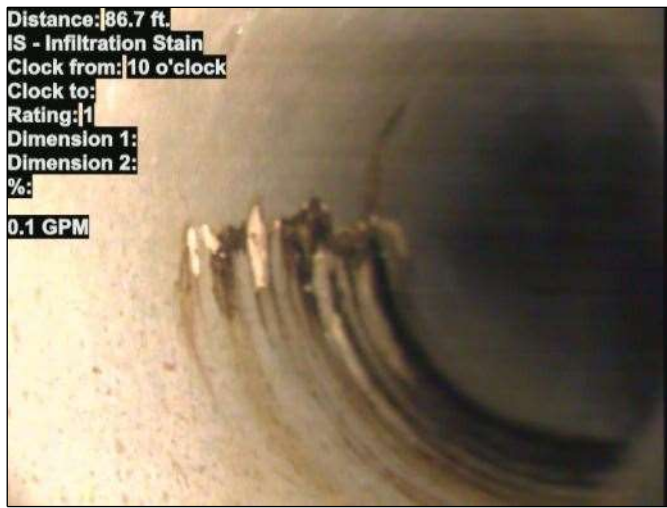
Distance: 86.7 ft.  
IS - Infiltration Stain  
Clock from: 10 o'clock  
Clock to:  
Rating: 1  
Dimension 1:  
Dimension 2:  
%:  
0.1 GPM  
Photo: 15\_014-15\_015-20230724-143825.JPG  
At: 86.7 ft. 10/. IS - Infiltration Stain  
Joint: No 0.1 GPM

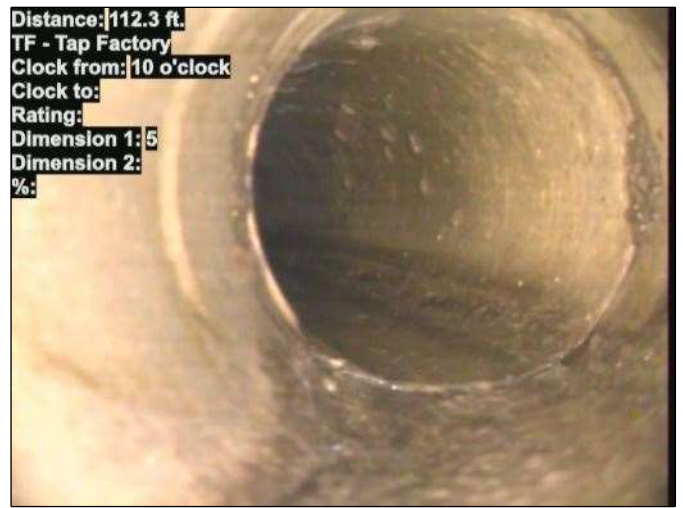
Distance: 112.3 ft.  
TF - Tap Factory  
Clock from: 10 o'clock  
Clock to:  
Rating:  
Dimension 1: 5  
Dimension 2:  
%:  
Photo: 15\_014-15\_015-20230724-144011.JPG  
At: 112.3 ft. 10/. TF - Tap Factory  
Joint: No

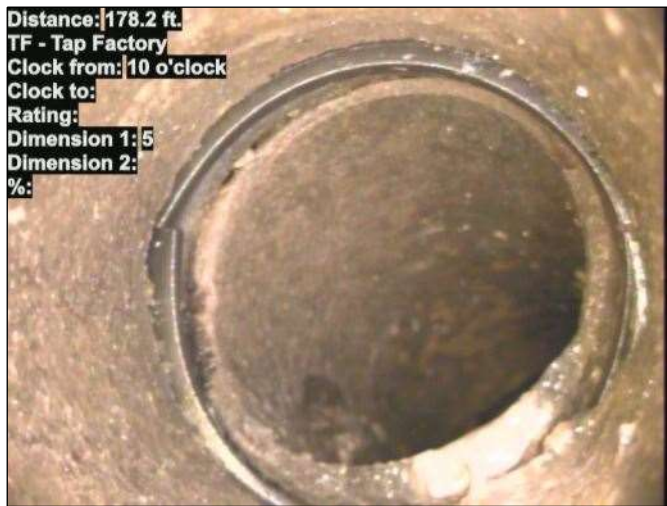
Distance: 178.2 ft.  
TF - Tap Factory  
Clock from: 10 o'clock  
Clock to:  
Rating:  
Dimension 1: 5  
Dimension 2:  
%:  
Photo: 15\_014-15\_015-20230724-144249.JPG  
At: 178.2 ft. 10/. TF - Tap Factory  
Joint: No

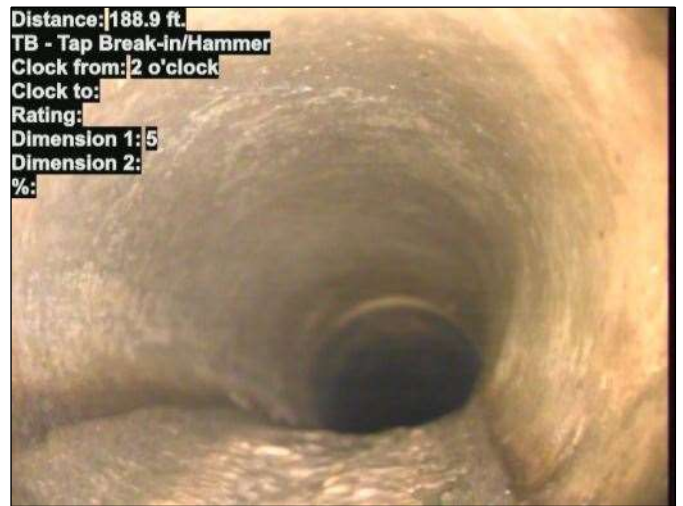
Distance: 188.9 ft.  
TB - Tap Break-in/Hammer  
Clock from: 2 o'clock  
Clock to:  
Rating:  
Dimension 1: 5  
Dimension 2:  
%:  
Photo: 15\_014-15\_015-20230724-144333.JPG  
At: 188.9 ft. 2/. TB - Tap Break-in/Hammer  
Joint: No

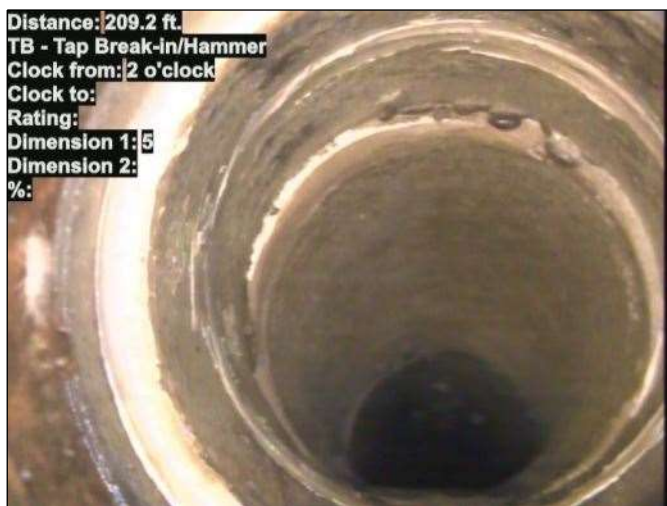
Distance: 209.2 ft.  
TB - Tap Break-in/Hammer  
Clock from: 2 o'clock  
Clock to:  
Rating:  
Dimension 1: 5  
Dimension 2:  
%:  
Photo: 15\_014-15\_015-20230724-144425.JPG  
At: 209.2 ft. 2/. TB - Tap Break-in/Hammer  
Joint: No

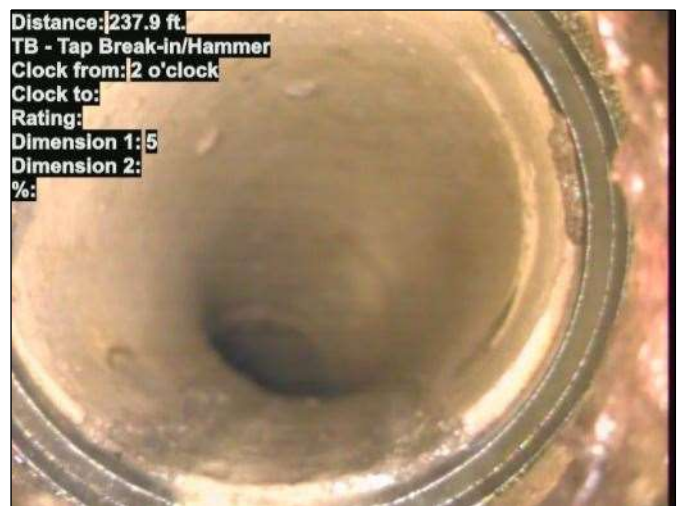
Distance: 237.9 ft.  
TB - Tap Break-in/Hammer  
Clock from: 2 o'clock  
Clock to:  
Rating:  
Dimension 1: 5  
Dimension 2:  
%:  
Photo: 15\_014-15\_015-20230724-144538.JPG  
At: 237.9 ft. 2/. TB - Tap Break-in/Hammer  
Joint: No
