**APPENDIX C**  
CCTV Reports

## NWMCC INSPECTION REPORT

Start date/time: <b>20230725 12:13</b>	Weather: <b>Dry - No precipitation during survey</b>	Surveyed by: <b>C.Arruda</b>	Certificate number: <b>U-910-11364</b>	Pipe segment ref.: <b>15/002 - 15/001</b>	
Owner:	Customer:	Pre-cleaning: <b>Light Cleaning</b>	Date cleaned: <b>20230725</b>	Project name: <b>ENV017-13</b>	
City: <b>WESTWOOD MA</b>	Street: <b>NAHATAN ST</b>	Location code:	Pipe use: <b>Sanitary Sewage Pipe</b>	Drainage area: 	Flow control: 
Upstream MH No: <b>15/001</b>	Downstream MH No: <b>15/002</b>	Direction: <b>U</b>	Total length: <b>304.300 ft.</b>	Length surveyed: <b>304.300 ft.</b>	
Purpose: <b>Maintenance Related</b>	Pipe joint length: 	Height: <b>8 in.</b>	Material: <b>Asbestos Cement</b>	LateralsCounter: 	Additional info:

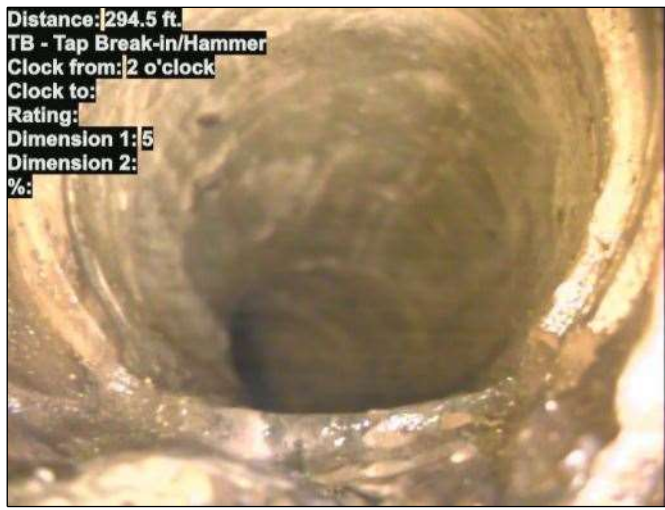
Distance: 294.5 ft.  
TB - Tap Break-in/Hammer  
Clock from: 2 o'clock  
Clock to:  
Rating:  
Dimension 1: 5  
Dimension 2:  
%:

Photo: 15\_014-15\_015-20230724-144716.JPG  
At: 294.5 ft. 2/. TB - Tap Break-in/Hammer  
Joint: No

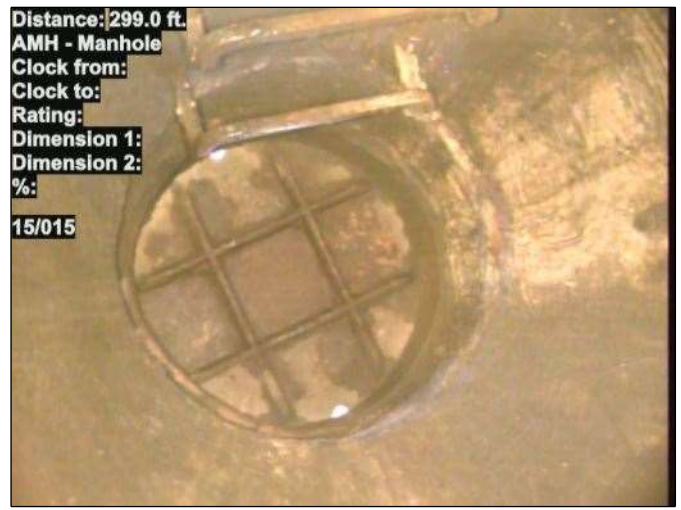
15/015

Distance: 299.0 ft.  
AMH - Manhole  
Clock from:  
Clock to:  
Rating:  
Dimension 1:  
Dimension 2:  
%:

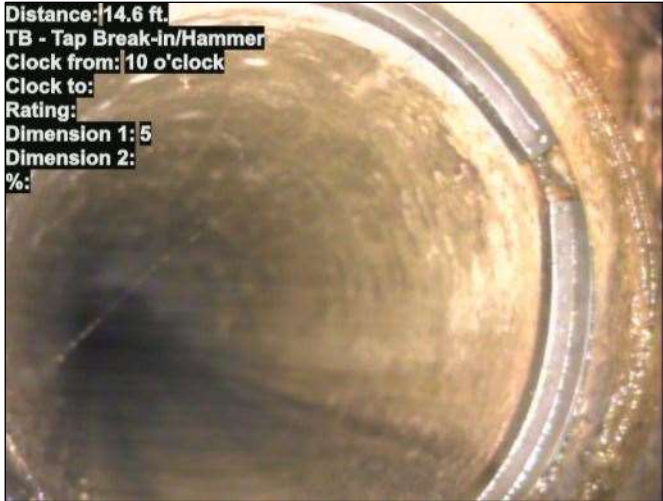
Photo: 15\_015-15\_016-20230724-135227.JPG  
At: 14.6 ft. 10/. TB - Tap Break-in/Hammer  
Joint: No

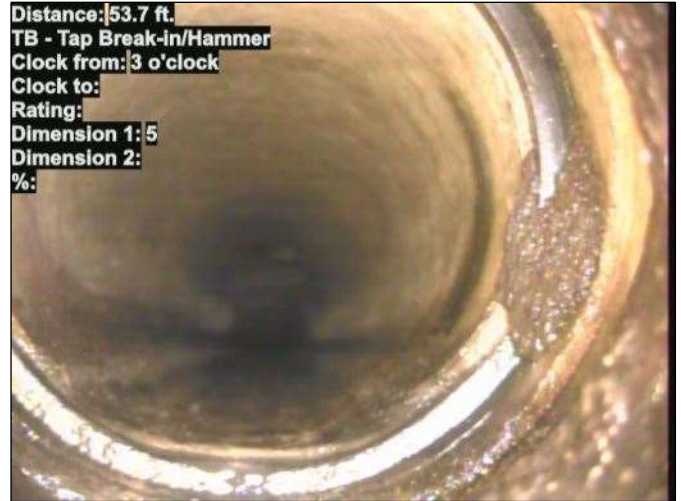
Photo: 15\_015-15\_016-20230724-135350.JPG  
At: 53.7 ft. 3/. TB - Tap Break-in/Hammer  
Joint: No

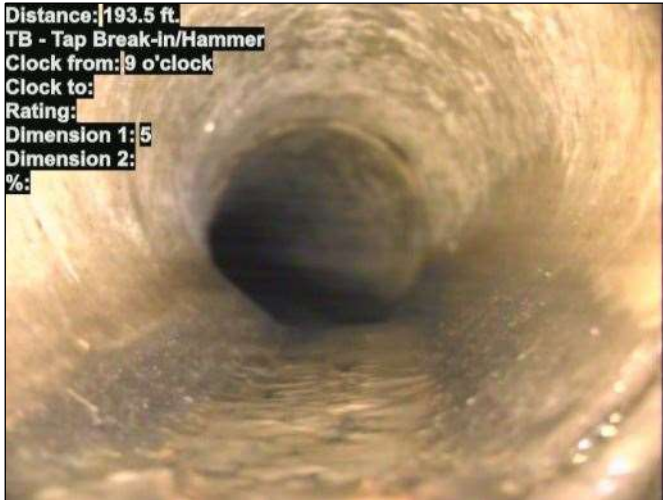
Photo: 15\_015-15\_016-20230724-135701.JPG  
At: 193.5 ft. 9/. TB - Tap Break-in/Hammer  
Joint: No

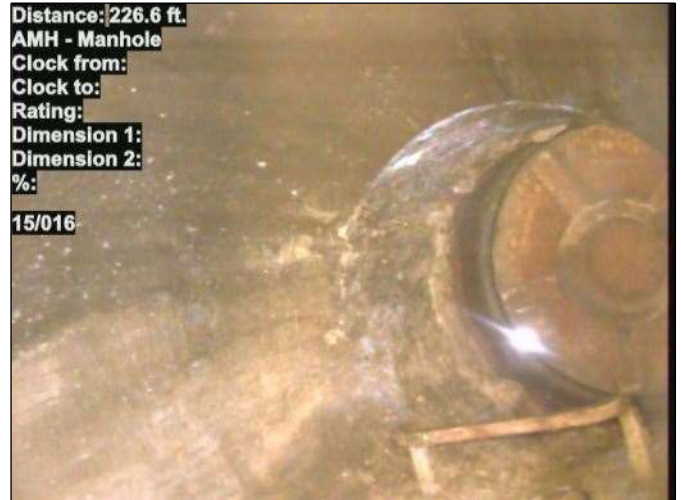
Photo: 15\_015-15\_016-20230724-135816.JPG  
At: 226.6 ft. AMH - Manhole  
Joint: No 15/016

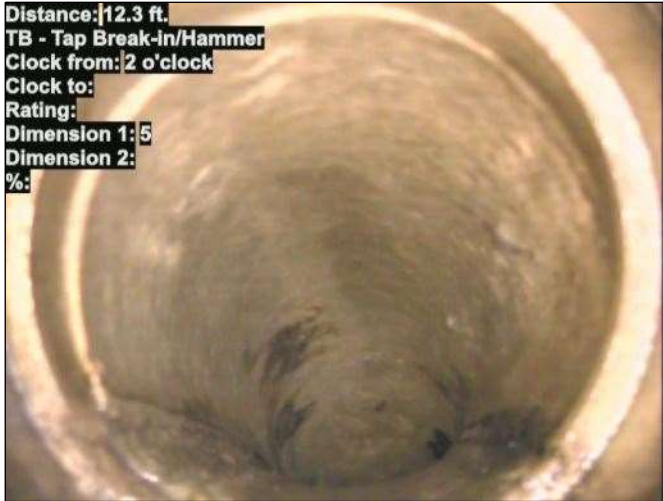
Photo: 15\_016-15\_017-20230724-140230.JPG  
At: 12.3 ft. 2/. TB - Tap Break-in/Hammer  
Joint: No

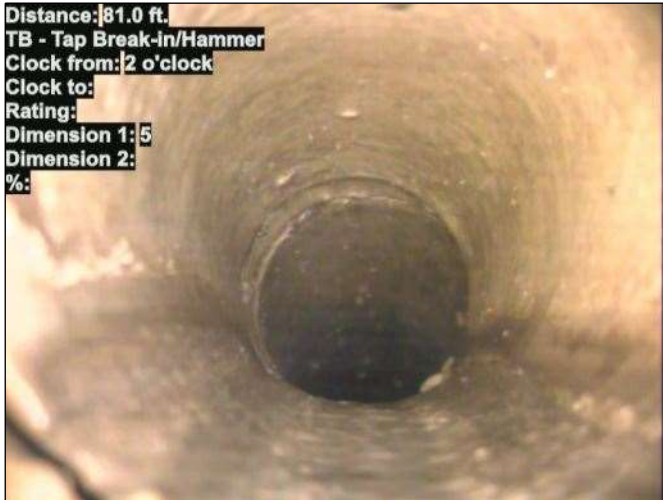
Photo: 15\_016-15\_017-20230724-140515.JPG  
At: 81 ft. 2/. TB - Tap Break-in/Hammer  
Joint: No

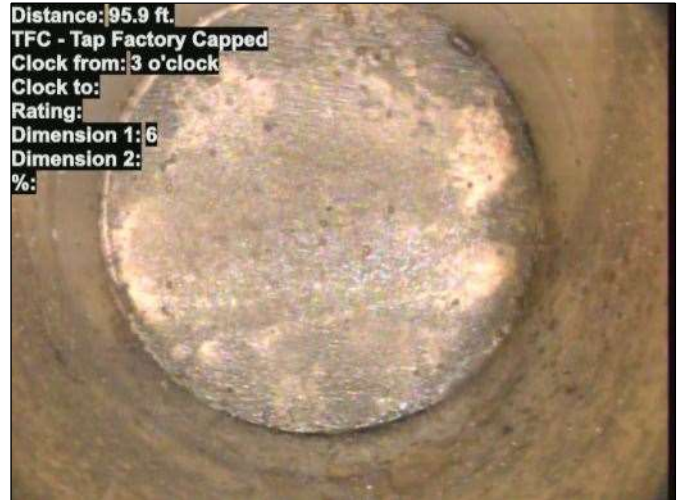
Photo: 15\_016-15\_017-20230724-140628.JPG  
At: 95.9 ft. 3/. TFC - Tap Factory Capped  
Joint: No

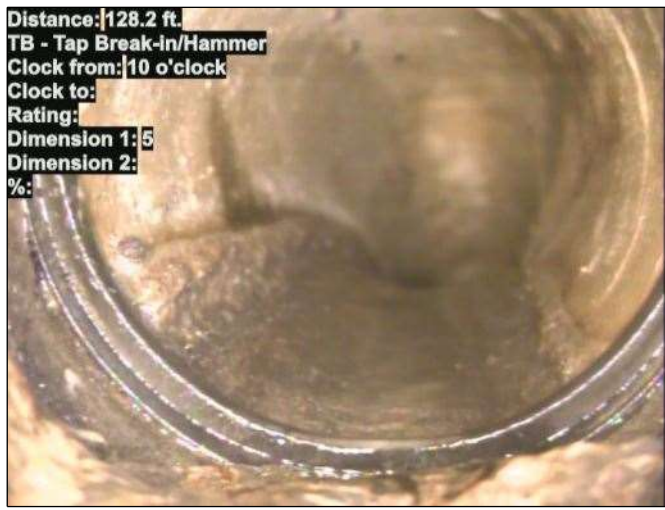
Distance: 128.2 ft.  
TB - Tap Break-in/Hammer  
Clock from: 10 o'clock  
Clock to:  
Rating:  
Dimension 1: 5  
Dimension 2:  
%:  
Photo: 15\_016-15\_017-20230724-140737.JPG  
At: 128.2 ft. 10/. TB - Tap Break-in/Hammer  
Joint: No

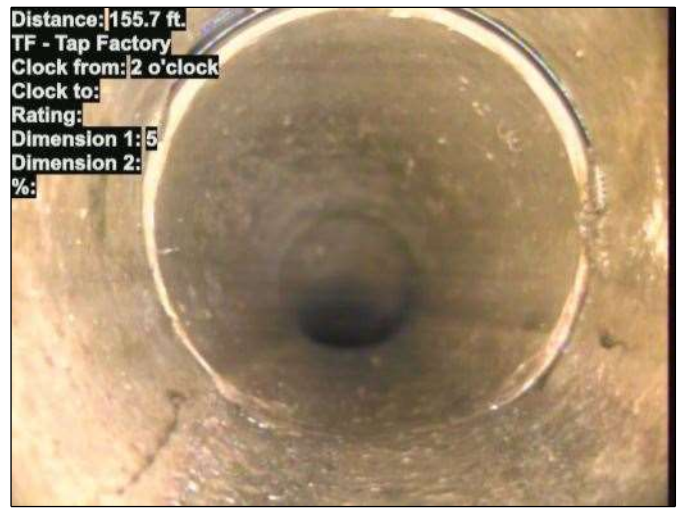
Distance: 155.7 ft.  
TF - Tap Factory  
Clock from: 2 o'clock  
Clock to:  
Rating:  
Dimension 1: 5  
Dimension 2:  
%:  
Photo: 15\_016-15\_017-20230724-140839.JPG  
At: 155.7 ft. 2/. TF - Tap Factory  
Joint: No

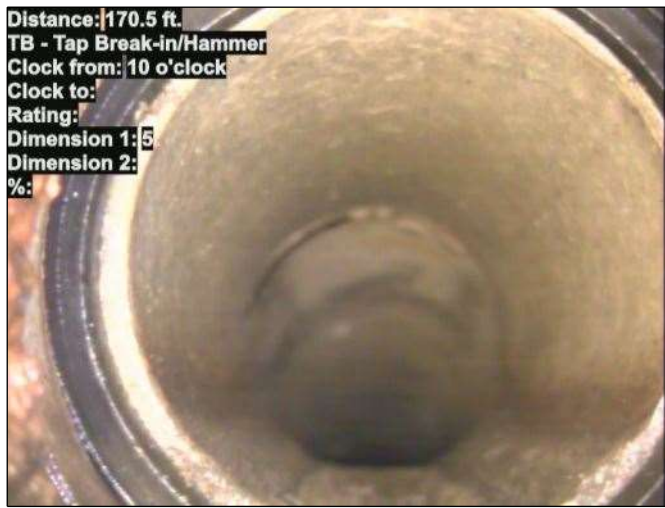
Distance: 170.5 ft.  
TB - Tap Break-in/Hammer  
Clock from: 10 o'clock  
Clock to:  
Rating:  
Dimension 1: 5  
Dimension 2:  
%:  
Photo: 15\_016-15\_017-20230724-140931.JPG  
At: 170.5 ft. 10/. TB - Tap Break-in/Hammer  
Joint: No

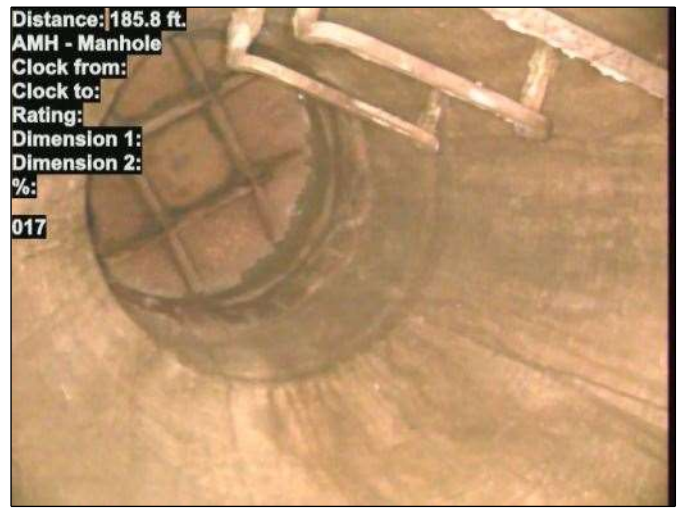
Distance: 185.8 ft.  
AMH - Manhole  
Clock from:  
Clock to:  
Rating:  
Dimension 1:  
Dimension 2:  
%:  
017  
Photo: 15\_016-15\_017-20230724-141048.JPG  
At: 185.8 ft. AMH - Manhole  
Joint: No 017

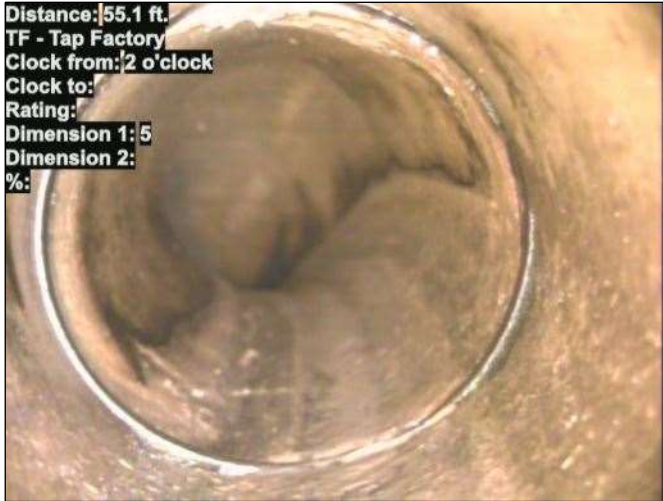
Photo: 15\_017-15\_018-20230724-150507.JPG  
At: 55.1 ft. 2/. TF - Tap Factory  
Joint: No

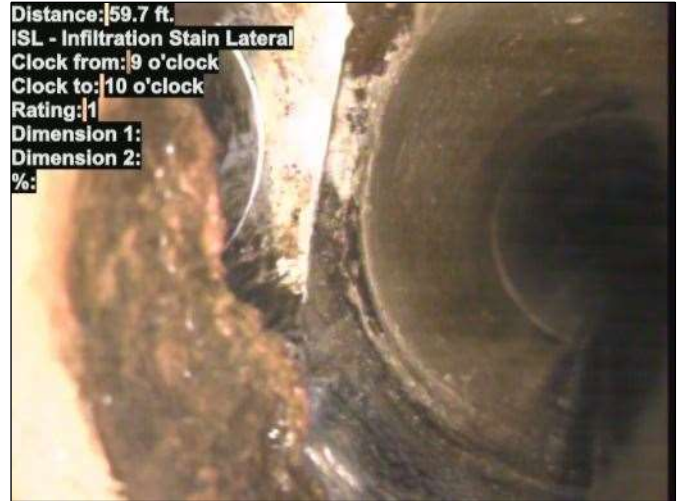
Photo: 15\_017-15\_018-20230724-150624.JPG  
At: 59.7 ft. 9/10 ISL - Infiltration Stain Lateral  
Joint: No

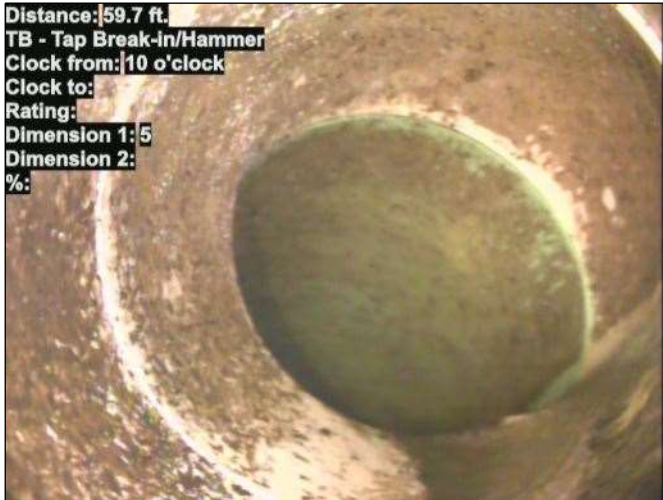
Photo: 15\_017-15\_018-20230724-150542.JPG  
At: 59.7 ft. 10/. TB - Tap Break-in/Hammer  
Joint: No

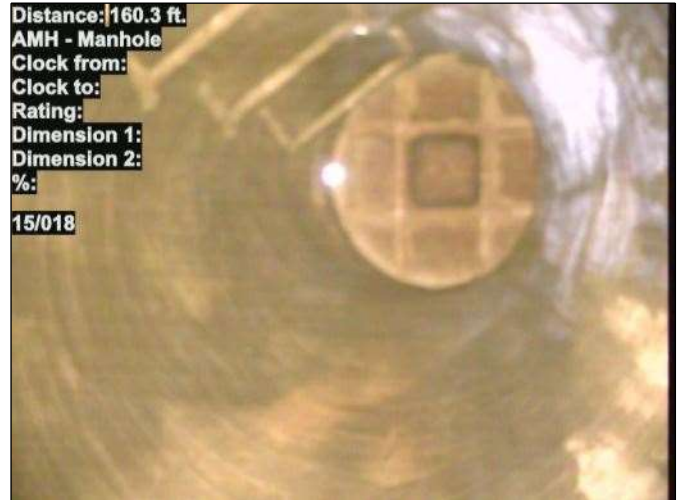
Photo: 15\_017-15\_018-20230724-150929.JPG  
At: 160.3 ft. AMH - Manhole  
Joint: No 15/018

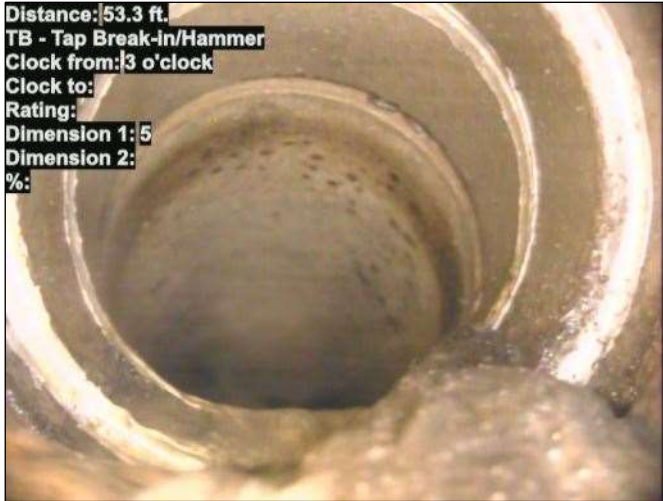
Photo: 15\_018-15\_025-20230801-095000.JPG  
At: 53.3 ft. 3/. TB - Tap Break-in/Hammer  
Joint: No

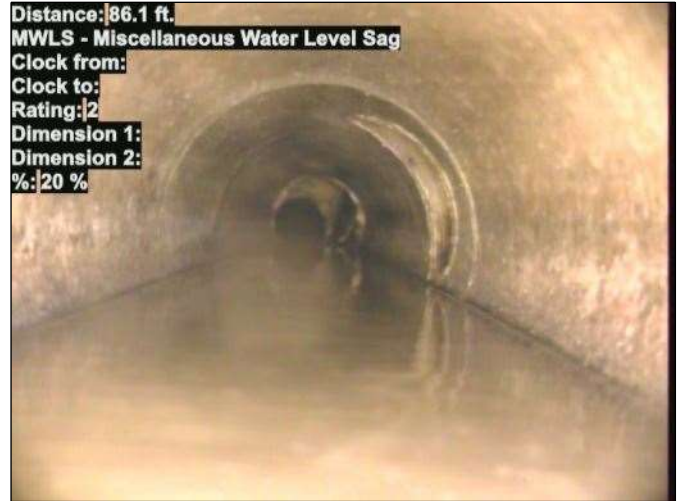
Photo: 15\_018-15\_025-20230801-095130.JPG  
At: 86.1 ft. MWLS - Miscellaneous Water Level Sag  
Joint: No 20 %

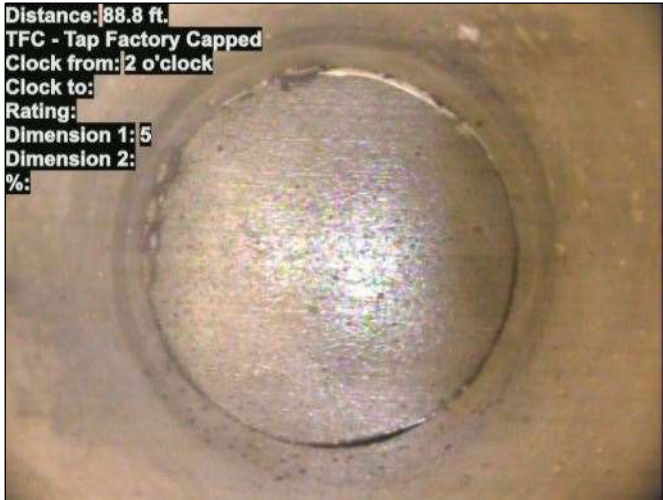
Photo: 15\_018-15\_025-20230801-095221.JPG  
At: 88.8 ft. 2/. TFC - Tap Factory Capped  
Joint: No

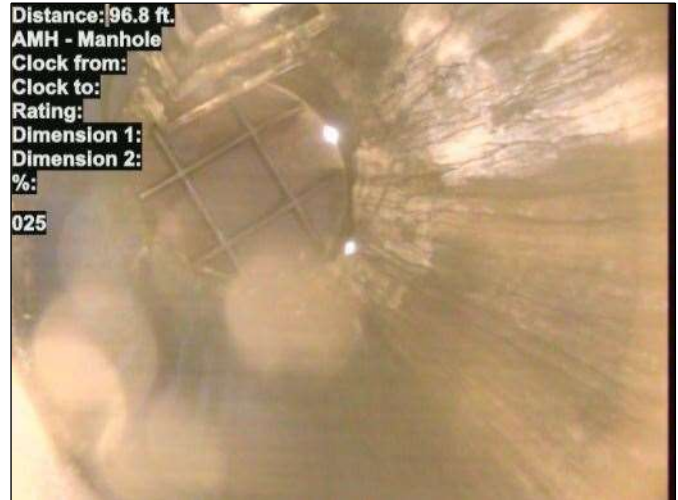
Photo: 15\_018-15\_025-20230801-095321.JPG  
At: 96.8 ft. AMH - Manhole  
Joint: No 025

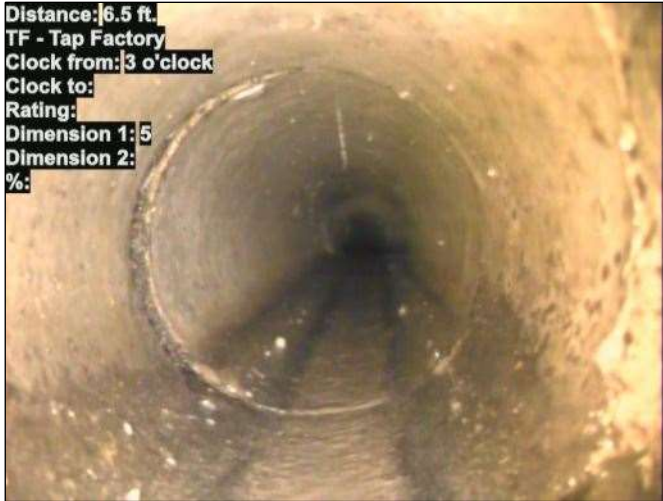
Photo: 15\_019-15\_018-20230721-114038.JPG  
At: 6.5 ft. 3/. TF - Tap Factory  
Joint: No

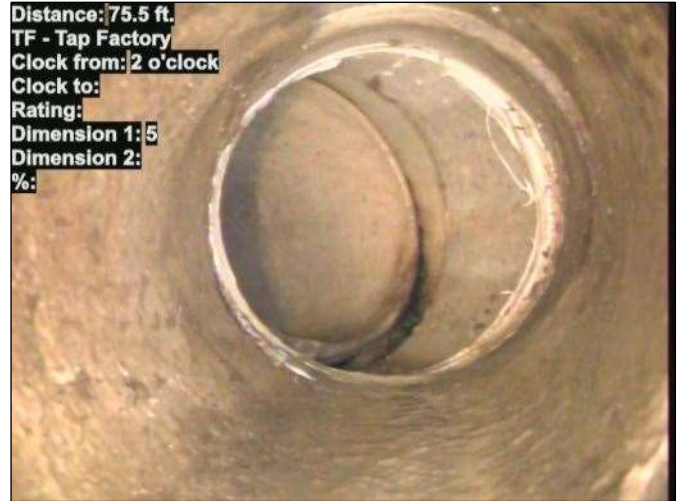
Photo: 15\_019-15\_018-20230721-114359.JPG  
At: 75.5 ft. 2/. TF - Tap Factory  
Joint: No

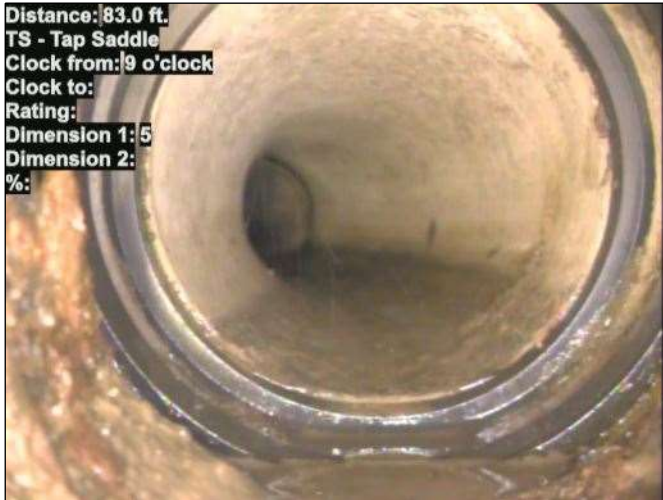
Photo: 15\_019-15\_018-20230721-114440.JPG  
At: 83 ft. 9/. TS - Tap Saddle  
Joint: No

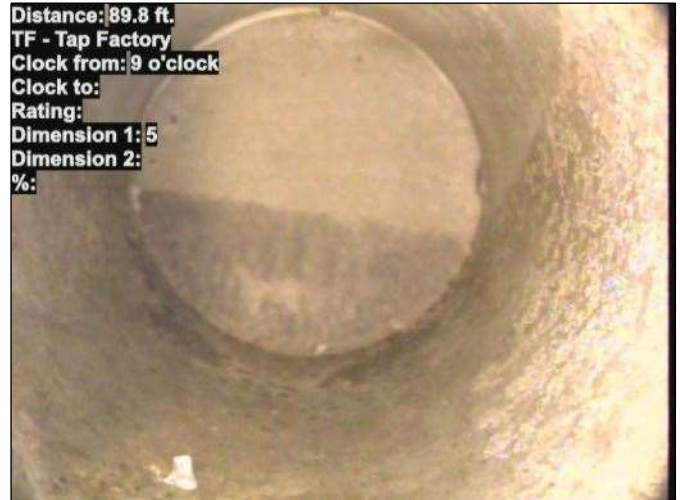
Photo: 15\_019-15\_018-20230721-114524.JPG  
At: 89.8 ft. 9/. TF - Tap Factory  
Joint: No

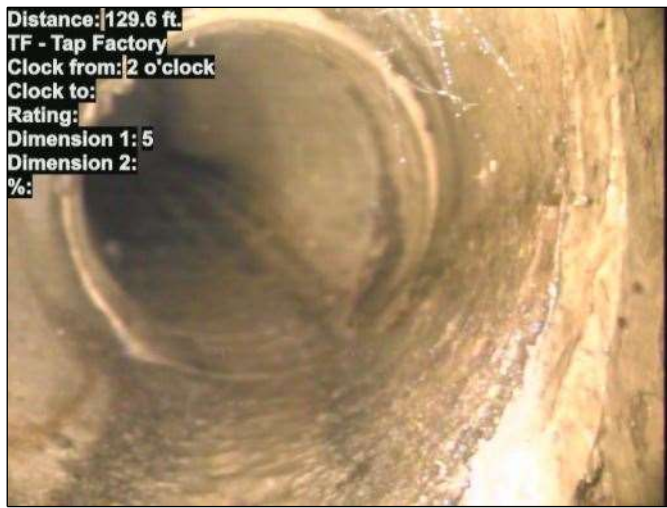
Distance: 129.6 ft.  
TF - Tap Factory  
Clock from: 2 o'clock  
Clock to:  
Rating: 5  
Dimension 1: 5  
Dimension 2:  
%:  
Photo: 15\_019-15\_018-20230721-114702.JPG  
At: 129.6 ft. 2/. TF - Tap Factory  
Joint: No

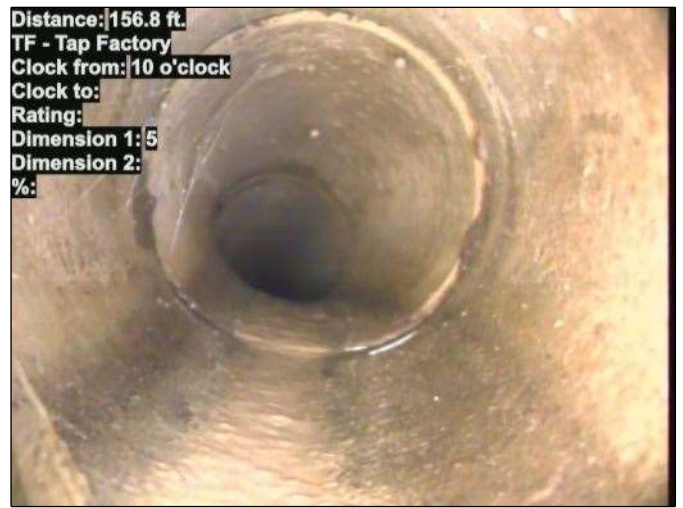
Distance: 156.8 ft.  
TF - Tap Factory  
Clock from: 10 o'clock  
Clock to:  
Rating: 5  
Dimension 1: 5  
Dimension 2:  
%:  
Photo: 15\_019-15\_018-20230721-114812.JPG  
At: 156.8 ft. 10/. TF - Tap Factory  
Joint: No

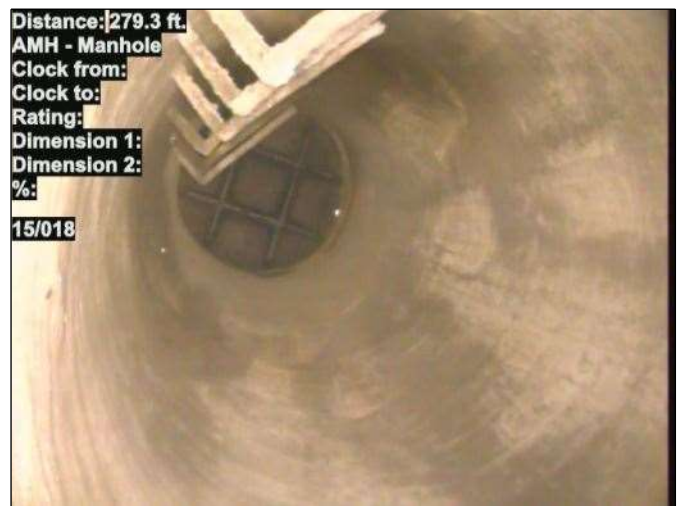
Distance: 279.3 ft.  
AMH - Manhole  
Clock from:  
Clock to:  
Rating: 5  
Dimension 1:  
Dimension 2:  
%:  
15/018  
Photo: 15\_019-15\_018-20230721-115327.JPG  
At: 279.3 ft. AMH - Manhole  
Joint: No 15/018

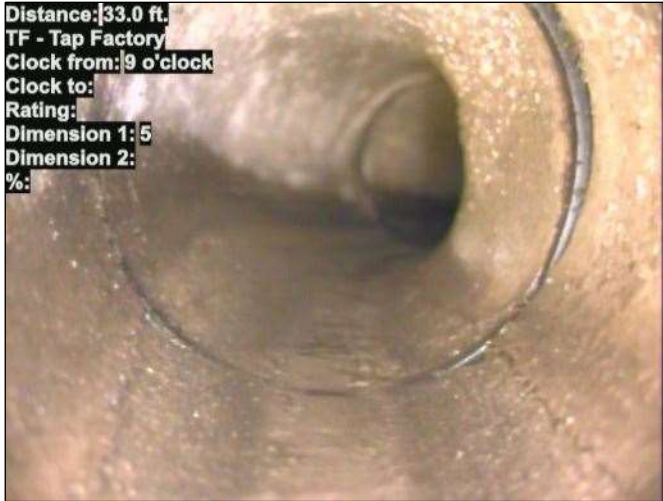
Photo: 15\_020-15\_021-20230724-152349.JPG  
At: 33 ft. 9/. TF - Tap Factory  
Joint: No

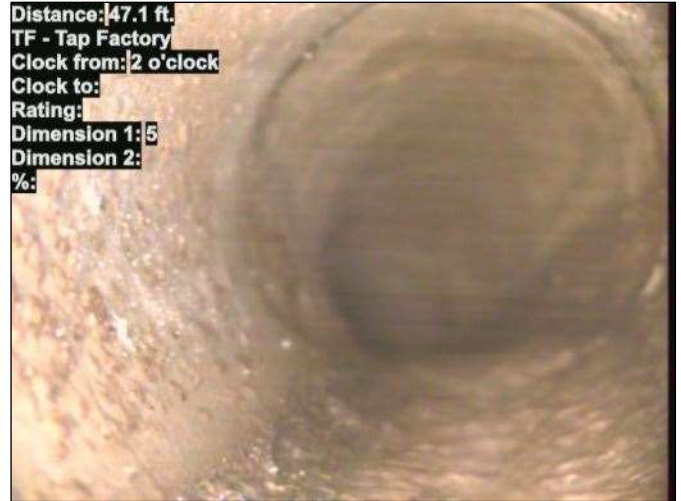
Photo: 15\_020-15\_021-20230724-152430.JPG  
At: 47.1 ft. 2/. TF - Tap Factory  
Joint: No

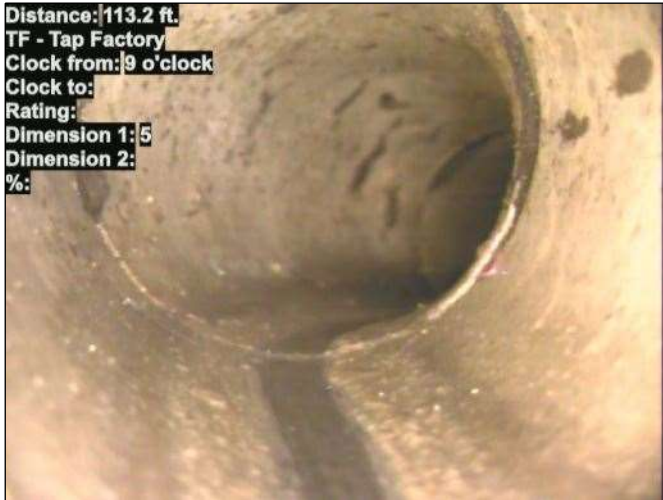
Photo: 15\_020-15\_021-20230724-152641.JPG  
At: 113.2 ft. 9/. TF - Tap Factory  
Joint: No

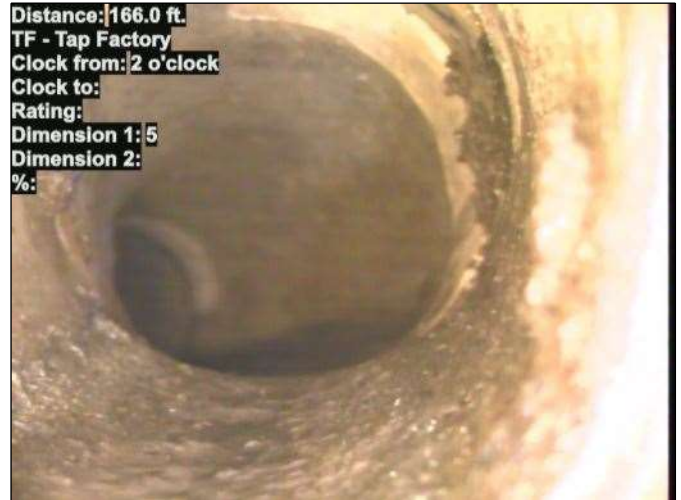
Photo: 15\_020-15\_021-20230724-152826.JPG  
At: 166 ft. 2/. TF - Tap Factory  
Joint: No

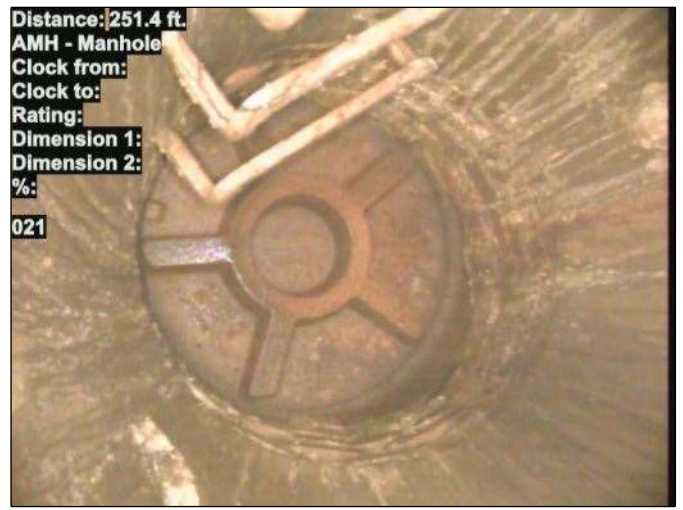
Photo: 15\_020-15\_021-20230724-153207.JPG  
At: 251.4 ft. AMH - Manhole  
Joint: No 021

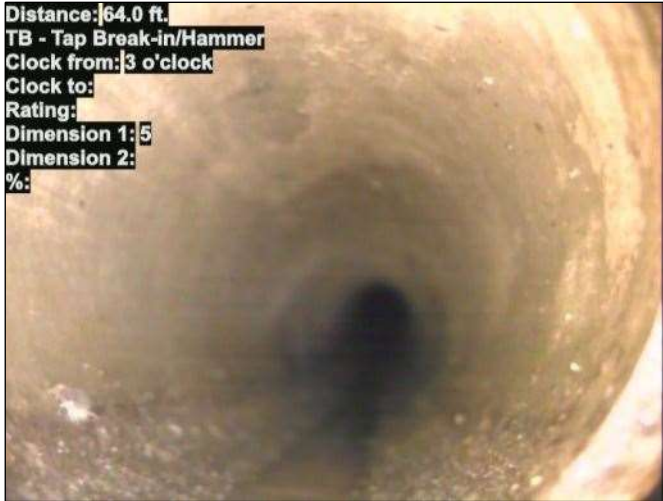
Photo: 15\_021-15\_022-20230724-153618.JPG  
At: 64 ft. 3/. TB - Tap Break-in/Hammer  
Joint: No

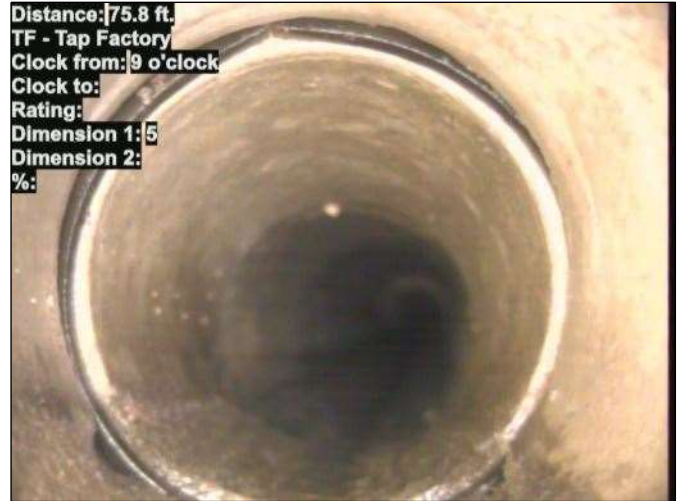
Photo: 15\_021-15\_022-20230724-153703.JPG  
At: 75.8 ft. 9/. TF - Tap Factory  
Joint: No

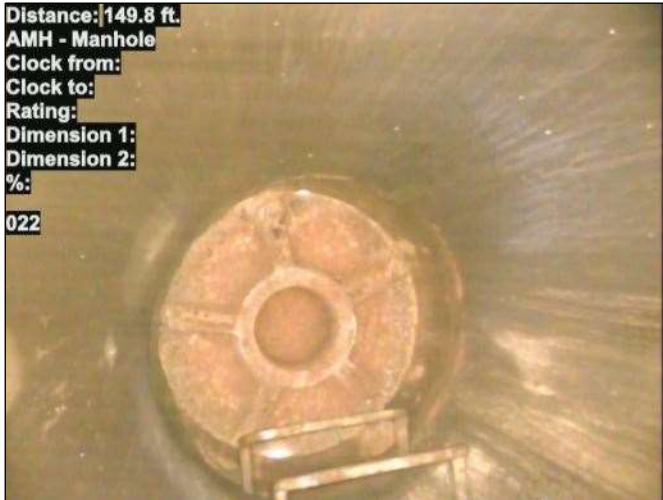
Photo: 15\_021-15\_022-20230724-153957.JPG  
At: 149.8 ft. AMH - Manhole  
Joint: No 022

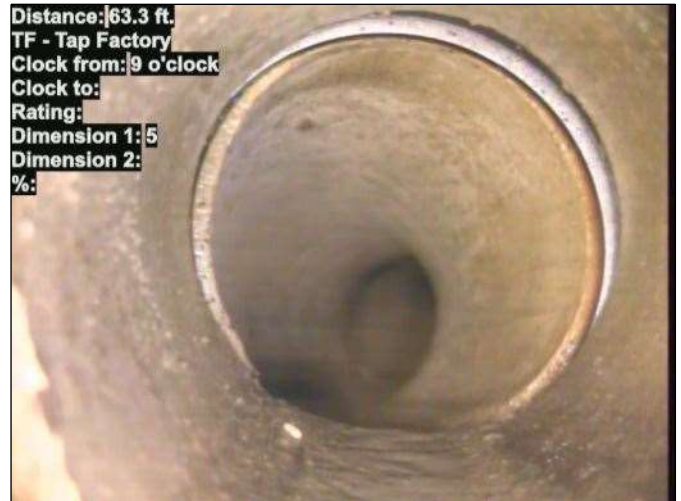
Photo: 15\_022-15\_023-20230724-154553.JPG  
At: 63.3 ft. 9/ TF - Tap Factory  
Joint: No

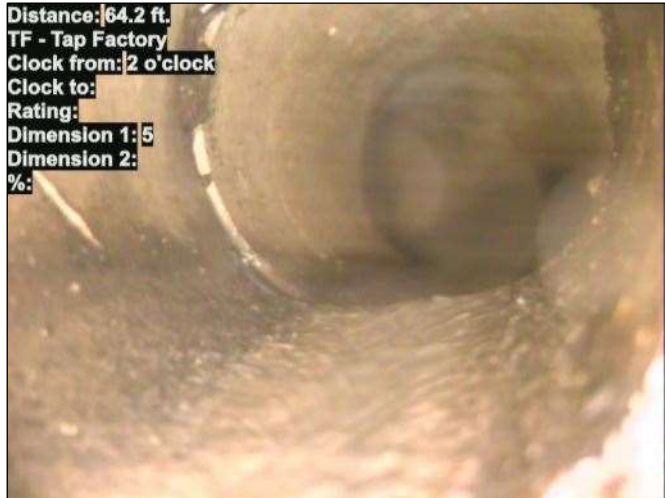
Photo: 15\_022-15\_023-20230724-154609.JPG  
At: 64.2 ft. 2/ TF - Tap Factory  
Joint: No

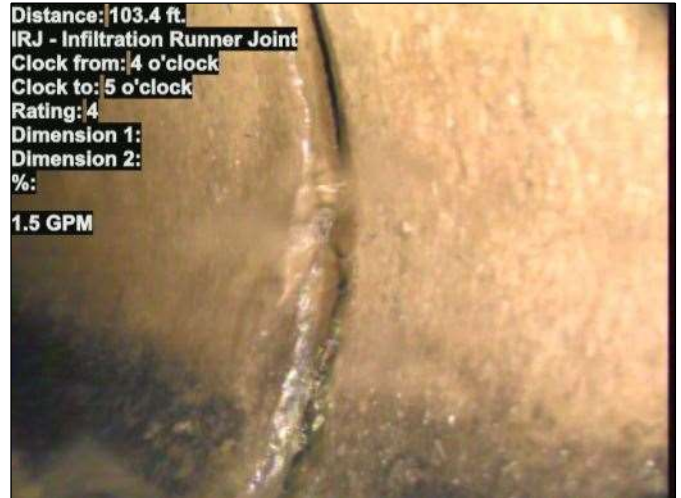
Photo: 15\_022-15\_023-20230724-154742.JPG  
At: 103.4 ft. 4/5 IRJ - Infiltration Runner Joint  
Joint: Yes 1.5 GPM

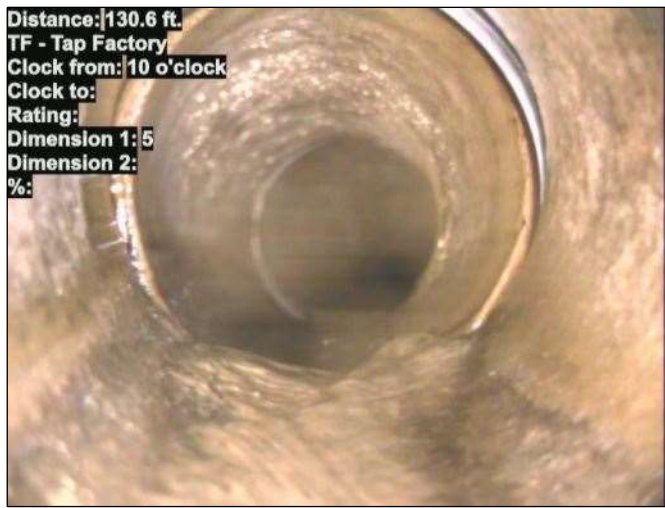
Distance:|130.6 ft.  
TF - Tap Factory  
Clock from:|10 o'clock  
Clock to:  
Rating:  
Dimension 1:|5  
Dimension 2:  
%:

Photo: 15\_022-15\_023-20230724-154854.JPG  
At: 130.6 ft. 10/. TF - Tap Factory  
Joint: No

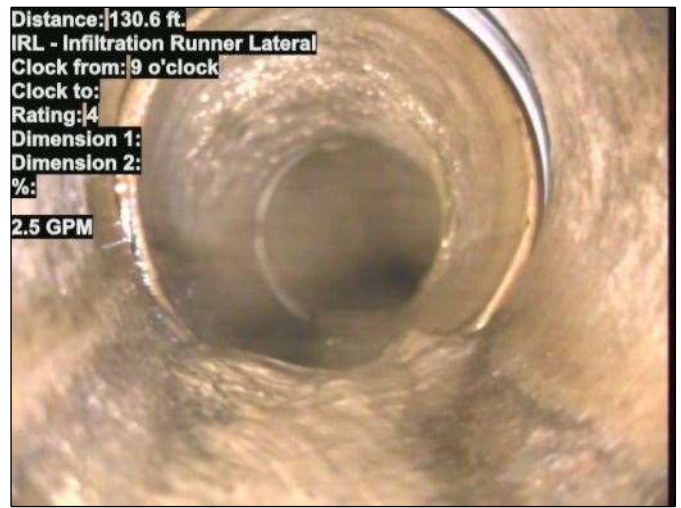
Distance:|130.6 ft.  
IRL - Infiltration Runner Lateral  
Clock from:|9 o'clock  
Clock to:  
Rating:|4  
Dimension 1:  
Dimension 2:  
%:  
2.5 GPM

Photo: 15\_022-15\_023-20230724-154903.JPG  
At: 130.6 ft. 9/. IRL - Infiltration Runner Lateral  
Joint: No 2.5 GPM

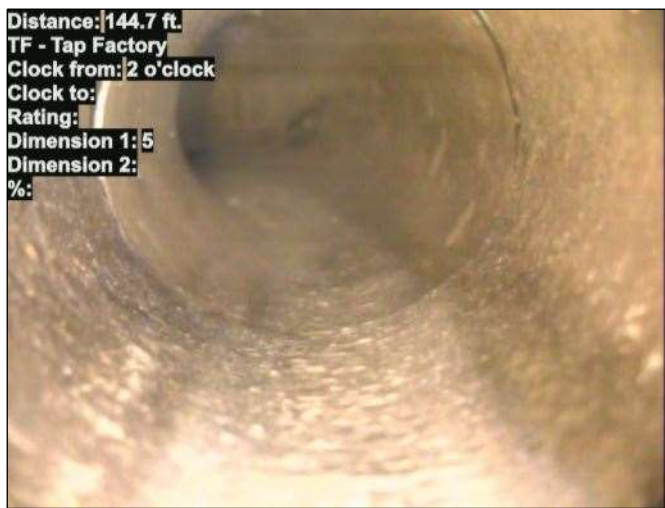
Distance:|144.7 ft.  
TF - Tap Factory  
Clock from:|2 o'clock  
Clock to:  
Rating:  
Dimension 1:|5  
Dimension 2:  
%:

Photo: 15\_022-15\_023-20230724-154945.JPG  
At: 144.7 ft. 2/. TF - Tap Factory  
Joint: No

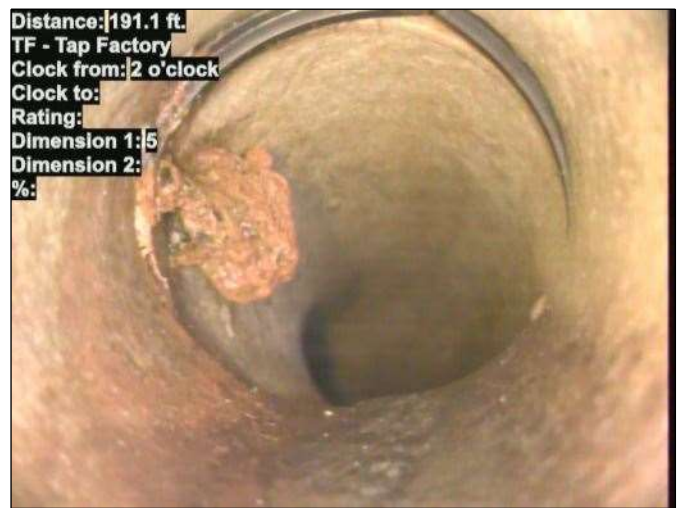
Distance:|191.1 ft.  
TF - Tap Factory  
Clock from:|2 o'clock  
Clock to:  
Rating:  
Dimension 1:|5  
Dimension 2:  
%:

Photo: 15\_022-15\_023-20230724-155104.JPG  
At: 191.1 ft. 2/. TF - Tap Factory  
Joint: No

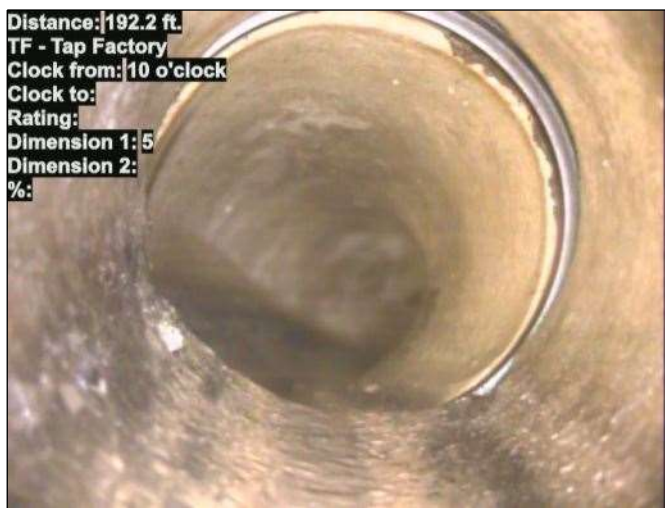
Distance:|192.2 ft.  
TF - Tap Factory  
Clock from:|10 o'clock  
Clock to:  
Rating:  
Dimension 1:|5  
Dimension 2:  
%:

Photo: 15\_022-15\_023-20230724-155121.JPG  
At: 192.2 ft. 10/. TF - Tap Factory  
Joint: No

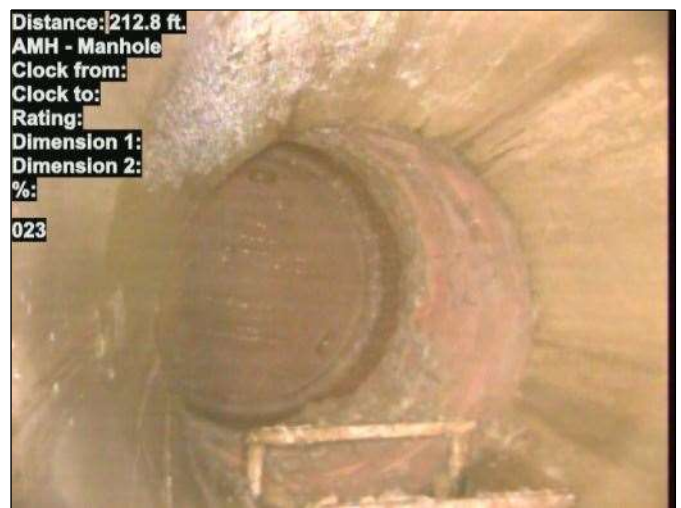
Distance:|212.8 ft.  
AMH - Manhole  
Clock from:  
Clock to:  
Rating:  
Dimension 1:  
Dimension 2:  
%:  
023

Photo: 15\_022-15\_023-20230724-155218.JPG  
At: 212.8 ft. AMH - Manhole  
Joint: No 023

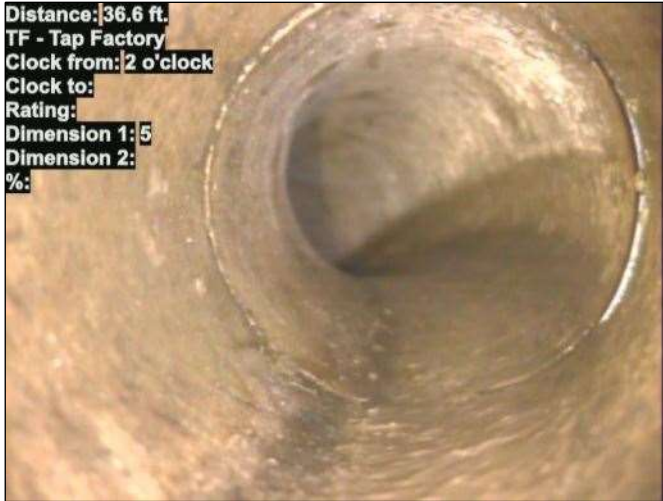
Photo: 15\_023-15\_024-20230724-155519.JPG  
At: 36.6 ft. 2/. TF - Tap Factory  
Joint: No

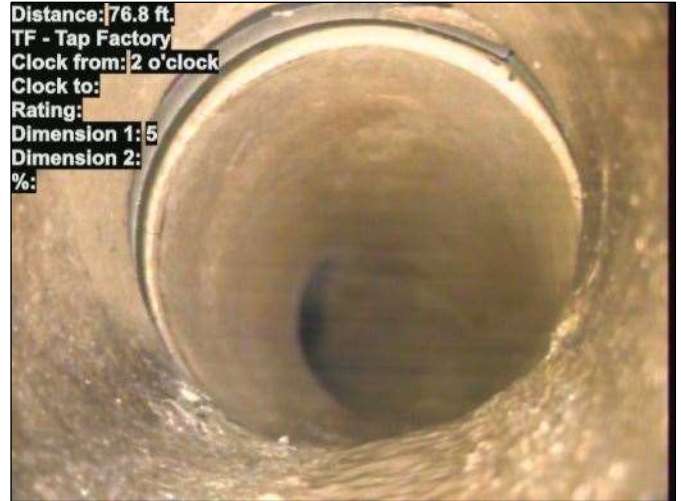
Photo: 15\_023-15\_024-20230724-155643.JPG  
At: 76.8 ft. 2/. TF - Tap Factory  
Joint: No

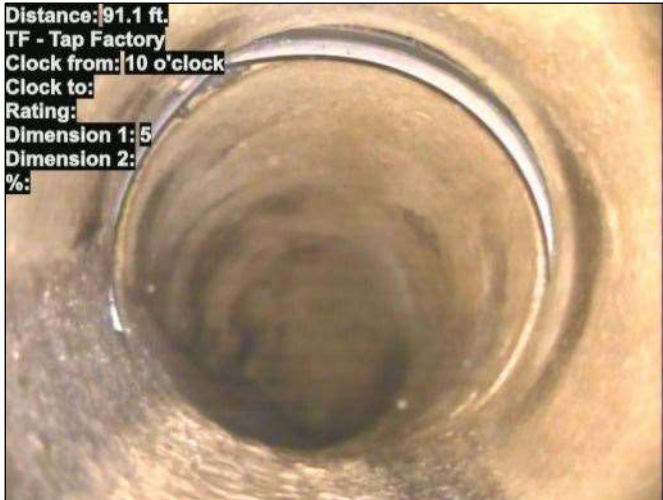
Photo: 15\_023-15\_024-20230724-155732.JPG  
At: 91.1 ft. 10/. TF - Tap Factory  
Joint: No

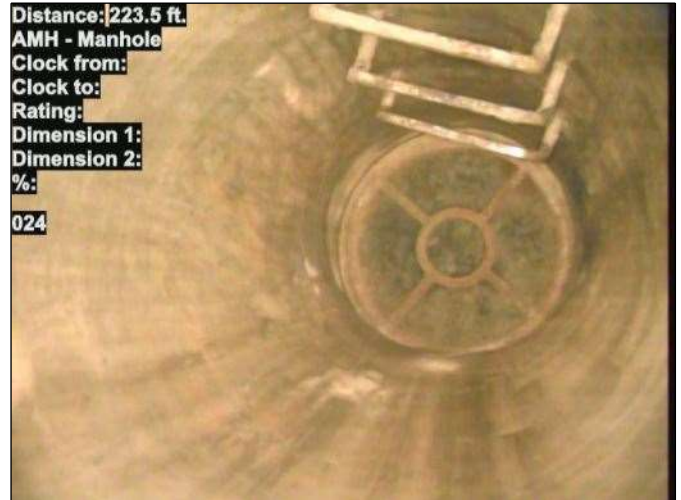
Photo: 15\_023-15\_024-20230724-160303.JPG  
At: 223.5 ft. AMH - Manhole  
Joint: No 024

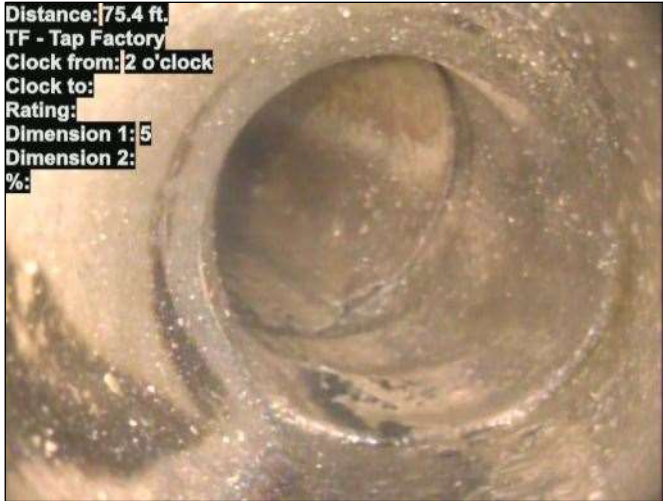
Photo: 15\_024-15\_033-20230801-101123.JPG  
At: 75.4 ft. 2/. TF - Tap Factory  
Joint: No

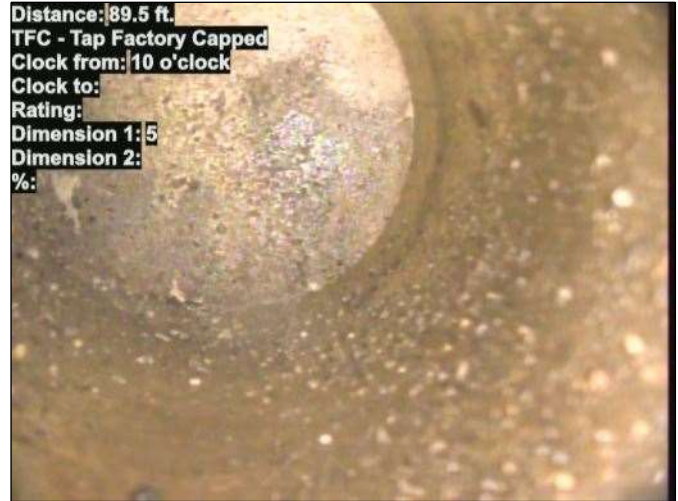
Photo: 15\_024-15\_033-20230801-101217.JPG  
At: 89.5 ft. 10/. TFC - Tap Factory Capped  
Joint: No

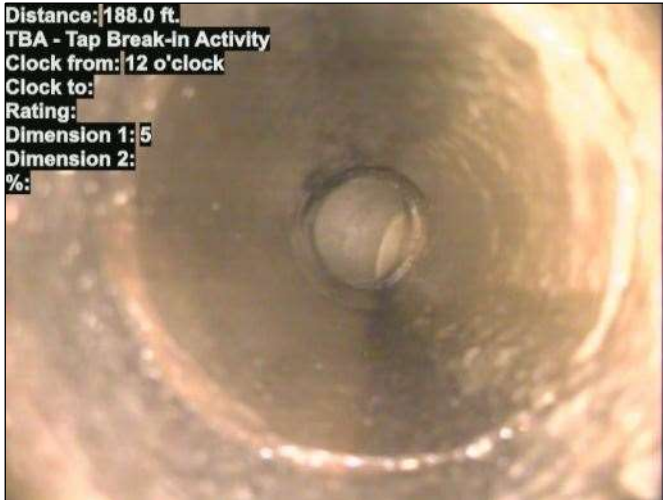
Photo: 15\_024-15\_033-20230801-101537.JPG  
At: 188 ft. 12/. TBA - Tap Break-in Activity  
Joint: No

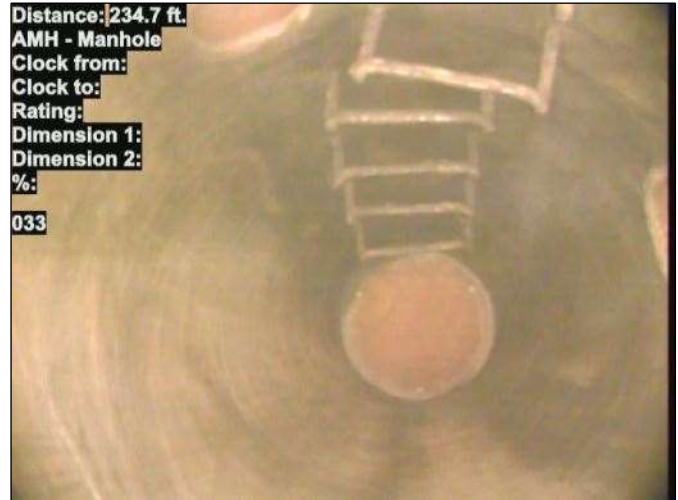
Photo: 15\_024-15\_033-20230801-101754.JPG  
At: 234.7 ft. AMH - Manhole  
Joint: No 033

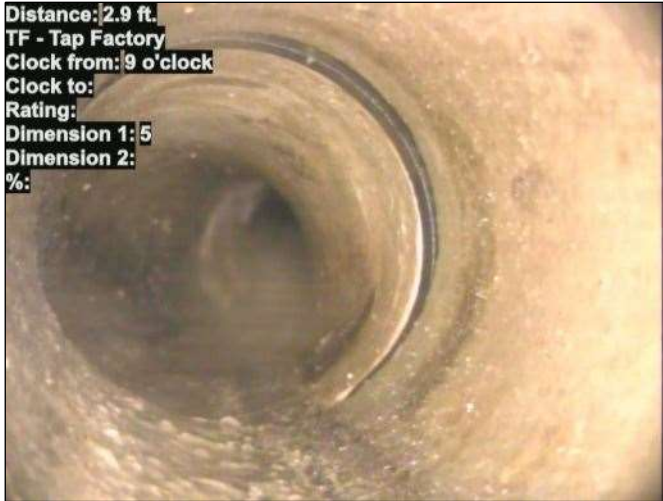
Photo: 15\_025-15\_024-20230801-095807.JPG  
At: 2.9 ft. 9/. TF - Tap Factory  
Joint: No

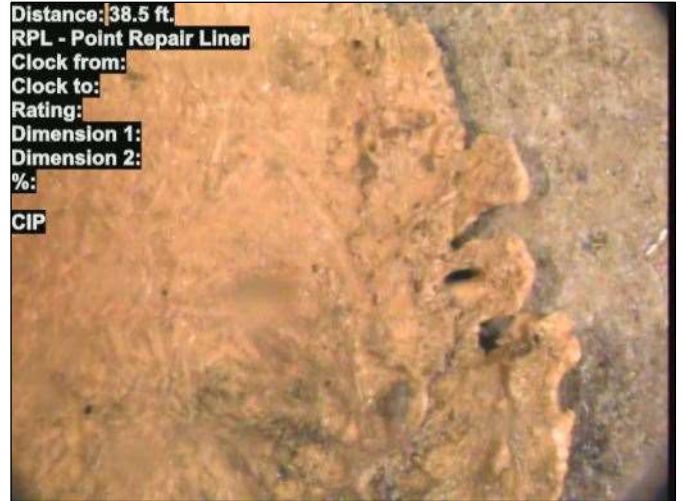
Photo: 15\_025-15\_024-20230801-095934.JPG  
At: 38.5 ft. RPL - Point Repair Liner  
Joint: No CIP

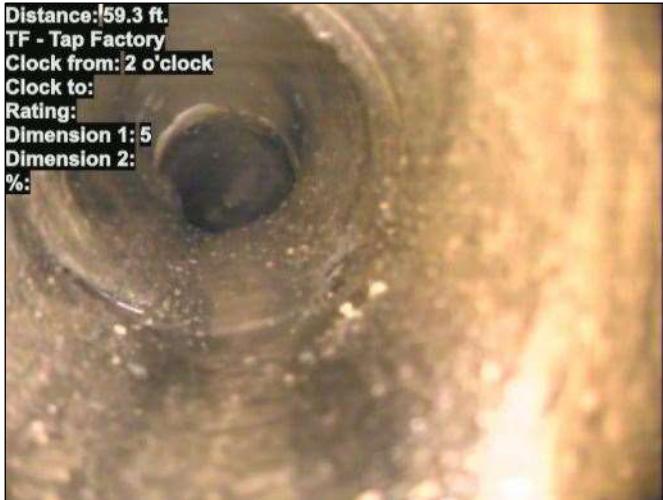
Photo: 15\_025-15\_024-20230801-100111.JPG  
At: 59.3 ft. 2/. TF - Tap Factory  
Joint: No

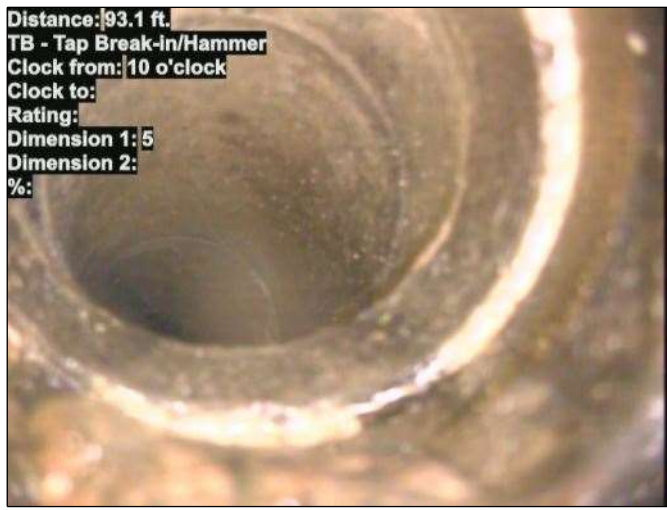
Distance: 93.1 ft.  
TB - Tap Break-in/Hammer  
Clock from: 10 o'clock  
Clock to:  
Rating:  
Dimension 1: 5  
Dimension 2:  
%:

Photo: 15\_025-15\_024-20230801-100247.JPG  
At: 93.1 ft. 10/. TB - Tap Break-in/Hammer  
Joint: No

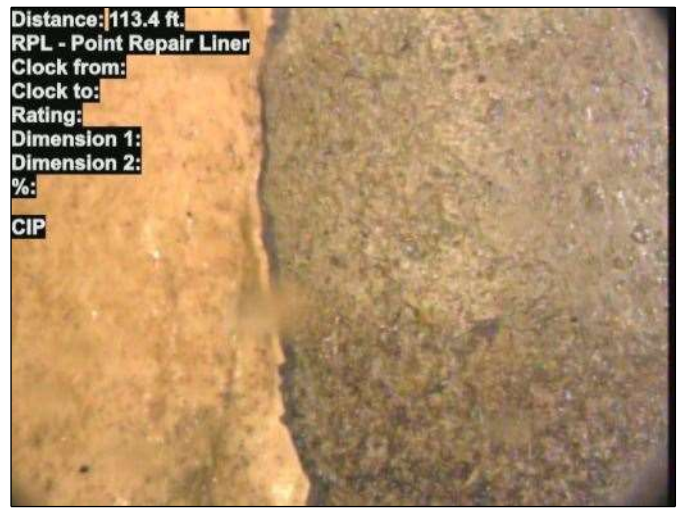
Distance: 113.4 ft.  
RPL - Point Repair Liner  
Clock from:  
Clock to:  
Rating:  
Dimension 1:  
Dimension 2:  
%:  
CIP

Photo: 15\_025-15\_024-20230801-100340.JPG  
At: 113.4 ft. RPL - Point Repair Liner  
Joint: No CIP

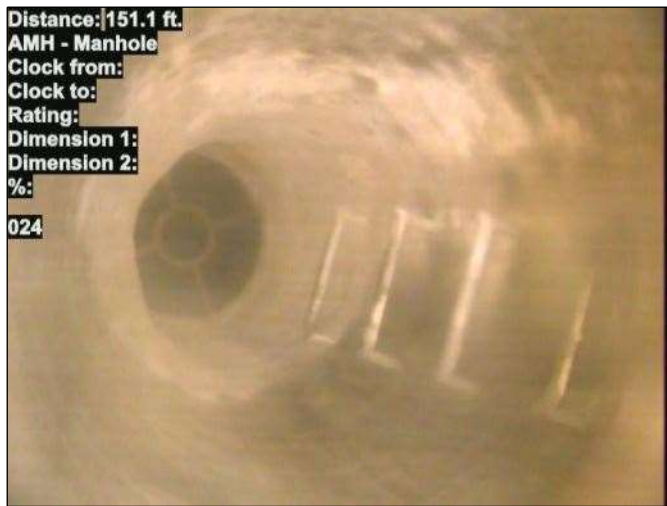
Distance: 151.1 ft.  
AMH - Manhole  
Clock from:  
Clock to:  
Rating:  
Dimension 1:  
Dimension 2:  
%:  
024

Photo: 15\_025-15\_024-20230801-100628.JPG  
At: 151.1 ft. AMH - Manhole  
Joint: No 024

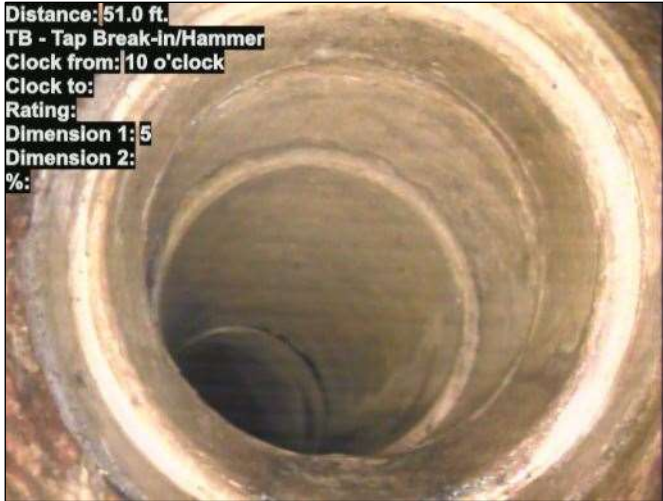
Distance: 51.0 ft.  
TB - Tap Break-in/Hammer  
Clock from: 10 o'clock  
Clock to:  
Rating:  
Dimension 1: 5  
Dimension 2:  
%:

Photo: 15\_026-15\_024-20230725-184620.JPG  
At: 51 ft. 10/. TB - Tap Break-in/Hammer  
Joint: No

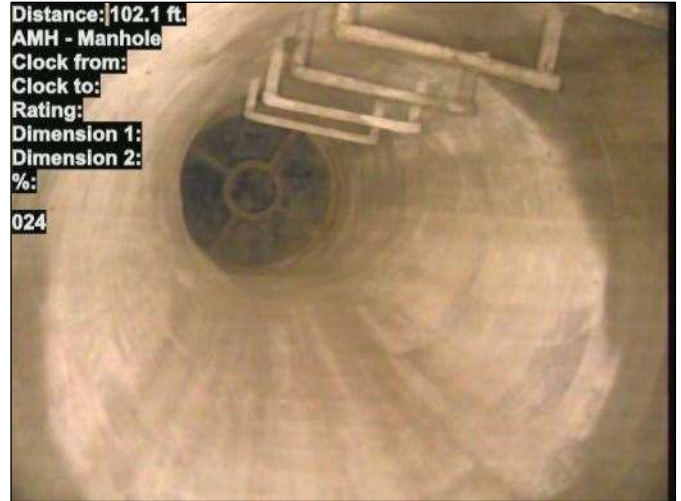
Distance: 102.1 ft.  
AMH - Manhole  
Clock from:  
Clock to:  
Rating:  
Dimension 1:  
Dimension 2:  
%:  
024

Photo: 15\_026-15\_024-20230725-185107.JPG  
At: 102.1 ft. AMH - Manhole  
Joint: No 024
