**APPENDIX C**  
CCTV Reports

## NWMCC INSPECTION REPORT

Start date/time: <b>20230725 12:13</b>	Weather: <b>Dry - No precipitation during survey</b>	Surveyed by: <b>C.Arruda</b>	Certificate number: <b>U-910-11364</b>	Pipe segment ref.: <b>15/002 - 15/001</b>	
Owner:	Customer:	Pre-cleaning: <b>Light Cleaning</b>	Date cleaned: <b>20230725</b>	Project name: <b>ENV017-13</b>	
City: <b>WESTWOOD MA</b>	Street: <b>NAHATAN ST</b>	Location code:	Pipe use: <b>Sanitary Sewage Pipe</b>	Drainage area: 	Flow control: 
Upstream MH No: <b>15/001</b>	Downstream MH No: <b>15/002</b>	Direction: <b>U</b>	Total length: <b>304.300 ft.</b>	Length surveyed: <b>304.300 ft.</b>	
Purpose: <b>Maintenance Related</b>	Pipe joint length: 	Height: <b>8 in.</b>	Material: <b>Asbestos Cement</b>	LateralsCounter: 	Additional info:

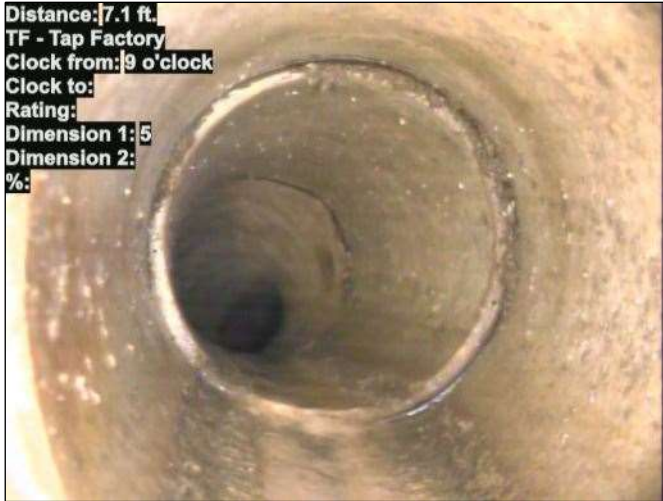
Photo: 15\_027-15\_026-20230725-182351.JPG  
At: 7.1 ft. 9/. TF - Tap Factory  
Joint: No

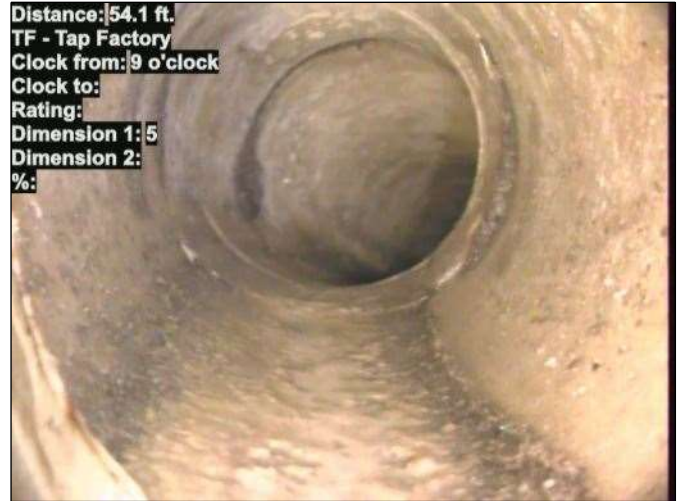
Photo: 15\_027-15\_026-20230725-182640.JPG  
At: 54.1 ft. 9/. TF - Tap Factory  
Joint: No

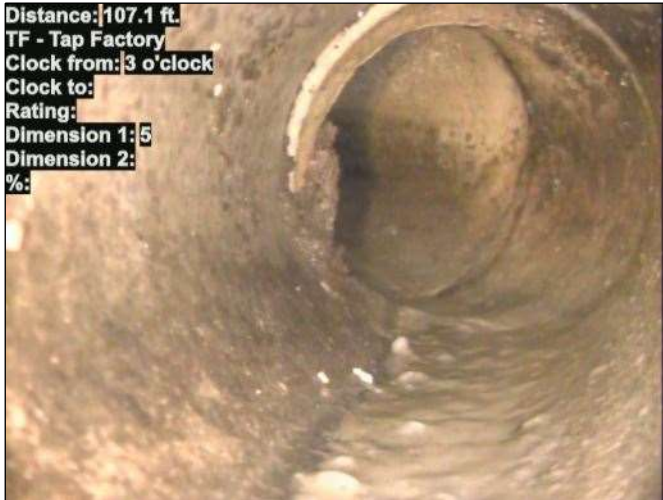
Photo: 15\_027-15\_026-20230725-182849.JPG  
At: 107.1 ft. 3/. TF - Tap Factory  
Joint: No

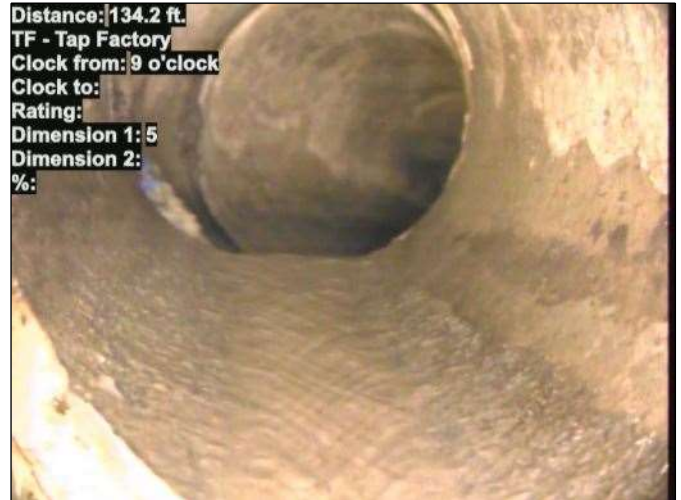
Photo: 15\_027-15\_026-20230725-183054.JPG  
At: 134.2 ft. 9/. TF - Tap Factory  
Joint: No

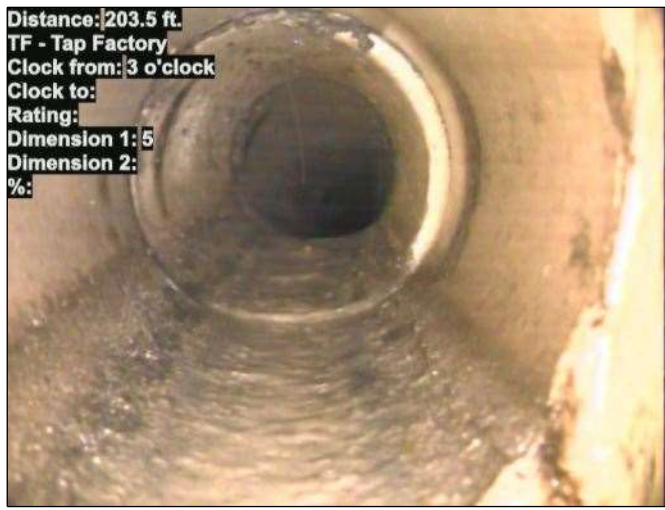
Distance: 203.5 ft.  
TF - Tap Factory  
Clock from: 3 o'clock  
Clock to:  
Rating:  
Dimension 1: 5  
Dimension 2:  
%:

Photo: 15\_027-15\_026-20230725-183326.JPG  
At: 203.5 ft. 3/. TF - Tap Factory  
Joint: No

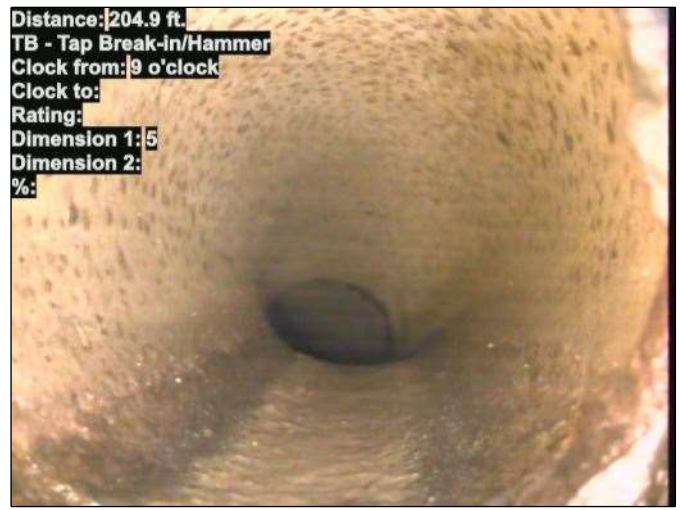
Distance: 204.9 ft.  
TB - Tap Break-in/Hammer  
Clock from: 9 o'clock  
Clock to:  
Rating:  
Dimension 1: 5  
Dimension 2:  
%:

Photo: 15\_027-15\_026-20230725-183345.JPG  
At: 204.9 ft. 9/. TB - Tap Break-in/Hammer  
Joint: No

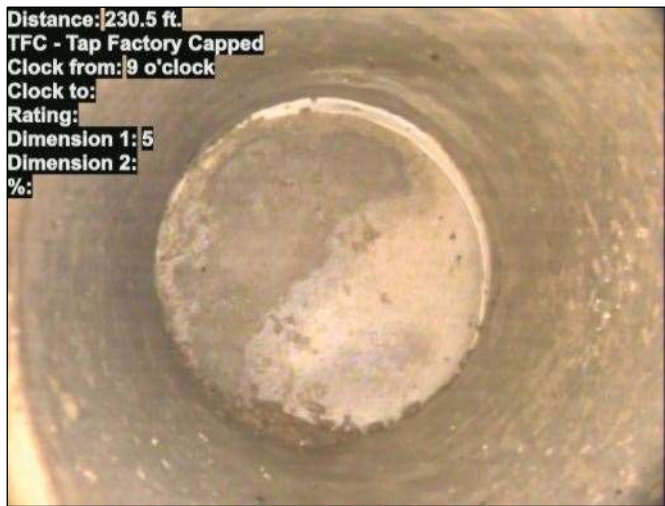
Distance: 230.5 ft.  
TFC - Tap Factory Capped  
Clock from: 9 o'clock  
Clock to:  
Rating:  
Dimension 1: 5  
Dimension 2:  
%:

Photo: 15\_027-15\_026-20230725-183456.JPG  
At: 230.5 ft. 9/. TFC - Tap Factory Capped  
Joint: No

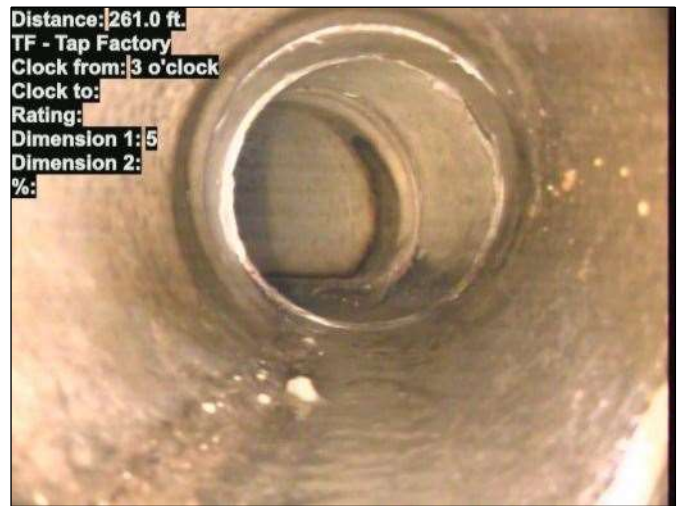
Distance: 261.0 ft.  
TF - Tap Factory  
Clock from: 3 o'clock  
Clock to:  
Rating:  
Dimension 1: 5  
Dimension 2:  
%:

Photo: 15\_027-15\_026-20230725-183629.JPG  
At: 261 ft. 3/. TF - Tap Factory  
Joint: No

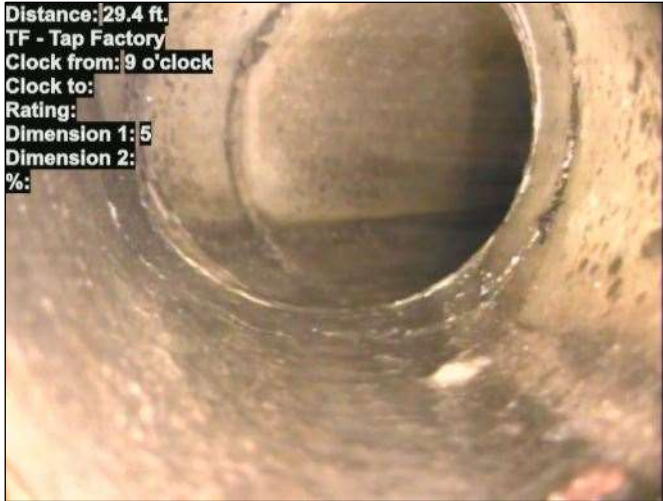
Photo: 15\_028-15\_029-20230724-163014.JPG  
At: 29.4 ft. 9/. TF - Tap Factory  
Joint: No

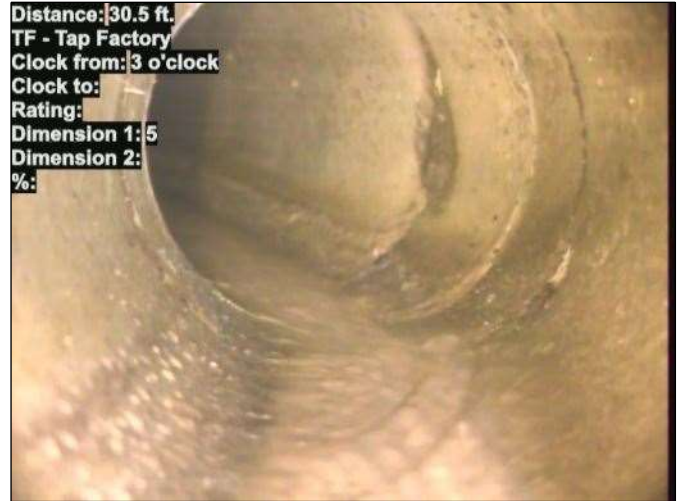
Photo: 15\_028-15\_029-20230724-163112.JPG  
At: 30.5 ft. 3/. TF - Tap Factory  
Joint: No

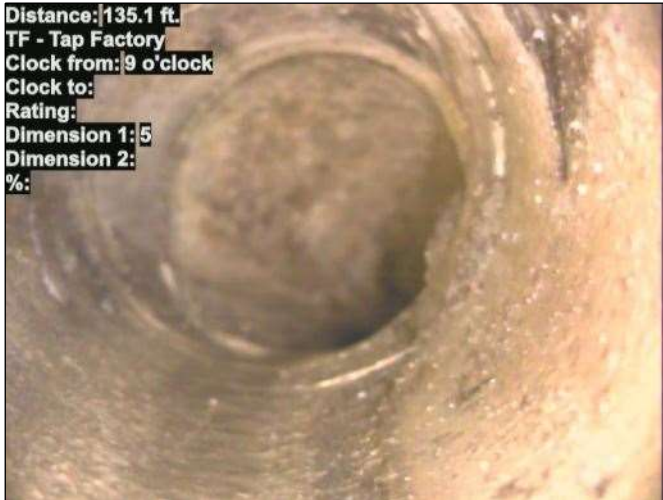
Photo: 15\_028-15\_029-20230724-163402.JPG  
At: 135.1 ft. 9/. TF - Tap Factory  
Joint: No

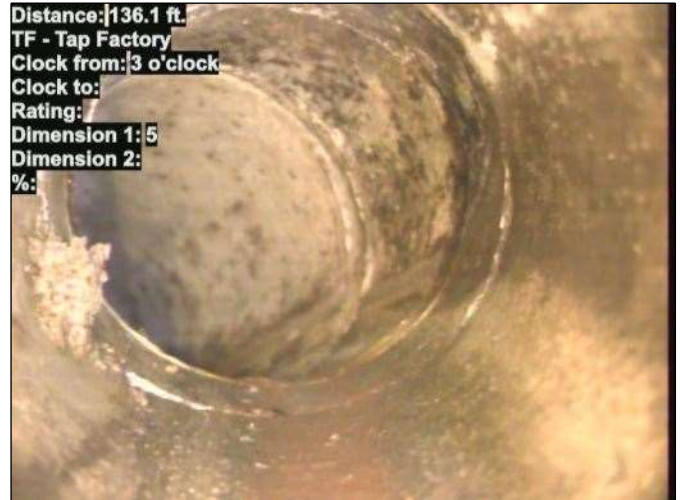
Photo: 15\_028-15\_029-20230724-163421.JPG  
At: 136.1 ft. 3/. TF - Tap Factory  
Joint: No

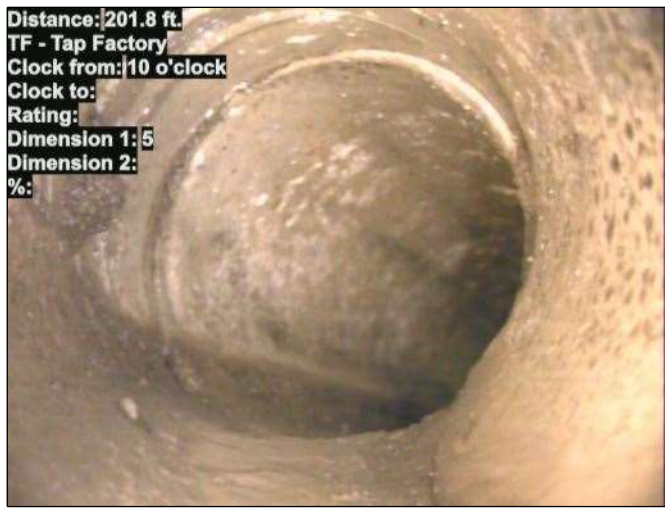
Distance: 201.8 ft.  
TF - Tap Factory  
Clock from: 10 o'clock  
Clock to:  
Rating:  
Dimension 1: 5  
Dimension 2:  
%:  
Photo: 15\_028-15\_029-20230724-163643.JPG  
At: 201.8 ft. 10/. TF - Tap Factory  
Joint: No

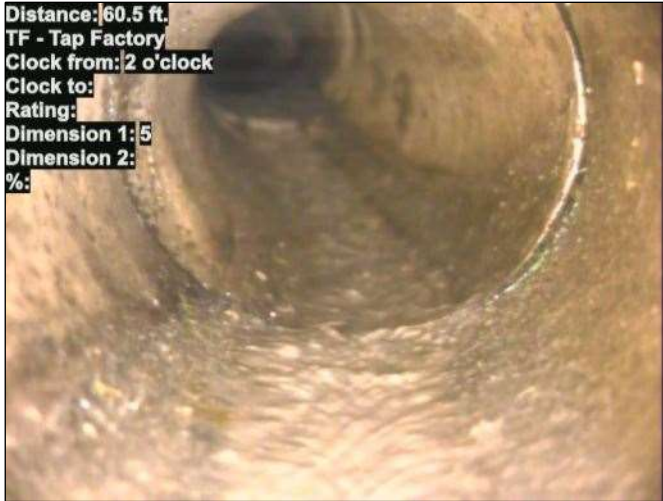
Photo: 15\_029-15\_030-20230724-164204.JPG  
At: 60.5 ft. 2/. TF - Tap Factory  
Joint: No

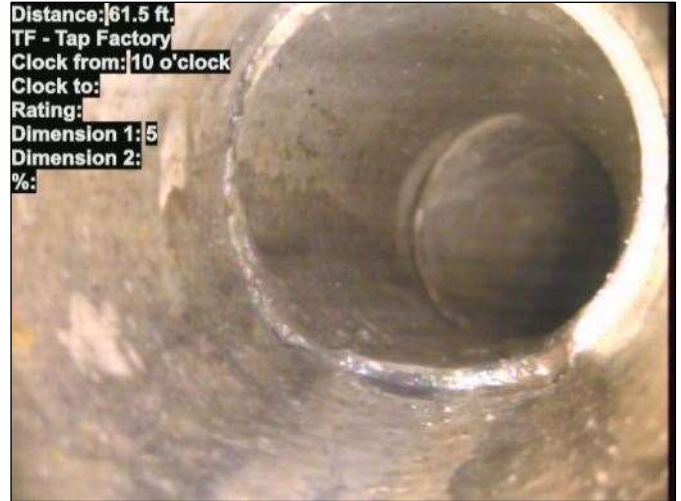
Photo: 15\_029-15\_030-20230724-164223.JPG  
At: 61.5 ft. 10/. TF - Tap Factory  
Joint: No

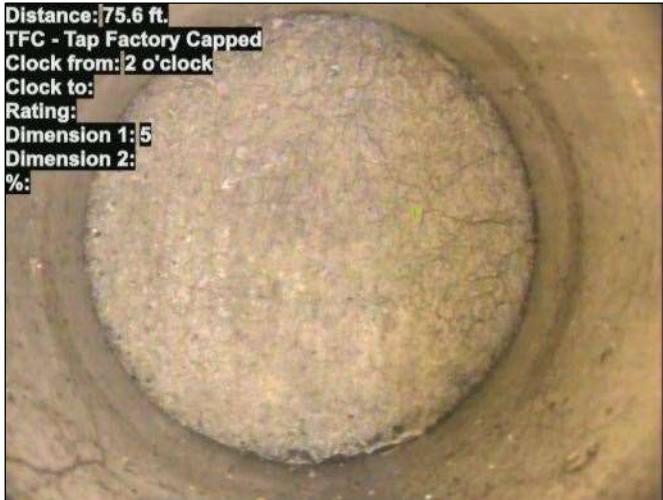
Photo: 15\_029-15\_030-20230724-164310.JPG  
At: 75.6 ft. 2/. TFC - Tap Factory Capped  
Joint: No

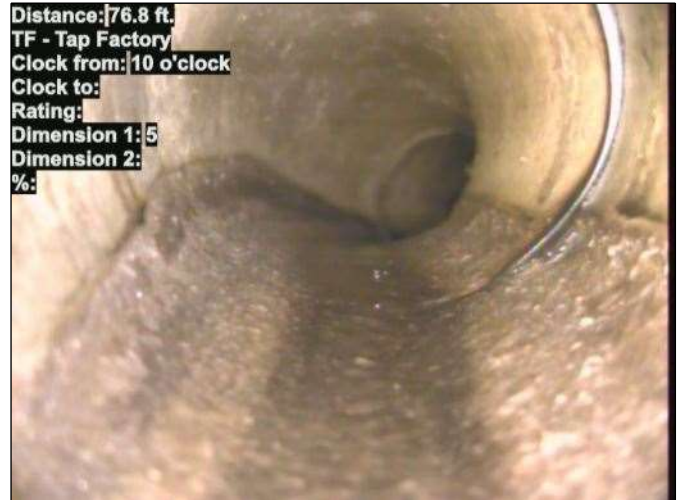
Photo: 15\_029-15\_030-20230724-164331.JPG  
At: 76.8 ft. 10/. TF - Tap Factory  
Joint: No

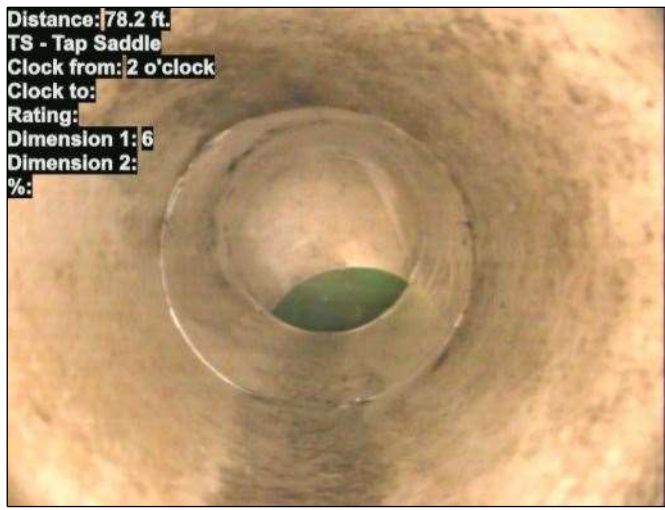
Distance: 78.2 ft.  
TS - Tap Saddle  
Clock from: 2 o'clock  
Clock to:  
Rating:  
Dimension 1: 6  
Dimension 2:  
%:

Photo: 15\_029-15\_030-20230724-164402.JPG  
At: 78.2 ft. 2/ TS - Tap Saddle  
Joint: No

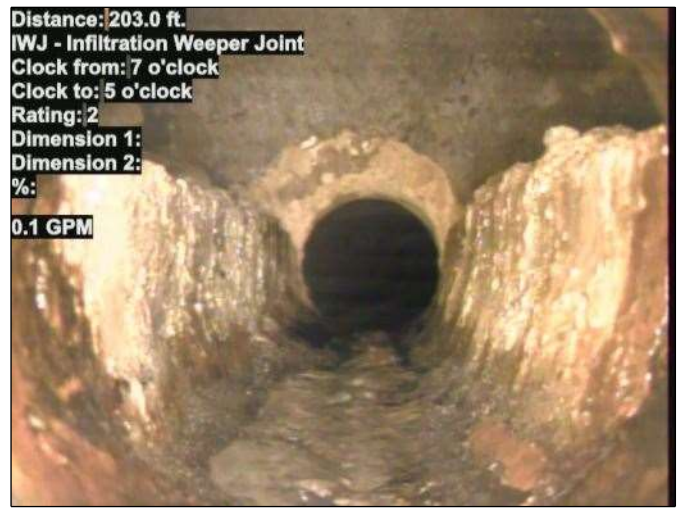
Distance: 203.0 ft.  
IWJ - Infiltration Weeper Joint  
Clock from: 7 o'clock  
Clock to: 5 o'clock  
Rating: 2  
Dimension 1:  
Dimension 2:  
%:  
0.1 GPM

Photo: 15\_029-15\_030-20230724-164719.JPG  
At: 203 ft. 7/5 IWJ - Infiltration Weeper Joint  
Joint: Yes 0.1 GPM

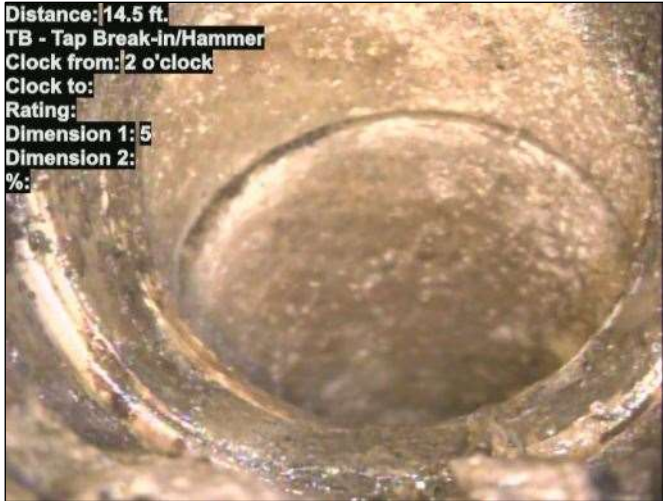
Photo: 15\_030-15\_031-20230724-165146.JPG  
At: 14.5 ft. 2/. TB - Tap Break-in/Hammer  
Joint: No

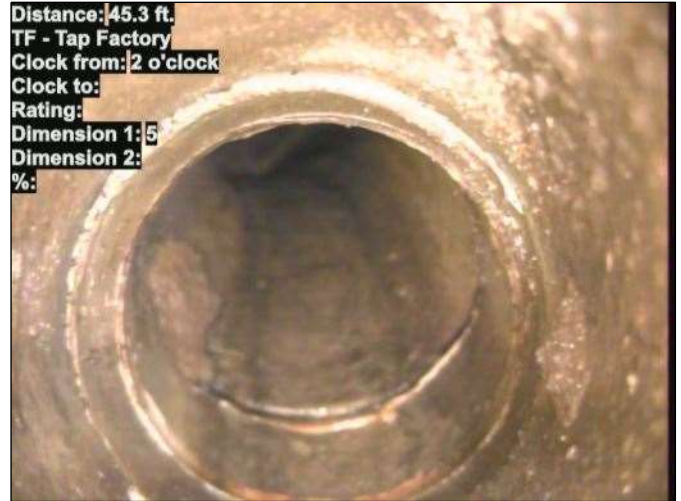
Photo: 15\_030-15\_031-20230724-165253.JPG  
At: 45.3 ft. 2/. TF - Tap Factory  
Joint: No

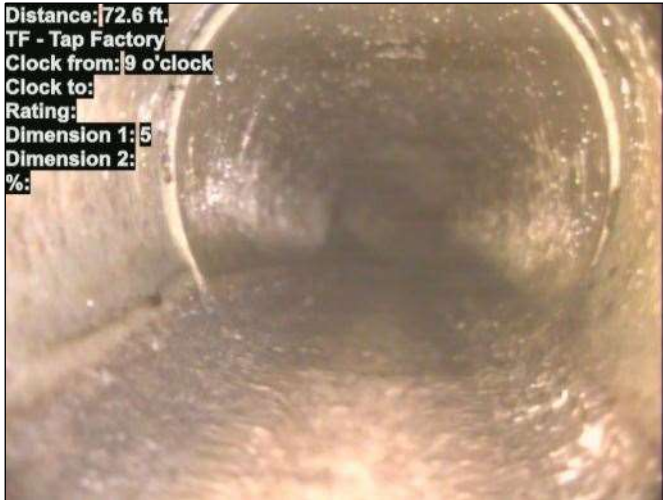
Photo: 15\_030-15\_031-20230724-165404.JPG  
At: 72.6 ft. 9/. TF - Tap Factory  
Joint: No

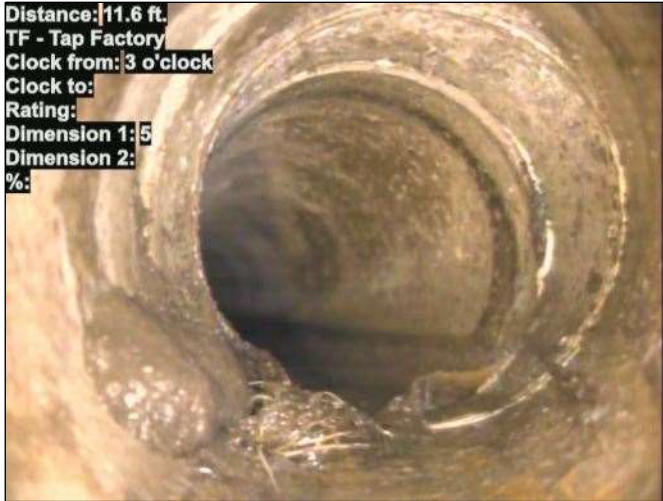
Photo: 15\_031-15\_032-20230724-165831.JPG  
At: 11.6 ft. 3/. TF - Tap Factory  
Joint: No

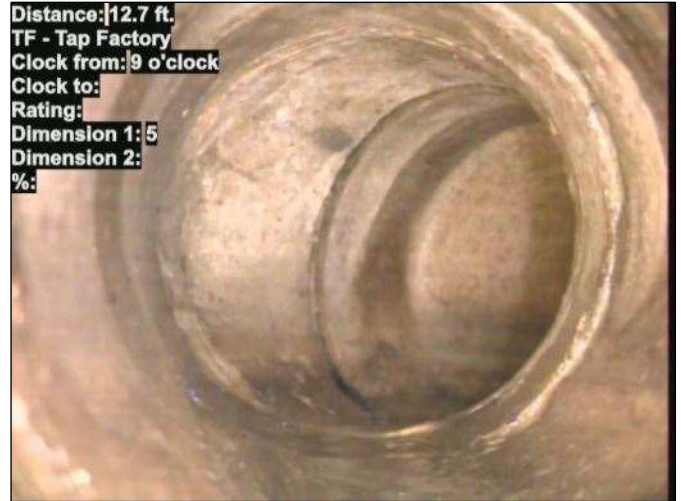
Photo: 15\_031-15\_032-20230724-165851.JPG  
At: 12.7 ft. 9/. TF - Tap Factory  
Joint: No

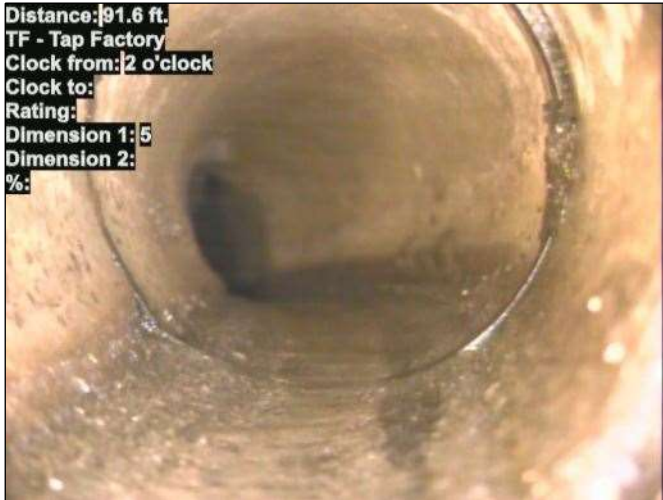
Photo: 15\_031-15\_032-20230724-170120.JPG  
At: 91.6 ft. 2/. TF - Tap Factory  
Joint: No

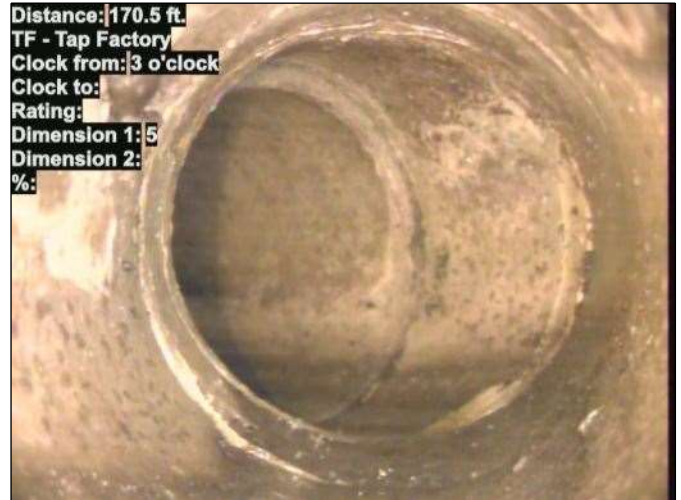
Photo: 15\_031-15\_032-20230724-170347.JPG  
At: 170.5 ft. 3/. TF - Tap Factory  
Joint: No

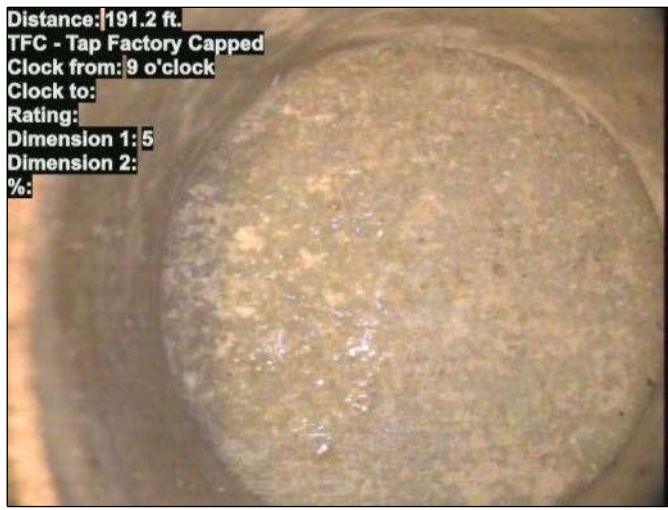
Distance: 191.2 ft.  
TFC - Tap Factory Capped  
Clock from: 9 o'clock  
Clock to:  
Rating:  
Dimension 1: 5  
Dimension 2:  
%:

Photo: 15\_031-15\_032-20230724-170524.JPG  
At: 191.2 ft. 9/. TFC - Tap Factory Capped  
Joint: No

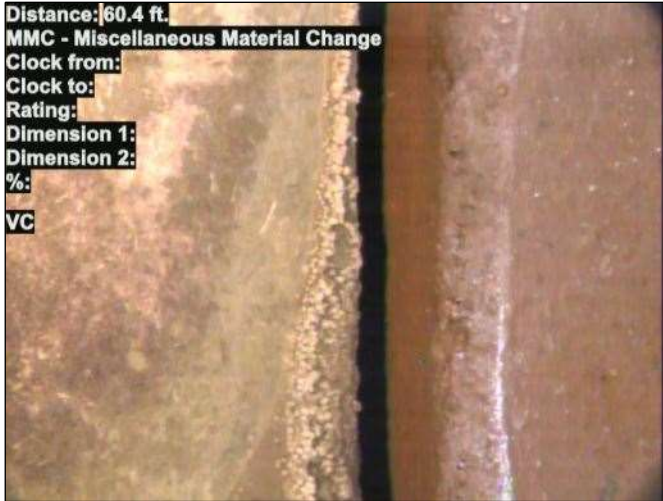
Photo: 15\_032-15\_033-20230725-071659.JPG  
At: 60.4 ft. MMC - Miscellaneous Material Change  
Joint: No VC

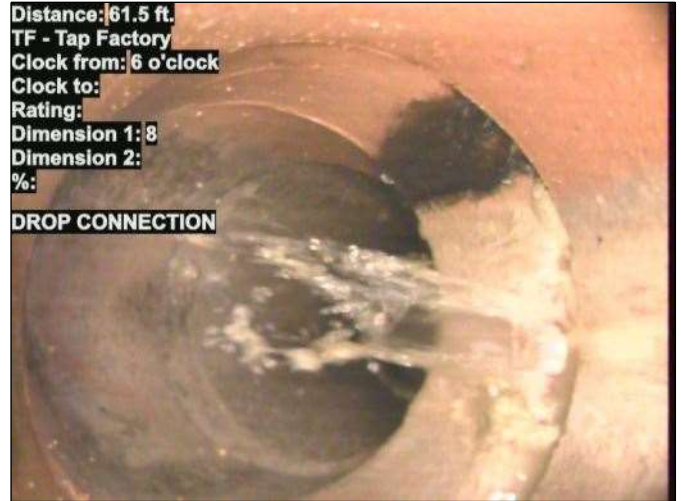
Photo: 15\_032-15\_033-20230725-071722.JPG  
At: 61.5 ft. 6/. TF - Tap Factory  
Joint: No DROP CONNECTION

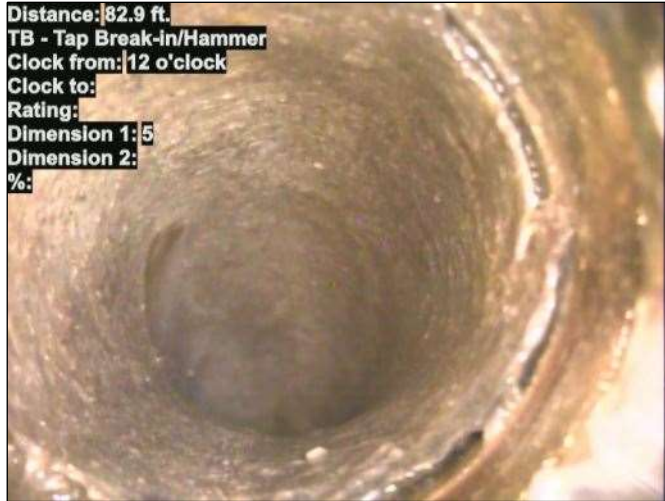
Photo: 15\_033-15\_034-20230801-104532.JPG  
At: 82.9 ft. 12/. TB - Tap Break-in/Hammer  
Joint: No

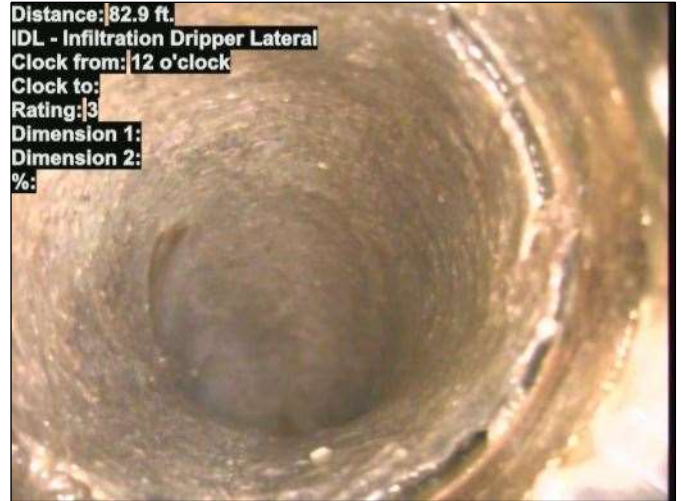
Photo: 15\_033-15\_034-20230801-104544.JPG  
At: 82.9 ft. 12/. IDL - Infiltration Dripper Lateral  
Joint: No

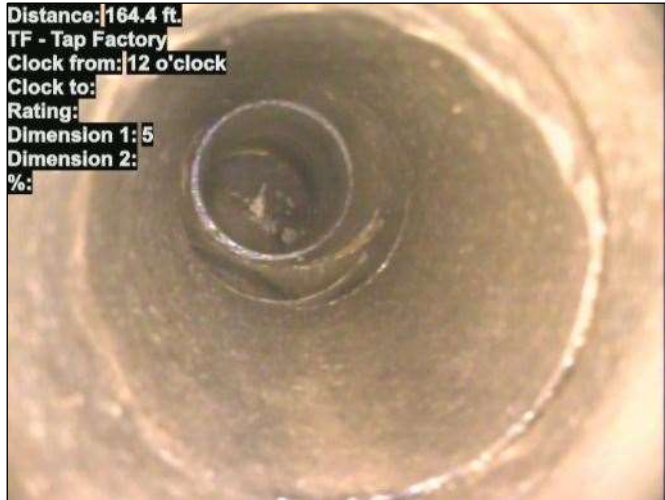
Photo: 15\_033-15\_034-20230801-104820.JPG  
At: 164.4 ft. 12/. TF - Tap Factory  
Joint: No

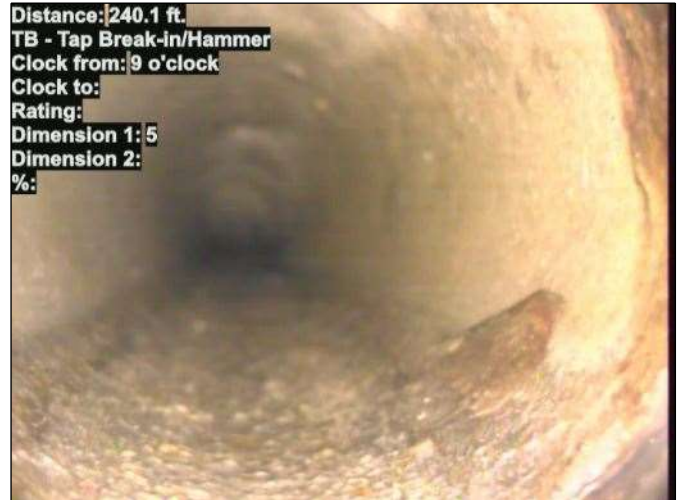
Photo: 15\_033-15\_034-20230801-105044.JPG  
At: 240.1 ft. 9/. TB - Tap Break-in/Hammer  
Joint: No

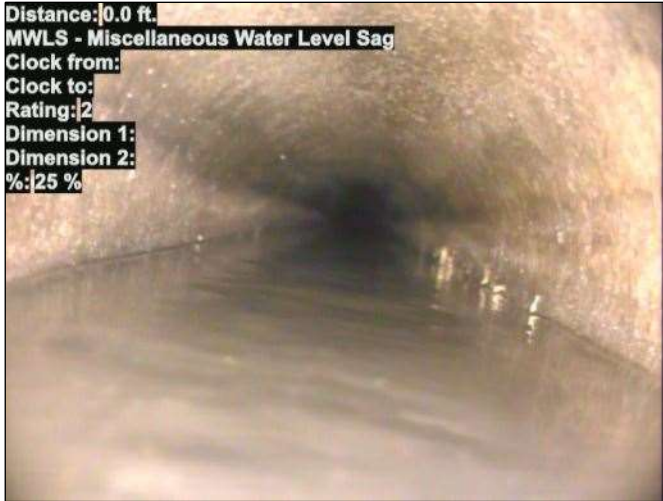
Photo: 15\_034-15\_036-20230801-105433.JPG  
At: 0 ft. MWLS - Miscellaneous Water Level Sag  
Joint: No 25 %

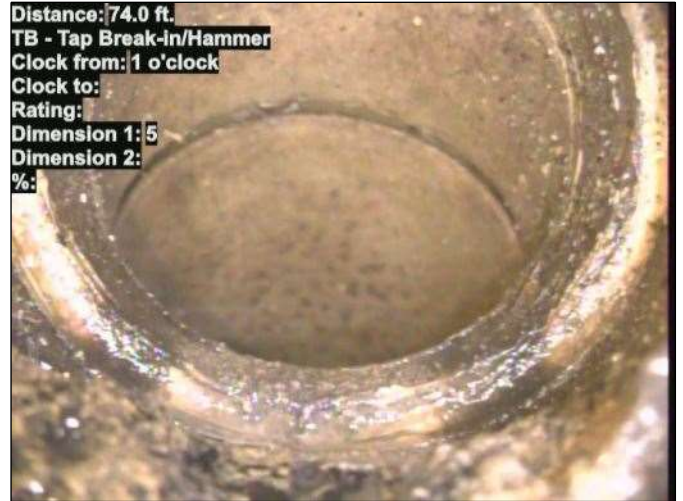
Photo: 15\_034-15\_036-20230801-105708.JPG  
At: 74 ft. 1/. TB - Tap Break-in/Hammer  
Joint: No

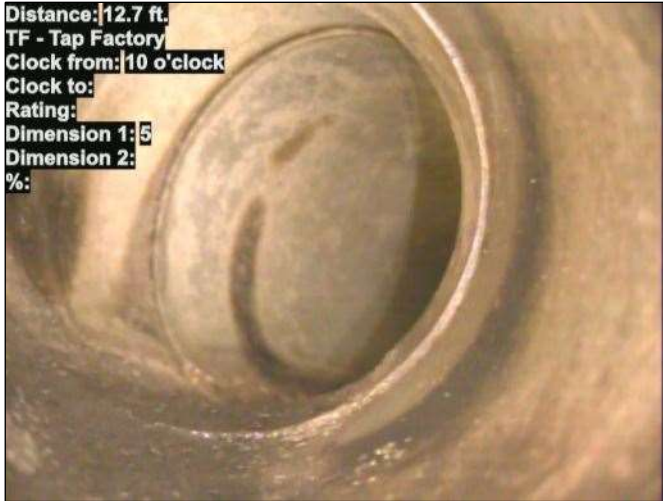
Photo: 15\_035-15\_034-20230801-084300.JPG  
At: 12.7 ft. 10/. TF - Tap Factory  
Joint: No

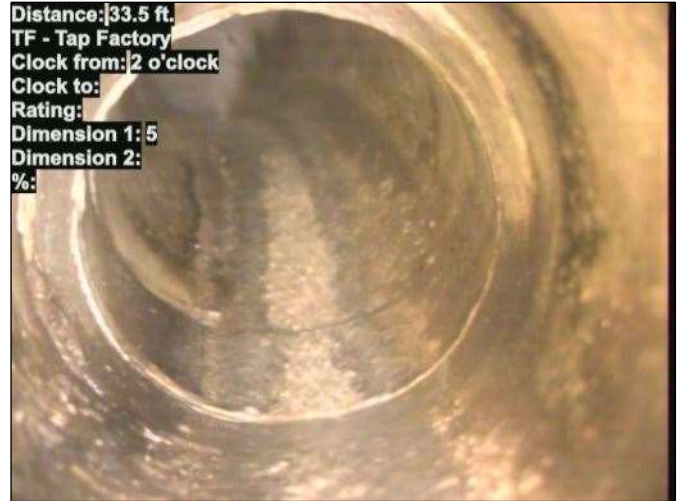
Photo: 15\_035-15\_034-20230801-084358.JPG  
At: 33.5 ft. 2/. TF - Tap Factory  
Joint: No

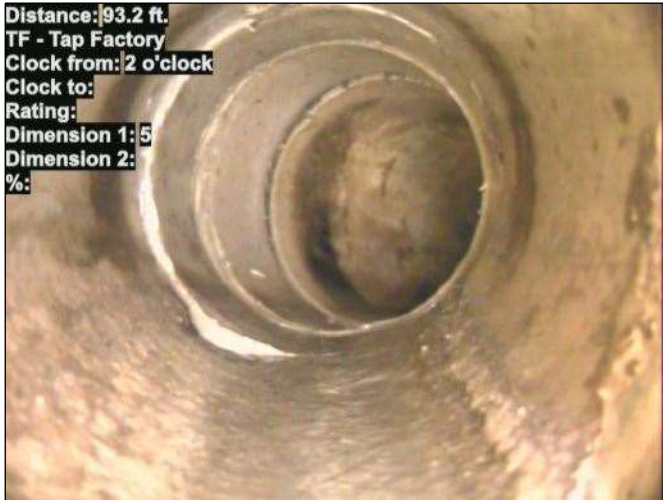
Photo: 15\_035-15\_034-20230801-084730.JPG  
At: 93.2 ft. 2/. TF - Tap Factory  
Joint: No

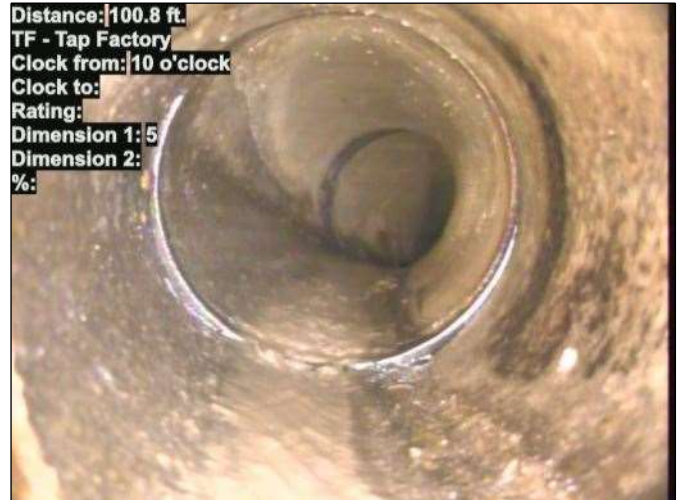
Photo: 15\_035-15\_034-20230801-084822.JPG  
At: 100.8 ft. 10/. TF - Tap Factory  
Joint: No

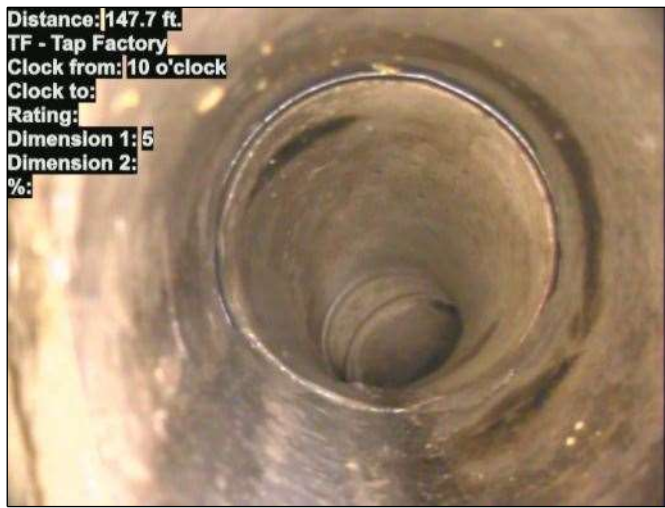
Distance: 147.7 ft.  
TF - Tap Factory  
Clock from: 10 o'clock  
Clock to:  
Rating:  
Dimension 1: 5  
Dimension 2:  
%:

Photo: 15\_035-15\_034-20230801-085109.JPG  
At: 147.7 ft. 10/. TF - Tap Factory  
Joint: No

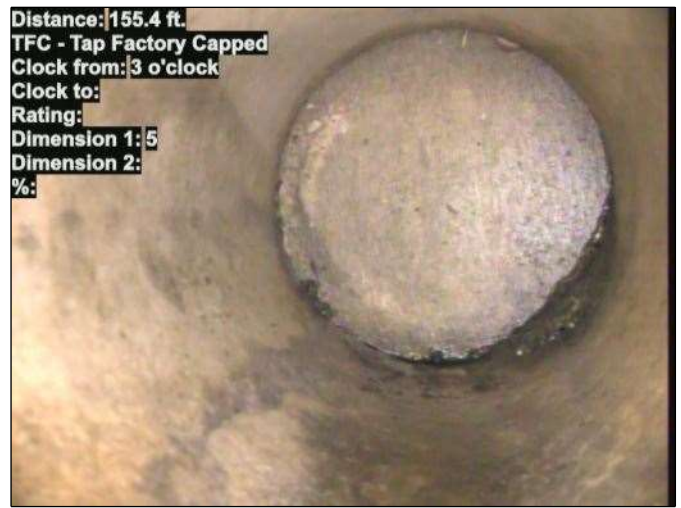
Distance: 155.4 ft.  
TFC - Tap Factory Capped  
Clock from: 3 o'clock  
Clock to:  
Rating:  
Dimension 1: 5  
Dimension 2:  
%:

Photo: 15\_035-15\_034-20230801-085143.JPG  
At: 155.4 ft. 3/. TFC - Tap Factory Capped  
Joint: No

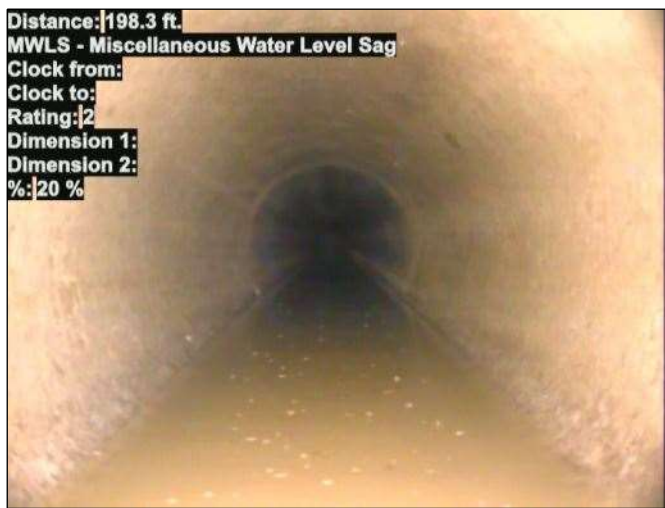
Distance: 198.3 ft.  
MWLS - Miscellaneous Water Level Sag  
Clock from:  
Clock to:  
Rating: 2  
Dimension 1:  
Dimension 2:  
%: 20 %

Photo: 15\_035-15\_034-20230801-085320.JPG  
At: 198.3 ft. MWLS - Miscellaneous Water Level Sag  
Joint: No 20 %

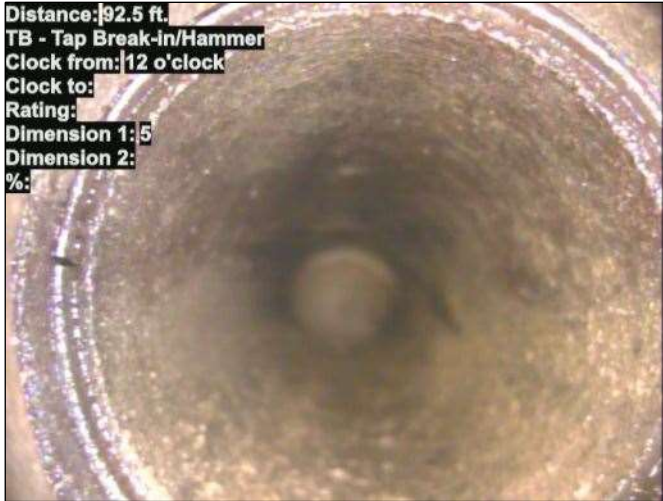
Photo: 15\_036-15\_040-20230801-111753.JPG  
At: 92.5 ft. 12/. TB - Tap Break-in/Hammer  
Joint: No

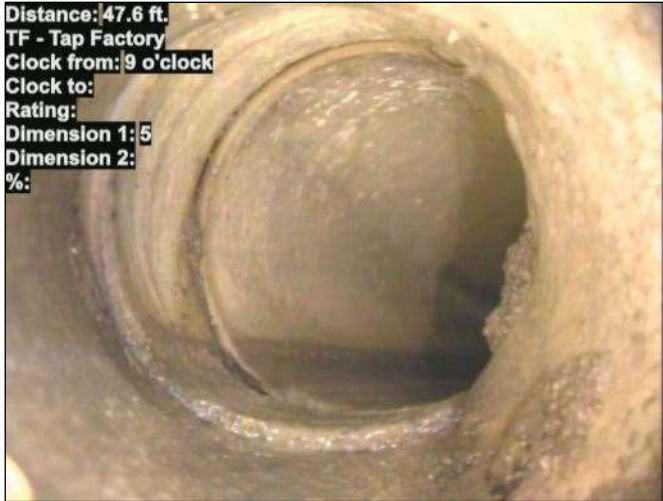
Photo: 15\_037-15\_038-20230724-121808.JPG  
At: 47.6 ft. 9/. TF - Tap Factory  
Joint: No

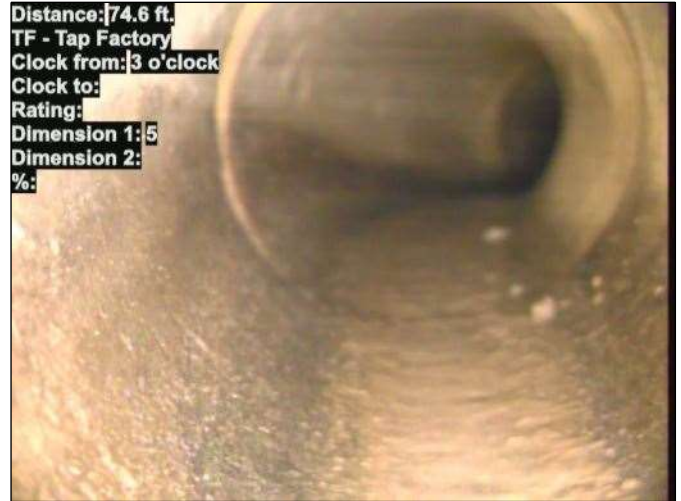
Photo: 15\_037-15\_038-20230724-121936.JPG  
At: 74.6 ft. 3/. TF - Tap Factory  
Joint: No

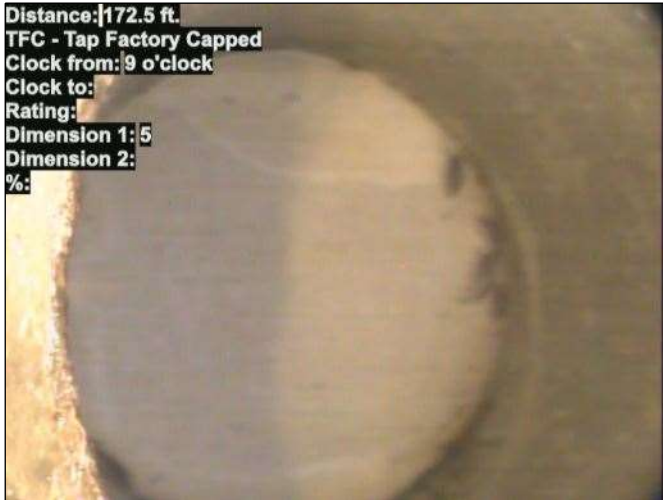
Photo: 15\_037-15\_038-20230724-122230.JPG  
At: 172.5 ft. 9/. TFC - Tap Factory Capped  
Joint: No

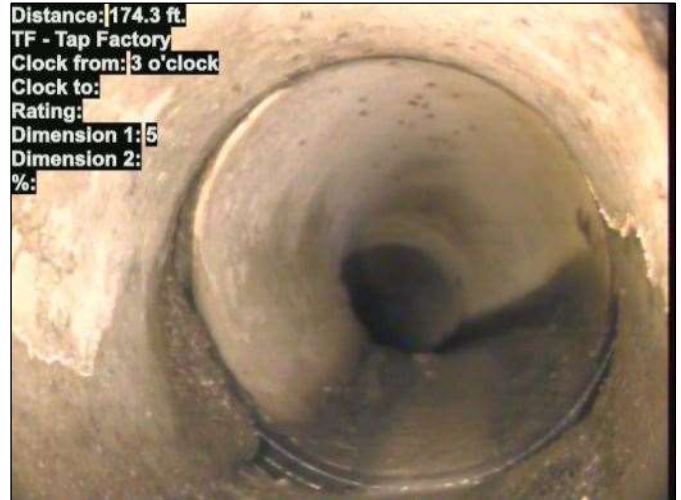
Photo: 15\_037-15\_038-20230724-122316.JPG  
At: 174.3 ft. 3/. TF - Tap Factory  
Joint: No

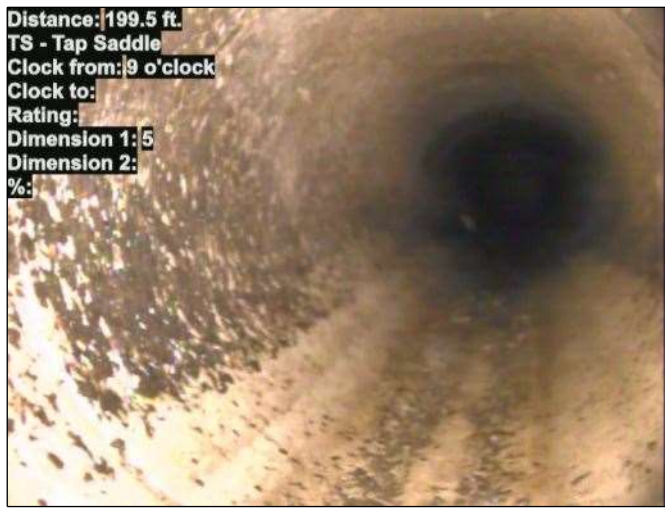
Distance: 199.5 ft.  
TS - Tap Saddle  
Clock from: 9 o'clock  
Clock to:  
Rating:  
Dimension 1: 5  
Dimension 2:  
%:

Photo: 15\_037-15\_038-20230724-122631.JPG  
At: 199.5 ft. 9/. TS - Tap Saddle  
Joint: No

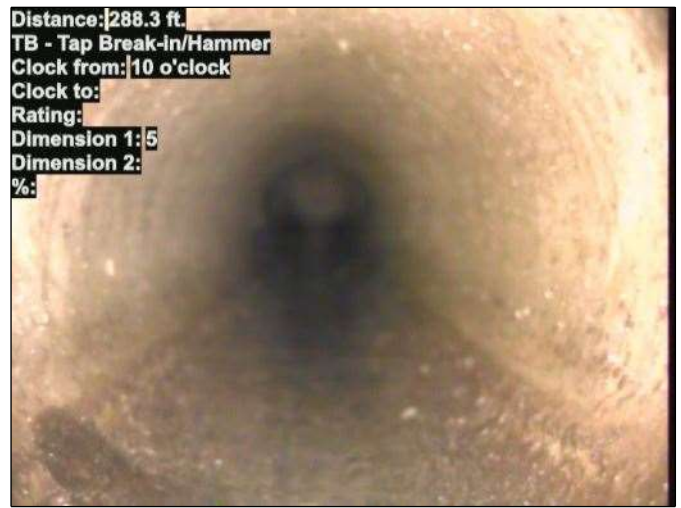
Distance: 288.3 ft.  
TB - Tap Break-in/Hammer  
Clock from: 10 o'clock  
Clock to:  
Rating:  
Dimension 1: 5  
Dimension 2:  
%:

Photo: 15\_037-15\_038-20230724-122854.JPG  
At: 288.3 ft. 10/. TB - Tap Break-in/Hammer  
Joint: No

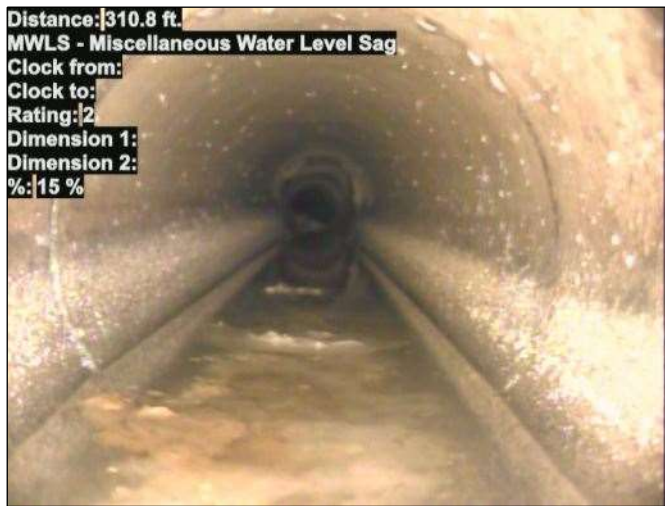
Distance: 310.8 ft.  
MWLS - Miscellaneous Water Level Sag  
Clock from:  
Clock to:  
Rating: 2  
Dimension 1:  
Dimension 2:  
%: 15 %

Photo: 15\_037-15\_038-20230724-122952.JPG  
At: 310.8 ft. MWLS - Miscellaneous Water Level Sag  
Joint: No 15 %

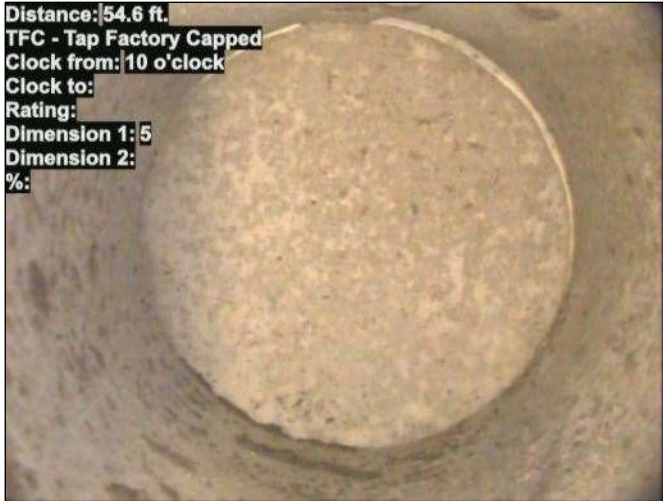
Photo: 15\_038-15\_039-20230724-123416.JPG  
At: 54.6 ft. 10/. TFC - Tap Factory Capped  
Joint: No

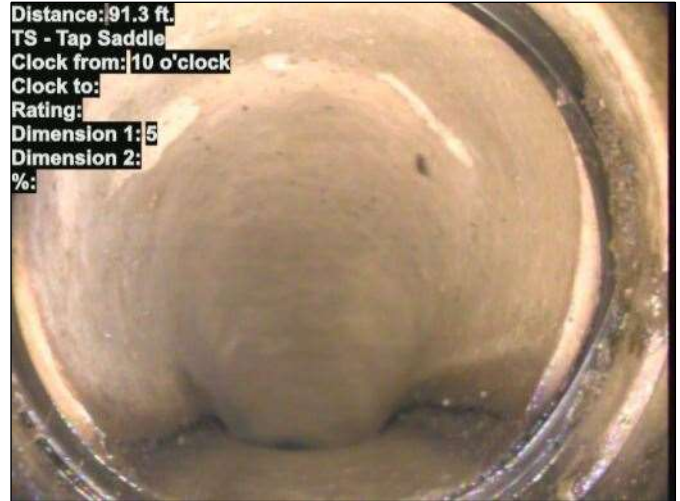
Photo: 15\_038-15\_039-20230724-123536.JPG  
At: 91.3 ft. 10/. TS - Tap Saddle  
Joint: No

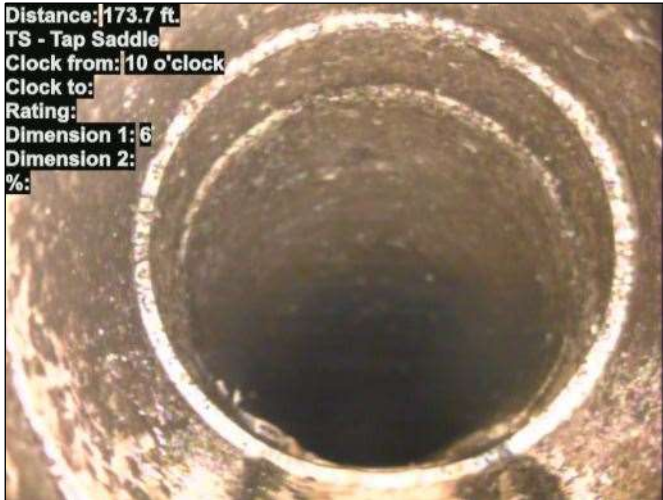
Photo: 15\_038-15\_039-20230724-123759.JPG  
At: 173.7 ft. 10/. TS - Tap Saddle  
Joint: No

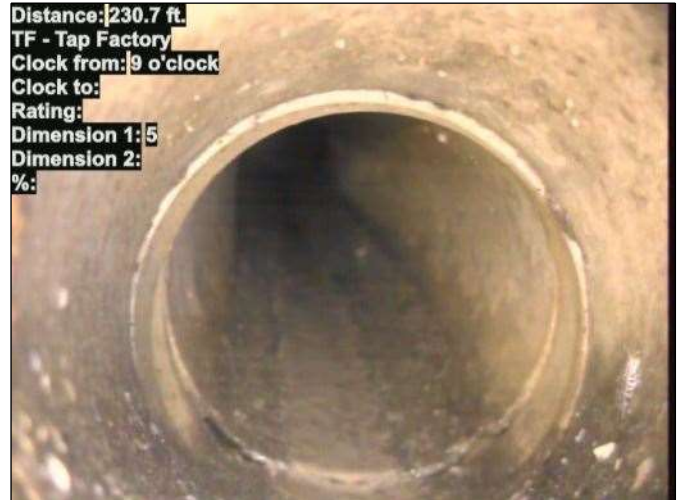
Photo: 15\_038-15\_039-20230724-123945.JPG  
At: 230.7 ft. 9/. TF - Tap Factory  
Joint: No

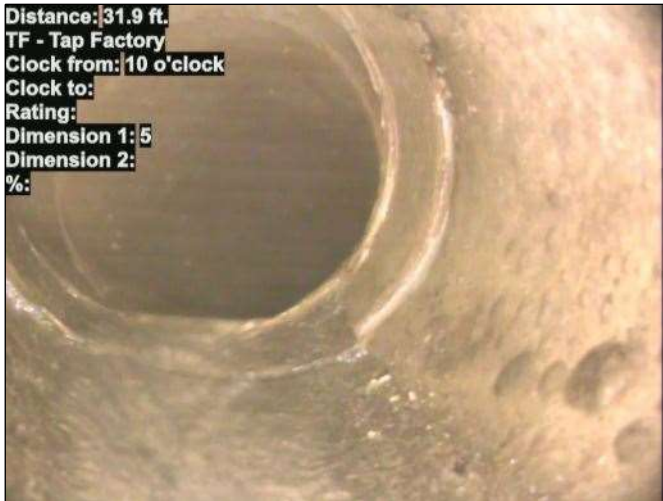
Photo: 15\_039-15\_040-20230724-124329.JPG  
At: 31.9 ft. 10/. TF - Tap Factory  
Joint: No

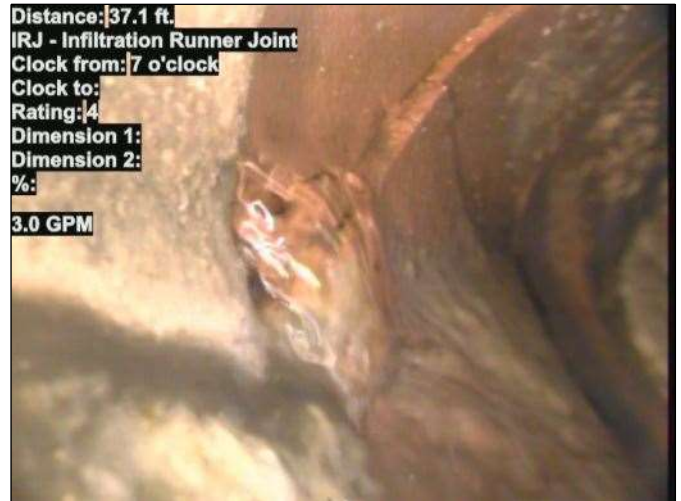
Photo: 15\_039-15\_040-20230724-124448.JPG  
At: 37.1 ft. 7/. IRJ - Infiltration Runner Joint  
Joint: Yes 3.0 GPM

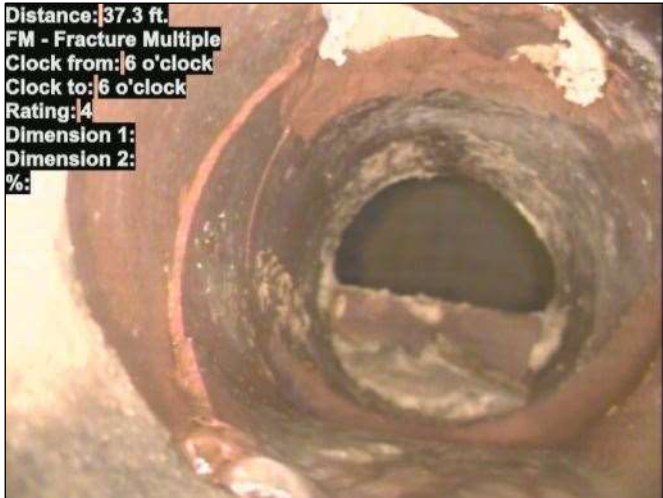
Photo: 15\_039-15\_040-20230724-124520.JPG  
At: 37.3 ft. 6/6 FM - Fracture Multiple  
Joint: No

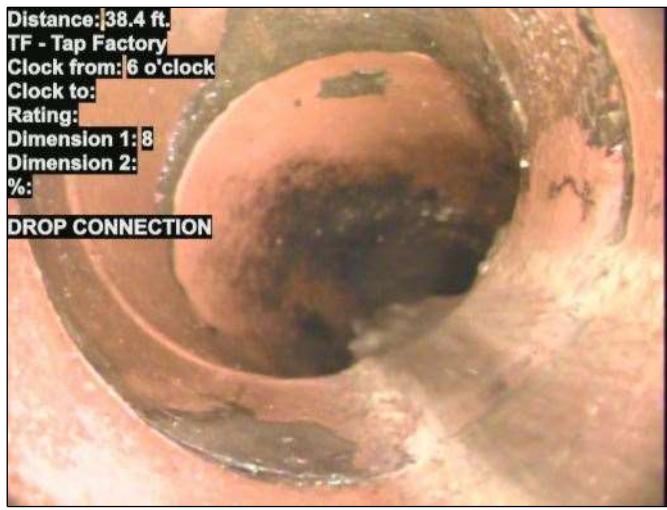
Distance: 38.4 ft.  
TF - Tap Factory  
Clock from: 6 o'clock  
Clock to:  
Rating:  
Dimension 1: 8  
Dimension 2:  
%:  
Photo: 15\_039-15\_040-20230724-124611.JPG  
At: 38.4 ft. 6/. TF - Tap Factory  
Joint: No DROP CONNECTION

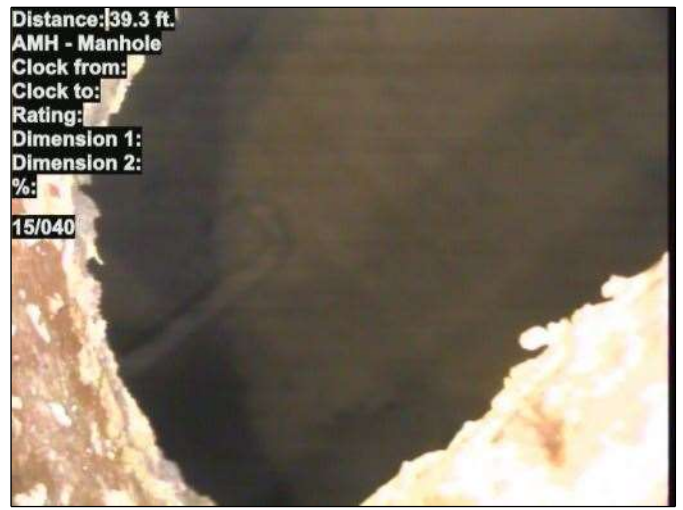
Distance: 39.3 ft.  
AMH - Manhole  
Clock from:  
Clock to:  
Rating:  
Dimension 1:  
Dimension 2:  
%:  
15/040  
Photo: 15\_039-15\_040-20230724-124639.JPG  
At: 39.3 ft. AMH - Manhole  
Joint: No 15/040

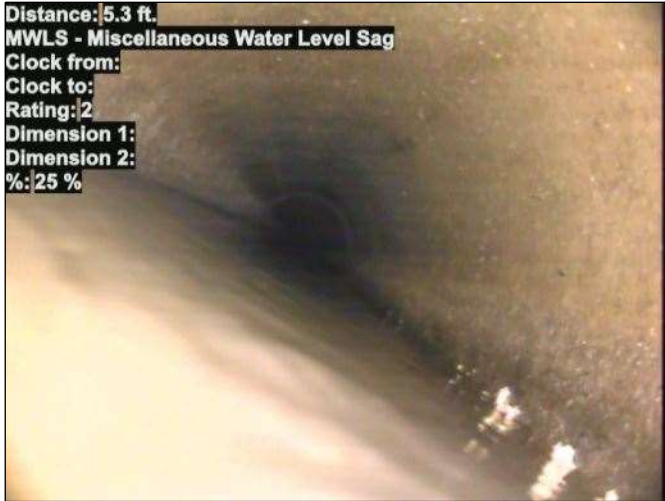
Photo: 15\_040-15\_041-20230801-123023.JPG  
At: 5.3 ft. MWLS - Miscellaneous Water Level Sag  
Joint: No 25 %

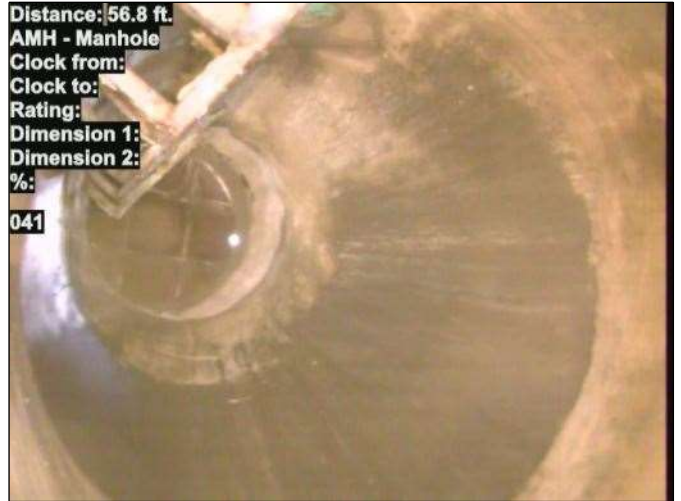
Photo: 15\_040-15\_041-20230801-123328.JPG  
At: 56.8 ft. AMH - Manhole  
Joint: No 041
