**APPENDIX C**  
CCTV Reports

## NWMCC INSPECTION REPORT

Start date/time: <b>20230725 12:13</b>	Weather: <b>Dry - No precipitation during survey</b>	Surveyed by: <b>C.Arruda</b>	Certificate number: <b>U-910-11364</b>	Pipe segment ref.: <b>15/002 - 15/001</b>	
Owner:	Customer:	Pre-cleaning: <b>Light Cleaning</b>	Date cleaned: <b>20230725</b>	Project name: <b>ENV017-13</b>	
City: <b>WESTWOOD MA</b>	Street: <b>NAHATAN ST</b>	Location code:	Pipe use: <b>Sanitary Sewage Pipe</b>	Drainage area: 	Flow control: 
Upstream MH No: <b>15/001</b>	Downstream MH No: <b>15/002</b>	Direction: <b>U</b>	Total length: <b>304.300 ft.</b>	Length surveyed: <b>304.300 ft.</b>	
Purpose: <b>Maintenance Related</b>	Pipe joint length: 	Height: <b>8 in.</b>	Material: <b>Asbestos Cement</b>	LateralsCounter: 	Additional info:

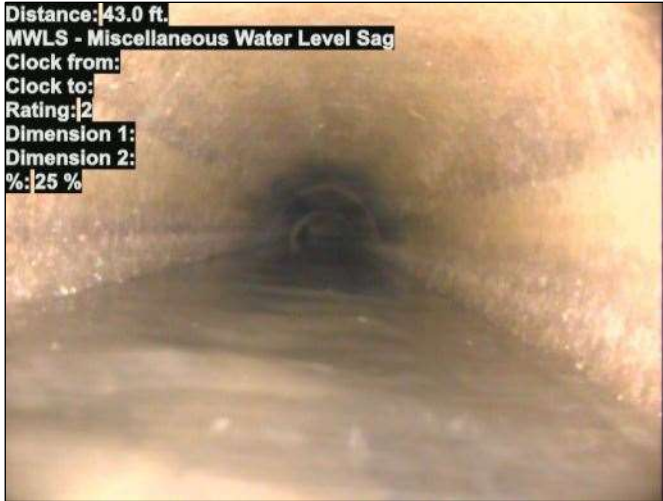
Photo: 15\_041-15\_042-20230801-123857.JPG  
At: 43 ft. MWLS - Miscellaneous Water Level Sag  
Joint: No 25 %

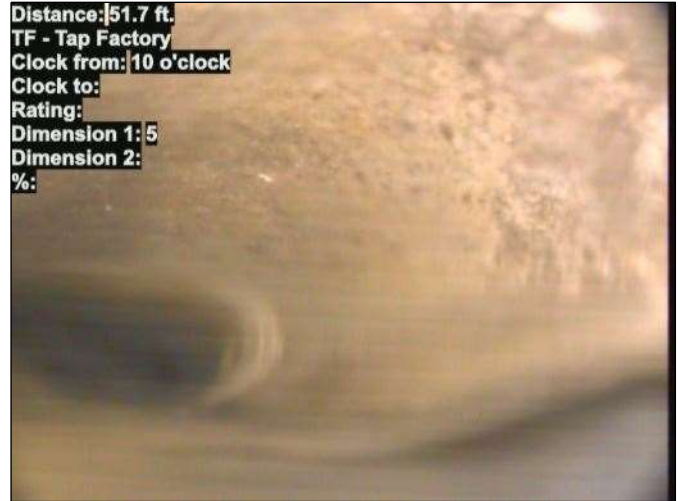
Photo: 15\_041-15\_042-20230801-124003.JPG  
At: 51.7 ft. 10/. TF - Tap Factory  
Joint: No

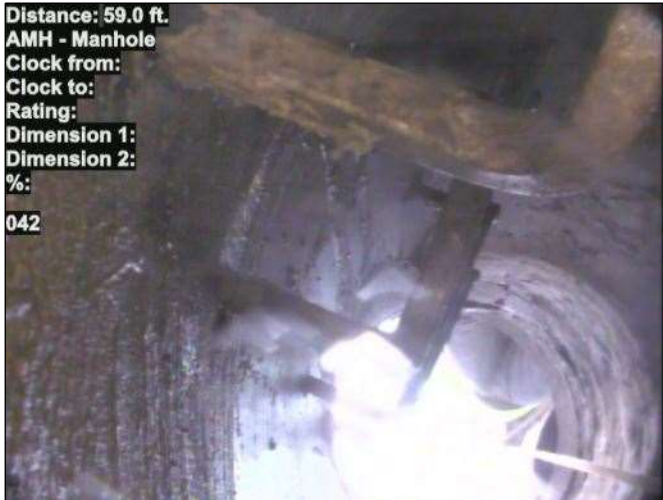
Photo: 15\_041-15\_042-20230801-124233.JPG  
At: 59 ft. AMH - Manhole  
Joint: No 042

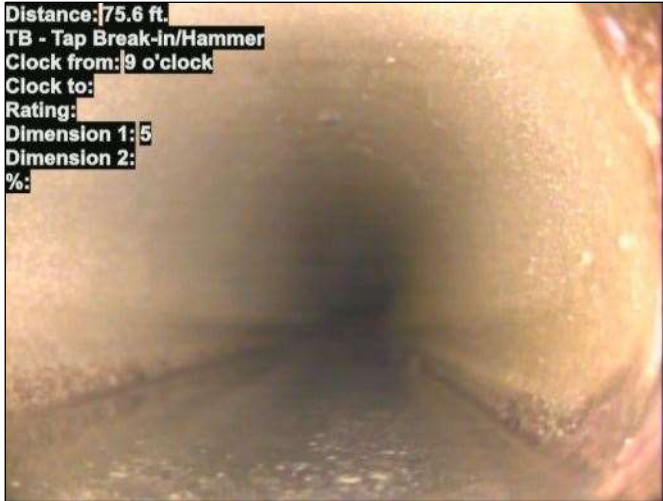
Photo: 15\_042-15\_043-20230801-130357.JPG  
At: 75.6 ft. 9/. TB - Tap Break-in/Hammer  
Joint: No

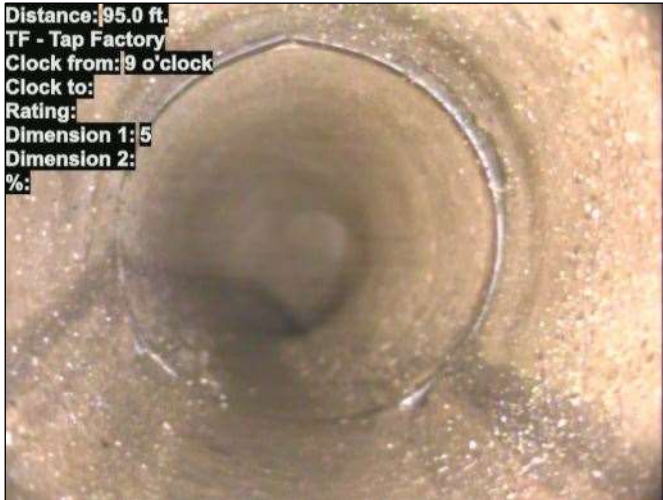
Photo: 15\_042-15\_043-20230801-130600.JPG  
At: 95 ft. 9/. TF - Tap Factory  
Joint: No

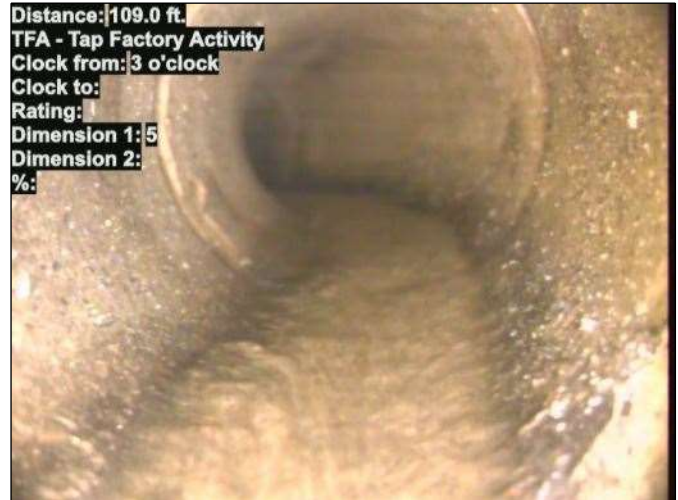
Photo: 15\_042-15\_043-20230801-130703.JPG  
At: 109 ft. 3/. TFA - Tap Factory Activity  
Joint: No

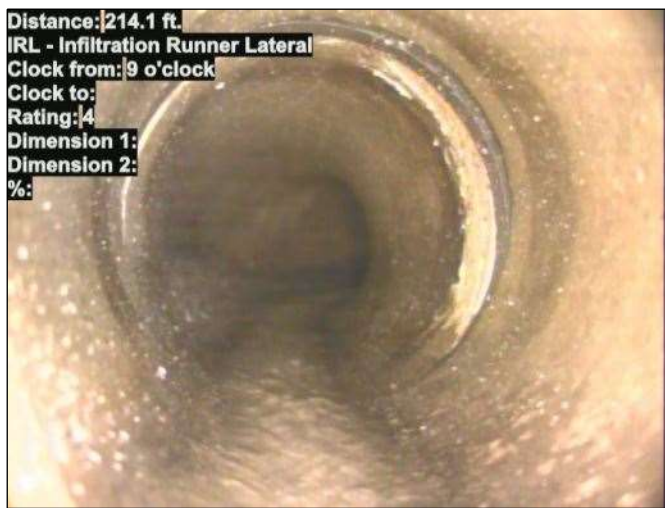
Distance: 214.1 ft.  
IRL - Infiltration Runner Lateral  
Clock from: 9 o'clock  
Clock to:  
Rating: 4  
Dimension 1:  
Dimension 2:  
%:

Photo: 15\_042-15\_043-20230801-131230.JPG  
At: 214.1 ft. 9/. IRL - Infiltration Runner Lateral  
Joint: No

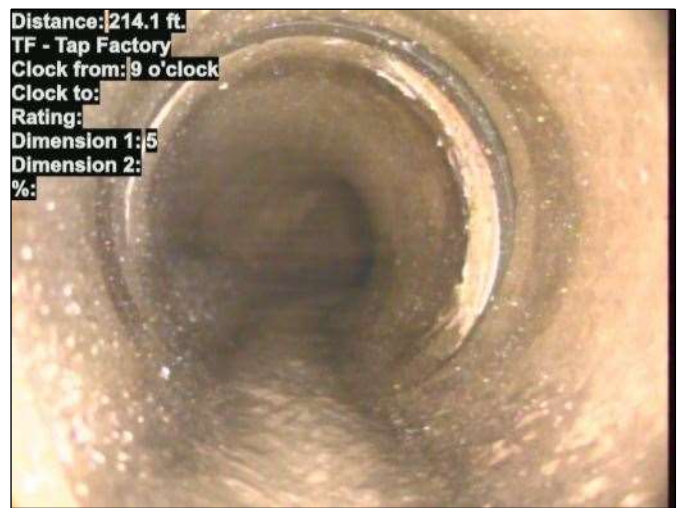
Distance: 214.1 ft.  
TF - Tap Factory  
Clock from: 9 o'clock  
Clock to:  
Rating:  
Dimension 1: 5  
Dimension 2:  
%:

Photo: 15\_042-15\_043-20230801-131209.JPG  
At: 214.1 ft. 9/. TF - Tap Factory  
Joint: No

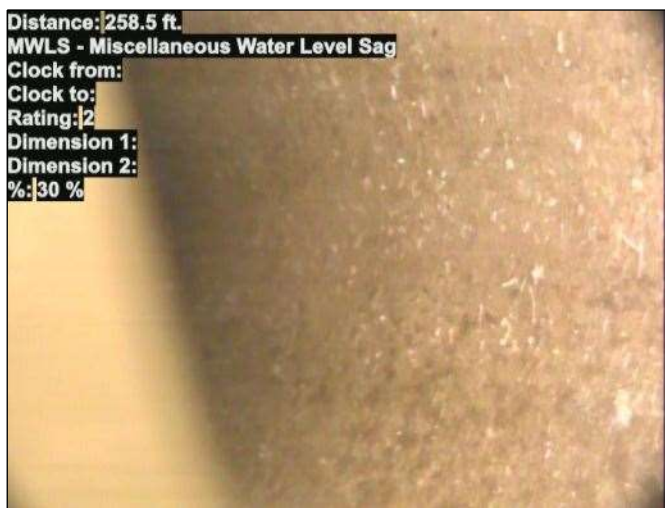
Distance: 258.5 ft.  
MWLS - Miscellaneous Water Level Sag  
Clock from:  
Clock to:  
Rating: 2  
Dimension 1:  
Dimension 2:  
%: 30 %

Photo: 15\_042-15\_043-20230801-131503.JPG  
At: 258.5 ft. MWLS - Miscellaneous Water Level Sag  
Joint: No 30 %

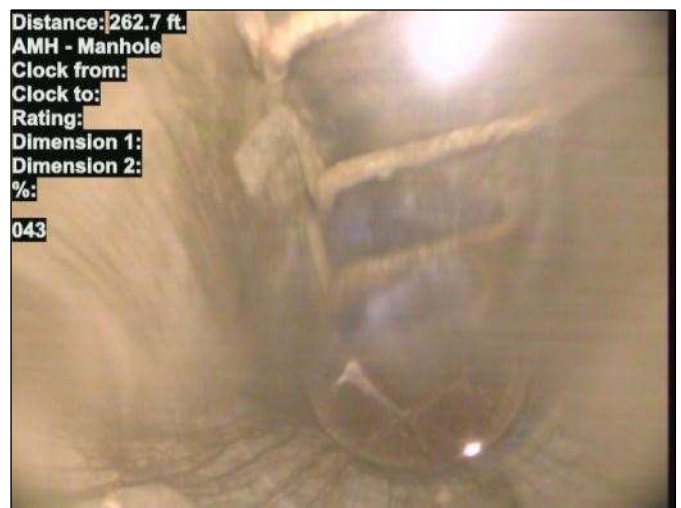
Distance: 262.7 ft.  
AMH - Manhole  
Clock from:  
Clock to:  
Rating:  
Dimension 1:  
Dimension 2:  
%:  
043

Photo: 15\_042-15\_043-20230801-131553.JPG  
At: 262.7 ft. AMH - Manhole  
Joint: No 043

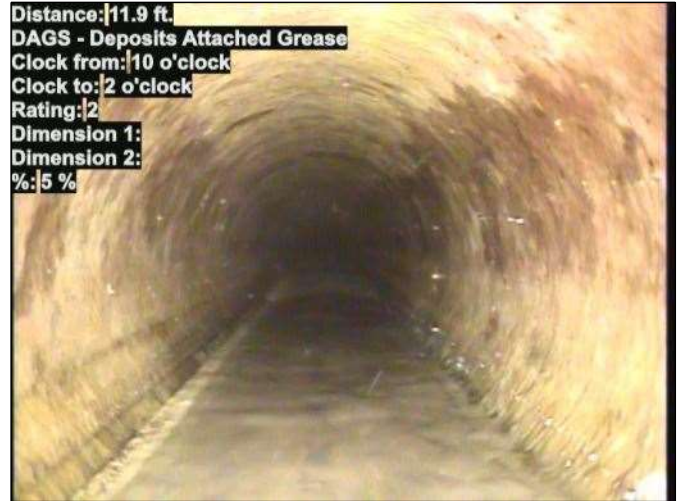
Photo: 15\_043-15\_058-20230804-071723.JPG  
At: 11.9 ft. 10/2 DABS - Deposits Attached Grease  
Joint: No 5 %

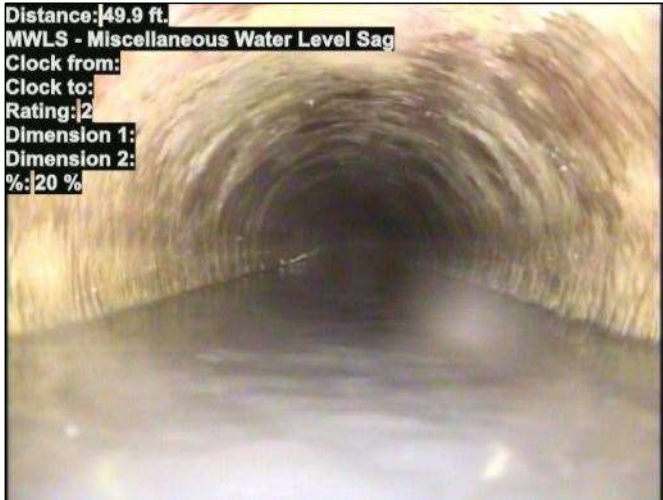
Photo: 15\_043-15\_058-20230804-071848.JPG  
At: 49.9 ft. MWLS - Miscellaneous Water Level Sag  
Joint: No 20 %

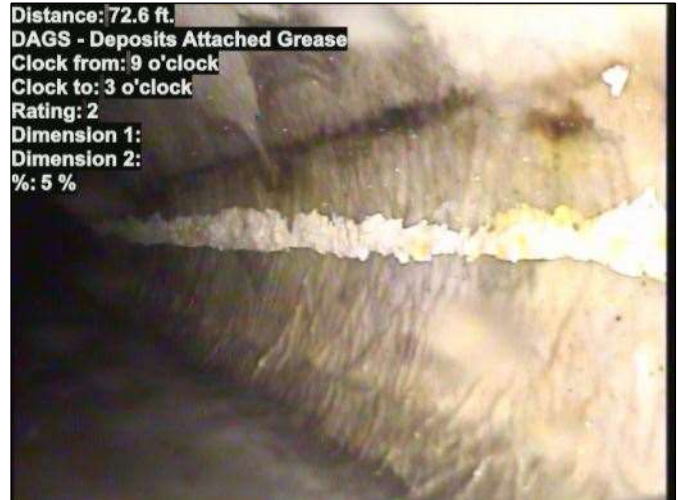
Photo: 15\_043-15\_058-20230804-071949.JPG  
At: 72.6 ft. 9/3 DABS - Deposits Attached Grease  
Joint: No 5 %

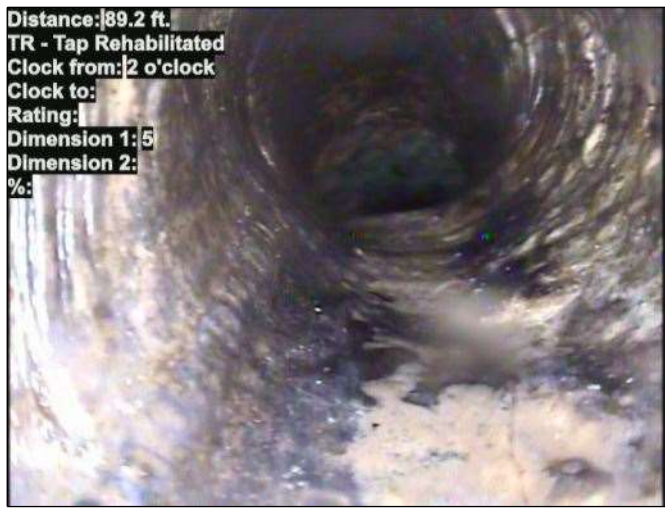
Distance: 89.2 ft.  
TR - Tap Rehabilitated  
Clock from: 2 o'clock  
Clock to:  
Rating:  
Dimension 1: 5  
Dimension 2:  
%:

Photo: 15\_043-15\_058-20230804-072107.JPG  
At: 89.2 ft. 2/. TR - Tap Rehabilitated  
Joint: No

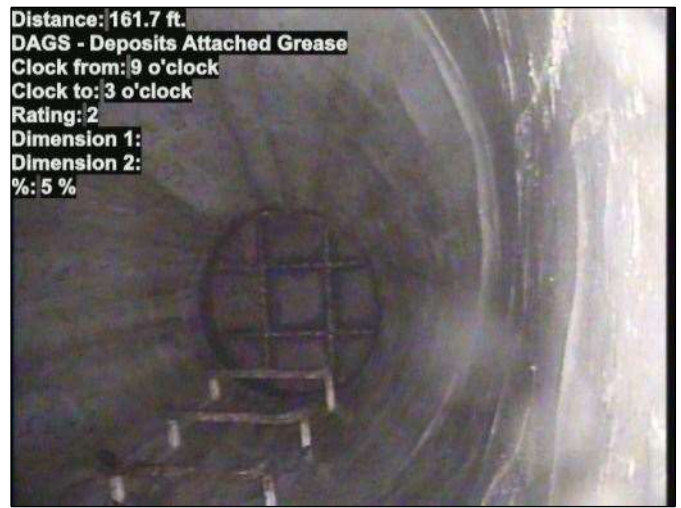
Distance: 161.7 ft.  
DAGS - Deposits Attached Grease  
Clock from: 9 o'clock  
Clock to: 3 o'clock  
Rating: 2  
Dimension 1:  
Dimension 2:  
%: 5 %

Photo: 15\_043-15\_058-20230804-072530.JPG  
At: 161.7 ft. 9/3 DAGS - Deposits Attached Grease  
Joint: No 5 %

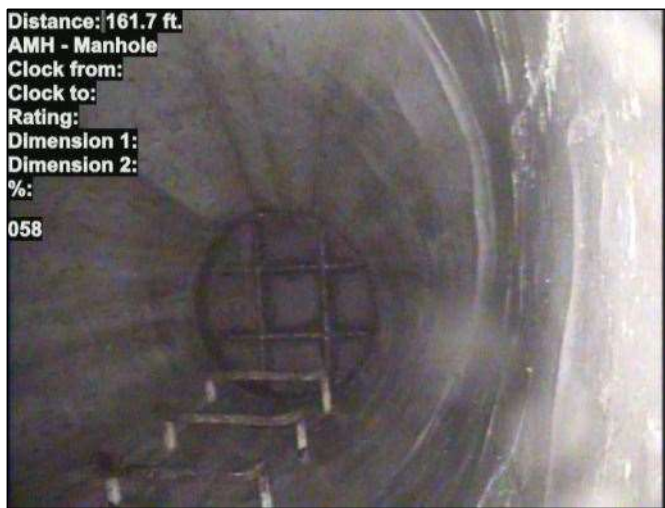
058

Distance: 161.7 ft.  
AMH - Manhole  
Clock from:  
Clock to:  
Rating:  
Dimension 1:  
Dimension 2:  
%:

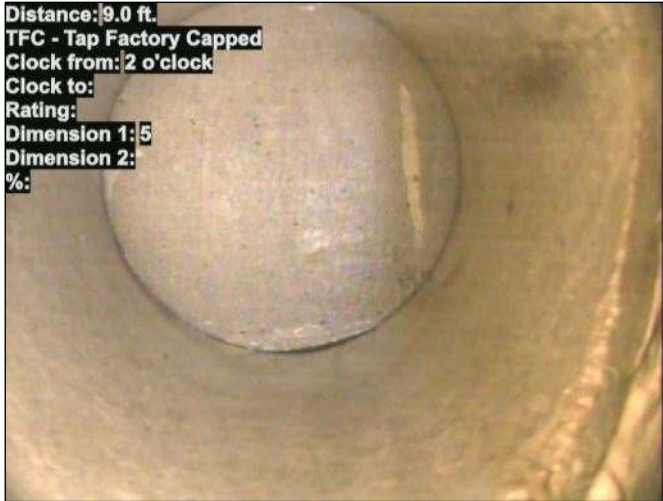
Photo: 15\_044-15\_045-20230725-085452.JPG  
At: 9 ft. 2/. TFC - Tap Factory Capped  
Joint: No

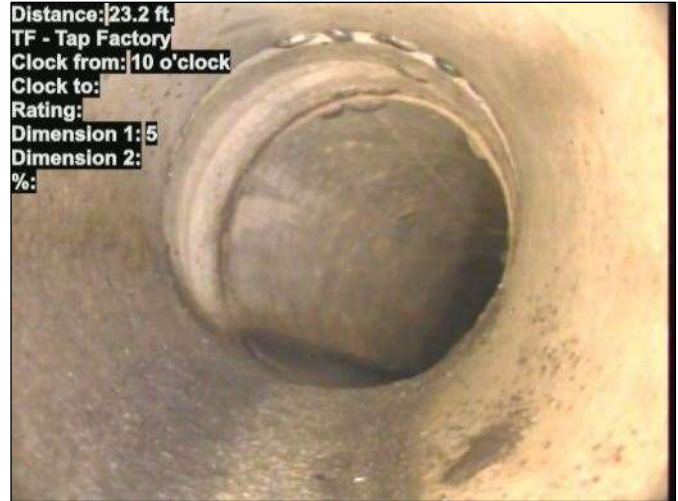
Photo: 15\_044-15\_045-20230725-085537.JPG  
At: 23.2 ft. 10/. TF - Tap Factory  
Joint: No

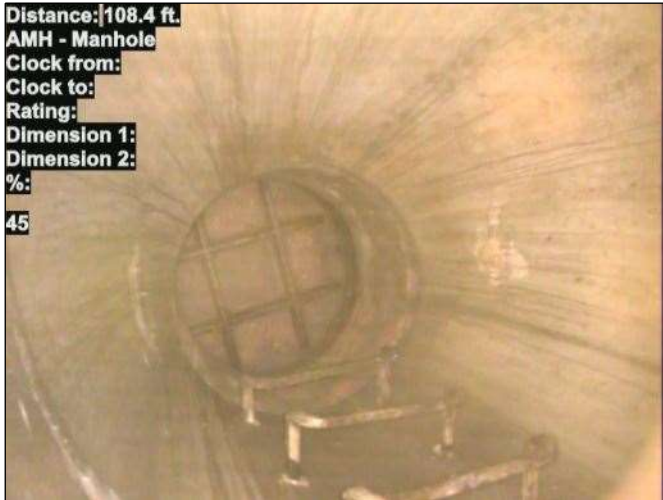
Photo: 15\_044-15\_045-20230725-085837.JPG  
At: 108.4 ft. AMH - Manhole  
Joint: No 45

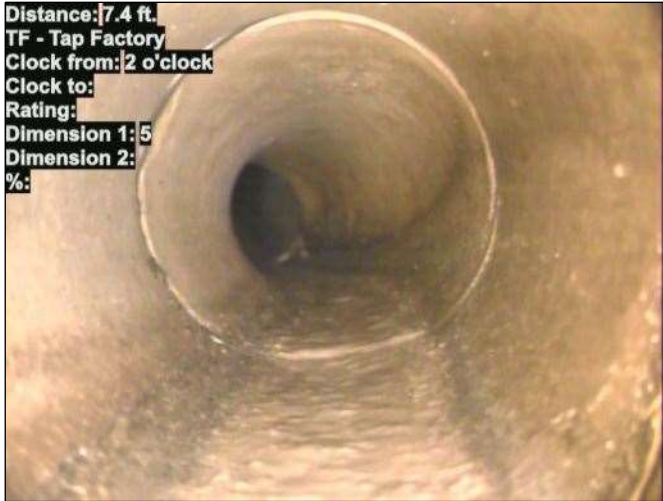
Photo: 15\_045-15\_046-20230725-090238.JPG  
At: 7.4 ft. 2/. TF - Tap Factory  
Joint: No

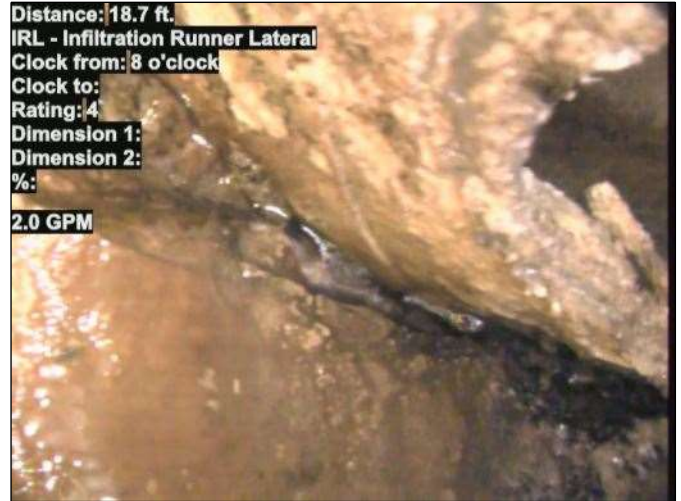
Photo: 15\_045-15\_046-20230725-090354.JPG  
At: 18.7 ft. 8/. IRL - Infiltration Runner Lateral  
Joint: No 2.0 GPM

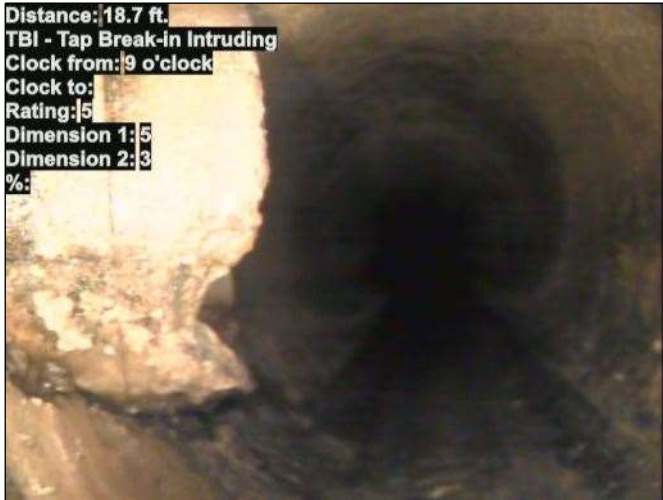
Photo: 15\_045-15\_046-20230725-090324\_1.JPG  
At: 18.7 ft. 9/. TBI - Tap Break-in Intruding  
Joint: No

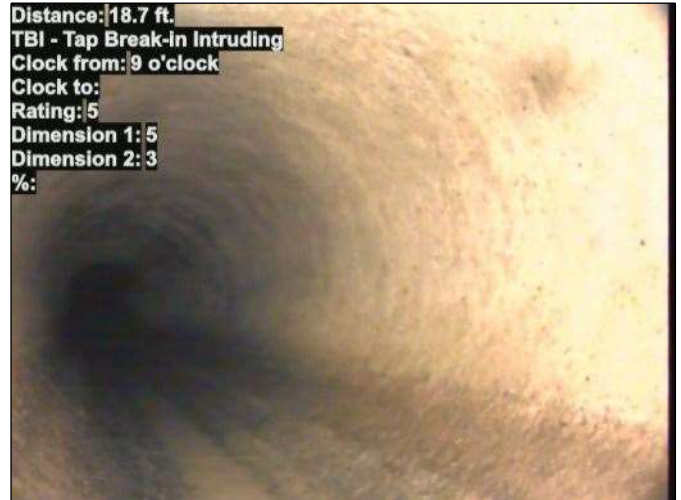
Photo: 15\_045-15\_046-20230725-090324.JPG  
At: 18.7 ft. 9/. TBI - Tap Break-in Intruding  
Joint: No

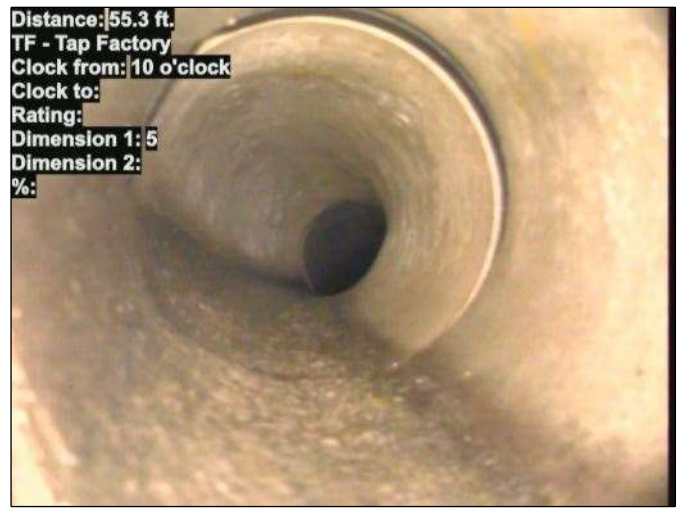
Distance: 55.3 ft.  
TF - Tap Factory  
Clock from: 10 o'clock  
Clock to:  
Rating:  
Dimension 1: 5  
Dimension 2:  
%:  
Photo: 15\_045-15\_046-20230725-090932.JPG  
At: 55.3 ft. 10/. TF - Tap Factory  
Joint: No

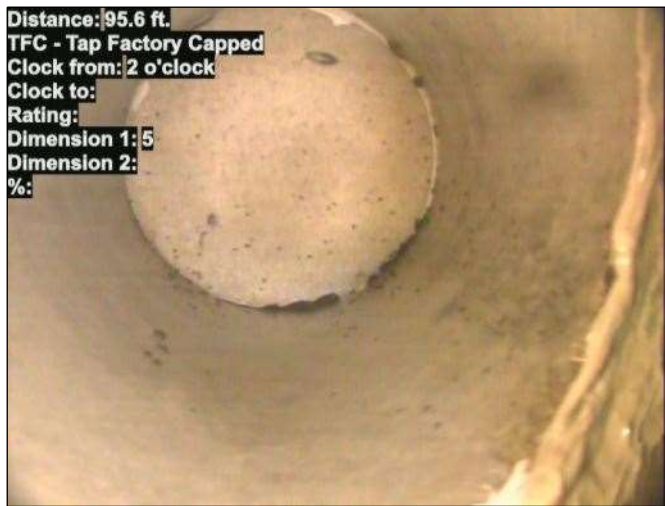
Distance: 95.6 ft.  
TFC - Tap Factory Capped  
Clock from: 2 o'clock  
Clock to:  
Rating:  
Dimension 1: 5  
Dimension 2:  
%:  
Photo: 15\_045-15\_046-20230725-091102.JPG  
At: 95.6 ft. 2/. TFC - Tap Factory Capped  
Joint: No

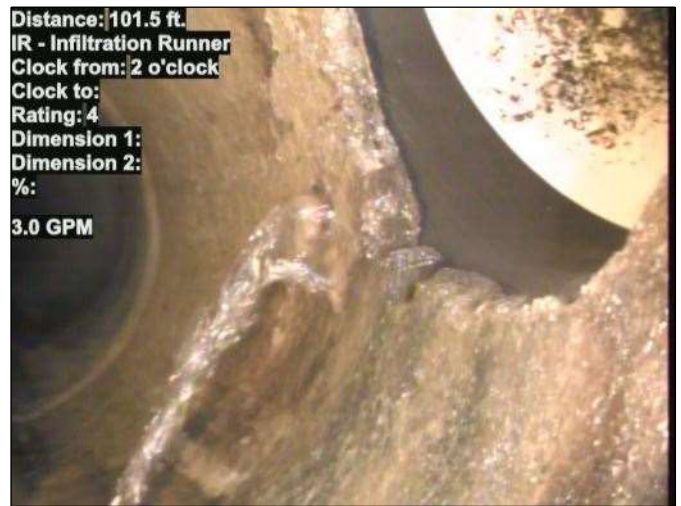
Distance: 101.5 ft.  
IR - Infiltration Runner  
Clock from: 2 o'clock  
Clock to:  
Rating: 4  
Dimension 1:  
Dimension 2:  
%:  
3.0 GPM  
Photo: 15\_045-15\_046-20230725-091147.JPG  
At: 101.5 ft. 2/. IR - Infiltration Runner  
Joint: No 3.0 GPM

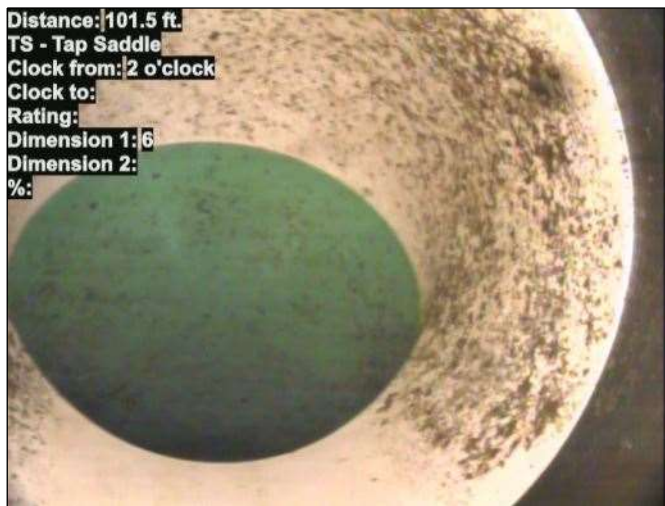
Distance: 101.5 ft.  
TS - Tap Saddle  
Clock from: 2 o'clock  
Clock to:  
Rating:  
Dimension 1: 6  
Dimension 2:  
%:  
Photo: 15\_045-15\_046-20230725-091130.JPG  
At: 101.5 ft. 2/. TS - Tap Saddle  
Joint: No

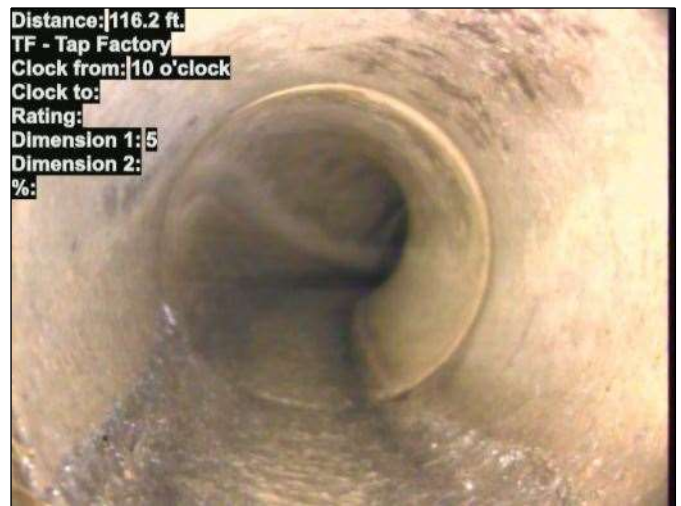
Distance: 116.2 ft.  
TF - Tap Factory  
Clock from: 10 o'clock  
Clock to:  
Rating:  
Dimension 1: 5  
Dimension 2:  
%:  
Photo: 15\_045-15\_046-20230725-091303.JPG  
At: 116.2 ft. 10/. TF - Tap Factory  
Joint: No

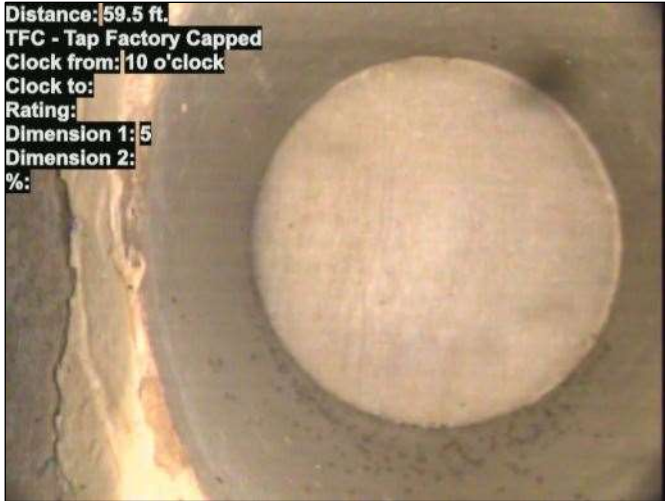
Photo: 15\_046-15\_047-20230725-092159.JPG  
At: 59.5 ft. 10/. TFC - Tap Factory Capped  
Joint: No

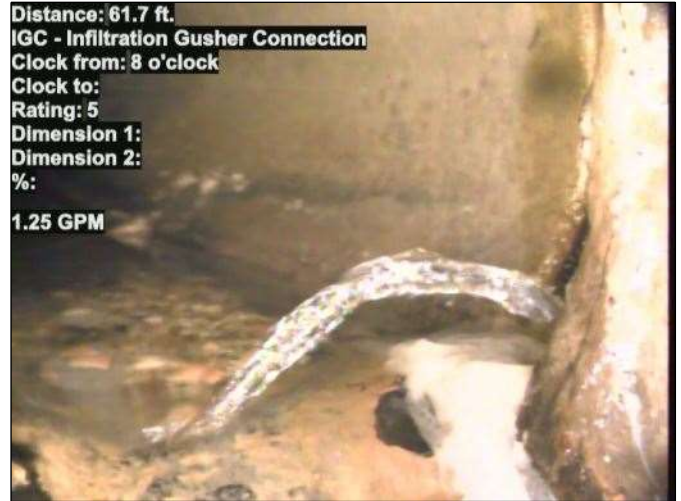
Photo: 15\_046-15\_047-20230725-092224.JPG  
At: 61.7 ft. 8/. IGC - Infiltration Gusher Connection  
Joint: No 1.25 GPM

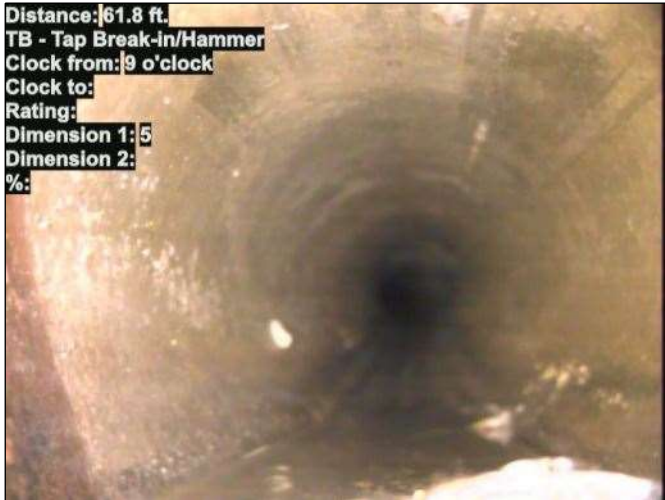
Photo: 15\_046-15\_047-20230725-092314.JPG  
At: 61.8 ft. 9/. TB - Tap Break-in/Hammer  
Joint: No

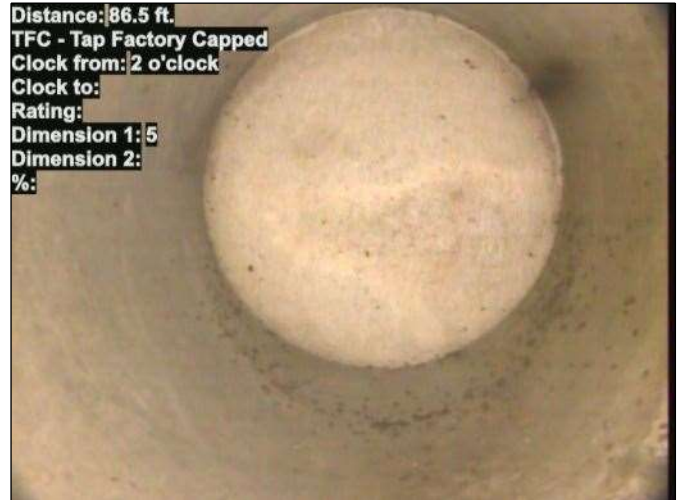
Photo: 15\_046-15\_047-20230725-092418.JPG  
At: 86.5 ft. 2/. TFC - Tap Factory Capped  
Joint: No

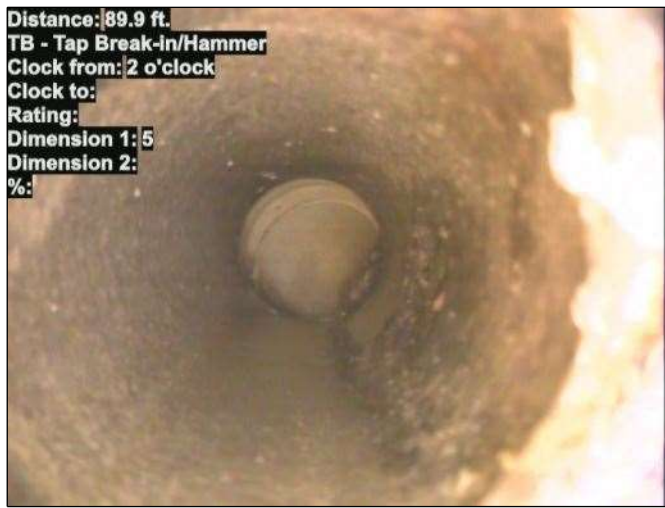
Photo: 15\_046-15\_047-20230725-092501.JPG  
At: 89.9 ft. 2/. TB - Tap Break-in/Hammer  
Joint: No

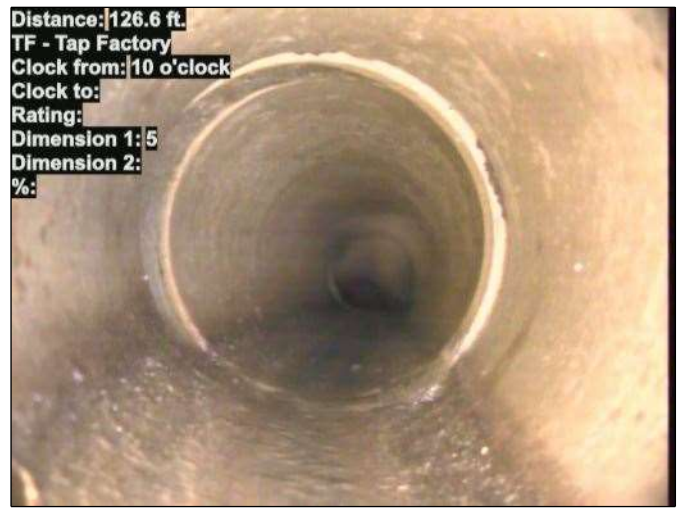
Photo: 15\_046-15\_047-20230725-092633.JPG  
At: 126.6 ft. 10/. TF - Tap Factory  
Joint: No

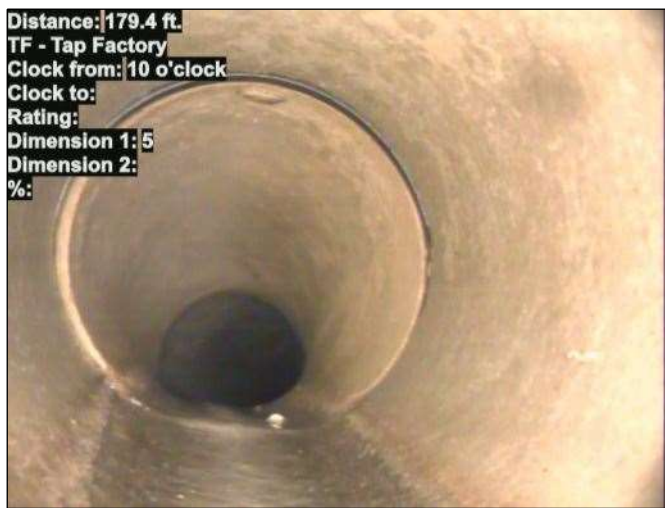
Photo: 15\_046-15\_047-20230725-092829.JPG  
At: 179.4 ft. 10/. TF - Tap Factory  
Joint: No

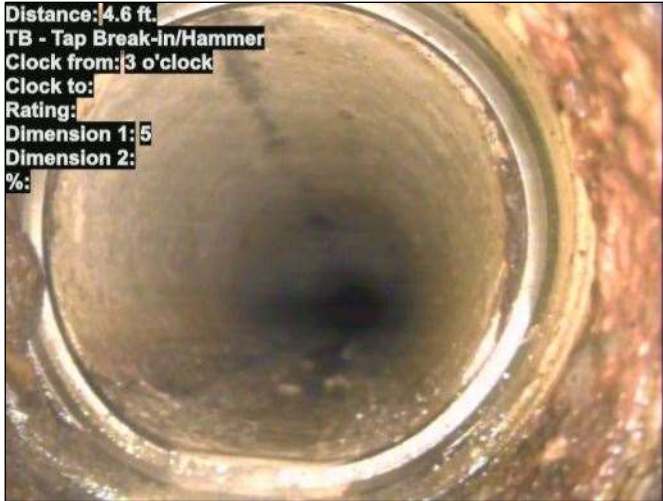
Photo: 15\_047-15\_048-20230725-093236.JPG  
At: 4.6 ft. 3/. TB - Tap Break-in/Hammer  
Joint: No

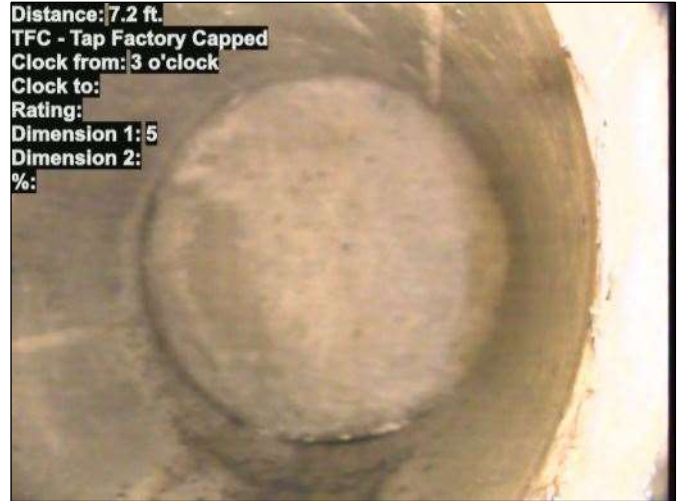
Photo: 15\_047-15\_048-20230725-093300.JPG  
At: 7.2 ft. 3/. TFC - Tap Factory Capped  
Joint: No

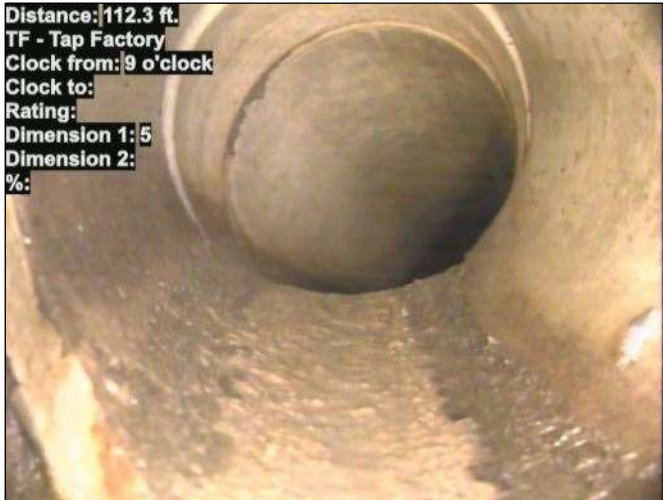
Photo: 15\_047-15\_048-20230725-093618.JPG  
At: 112.3 ft. 9/. TF - Tap Factory  
Joint: No

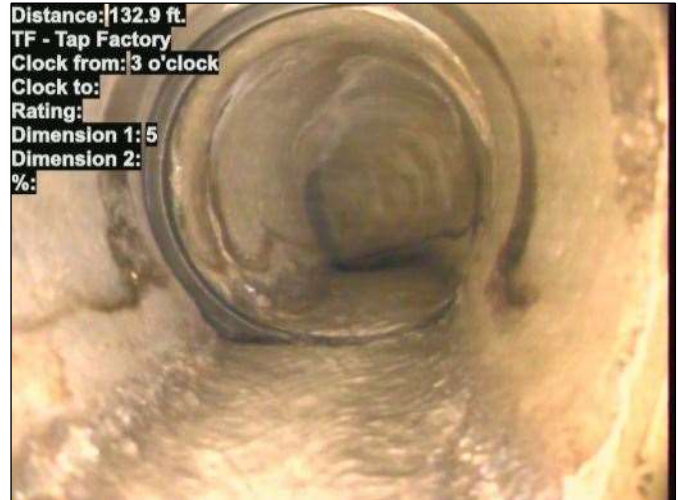
Photo: 15\_047-15\_048-20230725-093708.JPG  
At: 132.9 ft. 3/. TF - Tap Factory  
Joint: No

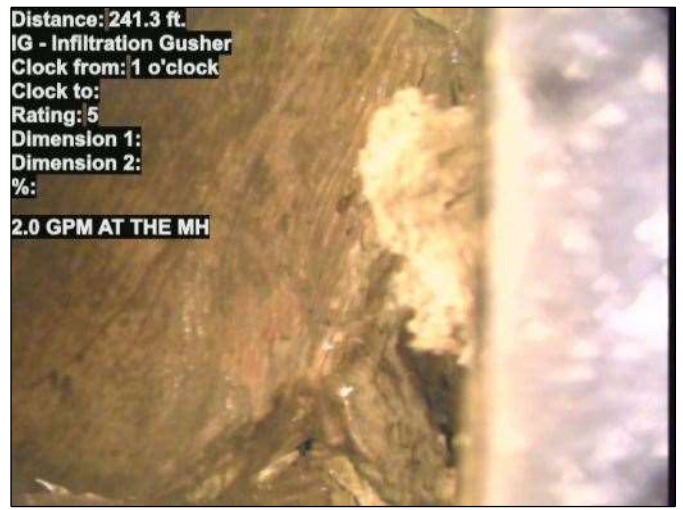
Distance: 241.3 ft.  
IG - Infiltration Gusher  
Clock from: 1 o'clock  
Clock to:  
Rating: 5  
Dimension 1:  
Dimension 2:  
%:  
2.0 GPM AT THE MH

Photo: 15\_047-15\_048-20230725-094057.JPG  
At: 241.3 ft. 1/. IG - Infiltration Gusher  
Joint: No 2.0 GPM AT THE MH

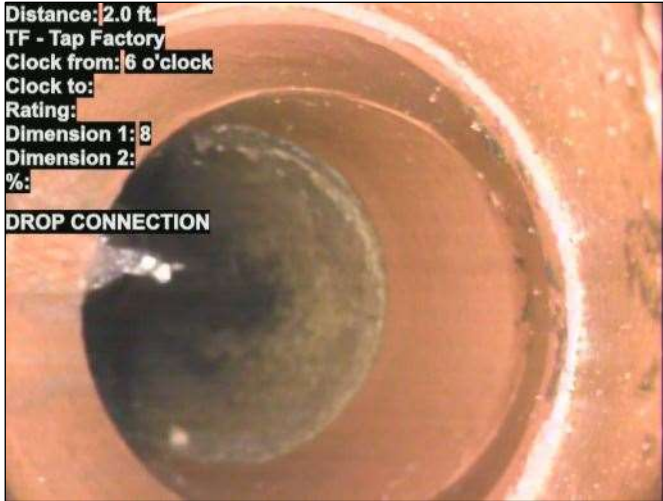
Photo: 15\_048-15\_033-20230725-103219.JPG  
At: 2 ft. 6/. TF - Tap Factory  
Joint: No DROP CONNECTION

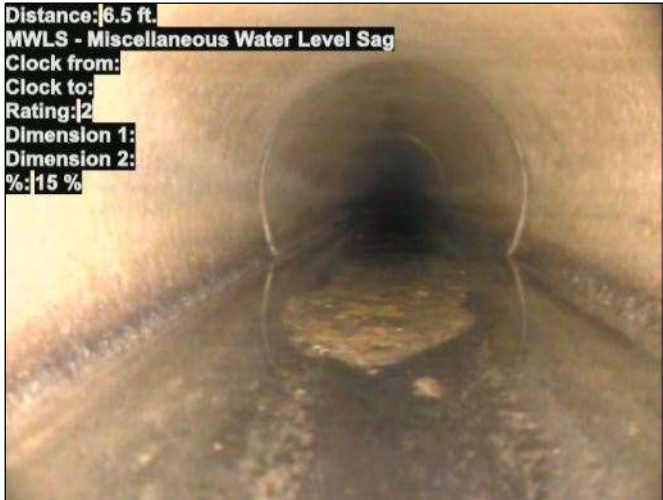
Photo: 15\_048-15\_033-20230725-103334.JPG  
At: 6.5 ft. MWLS - Miscellaneous Water Level Sag  
Joint: No 15 %

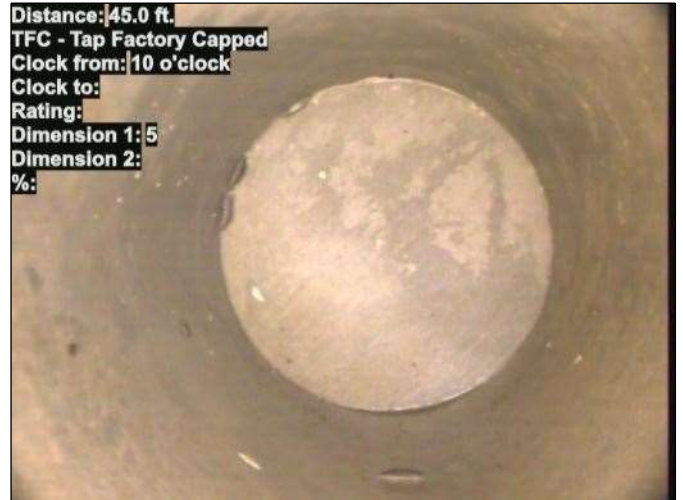
Photo: 15\_048-15\_033-20230725-103745.JPG  
At: 45 ft. 10/. TFC - Tap Factory Capped  
Joint: No

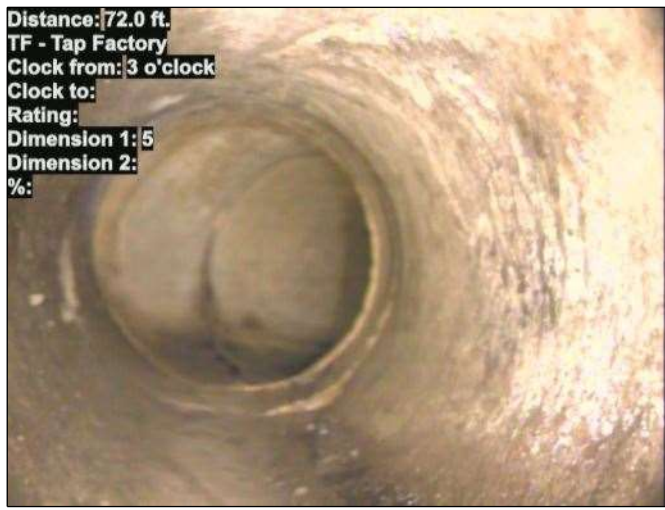
Distance: 72.0 ft.  
TF - Tap Factory  
Clock from: 3 o'clock  
Clock to:  
Rating:  
Dimension 1: 5  
Dimension 2:  
%:

Photo: 15\_048-15\_033-20230725-103851.JPG  
At: 72 ft. 3/. TF - Tap Factory  
Joint: No

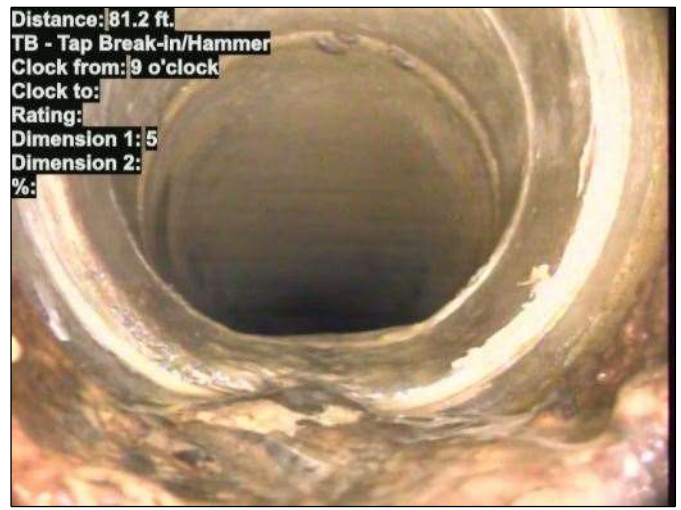
Distance: 81.2 ft.  
TB - Tap Break-in/Hammer  
Clock from: 9 o'clock  
Clock to:  
Rating:  
Dimension 1: 5  
Dimension 2:  
%:

Photo: 15\_048-15\_033-20230725-103929.JPG  
At: 81.2 ft. 9/. TB - Tap Break-in/Hammer  
Joint: No

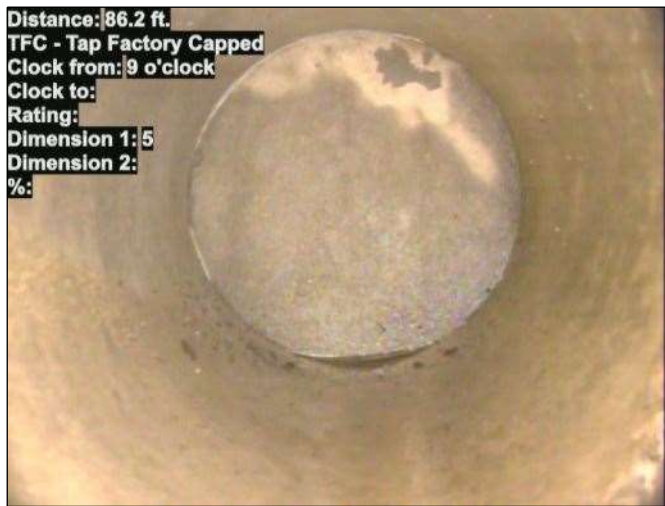
Distance: 86.2 ft.  
TFC - Tap Factory Capped  
Clock from: 9 o'clock  
Clock to:  
Rating:  
Dimension 1: 5  
Dimension 2:  
%:

Photo: 15\_048-15\_033-20230725-103955.JPG  
At: 86.2 ft. 9/. TFC - Tap Factory Capped  
Joint: No

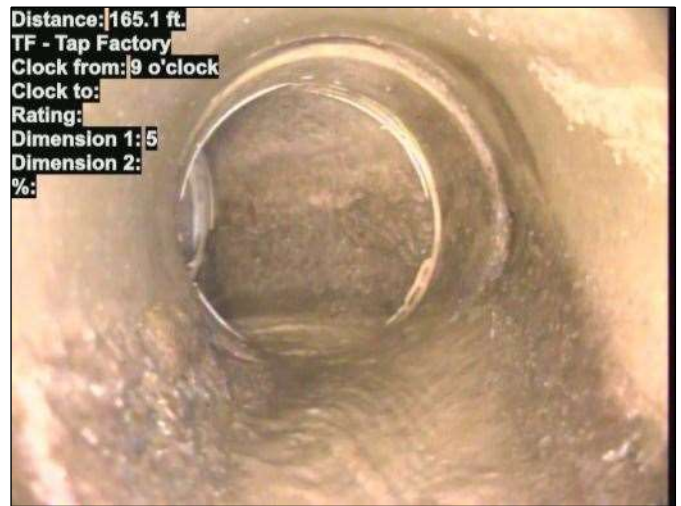
Distance: 165.1 ft.  
TF - Tap Factory  
Clock from: 9 o'clock  
Clock to:  
Rating:  
Dimension 1: 5  
Dimension 2:  
%:

Photo: 15\_048-15\_033-20230725-104235.JPG  
At: 165.1 ft. 9/. TF - Tap Factory  
Joint: No

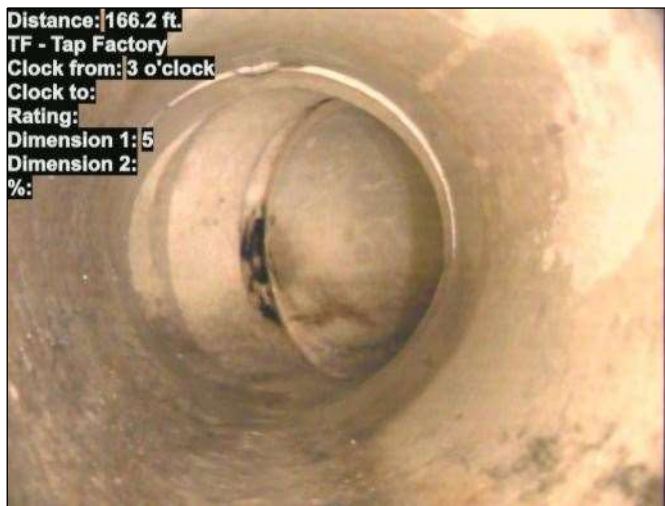
Distance: 166.2 ft.  
TF - Tap Factory  
Clock from: 3 o'clock  
Clock to:  
Rating:  
Dimension 1: 5  
Dimension 2:  
%:

Photo: 15\_048-15\_033-20230725-104252.JPG  
At: 166.2 ft. 3/. TF - Tap Factory  
Joint: No

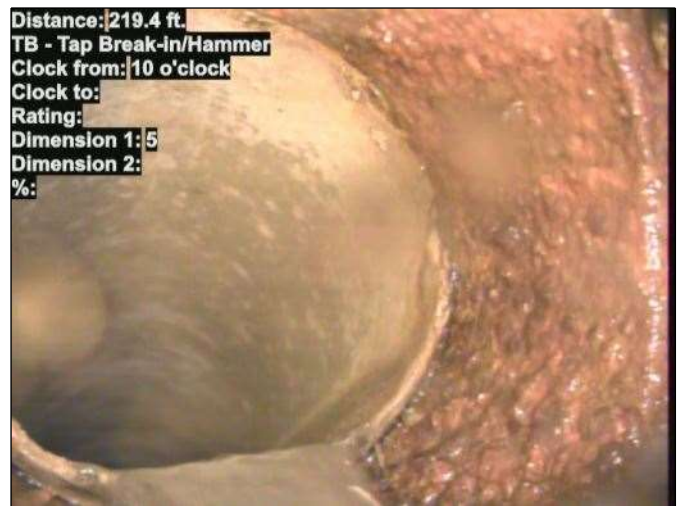
Distance: 219.4 ft.  
TB - Tap Break-in/Hammer  
Clock from: 10 o'clock  
Clock to:  
Rating:  
Dimension 1: 5  
Dimension 2:  
%:

Photo: 15\_048-15\_033-20230725-104545.JPG  
At: 219.4 ft. 10/. TB - Tap Break-in/Hammer  
Joint: No

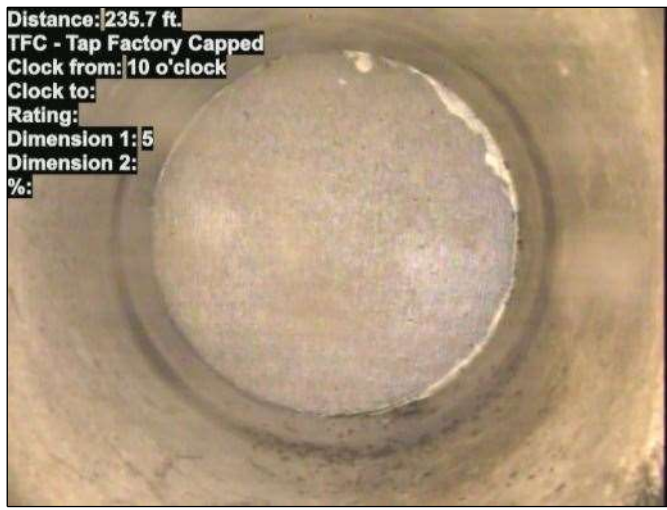
Distance: 235.7 ft.  
TFC - Tap Factory Capped  
Clock from: 10 o'clock  
Clock to:  
Rating:  
Dimension 1: 5  
Dimension 2:  
%:

Photo: 15\_048-15\_033-20230725-104634.JPG  
At: 235.7 ft. 10/. TFC - Tap Factory Capped  
Joint: No

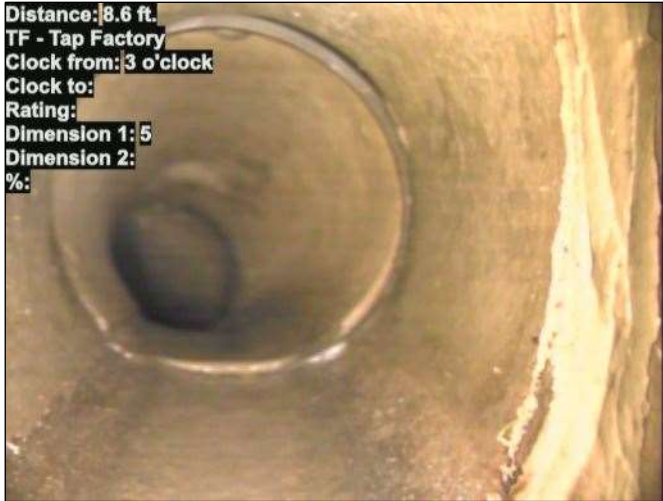
Photo: 15\_049-15\_050-20230726-063524.JPG  
At: 8.6 ft. 3/. TF - Tap Factory  
Joint: No

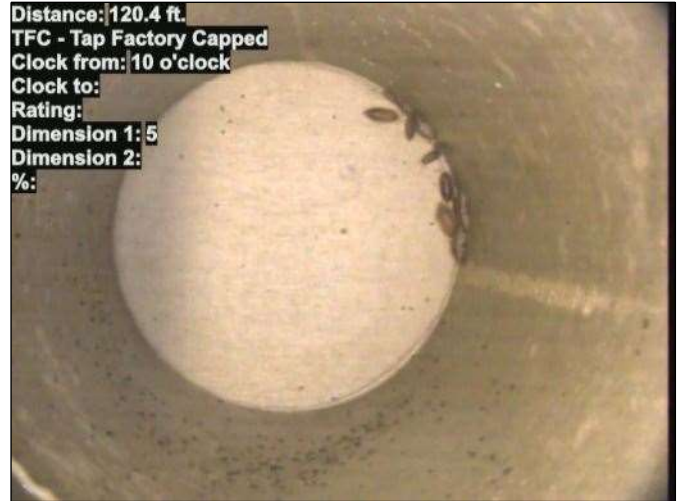
Photo: 15\_049-15\_050-20230726-063928.JPG  
At: 120.4 ft. 10/. TFC - Tap Factory Capped  
Joint: No

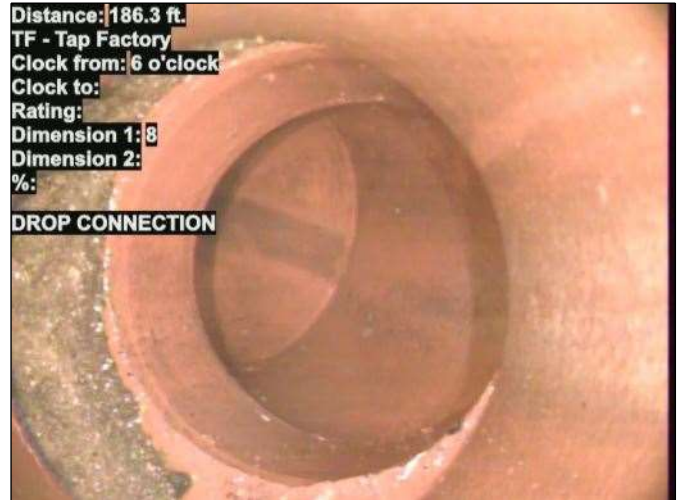
Photo: 15\_049-15\_050-20230726-064230.JPG  
At: 186.3 ft. 6/. TF - Tap Factory  
Joint: No DROP CONNECTION

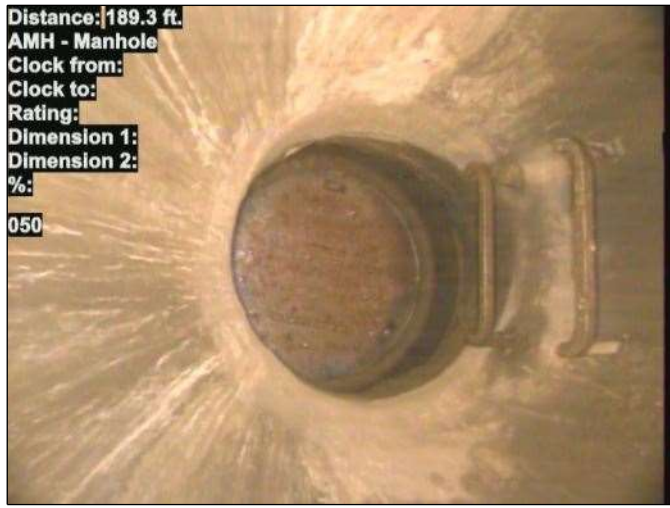
Photo: 15\_049-15\_050-20230726-064320.JPG

At: 189.3 ft. AMH - Manhole

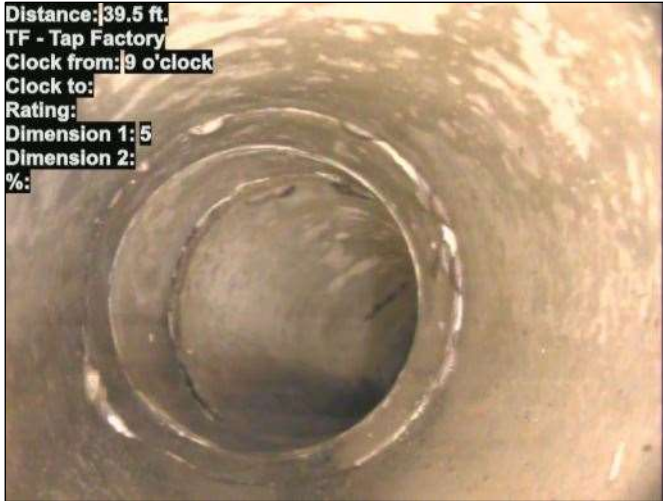
Photo: 15\_050-15\_051-20230726-070443.JPG  
At: 39.5 ft. 9/. TF - Tap Factory  
Joint: No

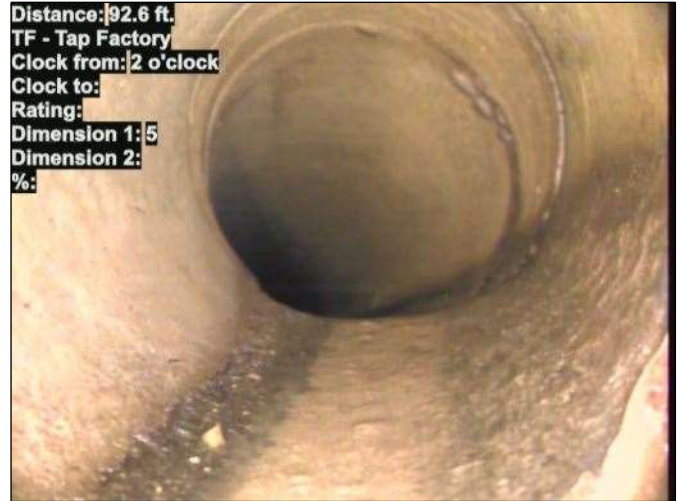
Photo: 15\_050-15\_051-20230726-070701.JPG  
At: 92.6 ft. 2/. TF - Tap Factory  
Joint: No

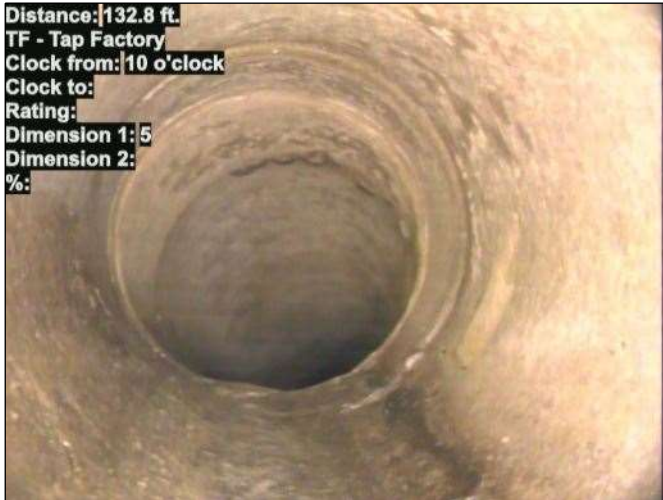
Photo: 15\_050-15\_051-20230726-070908.JPG  
At: 132.8 ft. 10/. TF - Tap Factory  
Joint: No

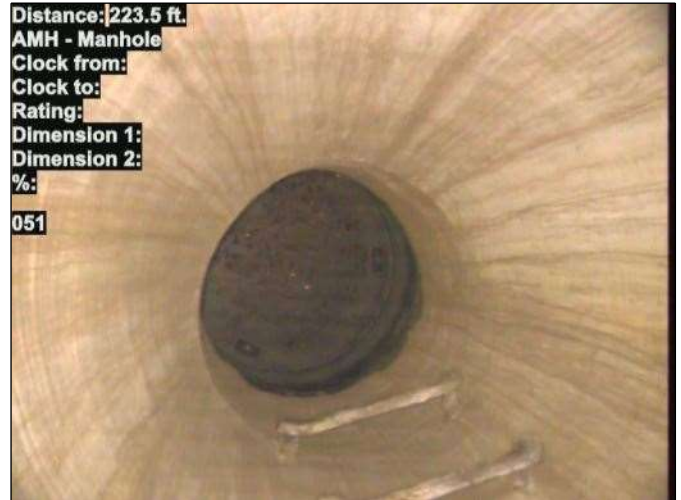
Photo: 15\_050-15\_051-20230726-071208.JPG  
At: 223.5 ft. AMH - Manhole  
Joint: No 051

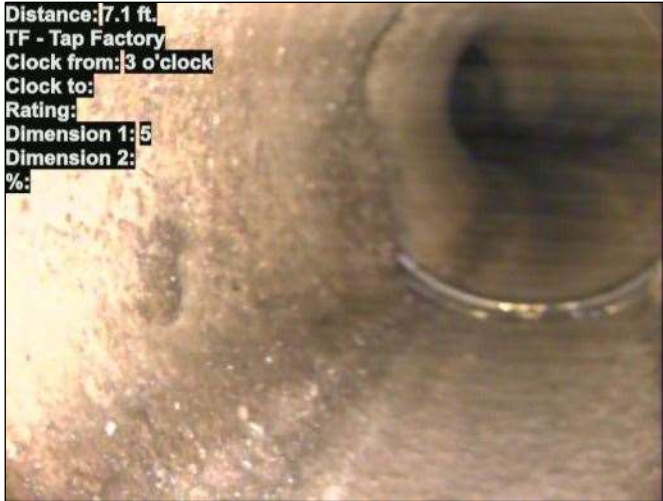
Photo: 15\_056-15\_057-20230725-074305.JPG  
At: 7.1 ft. 3/. TF - Tap Factory  
Joint: No

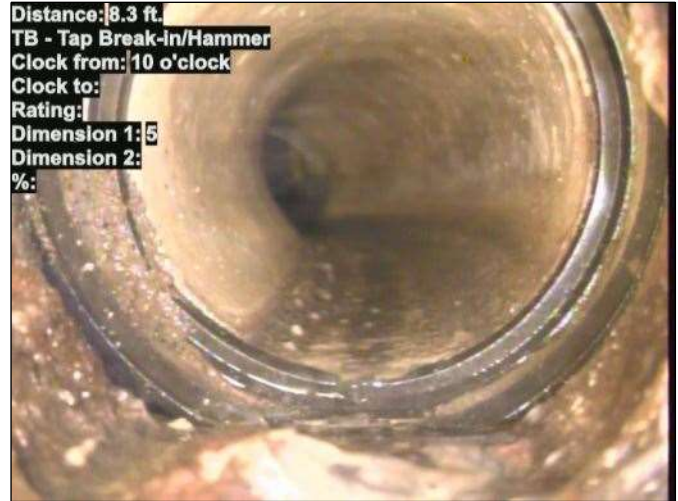
Photo: 15\_056-15\_057-20230725-074318.JPG  
At: 8.3 ft. 10/. TB - Tap Break-in/Hammer  
Joint: No
