**APPENDIX C**  
CCTV Reports

## NWMCC INSPECTION REPORT

Start date/time: <b>20230725 12:13</b>	Weather: <b>Dry - No precipitation during survey</b>	Surveyed by: <b>C.Arruda</b>	Certificate number: <b>U-910-11364</b>	Pipe segment ref.: <b>15/002 - 15/001</b>	
Owner:	Customer:	Pre-cleaning: <b>Light Cleaning</b>	Date cleaned: <b>20230725</b>	Project name: <b>ENV017-13</b>	
City: <b>WESTWOOD MA</b>	Street: <b>NAHATAN ST</b>	Location code:	Pipe use: <b>Sanitary Sewage Pipe</b>	Drainage area: 	Flow control: 
Upstream MH No: <b>15/001</b>	Downstream MH No: <b>15/002</b>	Direction: <b>U</b>	Total length: <b>304.300 ft.</b>	Length surveyed: <b>304.300 ft.</b>	
Purpose: <b>Maintenance Related</b>	Pipe joint length: 	Height: <b>8 in.</b>	Material: <b>Asbestos Cement</b>	LateralsCounter: 	Additional info:

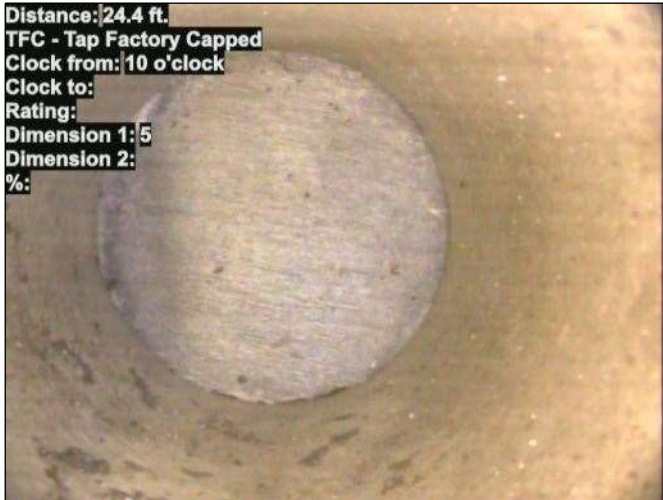
Photo: 15\_056-15\_057-20230725-074427.JPG  
At: 24.4 ft. 10/. TFC - Tap Factory Capped  
Joint: No

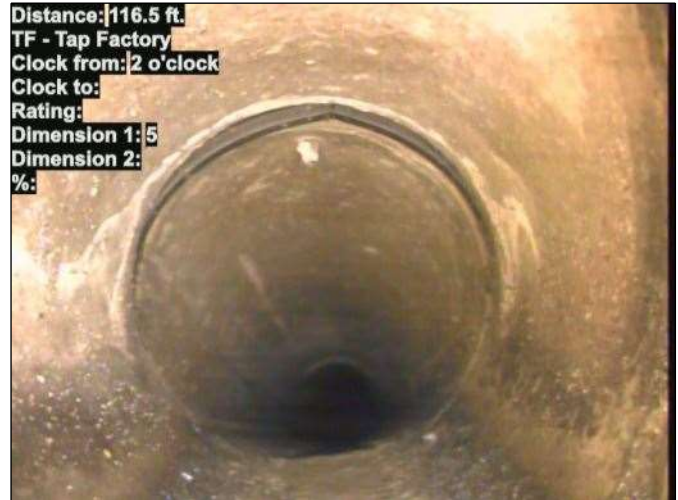
Photo: 15\_056-15\_057-20230725-074708.JPG  
At: 116.5 ft. 2/. TF - Tap Factory  
Joint: No

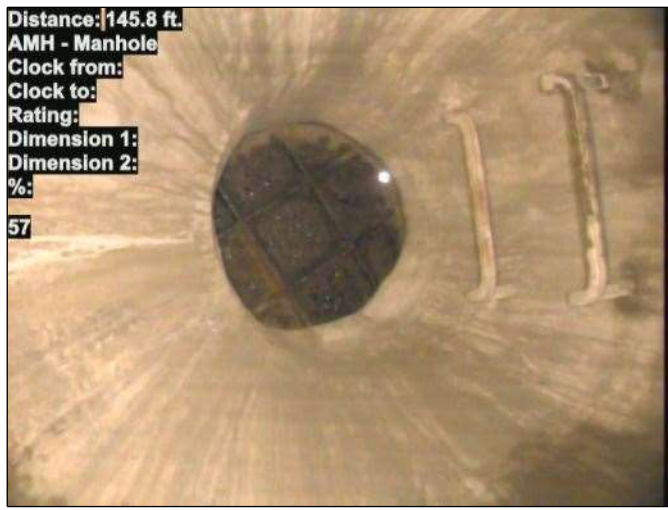
Photo: 15\_056-15\_057-20230725-074831.JPG

At: 145.8 ft. AMH - Manhole

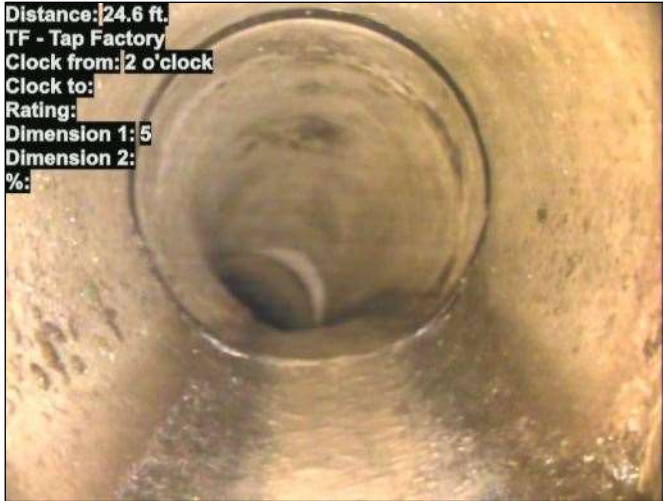
Photo: 15\_057-15\_046-20230725-080904.JPG  
At: 24.6 ft. 2/. TF - Tap Factory  
Joint: No

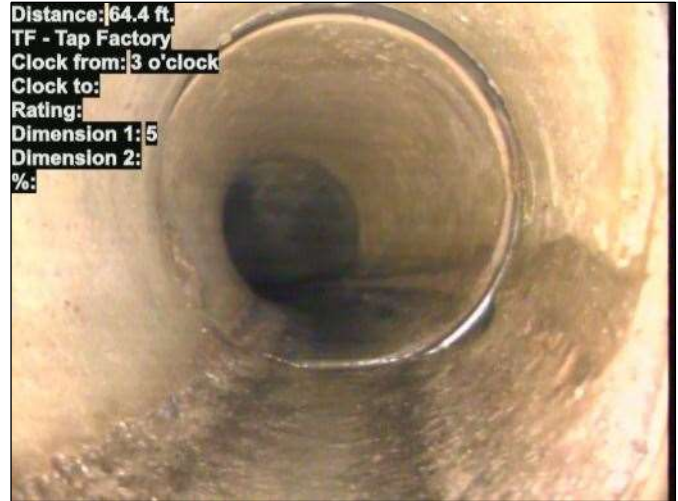
Photo: 15\_057-15\_046-20230725-081046.JPG  
At: 64.4 ft. 3/. TF - Tap Factory  
Joint: No

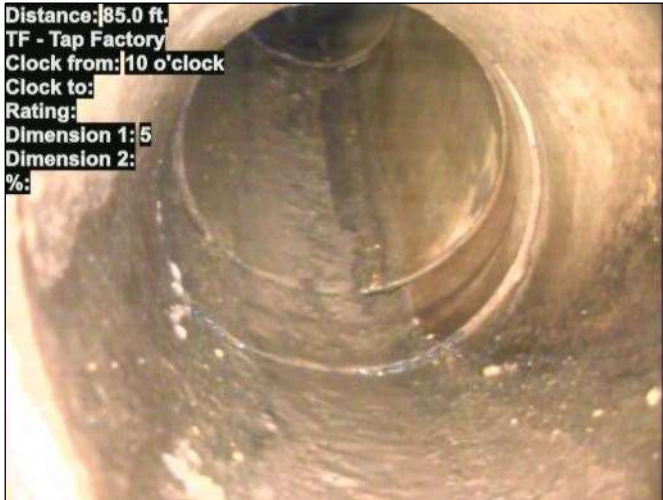
Photo: 15\_057-15\_046-20230725-081143.JPG  
At: 85 ft. 10/. TF - Tap Factory  
Joint: No

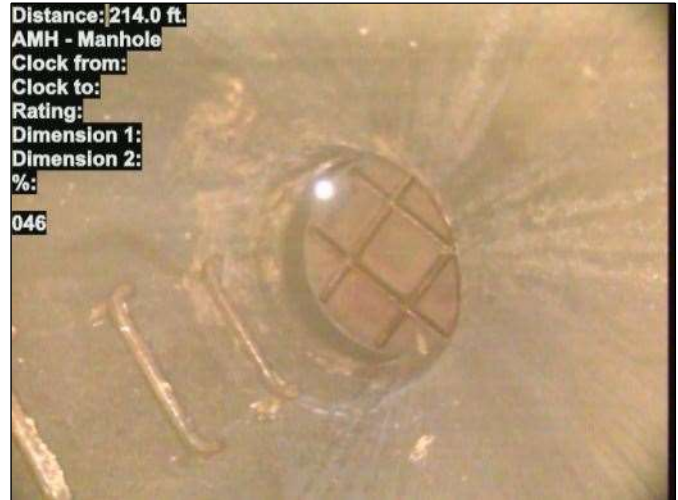
Photo: 15\_057-15\_046-20230725-081624.JPG  
At: 214 ft. AMH - Manhole  
Joint: No 046

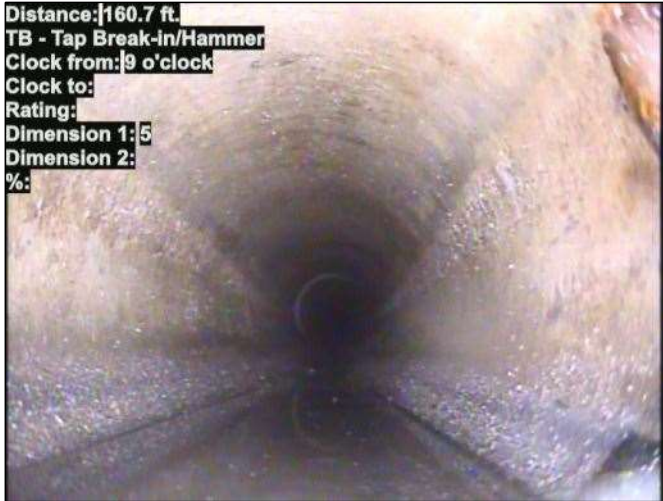
Photo: 15\_058-15\_059-20230804-073503.JPG  
At: 160.7 ft. 9/. TB - Tap Break-in/Hammer  
Joint: No

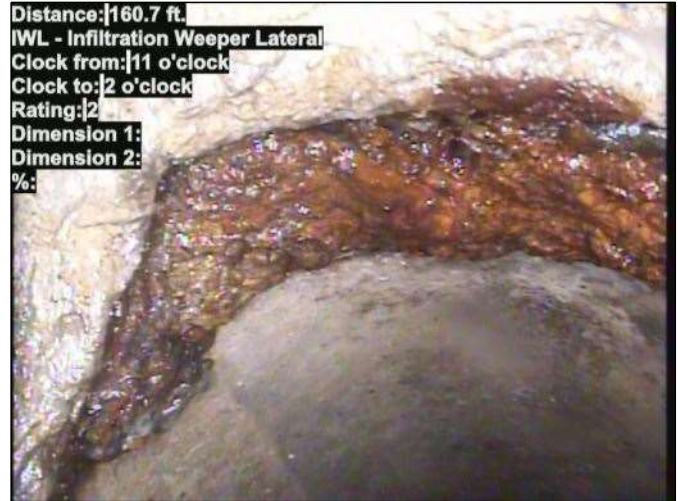
Photo: 15\_058-15\_059-20230804-073521.JPG  
At: 160.7 ft. IWL - Infiltration Weeper Lateral  
11/2  
Joint: No

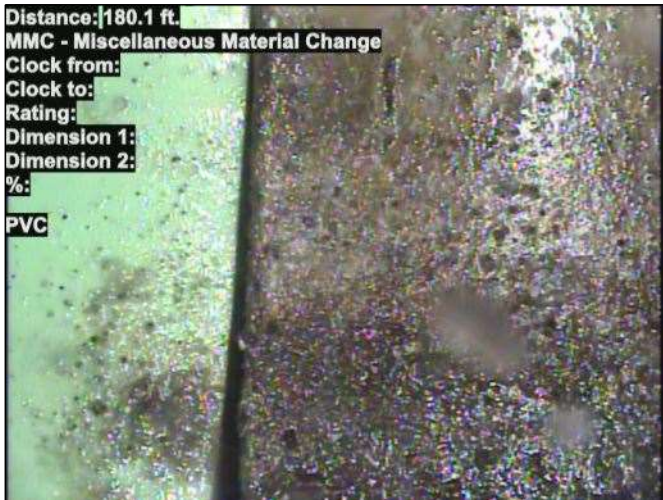
Photo: 15\_058-15\_059-20230804-073611.JPG  
At: 180.1 ft. MMC - Miscellaneous Material Change  
Joint: No PVC

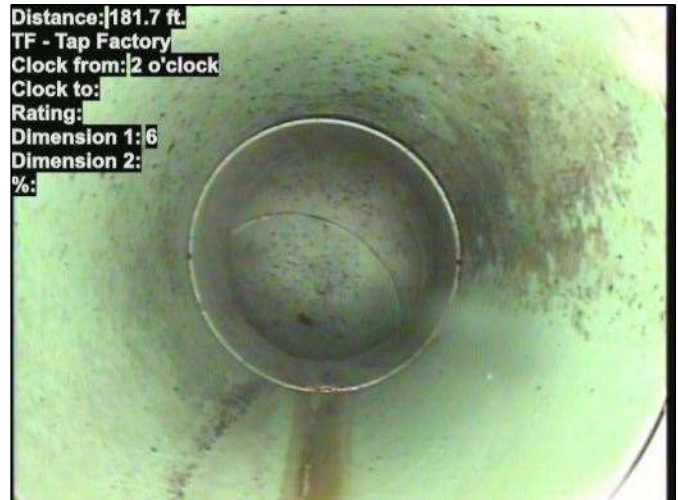
Photo: 15\_058-15\_059-20230804-073627.JPG  
At: 181.7 ft. 2/. TF - Tap Factory  
Joint: No

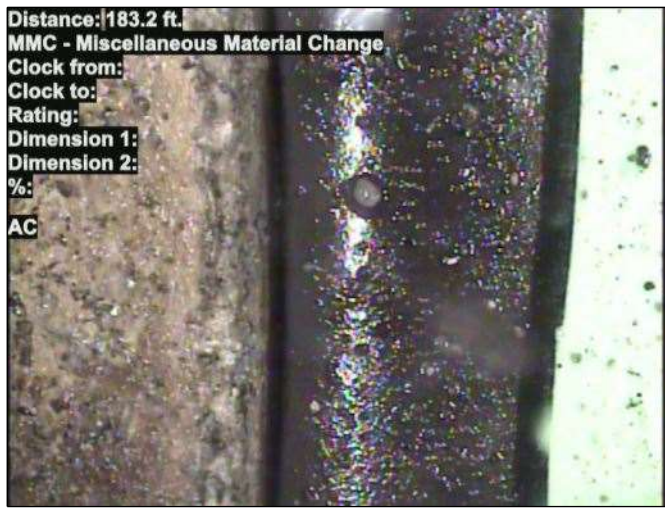
Distance: 183.2 ft.  
MMC - Miscellaneous Material Change  
Clock from:  
Clock to:  
Rating:  
Dimension 1:  
Dimension 2:  
%:  
AC

Photo: 15\_058-15\_059-20230804-073642.JPG  
At: 183.2 ft. MMC - Miscellaneous Material Change  
Joint: No AC

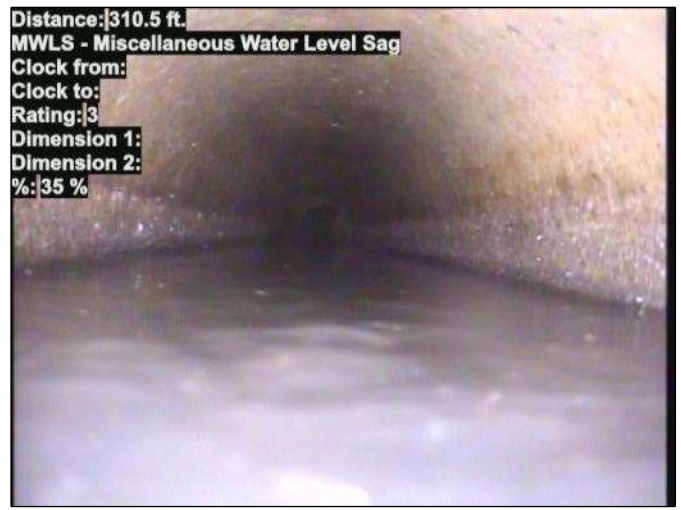
Distance: 310.5 ft.  
MWLS - Miscellaneous Water Level Sag  
Clock from:  
Clock to:  
Rating: 3  
Dimension 1:  
Dimension 2:  
%: 35 %

Photo: 15\_058-15\_059-20230804-074004.JPG  
At: 310.5 ft. MWLS - Miscellaneous Water Level Sag  
Joint: No 35 %

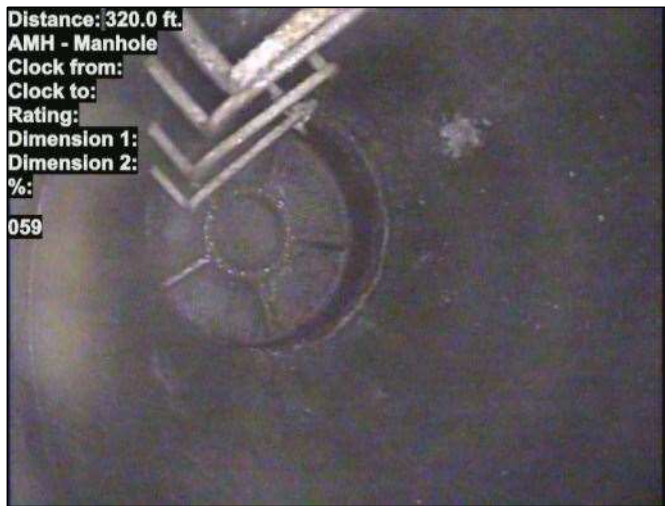
Distance: 320.0 ft.  
AMH - Manhole  
Clock from:  
Clock to:  
Rating:  
Dimension 1:  
Dimension 2:  
%:  
059

Photo: 15\_058-15\_059-20230804-074101.JPG  
At: 320 ft. AMH - Manhole  
Joint: No 059

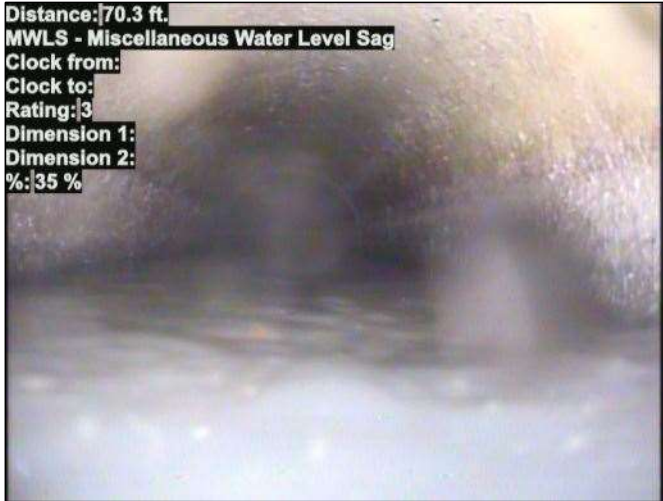
Photo: 15\_059-15\_060-20230804-085304.JPG  
At: 70.3 ft. MWLS - Miscellaneous Water Level Sag  
Joint: No 35 %

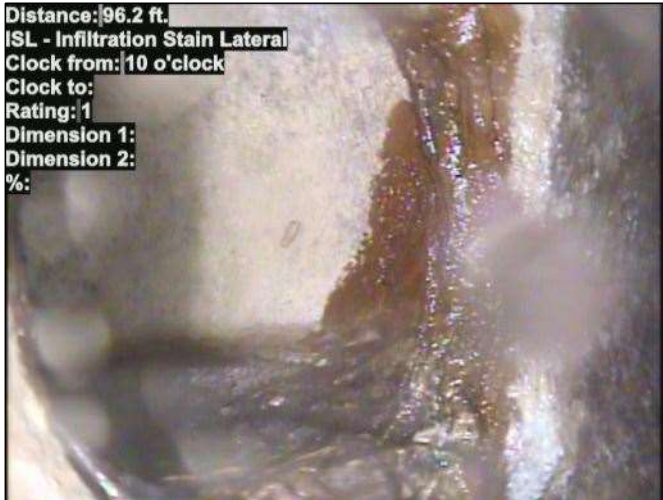
Photo: 15\_059-15\_060-20230804-085444.JPG  
At: 96.2 ft. 10/. ISL - Infiltration Stain Lateral  
Joint: No

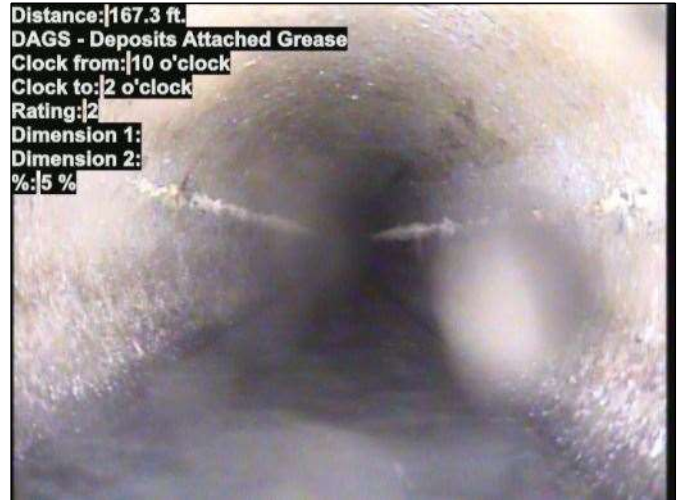
Photo: 15\_059-15\_060-20230804-085713.JPG  
At: 167.3 ft. DAGS - Deposits Attached Grease  
10/2  
Joint: No 5 %

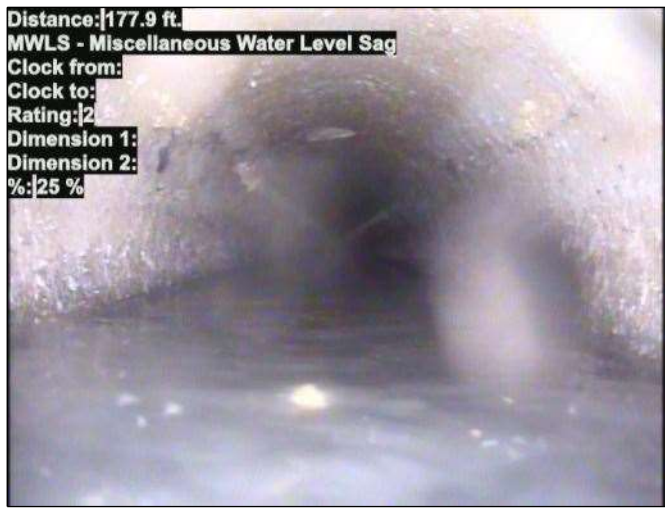
Distance: 177.9 ft.  
MWLS - Miscellaneous Water Level Sag  
Clock from:  
Clock to:  
Rating: 2  
Dimension 1:  
Dimension 2:  
%: 25 %

Photo: 15\_059-15\_060-20230804-085751.JPG  
At: 177.9 ft. MWLS - Miscellaneous Water Level Sag  
Joint: No 25 %

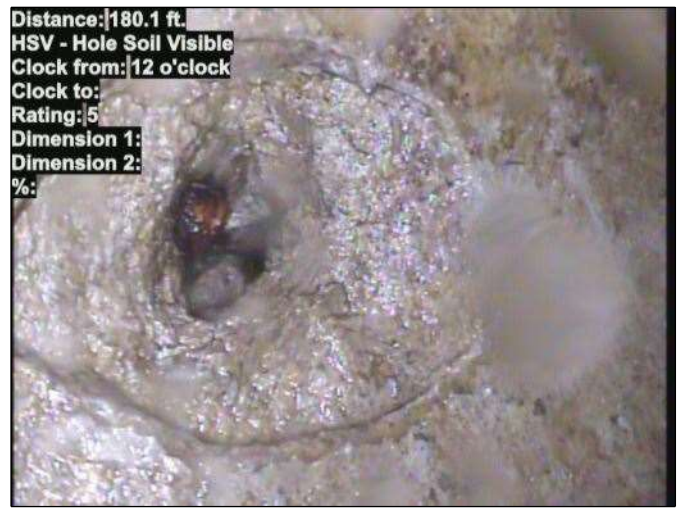
Distance: 180.1 ft.  
HSV - Hole Soil Visible  
Clock from: 12 o'clock  
Clock to:  
Rating: 5  
Dimension 1:  
Dimension 2:  
%:

Photo: 15\_059-15\_060-20230804-085823.JPG  
At: 180.1 ft. 12/. HSV - Hole Soil Visible  
Joint: No

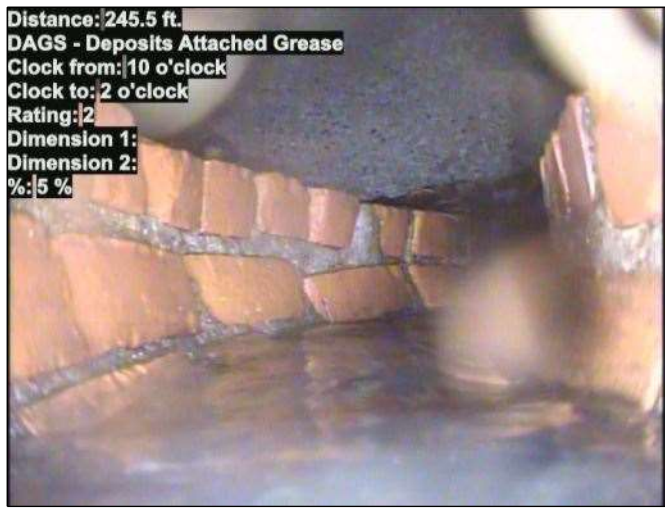
Distance: 245.5 ft.  
DAGS - Deposits Attached Grease  
Clock from: 10 o'clock  
Clock to: 2 o'clock  
Rating: 2  
Dimension 1:  
Dimension 2:  
%: 5 %

Photo: 15\_059-15\_060-20230804-090132.JPG  
At: 245.5 ft. DAGS - Deposits Attached Grease  
10/2  
Joint: No 5 %

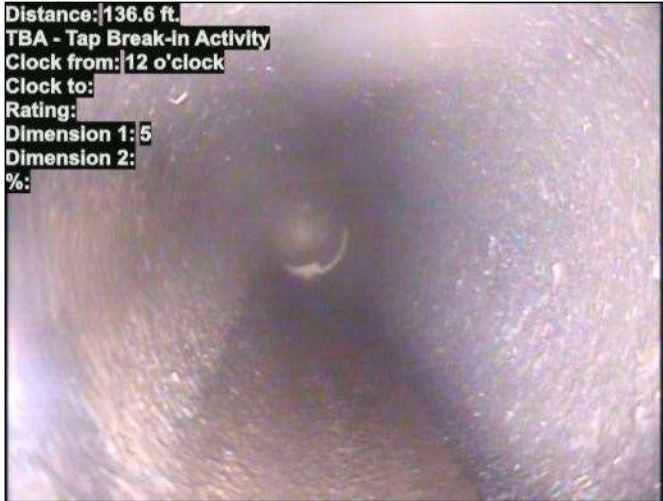
Photo: 15\_060-15\_061-20230804-101808.JPG  
At: 136.6 ft. 12/. TBA - Tap Break-in Activity  
Joint: No

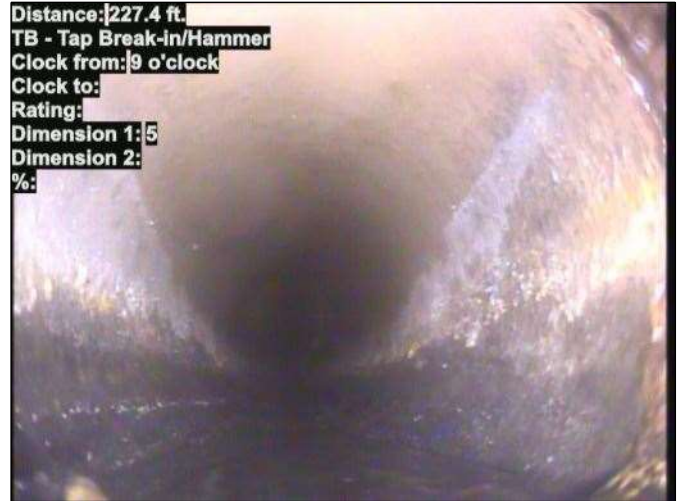
Photo: 15\_060-15\_061-20230804-102139.JPG  
At: 227.4 ft. 9/. TB - Tap Break-in/Hammer  
Joint: No

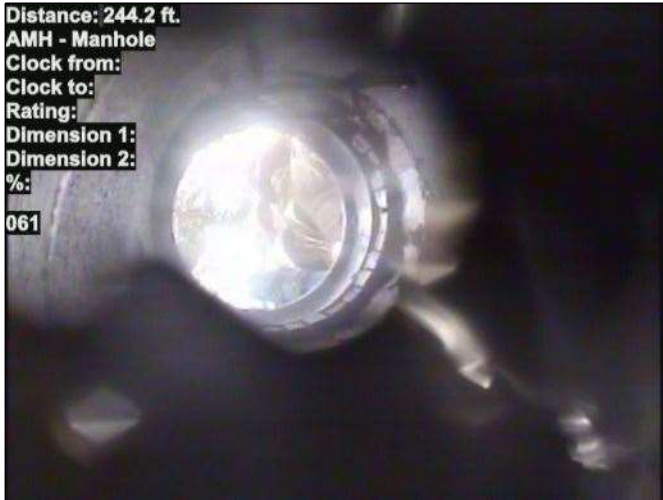
Photo: 15\_060-15\_061-20230804-102229.JPG  
At: 244.2 ft. AMH - Manhole  
Joint: No 061

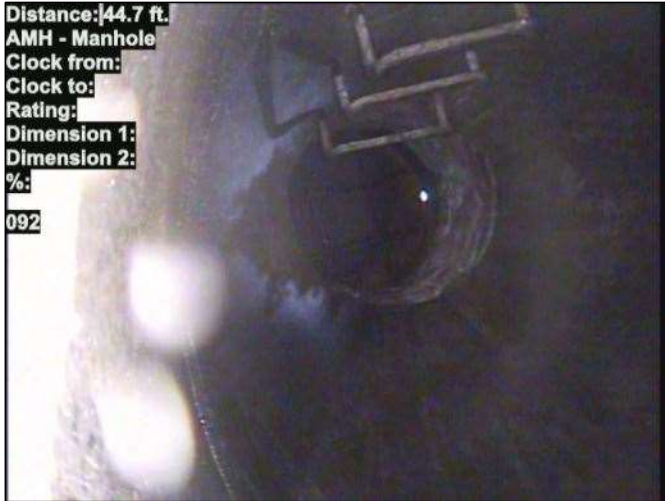
Photo: 15\_061-15\_092-20230804-110527.JPG

At: 44.7 ft. AMH - Manhole

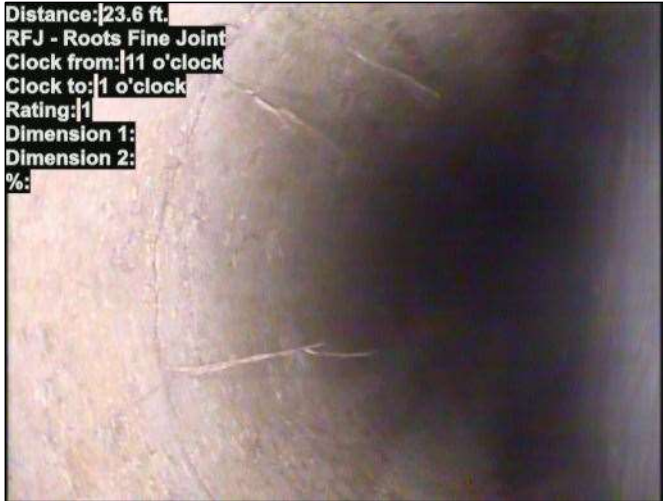
Photo: 15\_062-15\_081-20230804-124046.JPG  
At: 23.6 ft. 11/1 RFJ - Roots Fine Joint  
Joint: Yes

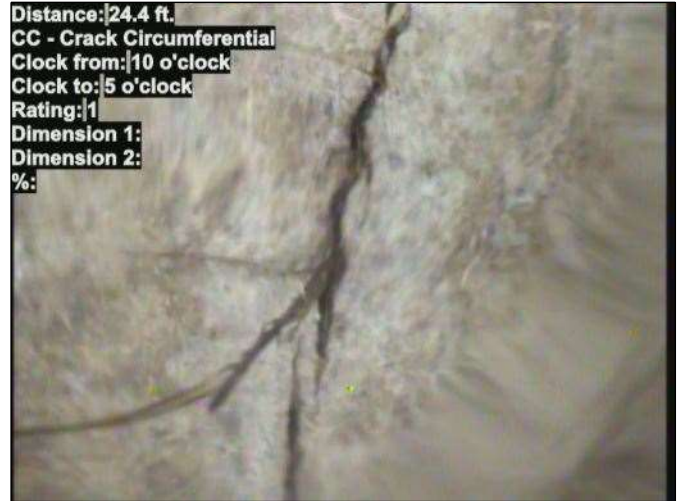
Photo: 15\_062-15\_081-20230804-121254\_1.JPG  
At: 24.4 ft. 10/5 CC - Crack Circumferential  
Joint: No

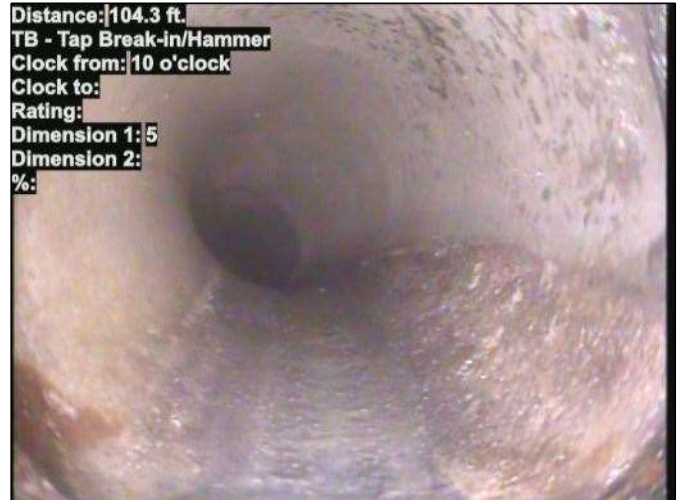
Photo: 15\_062-15\_081-20230804-122905\_1.JPG  
At: 104.3 ft. 10/. TB - Tap Break-in/Hammer  
Joint: No

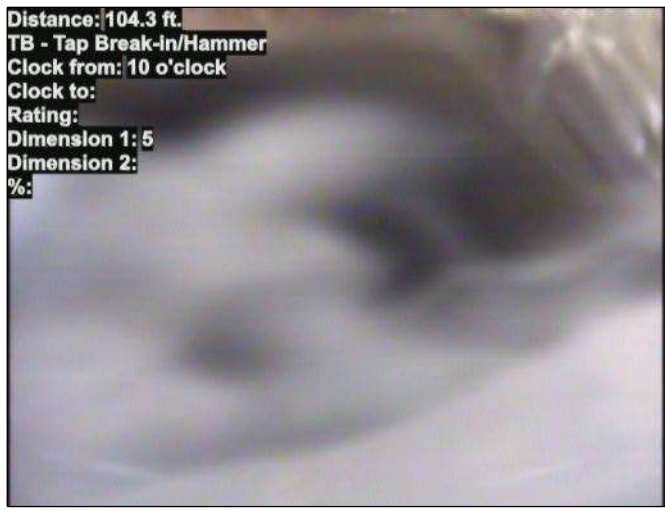
Distance: 104.3 ft.  
TB - Tap Break-in/Hammer  
Clock from: 10 o'clock  
Clock to:  
Rating:  
Dimension 1: 5  
Dimension 2:  
%:

Photo: 15\_062-15\_081-20230804-122905.JPG  
At: 104.3 ft. 10/. TB - Tap Break-in/Hammer  
Joint: No

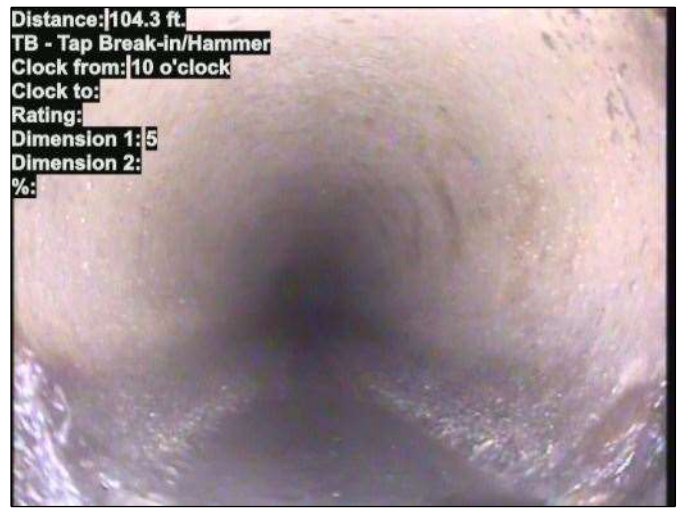
Distance: 104.3 ft.  
TB - Tap Break-in/Hammer  
Clock from: 10 o'clock  
Clock to:  
Rating:  
Dimension 1: 5  
Dimension 2:  
%:

Photo: 15\_062-15\_081-20230804-122810\_1.JPG  
At: 112.1 ft. 2/. TB - Tap Break-in/Hammer  
Joint: No

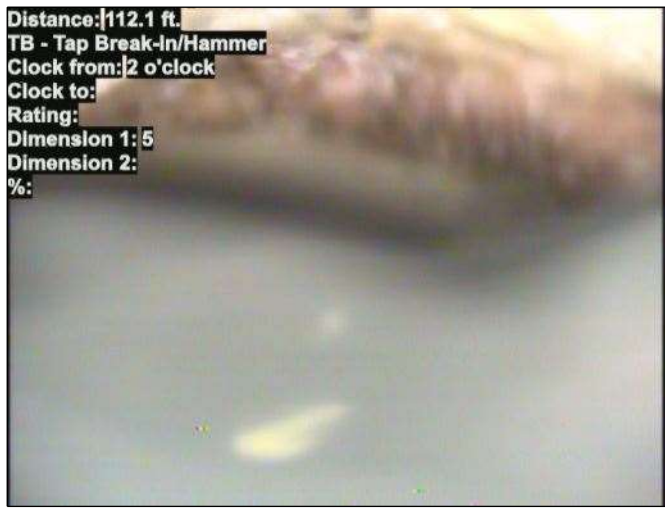
Distance: 112.1 ft.  
TB - Tap Break-in/Hammer  
Clock from: 2 o'clock  
Clock to:  
Rating:  
Dimension 1: 5  
Dimension 2:  
%:

Photo: 15\_062-15\_081-20230804-122810.JPG  
At: 112.1 ft. 2/. TB - Tap Break-in/Hammer  
Joint: No

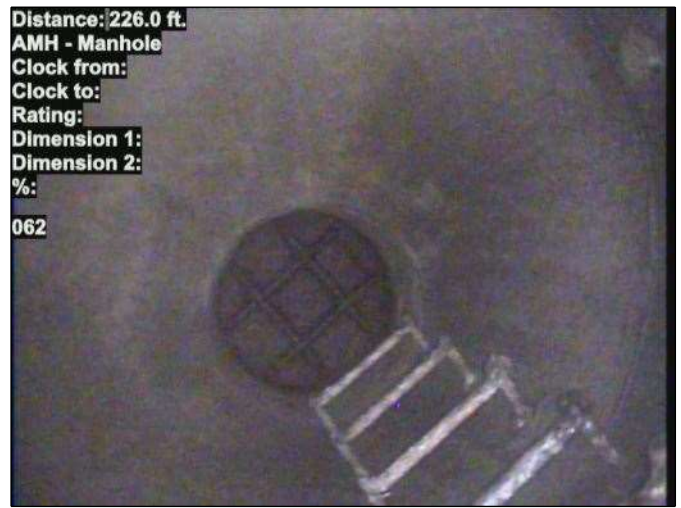
Distance: 226.0 ft.  
AMH - Manhole  
Clock from:  
Clock to:  
Rating:  
Dimension 1:  
Dimension 2:  
%:

Photo: 15\_062-15\_081-20230804-124947.JPG  
At: 226 ft. AMH - Manhole  
Joint: No 062

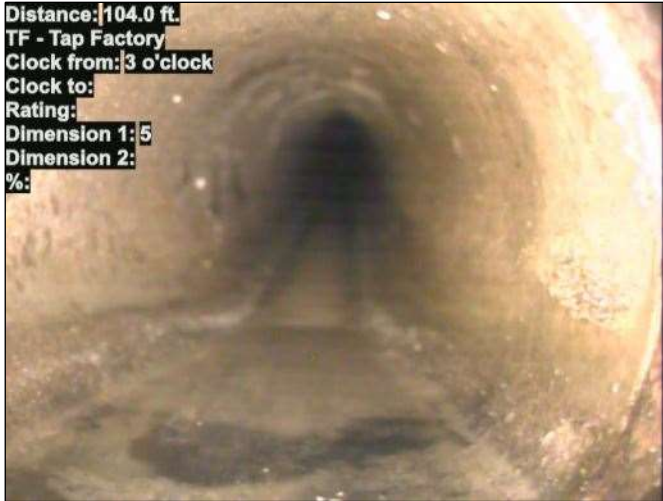
Photo: 15\_070-15\_071-20230726-081322.JPG  
At: 104 ft. 3/. TB - Tap Break-in/Hammer  
Joint: No

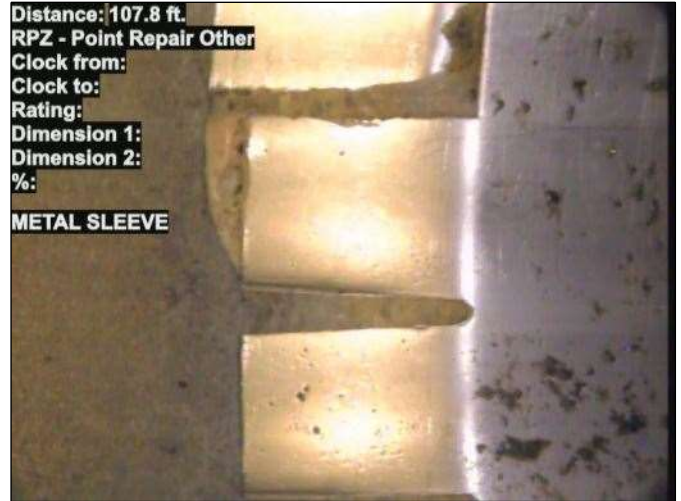
Photo: 15\_070-15\_071-20230726-081401.JPG  
At: 107.8 ft. RPZ - Point Repair Other  
Joint: No METAL SLEEVE

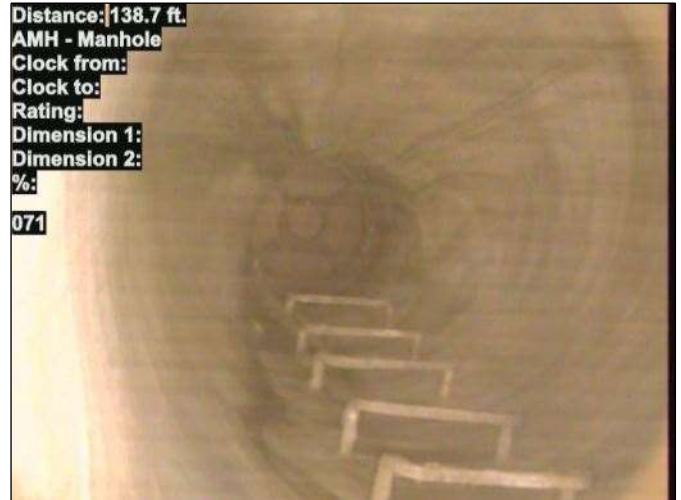
Photo: 15\_070-15\_071-20230726-081636.JPG  
At: 138.7 ft. AMH - Manhole  
Joint: No 071

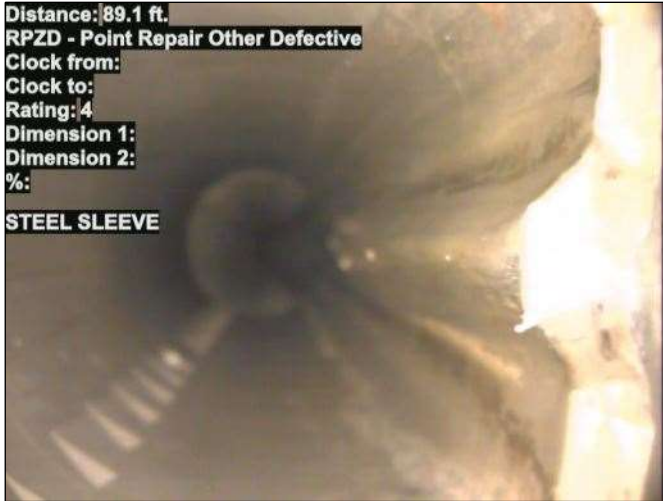
Photo: 15\_071-15\_072-20230726-082330\_1.JPG  
At: 89.1 ft. RPZD - Point Repair Other Defective  
Joint: No STEEL SLEEVE

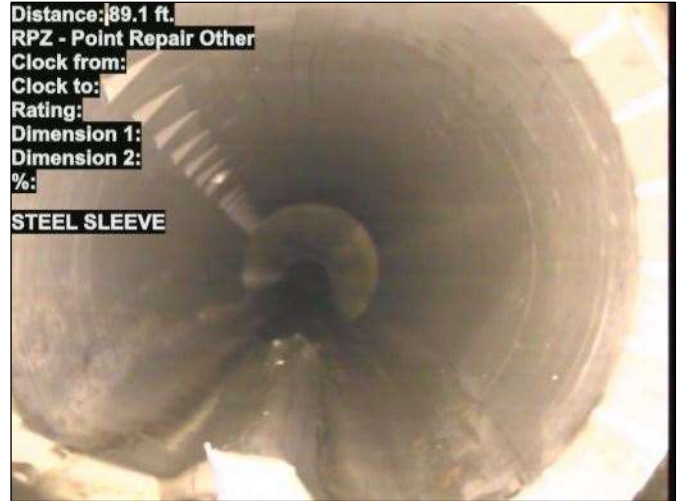
Photo: 15\_071-15\_072-20230726-082330.JPG  
At: 89.1 ft. RPZD - Point Repair Other Defective  
Joint: No STEEL SLEEVE

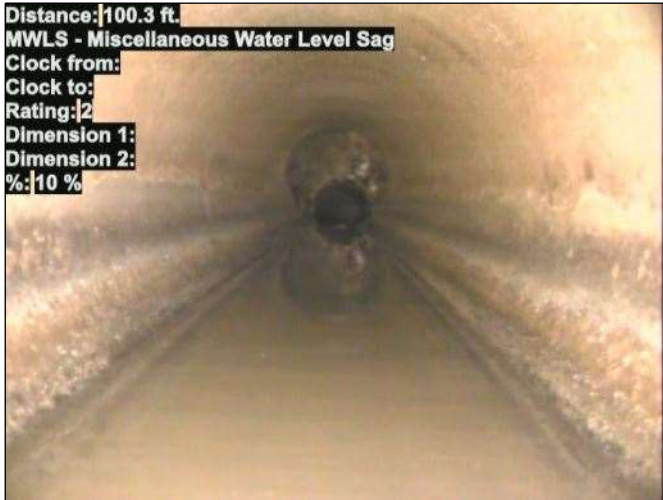
Photo: 15\_071-15\_072-20230726-082427.JPG  
At: 100.3 ft. MWLS - Miscellaneous Water Level Sag  
Joint: No 10 %

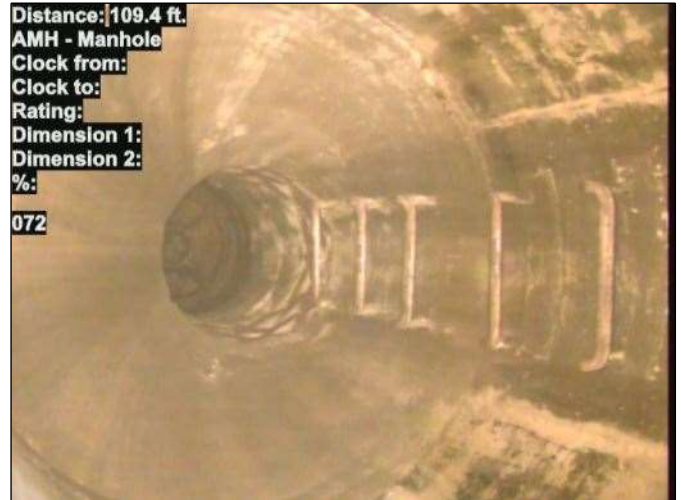
Photo: 15\_071-15\_072-20230726-082516.JPG  
At: 109.4 ft. AMH - Manhole  
Joint: No 072

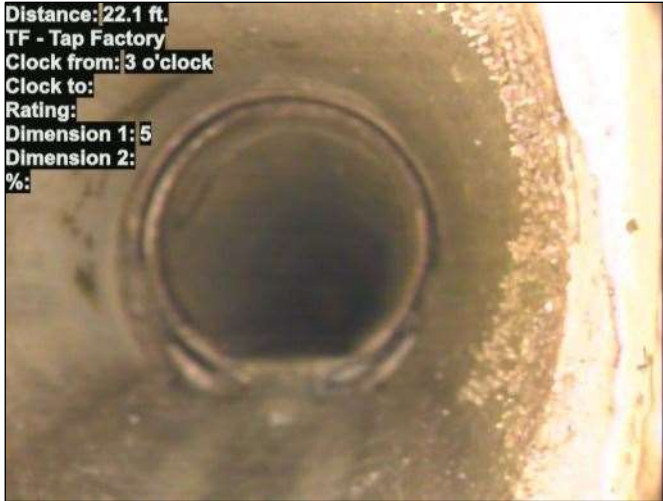
Distance: 22.1 ft.  
TF - Tap Factory  
Clock from: 3 o'clock  
Clock to:  
Rating:  
Dimension 1: 5  
Dimension 2:  
%:  
Photo: 15\_072-15\_074-20230726-082832.JPG  
At: 22.1 ft. 3/. TF - Tap Factory  
Joint: No

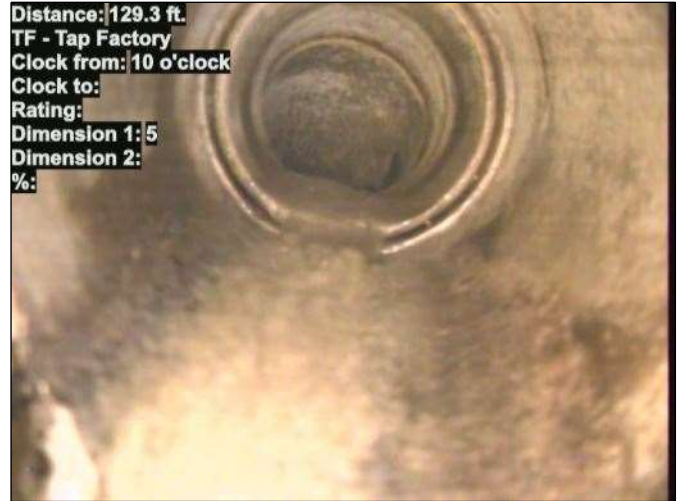
Distance: 129.3 ft.  
TF - Tap Factory  
Clock from: 10 o'clock  
Clock to:  
Rating:  
Dimension 1: 5  
Dimension 2:  
%:  
Photo: 15\_072-15\_074-20230726-083321.JPG  
At: 129.3 ft. 10/. TF - Tap Factory  
Joint: No

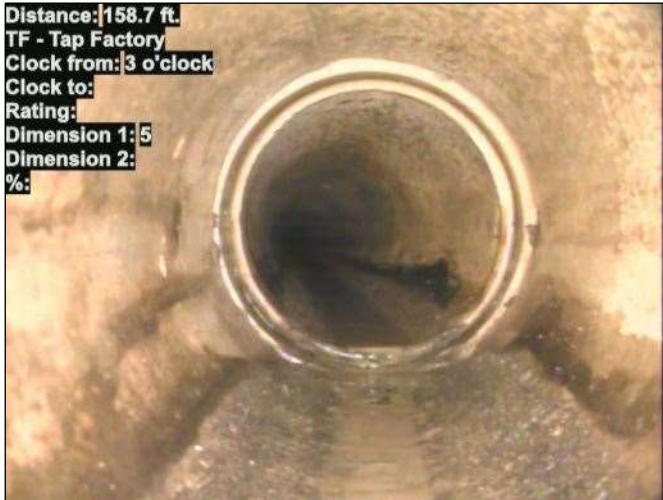
Distance: 158.7 ft.  
TF - Tap Factory  
Clock from: 3 o'clock  
Clock to:  
Rating:  
Dimension 1: 5  
Dimension 2:  
%:  
Photo: 15\_072-15\_074-20230726-083440.JPG  
At: 158.7 ft. 3/. TF - Tap Factory  
Joint: No

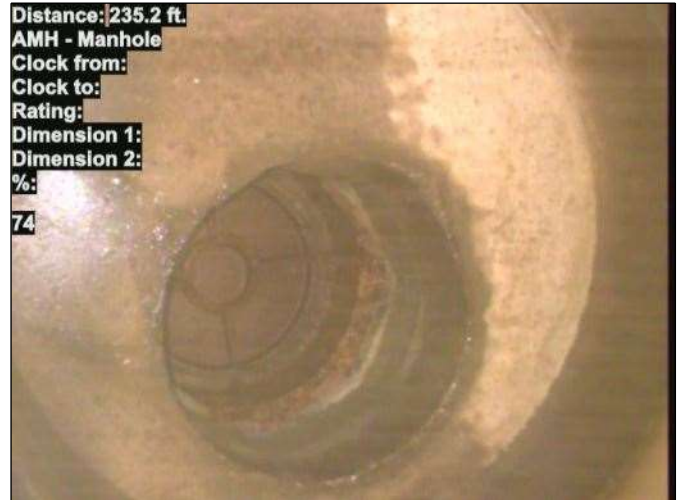
Distance: 235.2 ft.  
AMH - Manhole  
Clock from:  
Clock to:  
Rating:  
Dimension 1:  
Dimension 2:  
%:  
74  
Photo: 15\_072-15\_074-20230726-083726.JPG  
At: 235.2 ft. AMH - Manhole  
Joint: No 74

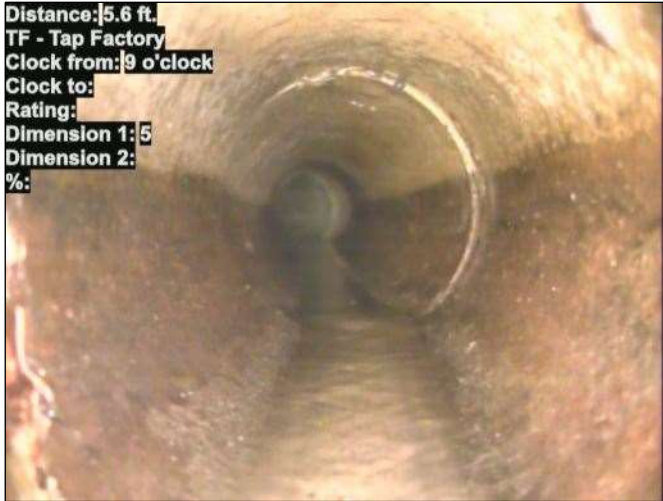
Photo: 15\_073-15\_072-20230726-073132.JPG  
At: 5.6 ft. 9/. TF - Tap Factory  
Joint: No

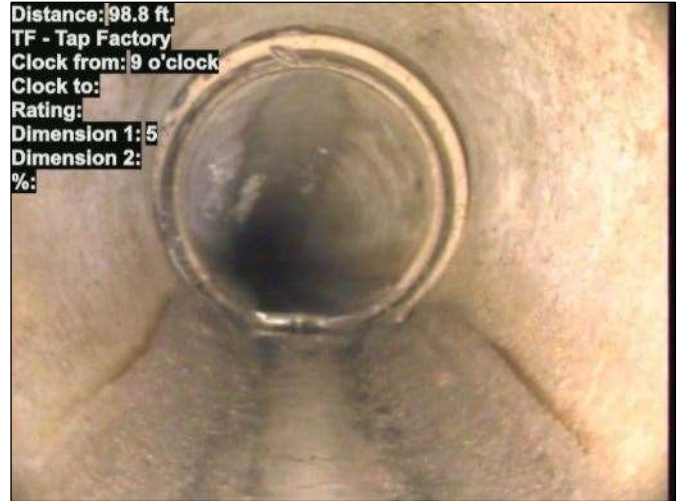
Photo: 15\_073-15\_072-20230726-073444.JPG  
At: 98.8 ft. 9/. TF - Tap Factory  
Joint: No

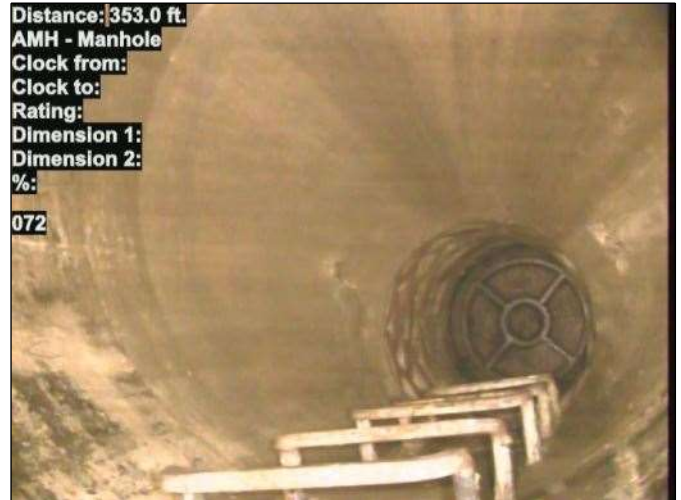
Photo: 15\_073-15\_072-20230726-074332.JPG  
At: 353 ft. AMH - Manhole  
Joint: No 072

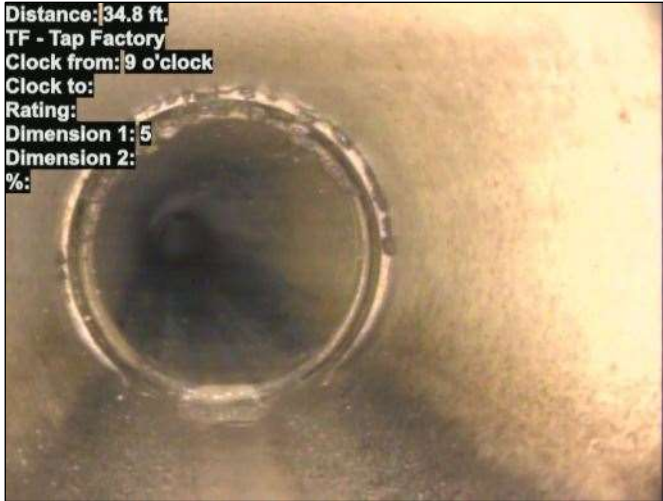
Photo: 15\_074-15\_075-20230726-084200.JPG  
At: 34.8 ft. 9/. TF - Tap Factory  
Joint: No

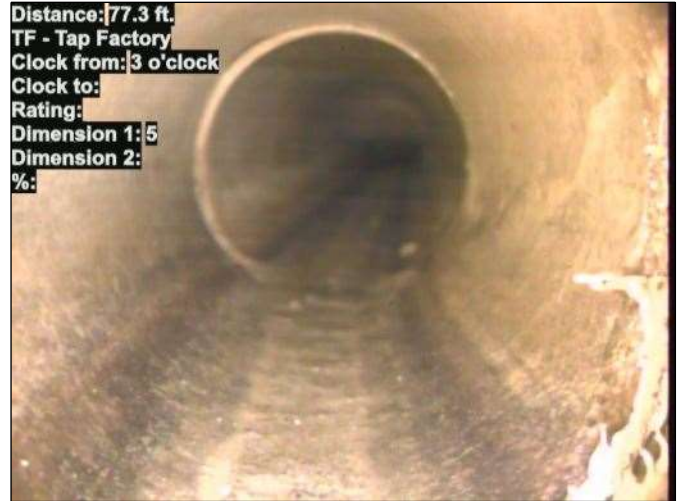
Photo: 15\_074-15\_075-20230726-084338.JPG  
At: 77.3 ft. 3/. TF - Tap Factory  
Joint: No

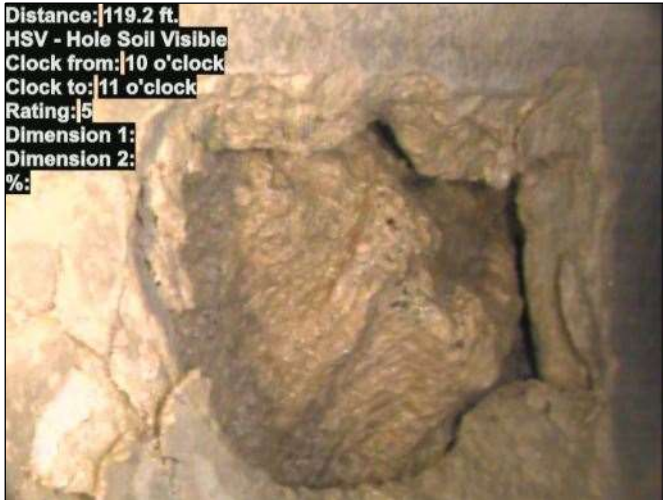
Photo: 15\_074-15\_075-20230726-084550.JPG  
At: 119.2 ft. HSV - Hole Soil Visible  
10/11  
Joint: No

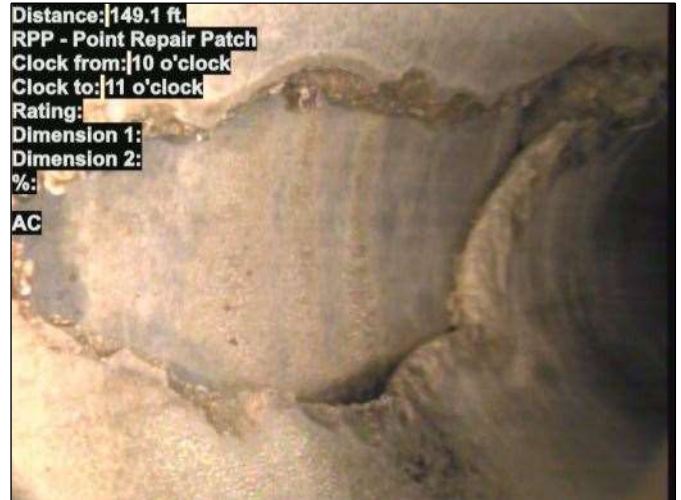
Photo: 15\_074-15\_075-20230726-084741.JPG  
At: 149.1 ft. RPP - Point Repair Patch  
10/11  
Joint: No AC

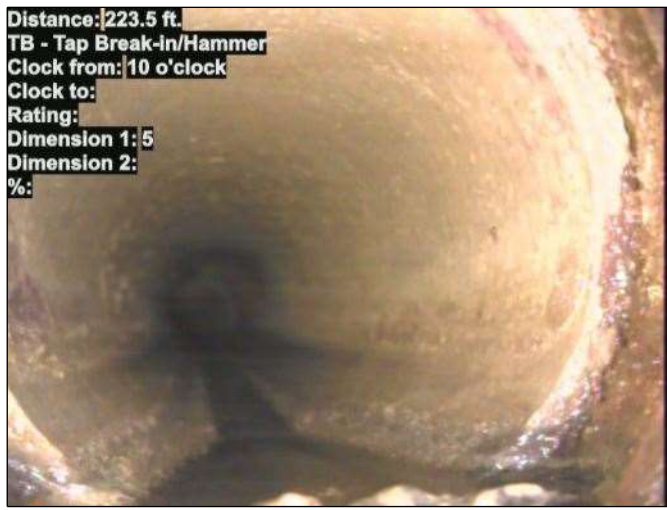
Distance: 223.5 ft.  
TB - Tap Break-in/Hammer  
Clock from: 10 o'clock  
Clock to:  
Rating:  
Dimension 1: 5  
Dimension 2:  
%:  
Photo: 15\_074-15\_075-20230726-085044.JPG  
At: 223.5 ft. 10/. TB - Tap Break-in/Hammer  
Joint: No

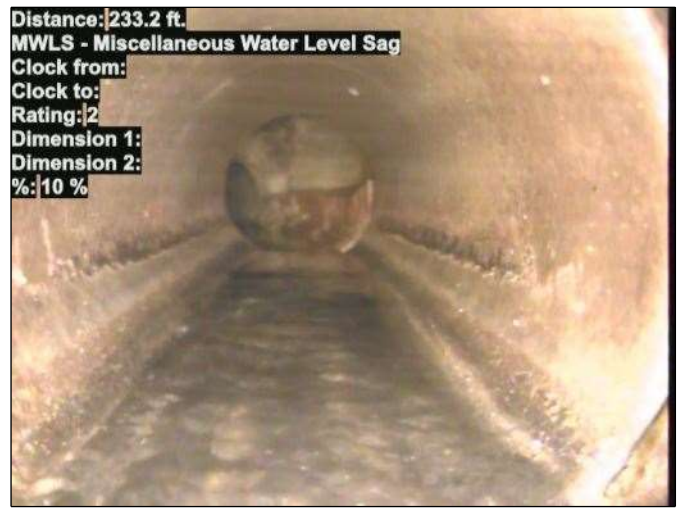
Distance: 233.2 ft.  
MWLS - Miscellaneous Water Level Sag  
Clock from:  
Clock to:  
Rating: 2  
Dimension 1:  
Dimension 2:  
%: 10 %  
Photo: 15\_074-15\_075-20230726-085126.JPG  
At: 233.2 ft. MWLS - Miscellaneous Water Level Sag  
Joint: No 10 %

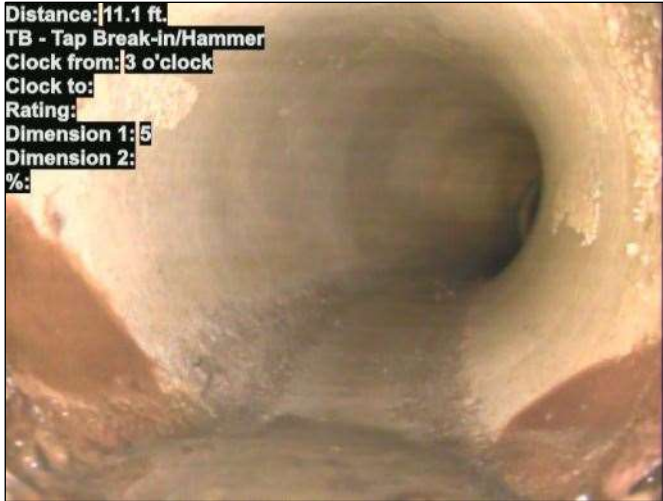
Photo: 15\_075-15\_076-20230726-085703.JPG  
At: 11.1 ft. 3/. TB - Tap Break-in/Hammer  
Joint: No

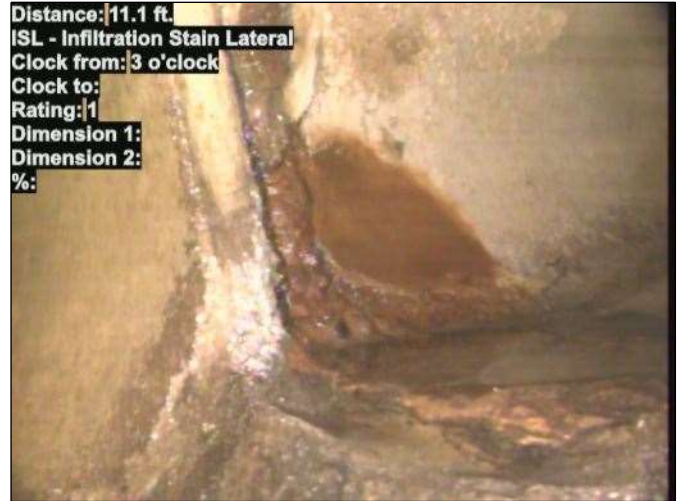
Photo: 15\_075-15\_076-20230726-085724.JPG  
At: 11.1 ft. 3/. ISL - Infiltration Stain Lateral  
Joint: No

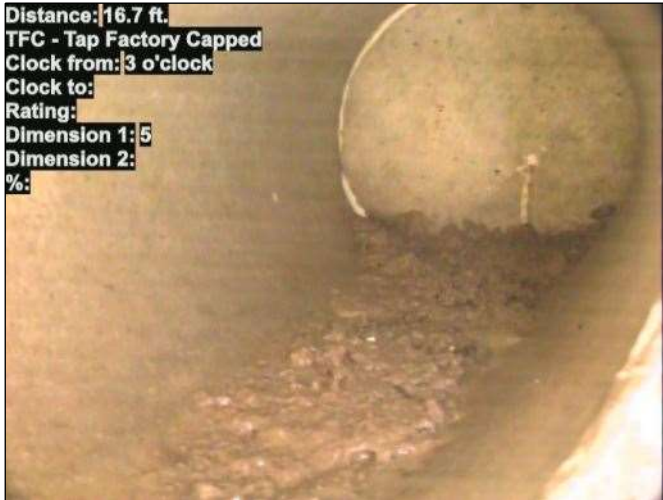
Photo: 15\_075-15\_076-20230726-085822.JPG  
At: 16.7 ft. 3/. TFC - Tap Factory Capped  
Joint: No

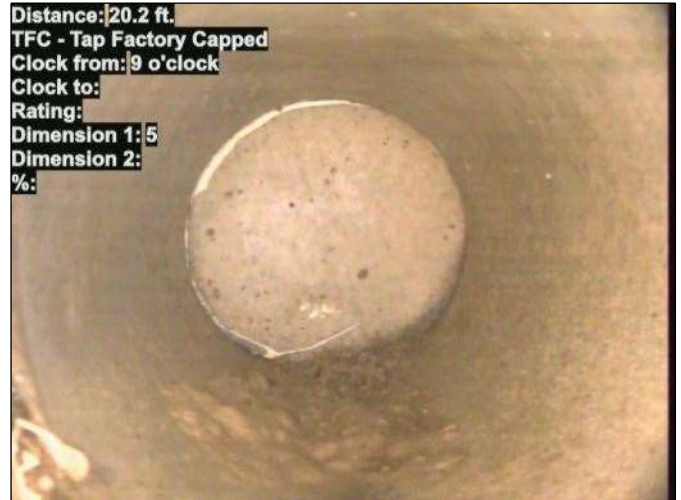
Photo: 15\_075-15\_076-20230726-085906.JPG  
At: 20.2 ft. 9/. TFC - Tap Factory Capped  
Joint: No

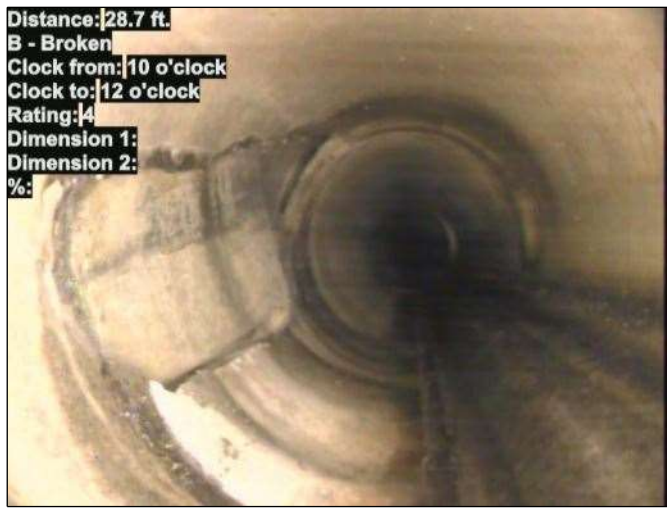
Distance: 28.7 ft.  
B - Broken  
Clock from: 10 o'clock  
Clock to: 12 o'clock  
Rating: 4  
Dimension 1:  
Dimension 2:  
%:

Photo: 15\_075-15\_076-20230726-090013.JPG

At: 28.7 ft. B - Broken  
10/12

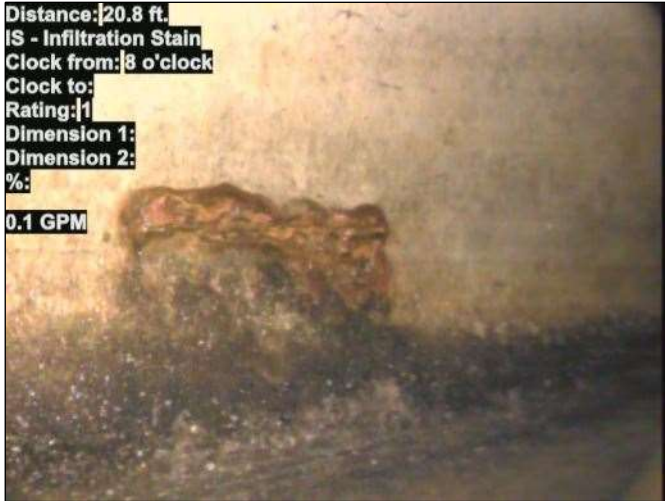
Photo: 15\_076-15\_077-20230726-091027.JPG  
At: 20.8 ft. 8/. IS - Infiltration Stain  
Joint: No 0.1 GPM

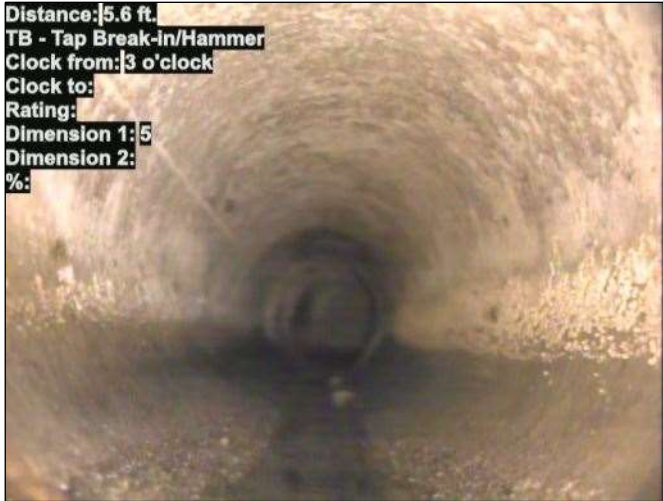
Photo: 15\_077-15\_078-20230801-071416.JPG  
At: 5.6 ft. 3/. TB - Tap Break-in/Hammer  
Joint: No

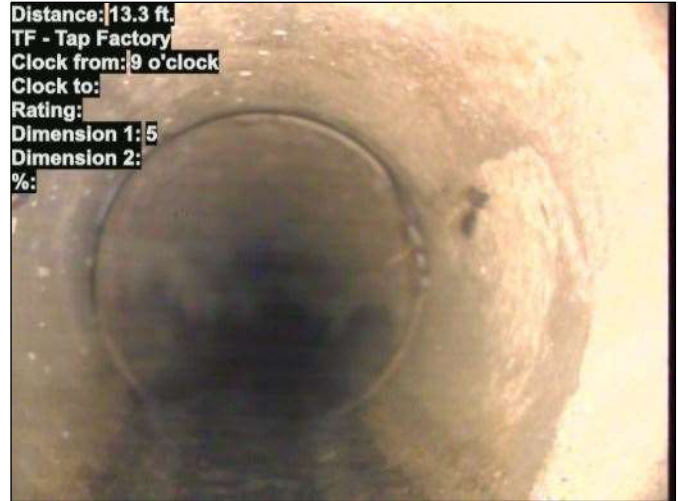
Photo: 15\_077-15\_078-20230801-071451.JPG  
At: 13.3 ft. 9/. TF - Tap Factory  
Joint: No

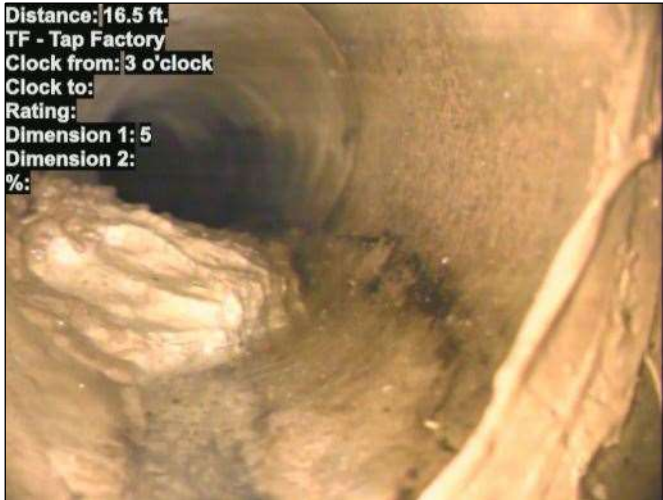
Photo: 15\_077-15\_078-20230801-071511.JPG  
At: 16.5 ft. 3/. TF - Tap Factory  
Joint: No

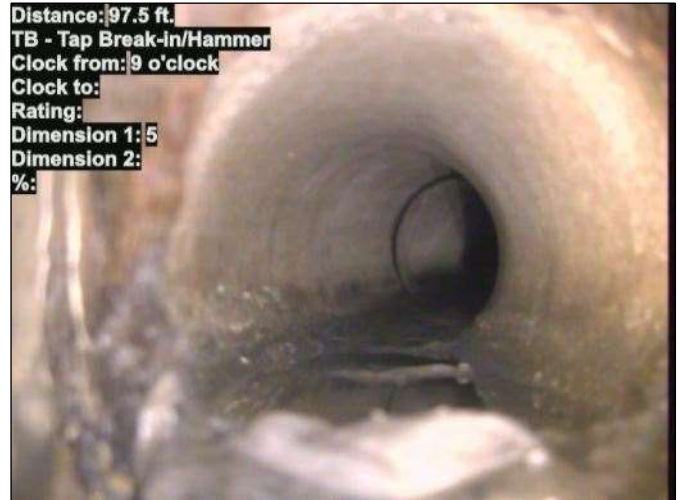
Photo: 15\_077-15\_078-20230801-071731.JPG  
At: 97.5 ft. 9/. TB - Tap Break-in/Hammer  
Joint: No
