**APPENDIX C**  
CCTV Reports

## NWMCC INSPECTION REPORT

Start date/time: <b>20230725 12:13</b>	Weather: <b>Dry - No precipitation during survey</b>	Surveyed by: <b>C.Arruda</b>	Certificate number: <b>U-910-11364</b>	Pipe segment ref.: <b>15/002 - 15/001</b>	
Owner:	Customer:	Pre-cleaning: <b>Light Cleaning</b>	Date cleaned: <b>20230725</b>	Project name: <b>ENV017-13</b>	
City: <b>WESTWOOD MA</b>	Street: <b>NAHATAN ST</b>	Location code:	Pipe use: <b>Sanitary Sewage Pipe</b>	Drainage area: 	Flow control: 
Upstream MH No: <b>15/001</b>	Downstream MH No: <b>15/002</b>	Direction: <b>U</b>	Total length: <b>304.300 ft.</b>	Length surveyed: <b>304.300 ft.</b>	
Purpose: <b>Maintenance Related</b>	Pipe joint length: 	Height: <b>8 in.</b>	Material: <b>Asbestos Cement</b>	LateralsCounter: 	Additional info:

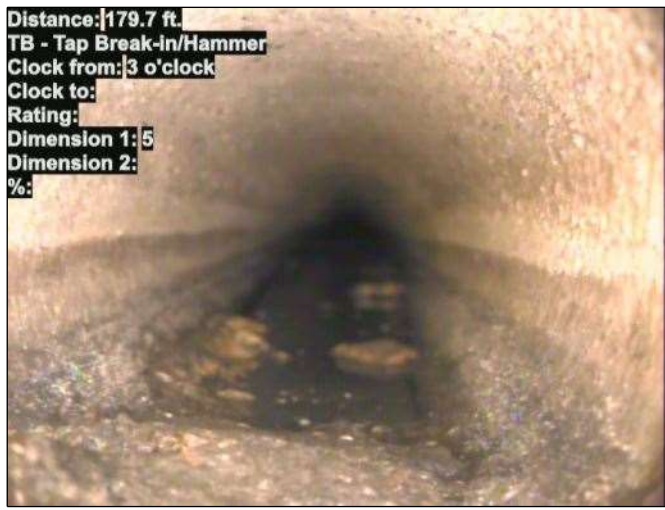
Distance: 179.7 ft.  
TB - Tap Break-in/Hammer  
Clock from: 3 o'clock  
Clock to:  
Rating:  
Dimension 1: 5  
Dimension 2:  
%:

Photo: 15\_077-15\_078-20230801-072022.JPG  
At: 179.7 ft. 3/. TB - Tap Break-in/Hammer  
Joint: No

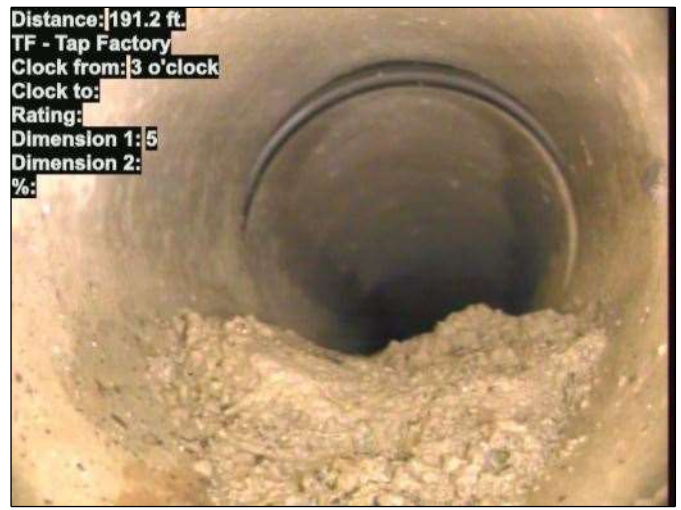
Distance: 191.2 ft.  
TF - Tap Factory  
Clock from: 3 o'clock  
Clock to:  
Rating:  
Dimension 1: 5  
Dimension 2:  
%:

Photo: 15\_077-15\_078-20230801-072059.JPG  
At: 191.2 ft. 3/. TF - Tap Factory  
Joint: No

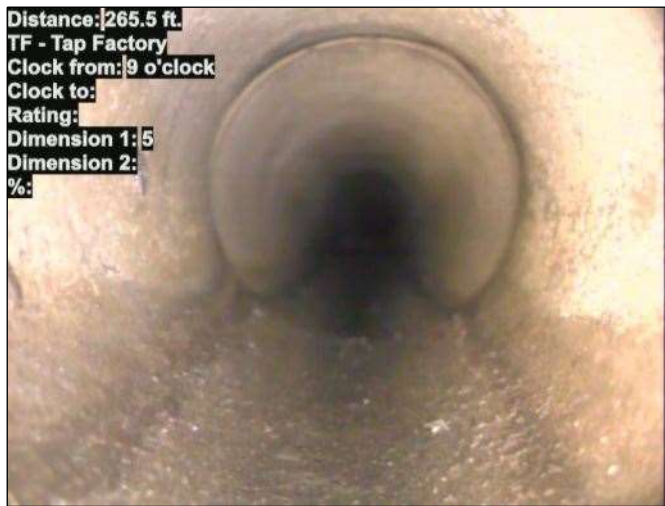
Distance: 265.5 ft.  
TF - Tap Factory  
Clock from: 9 o'clock  
Clock to:  
Rating:  
Dimension 1: 5  
Dimension 2:  
%:

Photo: 15\_077-15\_078-20230801-072316.JPG  
At: 265.5 ft. 9/. TF - Tap Factory  
Joint: No

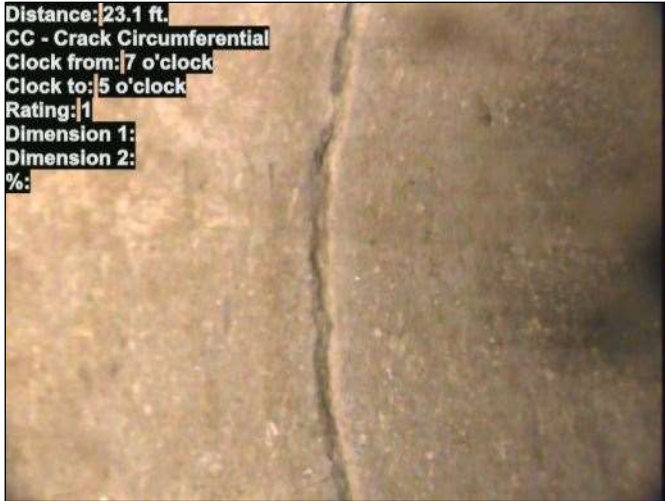
Photo: 15\_078-15\_061-20230801-082048.JPG  
At: 23.1 ft. 7/5 CC - Crack Circumferential  
Joint: No

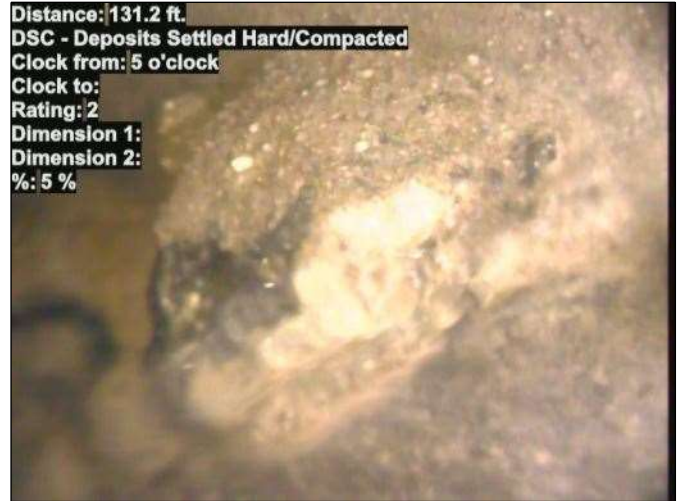
Photo: 15\_078-15\_061-20230801-082338.JPG  
At: 131.2 ft. 5/. DSC - Deposits Settled Hard/Compacted  
Joint: No 5 %

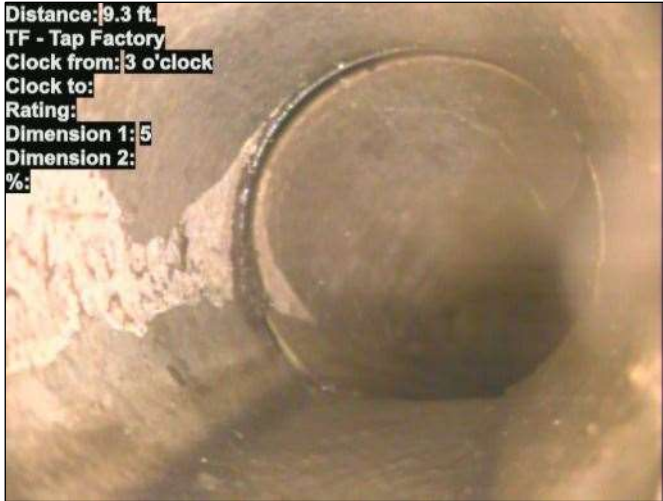
Photo: 15\_079-15\_078-20230801-081157.JPG  
At: 9.3 ft. 3/. TF - Tap Factory  
Joint: No

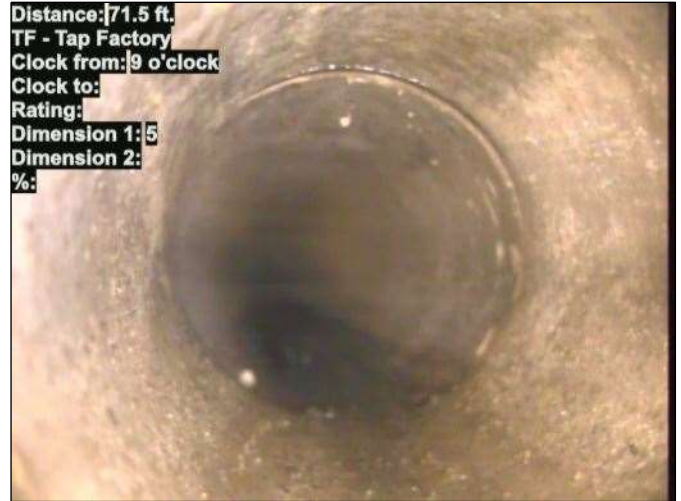
Photo: 15\_079-15\_078-20230801-081627.JPG  
At: 71.5 ft. 9/. TF - Tap Factory  
Joint: No

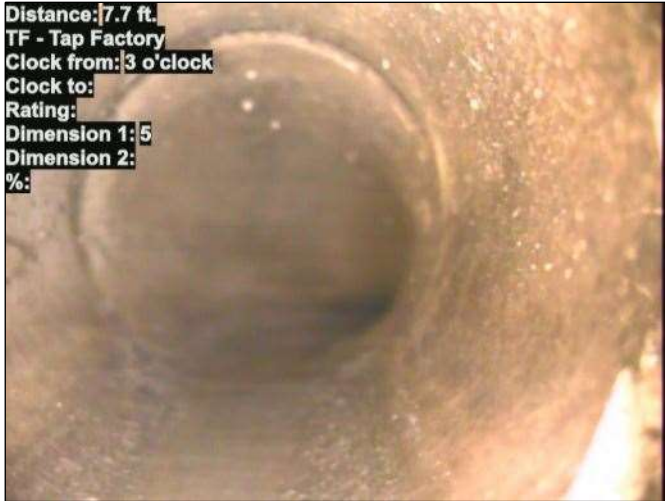
Photo: 15\_080-15\_079-20230801-080437.JPG  
At: 7.7 ft. 3/. TF - Tap Factory  
Joint: No

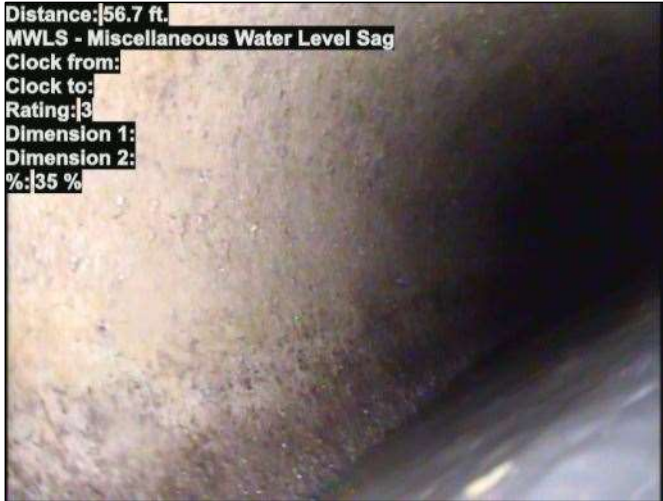
Distance: 56.7 ft.  
MWLS - Miscellaneous Water Level Sag  
Clock from:  
Clock to:  
Rating: 3  
Dimension 1:  
Dimension 2:  
%: 35 %  
Photo: 15\_092-15\_062-20230804-111229.JPG  
At: 56.7 ft. MWLS - Miscellaneous Water Level Sag  
Joint: No 35 %

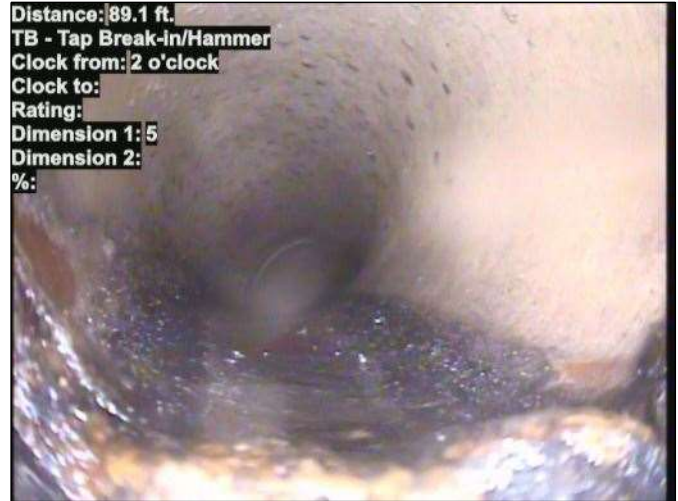
Distance: 89.1 ft.  
TB - Tap Break-in/Hammer  
Clock from: 2 o'clock  
Clock to:  
Rating:  
Dimension 1: 5  
Dimension 2:  
%:  
Photo: 15\_092-15\_062-20230804-112433.JPG  
At: 89.1 ft. 2/. TB - Tap Break-in/Hammer  
Joint: No

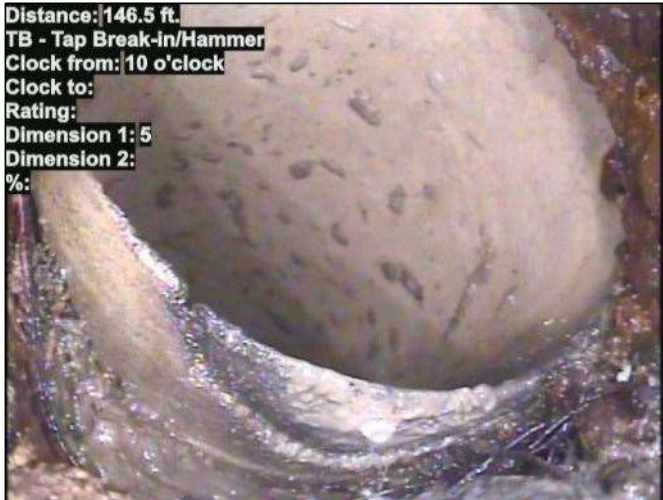
Distance: 146.5 ft.  
TB - Tap Break-in/Hammer  
Clock from: 10 o'clock  
Clock to:  
Rating:  
Dimension 1: 5  
Dimension 2:  
%:  
Photo: 15\_092-15\_062-20230804-112952.JPG  
At: 146.5 ft. 10/. TB - Tap Break-in/Hammer  
Joint: No

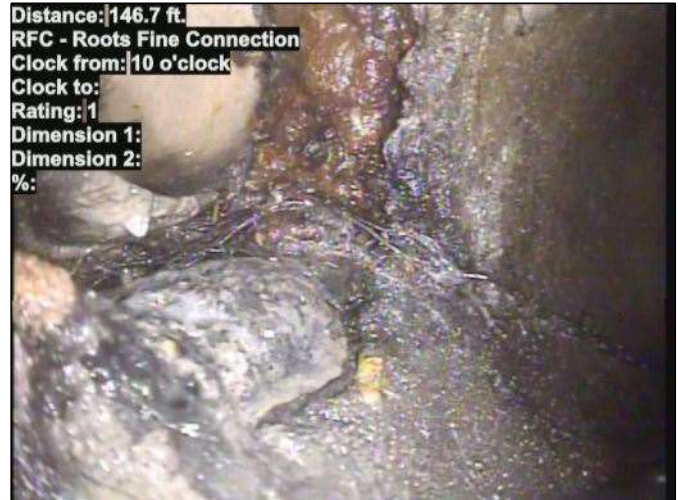
Distance: 146.7 ft.  
RFC - Roots Fine Connection  
Clock from: 10 o'clock  
Clock to:  
Rating: 1  
Dimension 1:  
Dimension 2:  
%:  
Photo: 15\_092-15\_062-20230804-112815.JPG  
At: 146.7 ft. 10/. RFC - Roots Fine Connection  
Joint: No

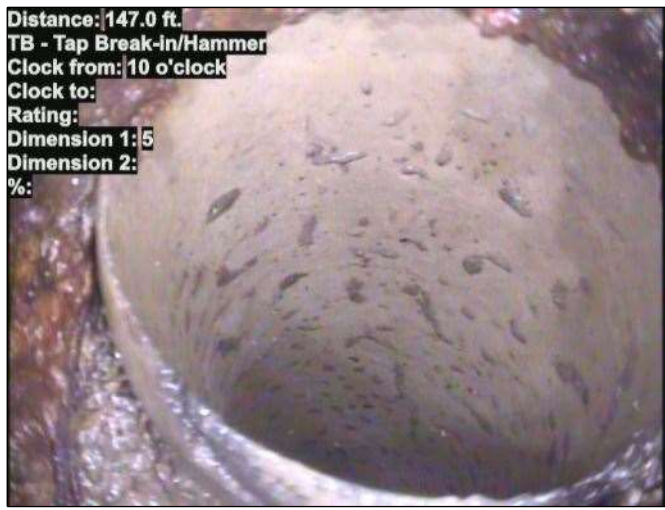
Distance: 147.0 ft.  
TB - Tap Break-in/Hammer  
Clock from: 10 o'clock  
Clock to:  
Rating:  
Dimension 1: 5  
Dimension 2:  
%:

Photo: 15\_092-15\_062-20230804-112744.JPG  
At: 147 ft. 10/. TB - Tap Break-in/Hammer  
Joint: No

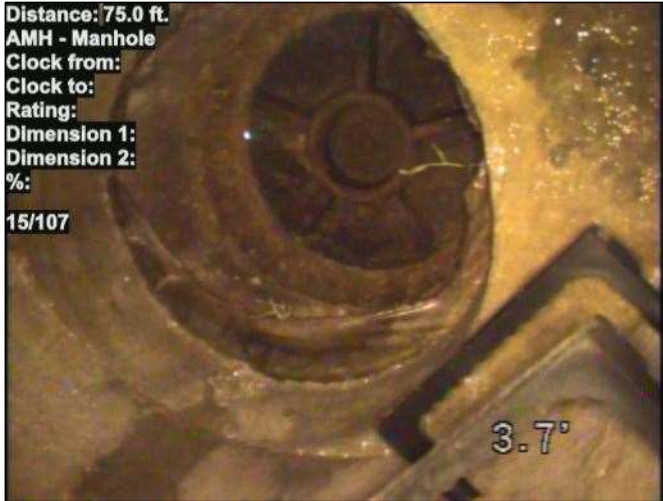
Photo: 15\_107-15\_110-20230807-101503.JPG  
At: 75 ft. AMH - Manhole  
Joint: No 15/107

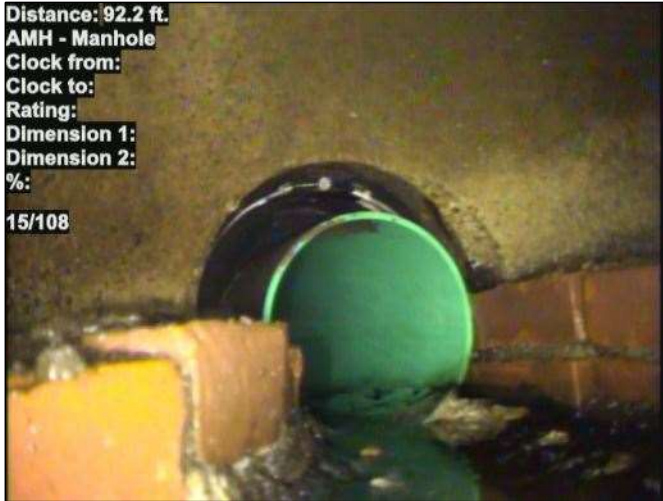
Photo: 15\_109-15\_108-20230807-082740.JPG

At: 92.2 ft. AMH - Manhole

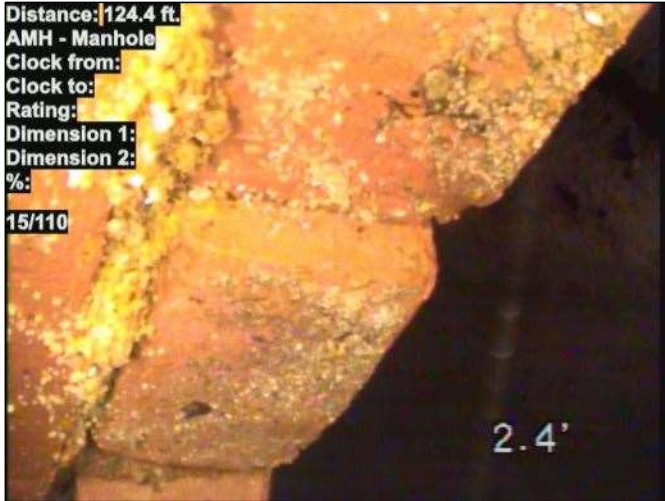
Photo: 15\_110-15\_111-20230807-100900.JPG

At: 124.4 ft. AMH - Manhole

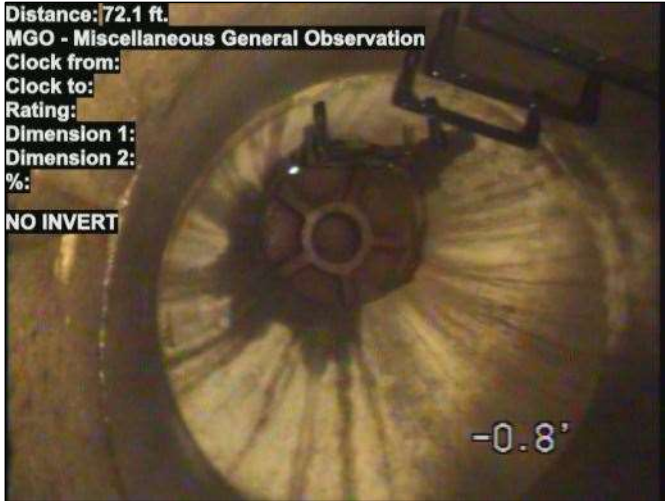
Photo: 15\_111-15\_112-20230807-102844.JPG  
At: 71 ft. MGO - Miscellaneous General Observation  
Joint: No NO INVERT

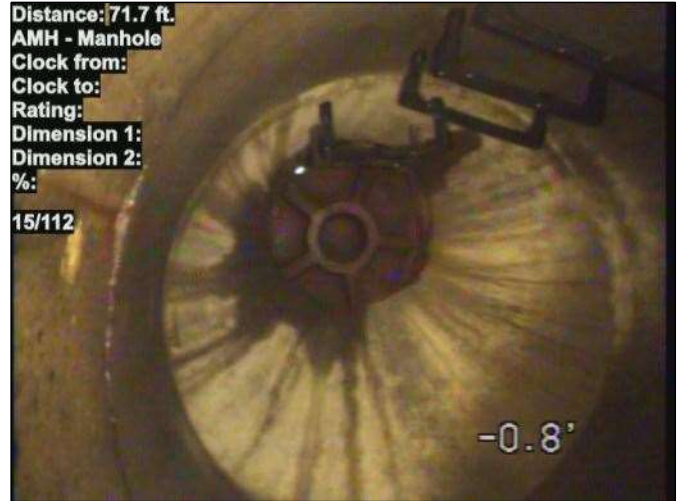
Photo: 15\_111-15\_112-20230807-102505.JPG  
At: 71.7 ft. AMH - Manhole  
Joint: No 15/112

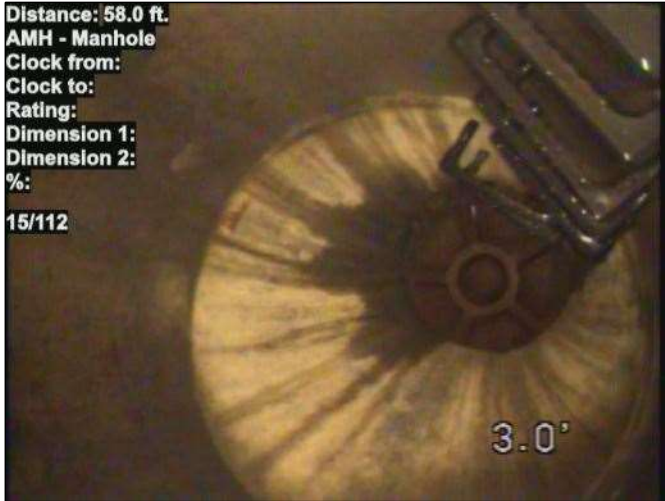
Photo: 15\_112-15\_005-20230807-104202.JPG  
At: 58 ft. AMH - Manhole  
Joint: No 15/112

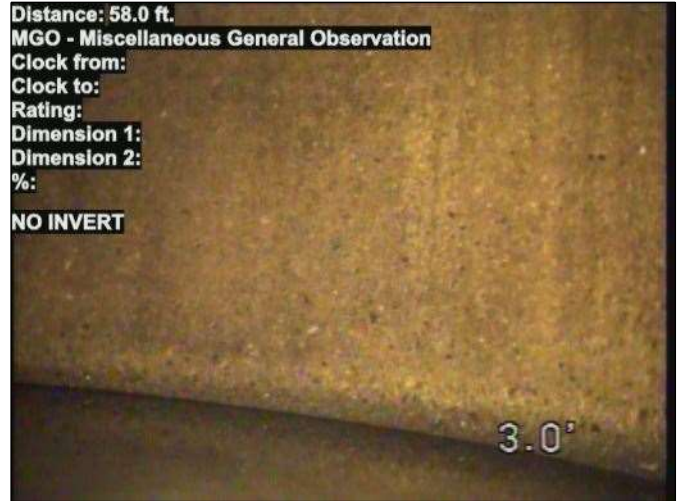
Photo: 15\_112-15\_005-20230807-104232.JPG  
At: 58 ft. MGO - Miscellaneous General Observation  
Joint: No NO INVERT

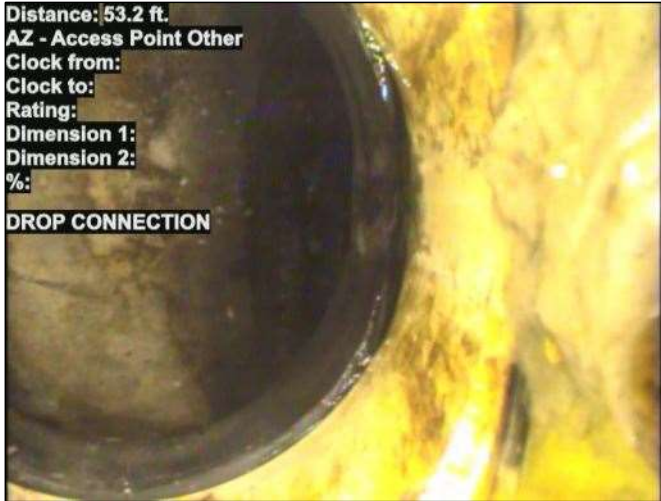
Photo: 15\_113-UNKOWN-20230807-124708.JPG  
At: 53.2 ft. AZ - Access Point Other  
Joint: No DROP CONNECTION

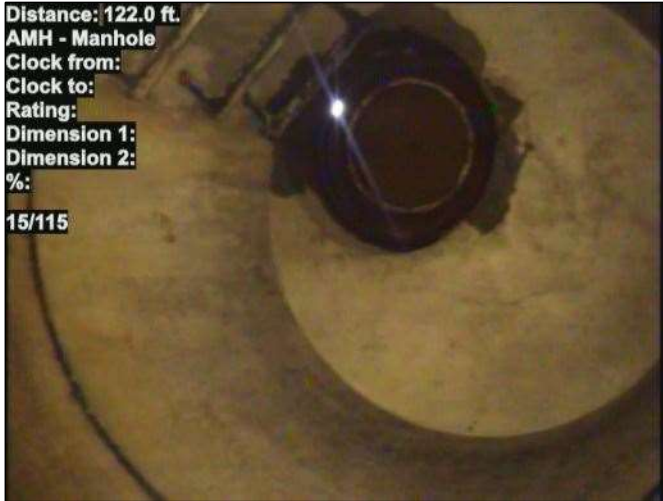
Distance: 122.0 ft.  
AMH - Manhole  
Clock from:  
Clock to:  
Rating:  
Dimension 1:  
Dimension 2:  
%:  
15/115

Photo: 15\_114-15\_115-20230807-130621.JPG  
At: 122 ft. AMH - Manhole  
Joint: No 15/115

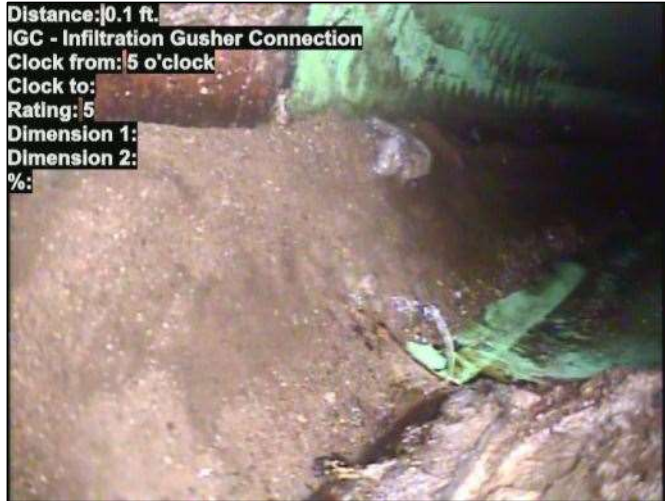
Photo: 15\_115-15\_003-20230804-132528.JPG  
At: 0.1 ft. 5/. IGC - Infiltration Gusher Connection  
Joint: No

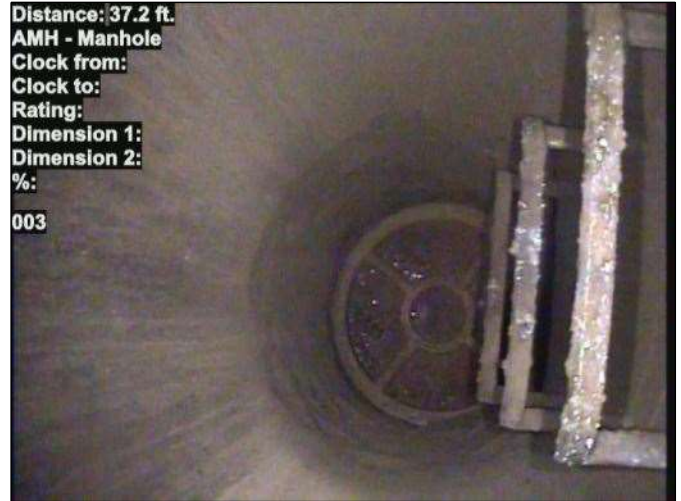
Photo: 15\_115-15\_003-20230804-132429.JPG  
At: 37.2 ft. AMH - Manhole  
Joint: No 003

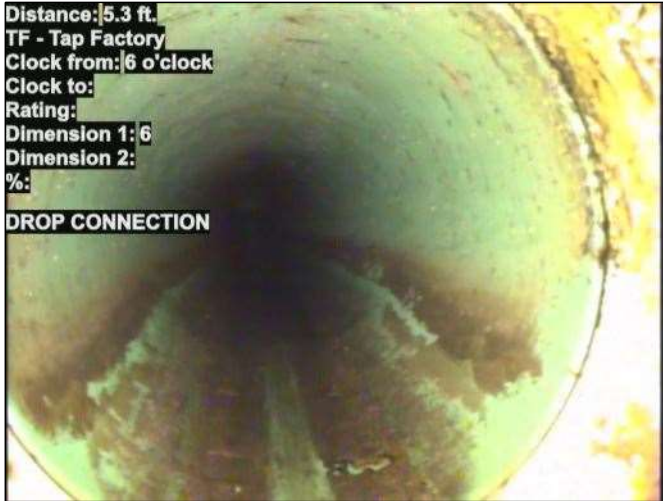
Photo: CLEANOUT-15\_108-20230807-093006.JPG  
At: 5.3 ft. 6/. TF - Tap Factory  
Joint: No DROP CONNECTION

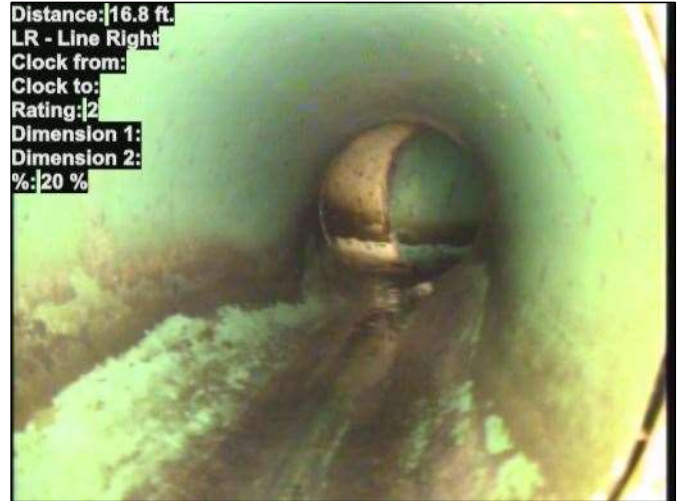
Photo: CLEANOUT-15\_108-20230807-093253.JPG  
At: 16.8 ft. LR - Line Right  
Joint: No 20 %

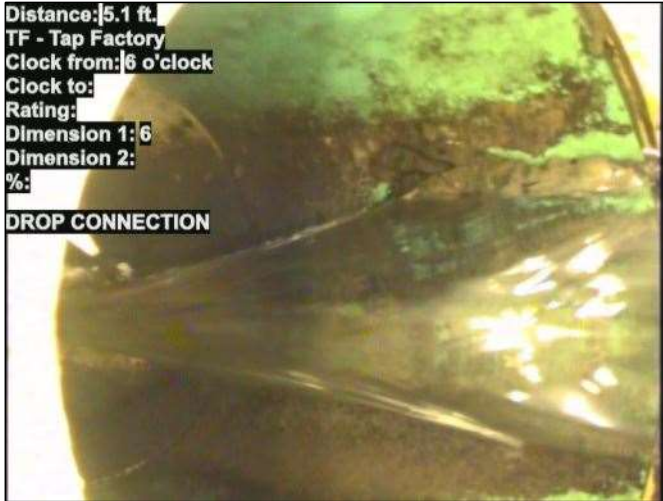
Photo: CLEANOUT-15\_109-20230807-085936.JPG  
At: 5.1 ft. 6/. TF - Tap Factory  
Joint: No DROP CONNECTION

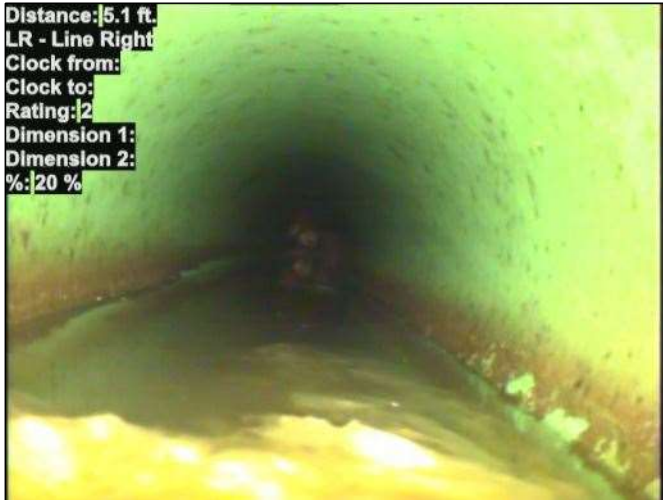
Photo: CLEANOUT-15\_109-20230807-090026.JPG  
At: 5.1 ft. LR - Line Right  
Joint: No 20 %

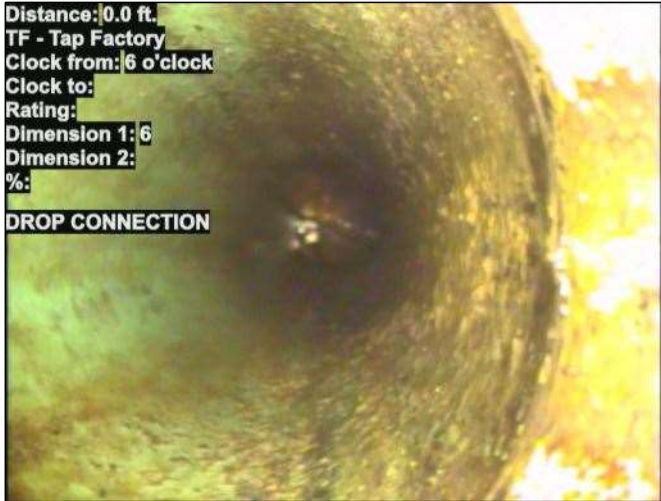
Photo: CLEANOUT-15\_111-20230807-094521.JPG  
At: 0 ft. 6/. TF - Tap Factory  
Joint: No DROP CONNECTION

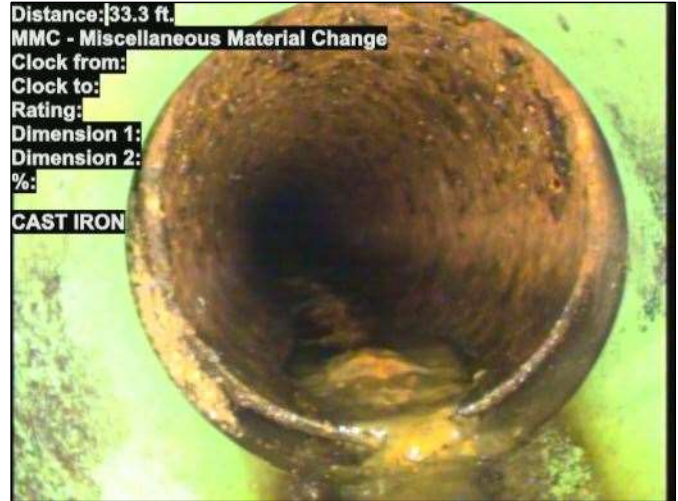
Photo: CLEANOUT-15\_111-20230807-094759.JPG  
At: 33.3 ft. MMC - Miscellaneous Material Change  
Joint: No CAST IRON

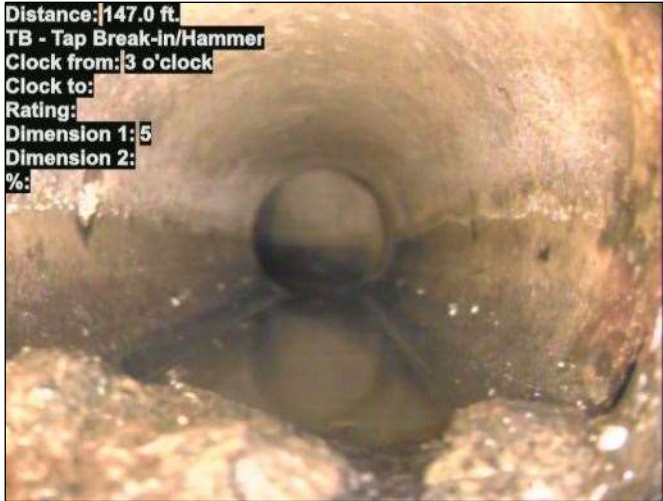
Photo: STUB-15\_012-20230726-113650.JPG  
At: 147 ft. 3/. TB - Tap Break-in/Hammer  
Joint: No

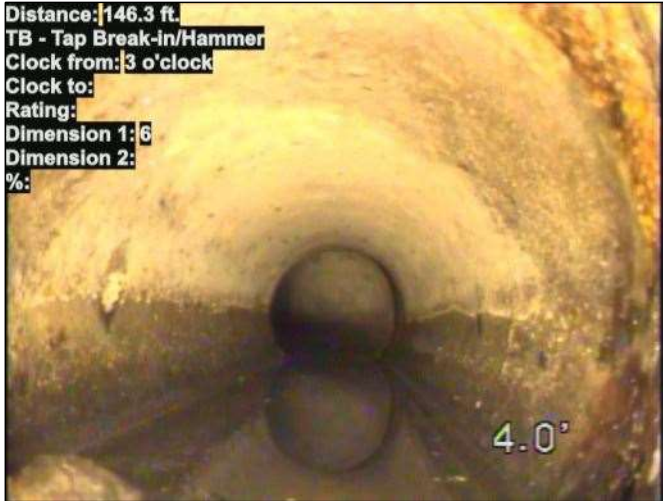
Photo: STUB-15\_012-20230807-120402.JPG  
At: 146.3 ft. 3/. TB - Tap Break-in/Hammer  
Joint: No

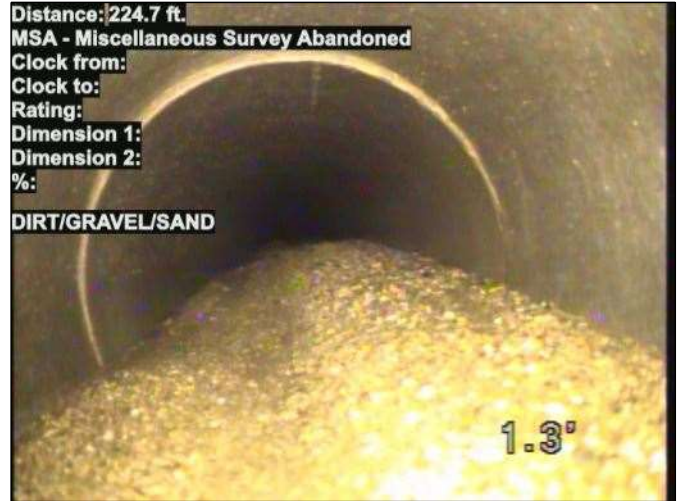
Photo: STUB-15\_012-20230807-122406.JPG  
At: 224.7 ft. MSA - Miscellaneous Survey Abandoned  
Joint: No DIRT/GRAVEL/SAND

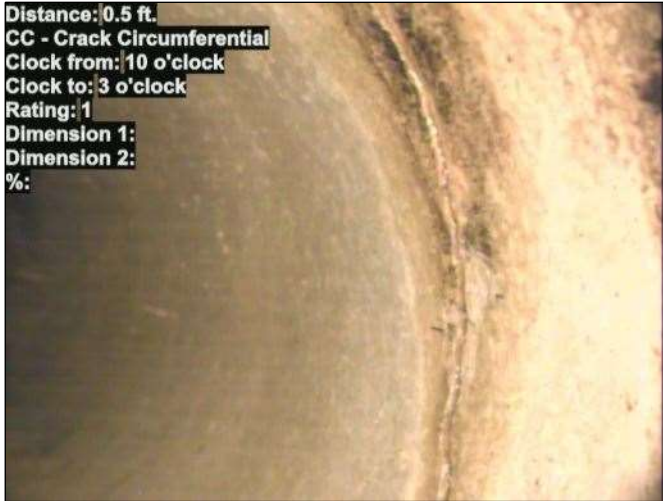
Photo: STUB-15\_013-20230725-130325.JPG  
At: 0.5 ft. 10/3 CC - Crack Circumferential  
Joint: Yes

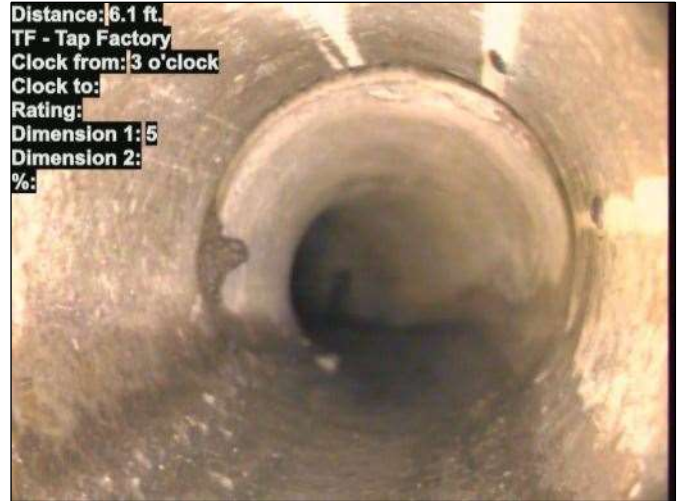
Photo: STUB-15\_013-20230725-130206.JPG  
At: 6.1 ft. 3/. TF - Tap Factory  
Joint: No

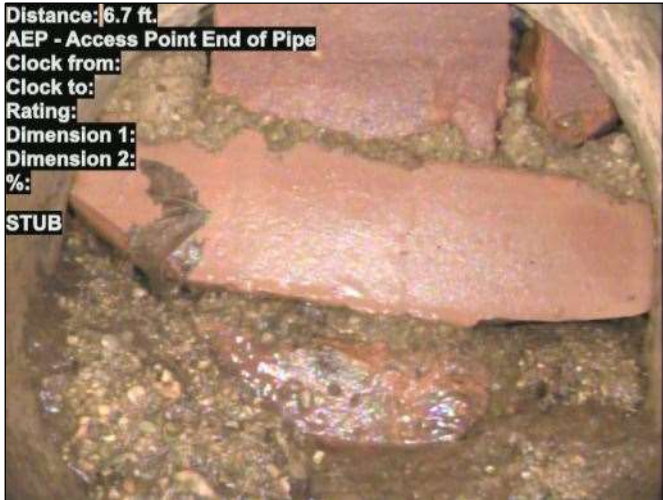
Photo: STUB-15\_013-20230725-130223.JPG  
At: 6.7 ft. AEP - Access Point End of Pipe  
Joint: No STUB

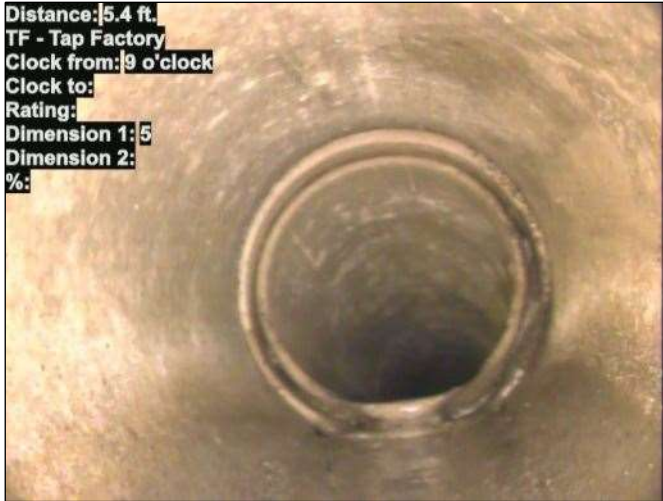
Photo: STUB-15\_070-20230726-094356.JPG  
At: 5.4 ft. 9/. TF - Tap Factory  
Joint: No

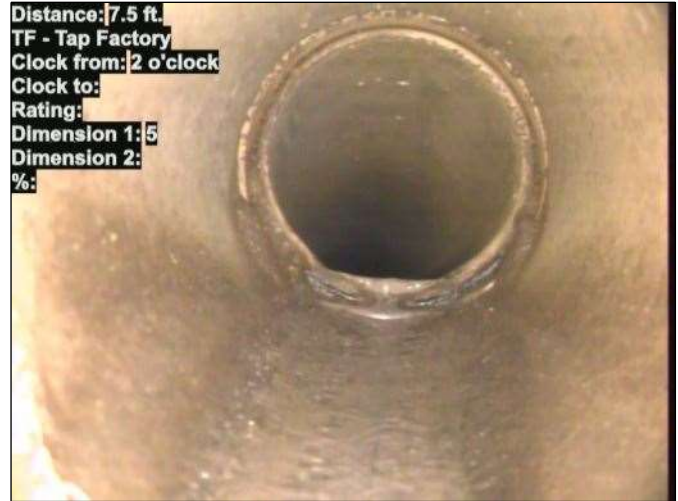
Photo: STUB-15\_070-20230726-094417.JPG  
At: 7.5 ft. 2/. TF - Tap Factory  
Joint: No

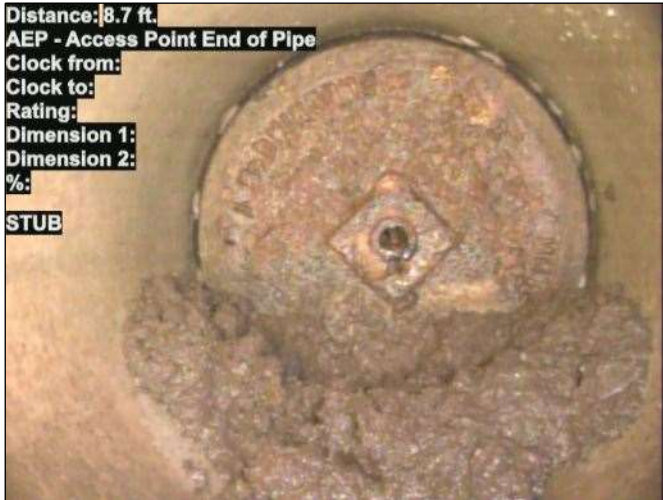
Photo: STUB-15\_070-20230726-094435.JPG  
At: 8.7 ft. AEP - Access Point End of Pipe  
Joint: No STUB
