Deerfield School Softball and Soccer Fields

Town of Westwood ADA Transition Plan

July 2023

Institute for Human Centered Design

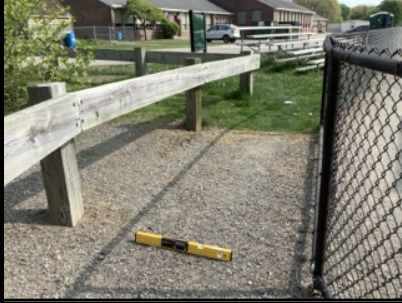
ID	Location	Floor	Room	Element	Type	Photo	Issues	Current Measure	Recommendations	Quantity	Price	Cost Estimation
<div style="border: 1px solid black; padding: 2px;">Approach and Entrance</div>												
<div style="border: 1px solid black; padding: 2px;">Exterior Access Route</div>												
1	Next to North Softball Field	Ext.		Exterior Access Route	Exterior

Cross slope > 1:50 (2.00%)	9.3%	Reduce the cross slope to be no steeper than 1:50 (2.00%). (Cost estimate provided for a 5' wide by 29' long asphalt route.)	1	1450	\$1450
											1450	
2	Route to North Softball Field	Ext.		Exterior Access Route	N/A

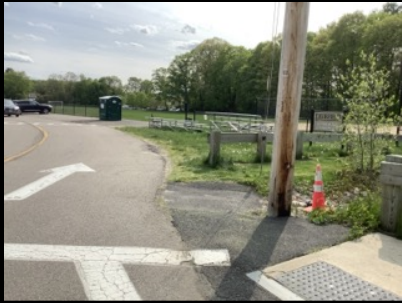
Accessible route not provided	-	Ensure an accessible route is provided to the fields from this sidewalk.	1	-	-
<div style="border: 1px solid black; padding: 2px;">Off-Street Parking Lot or Garage</div>												
3	West Parking Lot	Ext.		Off-Street Parking Lot or Garage	Visitor

Accessibility issues include routes with excessive cross slopes and lack of an accessible route to the north baseball field from the sidewalk and crosswalk.

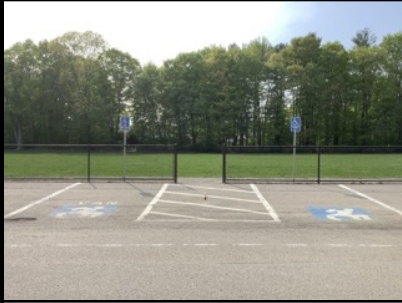
Total # of parking Total # of designated car accessible parking spaces Total # of designated van accessible spaces Running slope at access aisle > 1:50 (2.00%)	39 1 1 6%	Reduce running slope to be no steeper than 1:50 (2.00%).	2	-	-

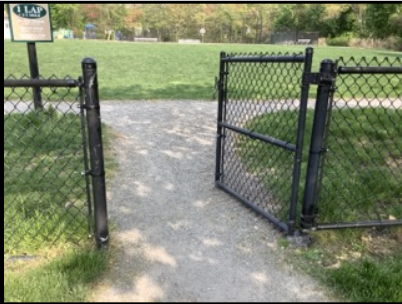
<div style="border: 1px solid black; padding: 2px;">Access to Goods and Services</div>												
<div style="border: 1px solid black; padding: 2px;">Doors, Doorways, & Gates</div>												
4	Route 109 to Soccer Field	Ext.		Doors, Doorways, & Gates	Other

Clear gate opening < 90 degrees	75 deg.	Ensure that the clear opening of swinging gates is 32" min., measured between the face of the gate and the latch, with the gate opening 90 degrees. Clear the dirt so that the gate does not get jammed.	1	Labor	Labor
<div style="border: 1px solid black; padding: 2px;">Toilet & Bathing Rooms</div>

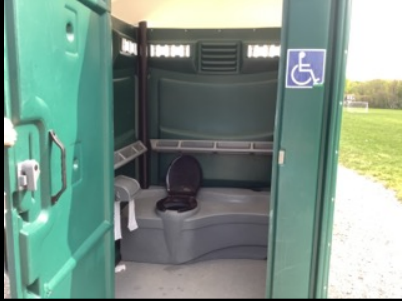
ID	Location	Floor	Room	Element	Type	Photo	Issues	Current Measure	Recommendations	Quantity	Price	Cost Estimation
Portable Toilet												
5	Next to North Softball Field	Ext.		Portable Toilet	N/A

Not located on an accessible route Accessible portable toilets not provided	- 61" x 58"	Locate portable toilet on an accessible route. Ensure that at least 5% of portable toilets (with a minimum of one) are accessible. (Cost estimate is for the cost of an accessible portable toilet only).	1	- 4600	\$4600
Play and Sport Areas												
Field												
6	North Softball Field	Ext.		Field	Softball

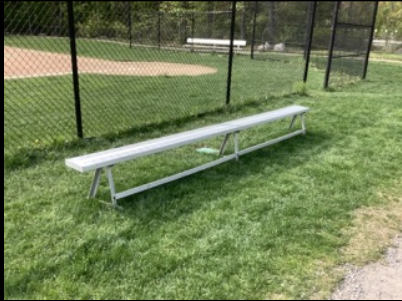
Accessible spaces are not provided at team seating Not connected to an accessible-route	- -	Provide a 36" x 48" stable, firm and slip resistant clear floor space at team seating. Provide an accessible route to the team seating area.	2	-	-
7	North Softball Field Spectator Seating Area	Ext.		Field	Softball

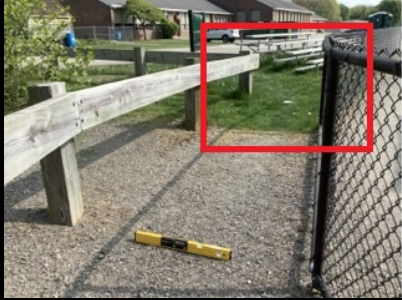
Accessible spaces not provided at sidelines seating Not connected to an accessible-route	- -	Provide a 36" x 60" clear floor space on each side of at both sidelines bleacher seating areas. Provide an accessible route to both sidelines bleacher seating areas.	2	-	-

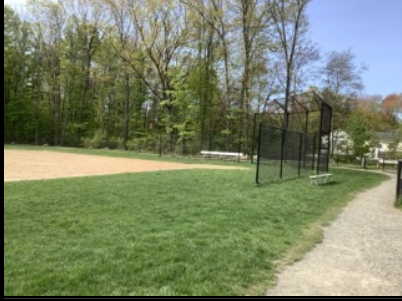
8	North Softball Field	Ext.		Field	Softball

Not connected to an accessible-route No accessible route to all areas of sport activity	- -	Provide an accessible route to the baseball field. Install an accessible route between all areas of sports activity including between all sports fields, team seating areas and practice areas.	1	-	-
9	South Softball Field	Ext.		Field	Softball

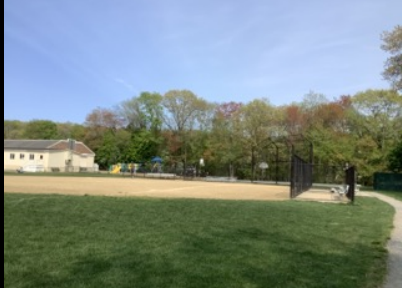
Not connected to an accessible-route No accessible route to all areas of sport activity	- -	Provide an accessible route to the baseball field. Install an accessible route between all areas of sports activity.	1	-	-

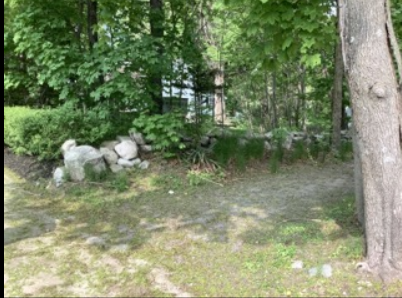
ID	Location	Floor	Room	Element	Type	Photo	Issues	Current Measure	Recommendations	Quantity	Price	Cost Estimation
<div style="border: 1px solid gray; padding: 2px; margin-bottom: 5px;">Best Practice ▼</div> <div style="border: 1px solid gray; padding: 2px;">Signage</div>												
10	Entrance From Route 109	Ext.		Signage	Informational

-	Recommend providing a sign at the secondary entrance to Deerfield School from Route 109.	1	-	-
11	Next to North Softball Field	Ext.		Signage	N/A

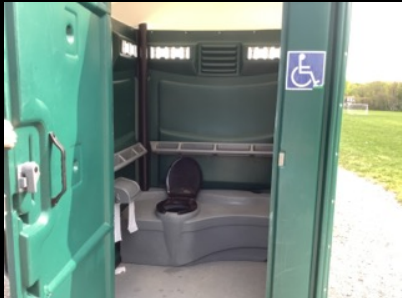
-	Recommend removing the International Symbol of Accessibility (ISA) from the non-accessible portable toilet.	1	-	-
