Martha Jones Baseball Field

Town of Westwood ADA Transition Plan

June 2023

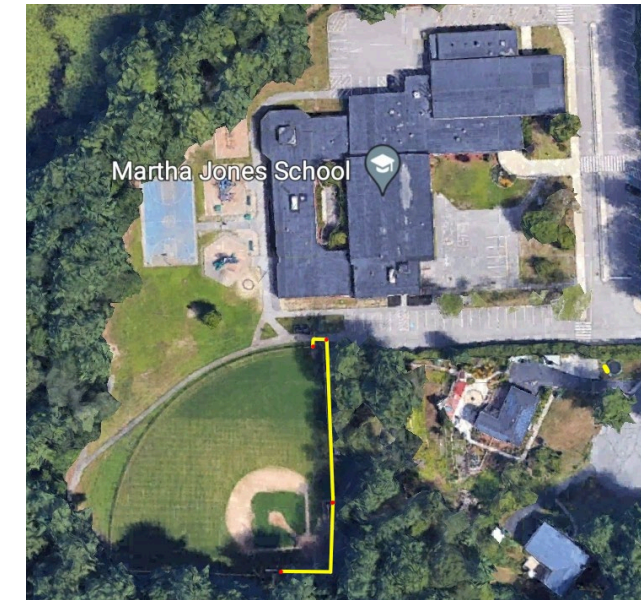
Figure 1: The following image uses a yellow line to indicate the approximate suggested location for a 48” wide min. stable, firm, and slip-resistant accessible route connecting park entry points to the team seating areas, the boundary of sport activity, and the portable toilet.

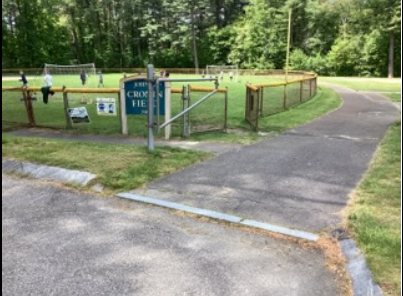
ID	Location	Floor	Room	Element	Type	Photo	Issues	Current Measure	Recommendations	Quantity	Price	Cost Estimation
Approach and Entrance												
Exterior Access Route												
1	To Baseball and Soccer	Ext.	Exterior Access Route	Walkway

Level changes > 1/4"	1.5"	Alter the change in level to be 1/4" high max.	1	208	\$208	
											208	
Off-Street Parking Lot or Garage												
2	Parking	Ext.	Off-Street Parking Lot or Garage	Visitor

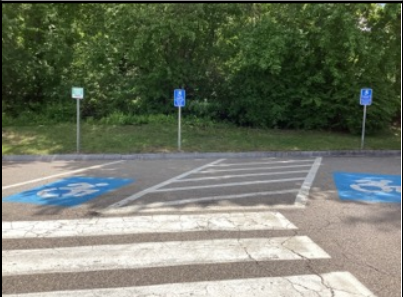
Total # of parking Total # of designated car accessible parking spaces Total # of designated van accessible spaces Sign does not have the designation "Van Accessible" International Symbol of Acc. not compliant	24 1 1 - -	Provide two (2) new signs containing the required International Symbol of Accessibility (ISA). Ensure that the designation "Van Accessible" is provided on the sign located at the van accessible space.	2	650	\$1300	
											1300	
Access to Goods and Services

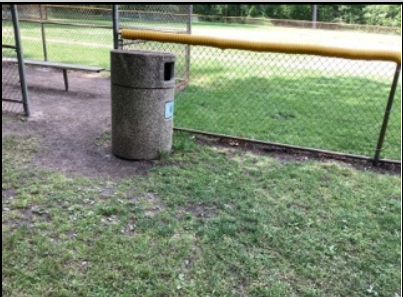
Trash / Recycling												
3	By Baseball	Ext.	Trash / Recycling	N/A

Surface not stable, firm, and slip-resistant at trash Trash container not connected to an accessible route	- -	Provide a 30" by 48" surface that is stable, firm, and slip-resistant at the trash container. Ensure trash container is located on an accessible route.	3	-	-	
Toilet & Bathing Rooms												
Portable Toilet												
4	By Baseball	Ext.	Portable Toilet	N/A

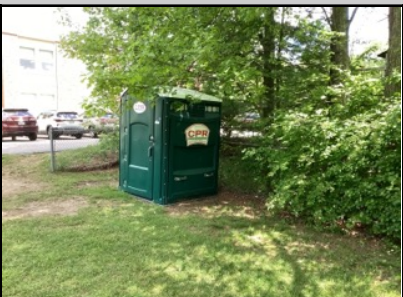
Not located on an accessible route Accessible portable toilets not provided 60" by 72" clear space not provided	- - 60"	Locate portable toilet on an accessible route. Ensure that at least 5% of portable toilets (with a minimum of one) are accessible. Provide an accessible portable toilet that has 60" wide and 72" deep at the toilet. (Cost estimate is for an accessible portable toilet.)	1	5980	\$5980	
											5980

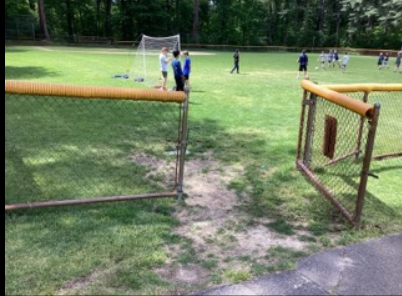
Not connected to an accessible-route No accessible route to all areas of sport activity	- -	Provide an accessible route to the field. Install an accessible route between all areas of sports activity.	1	-	-
6	Baseball Sideline Seating	Ext.		Field	Baseball

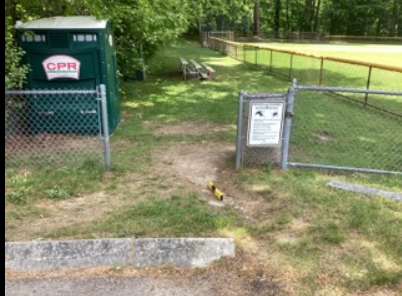
Accessible spaces not provided at sidelines seating Not connected to an accessible-route	- 13%	Provide a 36" x 60" clear floor space at sidelines seating on each side of the bleacher for wheelchair seating. Provide an accessible route to the sidelines seating.	1	-	-
7	Baseball Team Seating	Ext.		Field	Baseball

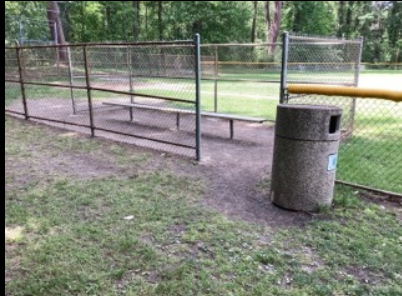
Accessible spaces are not provided at team seating Not connected to an accessible-route	- -	Provide a 36" x 48" clear floor space at team seating. Provide an accessible route to the field and to team seating areas.	2	-	-
