APPENDIX C

CCTV Reports

Project Name:		Town of Westwood MA WE 4-9-21						
US MH	DS MH	Pipe ID	Date	Street	Material	Size	Total	Insp
08-126	08-126A	08-126_08-126A	4/8/2021	Washington Street	Asbestos Cement	6	39	39
08-127	08-127A	08-127_08-127A	4/8/2021	Washington Street	Asbestos Cement	6	36	36
08-128	08-128A	08-128_08-128A	4/8/2021	Washington Street	Asbestos Cement	6	40	40
08-129	08-129A	08-129_08-129A	4/8/2021	Washington Street	Asbestos Cement	6	40	40

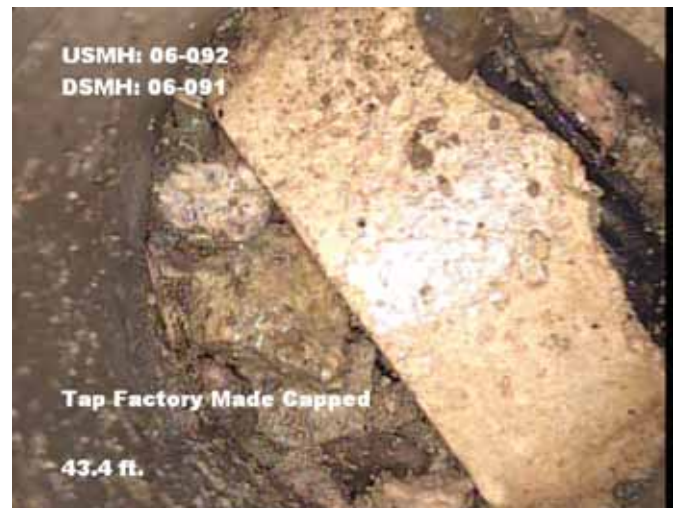
Distance: 43.4 ft. Grade: 0
Condition: Tap Factory Made Capped
Remarks: N/A

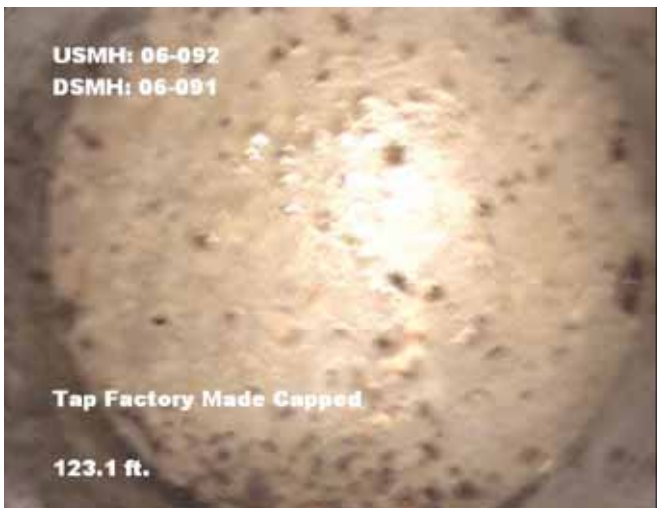
Distance: 123.1 ft. Grade: 0
Condition: Tap Factory Made Capped
Remarks: N/A

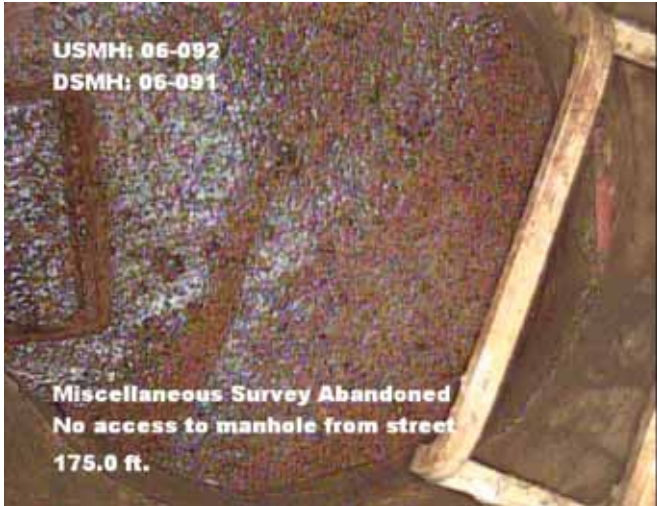
Distance: 175.0 ft. Grade: 0
 Condition: Miscellaneous Survey Abandoned
 Remarks: No access to manhole from street

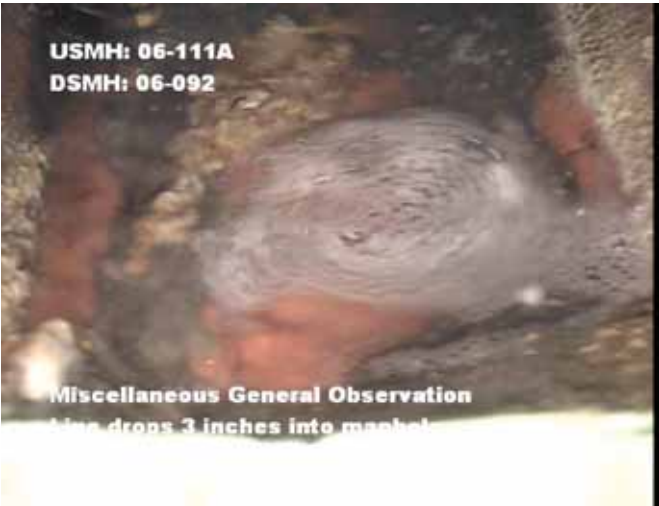
Distance: 94.0 ft. Grade: 0
 Condition: Miscellaneous General Observation
 Remarks: Line drops 3 inches into manhole

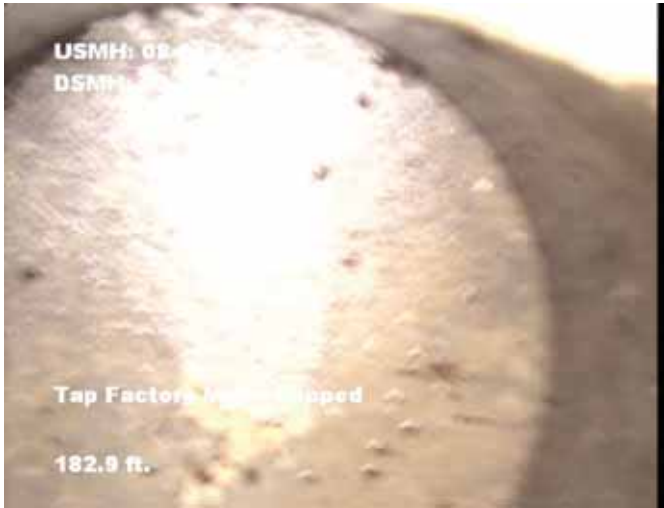
Distance: 182.9 ft. Grade: 0
 Condition: Tap Factory Made Capped
 Remarks: N/A

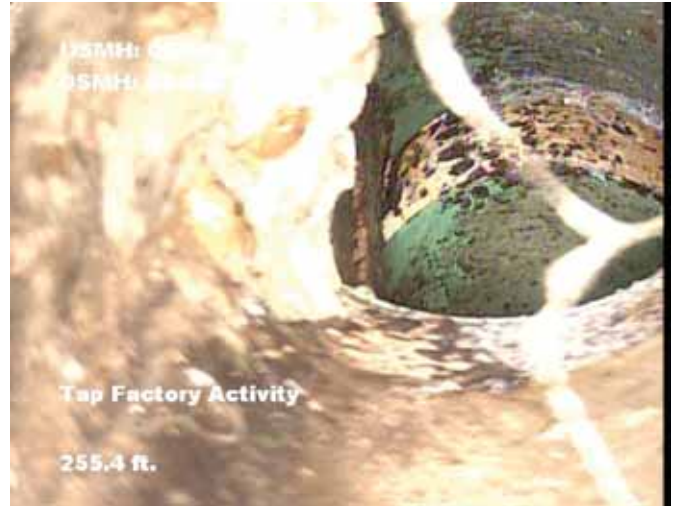
Distance: 255.4 ft. Grade: 0
Condition: Tap Factory Activity
Remarks: N/A

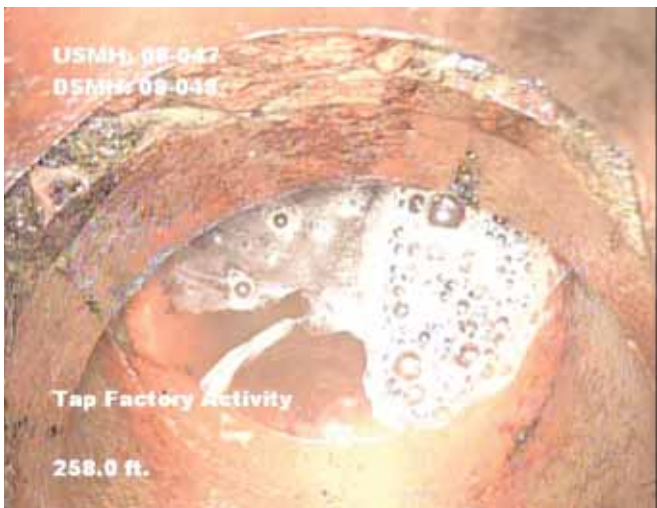
Distance: 258.0 ft. Grade: 0
Condition: Tap Factory Activity
Remarks: Drop

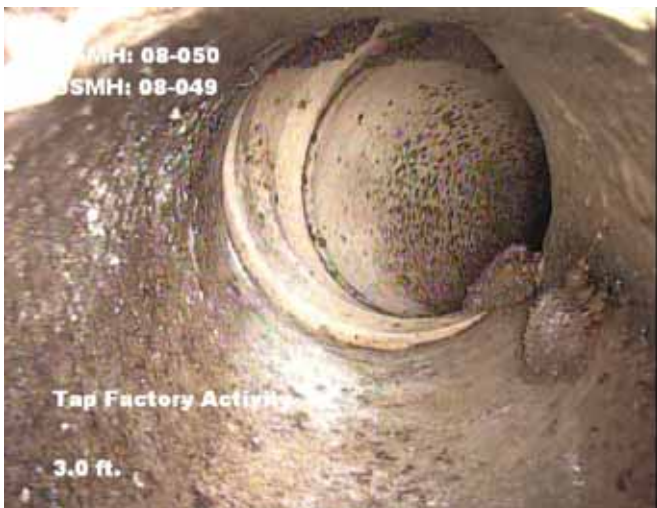
Distance: 3.0 ft. Grade: 0
Condition: Tap Factory Activity
Remarks: N/A

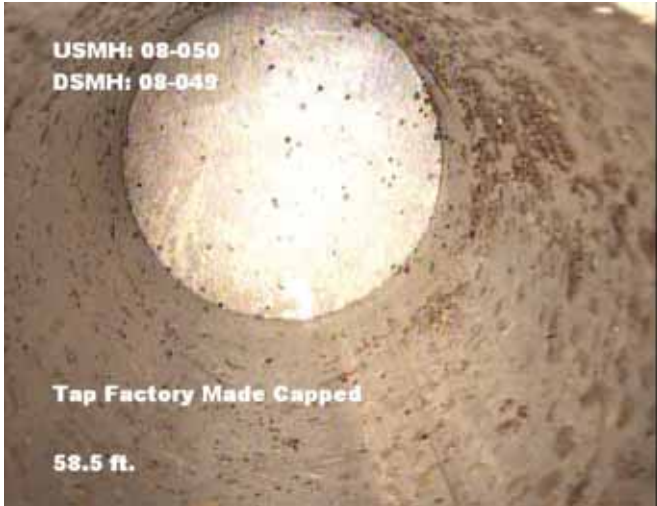
Distance: 58.5 ft. Grade: 0
Condition: Tap Factory Made Capped
Remarks: N/A

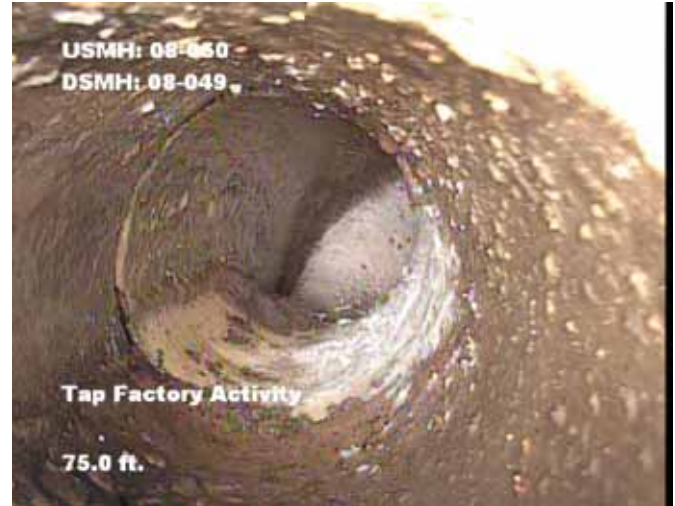
Distance: 75.0 ft. Grade: 0
Condition: Tap Factory Activity
Remarks: N/A

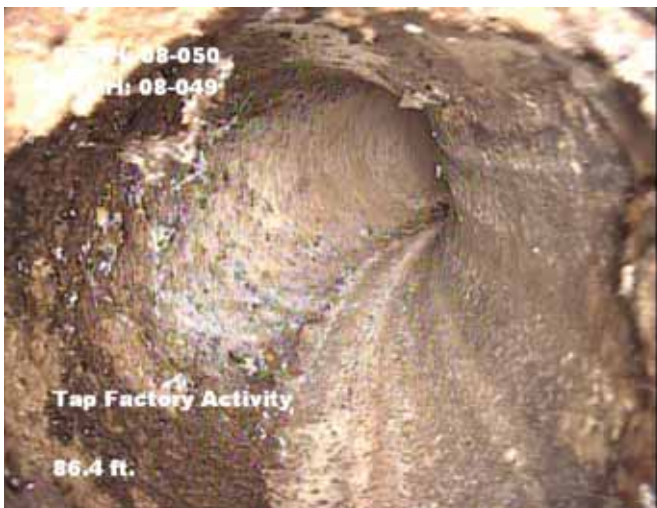
Distance: 86.4 ft. Grade: 0
Condition: Tap Factory Activity
Remarks: N/A

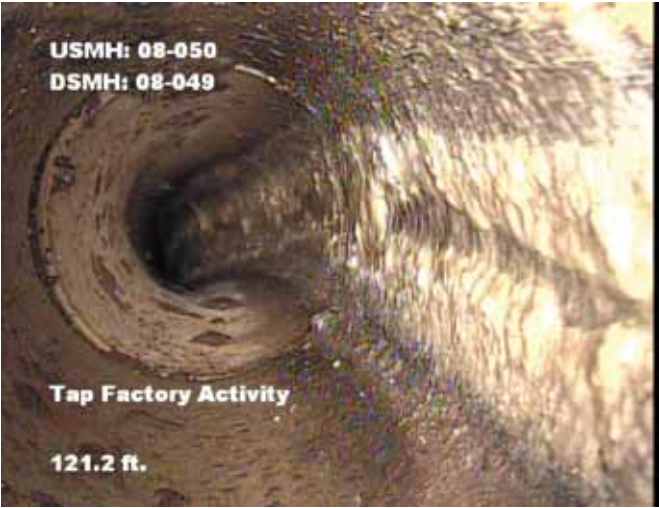
Distance: 121.2 ft. Grade: 0
 Condition: Tap Factory Activity
 Remarks: N/A

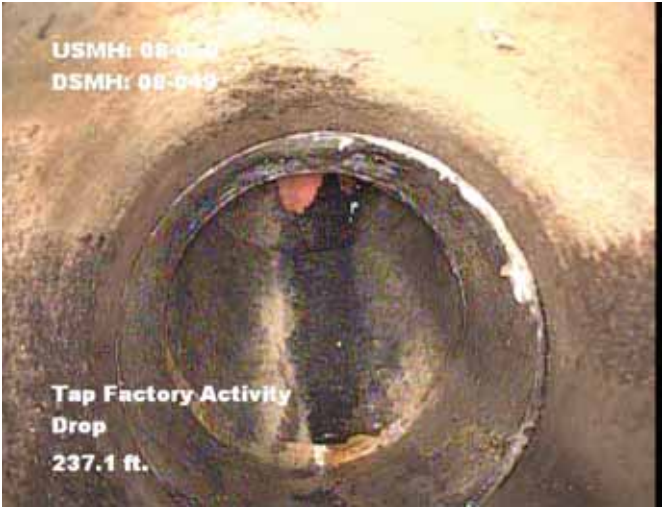
Distance: 237.1 ft. Grade: 0
 Condition: Tap Factory Activity
 Remarks: Drop

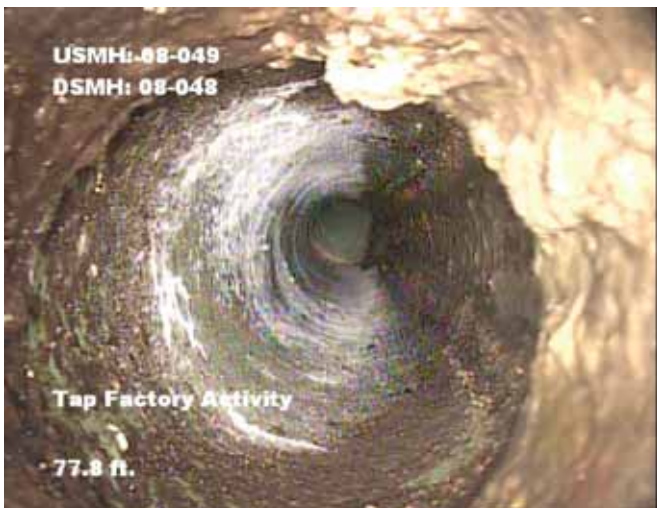
Distance: 77.8 ft. Grade: 0
Condition: Tap Factory Activity
Remarks: N/A

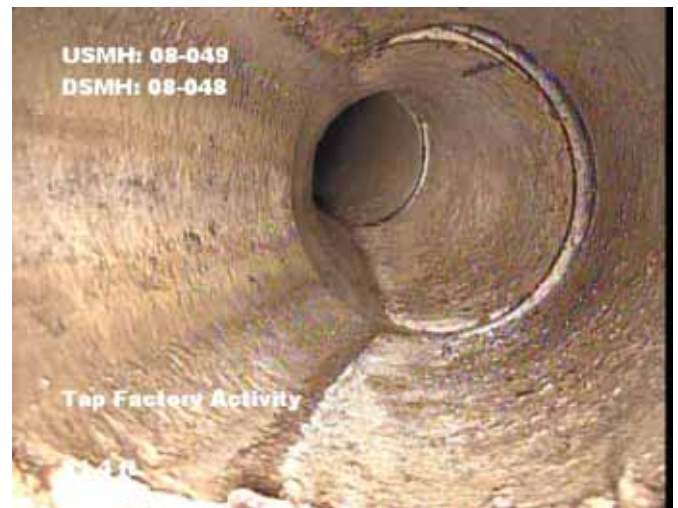
Distance: 81.4 ft. Grade: 0
Condition: Tap Factory Activity
Remarks: N/A

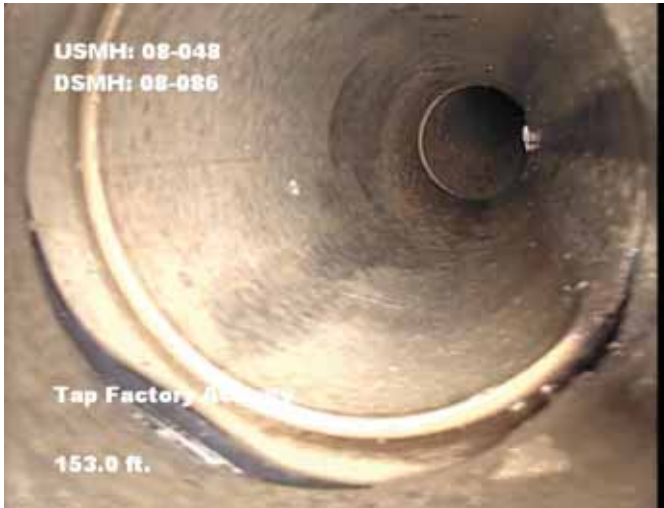
Distance: 153.0 ft. Grade: 0
 Condition: Tap Factory Activity
 Remarks: N/A

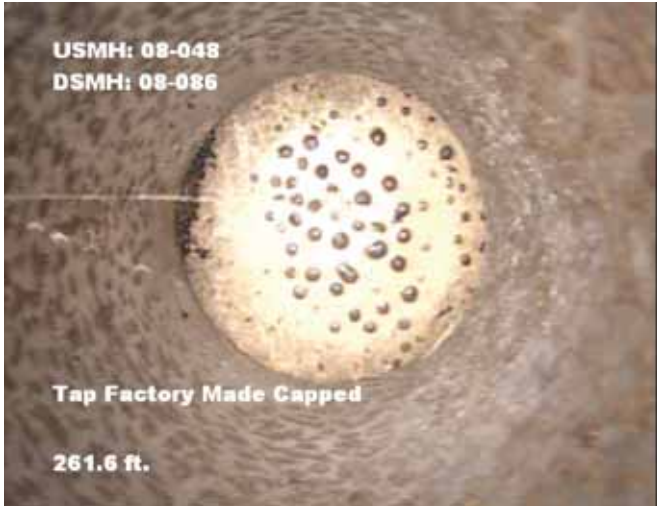
Distance: 261.6 ft. Grade: 0
Condition: Tap Factory Made Capped
Remarks: N/A

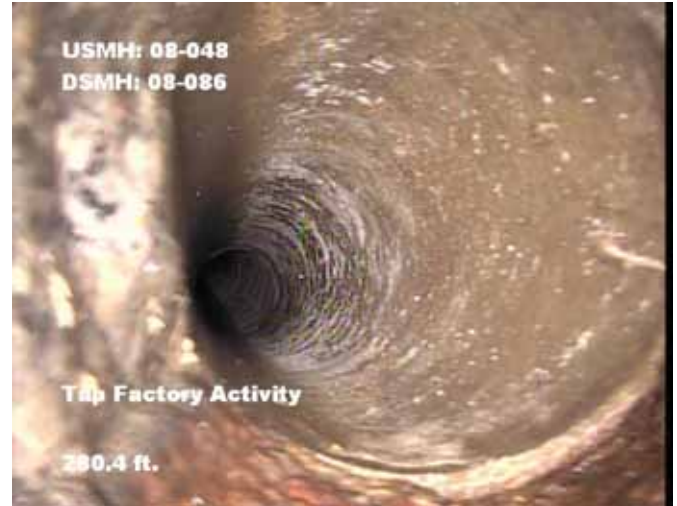
Distance: 280.4 ft. Grade: 0
Condition: Tap Factory Activity
Remarks: N/A

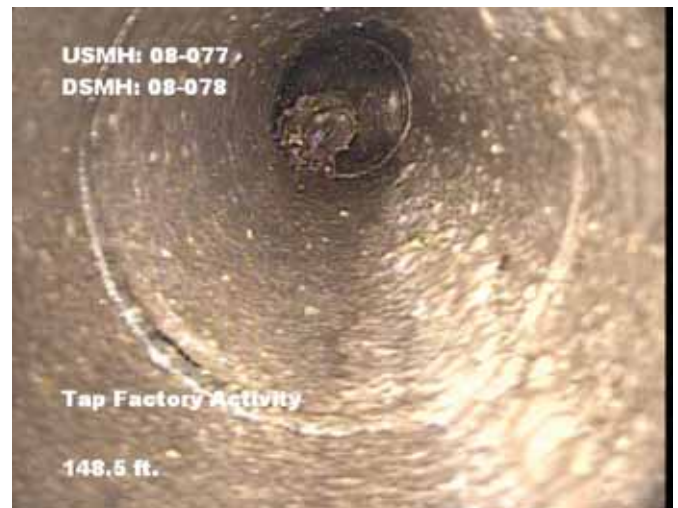
Distance: 148.5 ft. Grade: 0
Condition: Tap Factory Activity
Remarks: N/A

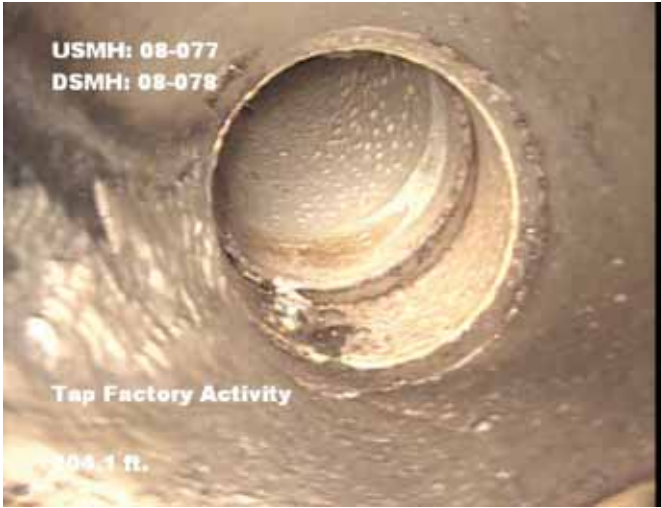
Distance: 204.1 ft. Grade: 0
 Condition: Tap Factory Activity
 Remarks: N/A

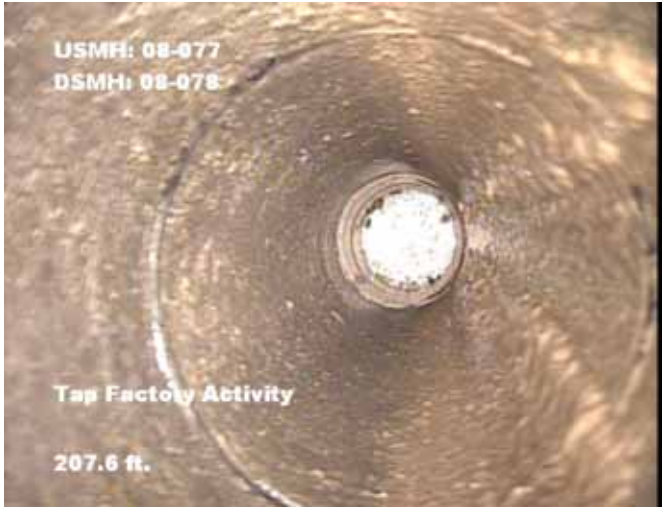
Distance: 207.6 ft. Grade: 0
 Condition: Tap Factory Activity
 Remarks: N/A

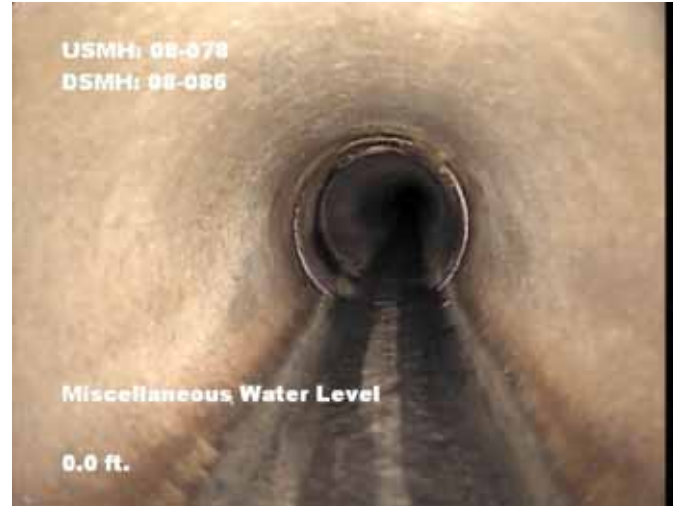
Distance: 0.0 ft. Grade: 0
Condition: Miscellaneous Water Level
Remarks: N/A

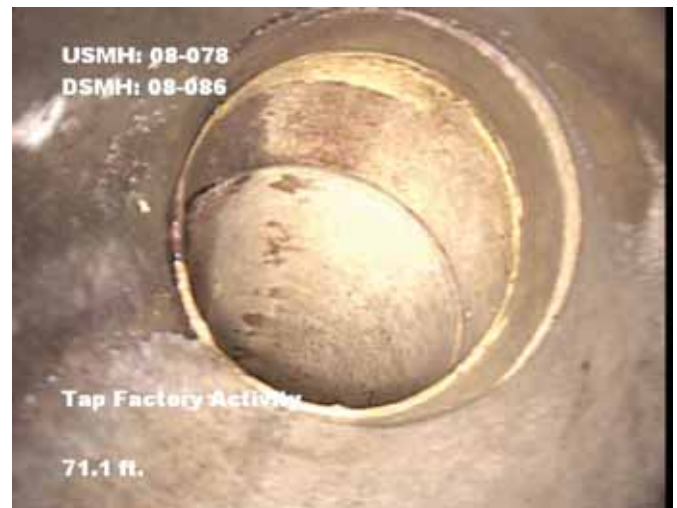
Distance: 71.1 ft. Grade: 0
Condition: Tap Factory Activity
Remarks: N/A

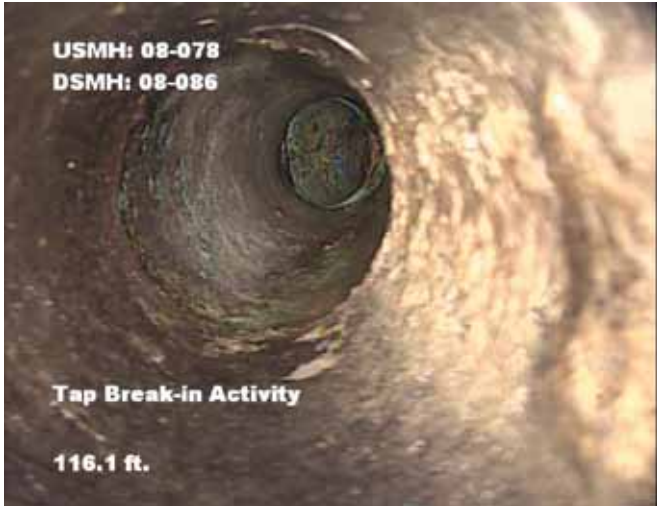
Distance: 116.1 ft. Grade: 0
Condition: Tap Break-in Activity
Remarks: N/A

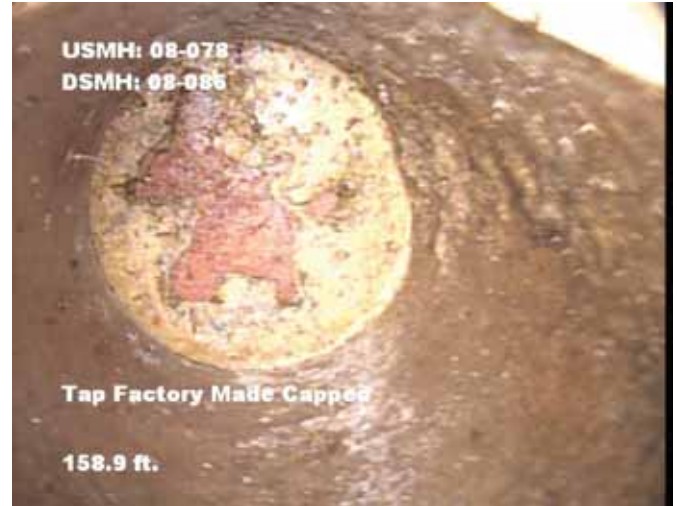
Distance: 158.9 ft. Grade: 0
Condition: Tap Factory Made Capped
Remarks: N/A

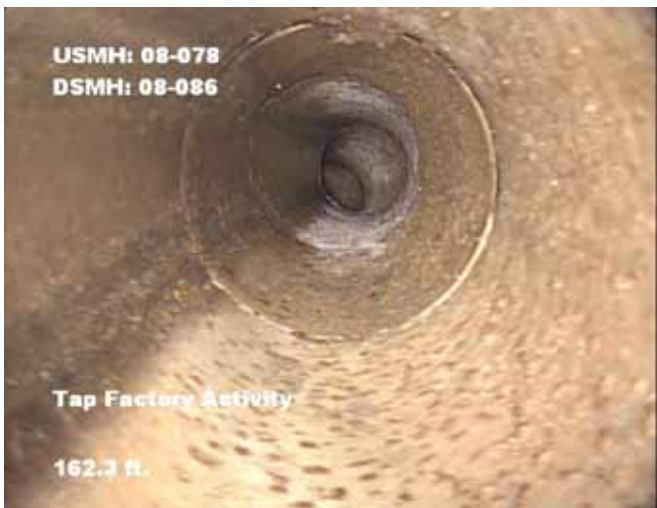
Distance: 162.3 ft. Grade: 0
Condition: Tap Factory Activity
Remarks: N/A

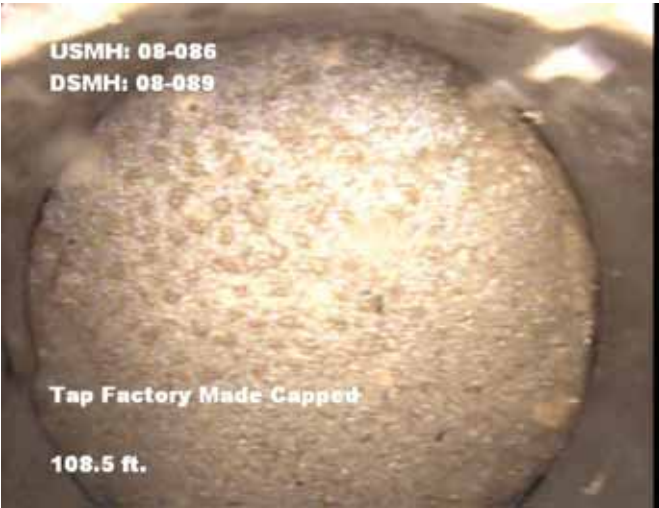
Distance: 108.5 ft. Grade: 0
 Condition: Tap Factory Made Capped
 Remarks: N/A

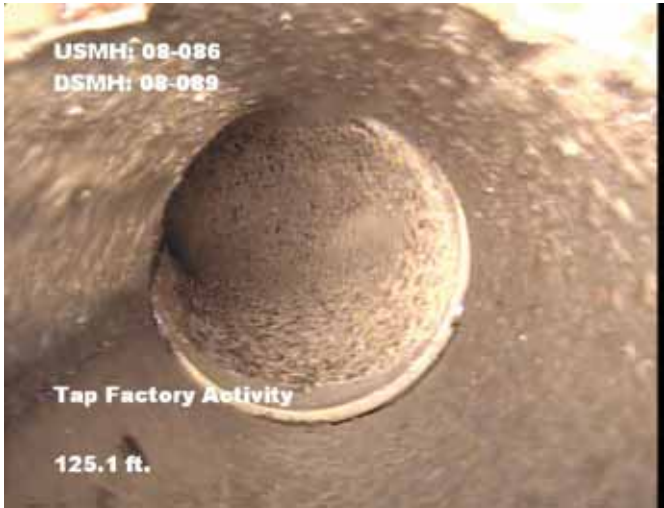
Distance: 125.1 ft. Grade: 0
 Condition: Tap Factory Activity
 Remarks: N/A

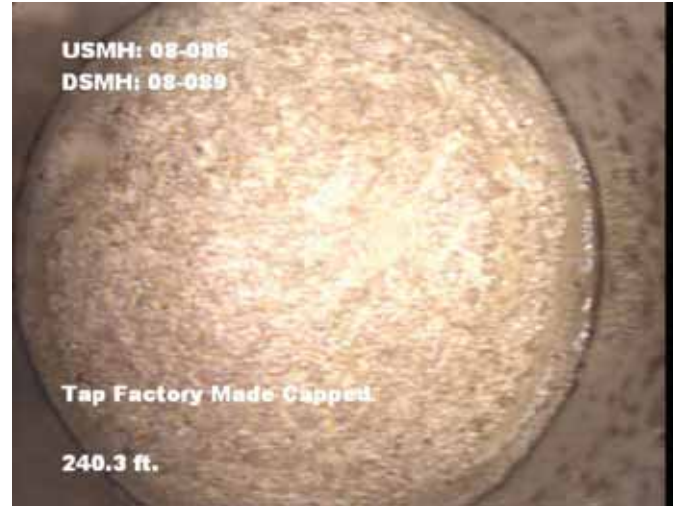
Distance: 240.3 ft. Grade: 0
 Condition: Tap Factory Made Capped
 Remarks: N/A

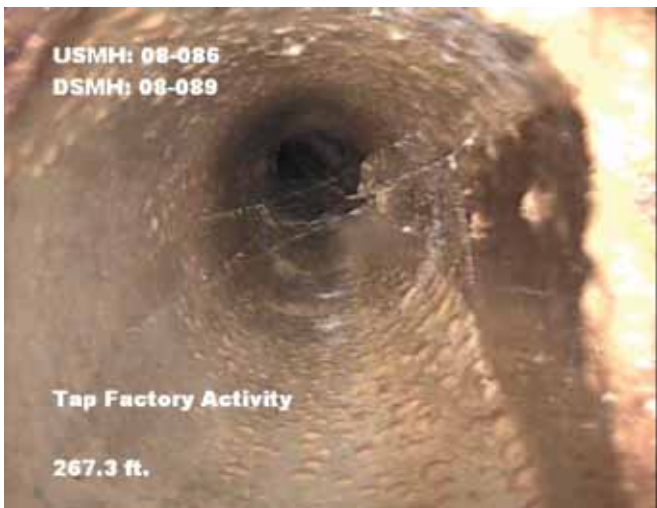
Distance: 267.3 ft. Grade: 0
 Condition: Tap Factory Activity
 Remarks: N/A

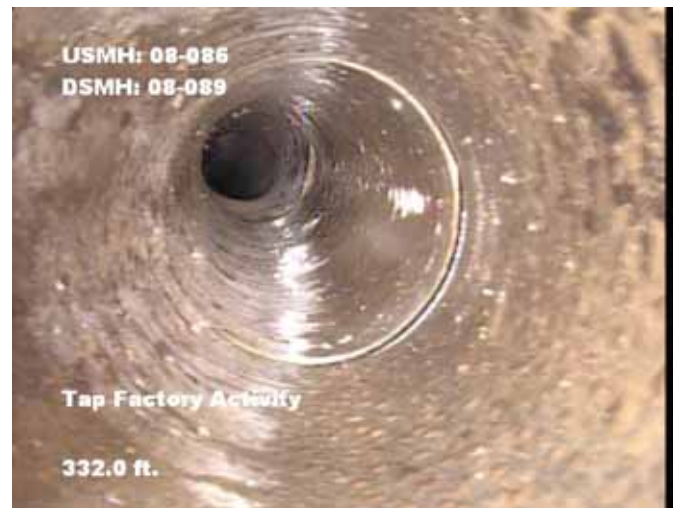
Distance: 332.0 ft. Grade: 0
 Condition: Tap Factory Activity
 Remarks: N/A

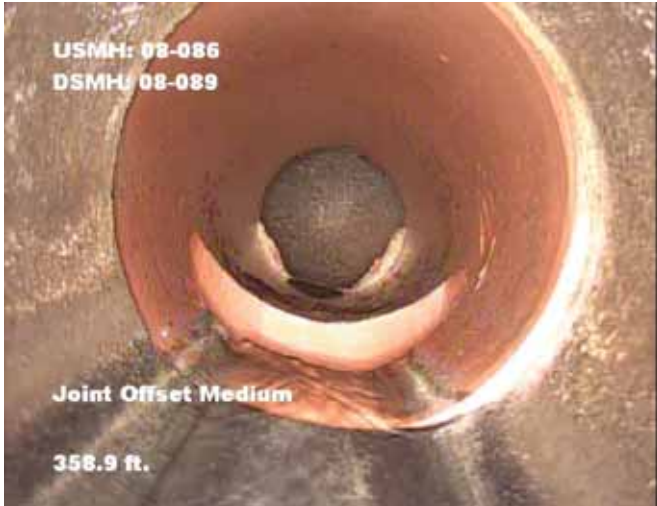
Distance: 358.9 ft. Grade: 3
Condition: Joint Offset Medium
Remarks: N/A

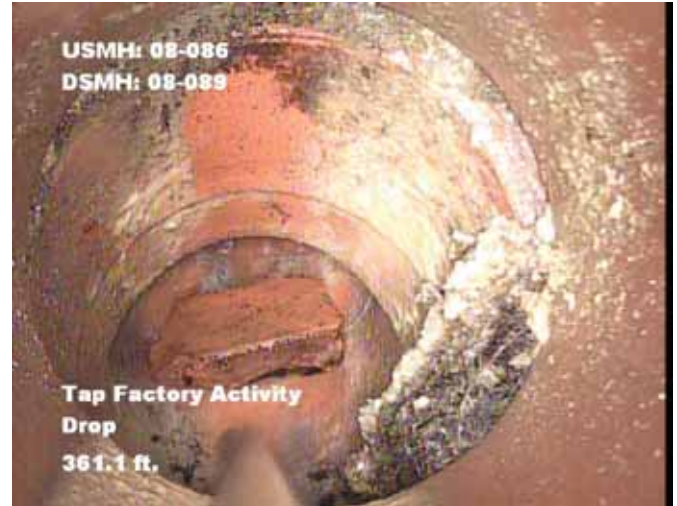
Distance: 361.1 ft. Grade: 0
Condition: Tap Factory Activity
Remarks: Drop

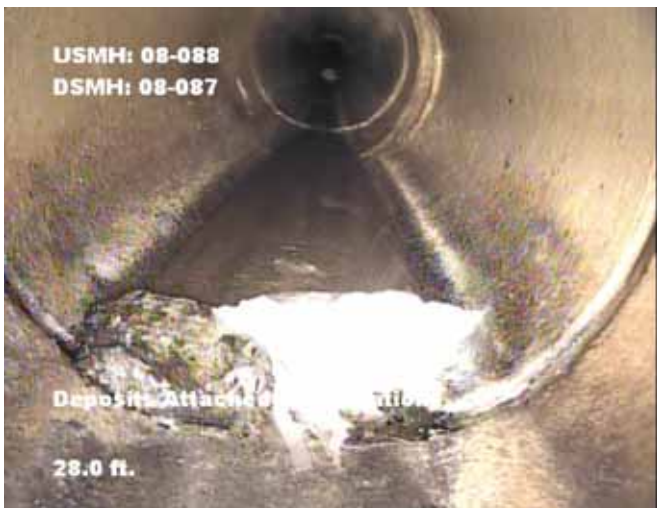
Distance: 28.0 ft. Grade: 2
Condition: Deposits Attached Encrustation
Remarks: N/A

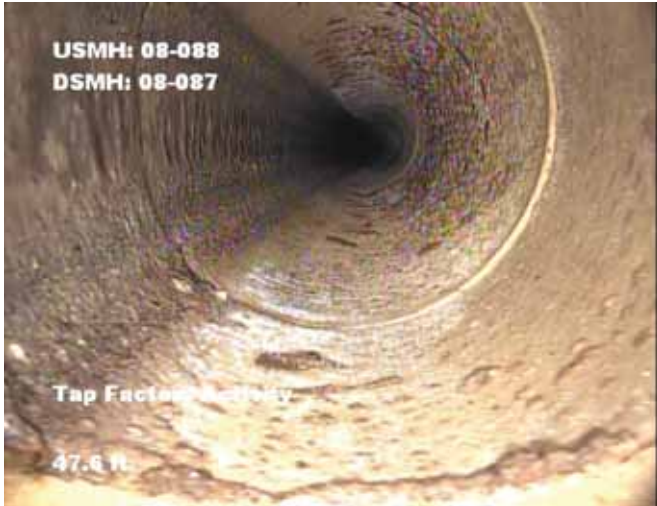
Distance: 47.6 ft. Grade: 0
Condition: Tap Factory Activity
Remarks: N/A

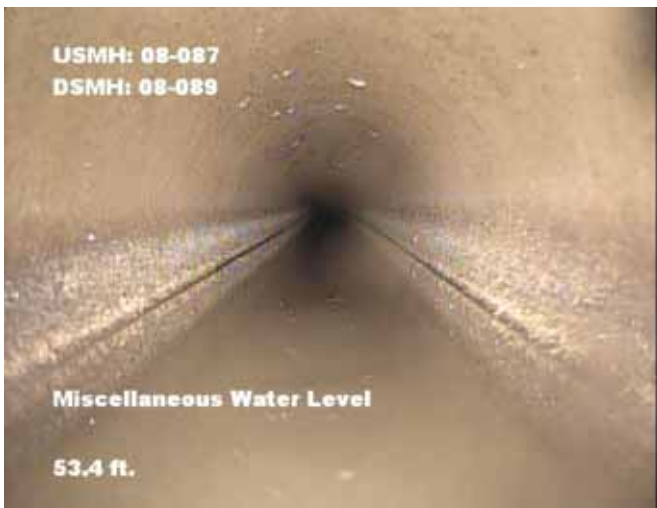
Distance: 53.4 ft. Grade: 0
Condition: Miscellaneous Water Level
Remarks: N/A

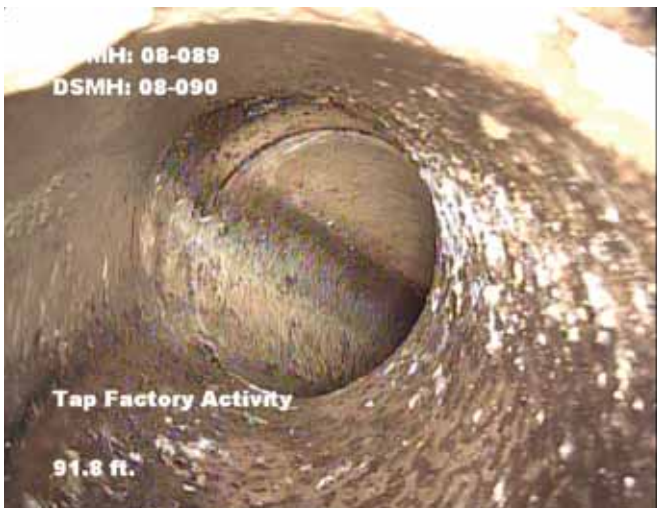
Distance: 91.8 ft. Grade: 0
Condition: Tap Factory Activity
Remarks: N/A

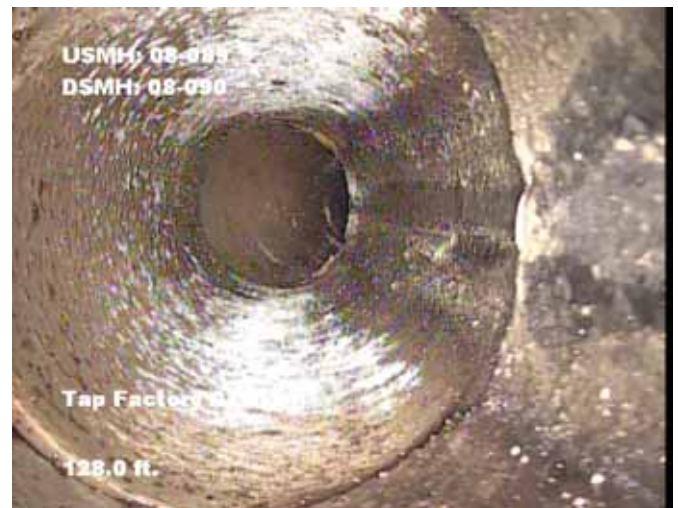
Distance: 128.0 ft. Grade: 0
Condition: Tap Factory Activity
Remarks: N/A

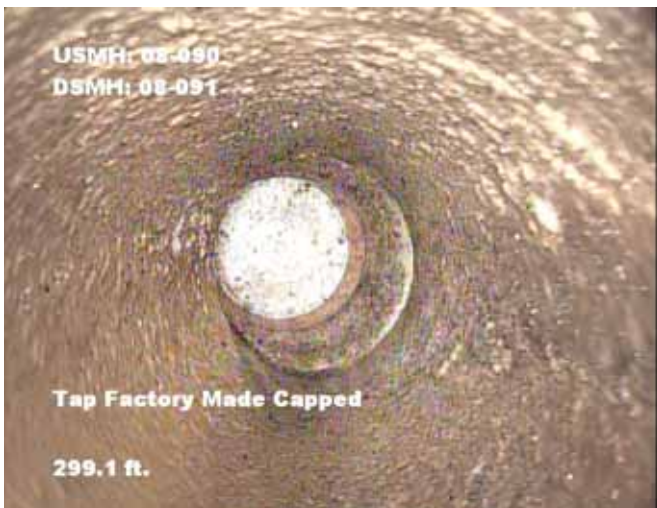
Distance: 299.1 ft. Grade: 0
Condition: Tap Factory Made Capped
Remarks: N/A

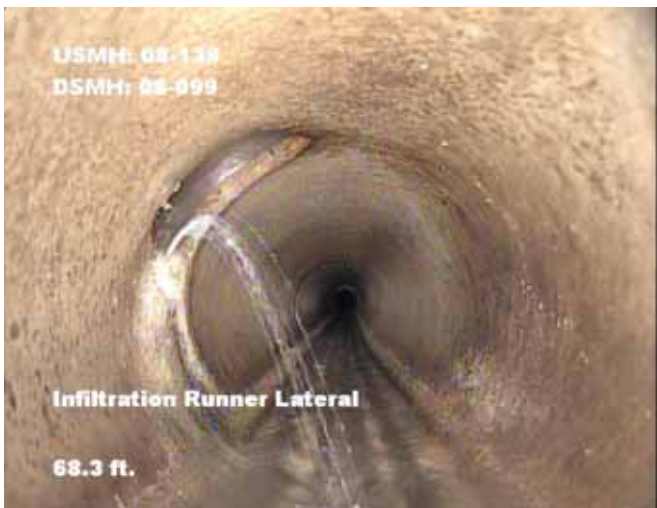
Distance: 68.3 ft. Grade: 4
Condition: Infiltration Runner Lateral
Remarks: N/A

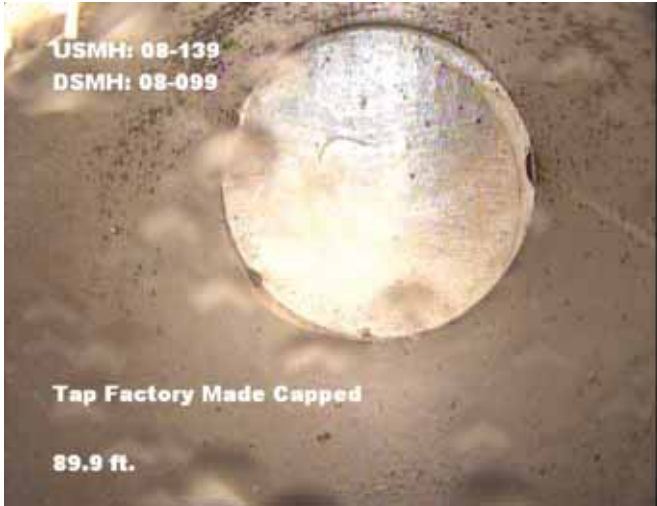
Distance: 89.9 ft. Grade: 0
Condition: Tap Factory Made Capped
Remarks: N/A

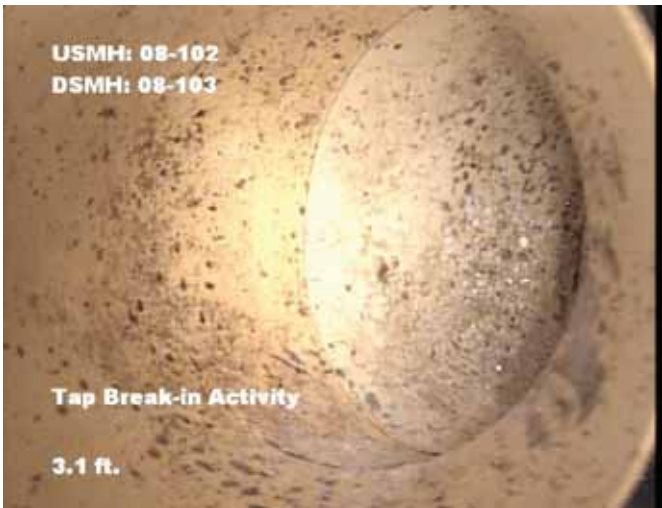
Distance: 3.1 ft. Grade: 0
 Condition: Tap Break-in Activity
 Remarks: N/A

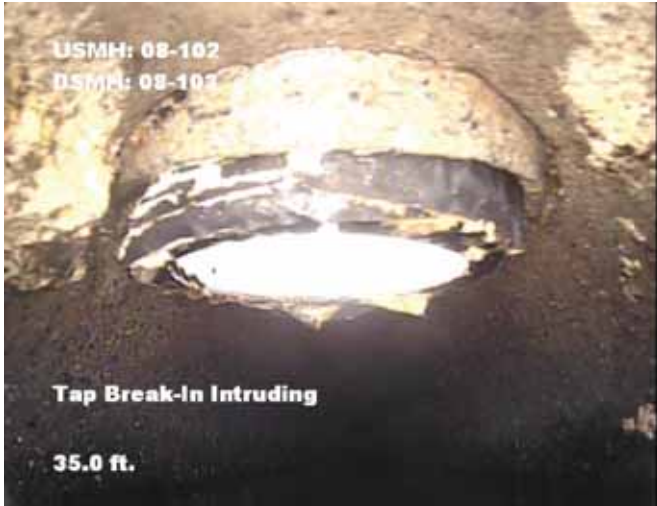
Distance: 35.0 ft. Grade: 4
Condition: Tap Break-In Intruding
Remarks: N/A

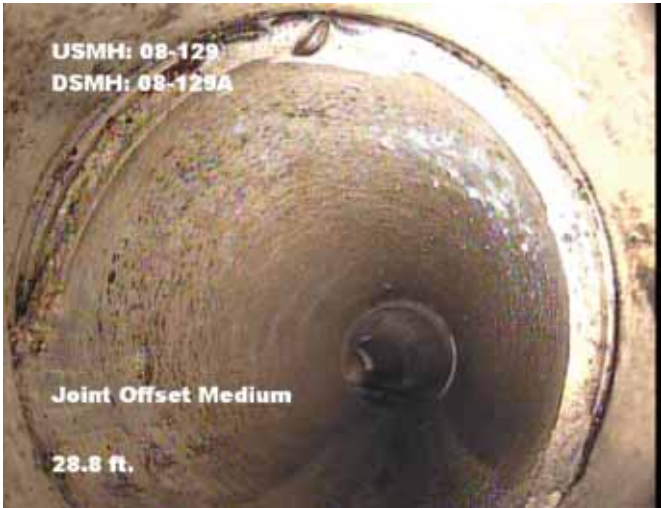
Distance: 28.8 ft. Grade: 3
 Condition: Joint Offset Medium
 Remarks: N/A

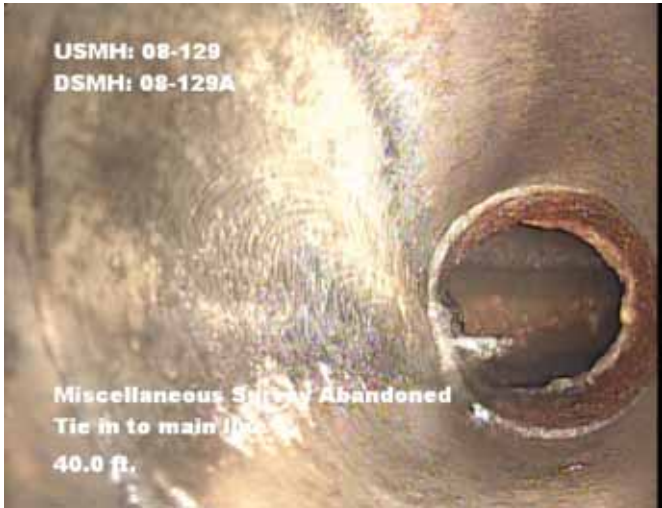
Distance: 40.0 ft. Grade: 0
 Condition: Miscellaneous Survey Abandoned
 Remarks: Tie in to main line

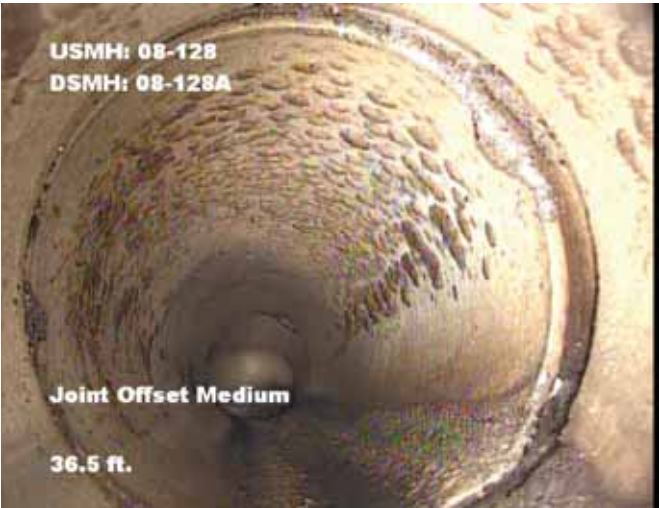
Distance: 36.5 ft. Grade: 3
 Condition: Joint Offset Medium
 Remarks: N/A

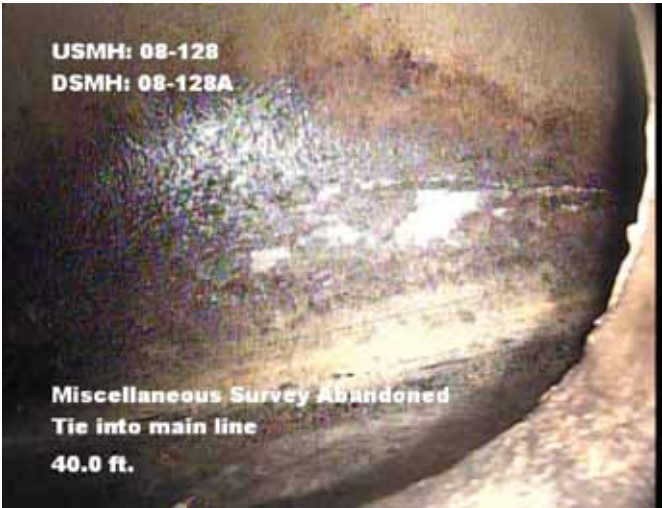
Distance: 40.0 ft. Grade: 0
 Condition: Miscellaneous Survey Abandoned
 Remarks: Tie into main line

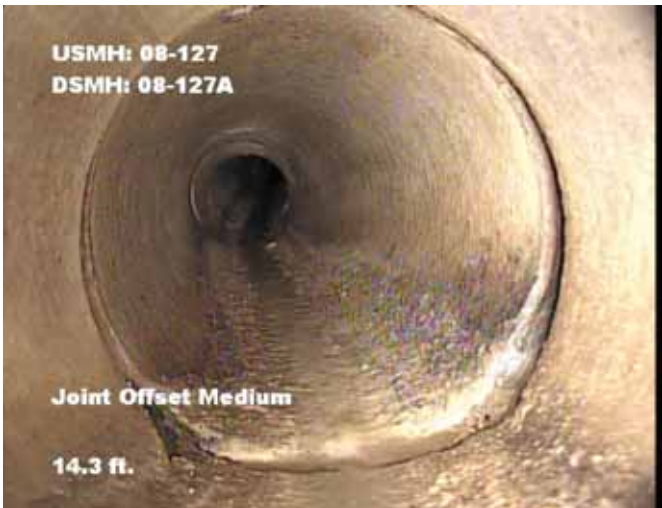
Distance: 14.3 ft. Grade: 3
 Condition: Joint Offset Medium
 Remarks: N/A

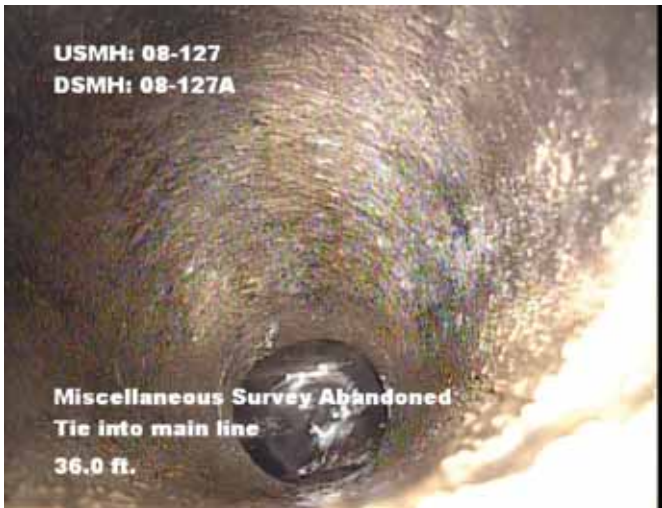
Distance: 36.0 ft. Grade: 0
 Condition: Miscellaneous Survey Abandoned
 Remarks: Tie into main line

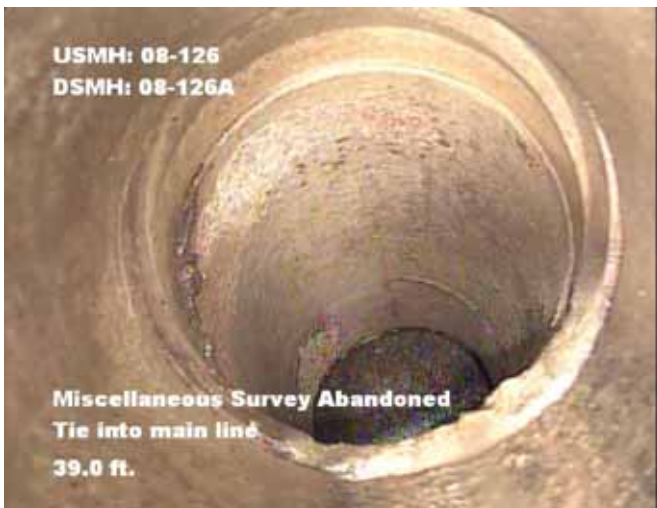
Distance: 39.0 ft. Grade: 0
Condition: Miscellaneous Survey Abandoned
Remarks: Tie into main line

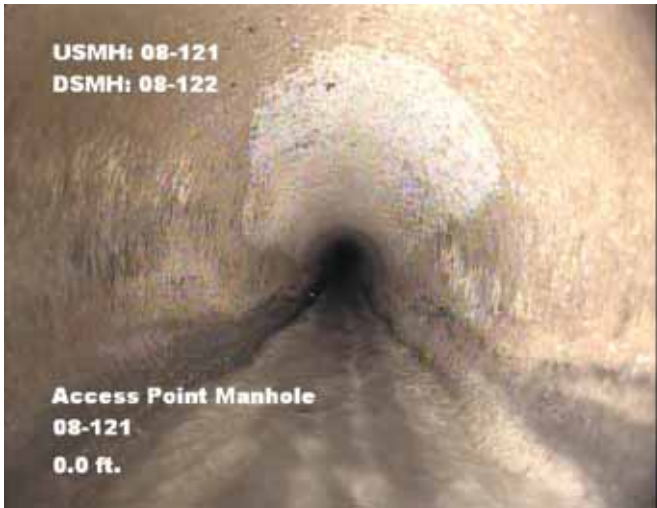
Distance: 0.0 ft. Grade: 0
Condition: Access Point Manhole
Remarks: 08-121

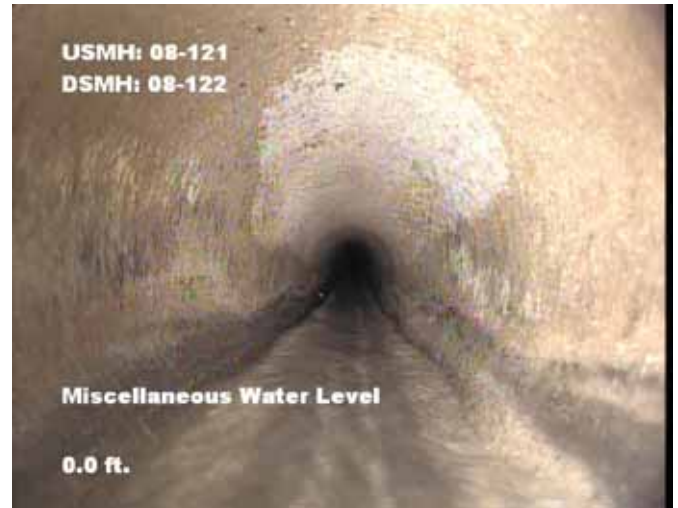
Distance: 0.0 ft. Grade: 0
Condition: Miscellaneous Water Level
Remarks: N/A

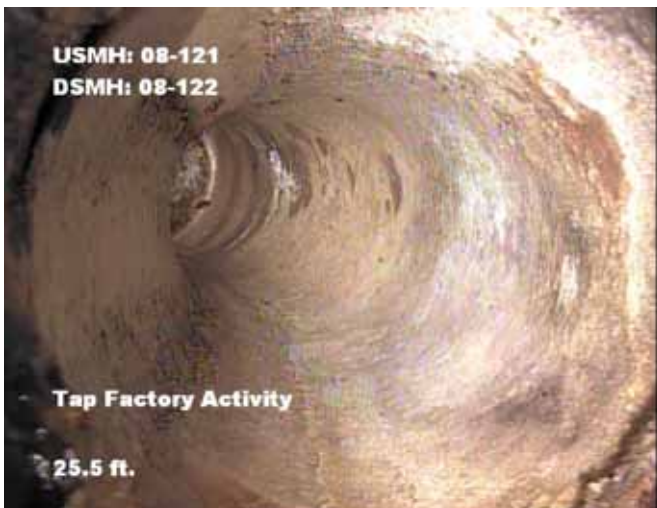
Distance: 25.5 ft. Grade: 0
Condition: Tap Factory Activity
Remarks: N/A

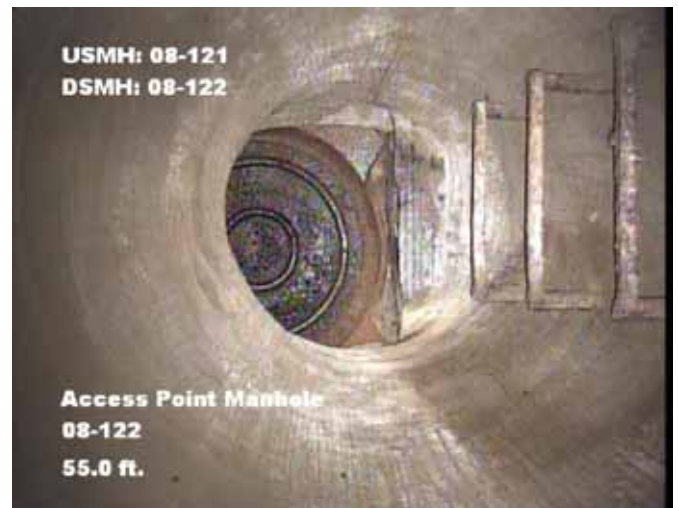
Distance: 55.0 ft. Grade: 0
Condition: Access Point Manhole
Remarks: 08-122

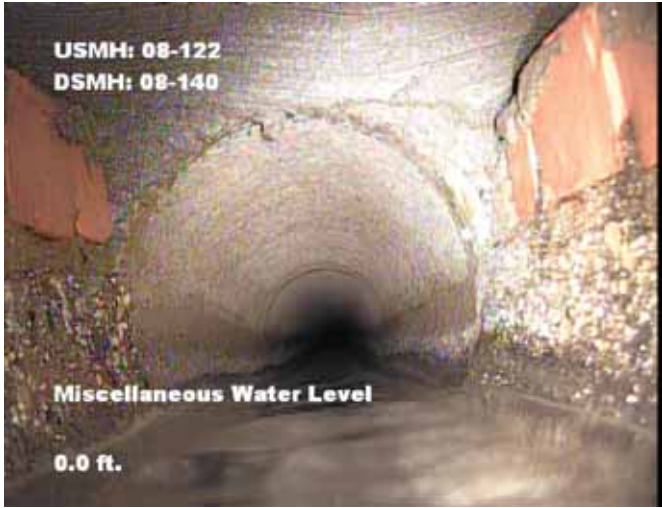
Distance: 0.0 ft. Grade: 0
 Condition: Miscellaneous Water Level
 Remarks: N/A

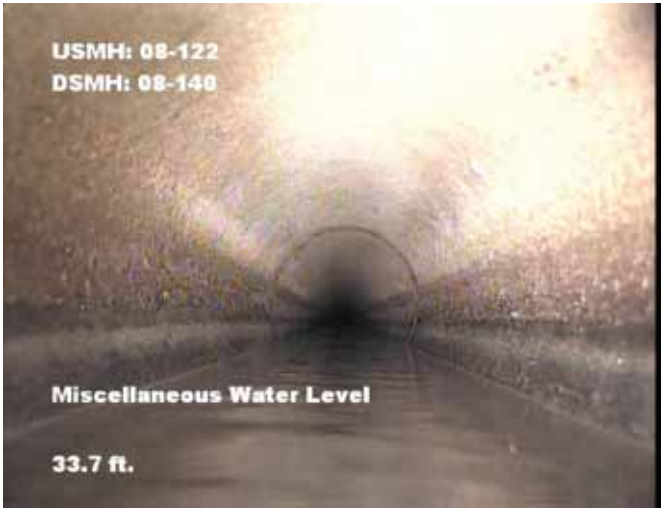
Distance: 33.7 ft. Grade: 0
 Condition: Miscellaneous Water Level
 Remarks: N/A

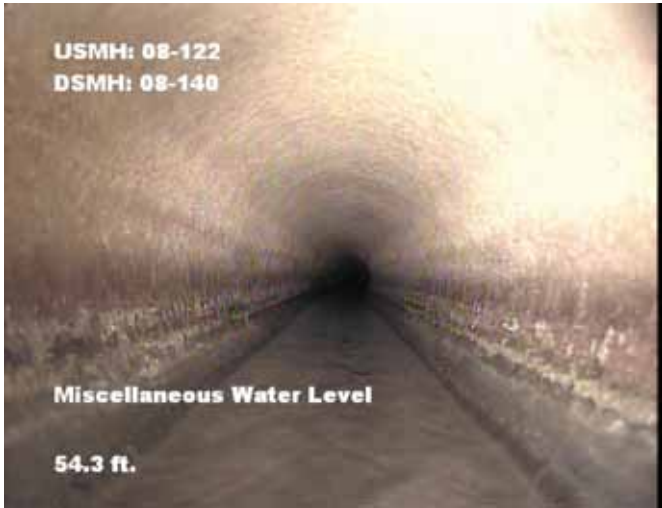
Distance: 54.3 ft. Grade: 0
 Condition: Miscellaneous Water Level
 Remarks: N/A

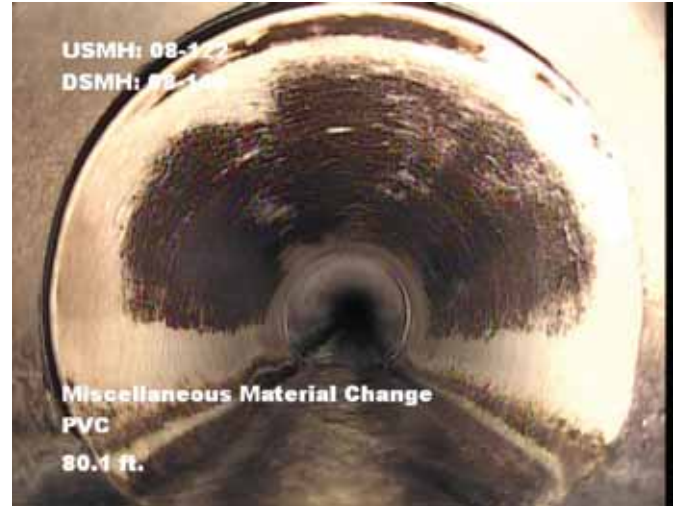
Distance: 80.1 ft. Grade: 0
Condition: Miscellaneous Material Change
Remarks: PVC

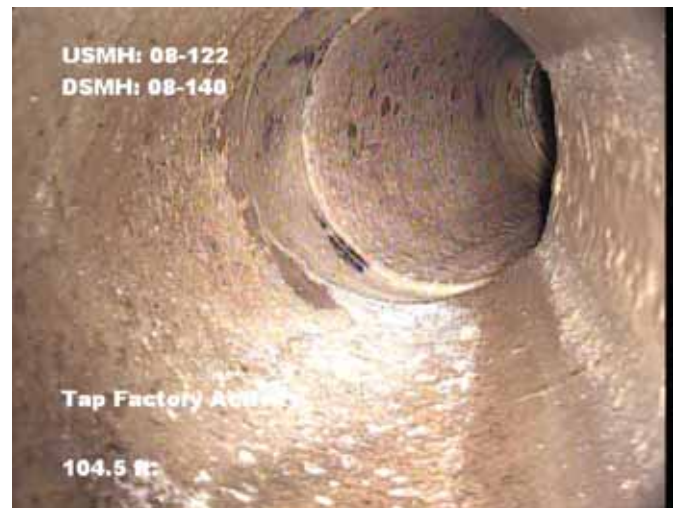
Distance: 104.5 ft. Grade: 0
Condition: Tap Factory Activity
Remarks: N/A

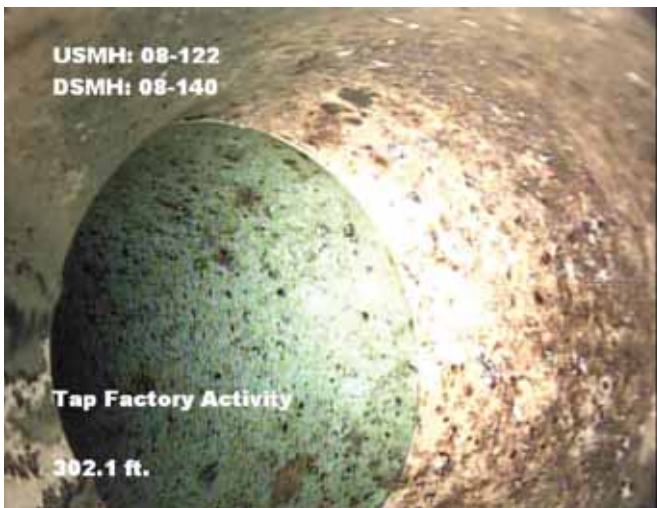
Distance: 302.1 ft. Grade: 0
Condition: Tap Factory Activity
Remarks: N/A

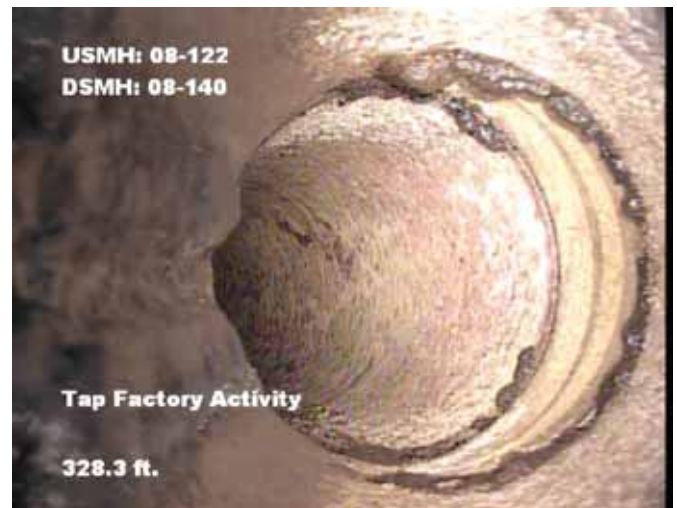
Distance: 328.3 ft. Grade: 0
Condition: Tap Factory Activity
Remarks: N/A

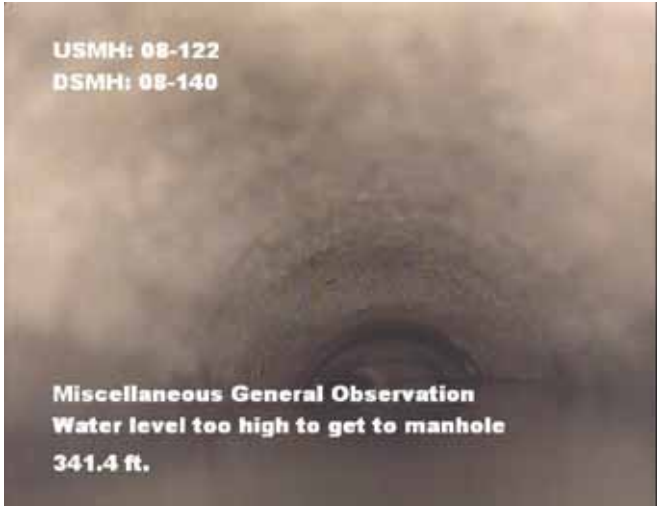
Distance: 341.4 ft. Grade: 0
Condition: Miscellaneous General Observation
Remarks: Water level too high to get to manhole

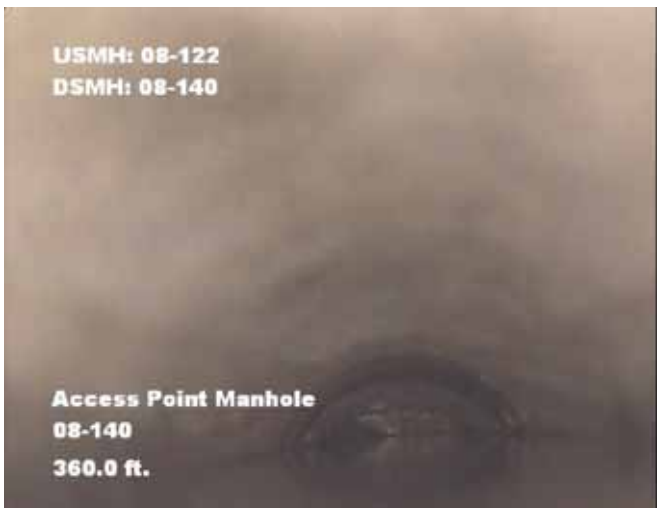
Distance: 360.0 ft. Grade: 0
Condition: Access Point Manhole
Remarks: 08-140

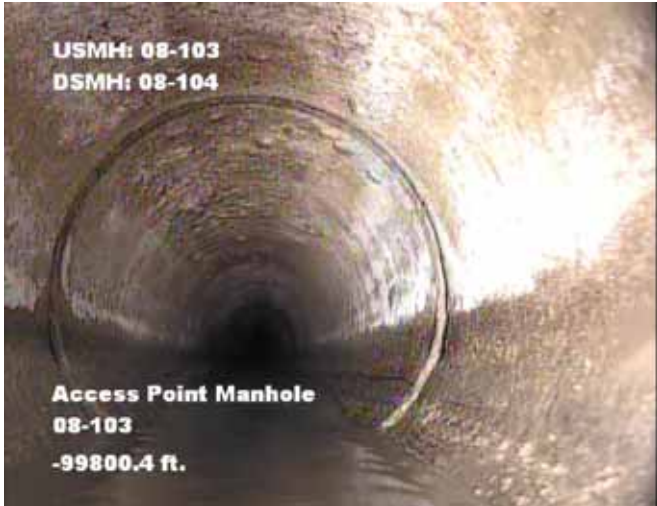
Distance: 0.0 ft. Grade: 0
Condition: Access Point Manhole
Remarks: 08-103
