APPENDIX C

CCTV Reports

Project Name:		Town of Westwood MA WE 4-9-21						
US MH	DS MH	Pipe ID	Date	Street	Material	Size	Total	Insp
08-126	08-126A	08-126_08-126A	4/8/2021	Washington Street	Asbestos Cement	6	39	39
08-127	08-127A	08-127_08-127A	4/8/2021	Washington Street	Asbestos Cement	6	36	36
08-128	08-128A	08-128_08-128A	4/8/2021	Washington Street	Asbestos Cement	6	40	40
08-129	08-129A	08-129_08-129A	4/8/2021	Washington Street	Asbestos Cement	6	40	40

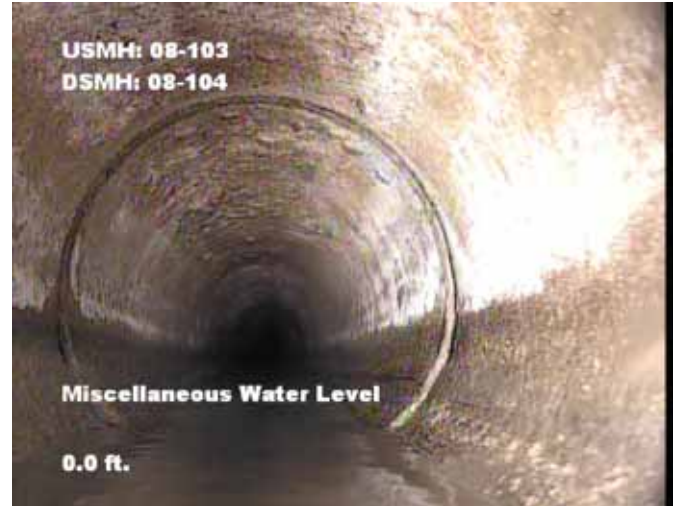
Distance: 0.0 ft. Grade: 0
Condition: Miscellaneous Water Level
Remarks: N/A

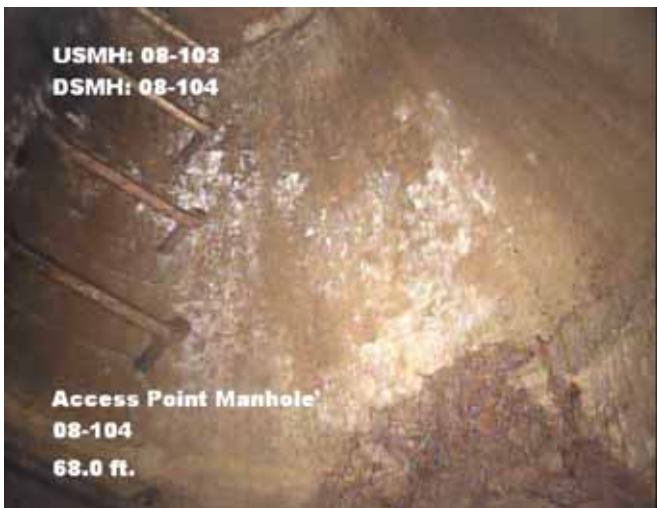
Distance: 68.0 ft. Grade: 0
Condition: Access Point Manhole
Remarks: 08-104

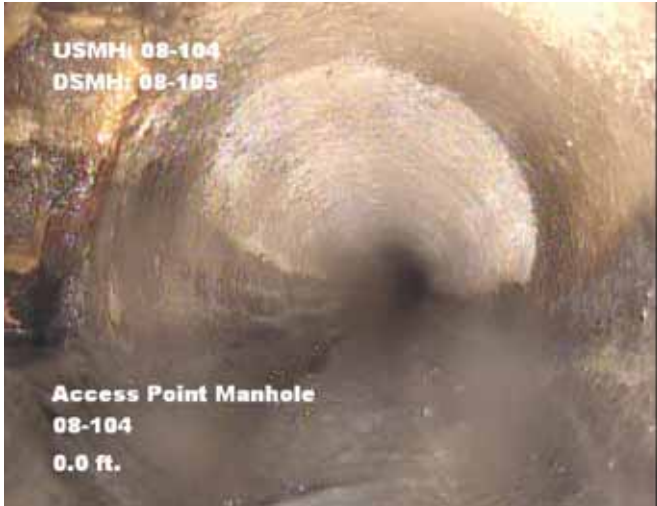
Distance: 0.0 ft. Grade: 0
Condition: Access Point Manhole
Remarks: 08-104

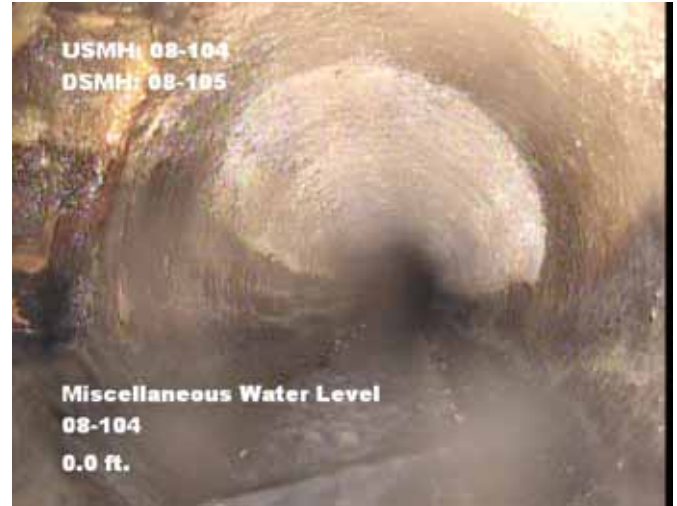
Distance: 0.0 ft. Grade: 0
Condition: Miscellaneous Water Level
Remarks: N/A

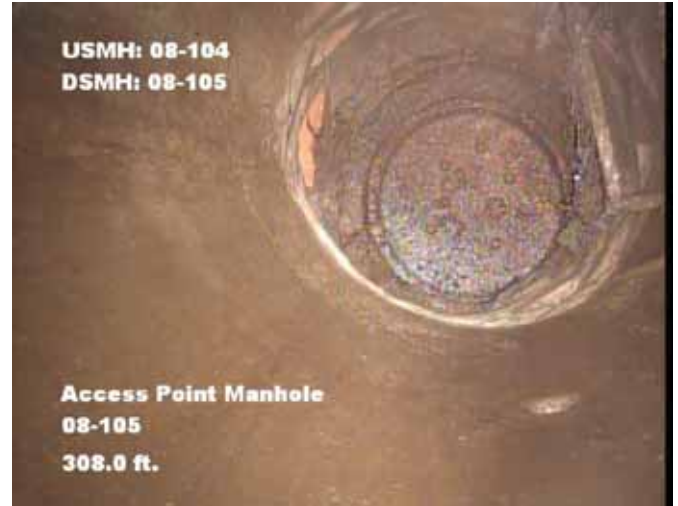
Distance: 308.0 ft. Grade: 0
Condition: Access Point Manhole
Remarks: 08-105

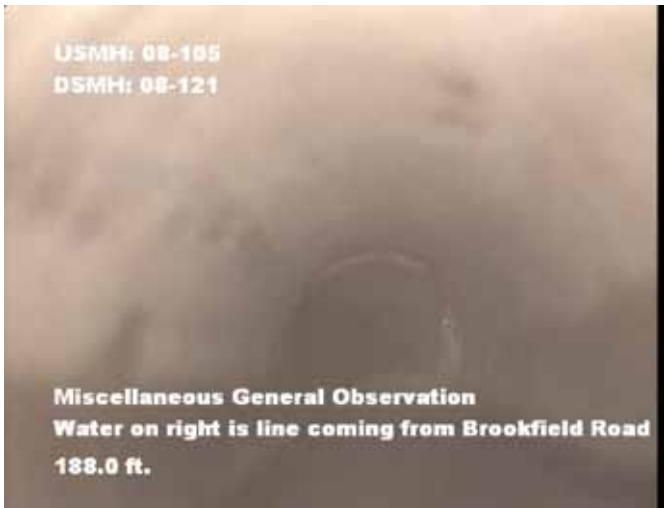
Distance: 188.0 ft. Grade: 0
 Condition: Miscellaneous General Observation
 Remarks: Water on right is line coming from Brookfield Road

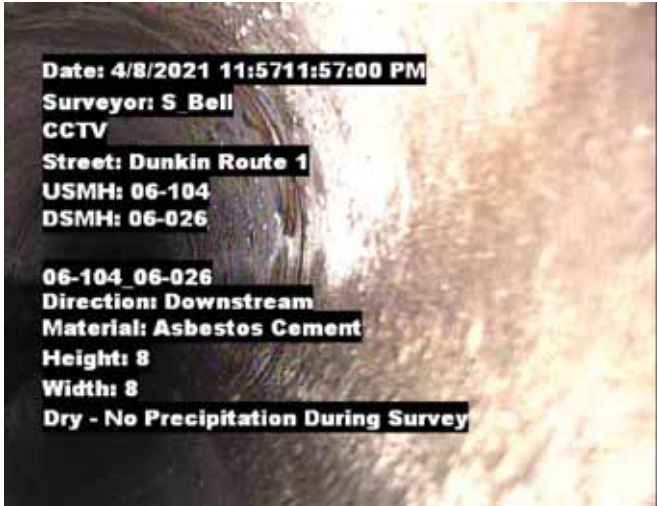
Distance: 0.0 ft. Grade: 0
Condition: Access Point Manhole
Remarks: 06-104

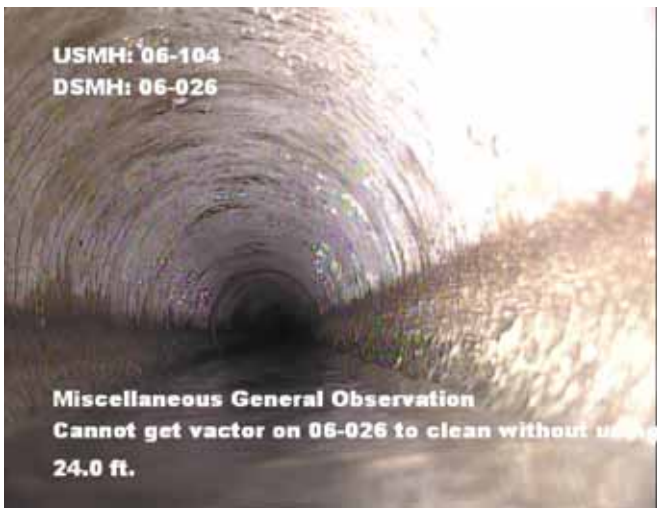
Distance: 24.0 ft. Grade: 0
Condition: Miscellaneous General Observation
Remarks: Cannot get vector on 06-026 to clean without using flex hose.

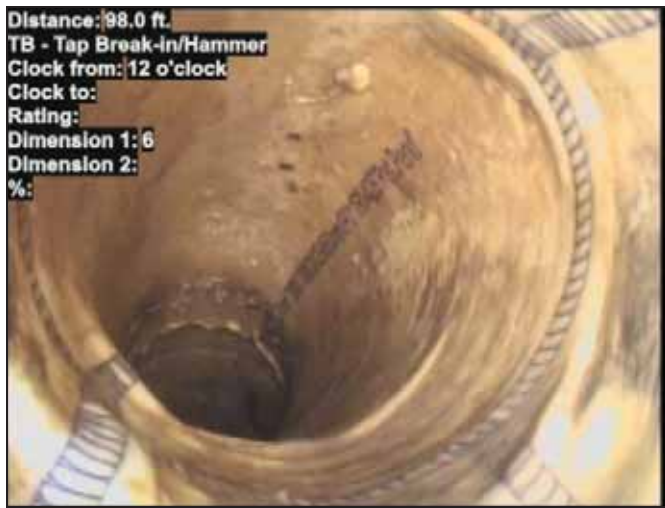
Photo: 10_078-10_079-04292020-TB-98.0 ft.-121541.JPG

Distance: 98.0 ft.
TB - Tap Break-in/Hammer
Clock from: 12 o'clock
Clock to:
Rating:
Dimension 1: 6
Dimension 2:
%:

At: 98.022 ft. TB - Tap Break-in/Hammer
12/.

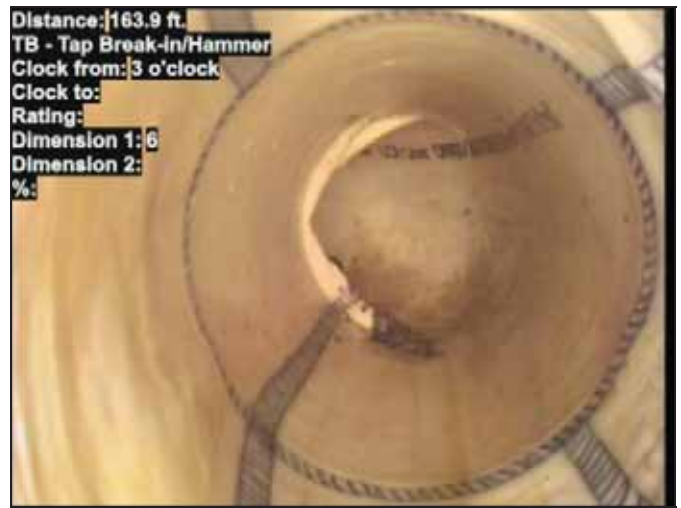
Photo: 10_078-10_079-04292020-TB-163.9 ft.-121825.JPG

Distance: 163.9 ft.
TB - Tap Break-in/Hammer
Clock from: 3 o'clock
Clock to:
Rating:
Dimension 1: 6
Dimension 2:
%:

At: 163.897 ft. TB - Tap Break-in/Hammer
3/.

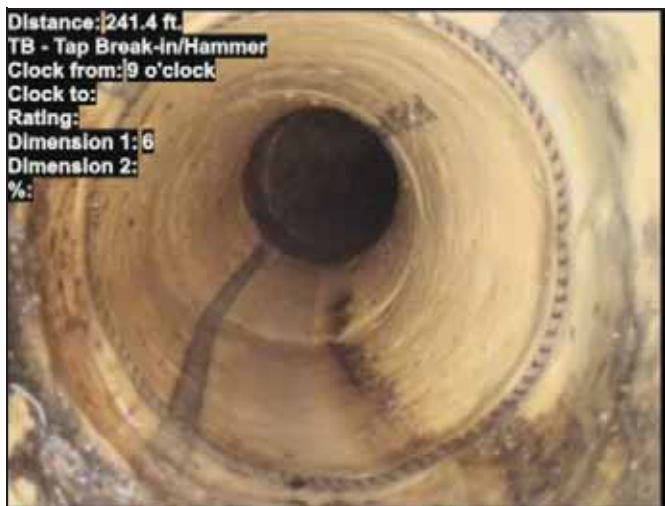
Photo: 10_078-10_079-04292020-TB-241.4 ft.-122047.JPG

Distance: 241.4 ft.
TB - Tap Break-in/Hammer
Clock from: 9 o'clock
Clock to:
Rating:
Dimension 1: 6
Dimension 2:
%:

At: 241.444 ft. TB - Tap Break-in/Hammer
9/.

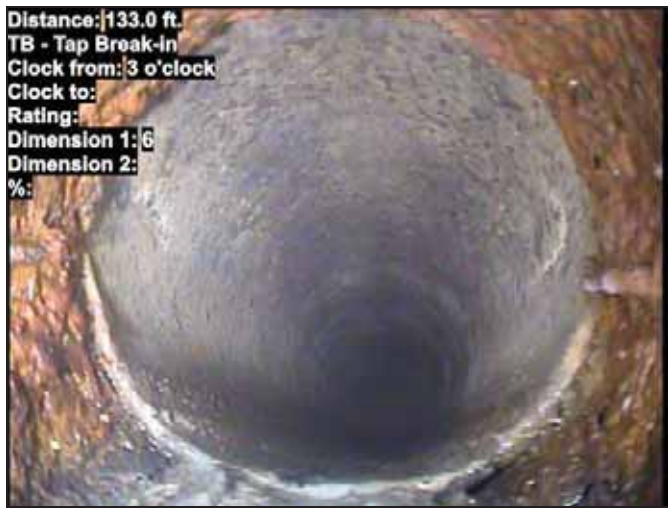
Distance: 133.0 ft.
TB - Tap Break-in
Clock from: 3 o'clock
Clock to:
Rating:
Dimension 1: 6
Dimension 2:
%:

Photo: 14_070-14_071-20181116-115834.JPG
At: 133 ft. 3/. TB - Tap Break-in
Joint: No

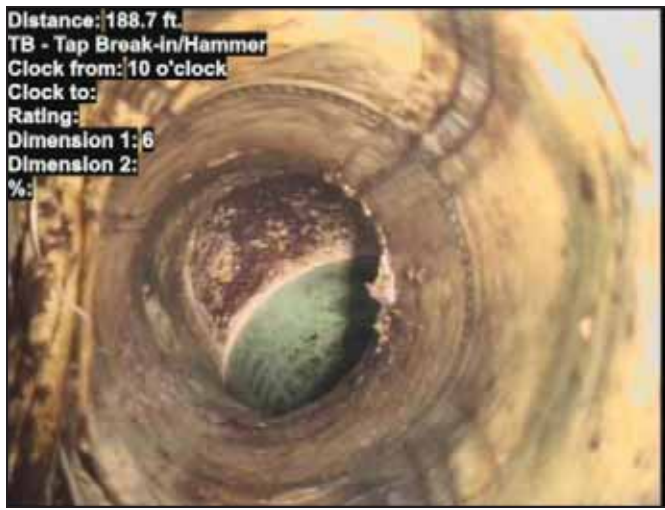
Distance: 188.7 ft.
TB - Tap Break-in/Hammer
Clock from: 10 o'clock
Clock to:
Rating:
Dimension 1: 6
Dimension 2:
%:

Photo: 16_067-16_068-04302020-TB-188.7 ft.-112529.JPG

At: 188.724 ft. TB - Tap Break-in/Hammer
10/.
